Loss of an Iridium-192 Source and  
Therapy Misadministration at  
Indiana Regional Cancer Center  
Indiana, Pennsylvania, on  
November 16, 1992

Manuscript Completed: February 1993  
Date Published: February 1993

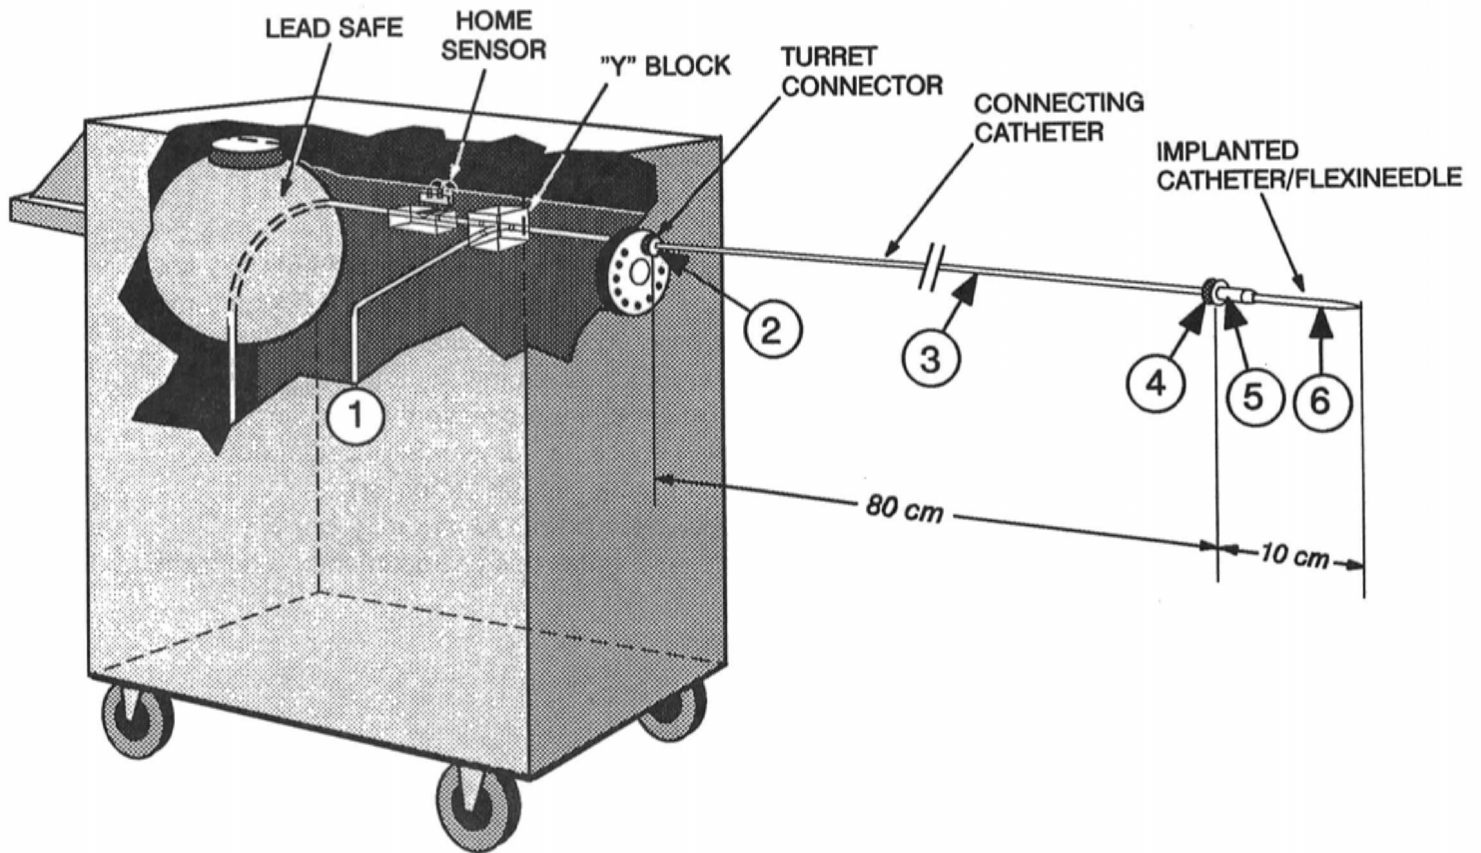
Figure 4.1 Source Wire – Possible Failure Areas

- ① Inside HDR Afterloader
- ② Turret connection (catheter connection)
- ③ Connecting catheter (teflon tube)
- ④ Connecting catheter connector
- ⑤ Flexineedle catheter connector
- ⑥ Flexineedle catheter

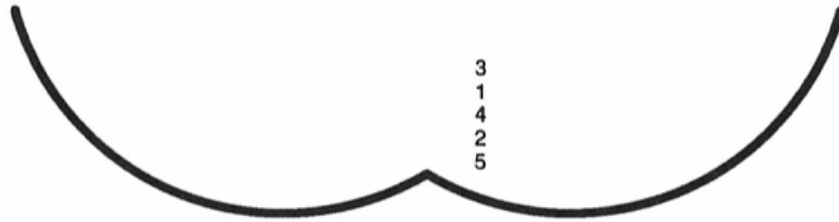
Figure 7.1 Treatment Plan Catheter Location

Numbers represent placement of implanted catheters within the patient and correspond to the treatment channel number indicated on the turret head.

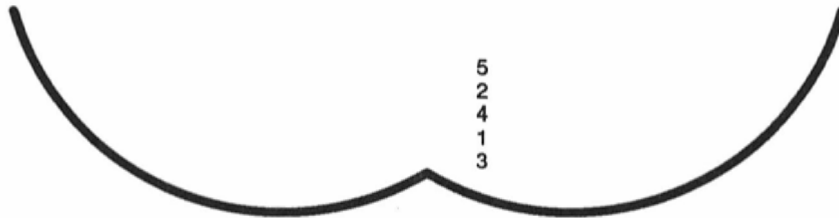
Figure 7.2 Actual Catheter Location

Numbers represent placement of implanted catheters within the patient and correspond to the treatment channel number indicated on the turret head.
