**NUCLEAR REGULATORY COMMISSION**

Title: Advisory Committee on Reactor Safeguards  
504th Meeting

Date: Friday, July 11, 2003

10 MEMBER SIEBER: You have basically three  
11 documents in front of you, one of which is a drawing  
12 of a bottom penetration and a set of slides for the  
13 South Texas Project, Unit One, bottom-mounted  
14 instrumentation nozzle leakage issue.

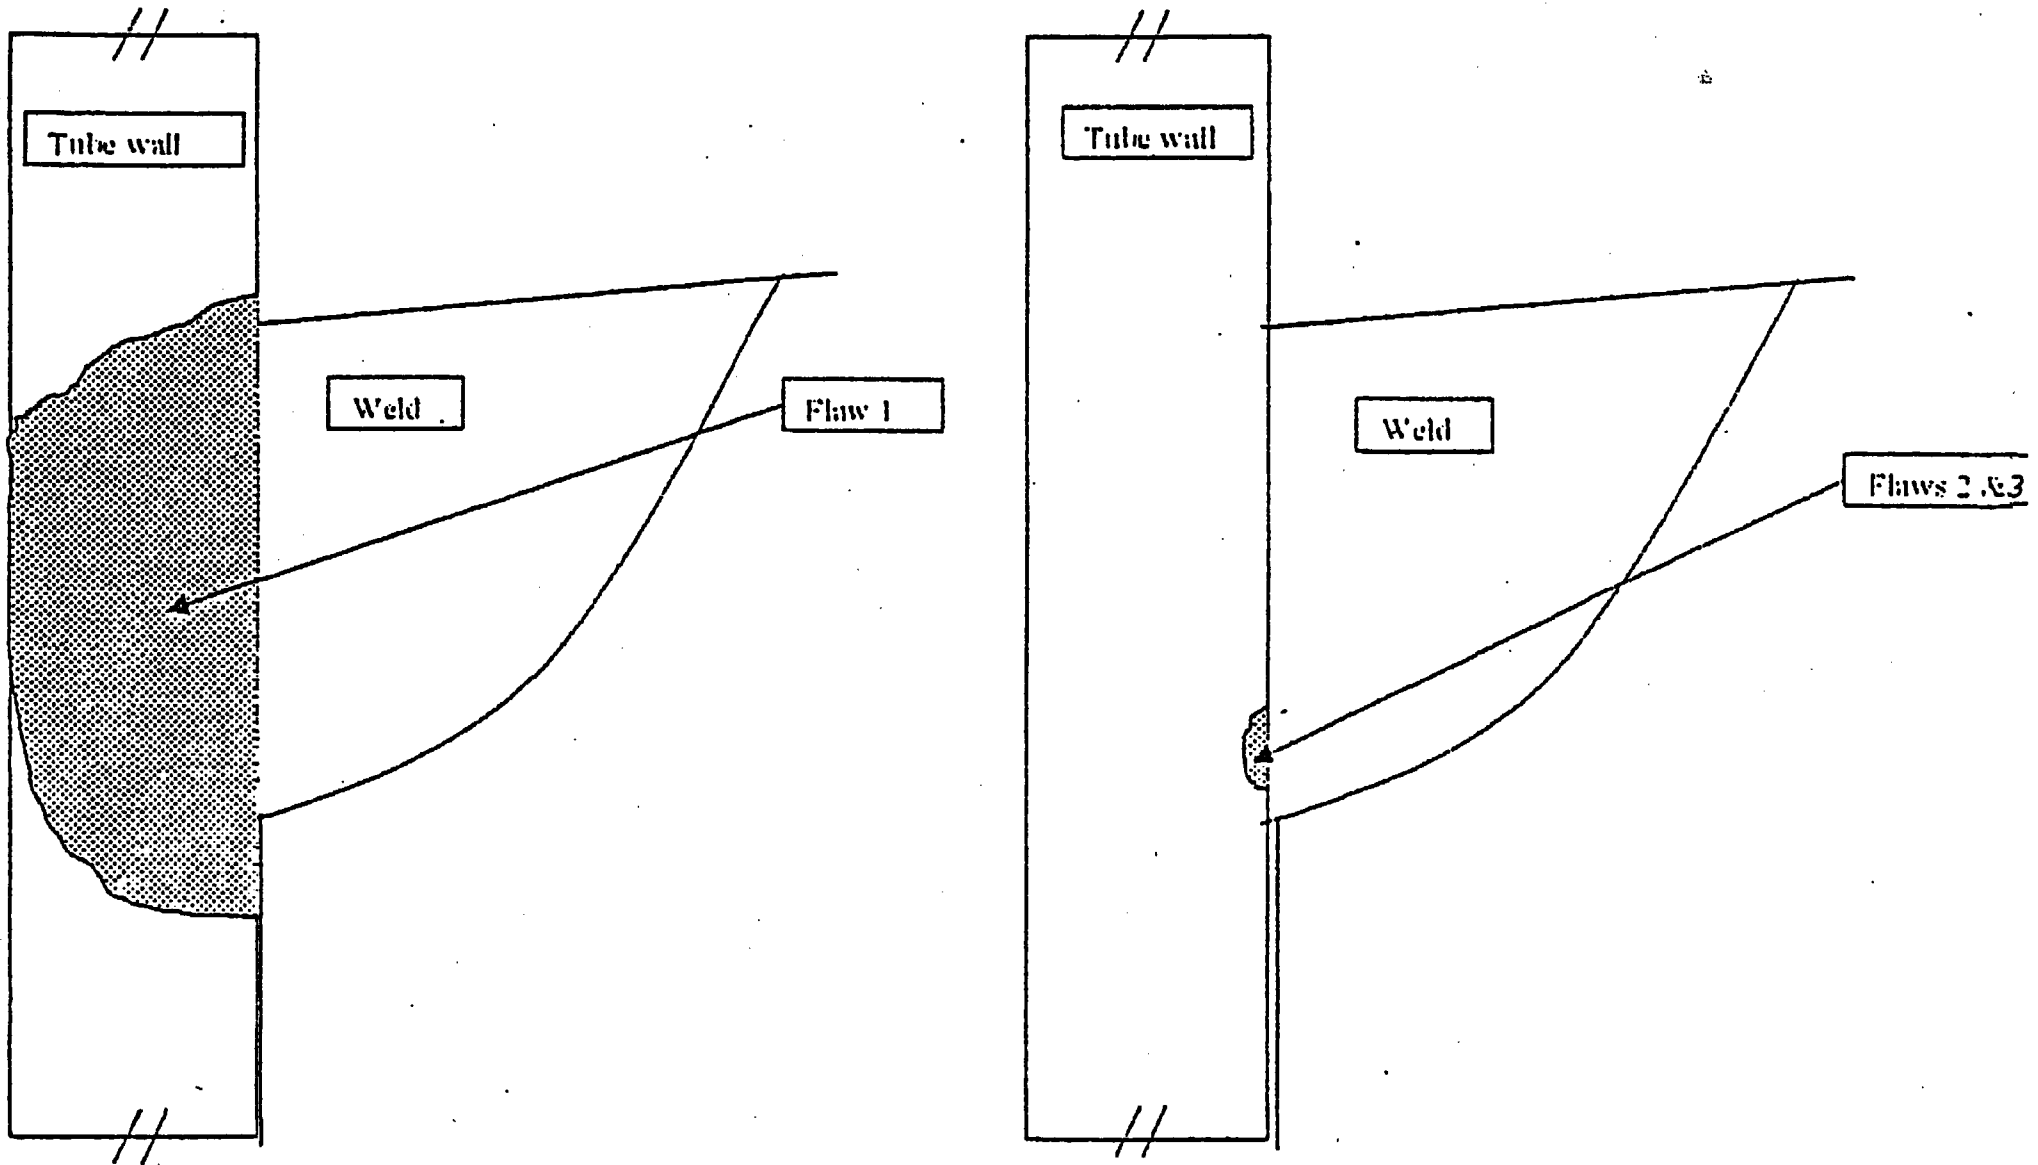
# Penetration #1

9 MR. MITCHELL: So in April of 2003, the  
10 licensee performed their bare metal visual examination  
11 and noted deposits around penetrations one and forty-  
12 six totaling about the size of one-half of an aspirin  
13 tablet. Subsequent chemical analysis showed evidence  
14 of both boron and lithium, lithium being particularly  
15 interesting and giving evidence that the source of the  
16 deposits was reactor coolant system leakage, or the  
17 most likely source. Subsequent radiochemical isotope  
18 dating indicated that the deposits, or the water that  
19 led to the deposits, had been out of the reactor for  
20 approximately four years.

15 CHAIRMAN BONACA: The question I had was  
16 that, looking at the figure on penetration one, that  
17 shows significant opening through the wall. I'm  
18 surprised that the leakage was so minor if I look at  
19 flaw No. 1.

16 Very briefly, the licensee has repaired  
17 the two nozzles on Unit One. They have employed what  
18 I think the Committee is familiar with: half-nozzle  
19 repair techniques where they have sectioned the  
20 nozzle, removed the outer part of the old nozzle,  
21 installed a new Alloy 690 tube, and welded it in this  
22 case to the outside surface of the reactor vessel head  
23 using a tempered pad also as part of the fabrication  
24 process.

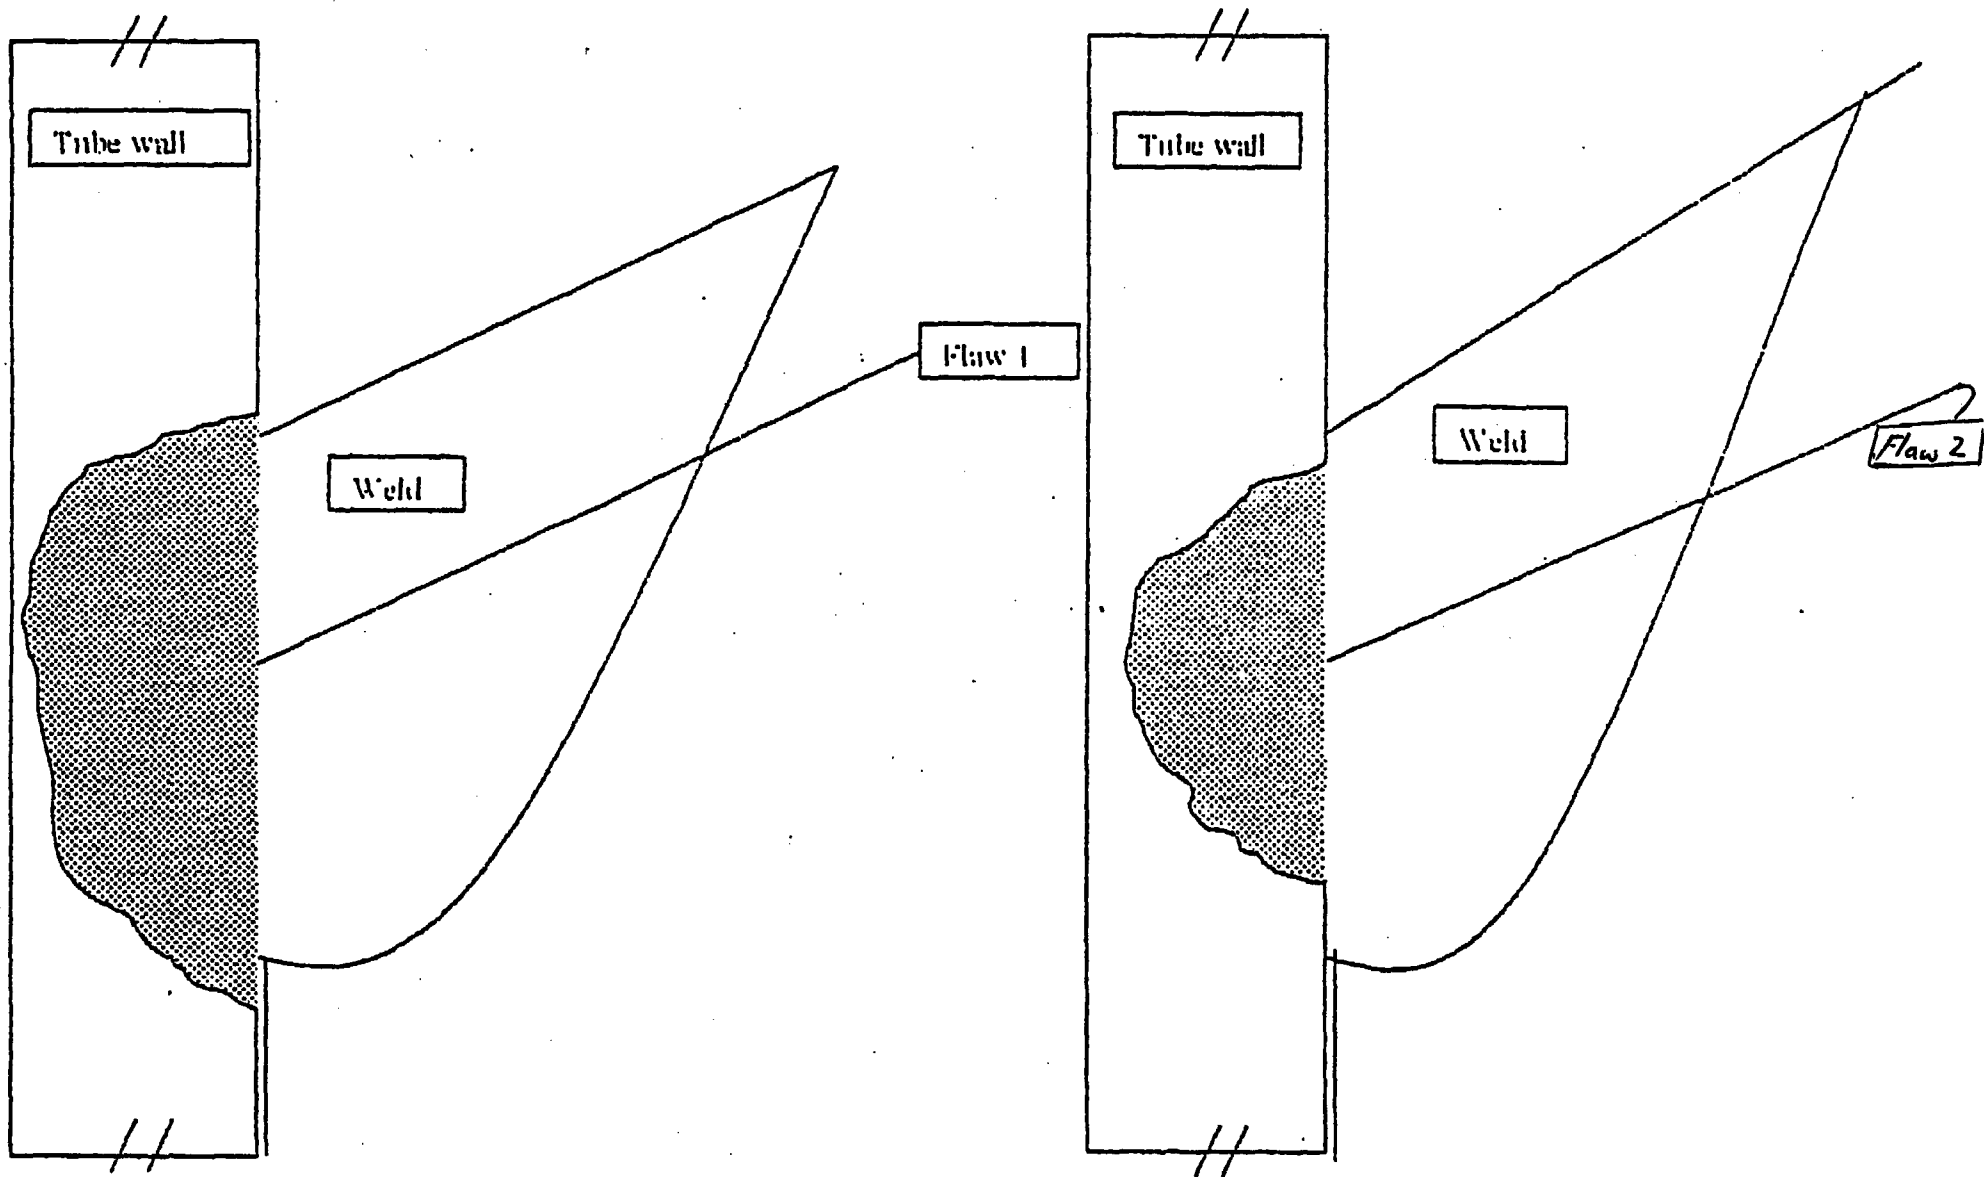
# Penetration #46

1 very typical, in particular, of penetration 46 at  
2 South Texas, one of the ones that did show signs of  
3 leakage, because of the sort of the hillside slope to  
4 the vessel that's depicted here.

13 MR. MITCHELL: The large embedded, what  
14 appears to be an embedded flaw in forty-six at this  
15 point defies a good rationalization. The licensee  
16 certainly is looking at option two on this particular  
17 viewgraph regarding cracking which may have been  
18 initiated at discontinuities within the weld, welding  
19 fabrication defects, lack of fusion, which were  
20 evident in penetrations one and forty-six. The zero-  
21 degree UT probe, in particular, showed evidence of  
22 these spots within the weld which are believed to be  
23 a welding defect, which may have served as an  
24 initiation location for cracking.
