Steam Generator Tube Integrity Program

Semiannual Report
October 1998 – March 1999

Argonne National Laboratory

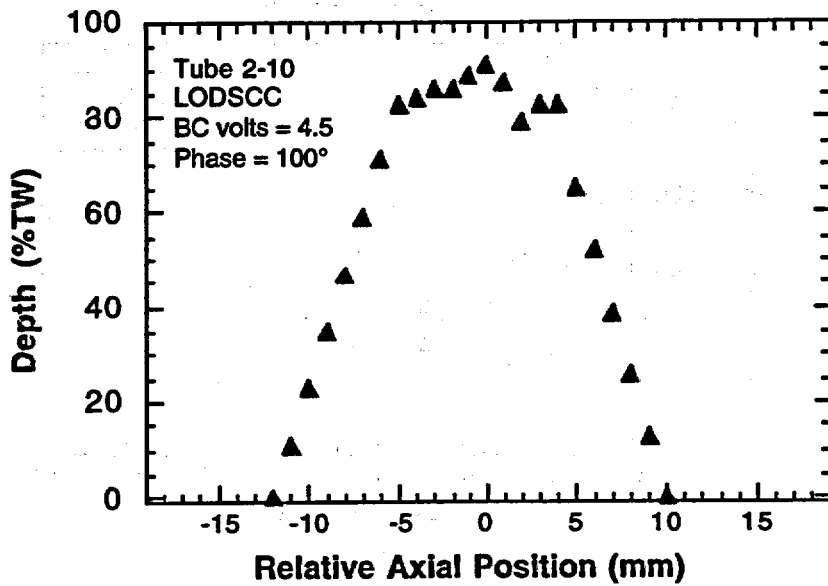
Fig. 2.5. Depth profile for Tube 2-10 containing single axial ODSCC grown under laboratory conditions using doped steam.

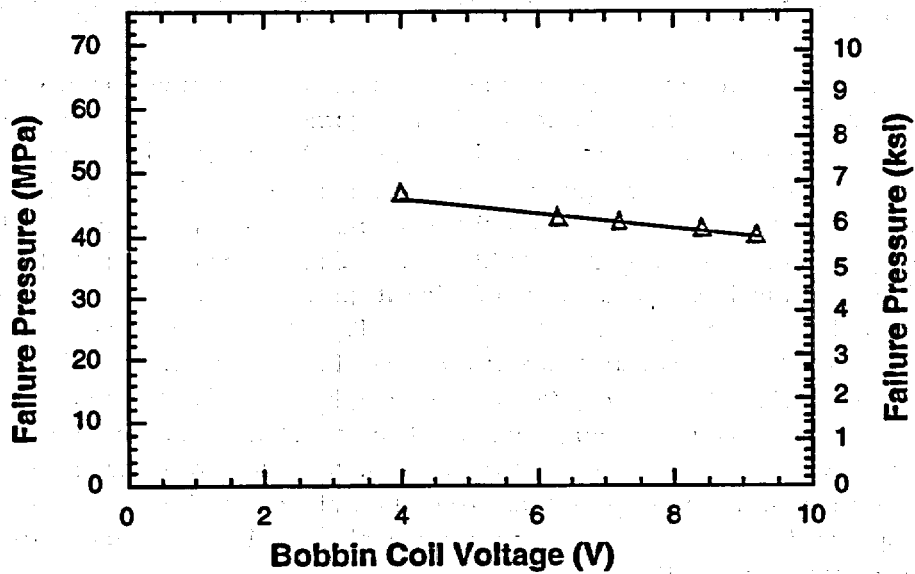
Fig. 2.6. Predicted failure pressure vs. BC voltage for five ANL-grown SCCs highlighted in Table 2. Estimated failure pressure is from alternate plugging criteria voltage-burst-pressure model for axial ODSCC at TSP.

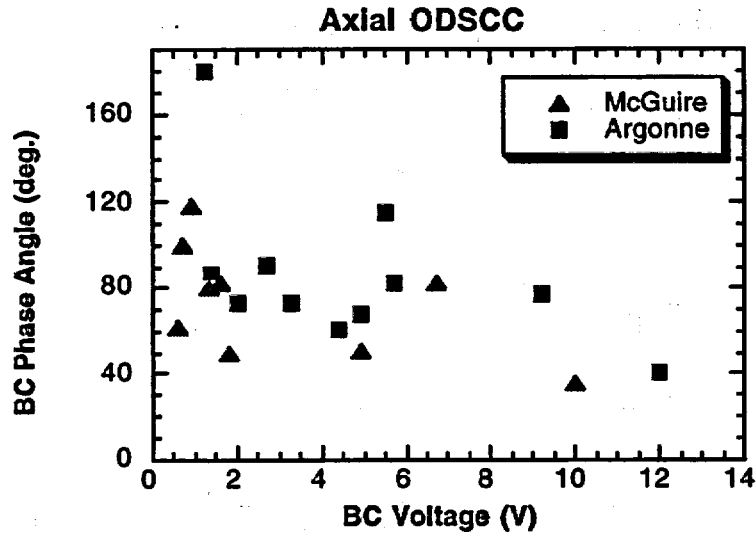
Fig. 2.7. Comparison of McGuire steam generator D BC voltages and phase from axial ODSCCs at tube support plates to voltages and phase from ANL-produced axial ODSCC. Ranges of plots are comparable.

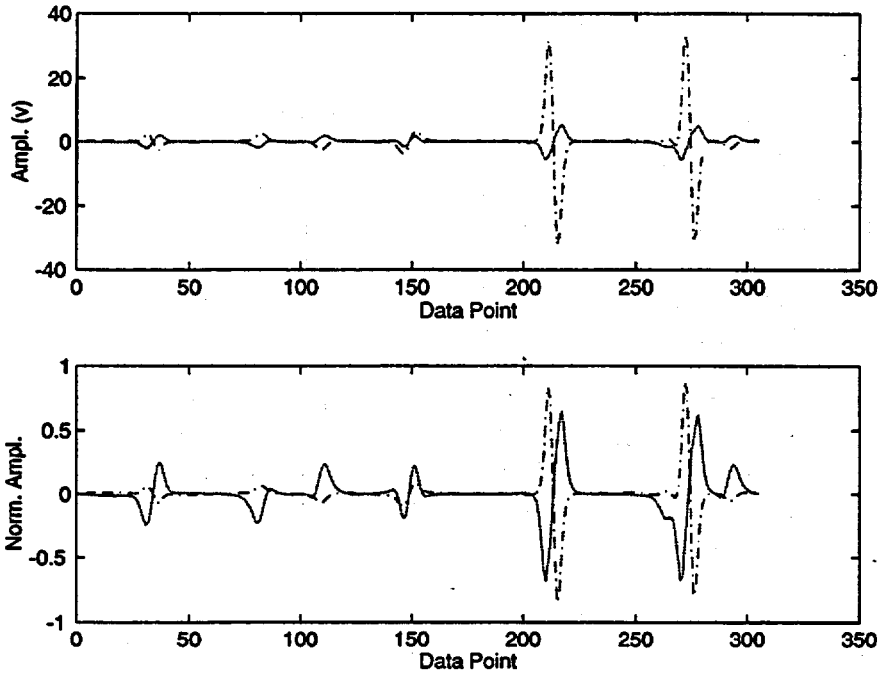
Fig. 3.1. *Differential BC horizontal and vertical signal components of calibrated original (top) and renormalized (bottom) traces at $f = 400$ kHz. Simulated indications from left to right consist of throughwall drilled hole, TSP ring, 10% OD and 20% ID circumferential grooves, and composite (of last three indications) signal.*

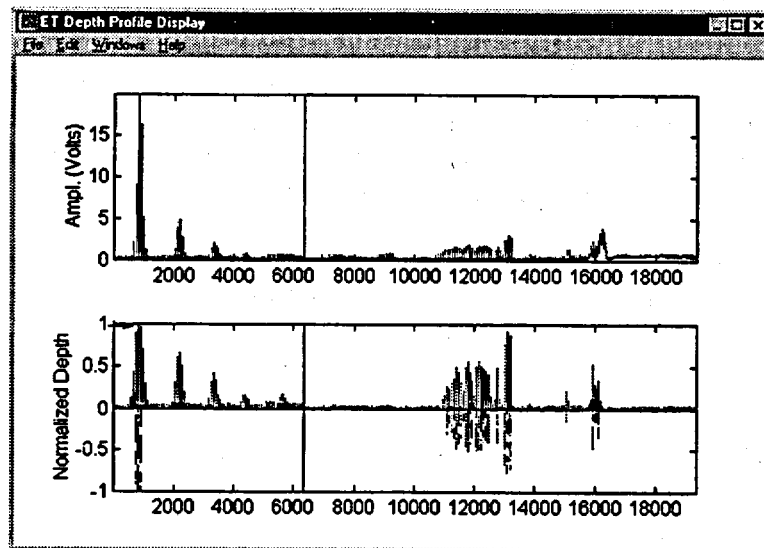
Fig. 3.8. Output of data analysis tool for roll-expanded specimen #1-03 that was destructively identified as having 43% (max. depth) CIDSCC degradation. Traces show calibrated amplitude in volts (top), and normalized multifrequency depth profile (bottom) of notch standard (left) followed by sample tube, suggesting $\approx 40-60\%$ range of degradation depth around scan locations 1.3×10^4 and 1.6×10^4 . Eddy current readings are from 2.92 mm (0.115 in.) pancake of three-coil rotating probe.

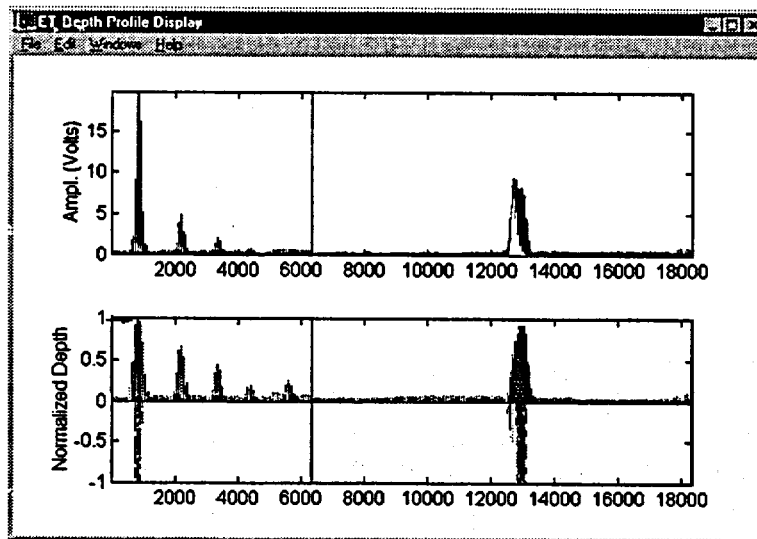
Fig. 3.9. Output of data analysis tool for roll-expanded specimen #1-11 that was destructively identified as having 100% (max. depth) LIDSCC degradation. Traces show calibrated amplitude in volts (top), and normalized multifrequency depth profile (bottom) of notch standard (left) followed by sample tube, suggesting $>80\%$ degradation depth around scan location 1.3×10^4 . Eddy current readings are from 2.92 mm (0.115 in.) pancake of three-coil rotating probe.

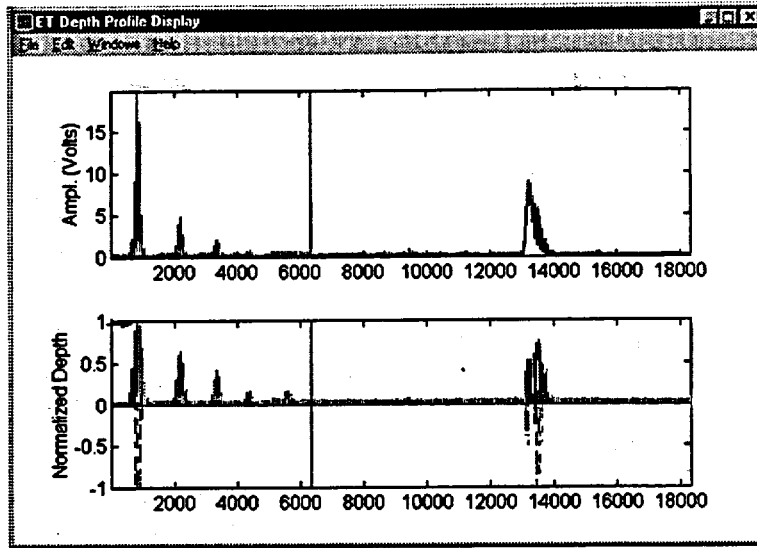
Fig. 3.10. Output of data analysis tool for roll-expanded specimen #1-19 that was destructively identified as having 100% (max. depth) LIDSCC degradation. Traces show calibrated amplitude in volts (top), and normalized multifrequency depth profile (bottom) of notch standard (left) followed by sample tube, suggesting >80% degradation depth around scan location 1.4×10^4 . Eddy current readings are from 2.92 mm (0.115 in.) pancake of three-coil rotating probe.

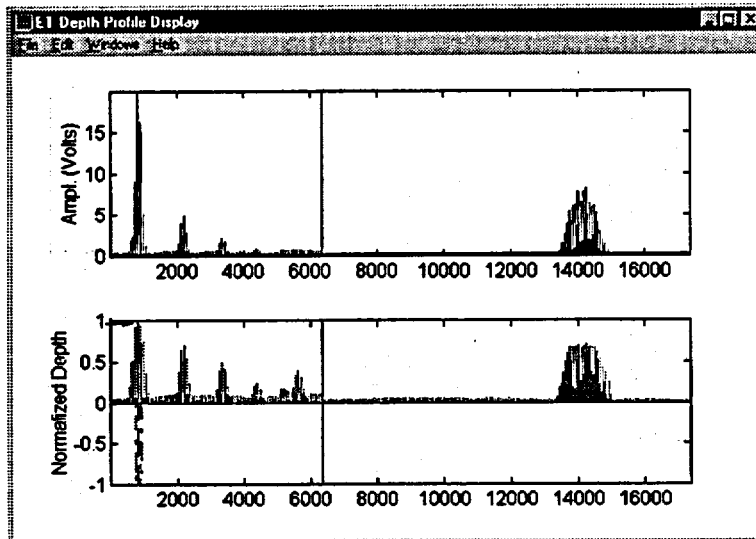
Fig. 3.11. Output of data analysis tool for roll-expanded specimen #2-06 that was destructively identified as having 100% (max. depth) LODSCC degradation. Traces show calibrated amplitude in volts (top), and normalized multifrequency depth profile (bottom) of notch standard (left) followed by sample tube, suggesting >80% degradation depth around scan location 1.4×10^4 . Eddy current readings are from 2.92 mm (0.115 in.) pancake of three-coil rotating probe.

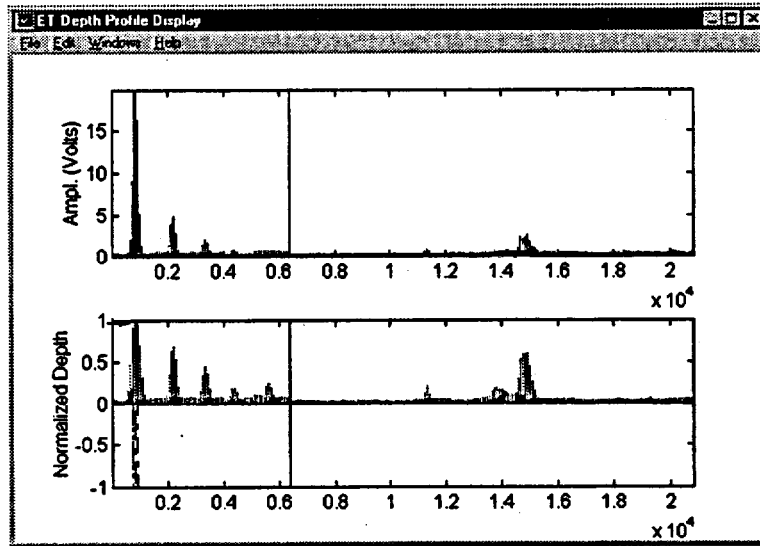
Fig. 3.12. Output of data analysis tool for specimen #2-11 that was destructively identified as having 95% (max. depth at a single point with all other indications marked <38%) LODSCC degradation. Traces show calibrated amplitude in volts (top), and normalized multifrequency depth profile (bottom) of notch standard (left) followed by sample tube, suggesting 60-80% range of degradation depth around scan location 1.5×10^4 . Eddy current readings are from 2.92 mm (0.115 in.) pancake of three-coil rotating probe.

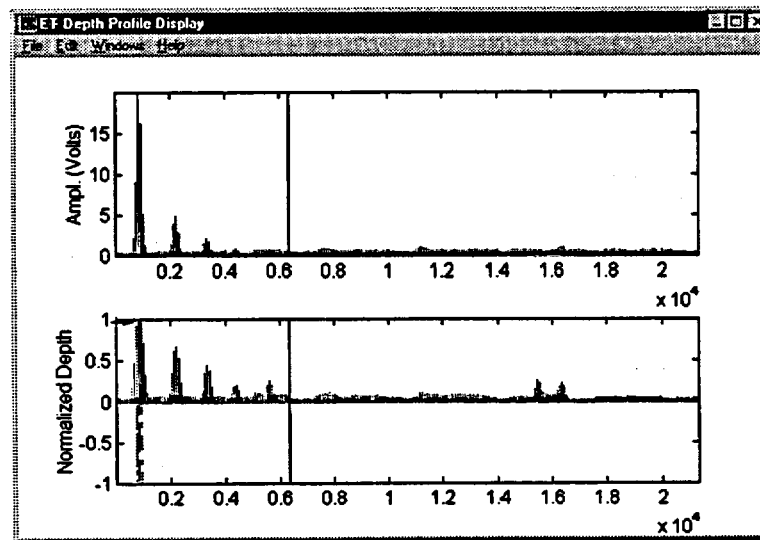
Fig. 3.13. Output of data analysis tool for specimen #2-19 that was destructively identified as having 46% (max. depth) LODSCC degradation. Traces show calibrated amplitude in volts (top), and normalized multifrequency depth profile (bottom) of notch standard (left) followed by sample tube, suggesting 20-40% range of degradation depth around scan location 1.6×10^4 . Eddy current readings are from 2.92 mm (0.115 in.) pancake of three-coil rotating probe.

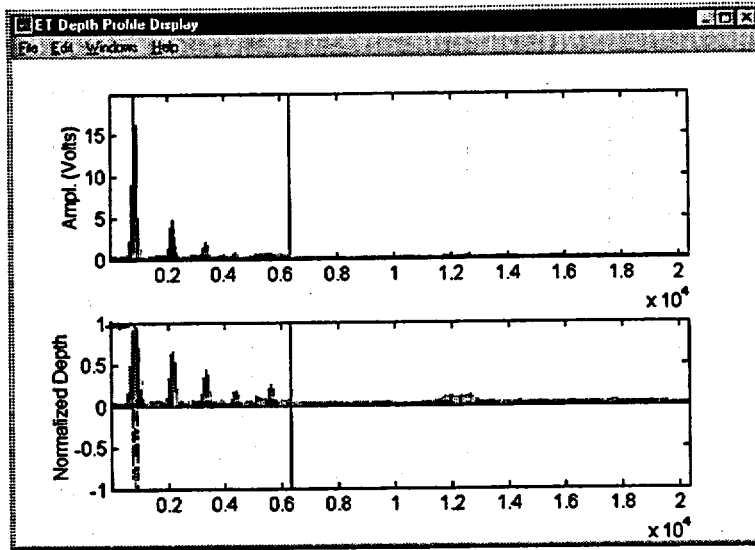
Fig. 3.14. Output of data analysis tool for specimen #2-20 that was destructively identified as having 16% (max. depth) LODSCC degradation. Traces show calibrated amplitude in volts (top), and normalized multifrequency depth profile (bottom) of notch standard (left) followed by sample tube, suggesting <20% range of degradation depth around scan location 1.2×10^4 . Eddy current readings are from 2.92 mm (0.115 in.) pancake of three-coil rotating probe.

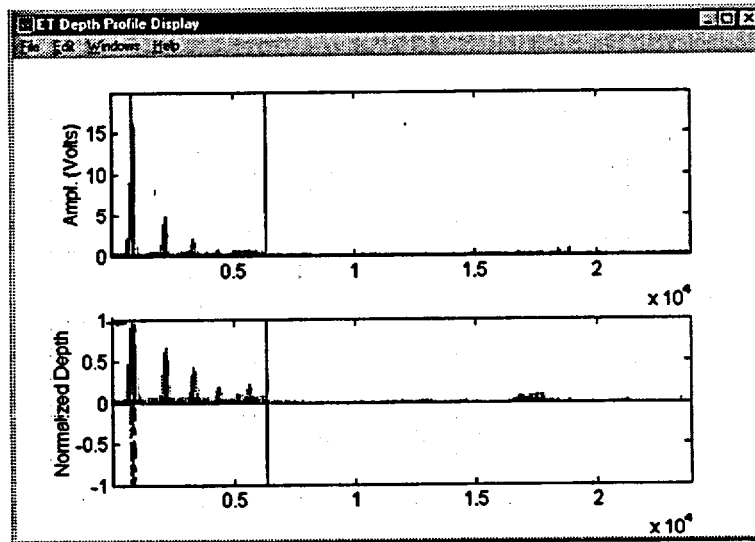
Fig. 3.15. Output of data analysis tool for specimen #2-21 that was destructively identified as having 30% (max. depth) LODSCC degradation. Traces show calibrated amplitude in volts (top), and normalized multifrequency depth profile (bottom) of notch standard (left) followed by the sample tube, suggesting <20% range of degradation depth around scan location 1.7×10^4 . Eddy current readings are from 2.92 mm (0.115 in.) pancake of three-coil rotating probe.

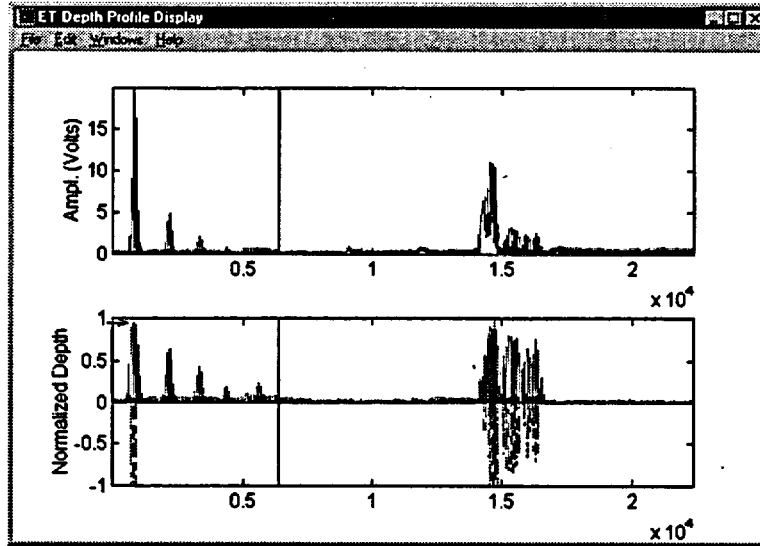
Fig. 3.16. Output of data analysis tool for roll-expanded specimen #3-05 that was destructively identified as having $\approx 70\%$ (max. depth) CIDSCC degradation. Traces show calibrated amplitude in volts (top), and normalized multifrequency depth profile (bottom) of notch standard (left) followed by sample tube, suggesting $>80\%$ range of degradation depth around scan location 1.5×10^4 . Eddy current readings are from 2.92 mm (0.115 in.) pancake of three-coil rotating probe.

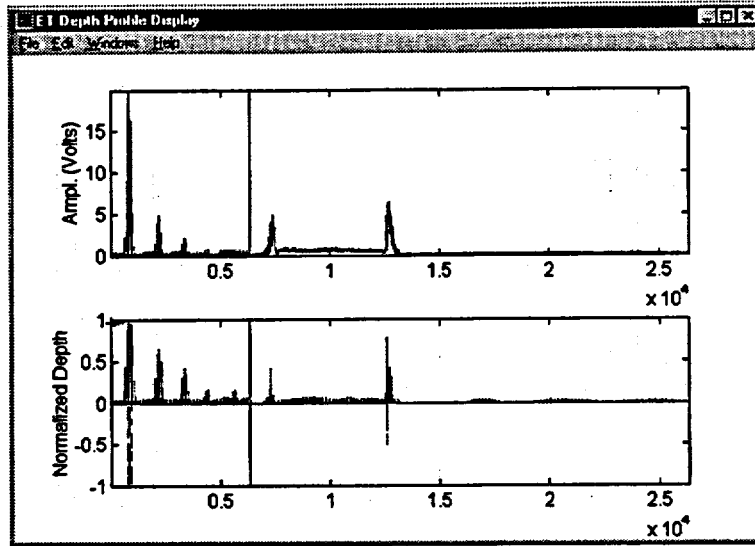
Fig. 3.18. Output of data analysis tool for roll-expanded specimen #4-01 that was destructively identified as having 83% (max. depth) CODSCC degradation. Traces show calibrated amplitude in volts (top), and normalized multifrequency depth profile (bottom) of notch standard (left) followed by sample tube, suggesting 60%-80% range of degradation depth around scan locations 0.7×10^4 and 1.25×10^4 . Eddy current readings are from 2.92 mm (0.115 in.) pancake of three-coil rotating probe.

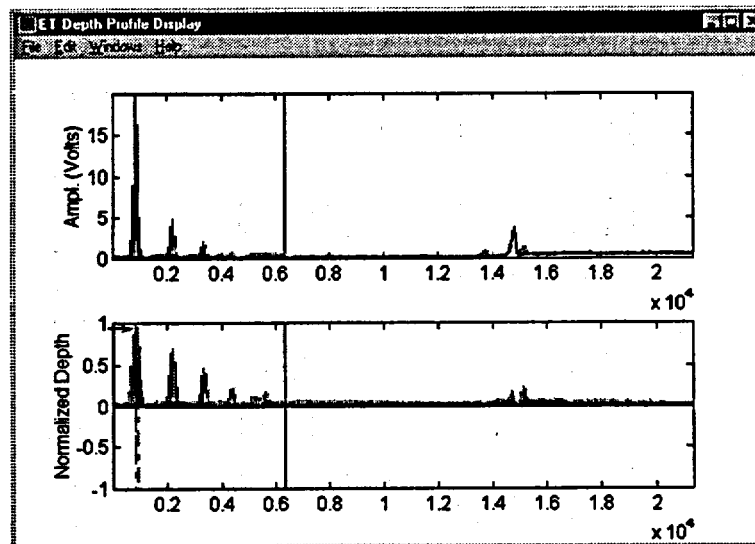
Fig. 3.19. Output of data analysis tool for roll-expanded specimen #4-04 that was destructively identified as having 64% (max. depth) CODSCC degradation. Traces show calibrated amplitude in volts (top), and normalized multifrequency depth profile (bottom) of notch standard (left) followed by sample tube, suggesting >40% range of degradation depth around scan location 1.5×10^4 . Eddy current readings are from 2.92 mm (0.115 in.) pancake of three-coil rotating probe.

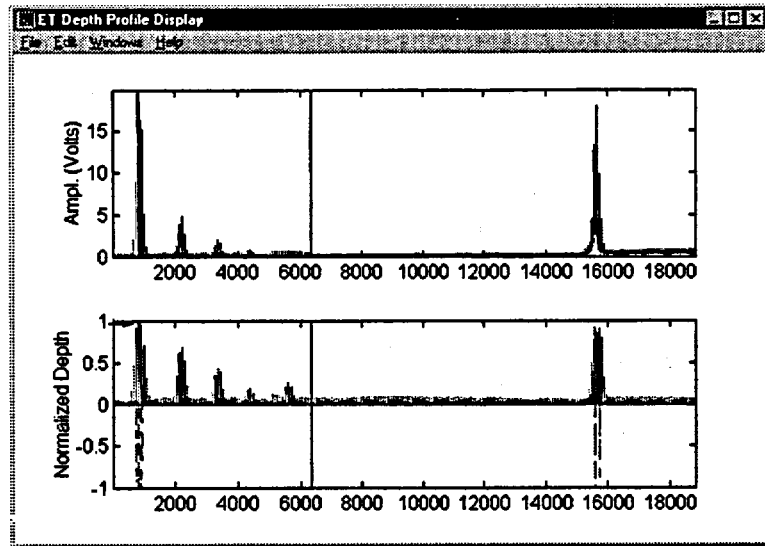
Fig. 3.20. Output of data analysis tool for roll-expanded specimen #4-06 that was destructively identified as having 100% (max. depth) CODSCC degradation. Traces show calibrated amplitude in volts (top), and normalized multifrequency depth profile (bottom) of notch standard (left) followed by sample tube, suggesting >80% range of degradation depth around scan location 1.6×10^4 . Eddy current readings are from 2.92 mm (0.115 in.) pancake of three-coil rotating probe.

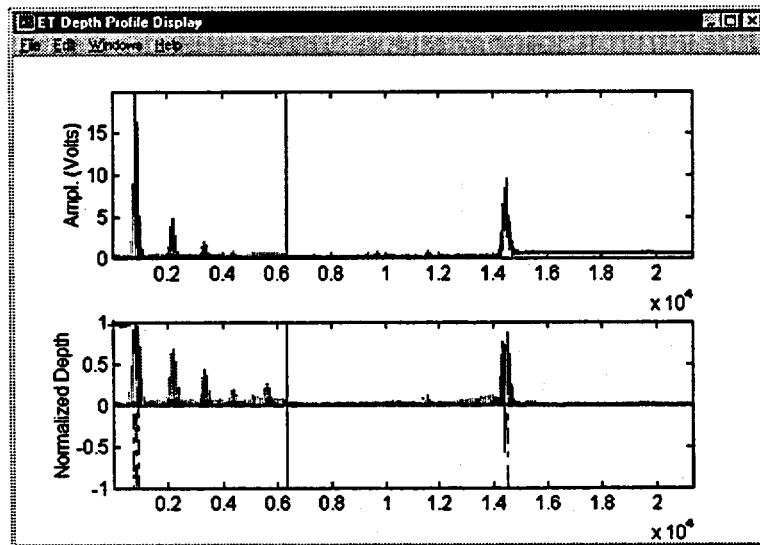
Fig. 3.21. Output of data analysis tool for roll-expanded specimen #4-10 that was destructively identified as having 100% (max. depth) CODSCC degradation. Traces show calibrated amplitude in volts (top), and normalized multifrequency depth profile (bottom) of notch standard (left) followed by sample tube, suggesting >80% range of degradation depth around scan location 1.4×10^4 . Eddy current readings are from 2.92 mm (0.115 in.) pancake of three-coil rotating probe.

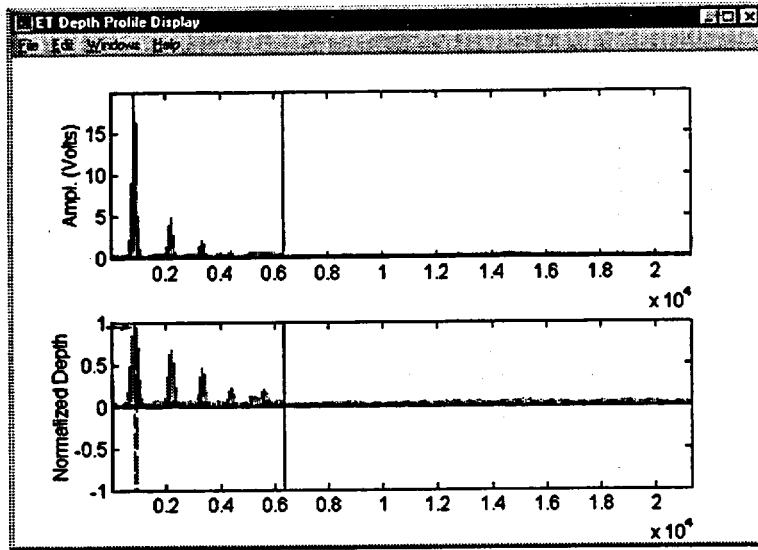
Fig. 3.22. Output of data analysis tool for roll-expanded specimen #5-02 that was destructively identified as having 4% (max. depth) IGA degradation. Traces show calibrated amplitude in volts (top), and normalized multifrequency depth profile (bottom) of notch standard (left) followed by sample tube, suggesting no detectable degradation. Eddy current readings are from 2.92 mm (0.115 in.) pancake of three-coil rotating probe.

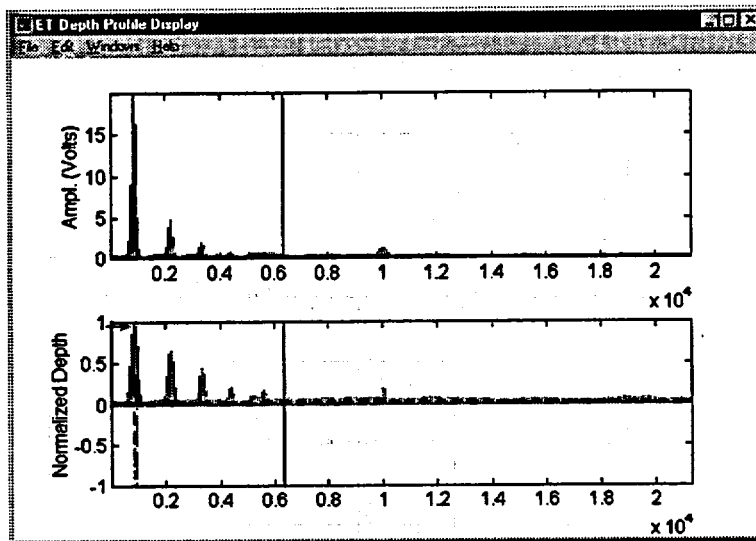
Fig. 3.23. Output of data analysis tool for roll-expanded specimen #5-03 that was destructively identified as having 5% (max. depth) IGA degradation. Traces show calibrated amplitude in volts (top), and normalized multifrequency depth profile (bottom) of notch standard (left) followed by sample tube, suggesting <20% range of degradation depth around scan location 1×10^4 . Eddy current readings are from 2.92 mm (0.115 in.) pancake of three-coil rotating probe.

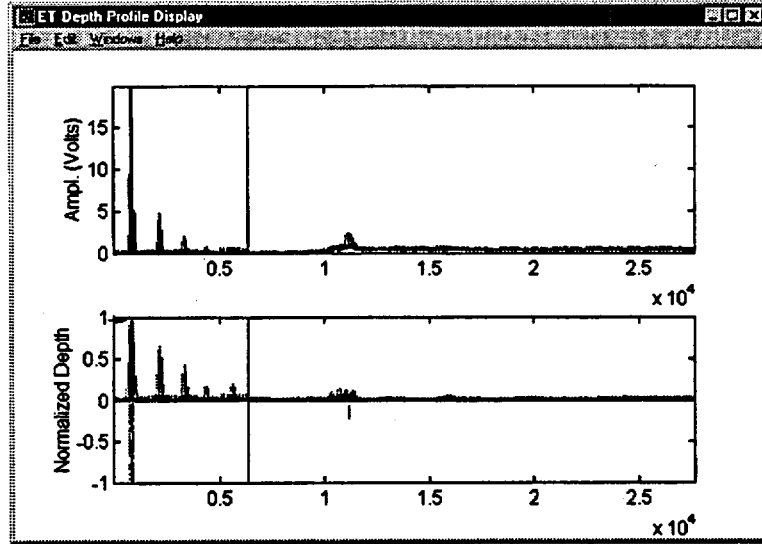
Fig. 3.24. Output of data analysis tool for roll-expanded specimen #5-04 that was destructively identified as having 24% (max. depth) IGA degradation. Traces show calibrated amplitude in volts (top), and normalized multifrequency depth profile (bottom) of notch standard (left) followed by sample tube, suggesting 20%-40% range of degradation depth around scan location 1.1×10^4 . Eddy current readings are from 2.92 mm (0.115 in.) pancake of three-coil rotating probe.

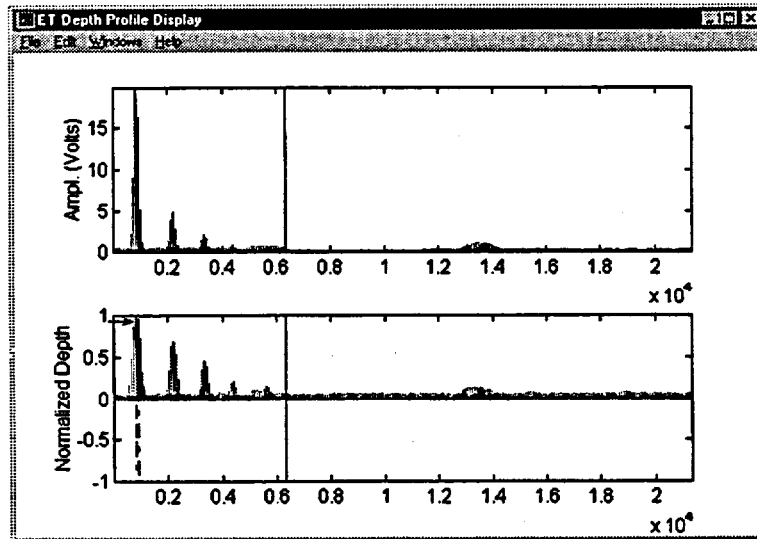
Fig. 3.25. Output of data analysis tool for roll-expanded specimen #5-09 that was destructively identified as having 43% (max. depth) IGA degradation. Traces show calibrated amplitude in volts (top), and normalized multifrequency depth profile (bottom) of notch standard (left) followed by sample tube, suggesting 20%-40% range of degradation depth around scan location 1.3×10^4 . Eddy current readings are from 2.92 mm (0.115 in.) pancake of three-coil rotating probe.

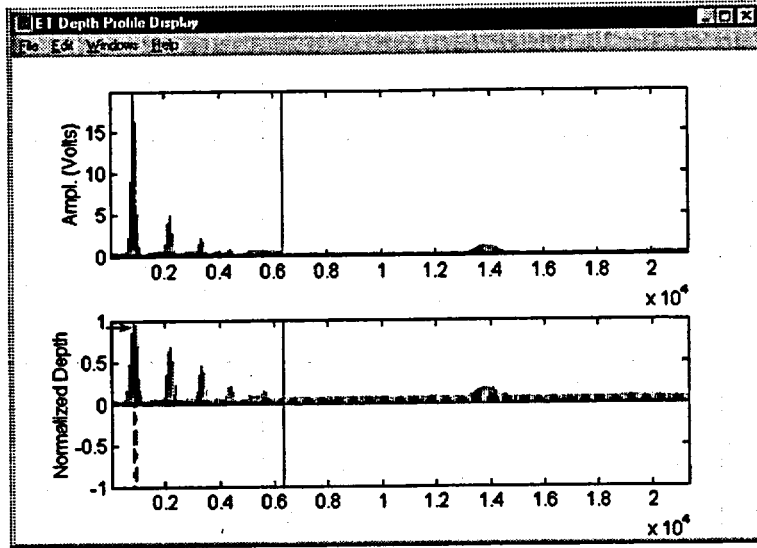
Fig. 3.26. Output of data analysis tool for roll-expanded specimen #5-25 that was destructively identified as having 66% (max. depth) IGA degradation. Traces show calibrated amplitude in volts (top), and normalized multifrequency depth profile (bottom) of notch standard (left) followed by sample tube, suggesting 20%-40% range of degradation depth around scan location 1.4×10^4 . Eddy current readings are from 2.92 mm (0.115 in.) pancake of three-coil rotating probe.

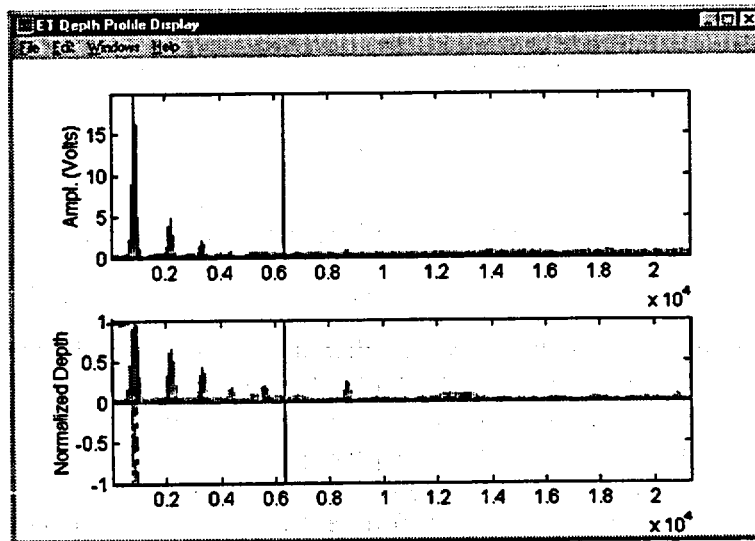
Fig. 3.27. Output of data analysis tool for roll-expanded specimen #B10-07 that was destructively identified as having 28% (max. depth) LODSCC degradation. Traces show calibrated amplitude in volts (top), and normalized multifrequency depth profile (bottom) of notch standard (left) followed by sample tube, suggesting 20-40% range of degradation depth around scan locations 0.9×10^4 and 1.3×10^4 . Eddy current readings are from 2.92 mm (0.115 in.) pancake of three-coil rotating probe.

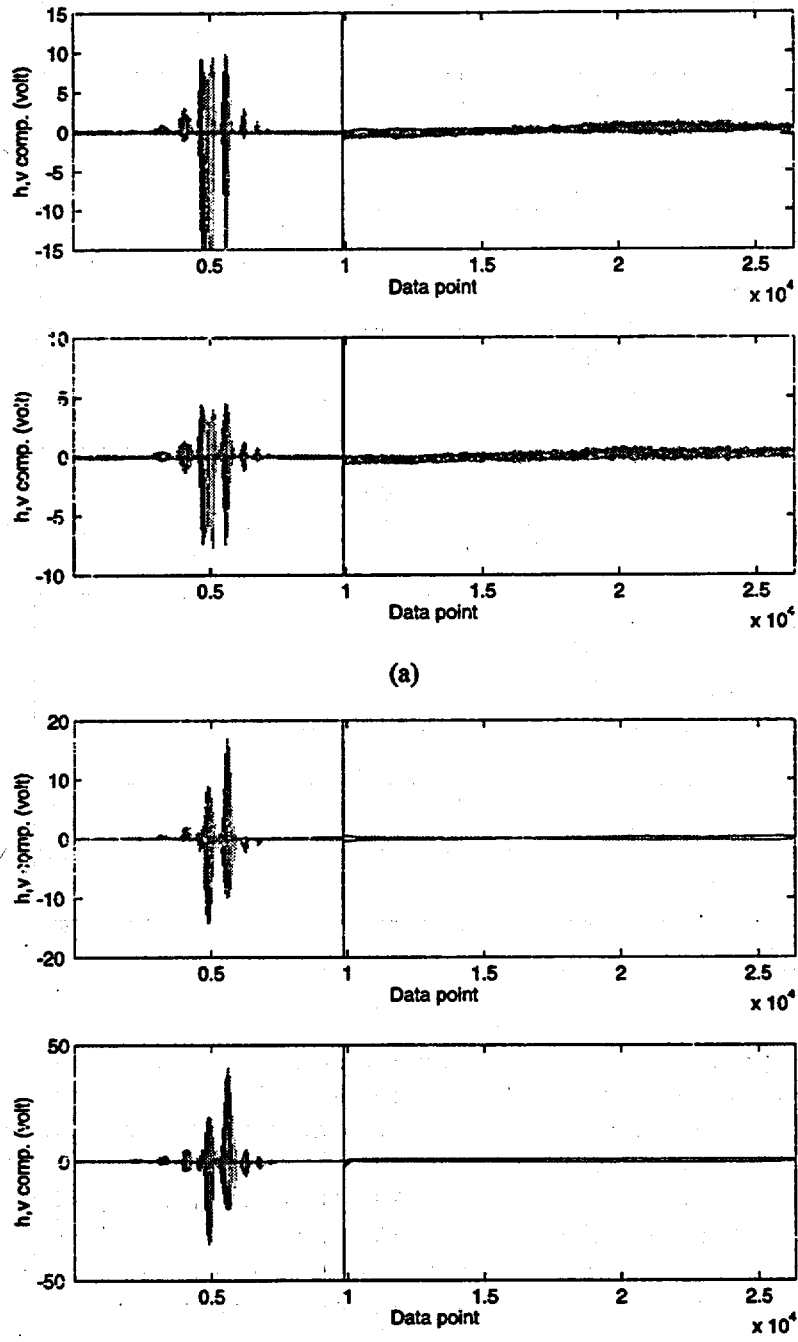
Fig. 3.29. Calibrated readings with (a) 2.92 mm (0.115-in.) pancake and (b) midrange +Point coils of three-coil rotating probe at 400 kHz (top) and 100 kHz (bottom) frequencies on 22.2-mm (0.875-in.)-diameter Alloy 600 tube. Response from 20-100% OD, 6.35-mm (0.25-in.)-long axial/circumferential EDM notches from in-line standard is shown on left; signal from test specimen SG-L432 is on right. No discernible indications are present in these traces, although a BC indication is present, as shown in Fig. 3.28.

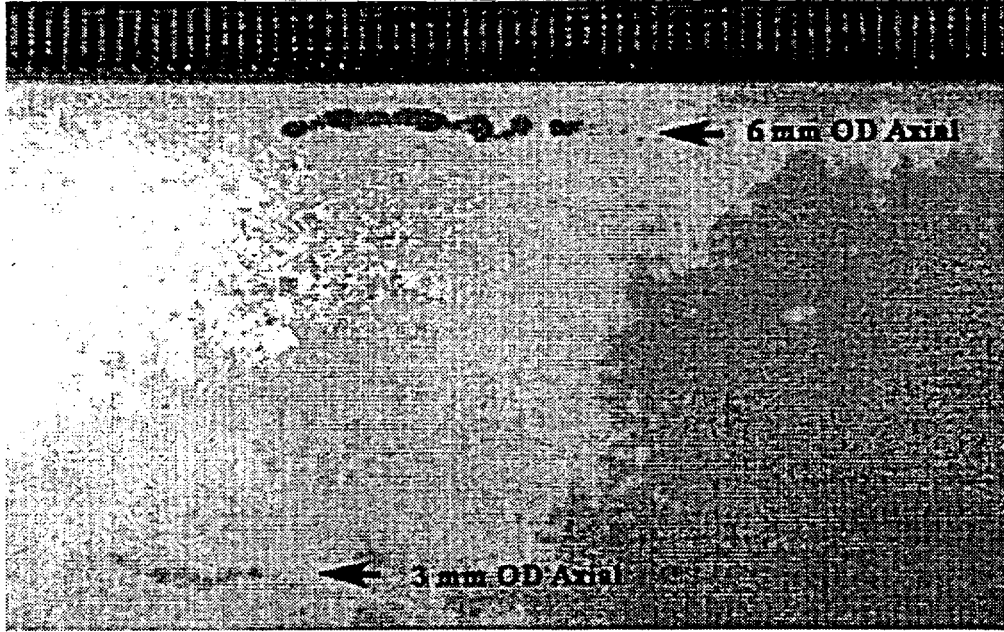
Fig. 4.1. Dye-penetrant examination of Specimen SGL288 showing two axial cracks.

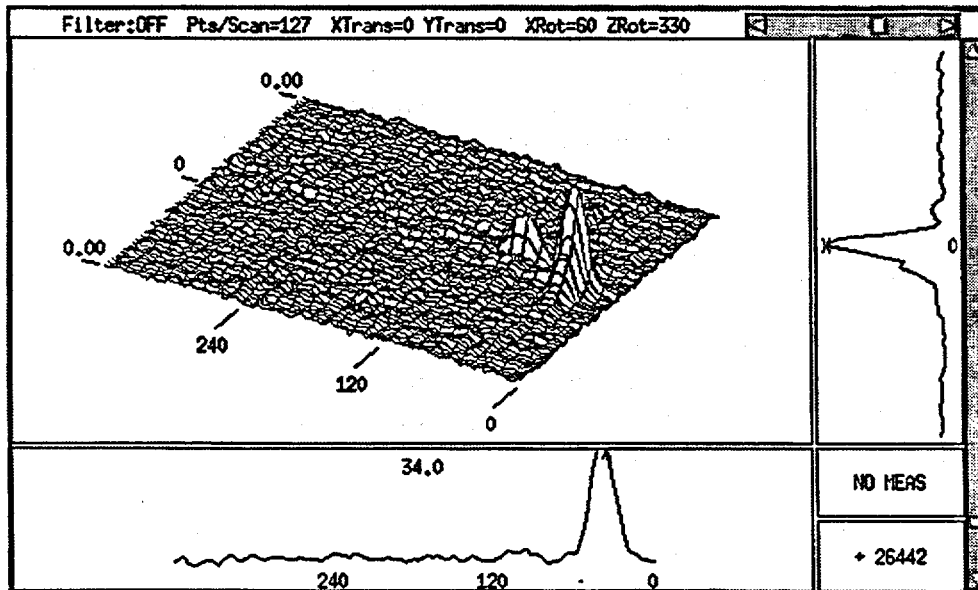
Fig. 4.2. Eddy current NDE test results from Specimen SGL288 showing axial ODSCC indication.

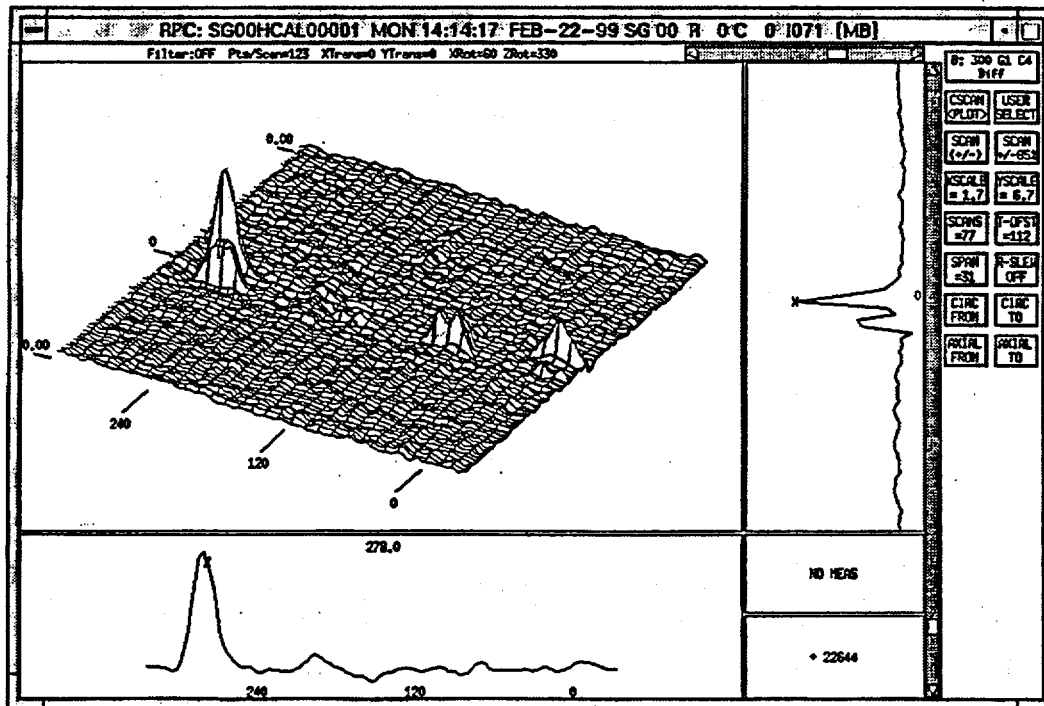
Fig. 4.8. Eddy current NDE test results for Alloy 600 tube SGLA79 showing three OD axial crack indications.

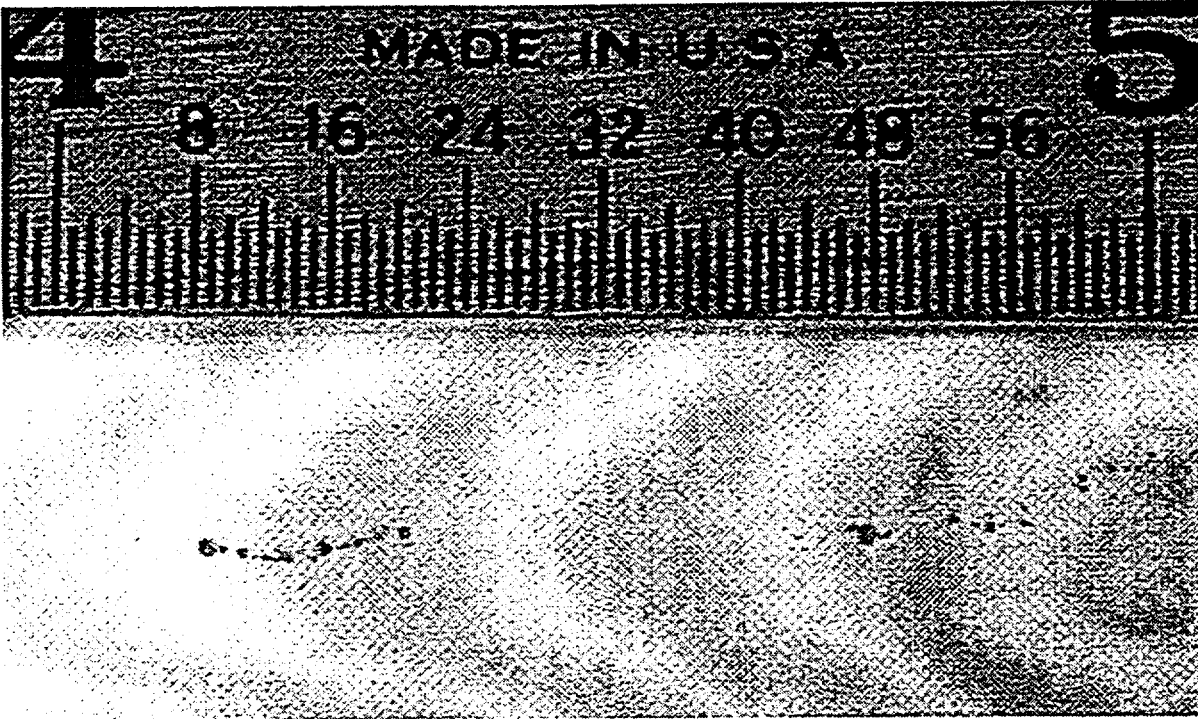
Fig. 4.9. Dye-penetrant examination results for Alloy 600 tube SGL495 showing segmented ODSCC indications.

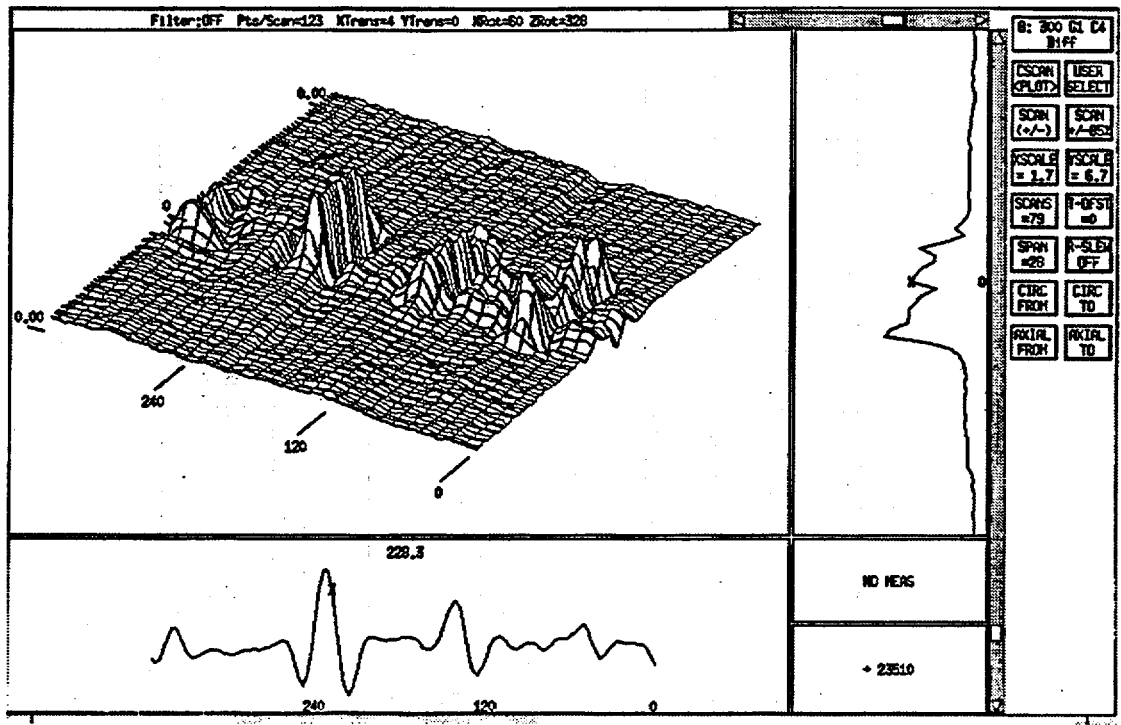
Fig. 4.13. Eddy current NDE test results for Alloy 600 tube SGL366 showing ODSCC indications in roll-expanded area.

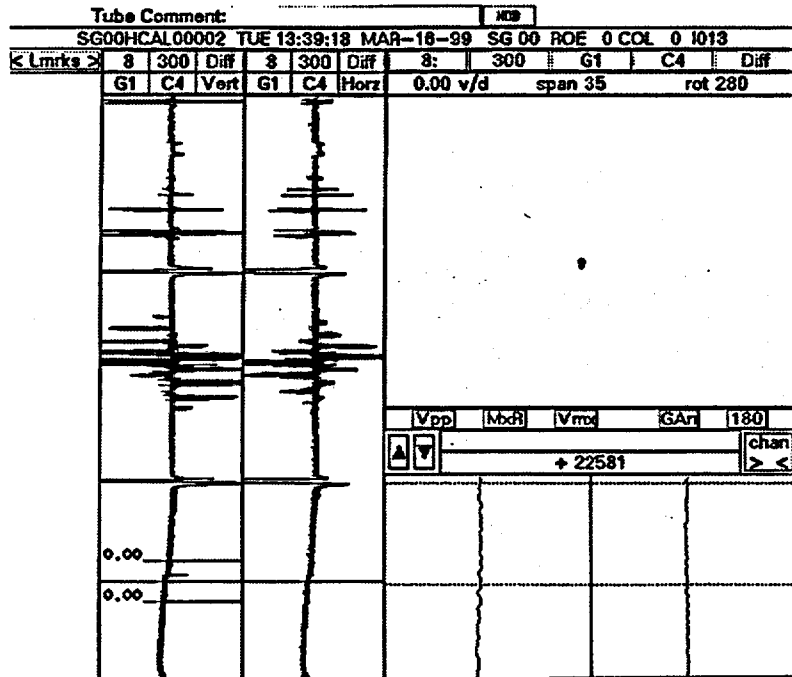
Fig. 4.15. Eddy current NDE test results from SGL397 before degradation.

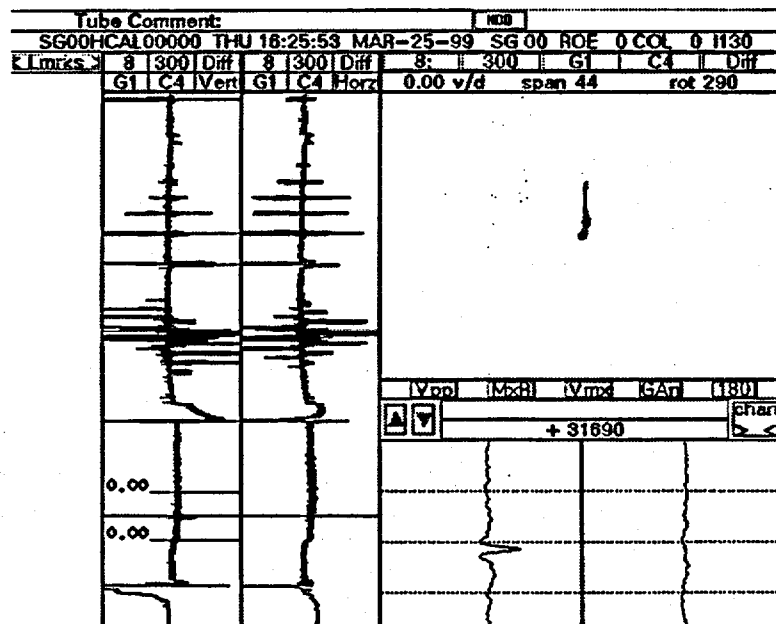
Fig. 4.16. Eddy current NDE test results from specimen SGL397 after degradation.

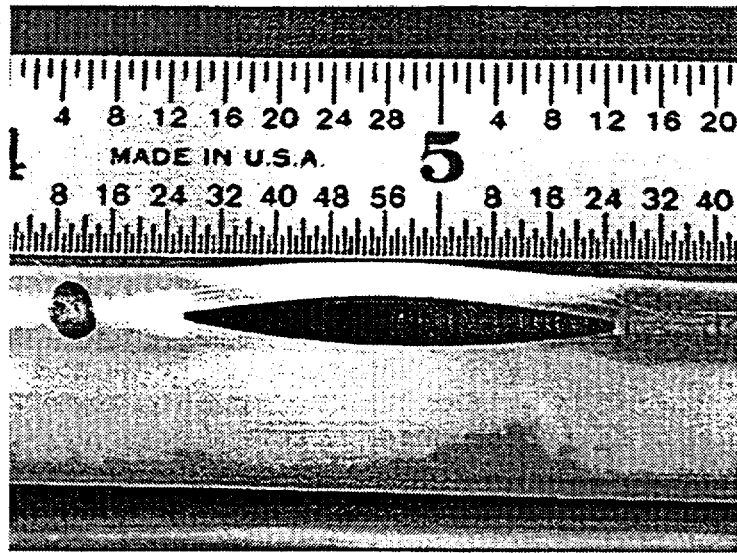
Fig. 4.17. Opening of 25.4-mm (1-in.)-long axial throughwall EDM notch (tube T14EATWX1) after test was interrupted at 13.8 MPa (2000 psi) to measure flaw area.

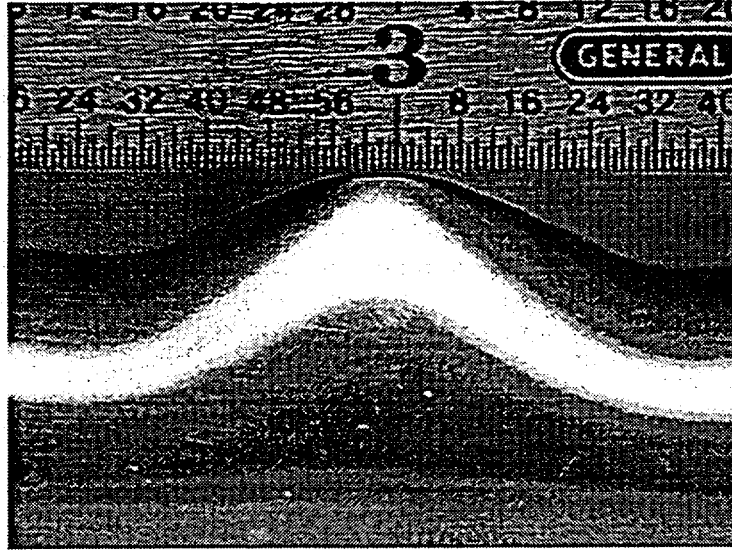
Fig. 4.19. Side view of tube specimen shown in Fig. 4.18, showing three-dimensional bulging at failure site.

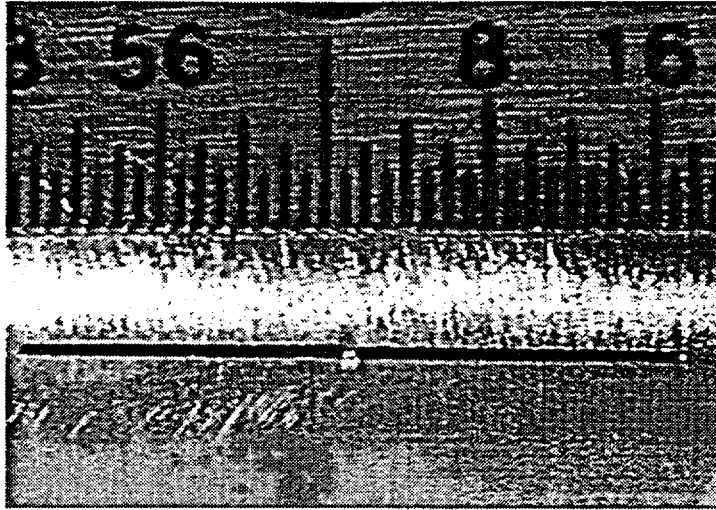
Fig. 4.20. Post-test photograph of tube T24EATWX.5 LIG tested at room temperature at pressures up to 17.2 MPa (2500 psi), showing little flaw distortion and intact ligament.

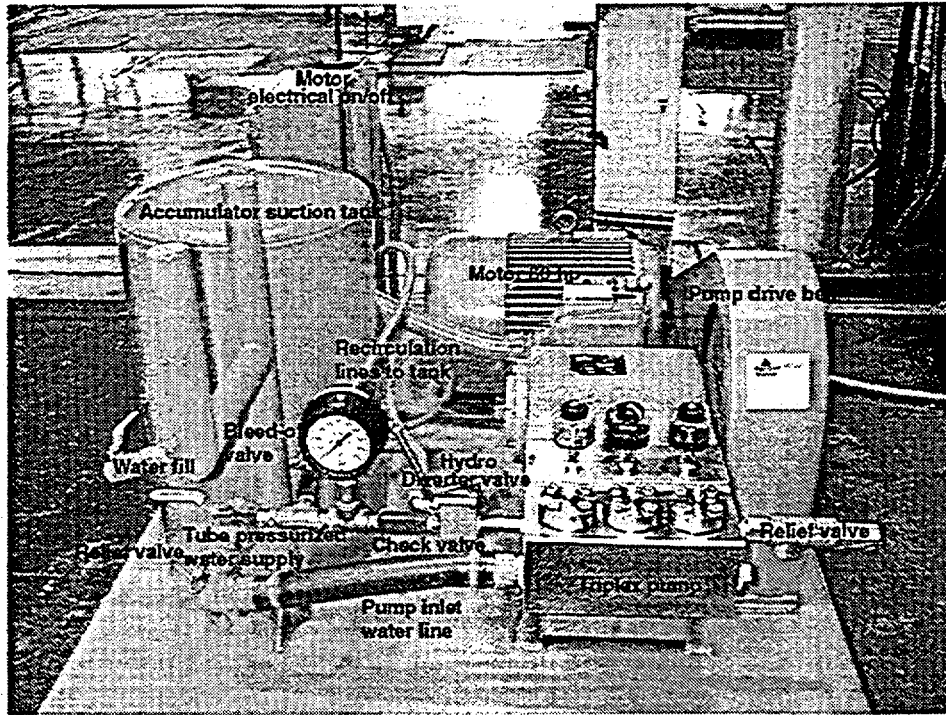
Figure 4.23. High-pressure pump and related components for high-pressure tube test facility.

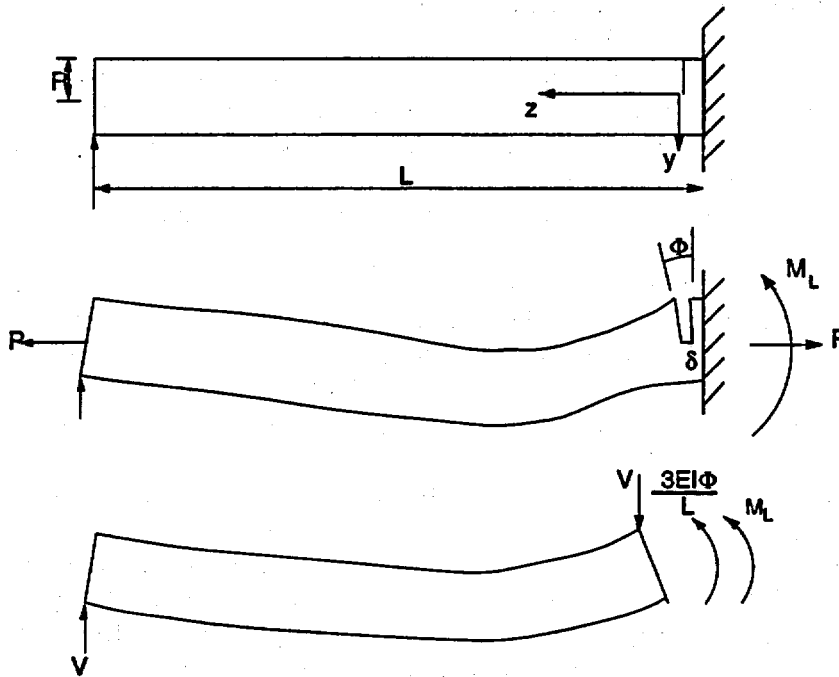
Fig. 4.24. Geometry, loading, and idealized deformation of tube with single throughwall circumferential crack.

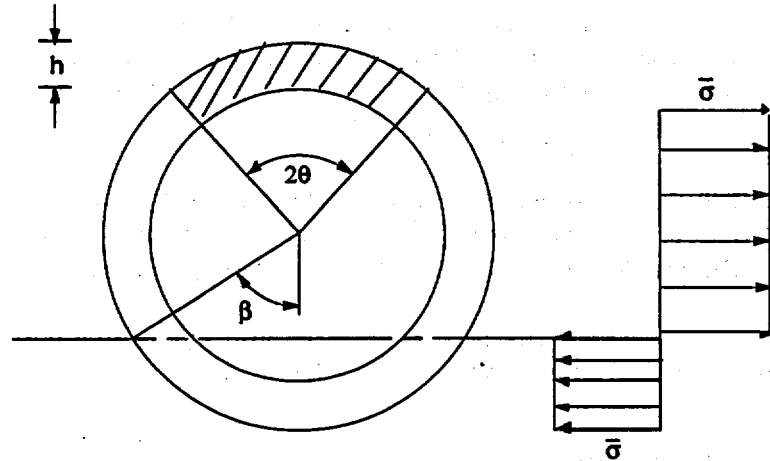
Fig. 4.26. Stress distribution through section at collapse of a tube with single throughwall circumferential crack.

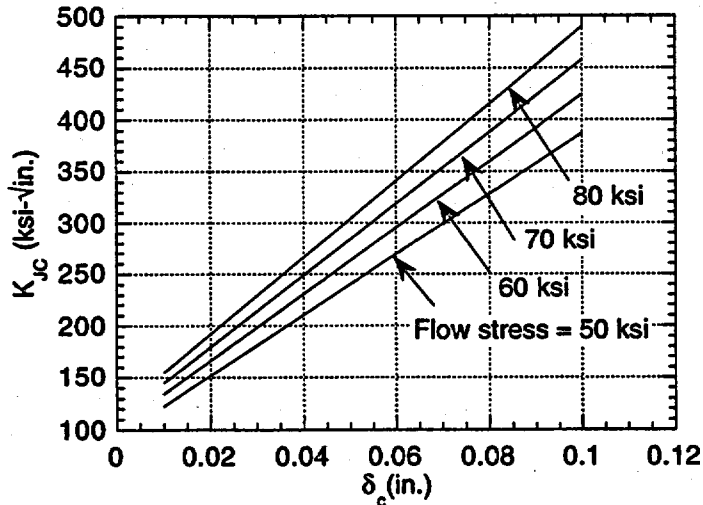
Fig. 4.27. Variation of fracture toughness with critical crack tip opening displacement.

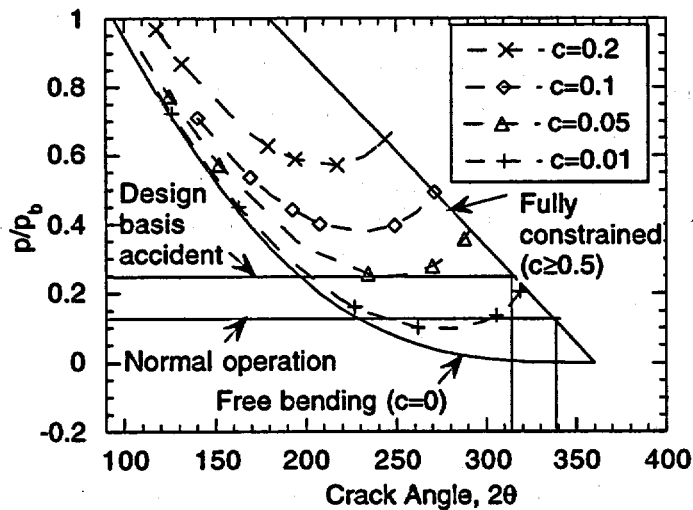
Fig. 4.28. Variation of failure pressure, normalized by unflawed burst pressure, of tube with crack angle of single throughwall circumferential crack.
