Steam Generator Tube Integrity Program

Semiannual Report
October 1998 – March 1999

Argonne National Laboratory

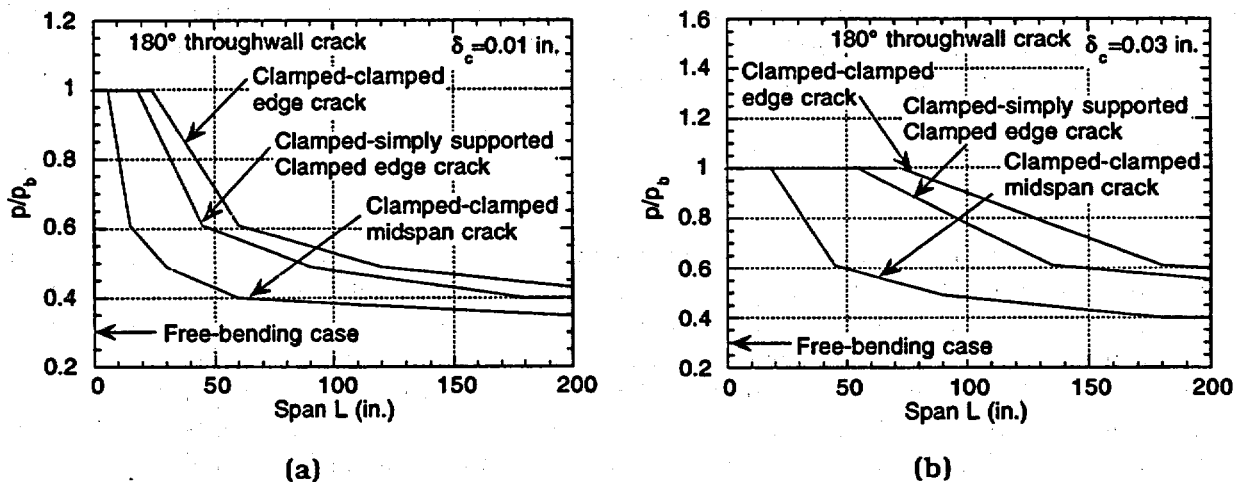
Fig. 4.29. Variation of failure pressure, normalized by unflawed burst pressure, of tube with 180° throughwall crack with span for several edge conditions, crack locations and δ_c values of (a) 0.25 mm (0.01 in.) and (b) 0.75 mm (0.03 in.).

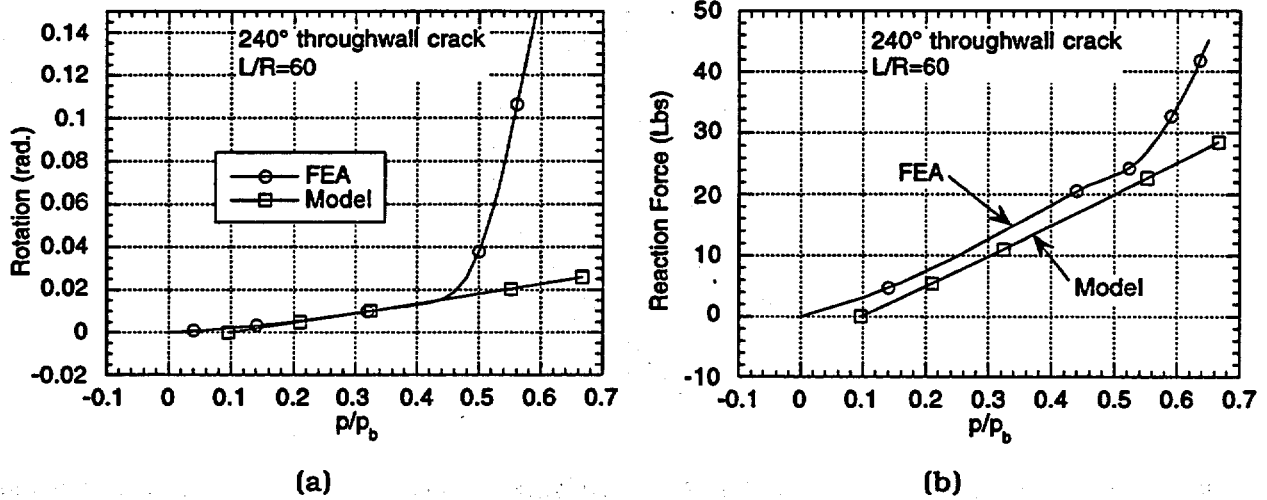
Fig. 4.35. Comparison of model prediction and elastic-plastic FEA results ($\sigma_y / \bar{\sigma} = 0.5$) for (a) crack section rotation and (b) support reaction force of tube simply supported at one end and clamped at the other (as in Fig. 4.29) at various normalized pressures.

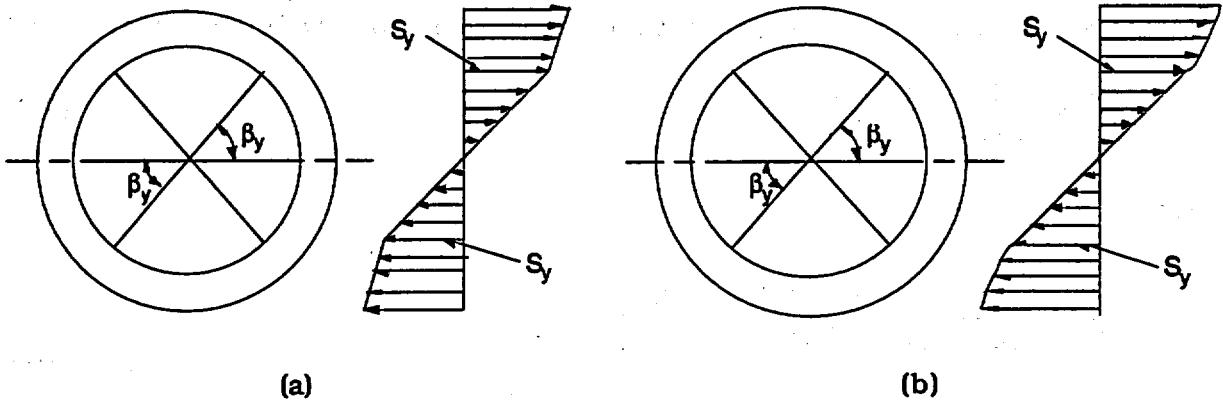
Fig. 4.38. Stress distribution through section away from crack section after yield, (a) bilinear for bilinear stress-strain curve and (b) nonlinear for power-law hardening curve.

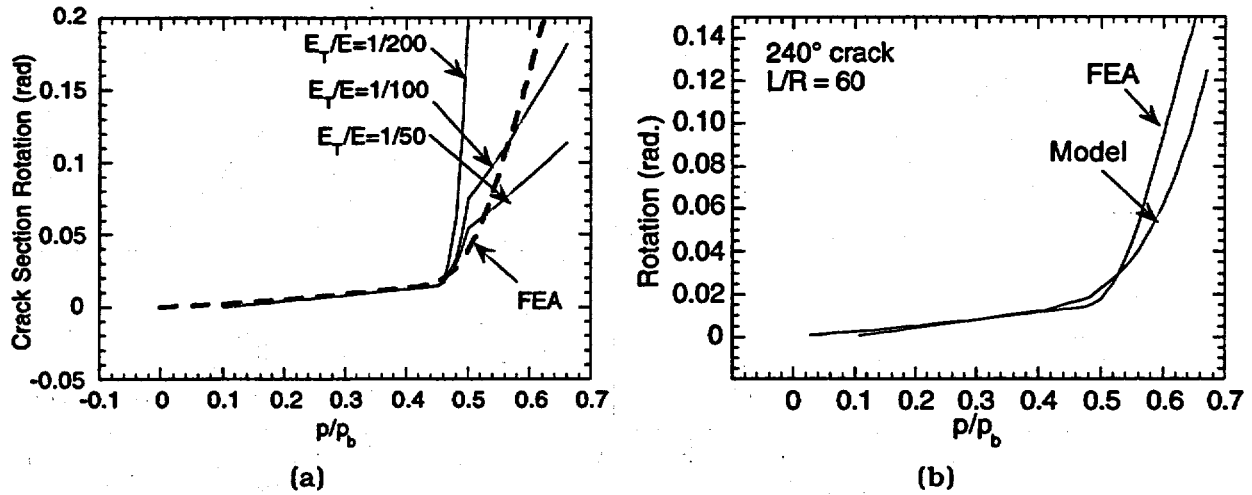
Fig. 4.41. Variation of crack section rotation with normalized pressure as calculated by FEA ($\sigma_y / \bar{\sigma} = 0.5$) and those calculated by a model that allows for plastic yielding away from crack plane using (a) bilinear stress-strain curve and (b) power-law hardening stress-strain curve.

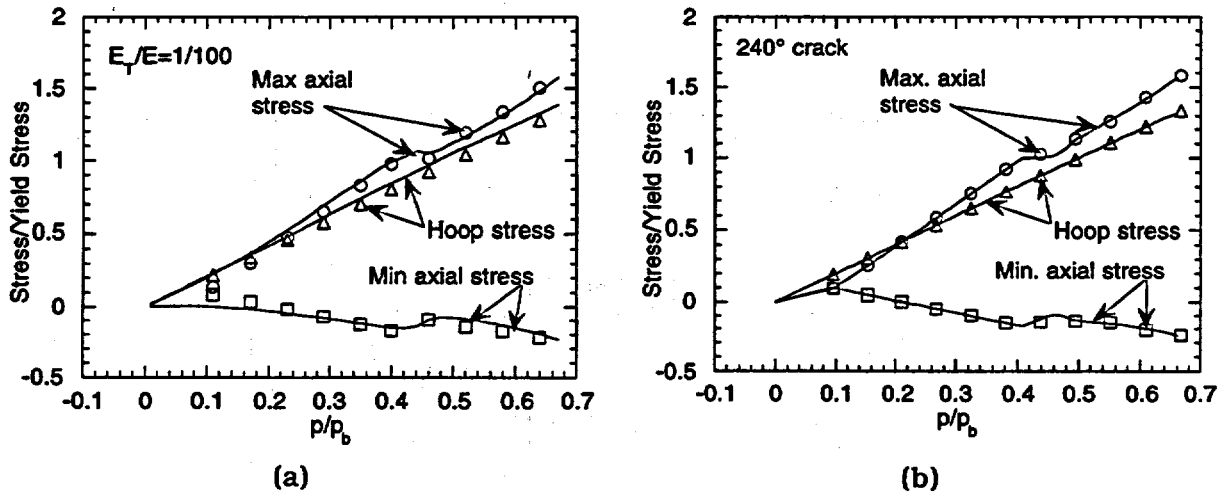
Fig. 4.42. Model predictions for stresses, allowing for plastic deformation ($\sigma_y / \bar{\sigma} = 0.5$) away from crack plane, using (a) bilinear stress-strain curve and (b) power-law hardening stress-strain curve and elastic-plastic FEA results for stresses at section located at distance $4R$ from crack plane in tube ($L/R = 60$) simply supported at one end and clamped at the other (as in Fig. 4.24) at various pressures. Symbols, and lines without symbols, represent model calculations and FEA results, respectively.

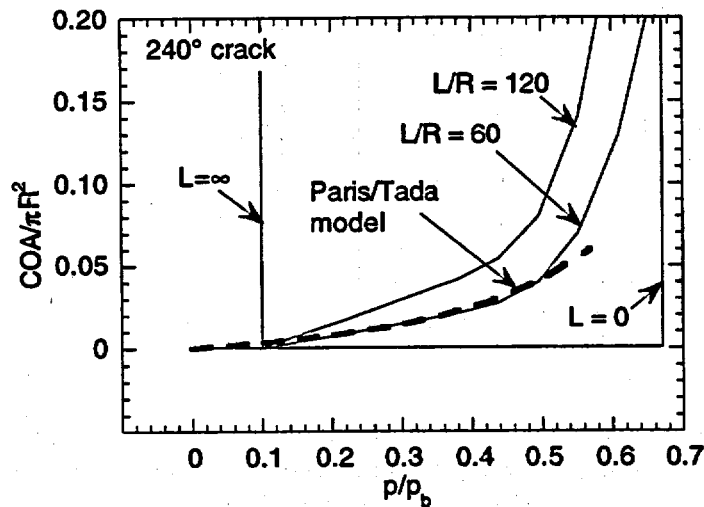
Fig. 4.44 Normalized crack opening area vs. pressure plots calculated by Paris/Tada model (dashed line) and by current model (solid lines) for $L/R = 0$ (fully constrained), 60, 120, and infinitely (free-bending) long simply-supported-clamped tube with 240° crack at clamped edge.

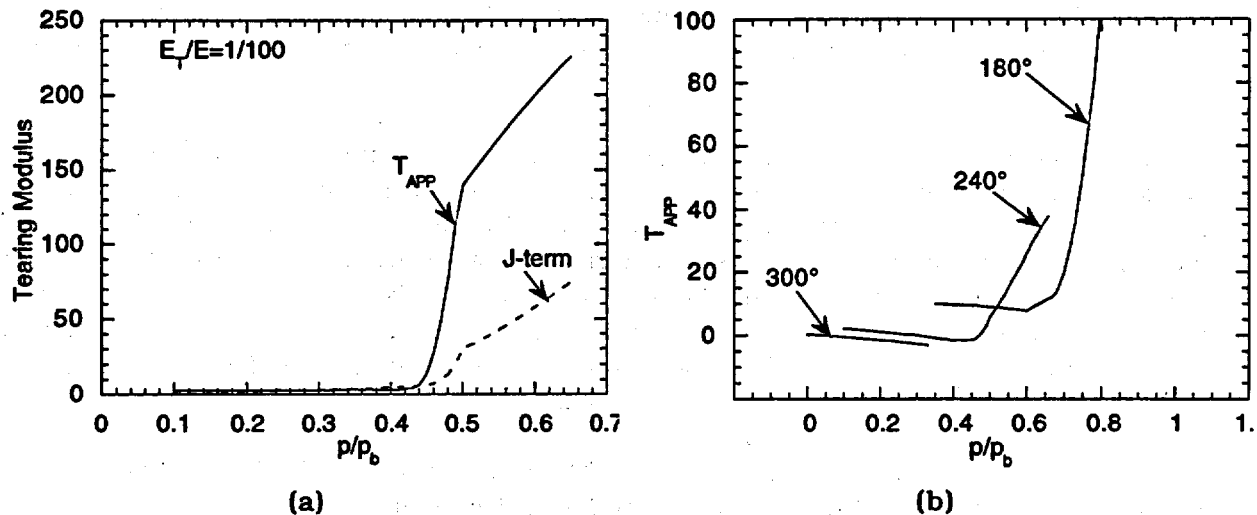
Fig. 4.45 Calculated variation of applied tearing modulus with pressure, normalized by unflawed burst pressure, for single throughwall circumferential crack in a tube, using elastic-plastic model with (a) bilinear stress-strain curve for 240° crack and (b) power-law hardening stress-strain curve for 180°, 240° and 300° cracks.

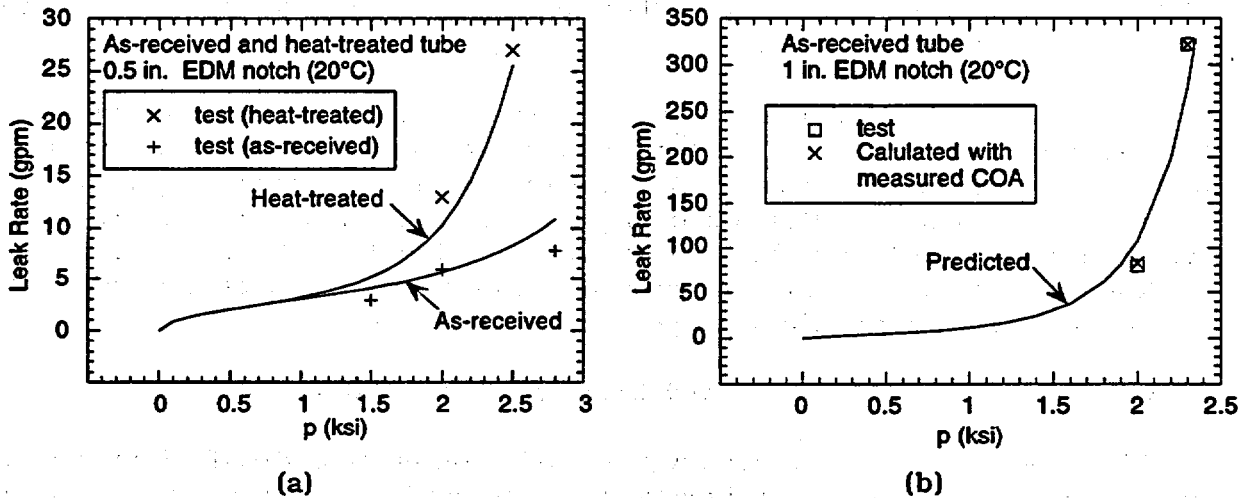
Fig. 4.47. Calculated (solid line) vs. experimentally measured (symbols) leak rates at 20°C for as-received and heat-treated 22.2-mm (7/8-in.)-diameter tubes with (a) 12.7-mm (0.5-in.) and (b) 25.4-mm (1-in.)-long throughwall axial EDM notches. Cross symbols in Fig. 4.47b denote calculated leak rates using post-test measured crack opening areas.

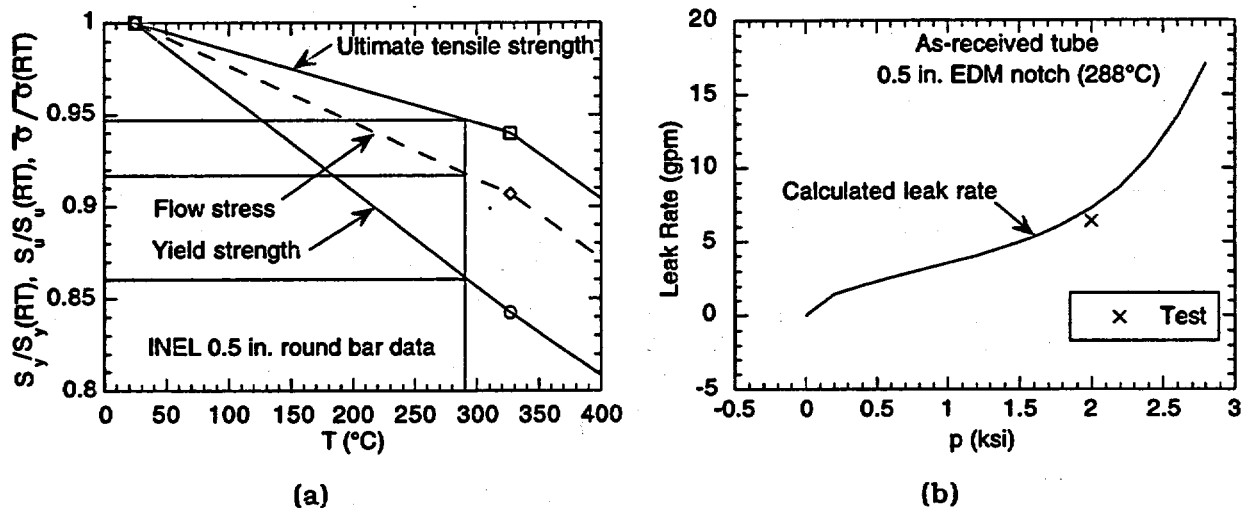
Fig. 4.48. (a) Variations of yield and ultimate tensile strengths and flow stress of Alloy 600 round bar stock with temperature and (b) comparison of calculated (solid line) versus experimentally measured (cross symbol) leak rates at 288°C for as-received 22.2-mm (7/8-in.)-diameter tube with 12.7-mm (0.5-in.)-long throughwall axial EDM notch.

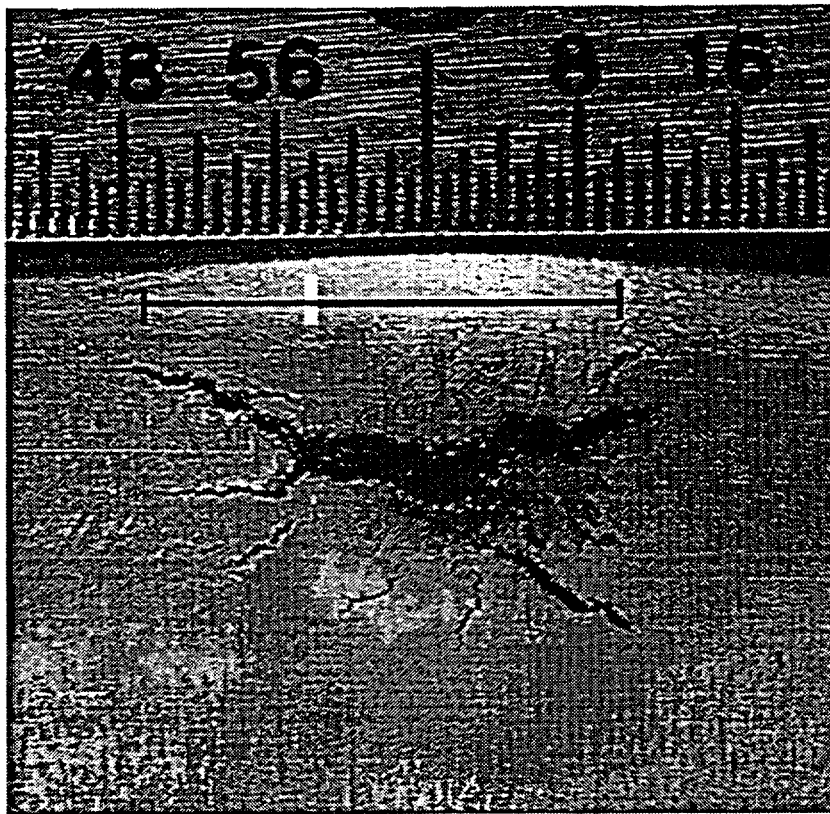
Fig. 4.51. Post-test view of OD crack of specimen SGL-104. Marker indicates effective throughwall crack length (10 mm or 0.39 in.) calculated from measured leak rate.
