**GSI-191: Experimental Studies of
Loss-of-Coolant-Accident-Generated
Debris Accumulation and Head Loss with
Emphasis on the Effects of Calcium Silicate
Insulation**

Los Alamos National Laboratory

**U.S. Nuclear Regulatory Commission
Office of Nuclear Regulatory Research
Washington, DC 20555-0001**

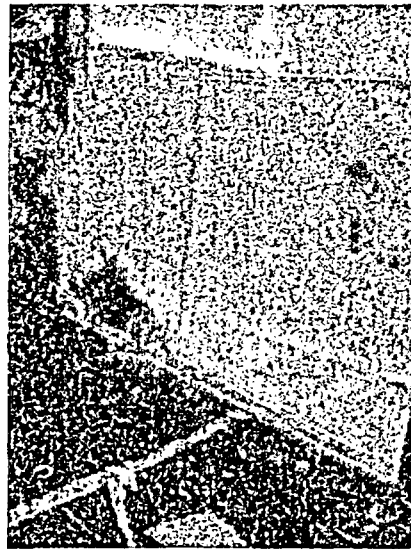
(iii) Pile of debris formed in front of the screen when flow through the flume was terminated.

Post-test examination of the debris bed composition was not possible in these tests because the debris bed did not remain attached to the screen when the test was terminated. When flow through the flume ceased at the end of the accumulation test (by turning off the pump), the pressure on either side of the debris bed equilibrated and the debris bed "bounced" back into the flume and collapsed as a pile of mixed debris at the base of the screen. The pile of rejected debris is shown in Figure 3.2(iii).

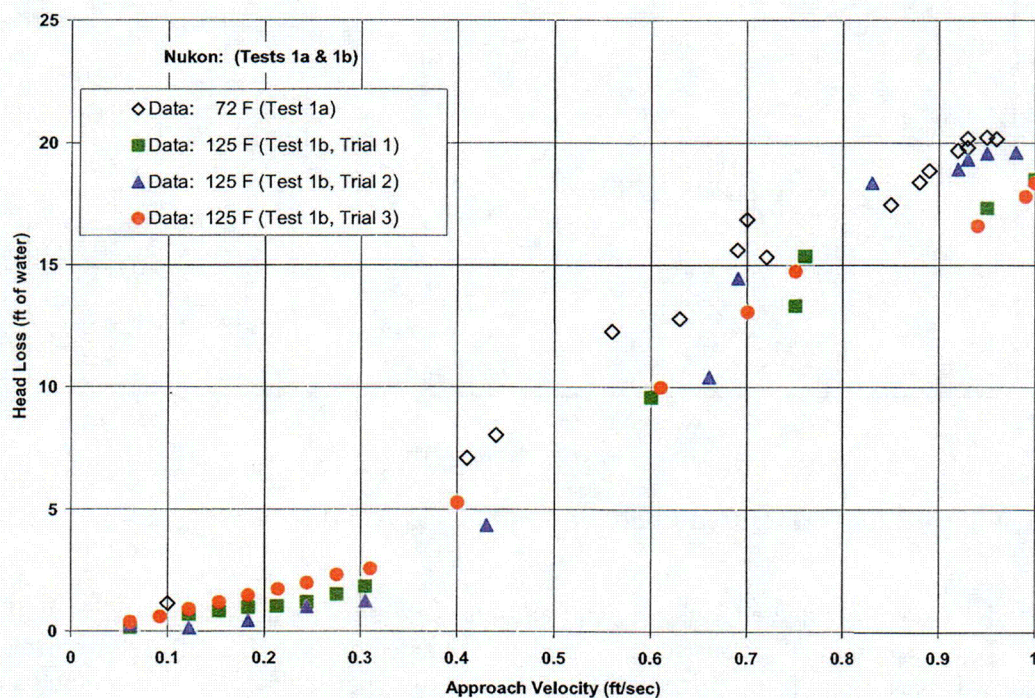
Figure 3.5. Measured head loss for NUKON™ fiber bed at two temperatures.

The first two tests measured head loss across a NUKON™ fiber bed, and the difference between Tests 1a and 1b was the temperature of water passing through the debris bed (72°F vs. 125°F). Test 1b was run three times to examine variance in measured results for the same test conditions. Results for these two tests are shown in Figure 3.5. Individual data points are tabulated in Appendix B.

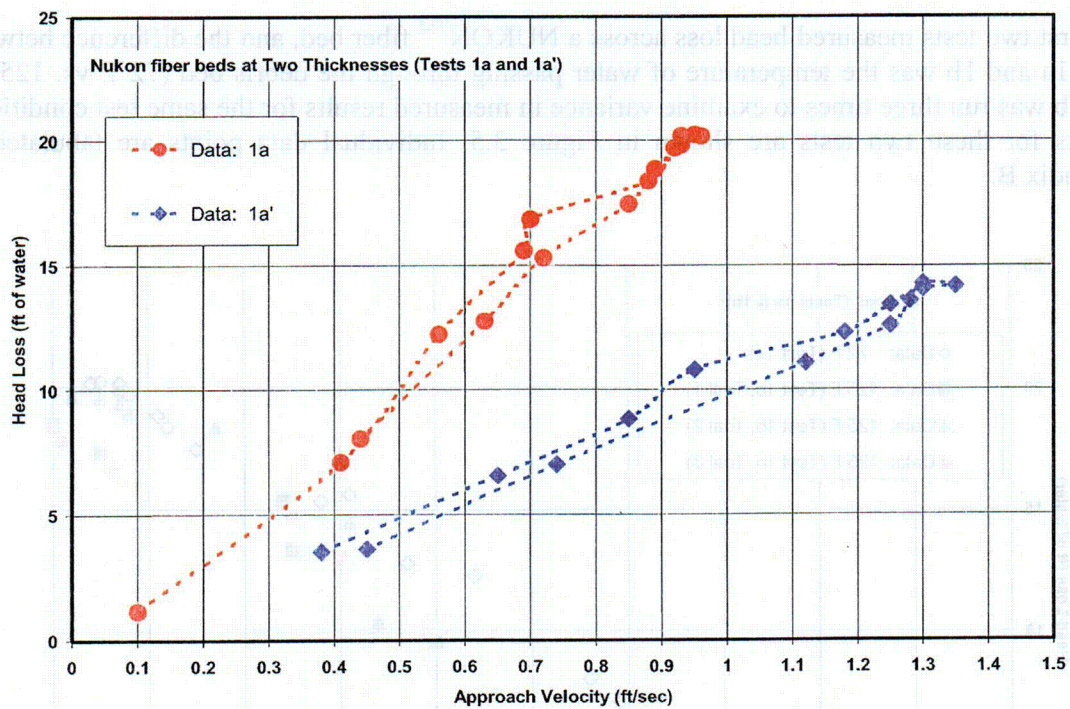
Figure 3.6. Measured fiber bed head loss at two thicknesses (72°F).

To further qualify the UNM facility, Test 1a was repeated as Test 1a' with roughly half the amount of fiber, reducing the theoretical bed thickness from ~1.72 to 0.86 in. The test data for Tests 1a and 1a' are compared in Figure 3.6, and the dashed lines in the figure indicate the order in which the data were taken, i.e., the data taken as the velocity were incrementally increased vs. when the velocity was incrementally decreased. The decreasing curves for both tests were somewhat higher than the increasing curves. This behavior is the typical compression hysteresis behavior, i.e., the bed does not expand as readily as it was compressed by the flow.

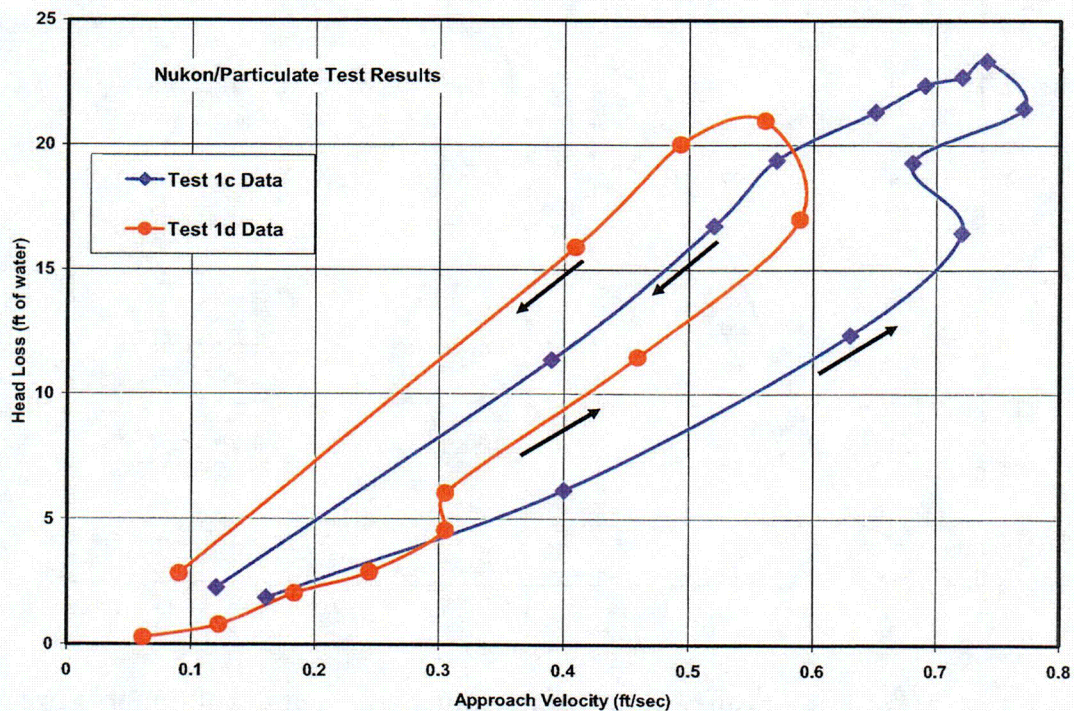
Figure 3.7. Measured head loss for NUKONTM fiber bed with particulate for two fiber bed thicknesses.

The head-loss data for Tests 1c and 1d are shown in Figure 3.7. The arrows shown in Figure 3.7 indicate the sequence of head-loss measurements as flow through the test facility was increased, then decreased. On the surface, this behavior appears to be a hysteresis effect, but it is not hysteresis behavior. When the flow velocity is first decreased from its maximum value in each test, the head loss increased significantly. Since there is no phenomenological reason for the head loss to increase with a velocity decrease for a given debris bed configuration, it appears that the debris bed was altered with the flow reduction. The debris bed must have become more uniform, and therefore the higher head losses associated with the decreasing velocity are more valid than the head losses associated with the increasing velocity. This type of behavior is also seen in several of the NUKONTM/CalSil tests.

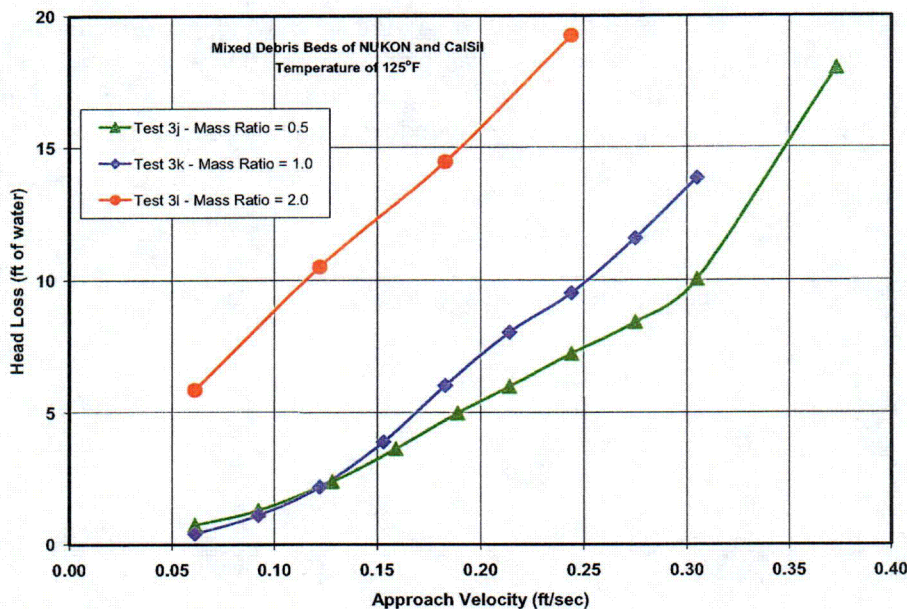
Figure 3.14. Head-loss measurements for CalSil/fiber debris mixtures: Tests 3j, 3k, and 3l.

Tests 3j through 3l were conducted using water heated to a nominal temperature of 125°F to examine the effect of water temperature on head loss. The temperature affected the head loss in two ways. First, the water viscosity decreases with temperature, thereby also decreasing the head loss. Second, the dissolution or disintegration of CalSil is enhanced by temperature, which was clearly demonstrated during the separate-effect debris characterization tests [Rao, 2002a]. Therefore, it should be expected that the lumps of CalSil will more readily disintegrate in the higher temperature test and subsequently form a more uniform bed. A comparison of the data from these tests is shown in Figure 3.14.

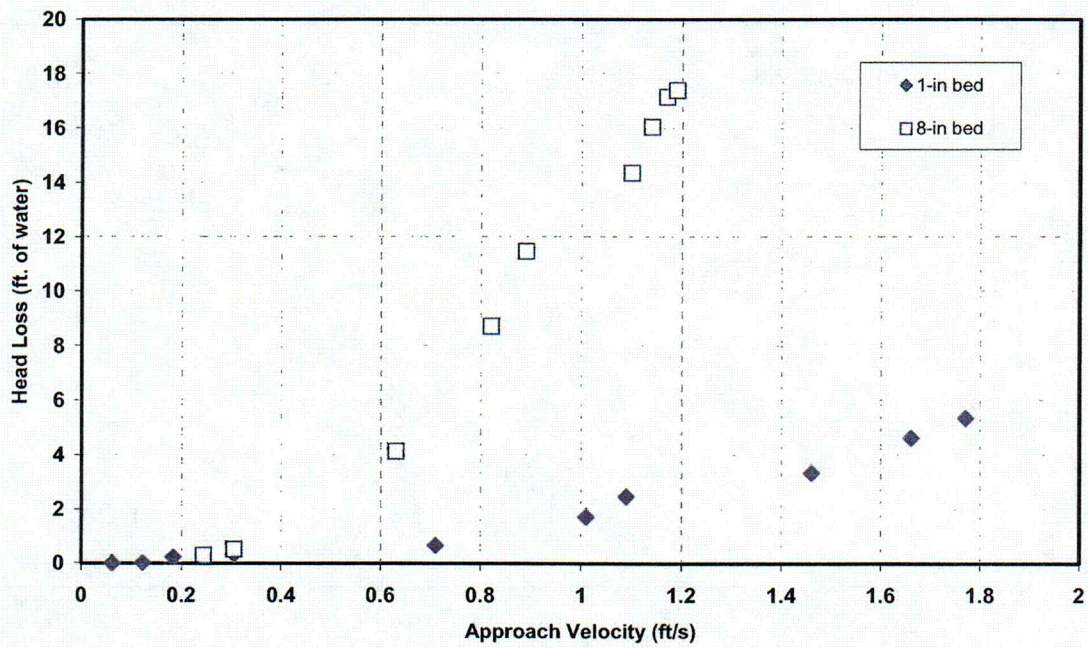
Figure 3.21. Stainless-steel RMI foil head-loss data.

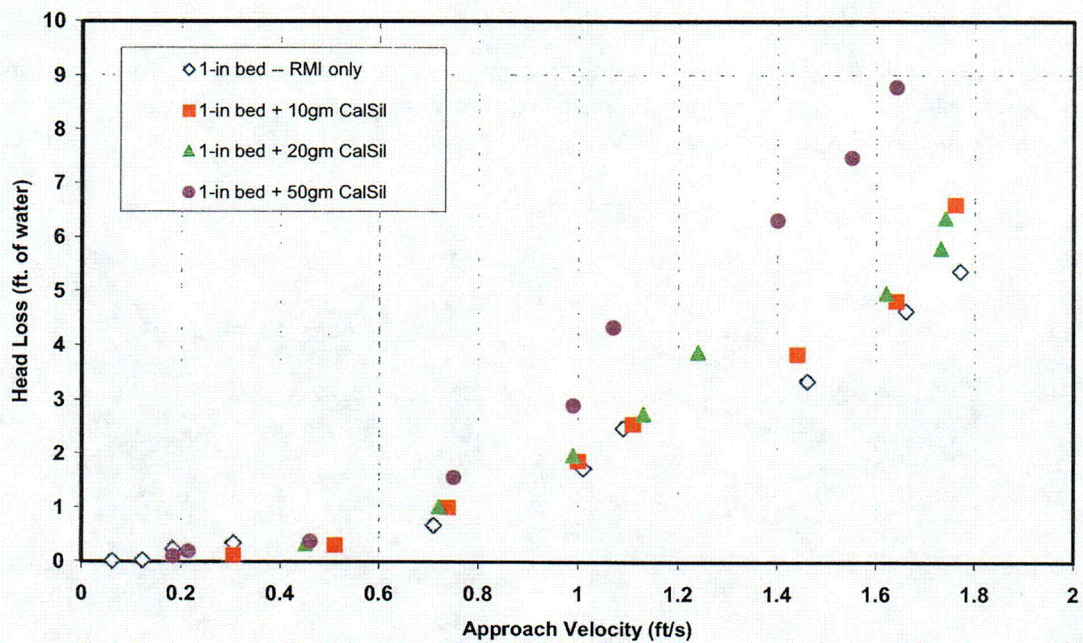
Figure 3.22. Incremental head loss due to the addition of CalSil to a 1-in. stainless-steel RMI debris bed.

Tests 5c through 5g examined the incremental effects of CalSil on the head loss generated by 1-in. and 8-in. beds of stainless-steel RMI debris. Results for the 1-in. RMI debris bed are shown in Figure 3.22; results for the 8-in. RMI debris bed are shown in Figure 3.23.

Head loss is clearly shown to increase with increasing amounts of CalSil. For the 1-in. debris bed, relatively little change is observed until the quantity of CalSil exceeded 20 g. Noticeable increases in head loss were measured with lower quantities of CalSil in the 8-in. RMI debris bed. Head loss doubled in magnitude when 50 g of CalSil was added to a 1-in. bed of crumpled RMI foils. It is interesting to note that the head loss across an 8-in. bed of RMI foils nearly doubled with considerably less CalSil.

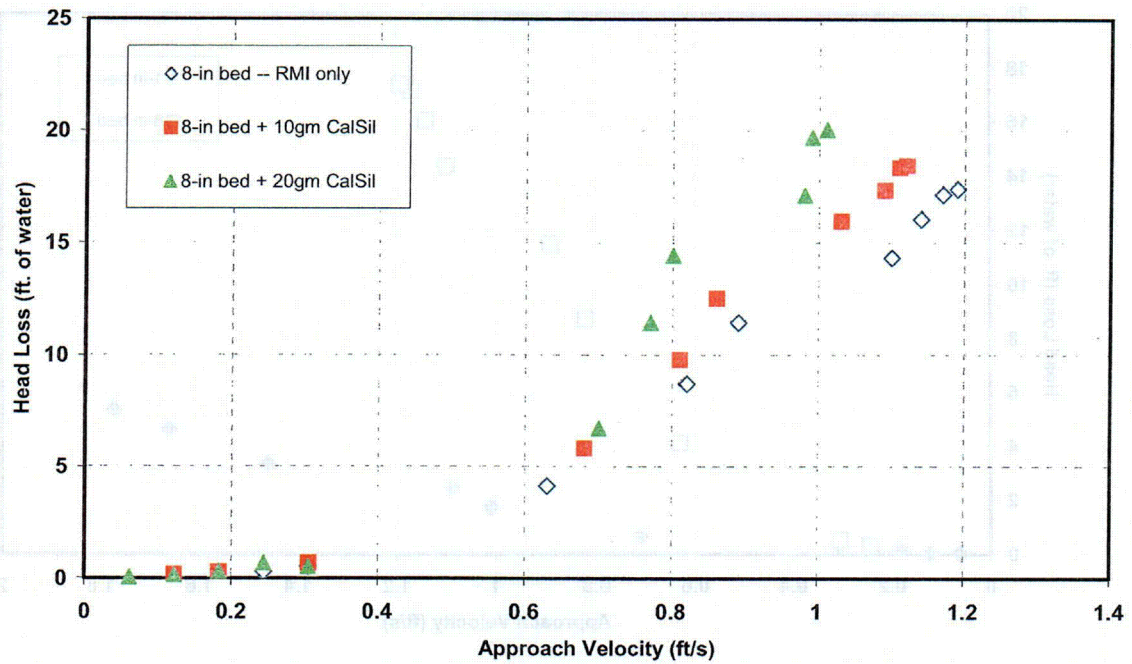
Figure 3.23. Incremental head loss due to the addition of CalSil to an 8-in. stainless-steel RMI debris bed.

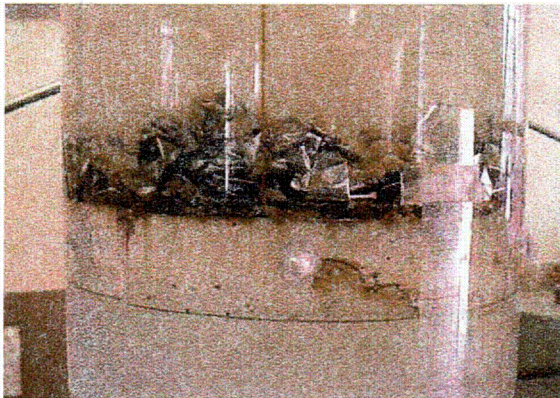
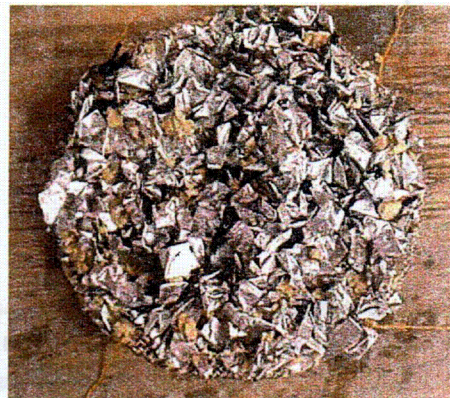
Figure 3.24. CalSil/RMI debris mixture in a typical 1-in. debris bed.

The distribution of CalSil within the RMI debris bed appeared to be nearly uniform in tests at each bed thickness. Photographs of typical post-test debris mixtures are shown in Figures 3.24 and 3.25 for the 1-in. and 8-in. beds, respectively.

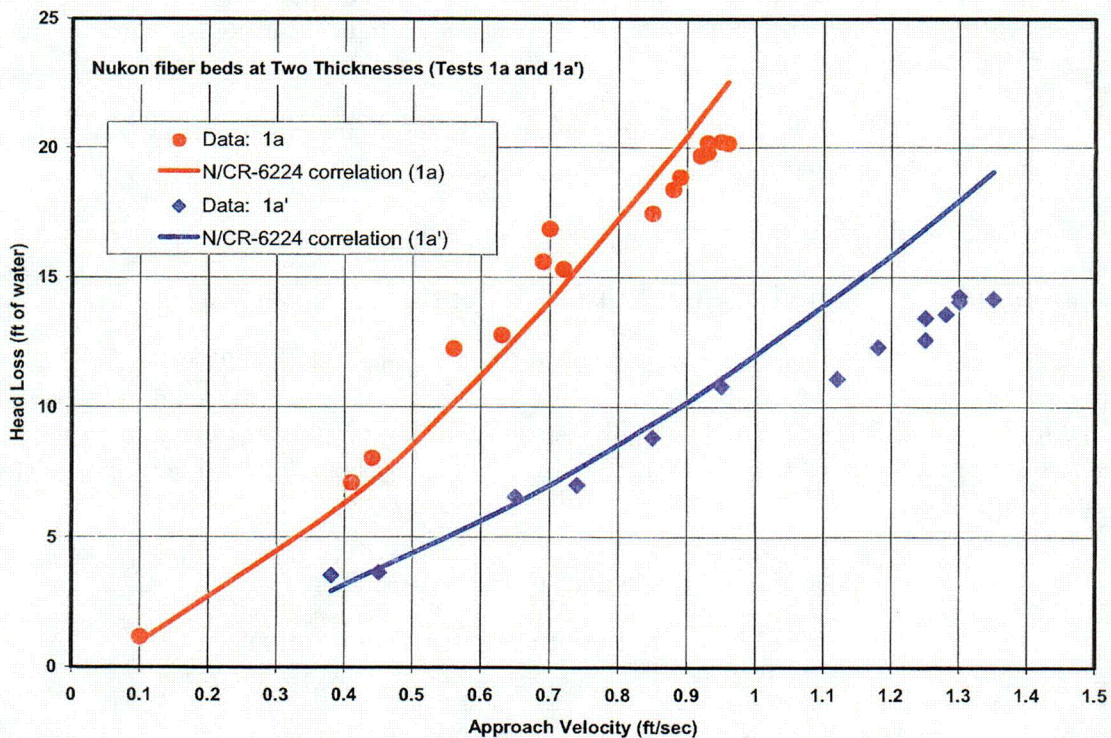
Figure 4.1. Comparison of tests with NUREG/CR-6224 correlation at two bed thicknesses.

The comparison of the two bed thicknesses with their corresponding NUREG/CR-6224 correlation predictions is shown in Figure 4.1. The debris bed in Test 1a is ~1.72 in. thick and is twice as thick as Test 1a'. As shown, the correlation does an excellent job of predicting both Tests 1a and 1a'. In Test 1a' with a bed thickness of 0.86 in., the test head loss appeared to fall away somewhat from the trend at the higher velocities; the reason for this behavior was not readily apparent.

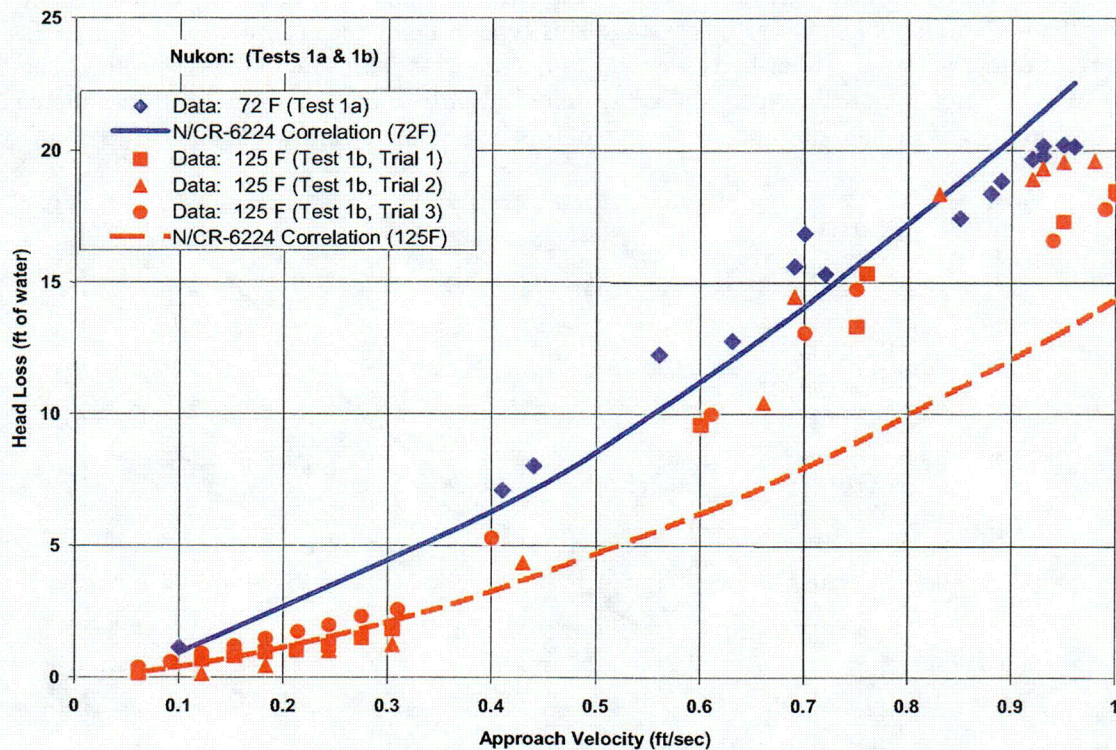
Figure 4.2. Comparison of tests with NUREG/CR-6224 correlation at two temperatures.

previously noted, the correlation does an excellent job of predicting Tests 1a. However, in Test 1b with its three separate trials, the correlation fell somewhat short at the higher velocities, whereas the correlation was accurate at the lower velocities. The principal effect that temperature has on the head losses is the variation in the viscosity and, to a lesser extent, the water density. Note that the test data for Test 1b tend to converge with the data for Test 1a when the velocity approaches 1 ft/s. The viscosity of room temperature water is ~80% higher than for water at 125°F. If the water cooled significantly during the course of Test 1b, the cooling could have contributed to the observed trend.

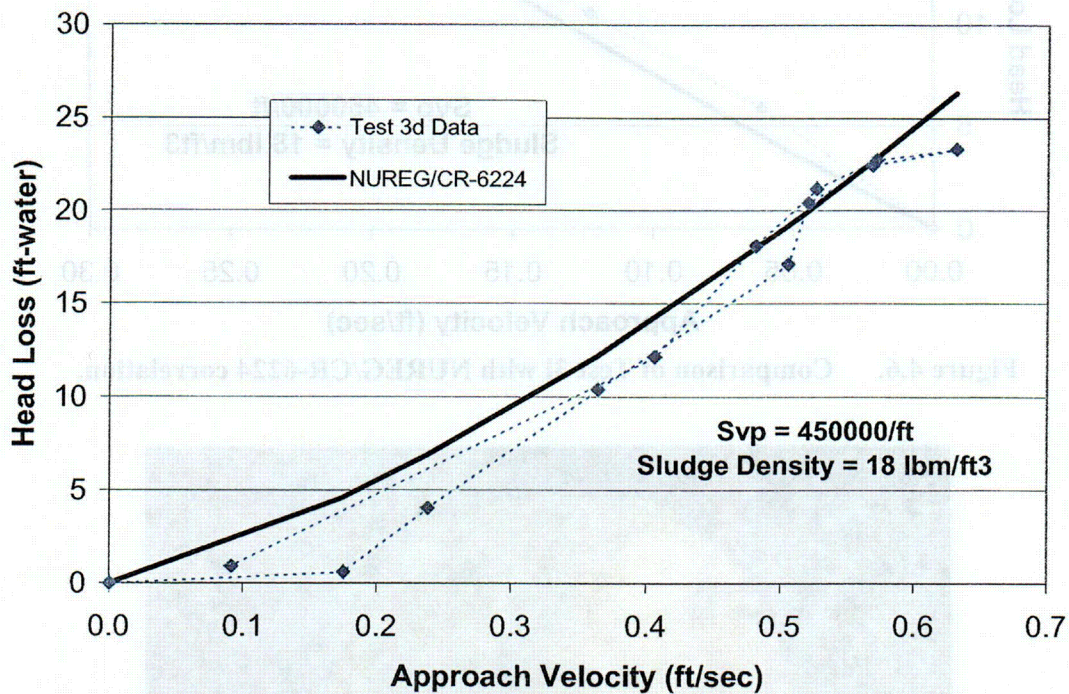
Figure 4.8. Comparison of Test 3d with NUREG/CR-6224 correlation.

Test 3d Test 3d was conducted using room temperature water, nominally at $\sim 70^{\circ}\text{F}$, 58 g of NUKONTM, and 29 g of CalSil (a particulate-to-fiber mass ratio of 0.5). The application of the NUREG/CR-6224 correlation to Test 3d data assumed a specific surface area of 450,000/ft and a sludge density of 18 lbm/ft³. The comparison of Test 3d data with the correlation is shown in Figure 4.8; the comparison looks very favorable. Note that the Test 3d shows some of the compression hysteresis behavior and that the behavior is not excessive.

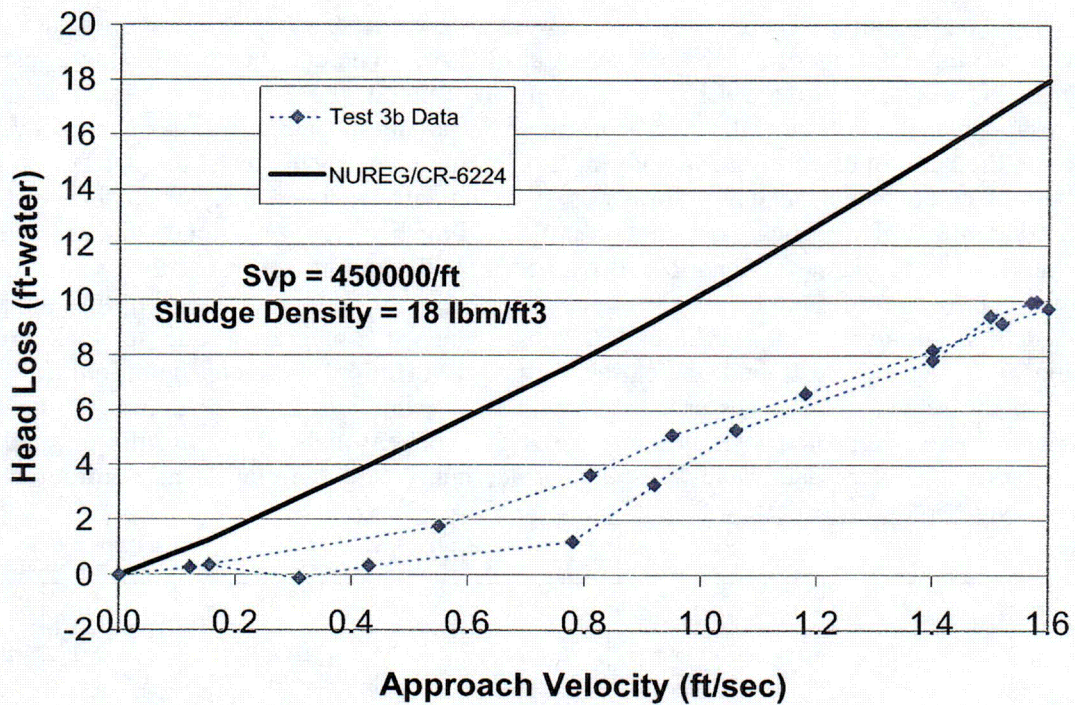
Figure 4.9. Comparison of Test 3b with NUREG/CR-6224 correlation.

Test 3b and 3c Tests 3b and 3c were conducted using room-temperature water, 7.3 g of NUKONTM, and 7.3 and 14.6 g of CalSil, respectively. The application of the NUREG/CR-6224 correlation to Tests 3b and 3c data assumed a specific surface area of 450,000/ft and a sludge density of 18 lbm/ft³. The comparison of Tests 3b and 3c data to the correlation is shown in Figures 4.9 and 4.10, respectively. The correlation greatly exceeds the test data of these two tests because the beds were very nonuniform and significant portions of the screen were essentially uncovered. Photos of these tests are shown in Figure 3.13. These tests are of little value.

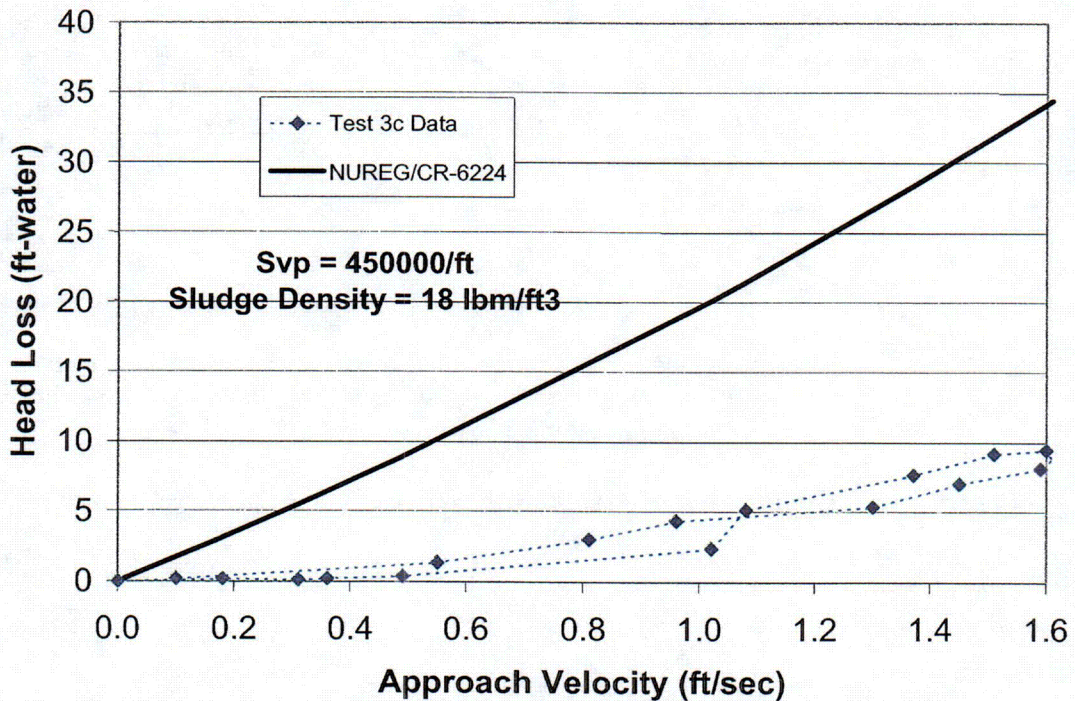
Figure 4.10. Comparison of Test 3c with NUREG/CR-6224 correlation.

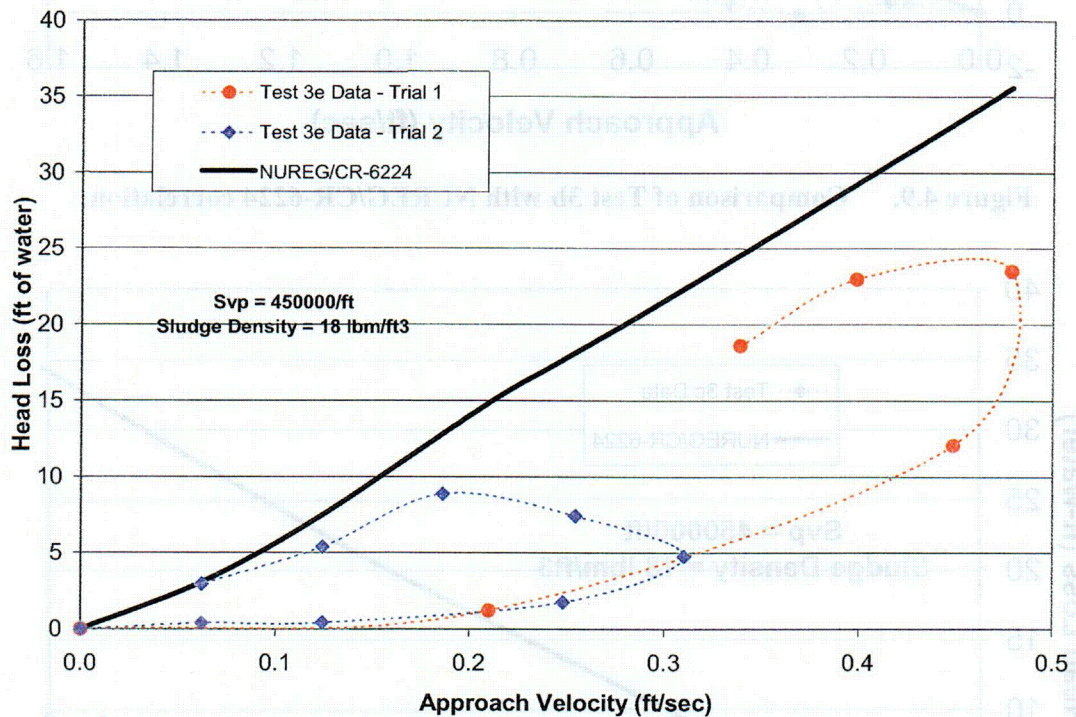
Figure 4.11. Comparison of Test 3e with NUREG/CR-6224 correlation.

Test 3e, 3f, 3g, 3h, and 3i Tests 3e through 3i were all conducted using room-temperature water but with varying amounts of NUKON™ and CalSil debris. The comparisons for these tests are shown in Figures 4.11 through 4.15, respectively. In general, the correlation, predicted higher head losses than the data, but the data from these tests had substantial scatter caused by such factors as the bed nonuniformities already noted. During some of the tests, the debris bed must have reconfigured when the pump flow was systematically reduced, i.e., when the head loss increased significantly following a reduction in flow. If the bed were uniform, then a reduction in flow could not have increased head loss, but a bed reconfiguration from a relatively nonuniform to a more uniform configuration would explain this behavior. It is quite possible that lumps of CalSil debris initially located in the bed subsequently disintegrated, due to soaking and turbulence during the test, and thereafter formed a different bed configuration. In these situations, the higher head losses associated with flow reduction are more applicable than the lower head losses. Repeated tests in some cases did not reasonably replicate the original test data. Although the test data have substantial uncertainty, the correlation as configured still conservatively predicts the data.

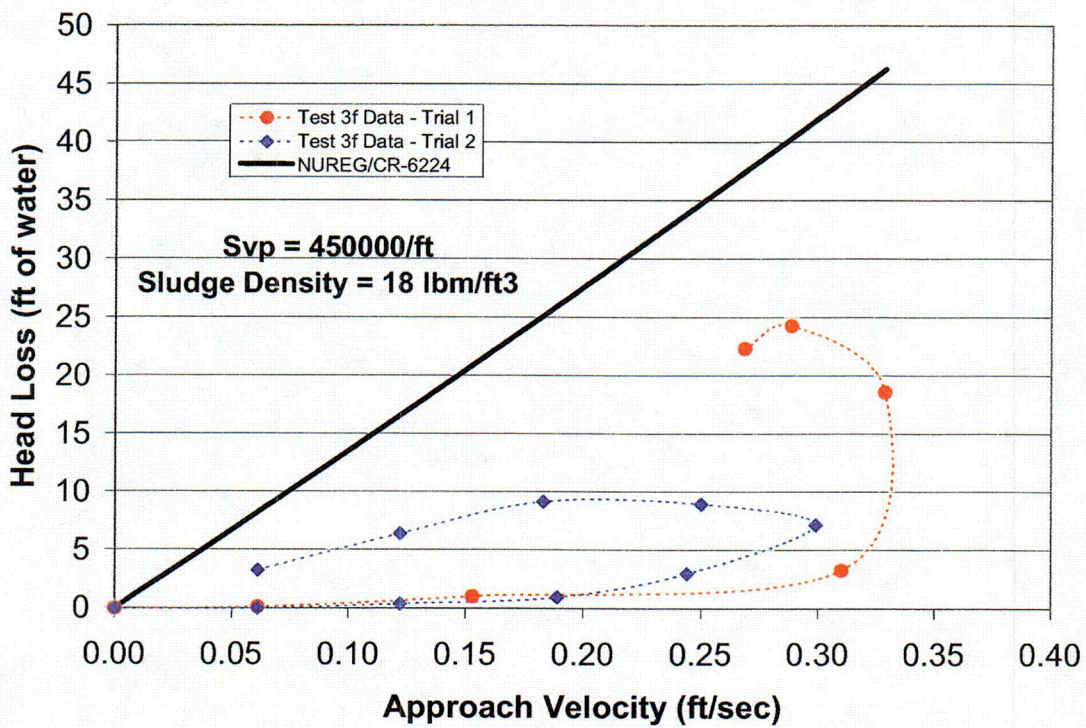
Figure 4.12. Comparison of Test 3f with NUREG/CR-6224 correlation.

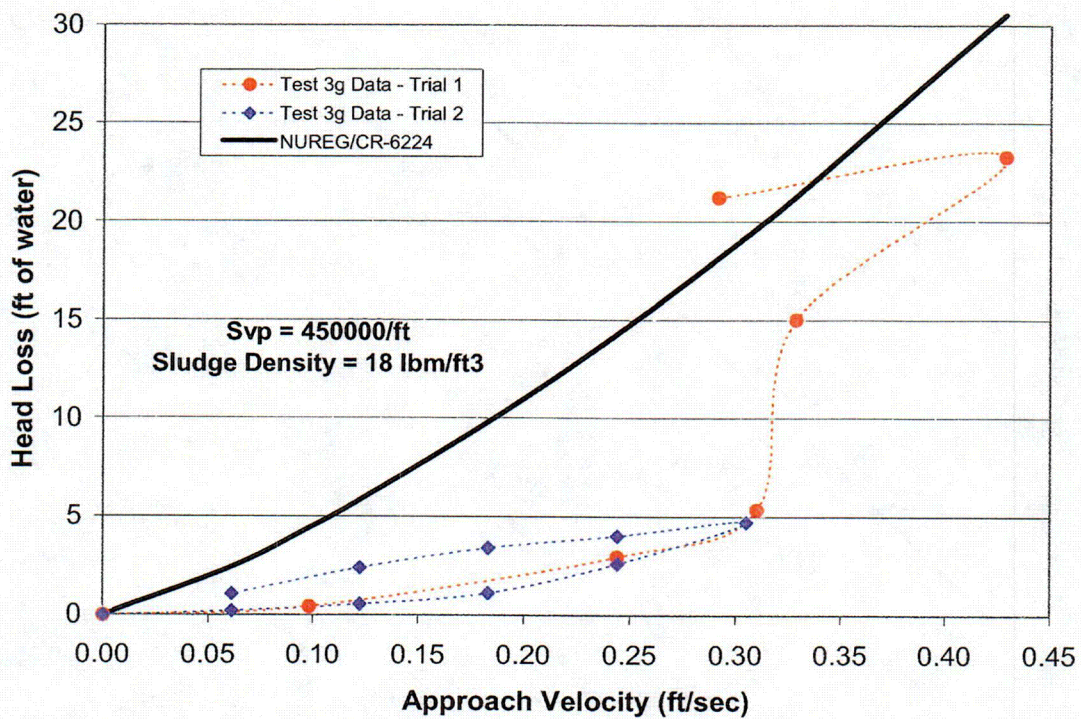
Figure 4.13. Comparison of Test 3g with NUREG/CR-6224 correlation.

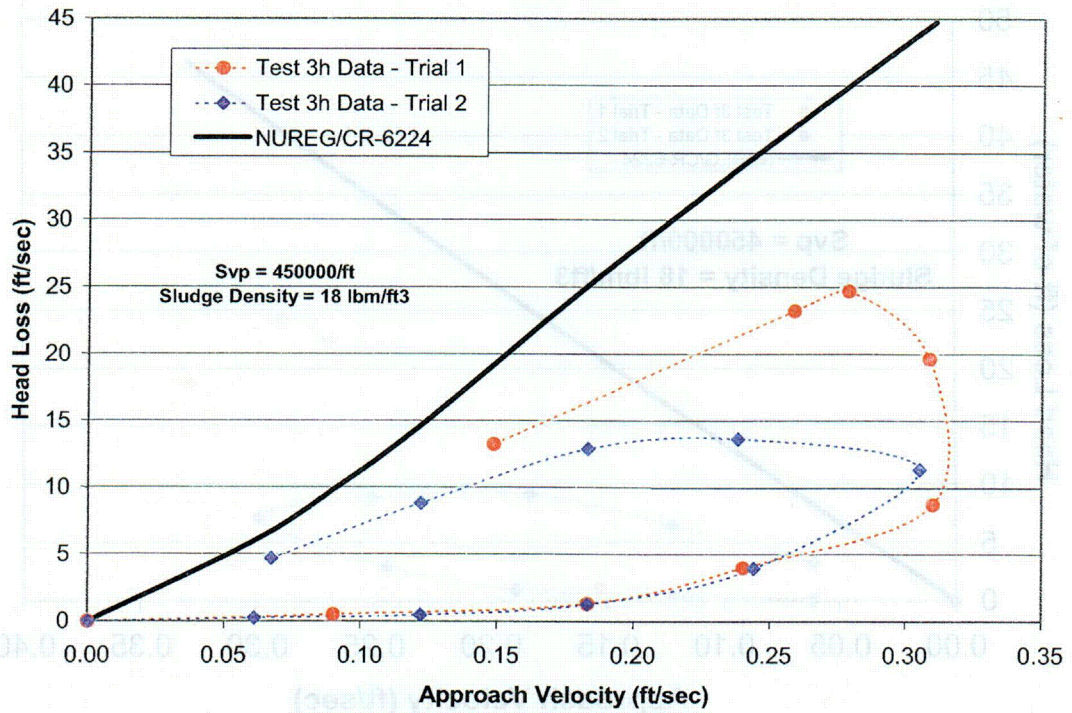
Figure 4.14. Comparison of Test 3h with NUREG/CR-6224 correlation.

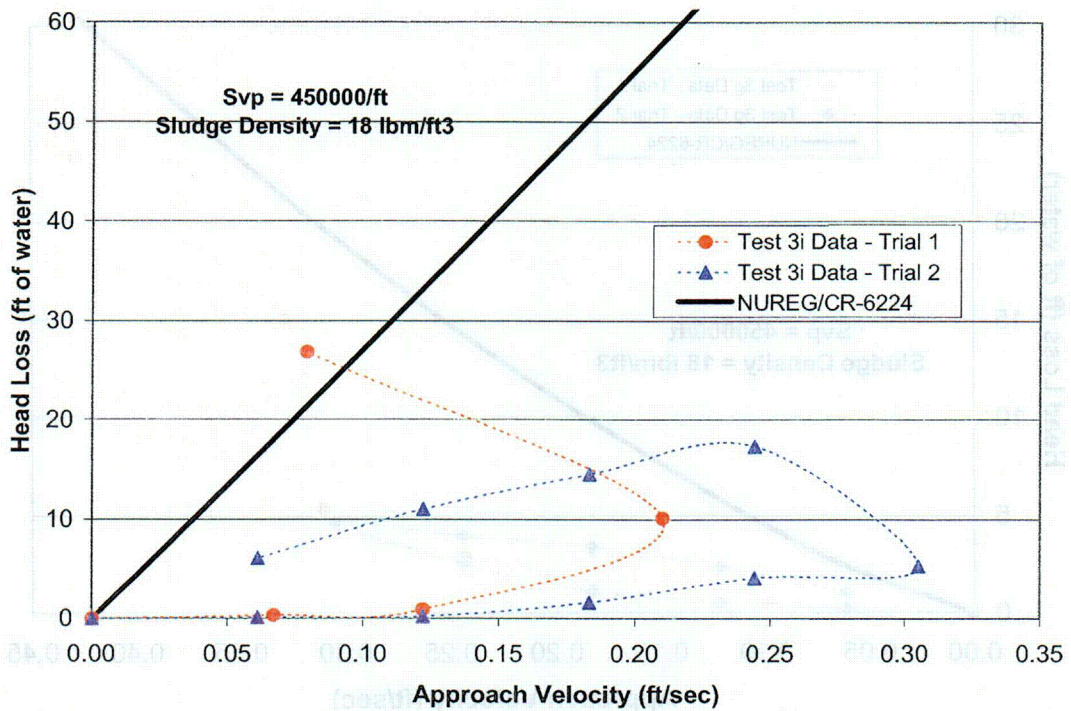
Figure 4.15. Comparison of Test 3i with NUREG/CR-6224 correlation.

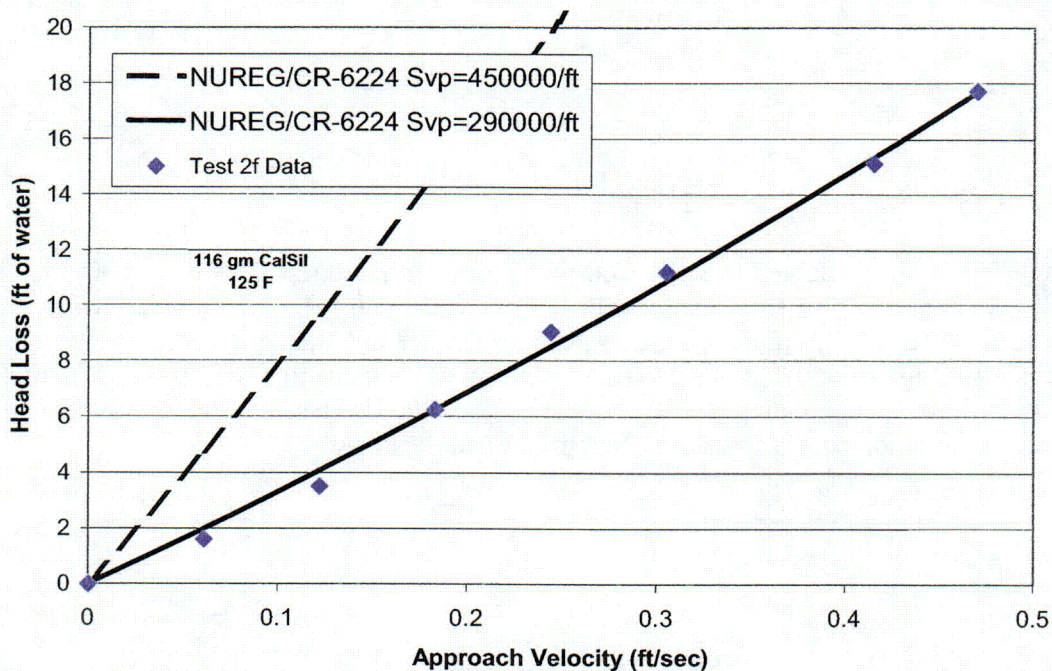
Figure 4.19. Comparison of Test 2f with NUREG/CR-6224 correlation.

The best of the six tests appears to be Test 2f, where 116 g of CalSil was used (i.e., thicker bed) and heated water was used so that the CalSil more readily disintegrated (i.e., fewer lumps in the CalSil). The data from Test 2f are compared with the NUREG/CR-6224 correlation in Figure 4.19 using specific surface areas of 290,000/ft and 450,000/ft. It is likely that a portion of the screen was not covered by CalSil, much as Tests 2b and 2c show in the photos in Figure 3.9. Such gaps in coverage would explain the discrepancy in the comparison.

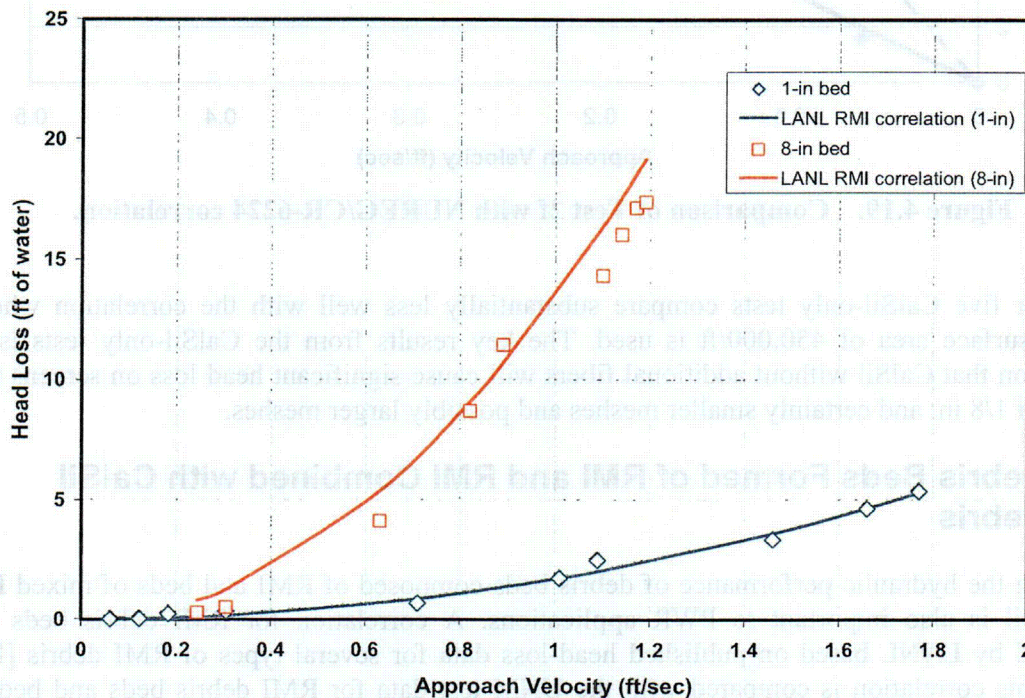
Figure 4.20. Comparison RMI-only Tests 5a and 5b with LANL RMI correlation.

The interfoil gap thickness is specific to a particular manufactured RMI design. In the current analysis, a value of 0.011 shows an excellent agreement with the data from the two RMI only debris tests, as shown in Figure 4.20. K_t values for the 2.5-mil stainless-steel insulation used by U.S. vendors range from 0.01 to 0.014 (ft), depending on the general size of the RMI debris, with the 0.01-ft value corresponding to smaller debris [Rao, 2003]. The RMI debris test data are well within the correlation parameters developed from earlier testing.

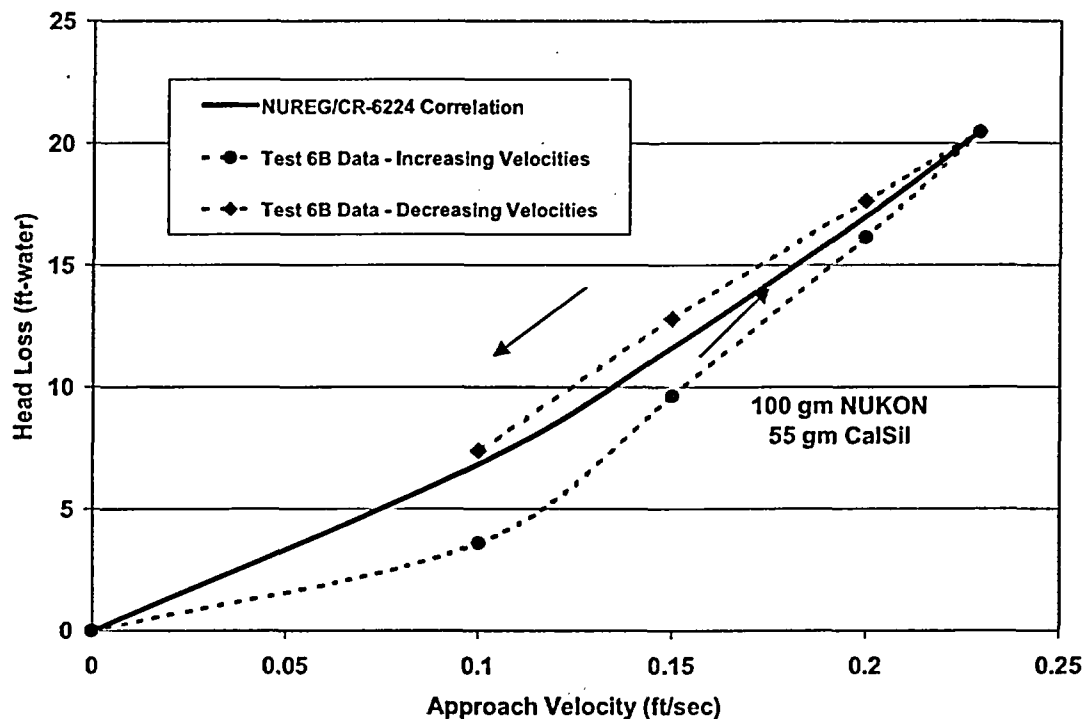
Figure 5.5. Comparison of NUREG/CR-6224 correlation with Test 6B head-loss data.

assumed to have accumulated in the debris bed, and the water temperature was the temperature at the highest velocity tested (111°F). The specific surface area that predicted the highest velocity data point was 543,000/ft. The head-loss data taken with both increasing and decreasing velocities are shown. At the highest velocity of 0.23 ft/s with an associated head loss of 20.5 ft, the limits of the apparatus had been reached because the piping had begun to vibrate sufficiently to generate a safety concern.

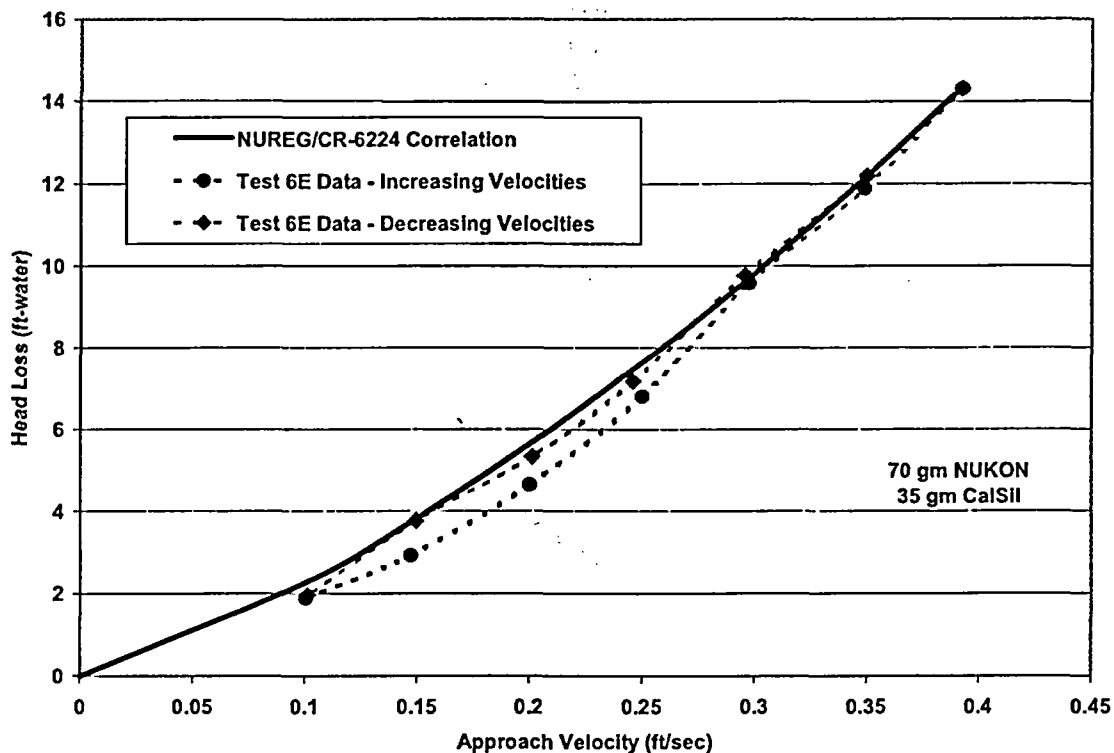
Figure 5.7. Comparison of NUREG/CR-6224 correlation with Test 6E head-loss data.

The head-loss data for Test 6E are compared with the NUREG/CR-6224 correlation in Figure 5.7, where the CalSil specific surface area again was adjusted until the correlation predicted the data point at the highest velocity tested. In this prediction, the entire 35 g of CalSil was assumed to have filtered from the debris bed and the water temperature for this data point was 129°F. The specific surface area that predicted the highest velocity data point was 423,000/ft. Head-loss data associated with both increasing and decreasing velocities are shown. At the highest velocity of 0.39 ft/s with the associated head loss of 14.3 ft, the flow regulation valve was fully open, with the flow passing through the small flow meter (2-in. pipe). A higher flow could have been achieved by switching to the large flow meter (6-in. pipe with less flow resistance); however, the transition would have put the integrity of the debris bed at an unnecessary risk. If the head-loss measurements had been taken at higher flow rates, a larger value for the specific surface area might have been determined.

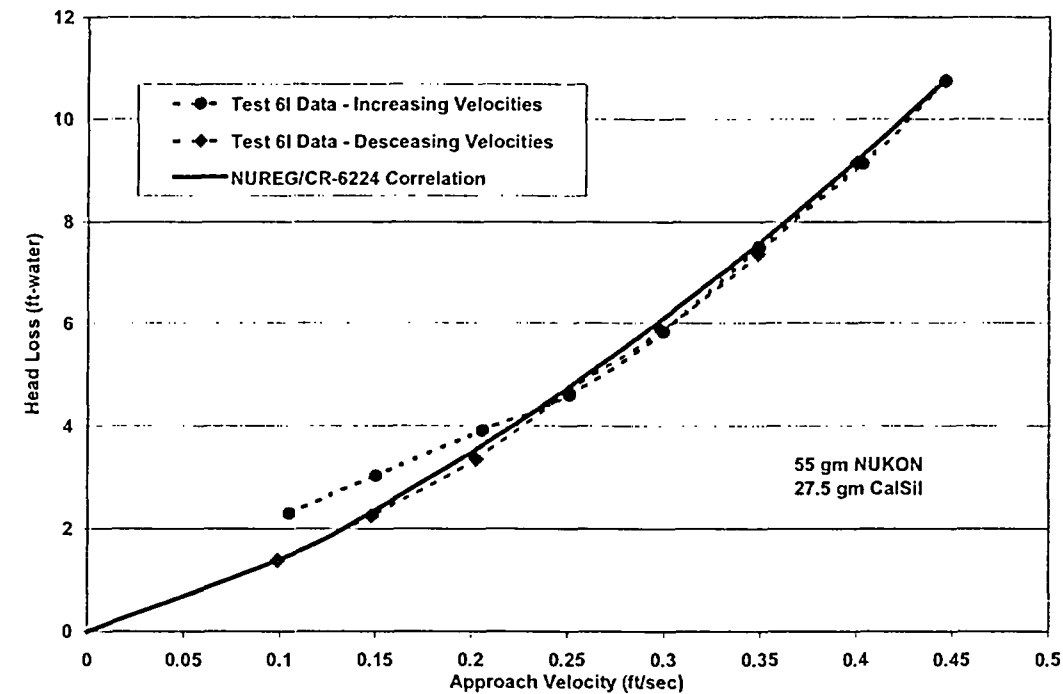
Figure 5.8. Comparison of NUREG/CR-6224 correlation with Test 6I head-loss data.

The head-loss data for Test 6I are compared with the NUREG/CR-6224 correlation in Figure 5.8, where the CalSil specific surface area again was adjusted until the correlation predicted the data point at the highest velocity tested. In this prediction, the entire 27.5 g of CalSil was assumed to have filtered from the debris bed, and the water temperature for this data point was 138°F. The specific surface area that predicted the highest velocity data point was 382,000/ft. The head-loss data associated with both increasing and decreasing velocities are shown. At the highest velocity of 0.46 ft/s with an associated head loss of 10.8 ft, the flow regulation valve was fully open, with the flow passing through the small flow meter (2-in. pipe).

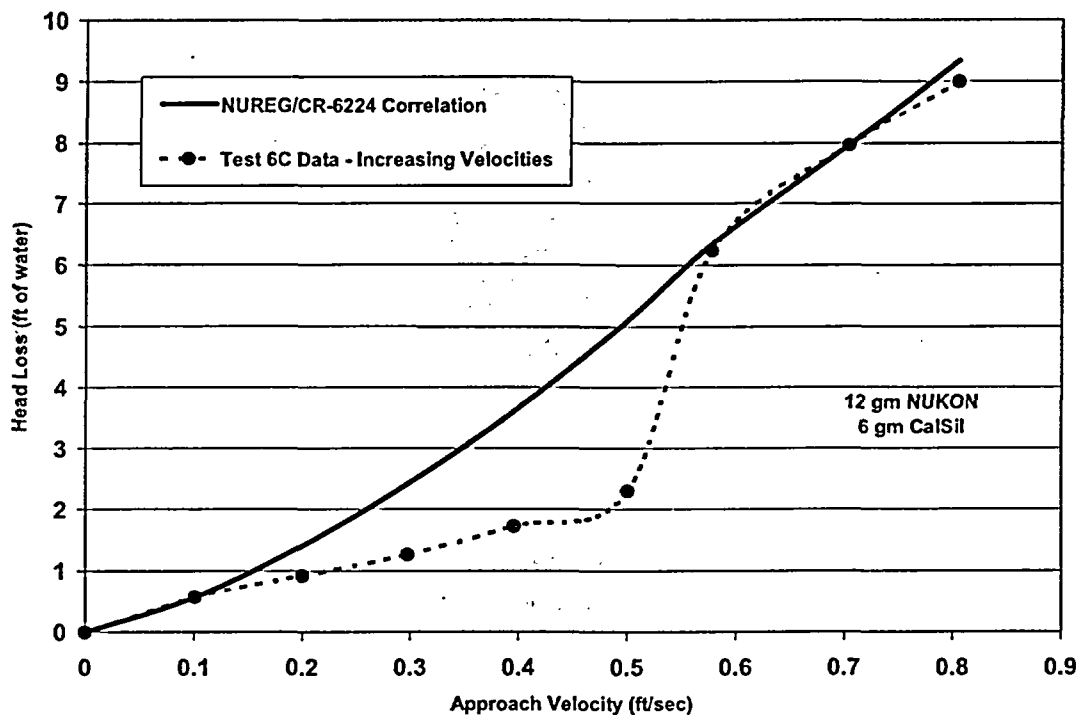
Figure 5.11. Comparison of NUREG/CR-6224 correlation with Test 6C head-loss data.

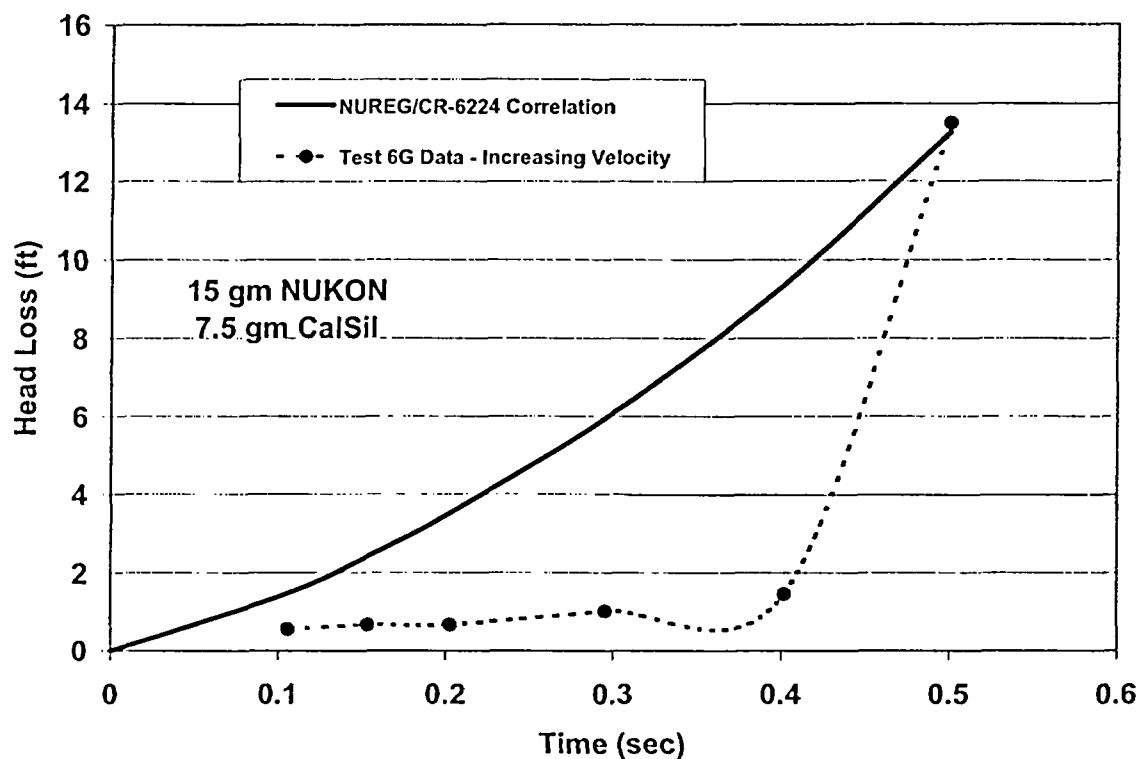
Figure 5.14. Comparison of NUREG/CR-6224 correlation with Test 6G head-loss data.
