**GSI-191: Experimental Studies of
Loss-of-Coolant-Accident-Generated
Debris Accumulation and Head Loss with
Emphasis on the Effects of Calcium Silicate
Insulation**

Los Alamos National Laboratory

**U.S. Nuclear Regulatory Commission
Office of Nuclear Regulatory Research
Washington, DC 20555-0001**

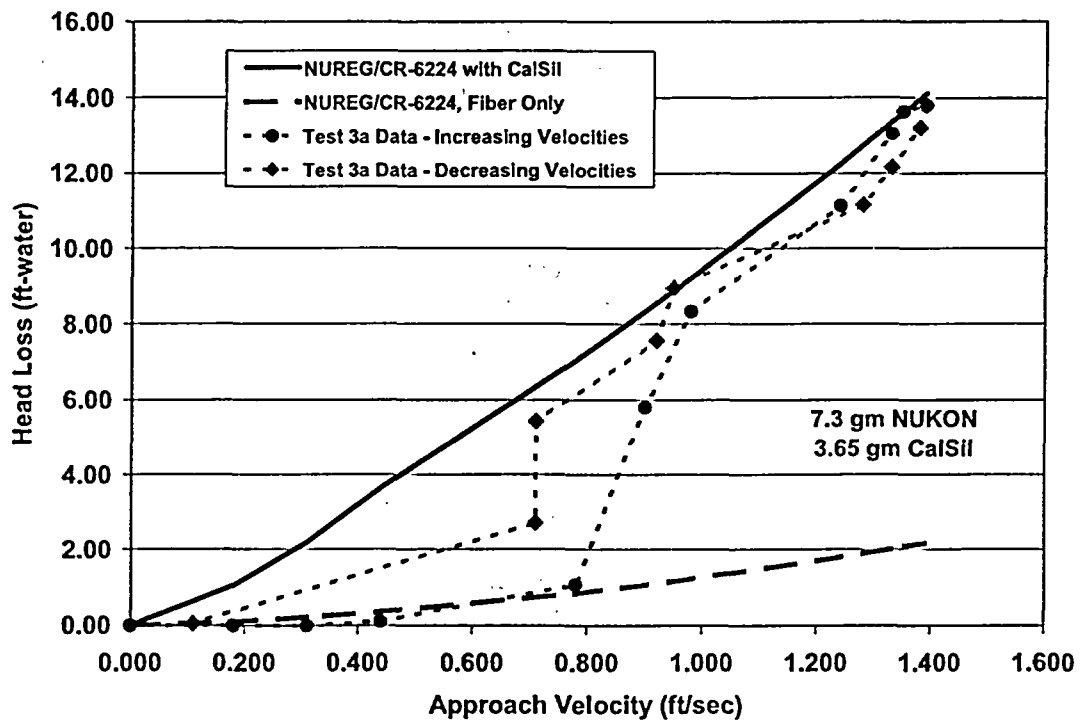
Figure 5.15. Comparison of NUREG/CR-6224 correlation with Test 3a head-loss data.

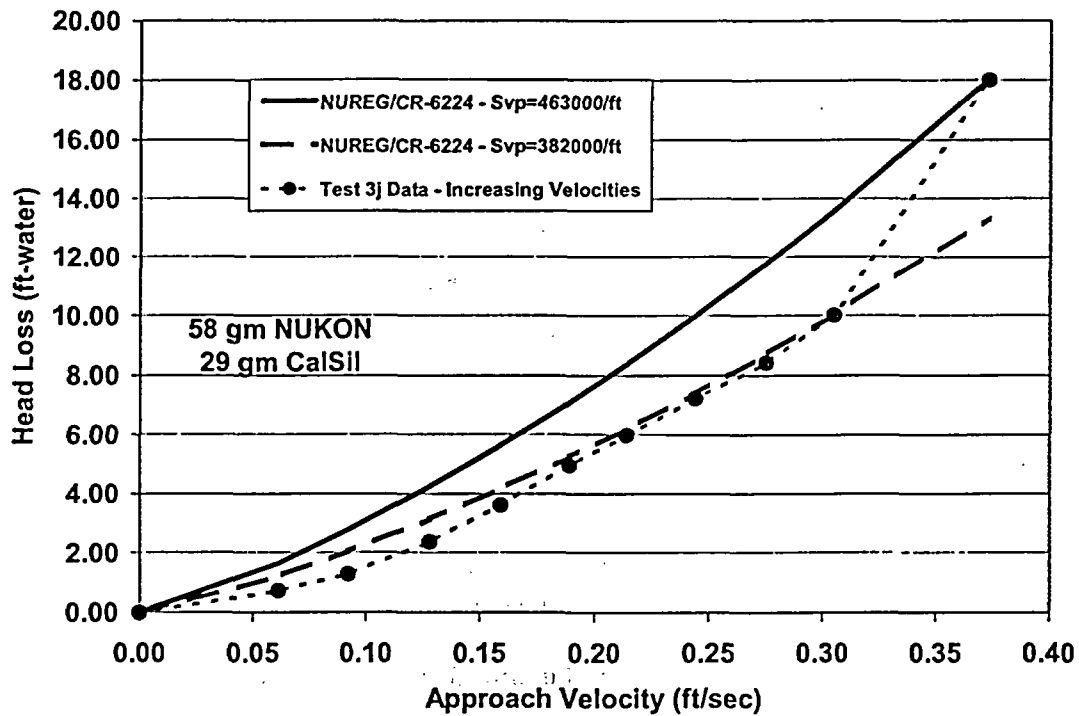
Figure 5.16. Comparison of NUREG/CR-6224 correlation with Test 3j head-loss data.

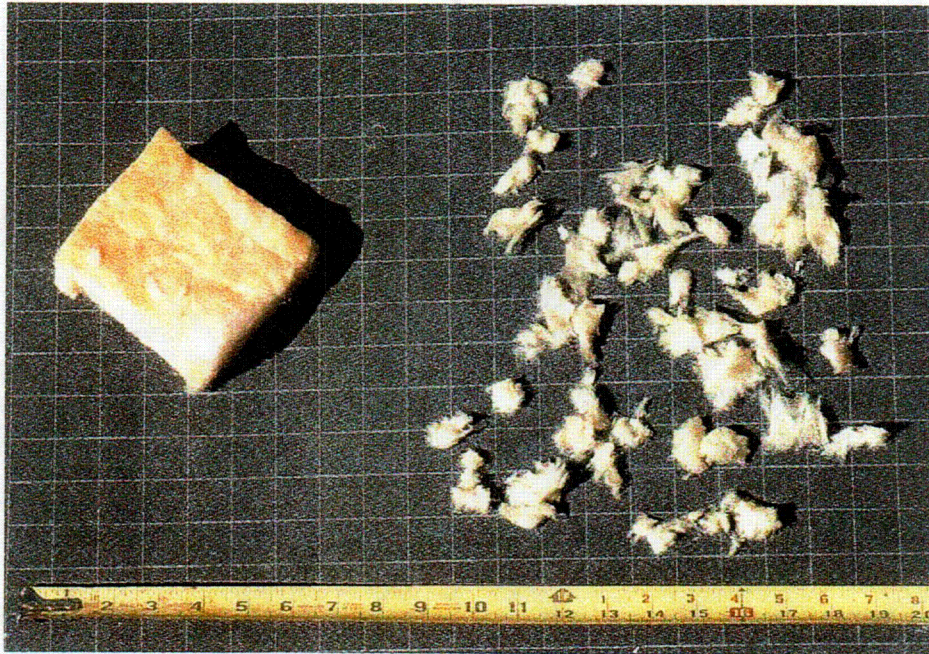
Figure C.1. NUKON™ fiber debris samples.

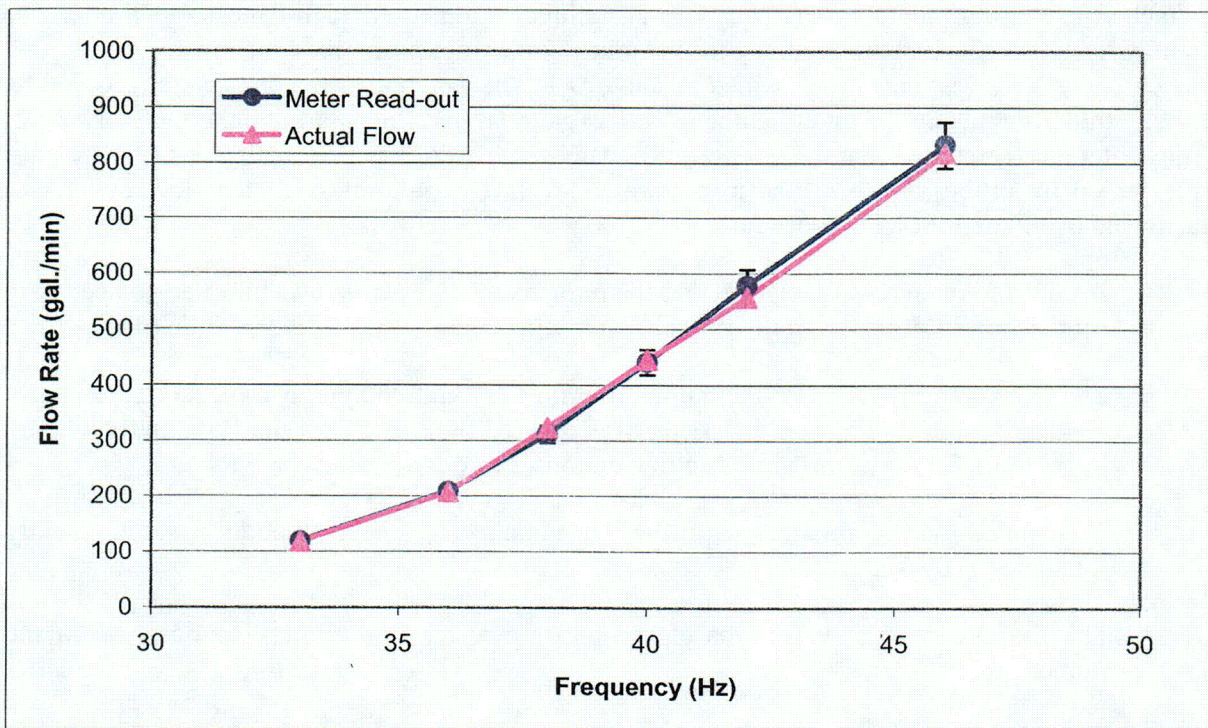
Figure D.1. Comparison of meter readout with actual flow measurements.

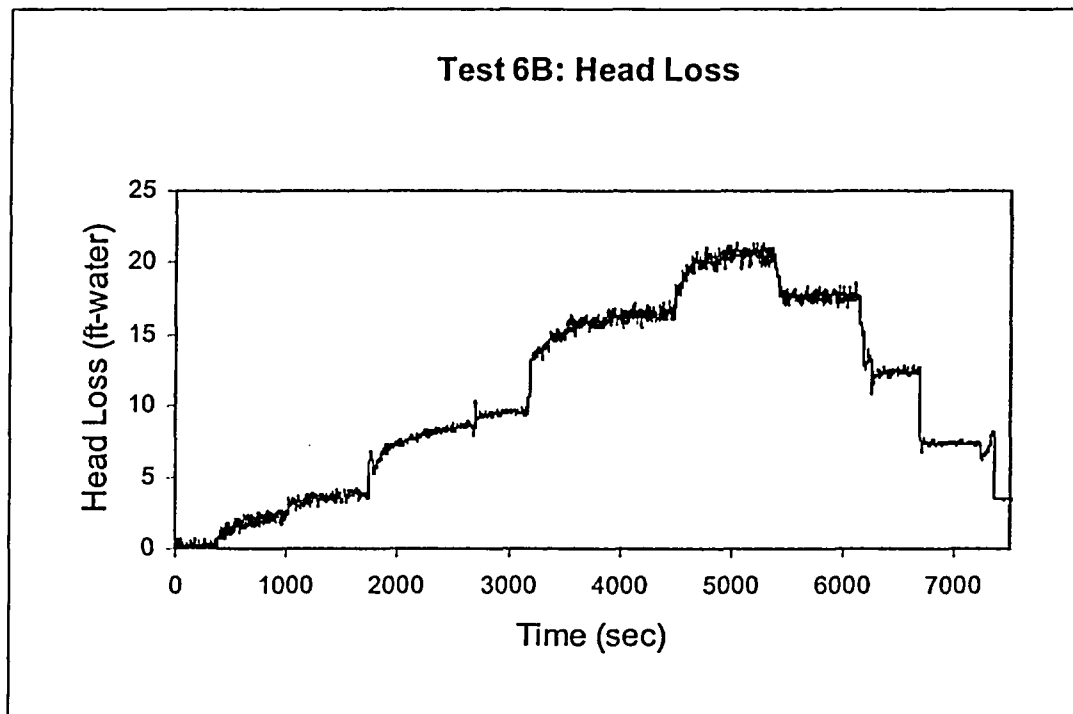
Figure F.1. Test 6B head-loss measurements.

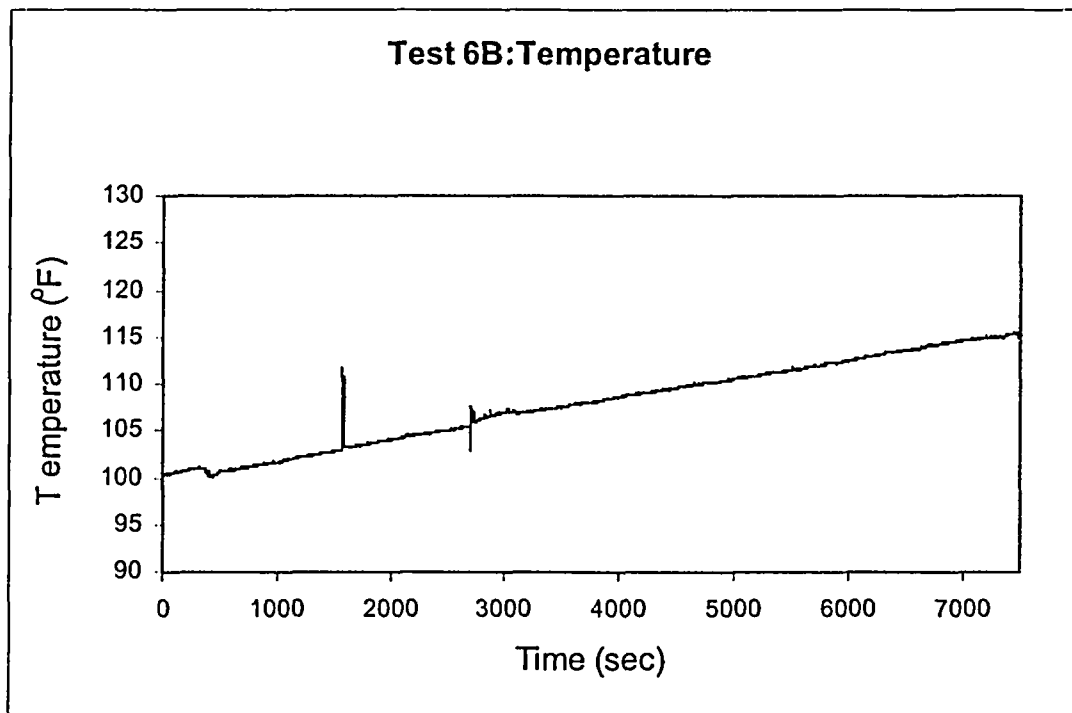
Figure F.2. Test 6B temperature measurements.

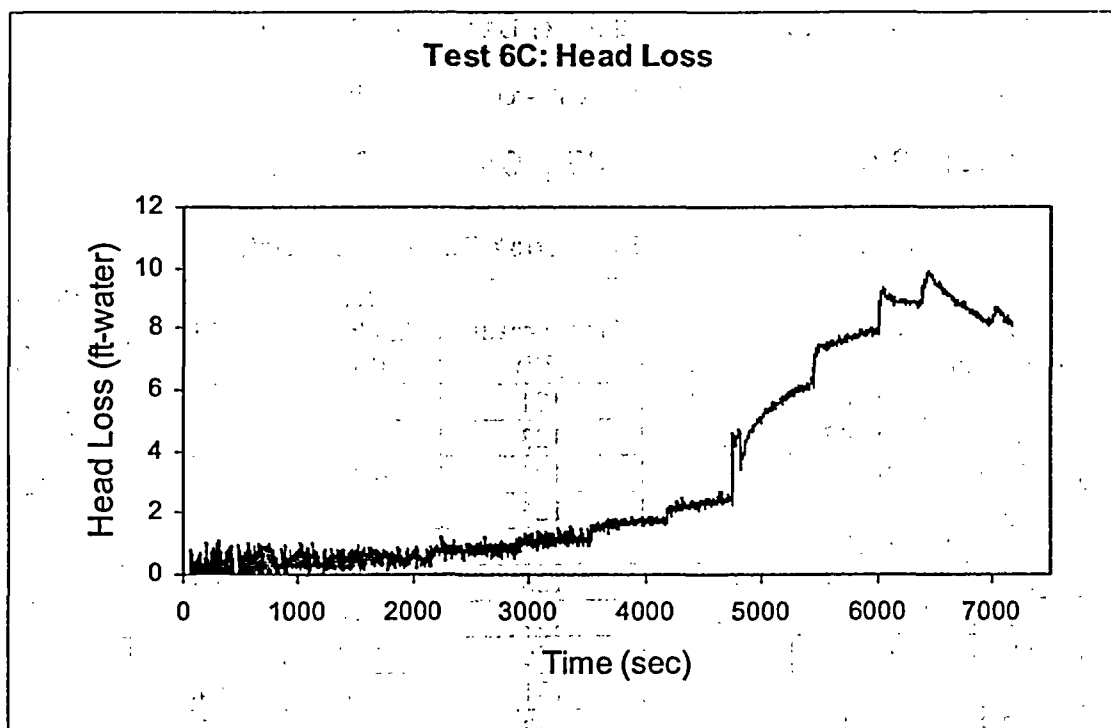
Figure F.3. Test 6C head-loss measurements.

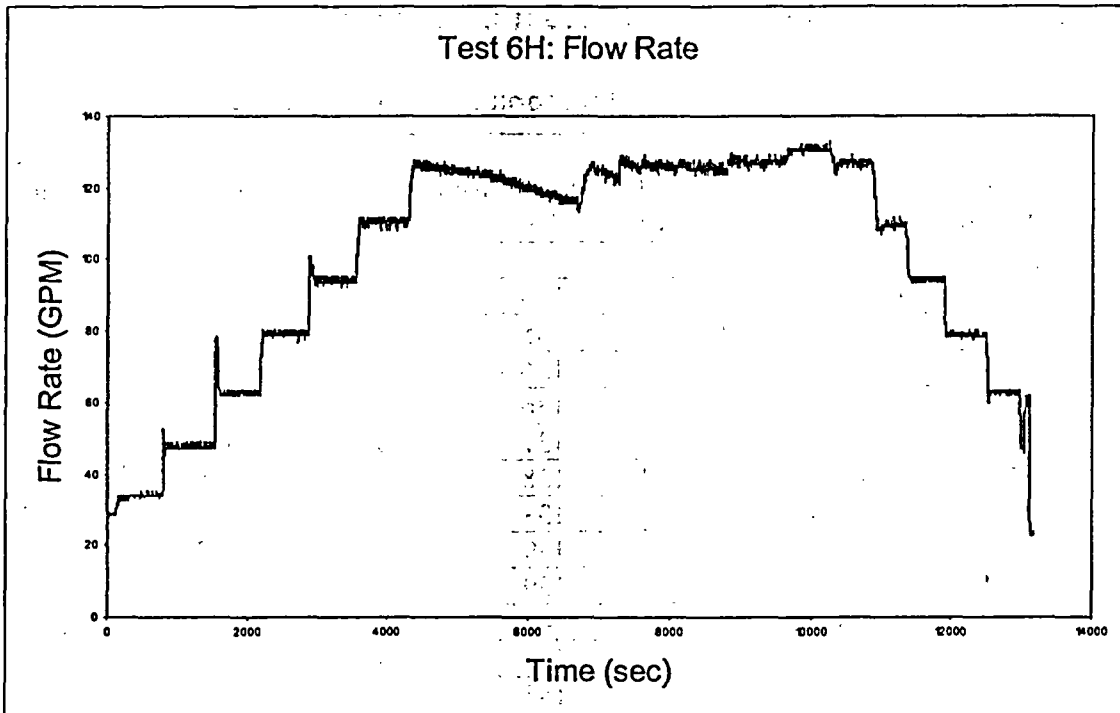
Figure F.10. Test 6H flow measurements.

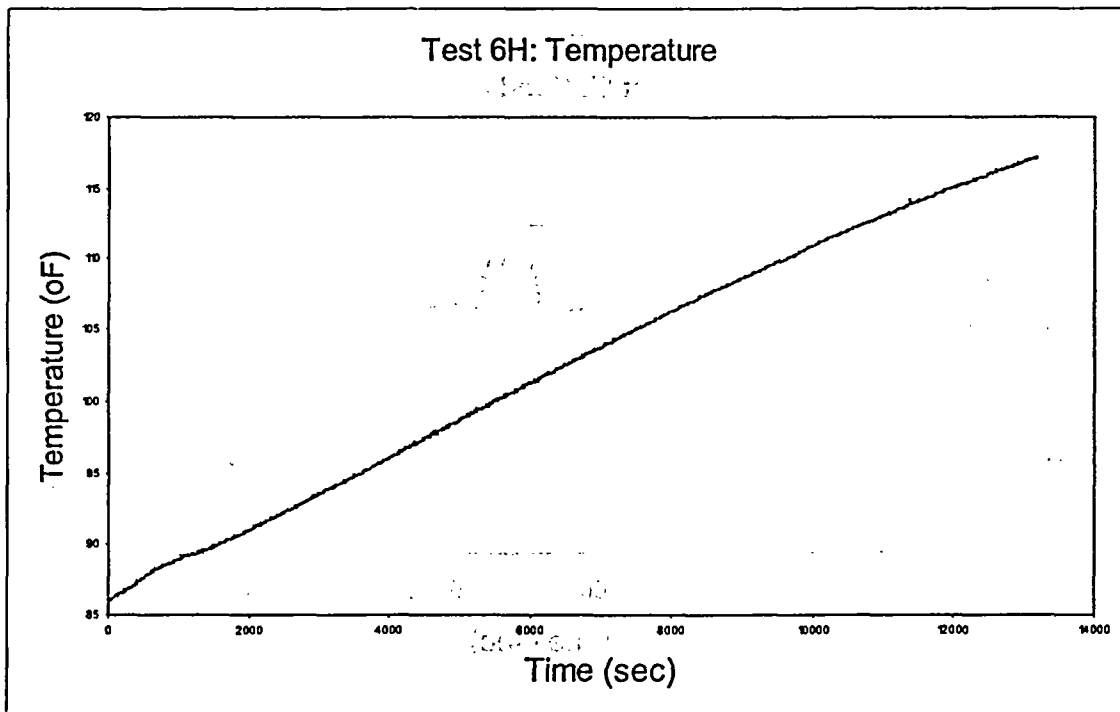
Figure F.11. Test 6H temperature measurements.

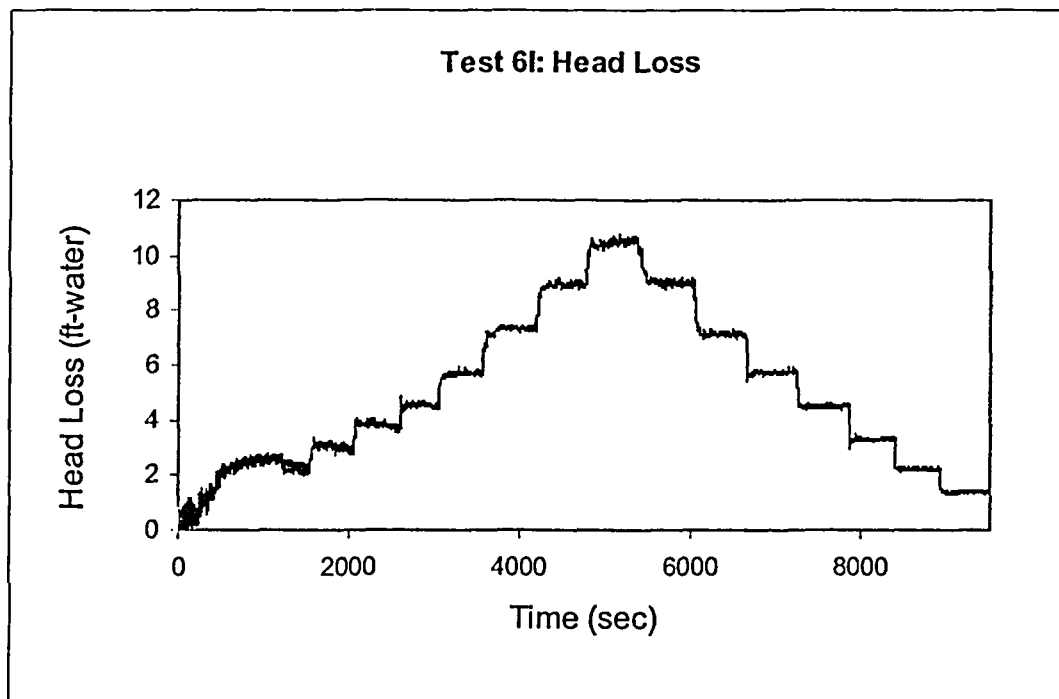
Figure F.12. Test 6I head-loss measurements.

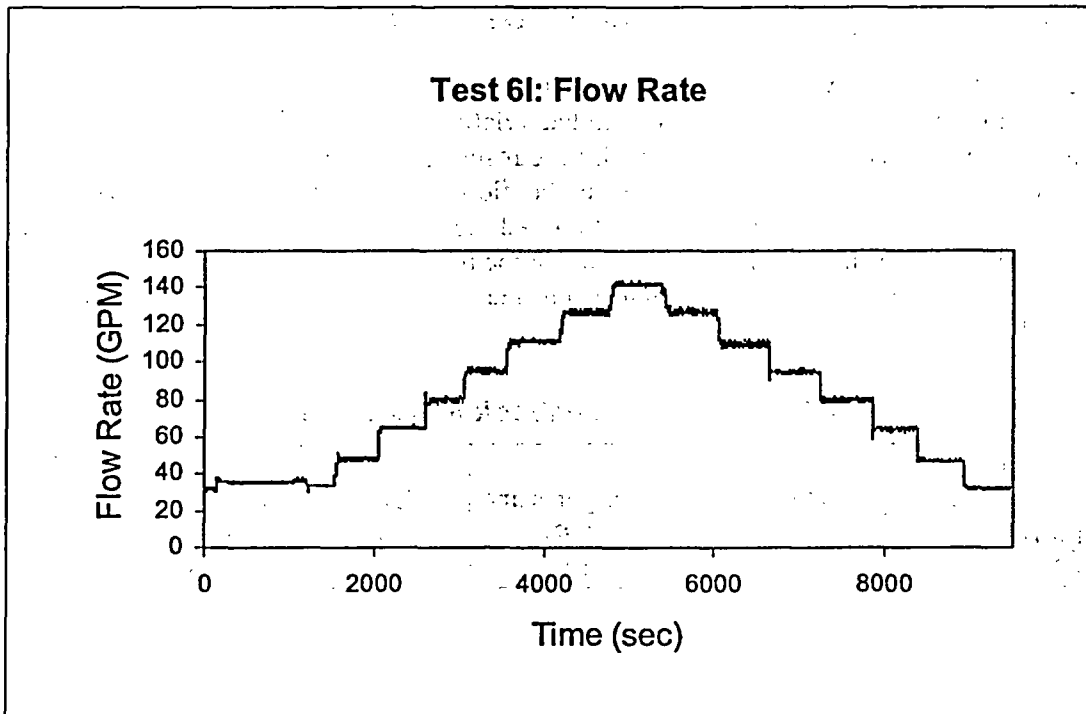
Figure F.13. Test 6I flow measurements.

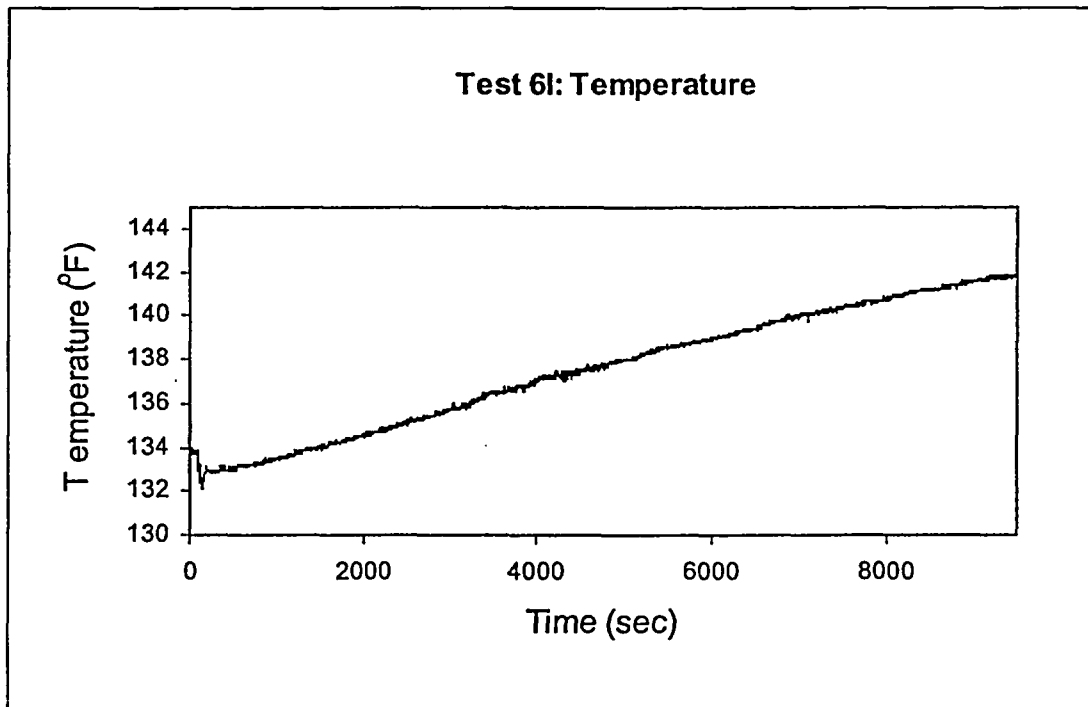
Figure F.14. Test 6I temperature measurements.
