Effects of Insulation Debris on Throttle-Valve Flow Performance

A Subtask of GSI-191

Los Alamos National Laboratory

**U.S. Nuclear Regulatory Commission
Office of Nuclear Regulatory Research
Washington, DC 20555-0001**

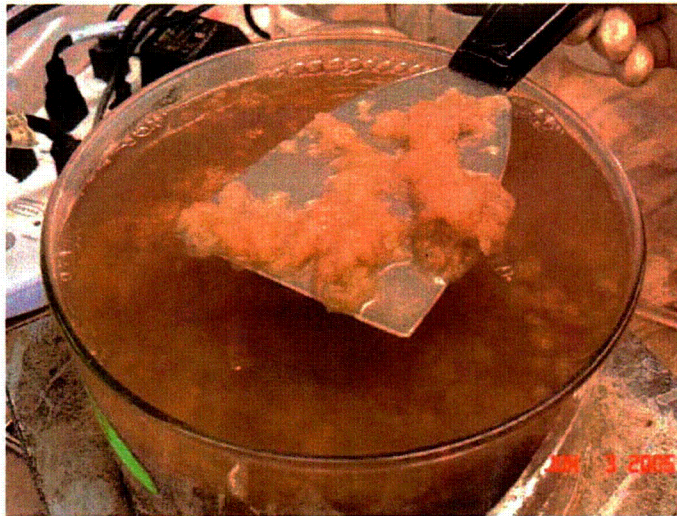
Figure 2-22. NUKON after Processing by Kitchen Blender

kitchen blender (Black and Decker, Model BL6000). Cold tap water was added in sufficient quantity to cover the NUKON fiber. The NUKON and water first were mixed at low speed for 2 min. Then the blender was turned off, and any NUKON fiber was flushed from the sides of the blender chamber. Then the NUKON and water was mixed at medium speed for 3 min. This process produced a slurry mix of NUKON and water, as shown in Figure 2-22. The NUKON and water slurry then was placed in a separate container before testing. All of the NUKON on the blender was flushed from the blender with water. The NUKON quickly settled to the bottom of the container. The NUKON slurry may have sat for several hours or days before being used in a test. When the NUKON slurry was to be placed in the debris insertion manifold, it was first mixed using a metal spoon. Some of the water that was in the manifold had to be removed to provide space for the NUKON slurry. This process was accomplished by draining the manifold before testing or by using a portable wet-dry vacuum. When the NUKON slurry was added to the debris insertion manifold, any space remaining was filled with tap water so that large air pockets were not created in the manifold. On several tests, the volume of the NUKON slurry exceeded the volume available in the manifold. With these tests, any excess NUKON slurry was oven-dried so that the weight of the excess could be subtracted from the original weight of the NUKON.

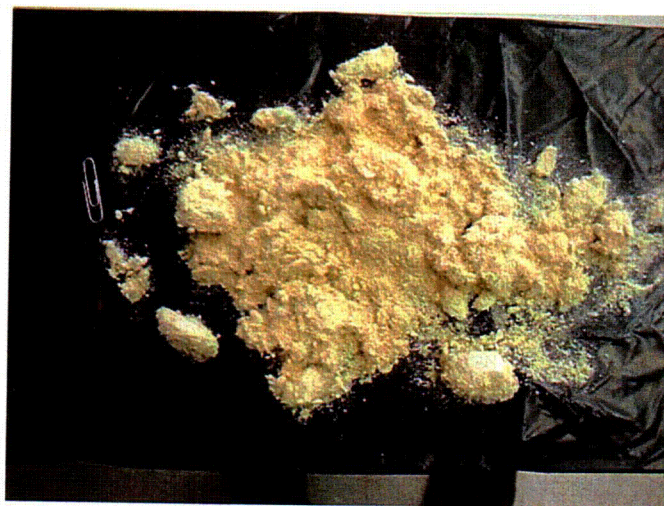
Figure 2-23. CalSil Sample

passing the material through a #4 [4.75-mm (0.19 in.)] or #8 [2.36-mm (0.09-in.)] sieve; the material that passed through the sieve was retained for testing. The material remaining on the sieve was removed, further crushed with a rubber-tipped pestle, and returned to the sieve. After several passes of crushing and sieving, any material remaining on the sieve was discarded. Except for one test, all of the CalSil used in the throttle valve test had passed a #4 or #8 sieve. For one test (test 5sc9) unsieved CalSil from the initial broken sample was tested. Most of the CalSil that had passed through the sieves was much finer than the sieve size, and little visual difference was observed between the CalSil that had passed the #4 sieve and the CalSil that had passed the #8 sieve. Before testing in the throttle valve apparatus, the appropriate quantity of dry CalSil was obtained with a 0.01-g balance. Then tap water was added in a sufficient quantity and mixed with the CalSil to form a slurry. Water in the debris insertion manifold was removed to provide space for the CalSil slurry using the same procedure as with the NUKON insulation.

In addition to the tests listed in Table 4-5, a test was performed with unsieved CalSil (Figure 2-23) using the 45L stem and an opening of 0.1 in. This bounding test was performed for the purpose of demonstrating test procedures to visiting NRC personnel, so the CalSil could not be characterized sufficiently before the test. The transient data are shown in Figure 4-6. The loss coefficient, *K*, increased by ~25% shortly after debris introduction but then decreased gradually over the remainder of the test. It appeared that unsieved CalSil clogged the valve initially but that the clogged debris eroded gradually over time, resulting in a reduction in the loss coefficient.

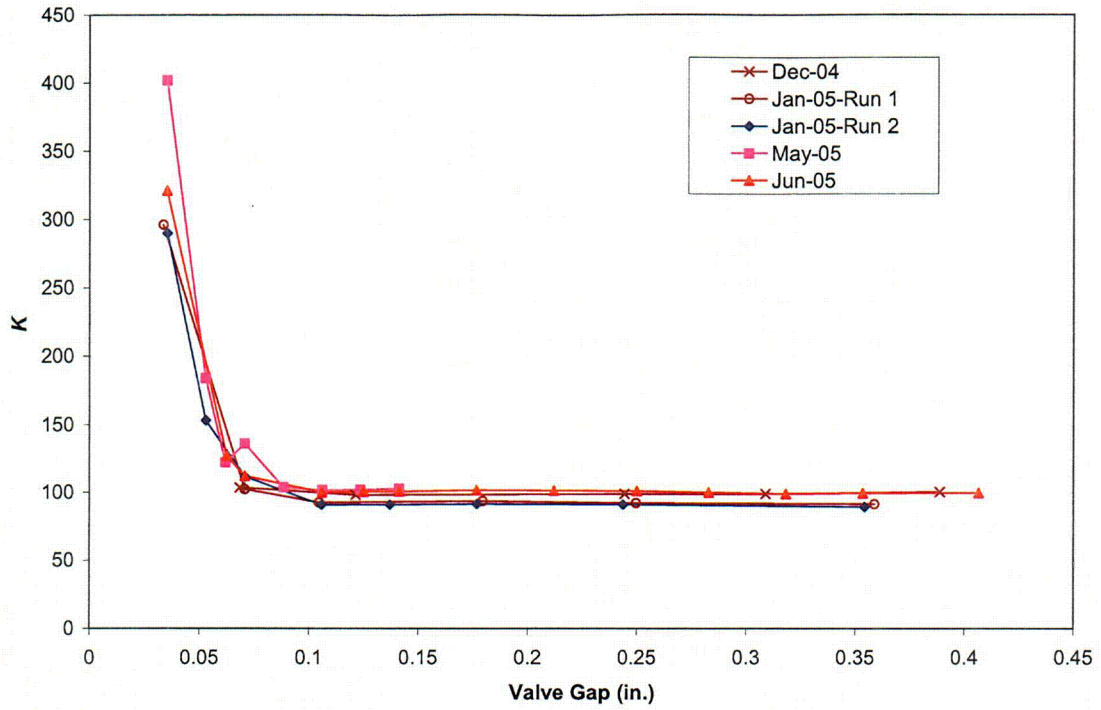
Figure 3-1. Baseline Data for 45L

The changes in K over time discussed previously did not impact the results of the current study adversely. The objective of evaluating debris blockage effects primarily required consideration of the change in K relative to the baseline established just before each test. Therefore, the absolute value at the beginning of the test is not that important. Additionally, most testing was conducted using larger valve gaps where K values do not vary much throughout the various baseline measurements (Figures 3-1 to 3-3).

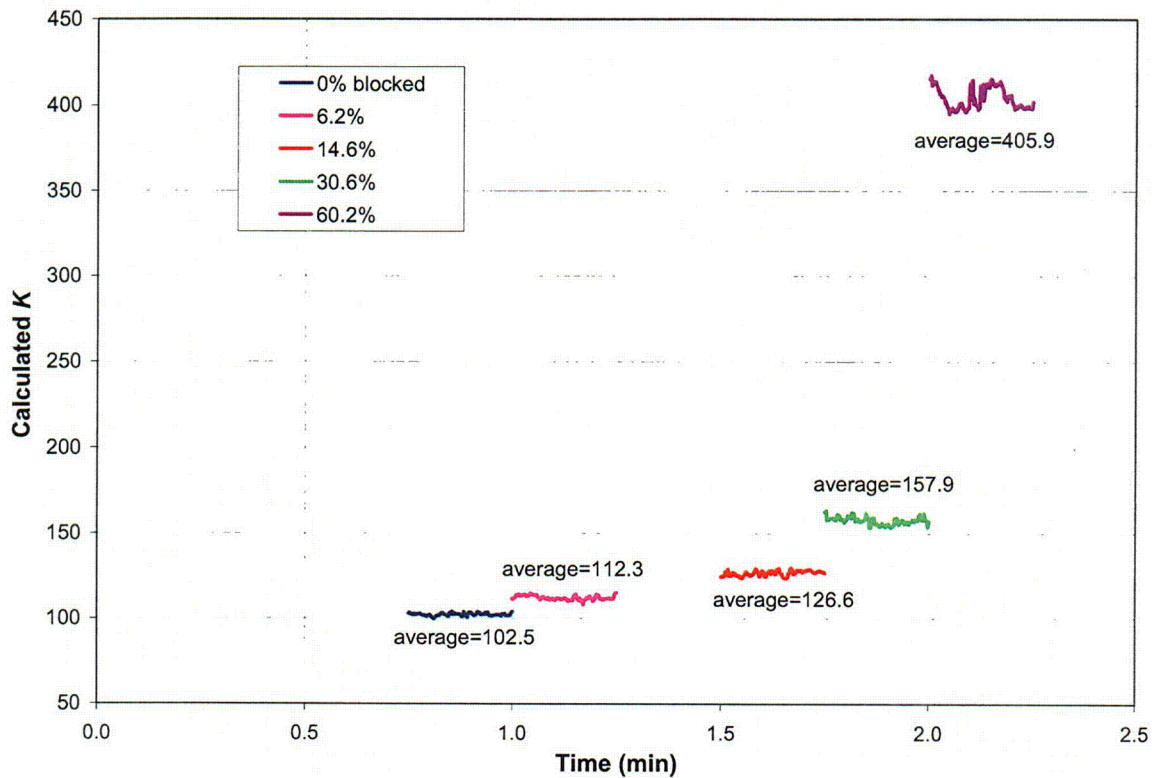
Figure 3-5. Transient Variation of K for Different Blockage Conditions

but it is reasonable to estimate that the detection threshold for the 45L valve configuration was on the order of 5% blockage of the flow area.

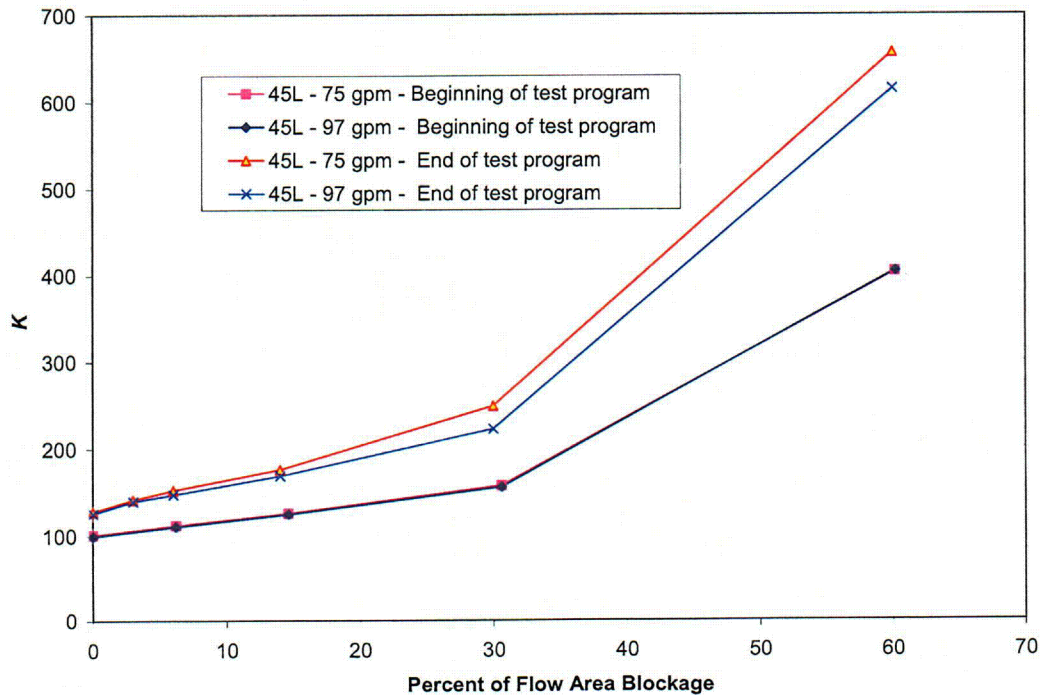
Figure 3-6. Blockage Test Data for 45L, Valve Opening = 0.159 cm (0.0625 in.)

Figure 3-6 also shows the shim test data for the 45L valve configuration, and Figure 3-7 presents the same data as a plot of the increase in K relative to unblocked flow ($\Delta K\%$). As seen in Figure 3-6 and Figure 3-7, the data for 45L, especially at 60% blockage, show a pronounced increase in K between the beginning and end of the test program. This increase is due to the combined effects of the pieces being remachined early in the test program followed by wear processes introduced during testing. However, there is essentially no K dependence on flow rate.

As discussed in Section 3, baseline data for known blockage conditions were obtained for the 45L and the 5L valve configurations for valve openings of 0.159 cm (0.0625 in.) and 0.13 cm (0.05 in.), respectively. Blockage-area fractions estimated using Eq. (3-2) for the NUKON tests using the 45L/0.159-cm (0.0625-in.)-opening and Eq. (3-3) for the 5L/0.13-cm (0.05-in.)-opening combinations are listed in Table 4-8. It should be noted that the shape of the blockage curves, as shown in Figure 3-6 and Figure 3-8, indicates
