**DOCKET NUMBER 50-483
CALLAWAY PLANT UNIT 1
UNION ELECTRIC CO.
FACILITY OPERATING LICENSE NPF-30
2005 ANNUAL ENVIRONMENTAL OPERATING REPORT**

2005 Callaway Plant

Annual Radiological Environmental Operating Report

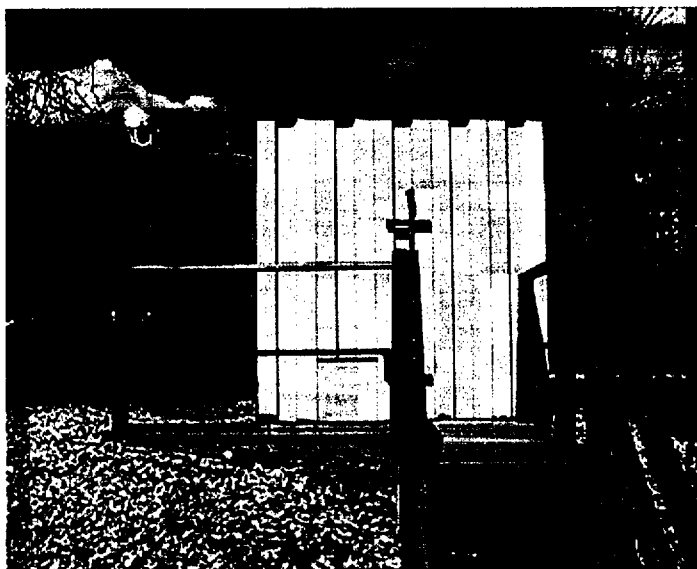
Sampling of the Missouri River is accomplished using an automated compositor. Samples are collected on an hourly basis and mixed to make the monthly composite sample. River sampling verifies that Callaway Plant discharges meet stringent regulatory requirements.
