NUREG/CR-7102
SAND2011-6548P

Kerite Analysis in Thermal Environment of FIRE (KATE-Fire): Test Results

Final Report

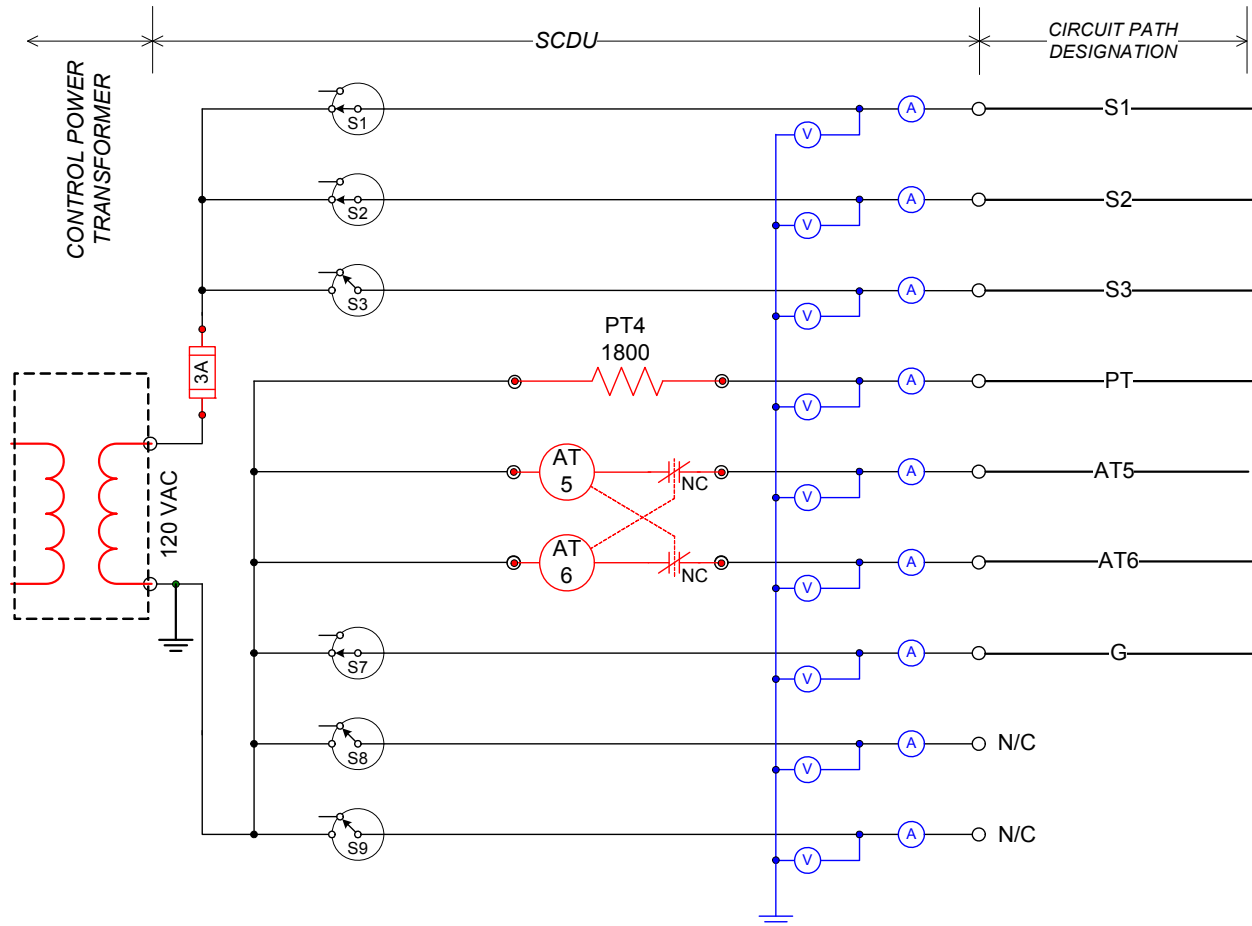
Figure 4.1: Circuit diagram for a generic SCDU including an active electrical interlock on the contactor pair.

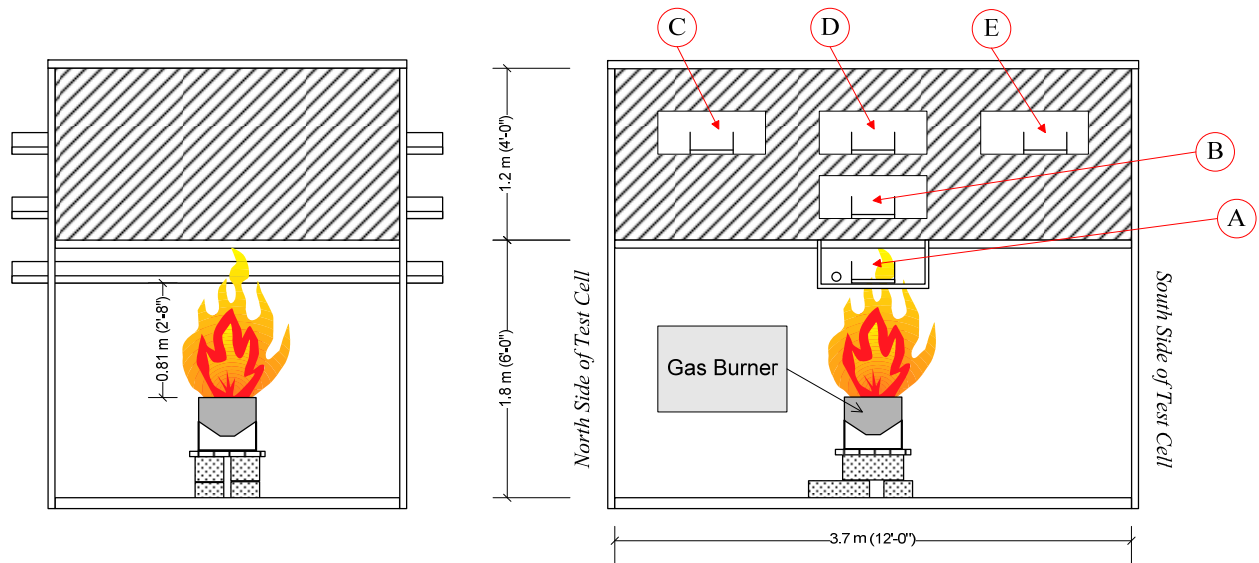
Figure 5.3: Schematic representation of the DESIREE-Fire intermediate-scale test structure.

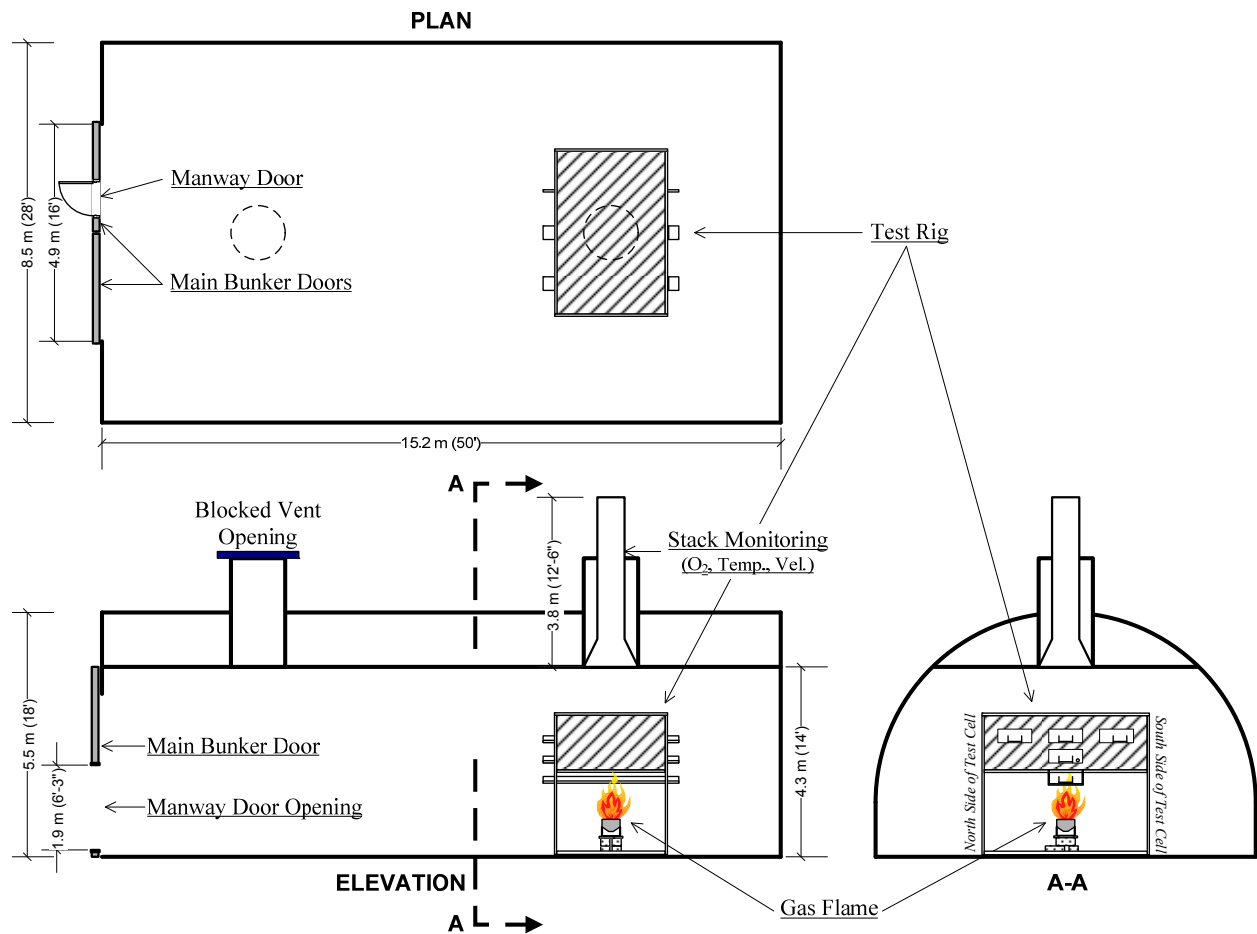
Figure 5.4: Schematic representation of the DESIREE-Fire intermediate-scale test structure located within the bunker facility.

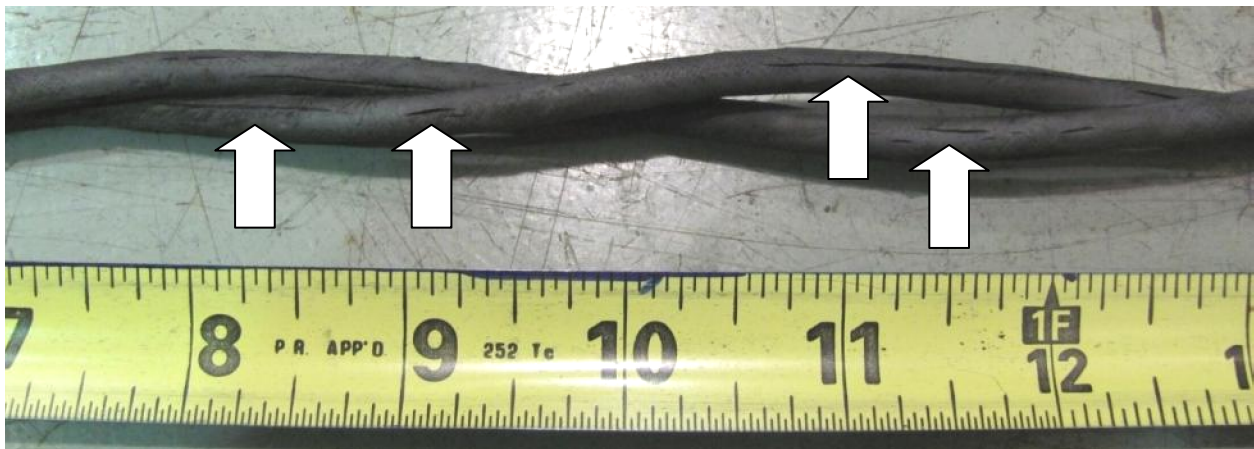
Figure 7.2: Longitudinal cracking along the conductors of Item A.

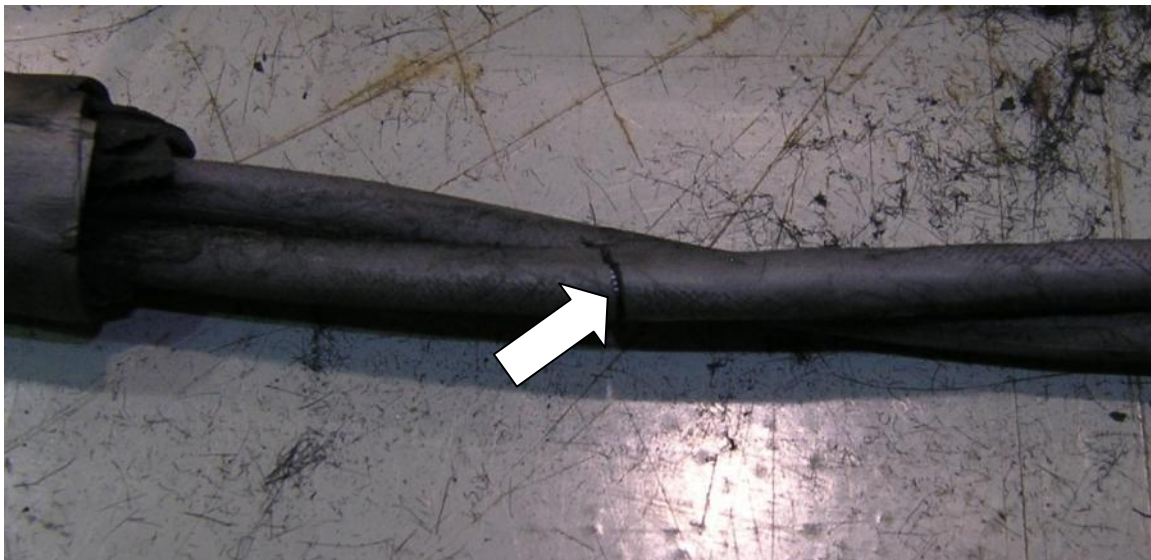
Figure 7.3: Circumferential cracking extending to the bare wire of Item A.

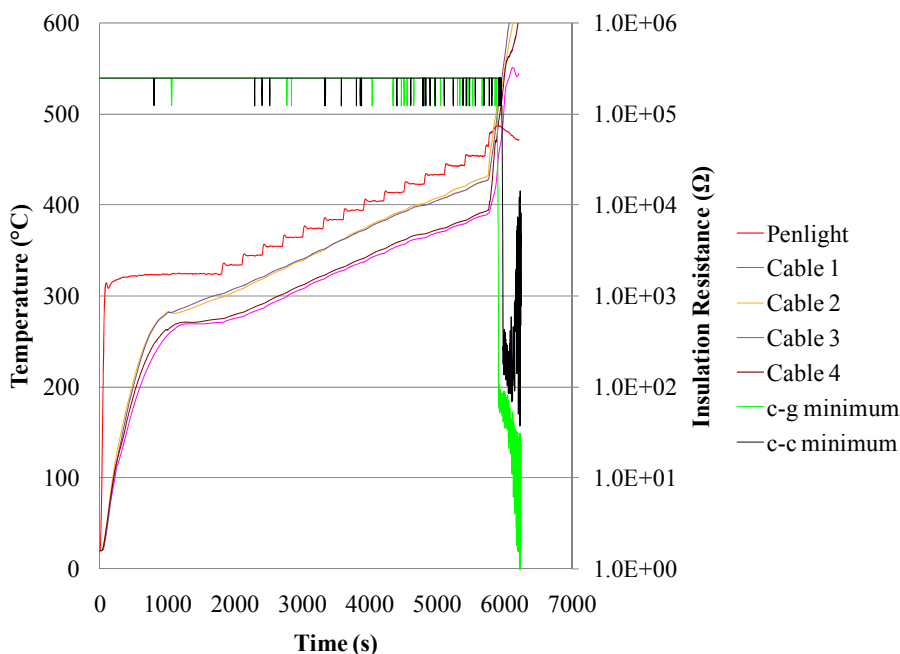
Figure 7.4 presents the failure of Item A during Test K16. Note that electrical failure occurred after ignition of the cable. The designation “c-c minimum” and “c-g minimum” represent conductor-to-conductor and conductor-to-ground IR values measured at each time step, respectively. The point of ignition is evident from the cable temperature plots based on the time (around 5600s) that these temperature traces suddenly depart from the general heating trend. From Figure 7.4, it is clear that the cable fails after ignition. Additional details from each of the Item A tests may be found in Appendix B.

Figure 7.4: IRMS data for Item A during test K16.

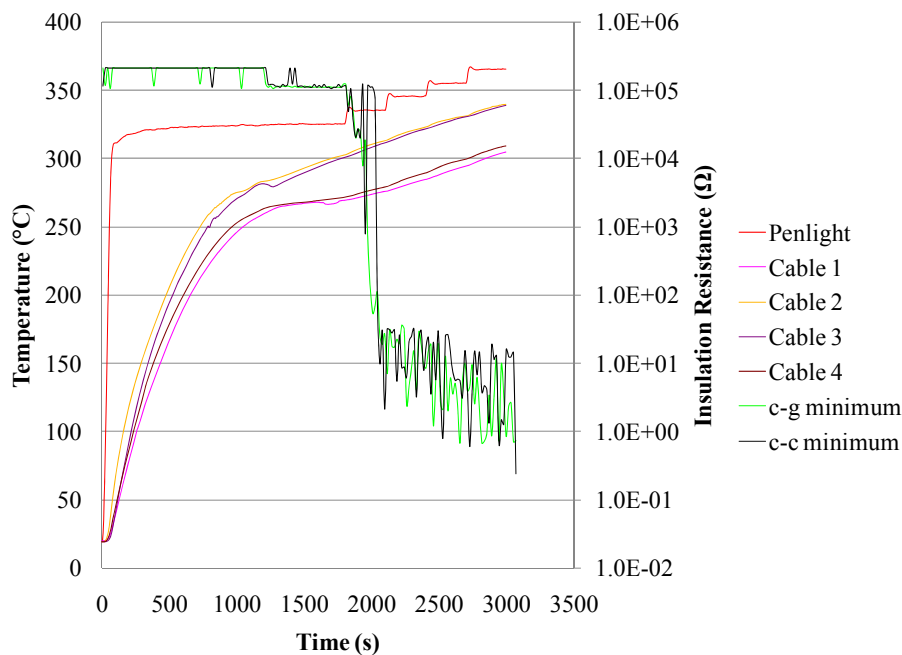
Three tests were conducted during KATE-Fire to gain additional insights on the failure behaviors for Item D. As previously mentioned, the IRMS system was utilized during two tests to investigate the extent of early cable degradation. Both of these tests revealed low impedance shorts (well below the nominal 1000 Ω criteria applied during CAROLFIRE) at relatively low temperatures. The results from Test K8, shown in Figure 7.12, indicate failure at 307°C. Results from Test K9, which failed at 311°C, may be found in Appendix B.

Figure 7.12: IRMS results from Test K8.

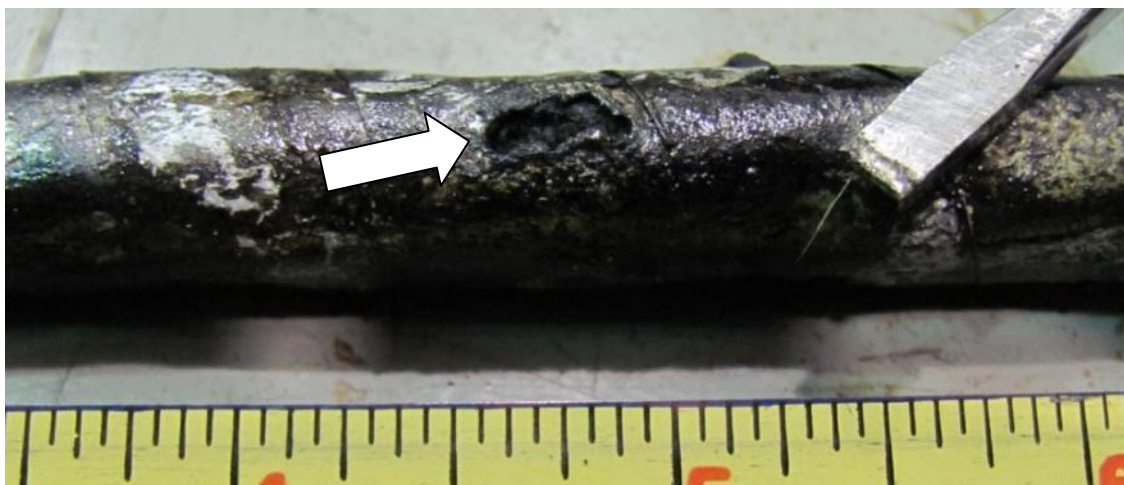
Figure 7.15: Larger hole found during the post-test analysis of Item D in Test K8.

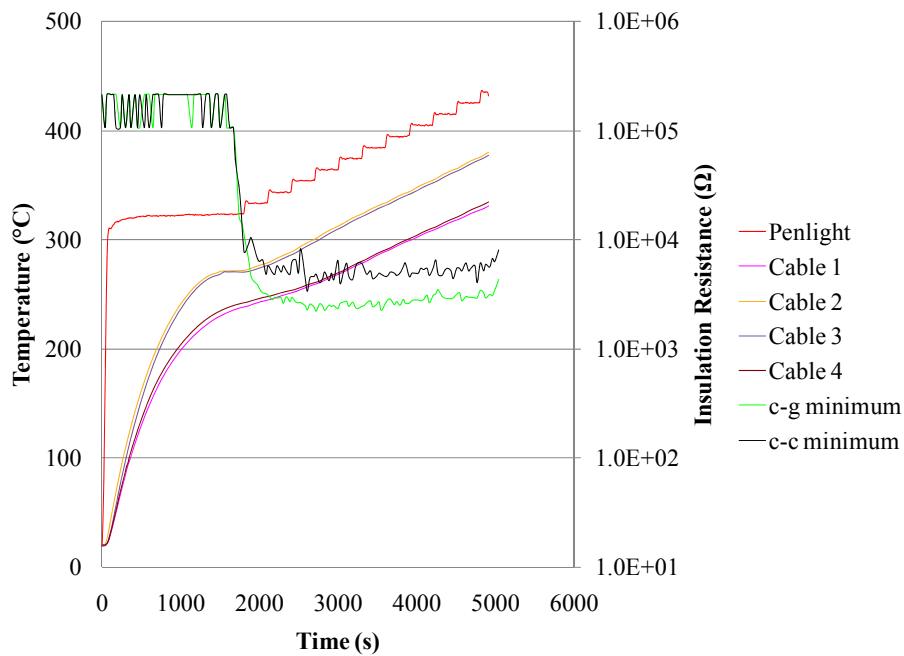
Figure 7.23: IRMS results from Test K6.

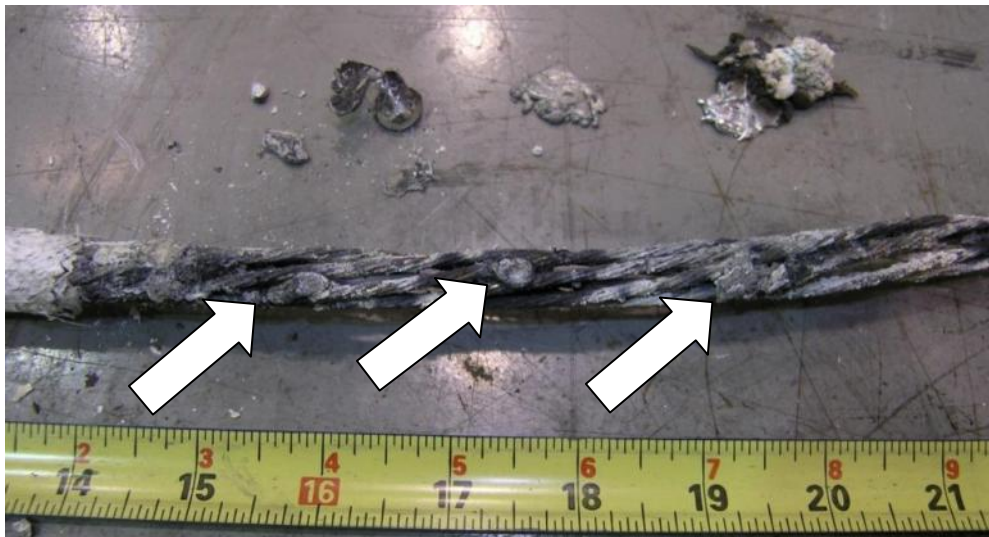
Similar low temperature degradation was observed in Test K7 beginning at a temperature of 285°C. The cable was taken to ignition and full failure. Ignition occurred at a cable temperature of roughly 417°C. The post-test cable analysis revealed zinc wrap slag adhered to the conductors as well as located at the bottom of Penlight, as illustrated in Figure 7.24. The zinc wrap welded multiple conductors together. It is not clear if this shielding occurred because of thermal influence or if it was related to electrical arcing. Zinc has a relatively low melting point at 419°C [13] and therefore it is entirely plausible that the heat produced by the ignition of the cable caused the wrap to melt onto the conductors. Low impedance shorting occurred abruptly and failures were detected shortly after ignition.

Figure 7.24: Zinc slag connecting conductors.

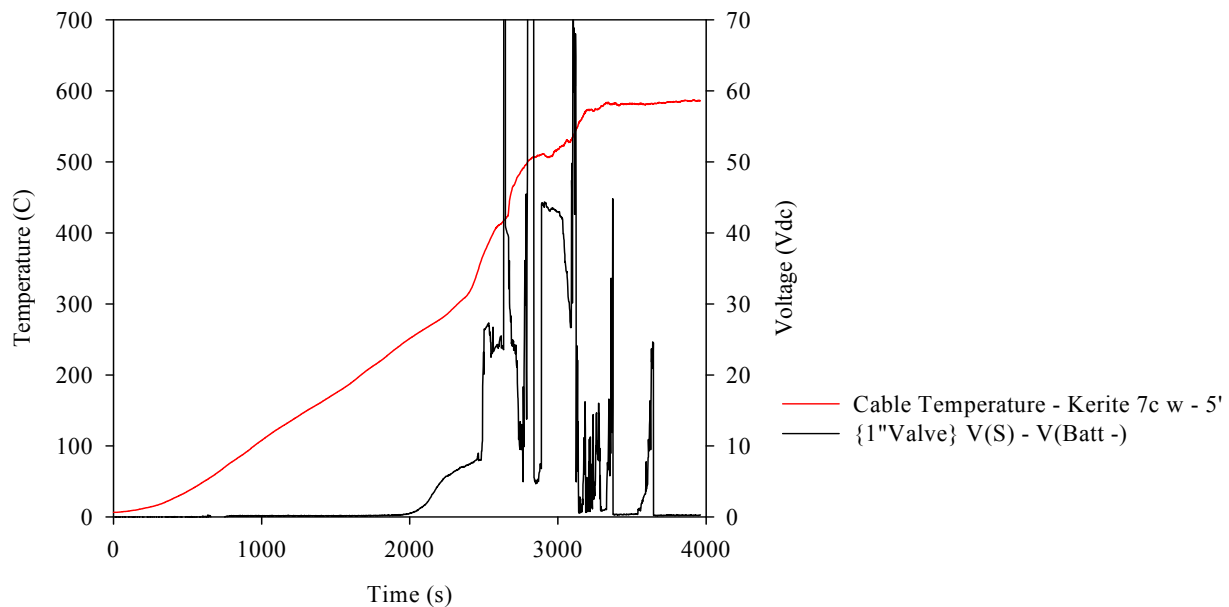
During Test IS10, the voltage increase detected on the target conductor is shown in Figure 7.25. The cable temperature is represented by a sub-jacket thermocouple located in the center of the thermally monitored cable. The as shown is the raw target voltage (i.e., V(S)) minus the negative battery reference voltage (i.e., V(Batt-)). This "corrected voltage" reflects the actual voltage applied across the valve coil. The voltage started increasing at approximately 1760 s to a maximum of 10 Vdc and then experienced an abrupt increase to about 25 Vdc at approximately 2400 s and a cable temperature of about 320°C. This cable ultimately experienced a hot short induced spurious actuation at about 2650 s.

Figure 7.25: Cable temperature and electrical response of Item E during Test IS10.

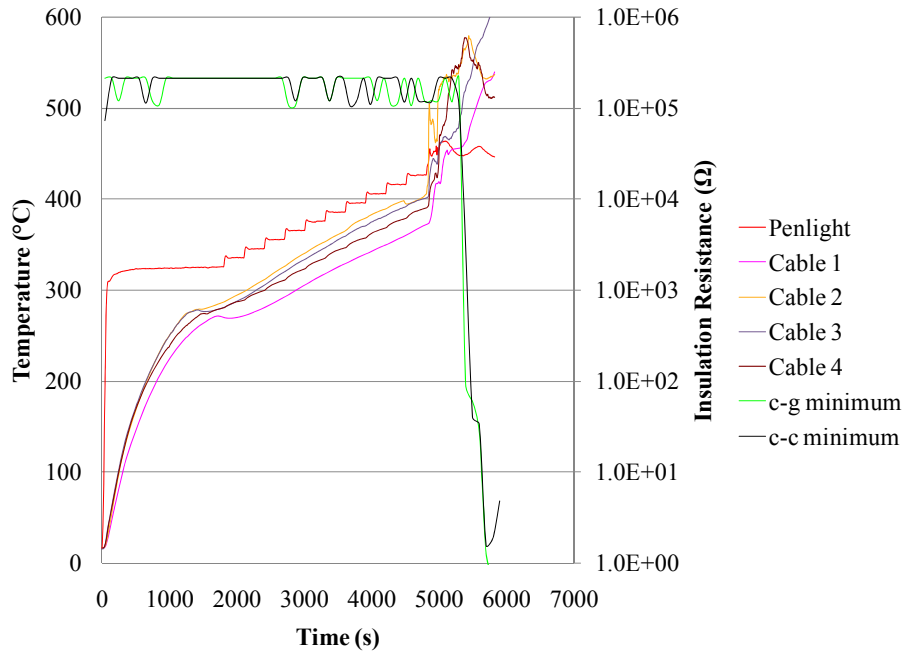
Figure 7.27: Insulation resistance data from Test K21.

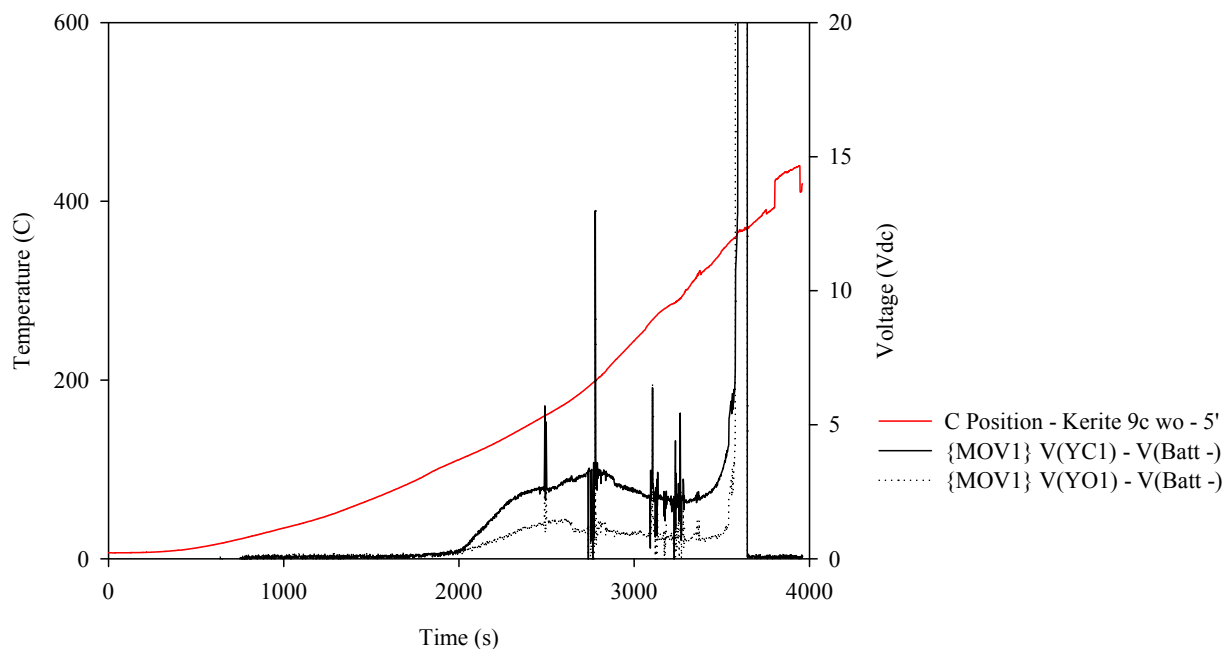
Figure 7.30: Cable temperature and electrical response of Item F during Test IS10.

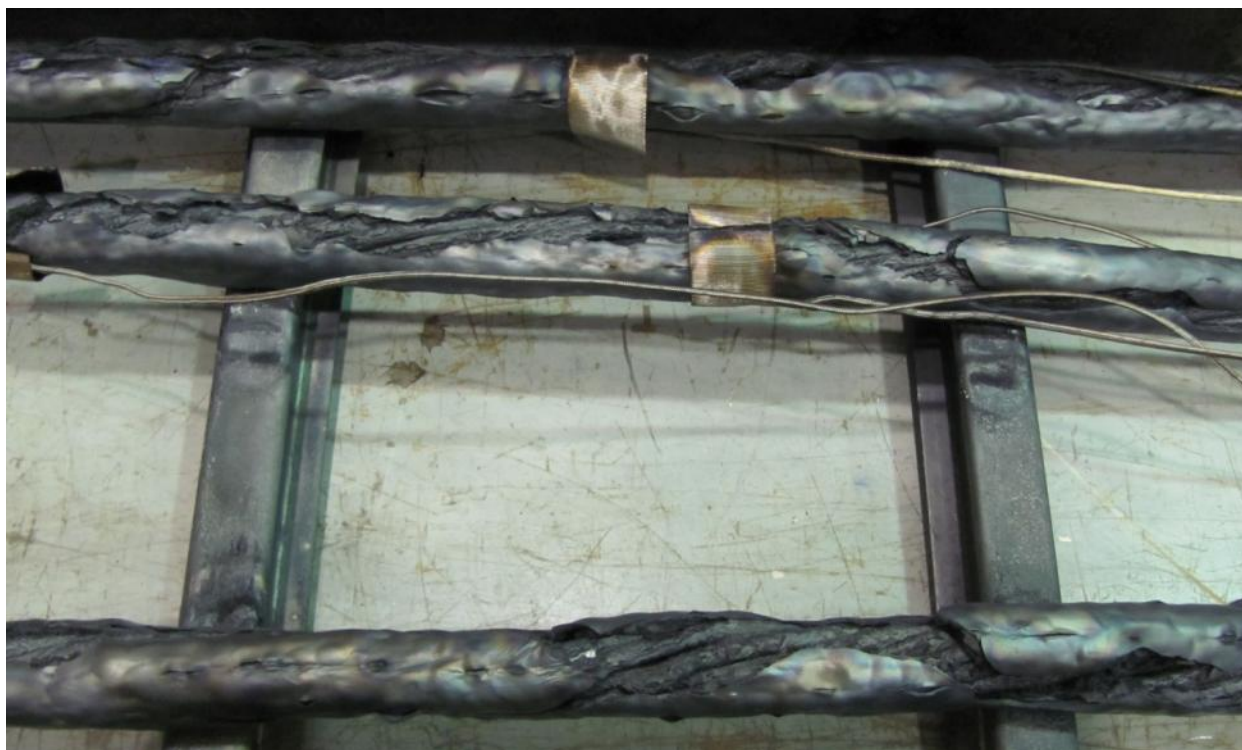
Figure 7.31: Post-test damage to Item G.

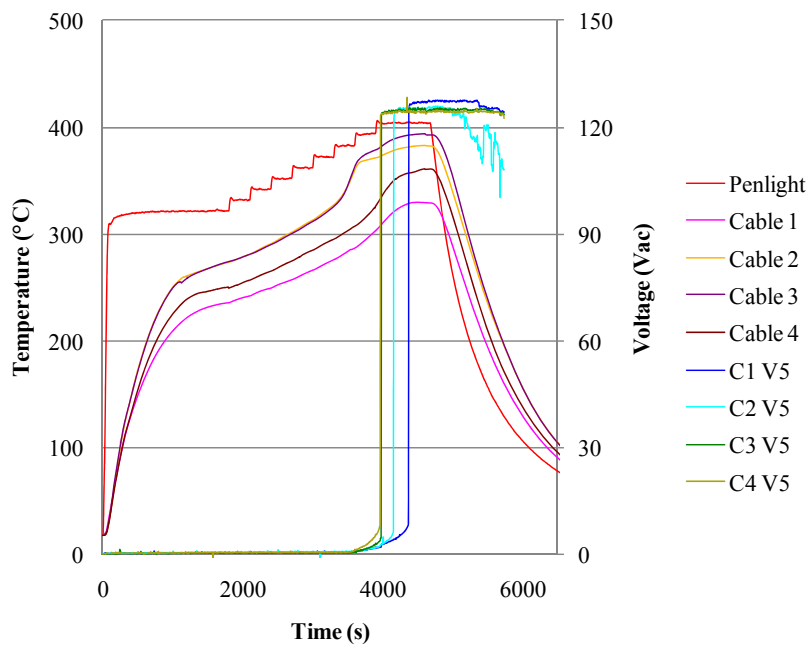
Figure 7.34: SCDU results from Test K3 for Item G.

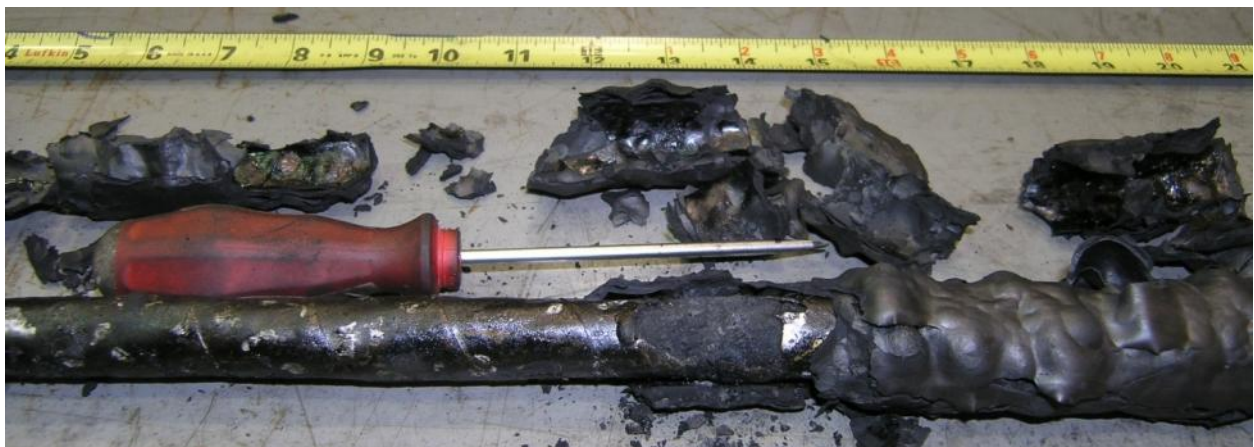
During examination of the cable from Test K4, as the jacketing material was removed, similar to the DESIREE-Fire experiments, an oily residue was found between the jacket and zinc wrap. As more of the cable jacket was removed, a large hole in the zinc wrap was discovered. This is shown in Figure 7.44 and Figure 7.45. After the jacketing material was detached from the thermally exposed section of cable, the zinc wrap was carefully removed, as shown in Figure 7.46 and Figure 7.47. Directly beneath the hole in the zinc wrap was a “soft spot” in the insulation material, very similar to that observed during the testing of Item D. This soft spot was comprised of charred insulation material held in place by the oily residue and the charring extended to the copper wire. The insulation surrounding the charred hole was still relatively flexible and resilient to the applied pressure of investigative tools. Unlike Test D13-qual, longitudinal and circumferential cracking along the conductors was not prevalent. The general cable condition is shown in Figure 7.48.

Figure 7.44: Large hole uncovered during the removal of the jacketing material.

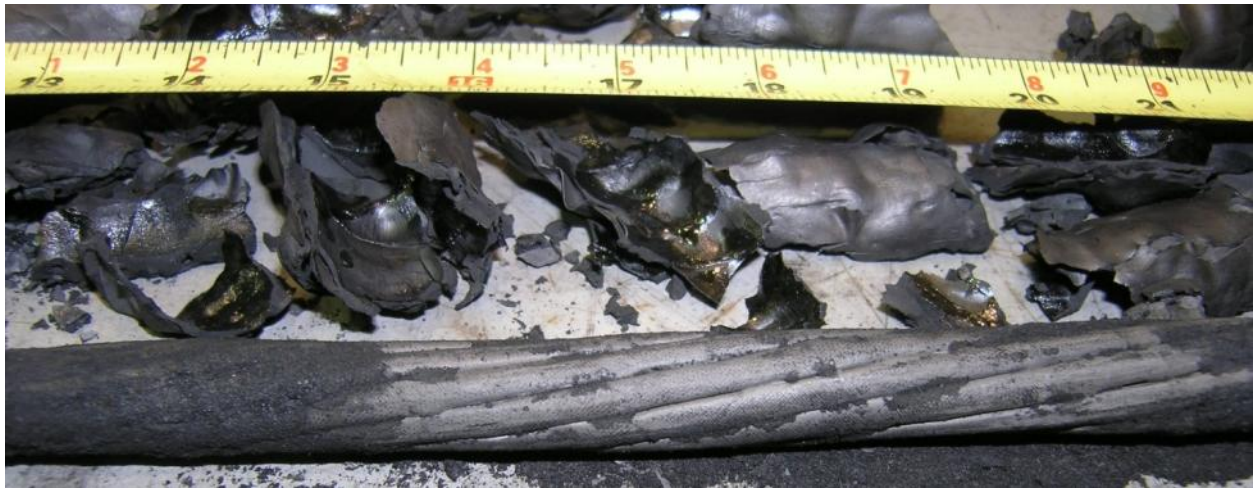
Figure 7.48: Post-test image of the conductors without insulation cracking for Item H.

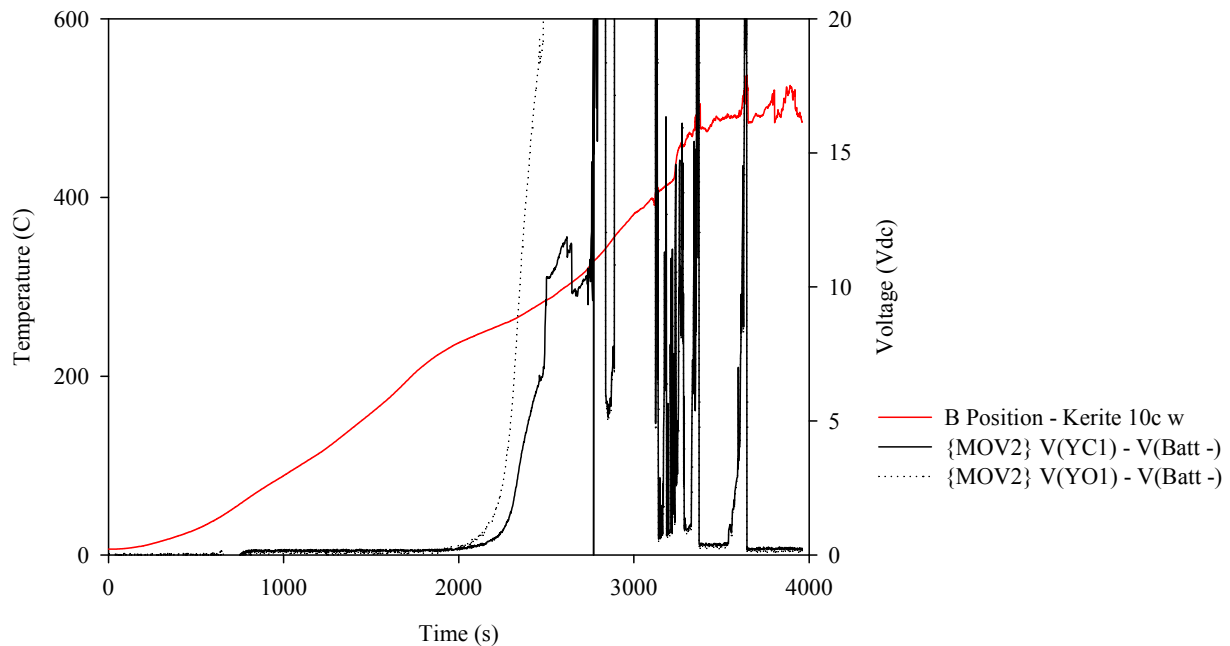
Item H was tested during both Test IS9 and Test IS10 of the DESIREE-Fire intermediate-scale experiments. For Test IS9, Item H was connected to the SOV1 circuit and located in Position B. In Test IS10, this cable sample was connected to MOV2 and again located in Position B. Early electrical degradation was observed in both Test IS9 and Test IS10 beginning at cable temperatures of 316°C and 251°C, respectively. These values are generally consistent with those observed during the Penlight tests. The ultimate failure mode during Test IS9 was a hot short to an indication lamp. The indicated cable temperature at the time of failure was in excess of 400°C. The results from Test IS10 are illustrated in Figure 7.49. During Test IS10, initial degradation was noted when the cable was at approximately 251°C and an outright failure (spurious actuation) occurred at a cable temperature of about 334°C.

Figure 7.49: Cable temperature and electrical response of Item H during Test IS10.

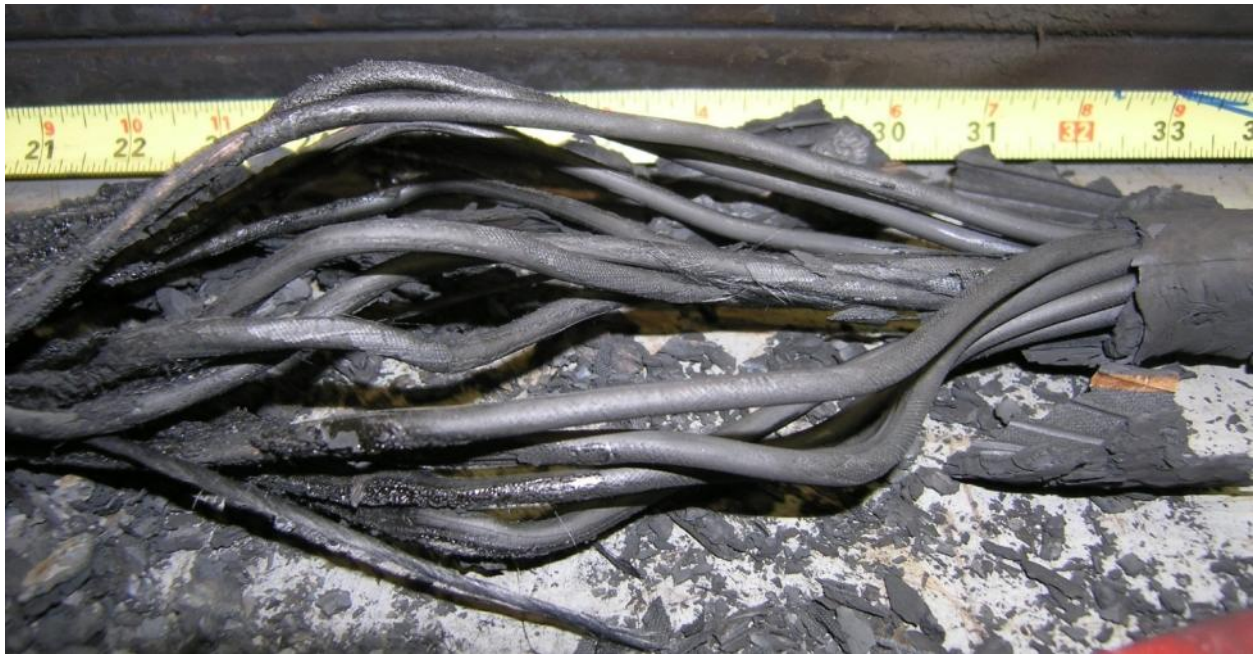
Figure 7.54: Opposite unburned section of Item I next to the leading flame edge.

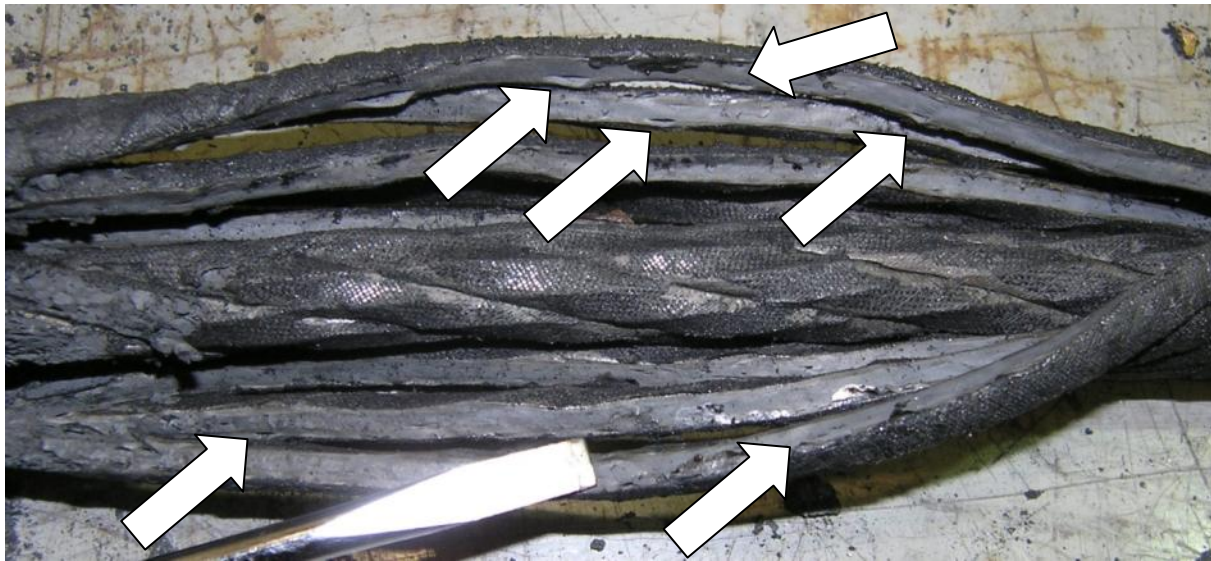
Figure 7.59: Longitudinal cracking along the conductors outside the burned section of cable indicated by arrows.

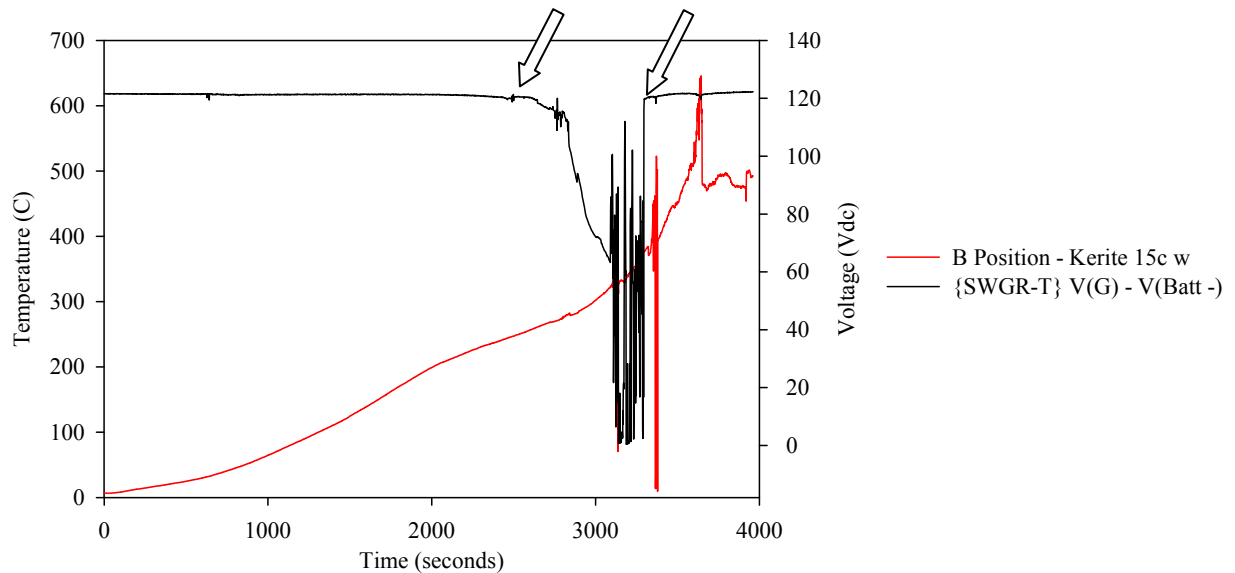
The results from the intermediate-scale tests were complimentary to the results obtained during the small scale experiments. Early degradation, in this case voltage leakage from the green indication lamp, was observed beginning at about 2646 s into the test and at a cable temperature of 261°C. Outright failure occurred at about 3108 s and at a cable temperature of about 337°C. This is shown in Figure 7.60 where the cable temperature shown in red and the voltage of conductor ‘G’ shown in black and the two arrows indicate the onset of initial degradation and outright failure.

Figure 7.60: Cable temperature and electrical response of Item J during Test IS10

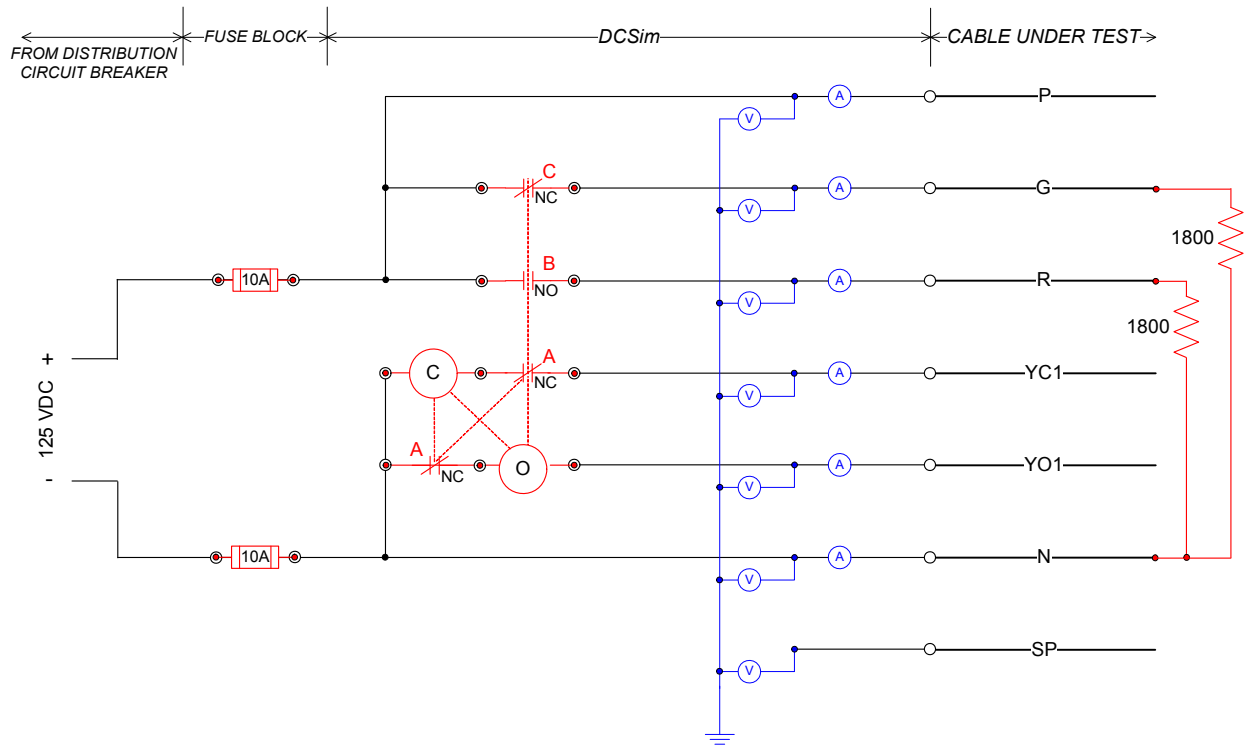
Figure A.1: DCSim panel layout for the control circuit on a dc MOV.

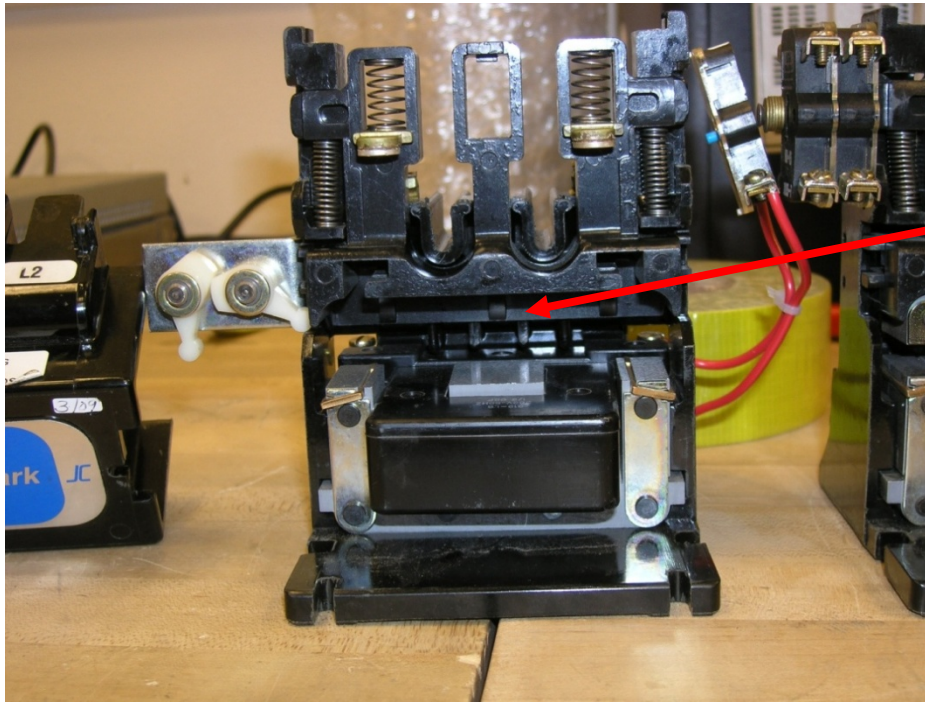
Moving core absent
from non- operational
motor control contactor
unit

Figure A.3: Close motor controller missing the metal driver for the moving core for the MOV2 circuit.

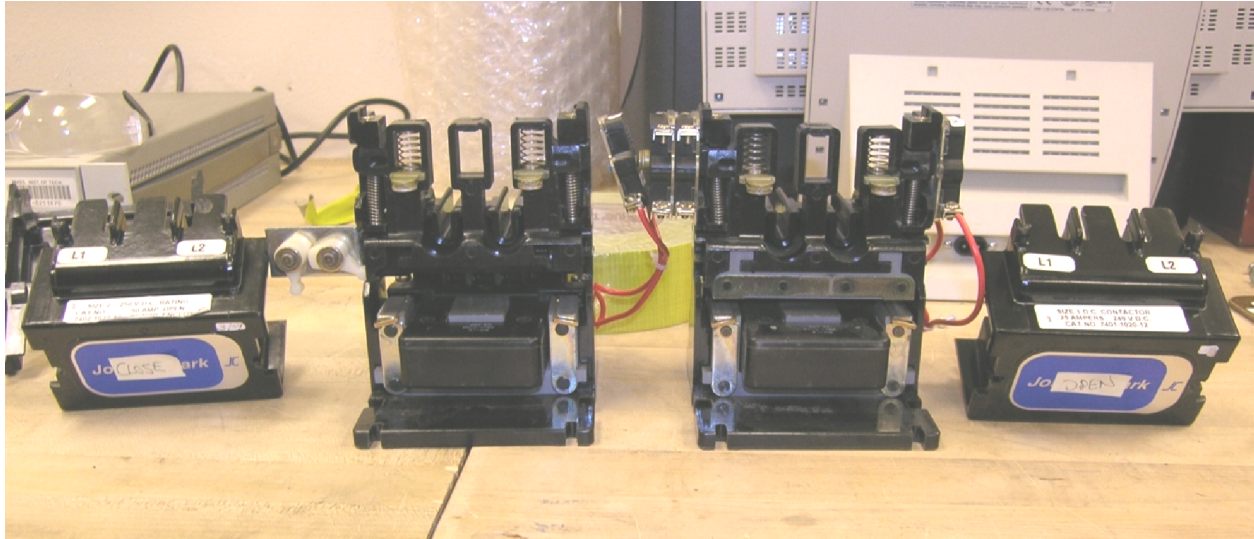
Figure A.4: Side-by-side comparison of the open and closed motor contactors for the MOV2 circuit.

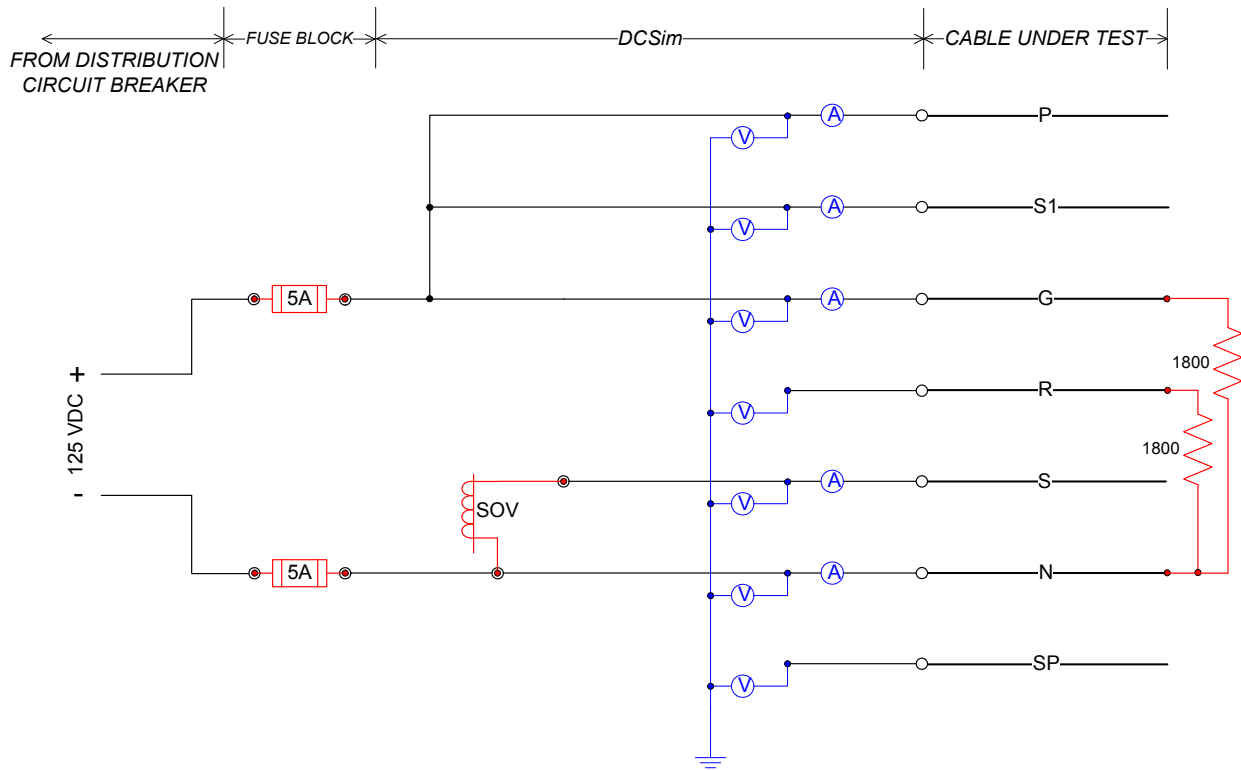
The small solenoid valve is shown in its normally closed position. Table A.4 identifies the conductor-to-conductor interactions required to occur within test cable to cause a specific circuit failure mode, including spurious opening of the valve. It is also worthwhile noting that no immediate discernible effect occurs if conductors P, N, S1, S2, or R experience an open circuit failure (conductor break) as the initial failure mode.

Figure A.5: DCSim panel layout for a small SOV dc circuit.

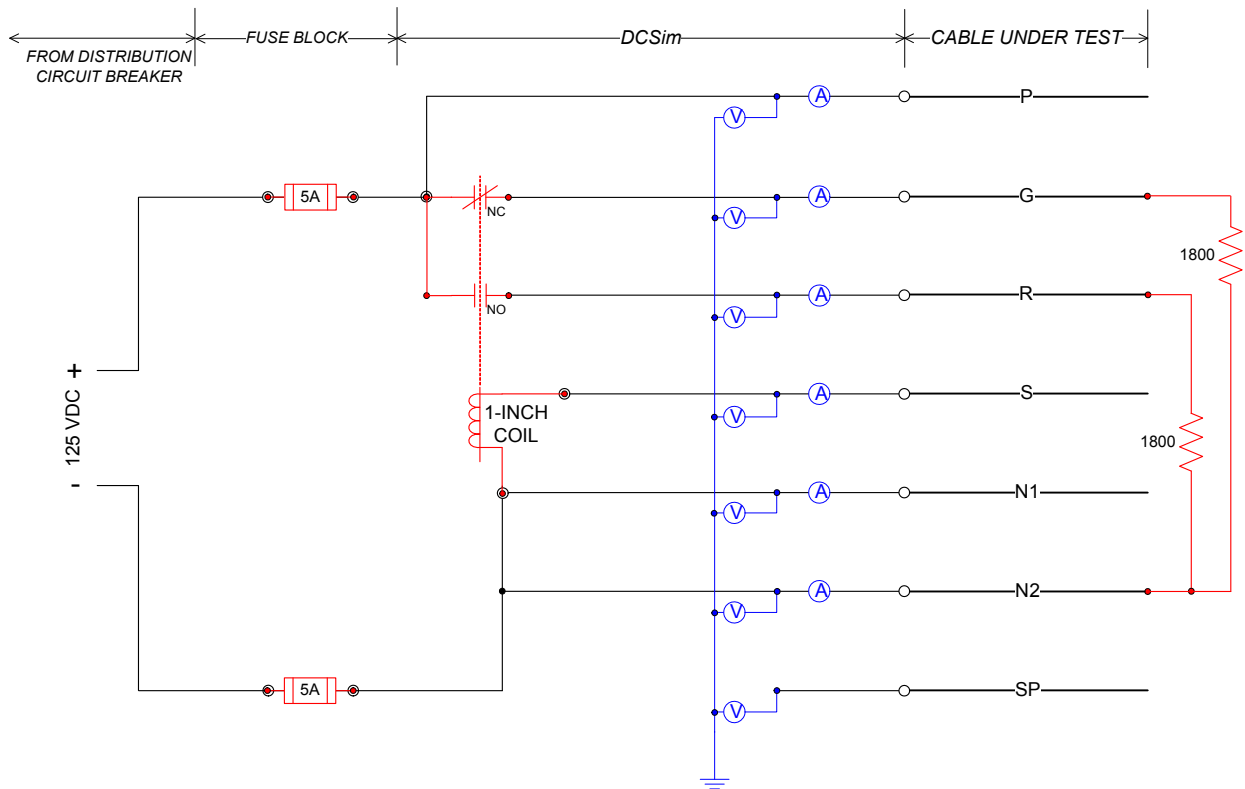
Figure A.6: Line drawing of the DCSim panel layout for a 1-in. valve circuit.

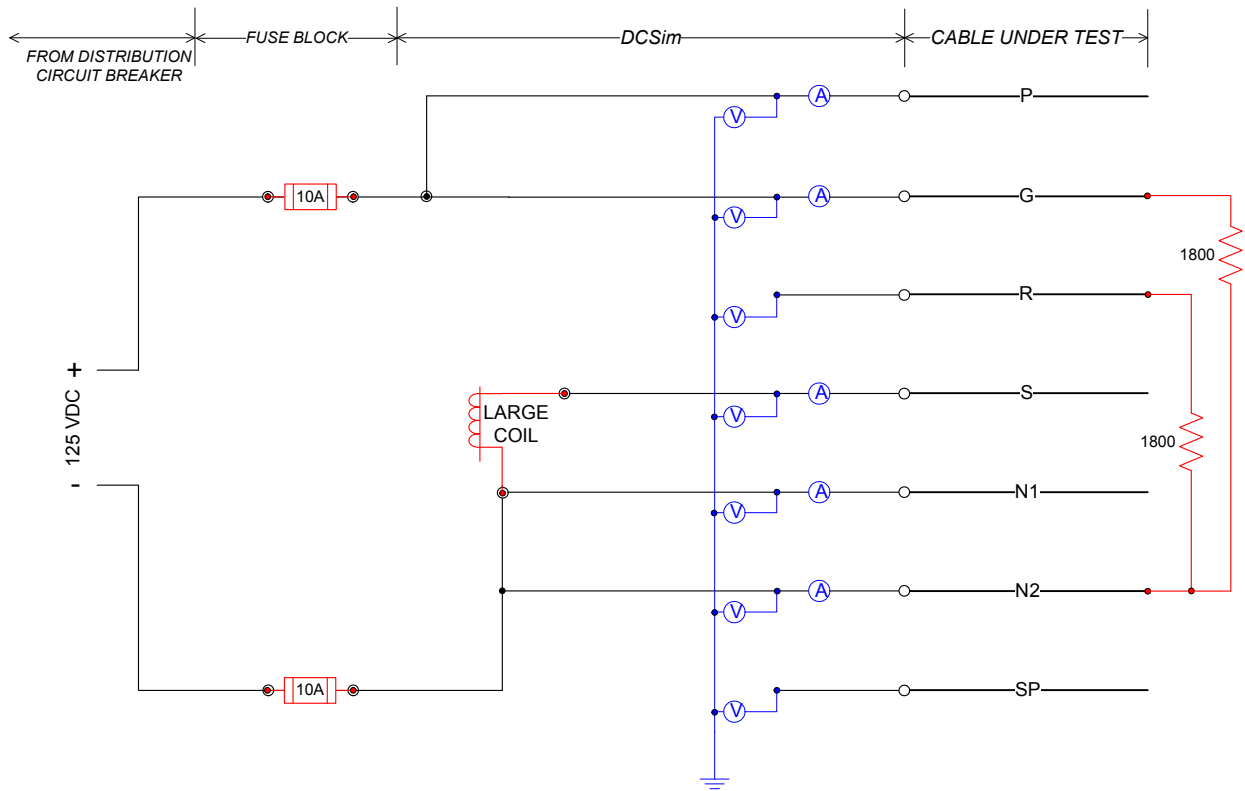
Figure A.7: Line drawing for the dc large coil circuit.
