NUREG/CR-7102
SAND2011-6548P

Kerite Analysis in Thermal Environment of FIRE (KATE-Fire): Test Results

Final Report

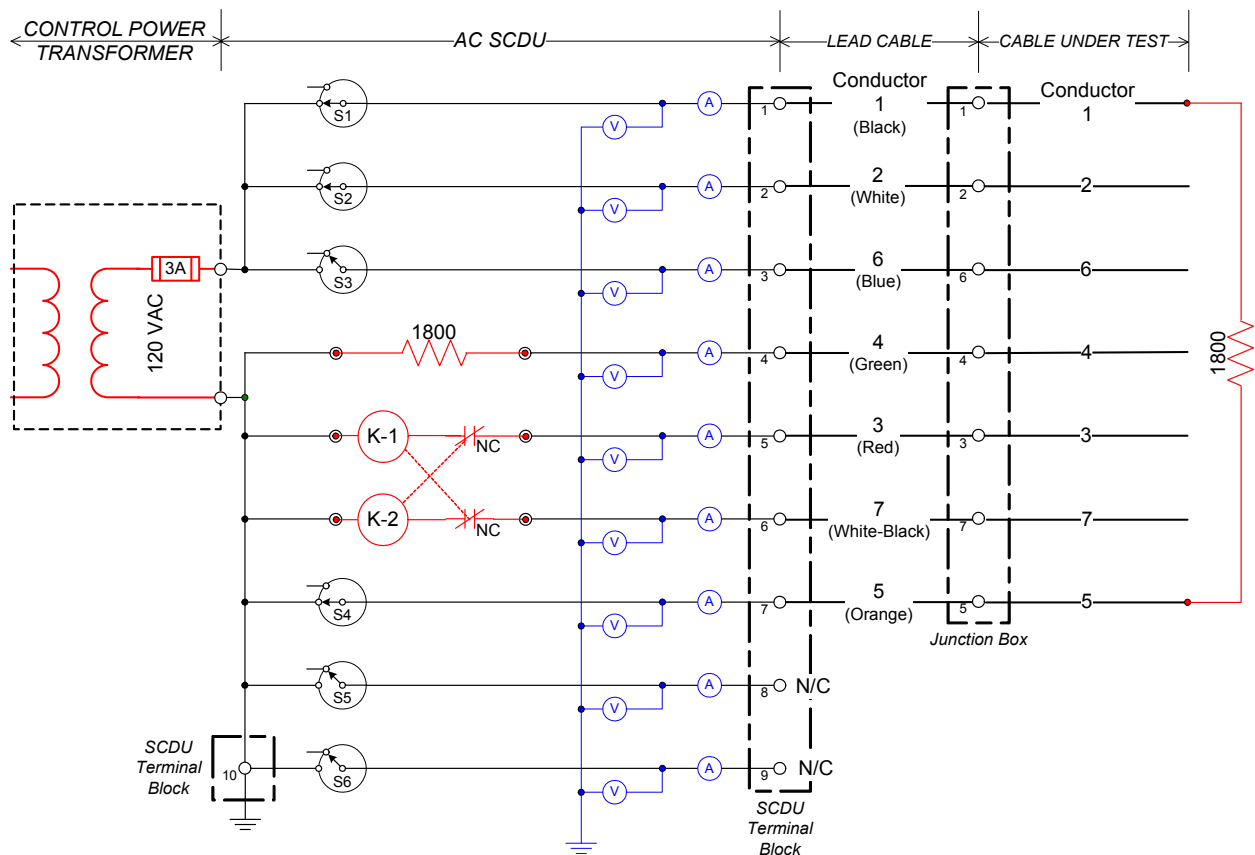
Figure A.16 shows the simulated MOV control circuit that was employed during the CAROLFIRE tests. An ac power source, an 1800 Ω resistor representing an indicator lamp, and two relay coil targets are connected to the simulated circuit. A seven-conductor cable connected to the Surrogate Circuit Diagnostic Unit (SCDU) is the device under test. Although it is possible to encounter a circuit in a NPP that is supplied with power directly for a power source, typically a CPT is used. In the SCDU chassis, four different circuits are used to monitor a cable's performance throughout fire exposure. The primary difference between each circuit is the CPT size. SCDU1 uses a 100 VA CPT, SCDU2 uses a 150 VA CPT, SCDU3 uses a 200 VA CPT, and SCDU4 uses a 75 VA CPT. All CPTs are grounded. Additional information may be found in NUREG/CR-6931 [5].

Figure A.16: Simulated ac MOV control circuit, with CPT, for typical cable tests.

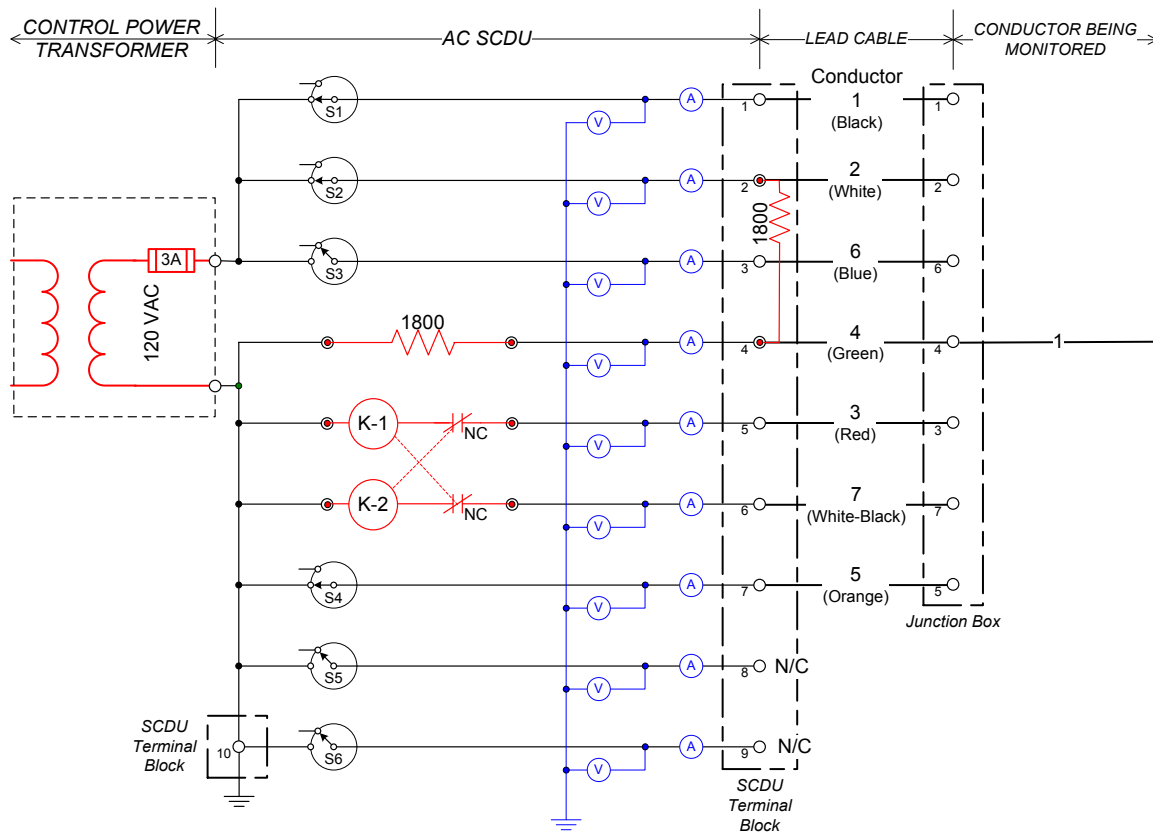
Figure A.17: Modified SCDU circuit with a resistor between a source conductor and the passive target.

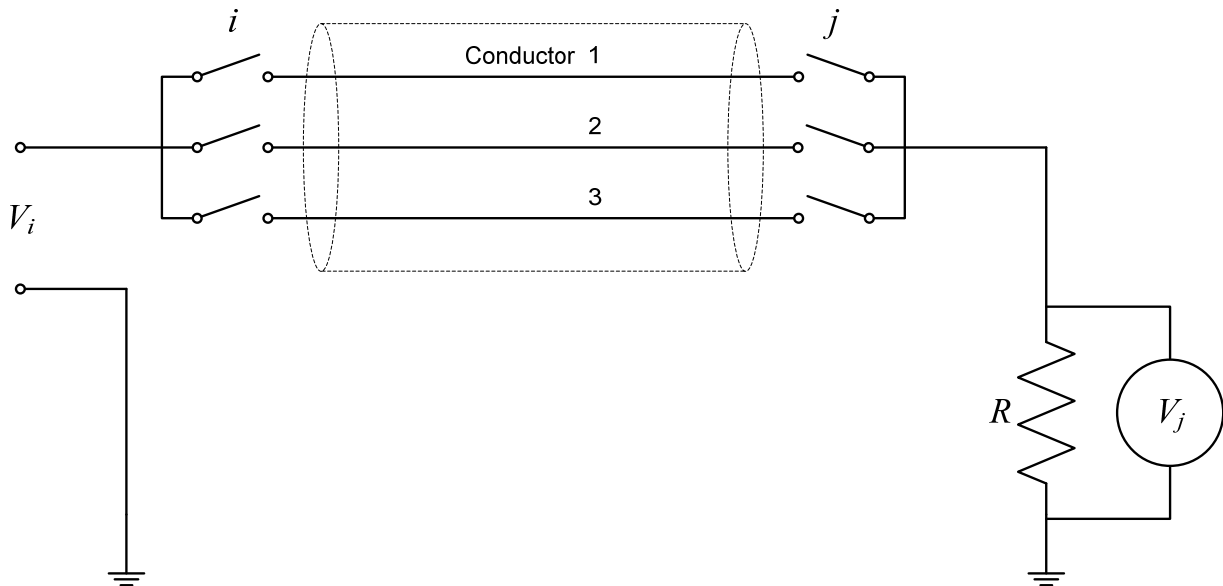
Figure A.19: Circuit for measuring insulation resistance between any conductor pair in a cable.

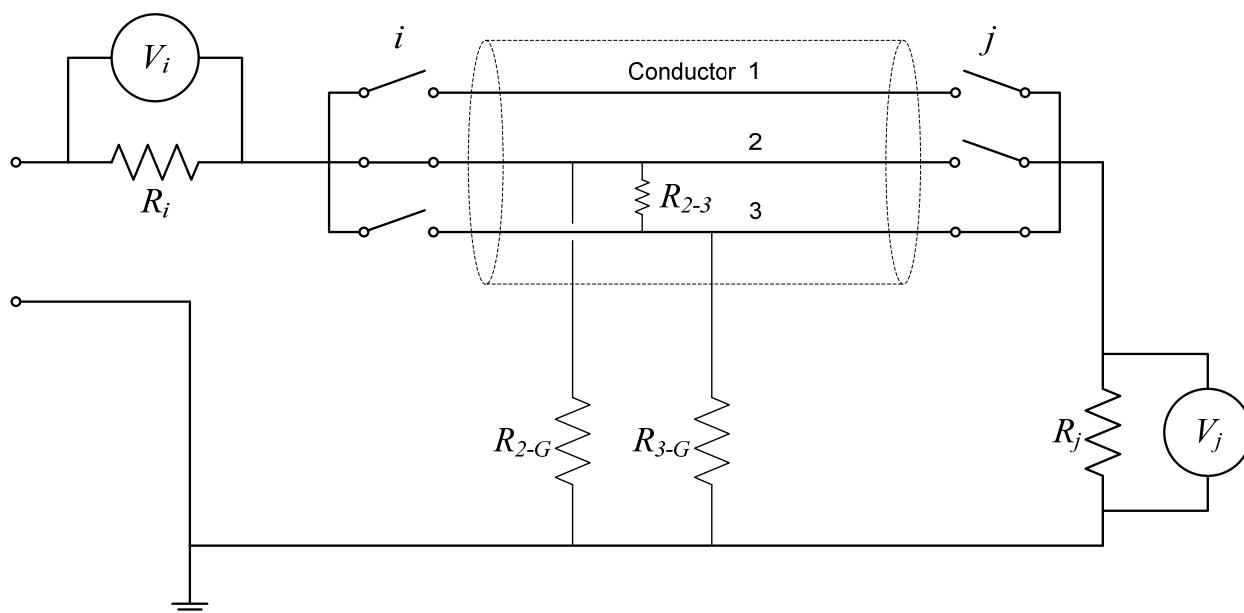
Figure A.21: Insulation resistance measuring circuit with ground paths.

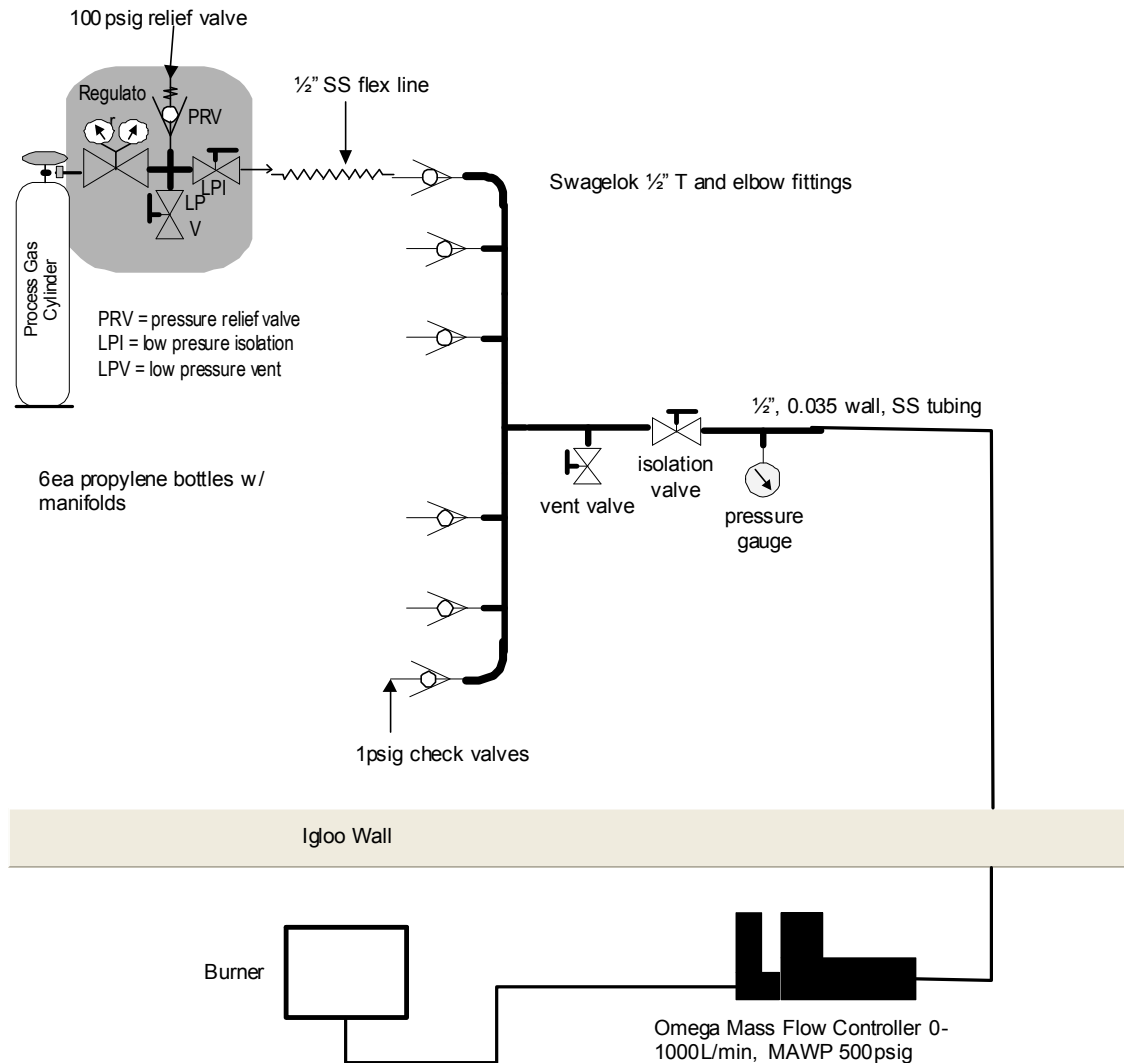
Figure A.30: Illustration of the propene pressure system for the intermediate-scale experiments

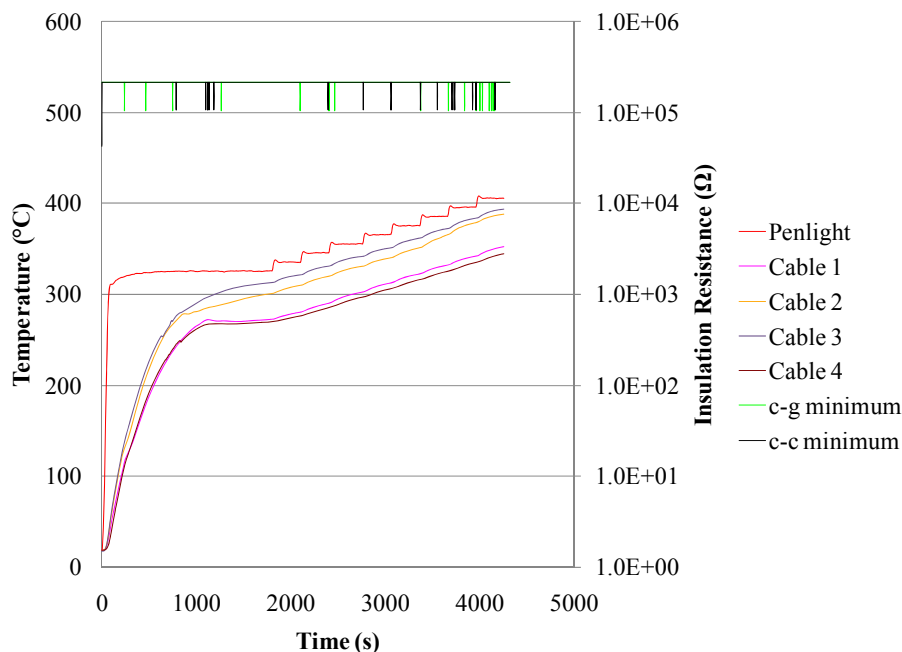
Figure B.8: Penlight shroud temperature, cable temperatures, and electrical performance data for Test K14.

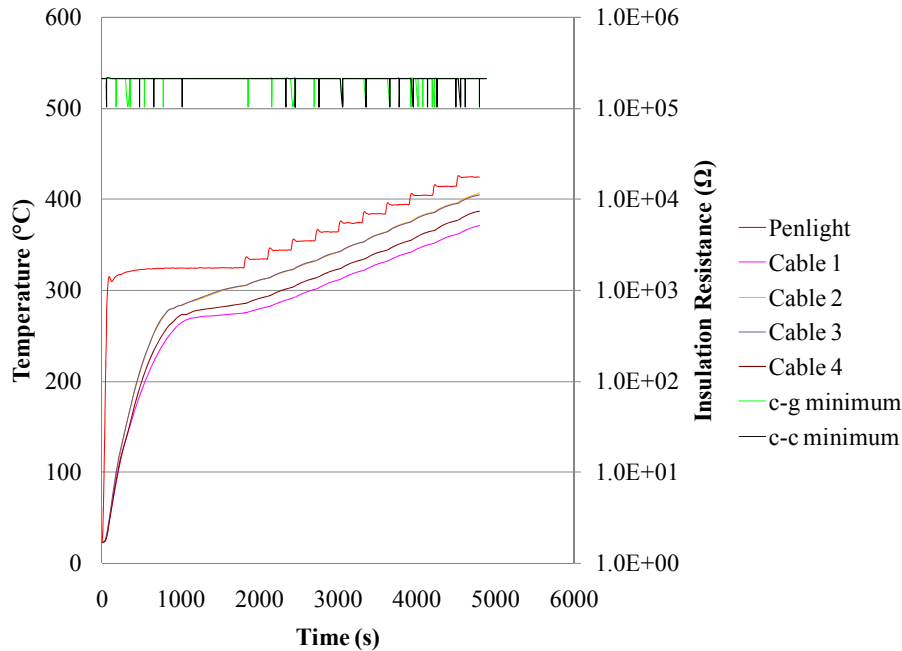
Figure B.9: Penlight shroud temperature, cable temperatures, and electrical performance data for Test K15.

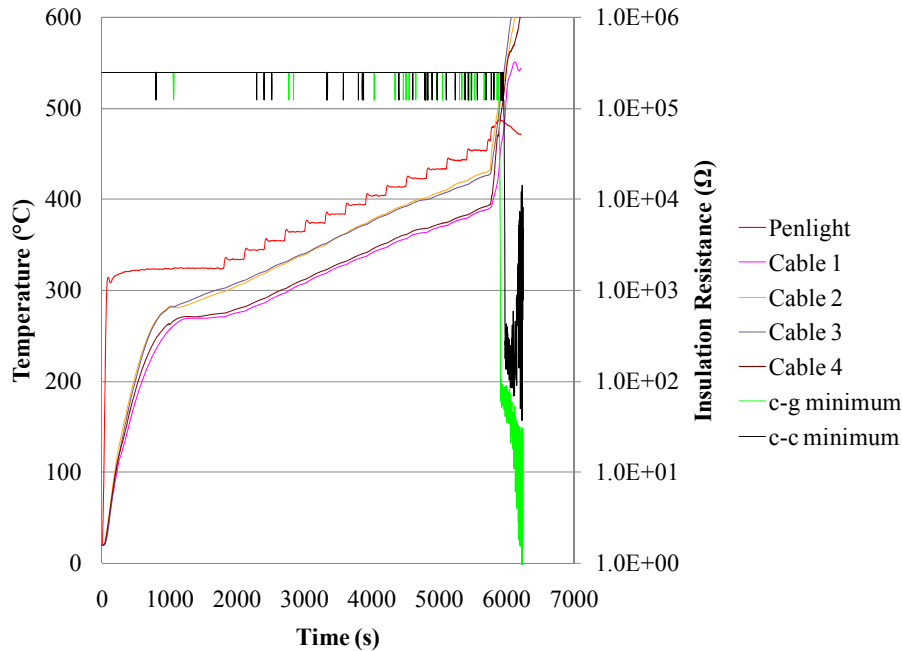
Figure B.10: Penlight shroud temperature, cable temperatures, and electrical performance data for Test K16.

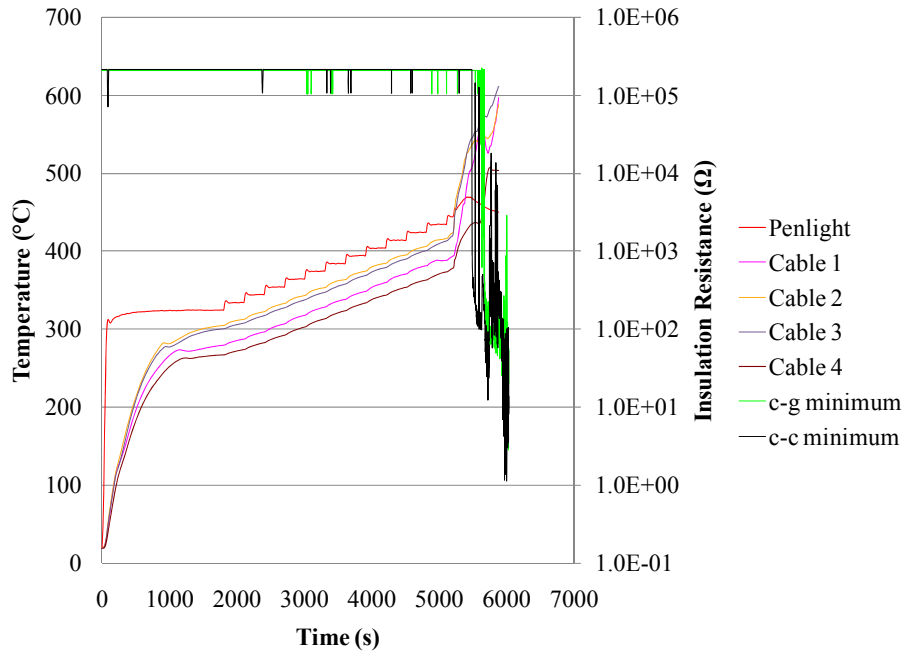
Figure B.12: Penlight shroud temperature, cable temperatures, and electrical performance data for Test K12.

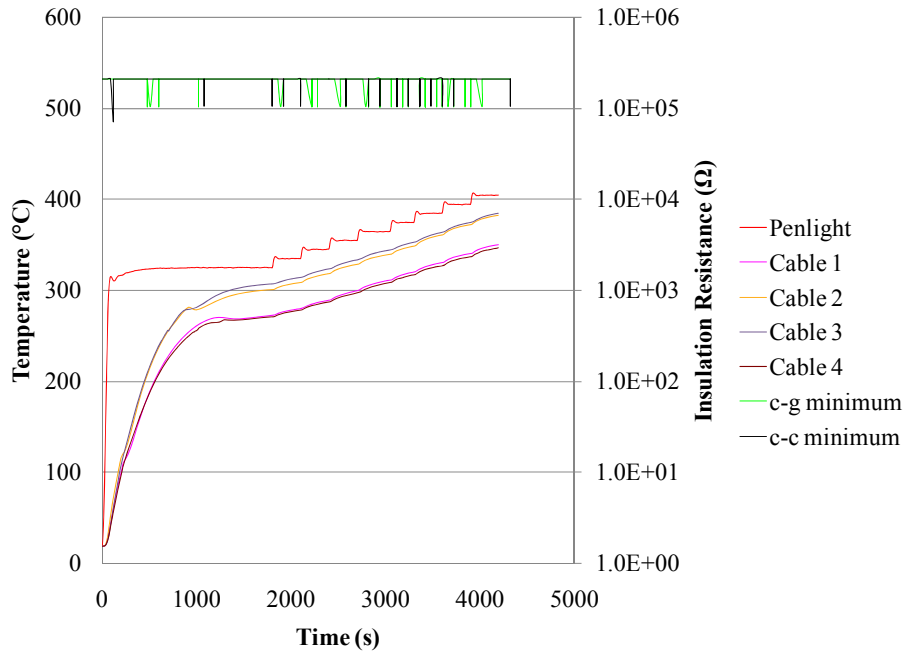
Figure B.13: Penlight shroud temperature, cable temperatures, and electrical performance data for Test K13.

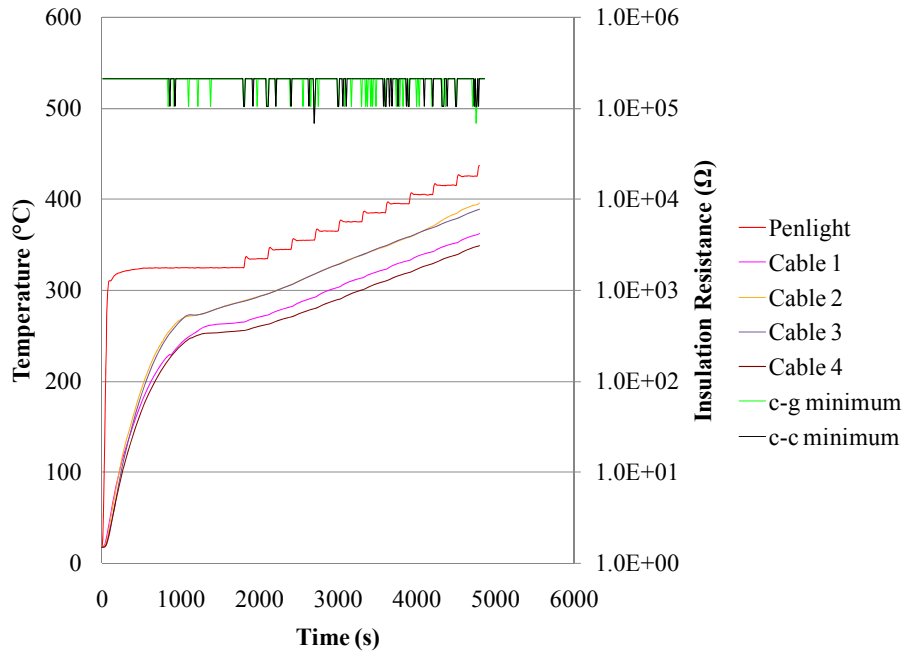
Figure B.17: Penlight shroud temperature, cable temperatures, and electrical performance data for Test K10.

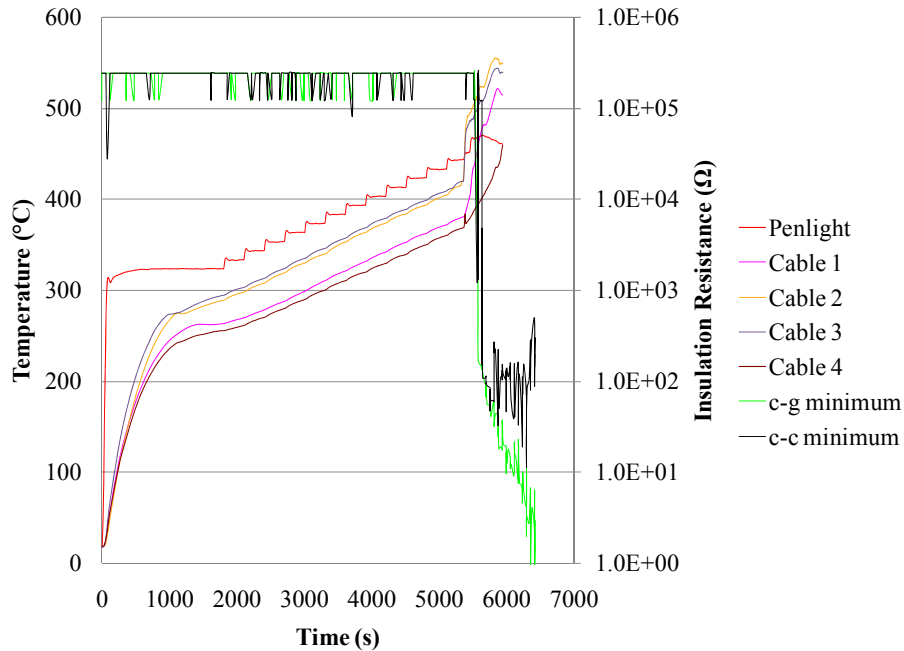
Figure B.18: Penlight shroud temperature, cable temperatures, and electrical performance data for Test K11.

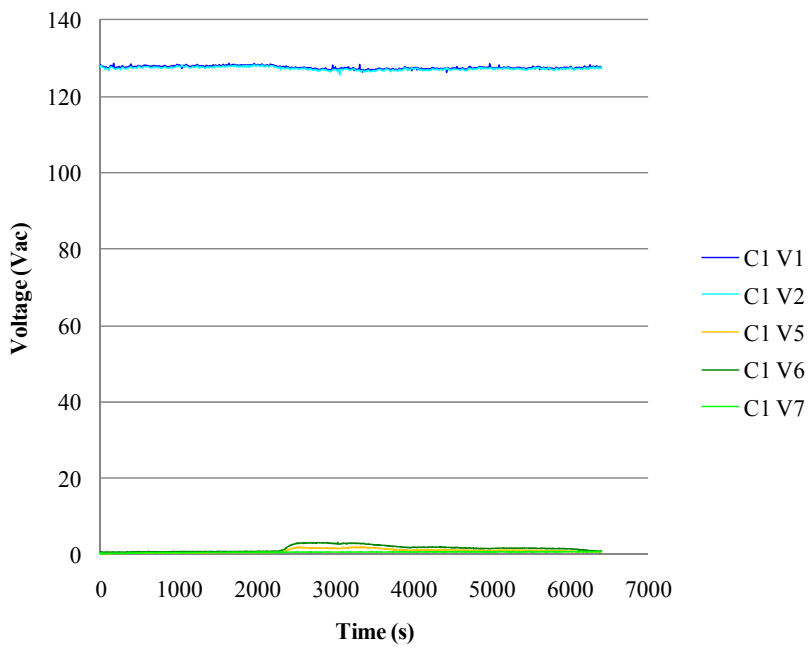
Figure B.27: All source and target conductor voltages for Test D15 displaying early degradation.

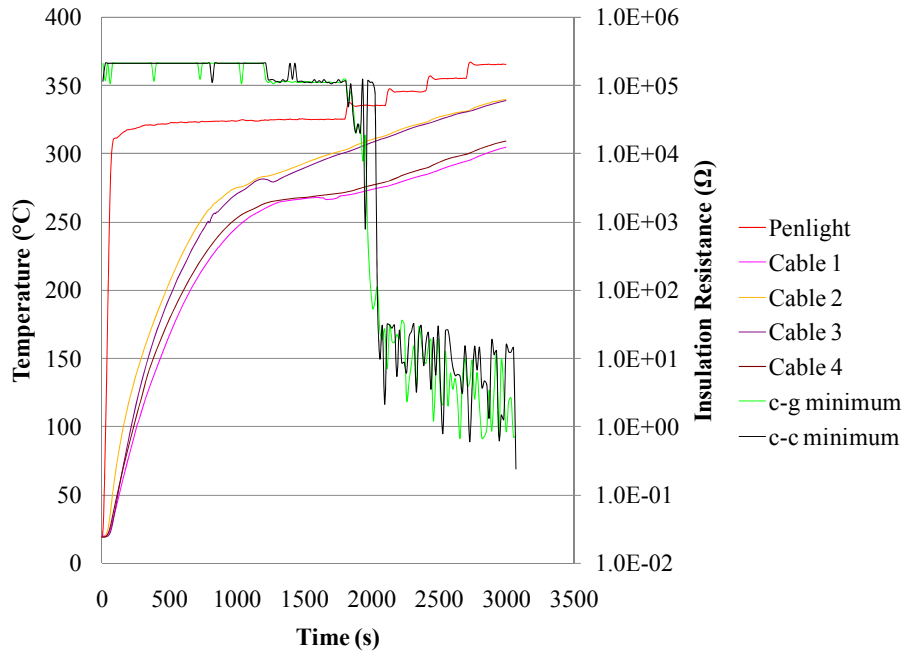
Figure B.37: Penlight shroud temperature, cable temperatures, and electrical performance data for Test K8.

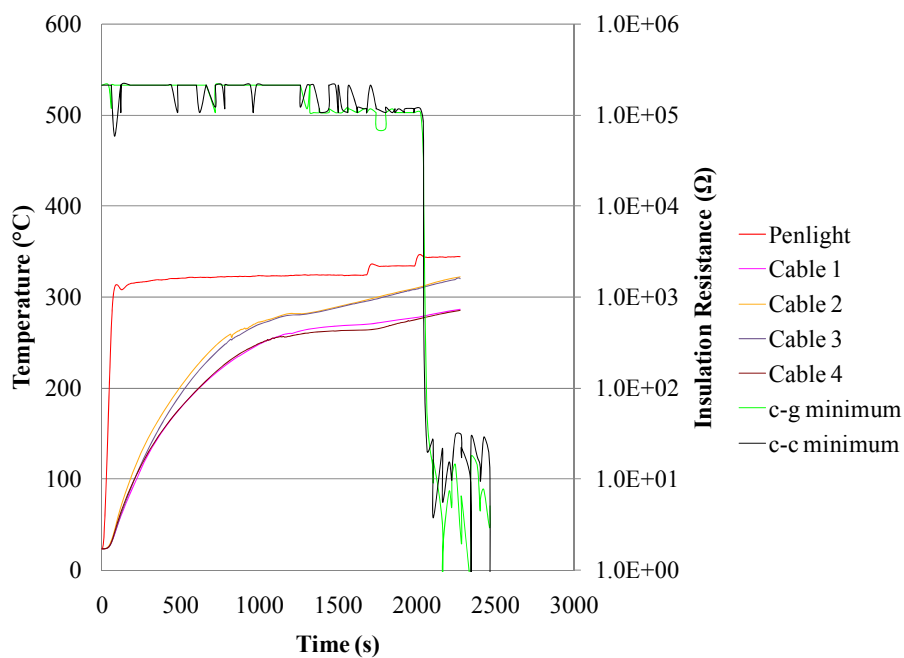
Figure B.38: Penlight shroud temperature, cable temperatures, and electrical performance data for Test K9.

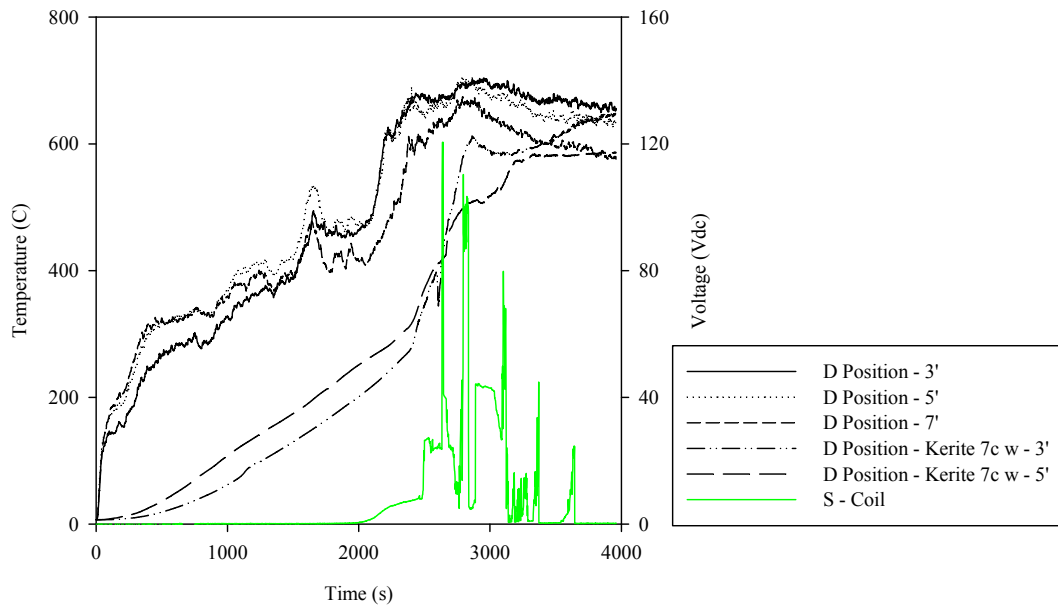
Figure B.42: Temperature profile of Test IS10 and the voltage response of the 1-in. valve coil.

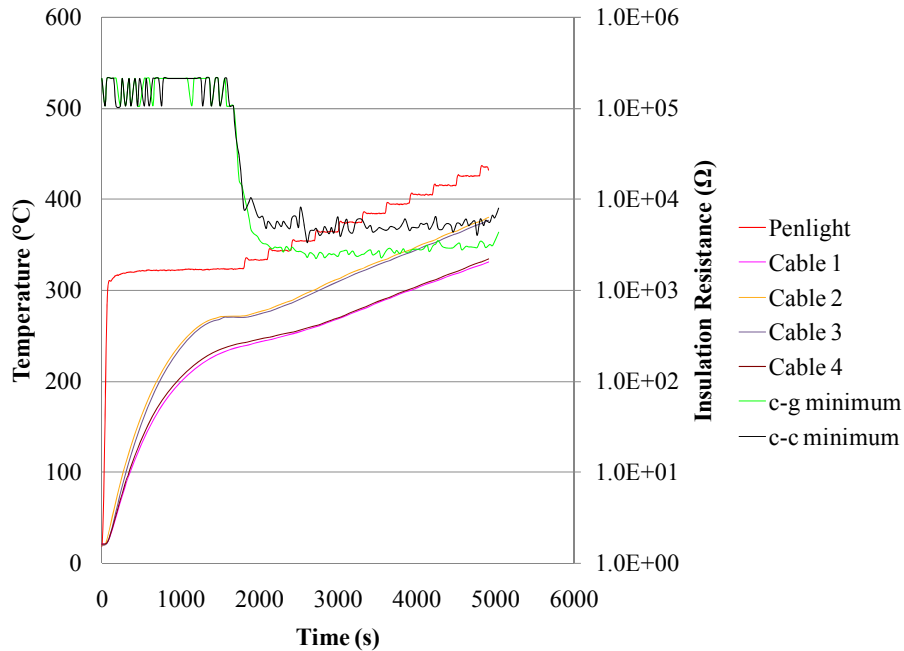
Figure B.47: Penlight shroud temperature, cable temperatures, and electrical performance data for Test K6.

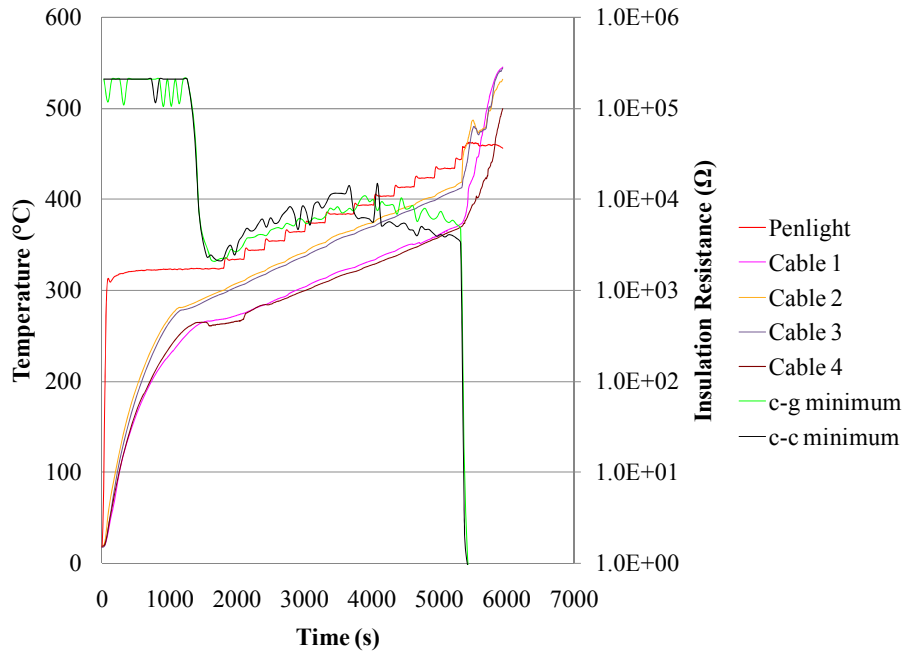
Figure B.48: Penlight shroud temperature, cable temperatures, and electrical performance data for Test K7.

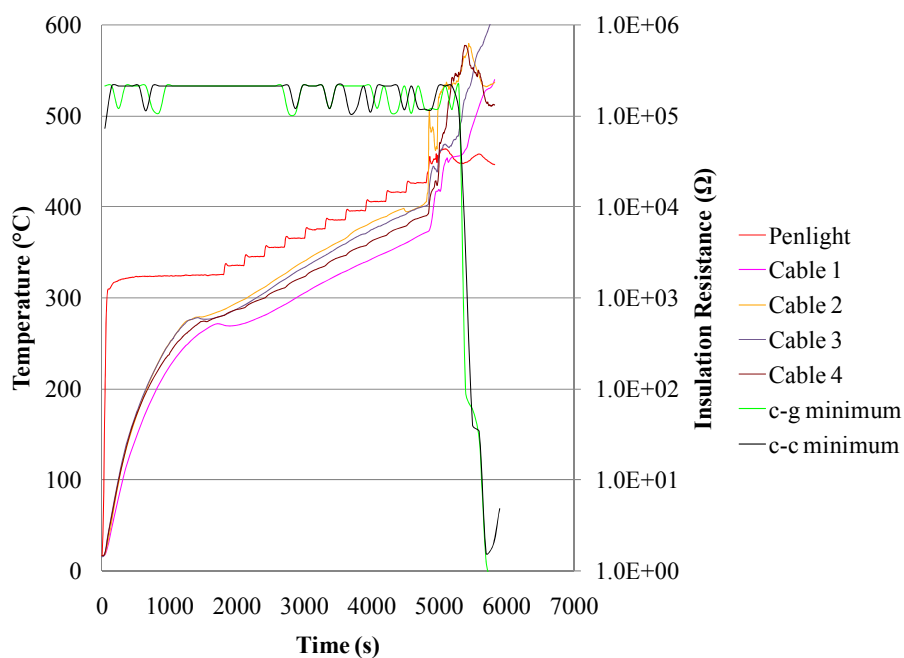
Figure B.81: Penlight shroud temperature, cable temperatures, and electrical performance data for Test K21.

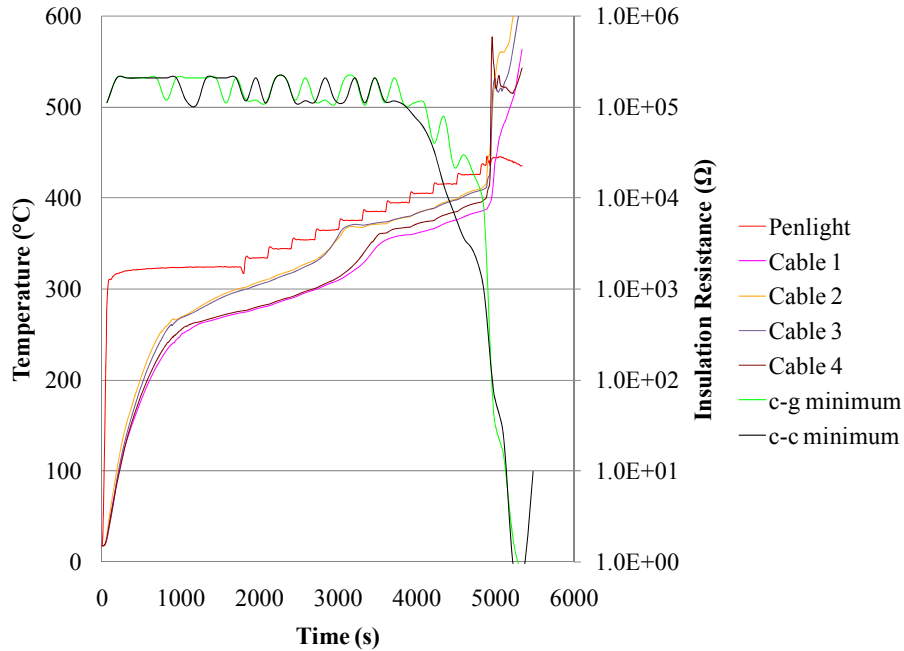
Figure B.96: Penlight shroud temperature, cable temperatures, and electrical performance data for Test K22.

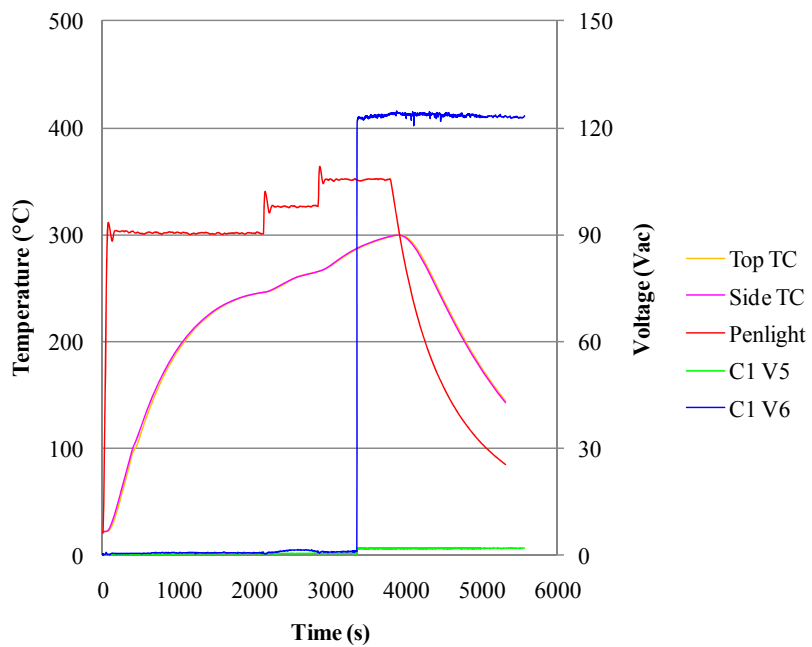
Figure B.104: Penlight shroud temperature and target conductor voltages for Test D13, Qual.

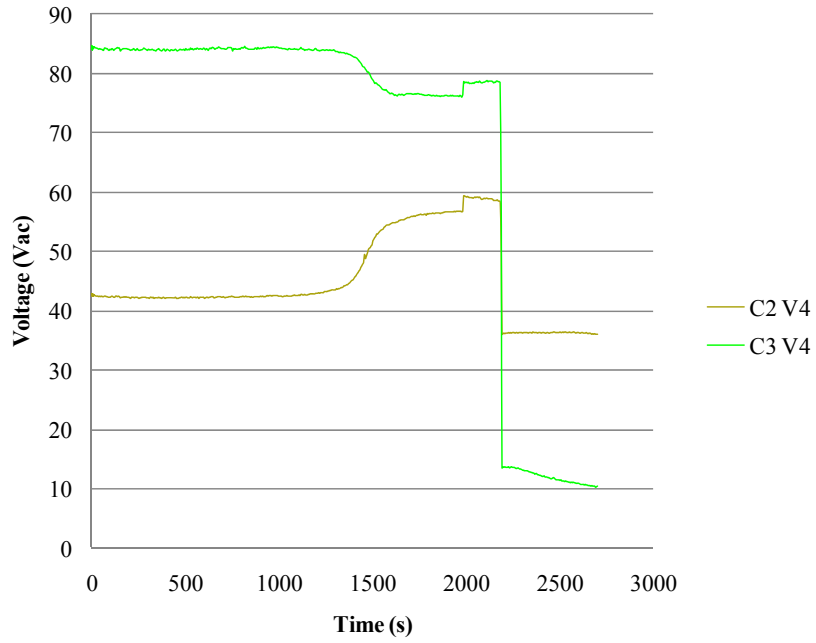
Figure B.124: Altered source conductor voltages for Test K4 displaying degradation.

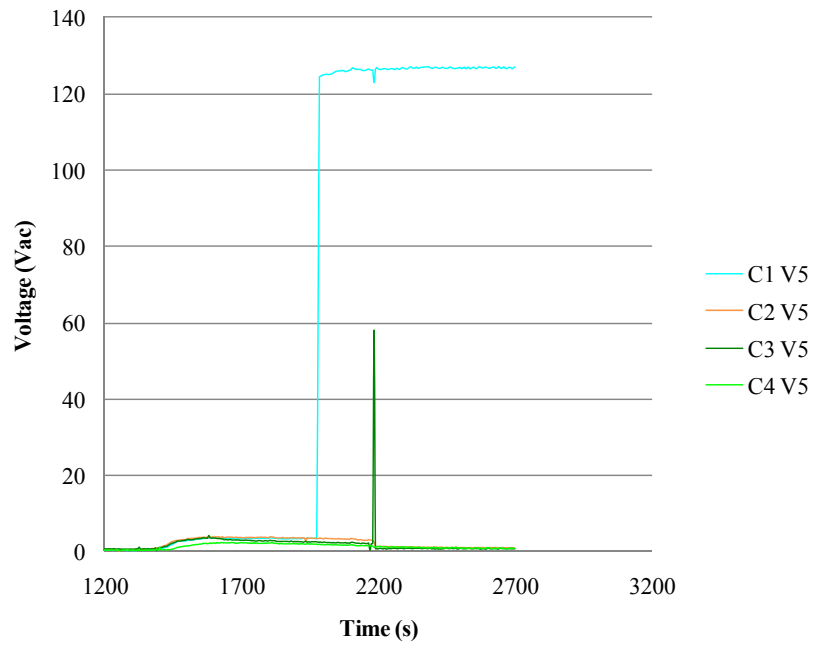
Figure B.125: All target conductor voltages for Test K4 displaying a spurious actuation.

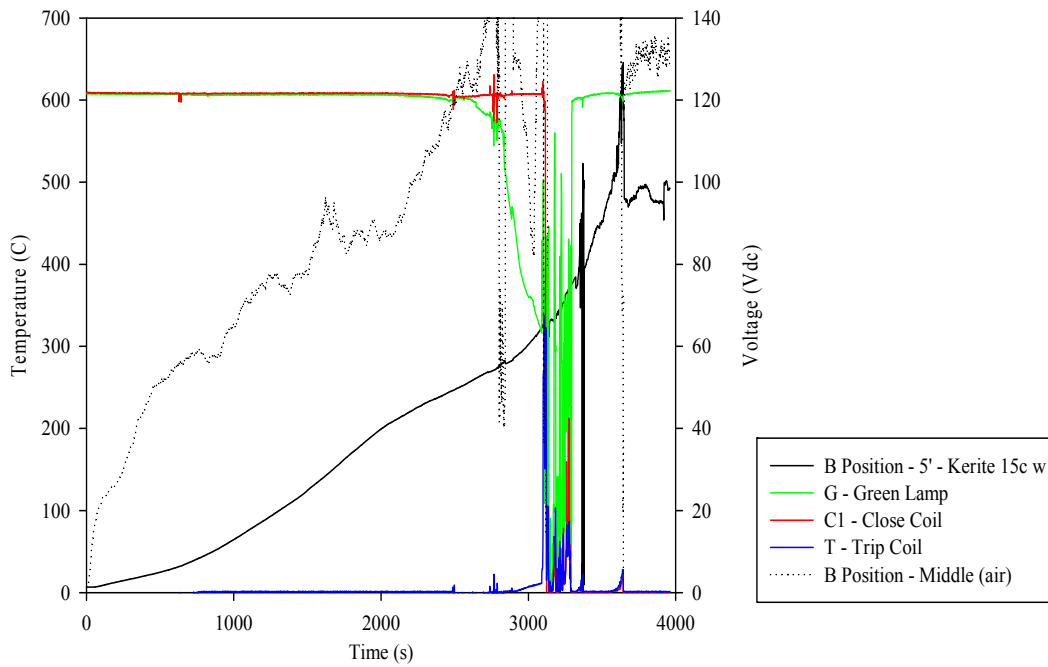
Figure B.139: Temperature profile and electrical response for Test IS10, SWGR.
