Performance of Metal and Polymeric O-Ring Seals in Beyond-Design-Basis Temperature Excursions

This report documents the beyond-design-basis thermal exposure test results of the performance of one type of metallic seal and two different polymeric compound (ethylene-propylene and polytetrafluoroethylene) seal designs typically used in spent fuel transportation packages. Fifteen tests were conducted using a small scale-model package made of stainless steel SS 304 filled with helium initially pressurized at either 5 bar or 2 bar at room temperature. The test package was then exposed in an electric furnace to temperatures equal to or over the specified maximum operating temperatures of these seals for a pre-determined period (typically 9 h). The pressure drop technique was used to determine if leakage occurred during thermal exposure. A total of fifteen tests, twelve used metallic seals, two used ethylene-propylene compound, and one used polytetrafluoroethylene, were performed. Leakage was observed in some of the thermal exposure tests. The time when leakage occurred varied. The overall goal of the project is to provide insights to the performance of these seals when exposed to beyond-

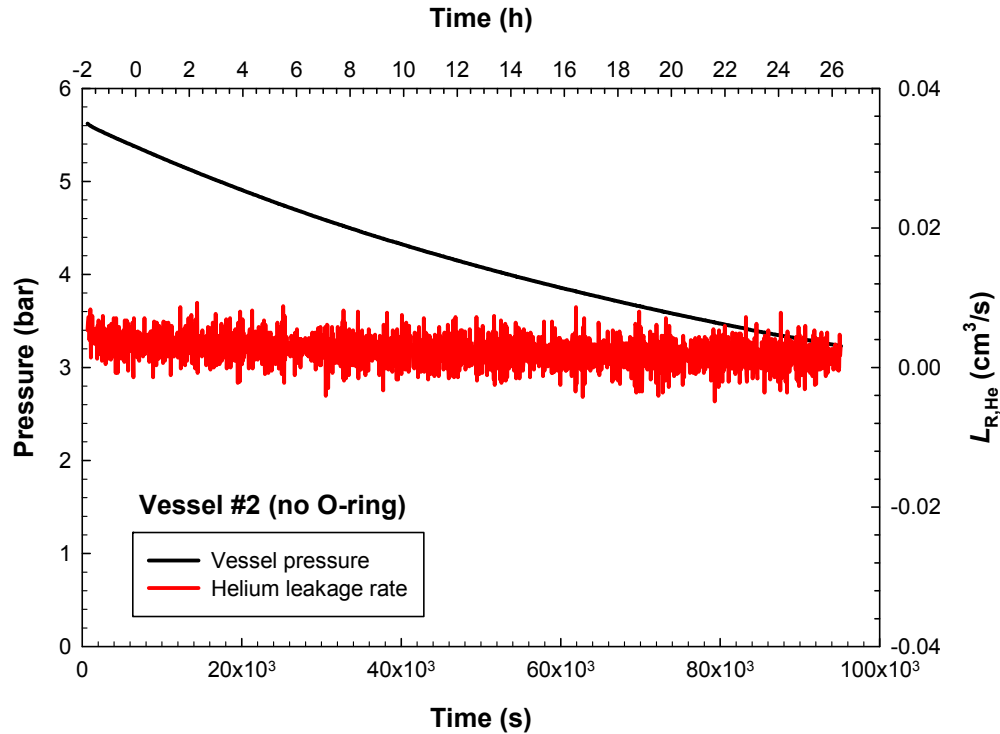
Figure 3-2. Temporal variations of vessel pressure at 24 °C without metallic O-ring.

Before Test #2 was conducted, an exploratory test was performed to examine the severity of the leak without using a metallic O-ring. The vessel was charged with helium to 5.62 bar at room temperature, and the vessel pressure was monitored at room temperature. Figure 3-2 is the test

result, which indicates that the vessel pressure began to drop and leakage occurred immediately at the start of the test and continued slowly over the entire experimental run-time (26.43 h). The reference helium leakage rates $L_{R,He}$ (ref·cm³/s) were estimated based on the method described in Appendix D. The time-averaged leakage rate is estimated to be 2.4×10^{-3} ref·cm³/s.

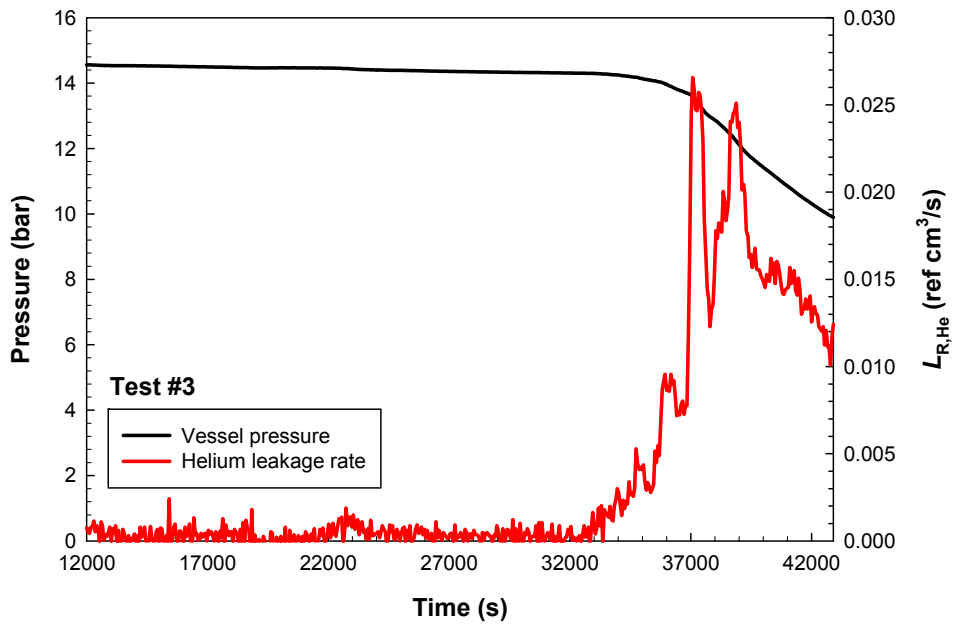
Figure 3-7. Isothermal reference helium leakage rate during the 9 h heating in Test #3.

Tests #3 is a repeat of Test #2. Figure 3-5 presents the test results which show the occurrence of a leak during the 9 h constant-temperature heating phase at 800 °C (1472 °F). In Test #3, the vessel pressure decreases slowly initially and then significantly after about 25 000 s (6.9 h) at 800 °C (1472 °F). Since the leakage rate is directly proportional to the time rate of change of pressure, this two-stage decrease in pressure indicates a slower leak rate (small dP/dt) at first and then a faster leak rate (large dP/dt) at the end. Another leak indicator is revealed in Figure 3-6, which shows the entire time history of the test. After cooling to room temperature, the vessel does not recover its initial charge pressure of approximately 5 bar because of the leak. Isothermal reference helium leakage rates ($L_{R,He}$) during the 9 h heating in this test are shown in Figure 3-7.

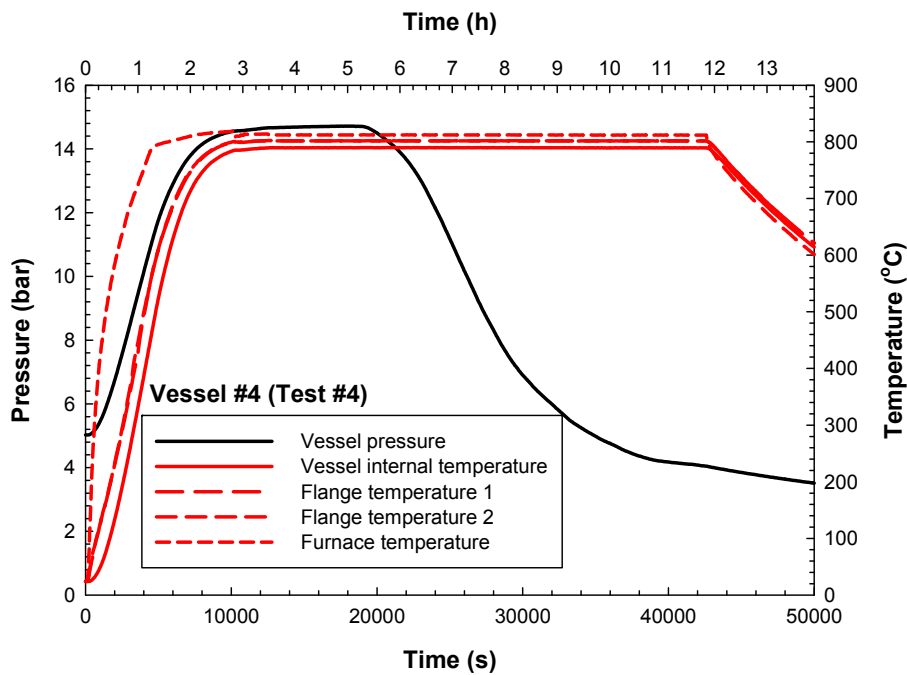
Figure 3-8. Temporal variations of vessel pressure and temperature in Test #4.

Test #4 is another repeat of the thermal exposure condition used in Test #2. Figure 3-8 shows the test results from Test #4. In this test, the pressure remained relatively constant for about 10 000 s (2.8 h) initially during the 9 h constant-temperature heating phase, begins to drop significantly for about 15 000 s (4.2 h) with large dP/dt , and decreases slowly with small dP/dt for the remaining duration. Figure 3-9 shows the complete time-pressure and time-temperature histories of the test. The calculated reference helium leakage rates are shown in Figure 3-10.

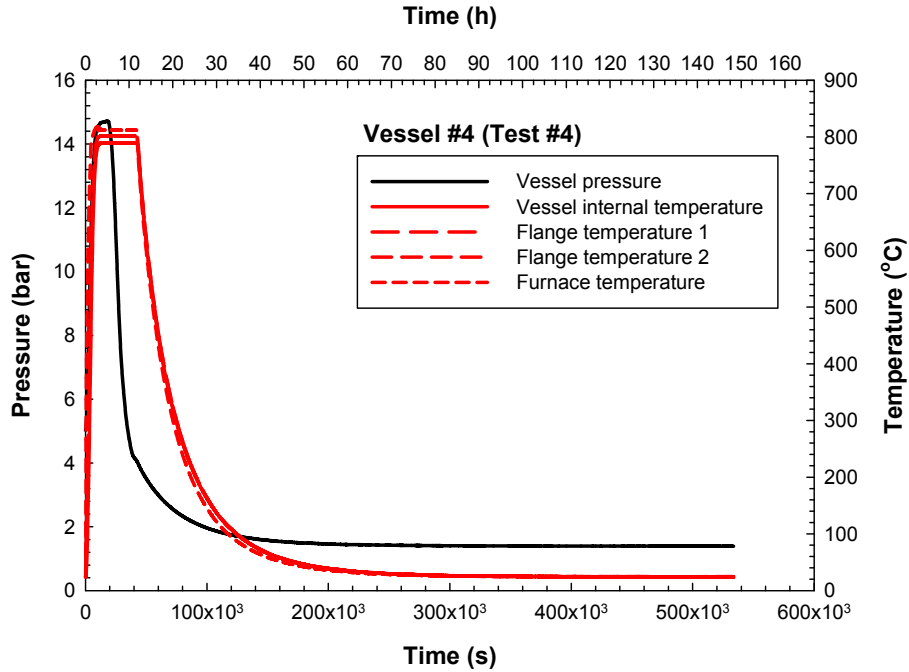
Figure 3-9. Temporal variations of vessel pressure and temperature in Test #4 (time scale extended, including the complete cool-down phase).

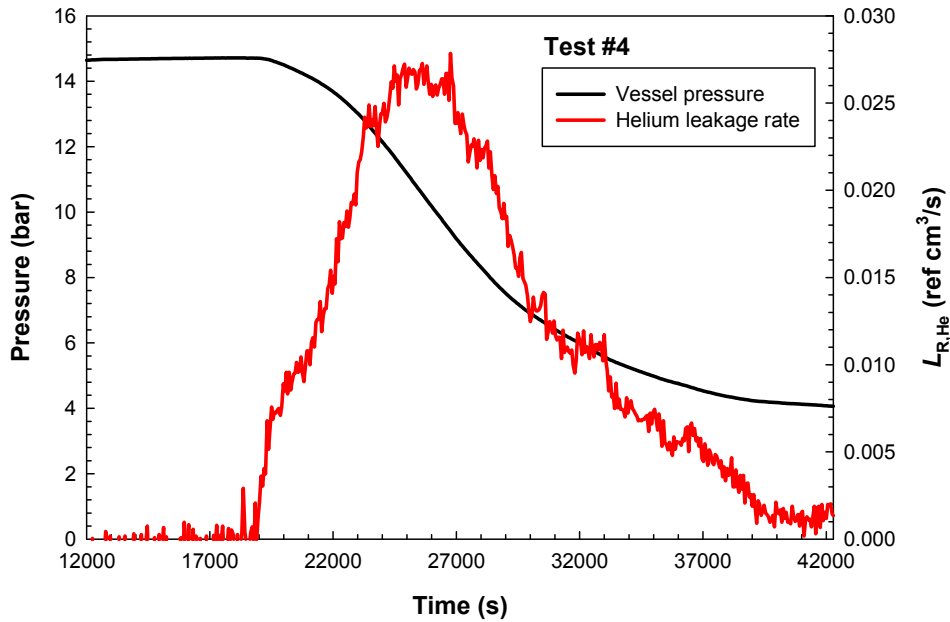
Figure 3-10. Isothermal reference helium leakage rate during the 9 h heating in Test #4.

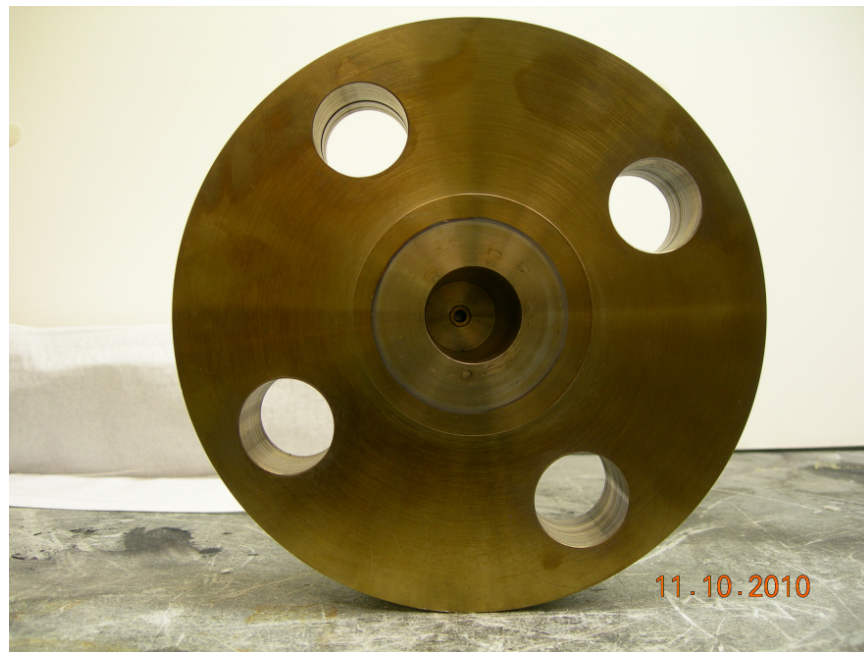
Figure 3-13. Post-test photograph of Vessel #5 (vessel body with O-ring removed) after exposure at 427 °C (800 °F) for 9 h.

A photograph of the exposed vessel is shown in Figure 3-13. The extent of discoloration of the vessel depends on the test temperature (Figure 3-1 vs. Figure 3-13). A post-test inspection revealed that the metallic O-ring seal was not soldered to either flange surfaces, and no silver coating from the seal was transferred to the O-ring groove.

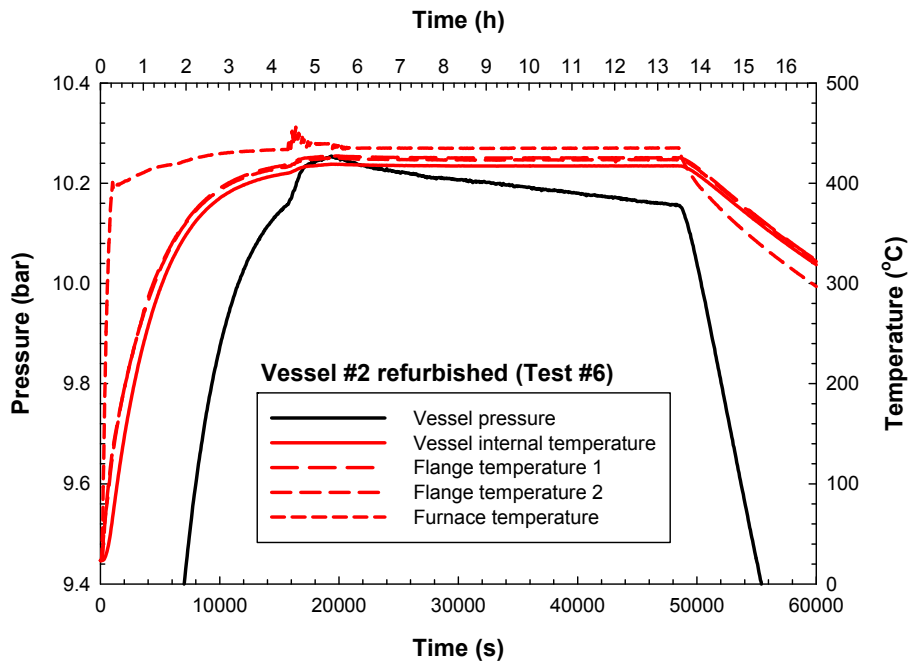
Figure 3-14. Temporal variations of vessel pressure and temperature in Test #6.

The results for Test #6 using the refurbished Vessel #2 are shown in Figure 3-14. The refurbishment only involved the re-facing of the surfaces of the flanges and O-ring groove to the specified tolerances. For this test, the vessel pressure started to decrease very slowly during the constant-temperature heating period. The scale of the ordinate is magnified in Figure 3-14 to elucidate the continuous decrease in pressure. However, the small pressure drop is within the pressure measurement uncertainty of 0.11 bar. Although the continuous decrease in pressure does seem to imply that a very small leak might have occurred during the test, the initial charge pressure was restored when the vessel was cooled to room temperature after the thermal exposure (as shown in Figure 3-15), an indication of no leakage.

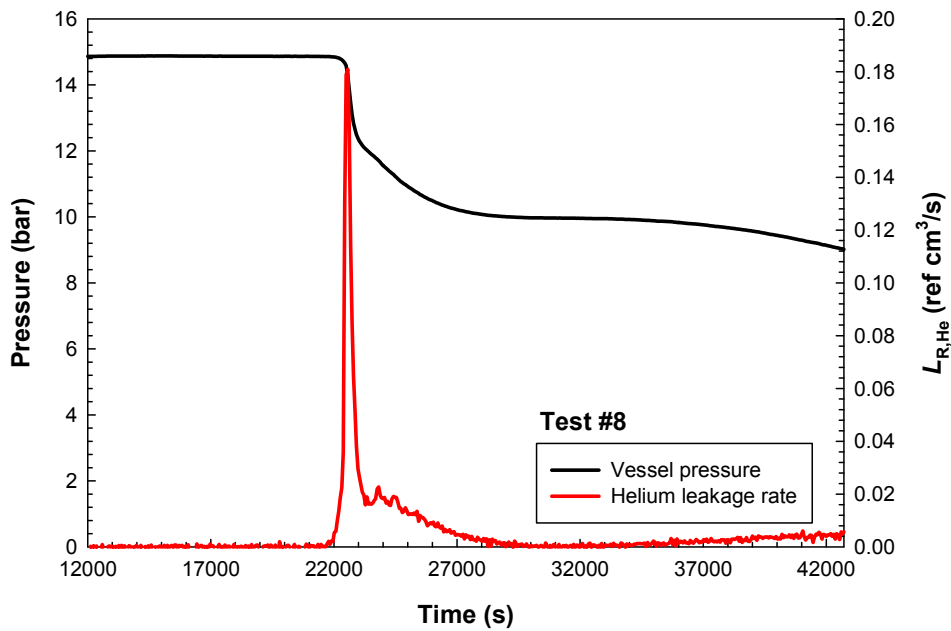
Figure 3-20. Isothermal reference helium leakage rate during the 9 h heating in Test #8.

The test conditions were similar to Tests #2, 3, and 4. Figure 3-18 shows the thermal exposure results for Vessel #6. The pressure trace indicates that leakage occurs after about 3 h exposure to 800 °C (1472 °F). For this test, the pressure initially decreases very rapidly, followed by a gradual decrease in vessel pressure. However, the pressure never dropped below 2 bar, indicating that the seal had some residual sealing capacity. Figure 3-19 is the complete time-pressure and time-temperature histories of Test #8. Figure 3-20 shows the calculated isothermal reference helium leakage rates during the 9 h heating.

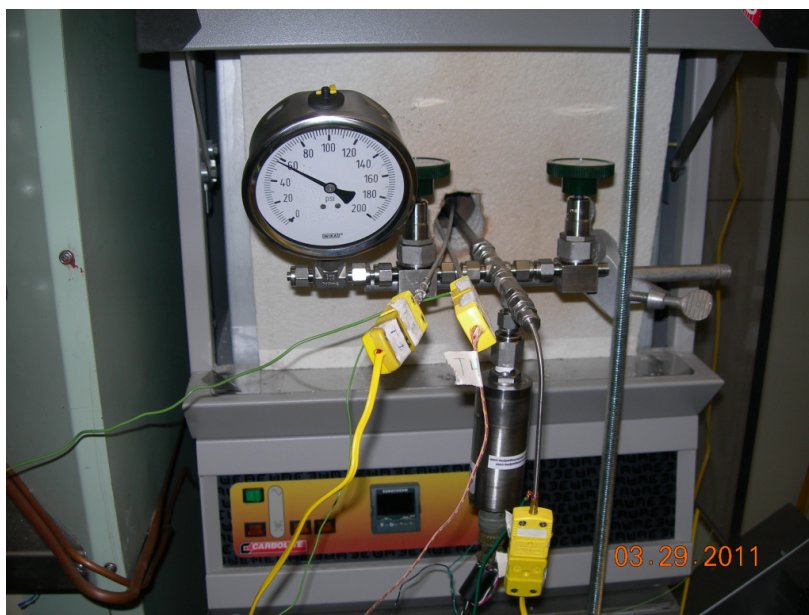
Figure 3-21. A photograph showing the pressure gauge used to check the pressure transducer performance.

The test protocol involved the heating of the vessel to 427 °C (800 °F). Once the vessel reached 427 °C (800 °F), the furnace temperature was raised to 800 °C (1472 °F), and the vessel was heated at 800 °C (1472 °F) for a little more than 3 h. Figure 3-22 and Figure 3-23 show the pressure and temperature data using different time scales respectively. No leak is indicated in the figures since the attainable pressure at 800 °C (1472 °F) remained constant. However, the pressure at 800 °C (1472 °F) was lower than those recorded in previous tests under similar conditions (≈ 12 bar vs. ≈ 14.5 bar). This is due to the increase of the measurement volume with the addition of the pressure gauge which used a C-shape Bourdon tube with a surprisingly large volume and was located outside the furnace at room temperature (see Appendix D for theoretical volume and pressure calculation) as shown in Figure 3-21. The gauge was disassembled and the internal volume of the Bourdon tube, which had a nearly elliptical cross section, was estimated to be more than 12 mL. Figure 3-24 correlates the pressure readings from the pressure transducer with those from the pressure gauge at different times during the heating phase. The pressure transducer clearly functioned properly, and the transducer readings correspond, within the measurement uncertainties, to those obtained from the pressure gauge.

⁸ WIKA model with a range of 0 bar (0 psig) to 13.79 bar (200 psig) and a resolution of 0.14 bar (2 psig).

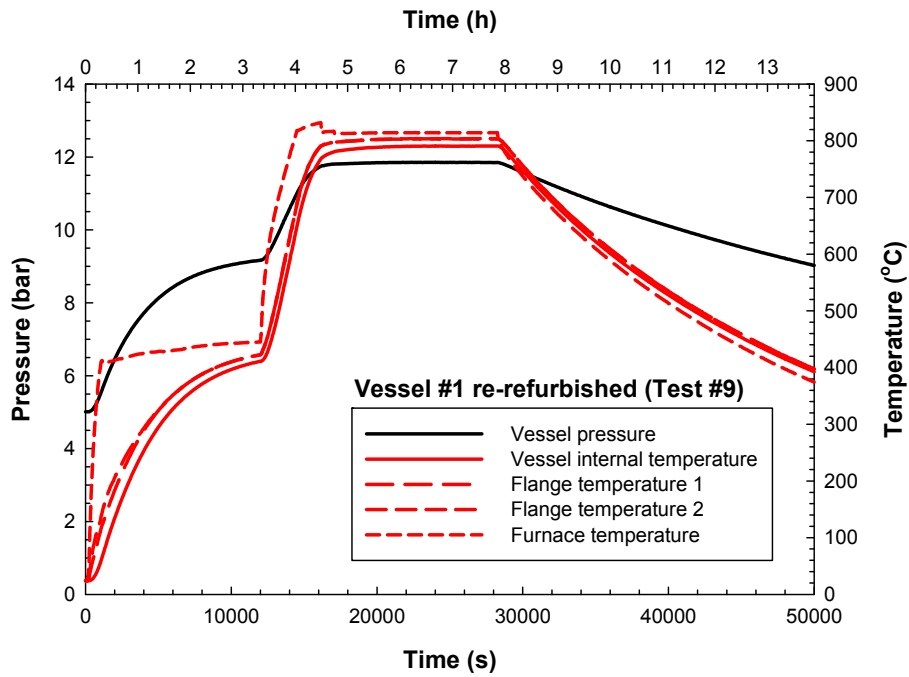
Figure 3-22. Temporal variations of vessel pressure and temperature in Test #9.

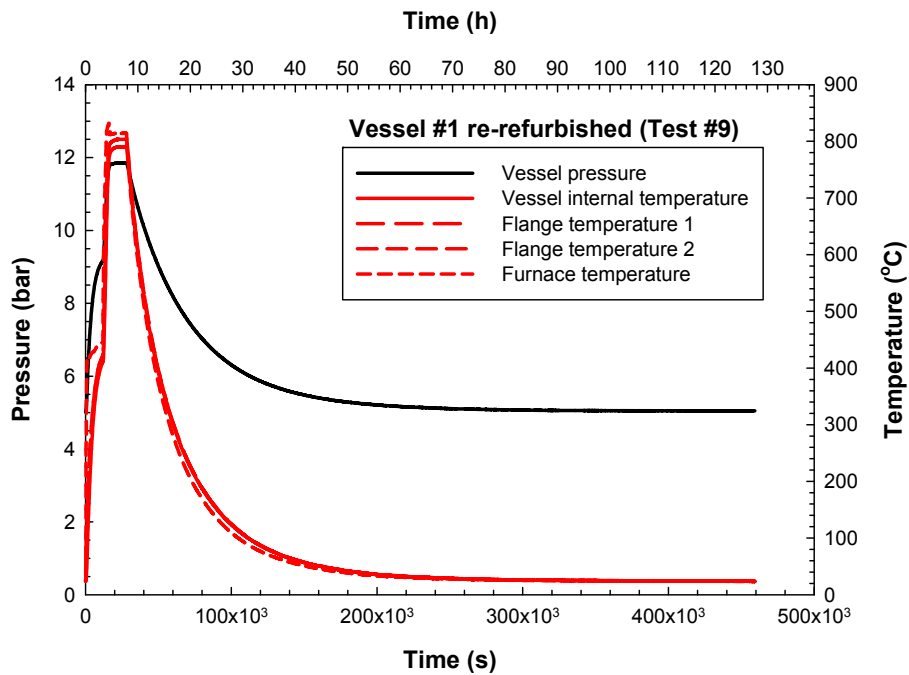
Figure 3-23. Temporal variations of vessel pressure and temperature in Test #9 (time scale extended, including the complete cool-down phase).

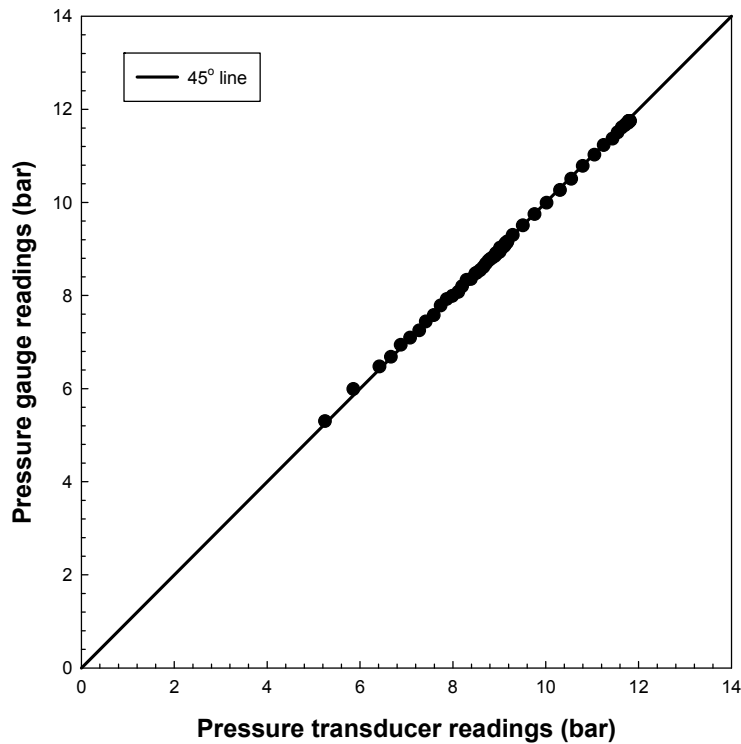
Figure 3-24. Comparison of pressure measurements from pressure transducer and pressure gauge.

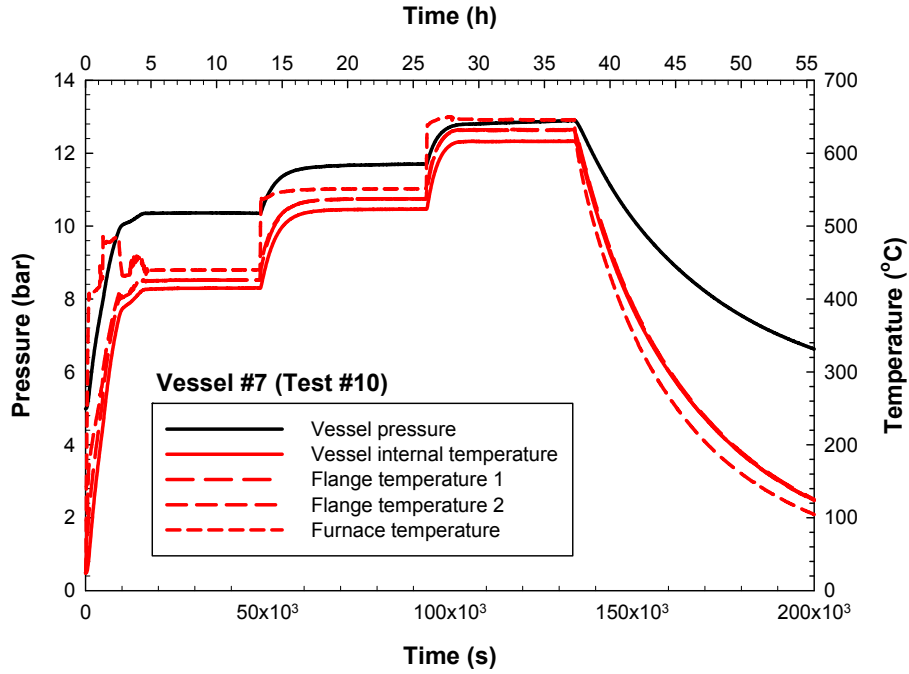
Figure 3-25. Temporal variations of vessel pressure and temperature in Test #10.

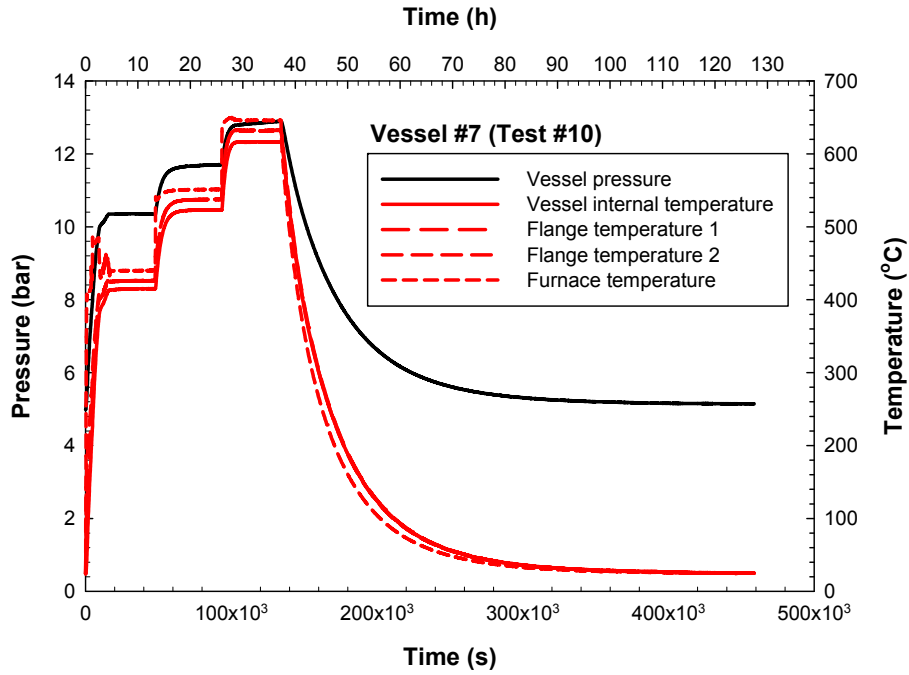
Figure 3-26. Temporal variations of vessel pressure and temperature in Test #10 (time scale extended, including the complete cool-down phase).

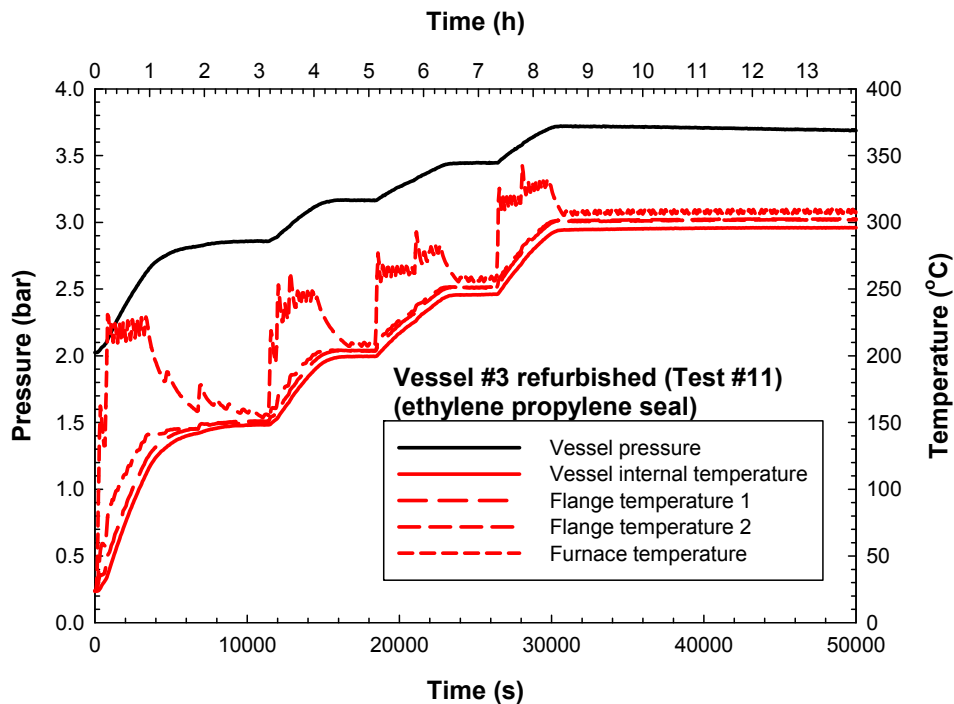
Figure 3-27. Temporal variations of vessel pressure and temperature in Test #11.

Figure 3-27 and Figure 3-28 are the test results plotted using different time scales. The spikes (overshoots) in the furnace temperature measurements reflect the way the furnace temperature was intentionally ramped and manipulated to accelerate the incremental heating of the vessel to the set temperatures. During the first 1 h heating at 150 °C (302 °F), the vessel pressure remained constant. The subsequent 1 h heating at 200 °C (392 °F) and the following 1 h heating at 250 °C (482 °F) also indicated the maintenance of vessel pressure. The final heating at 300 °C (572 °F) for more than 20 h shows a slow decrease in pressure, albeit within the pressure measurement uncertainty. However, the vessel pressure was restored to its initial value after the thermal exposure test, as shown in Figure 3-28. Post-test inspection of the exposed vessel revealed that the O-ring was still pliable and could be easily removed from the O-ring groove.

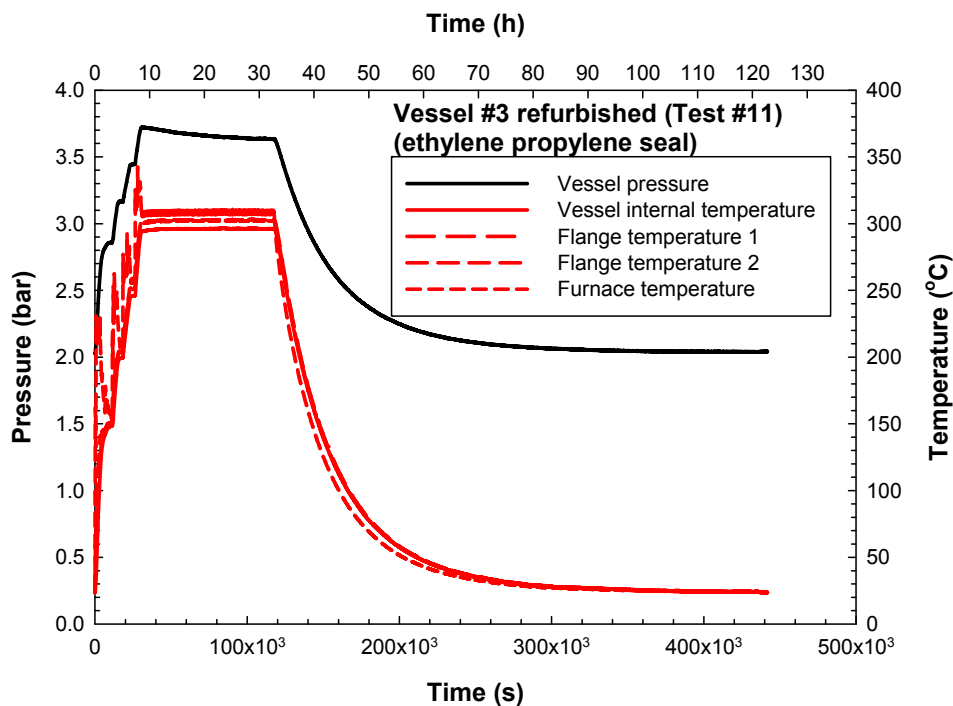
Figure 3-28. Temporal variations of vessel pressure and temperature in Test #11 (time scale extended, including the complete cool-down phase).

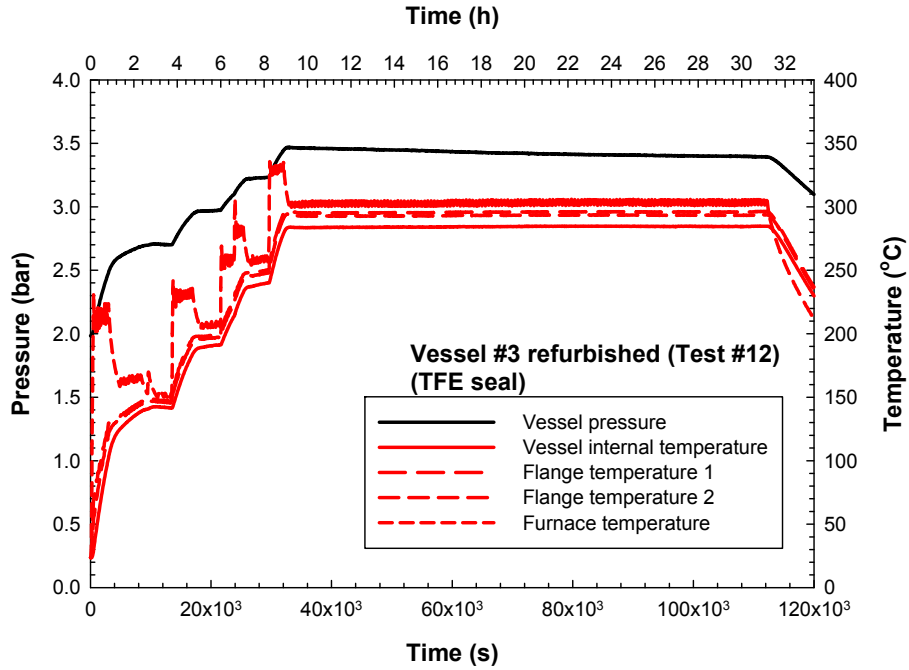
Figure 3-29. Temporal variations of vessel pressure and temperature in Test #12.

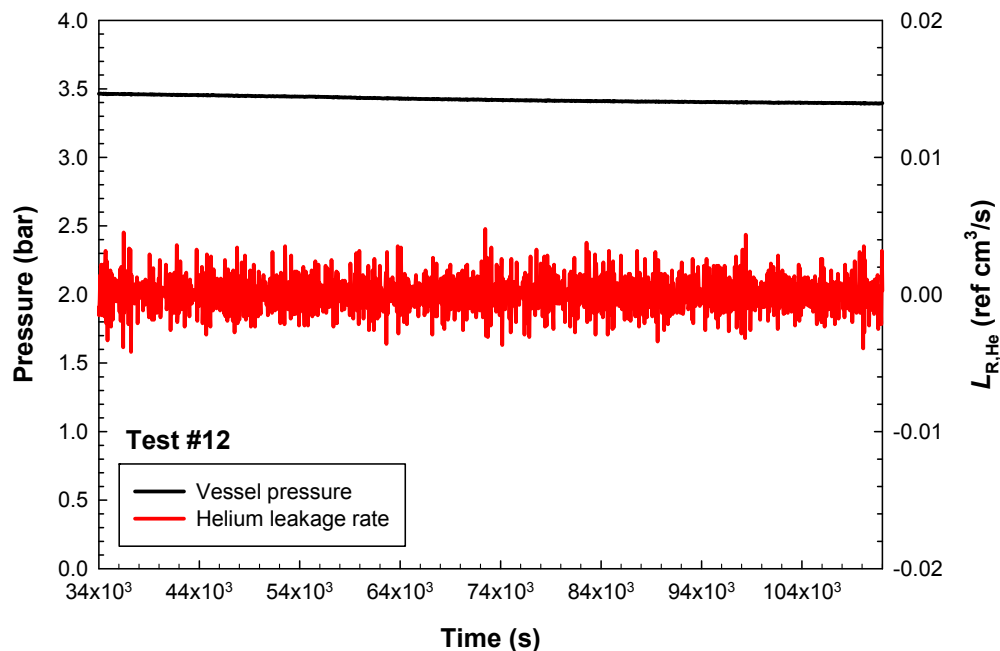
Figure 3-31. Isothermal reference helium leakage rate during the 22 h heating in Test #12.

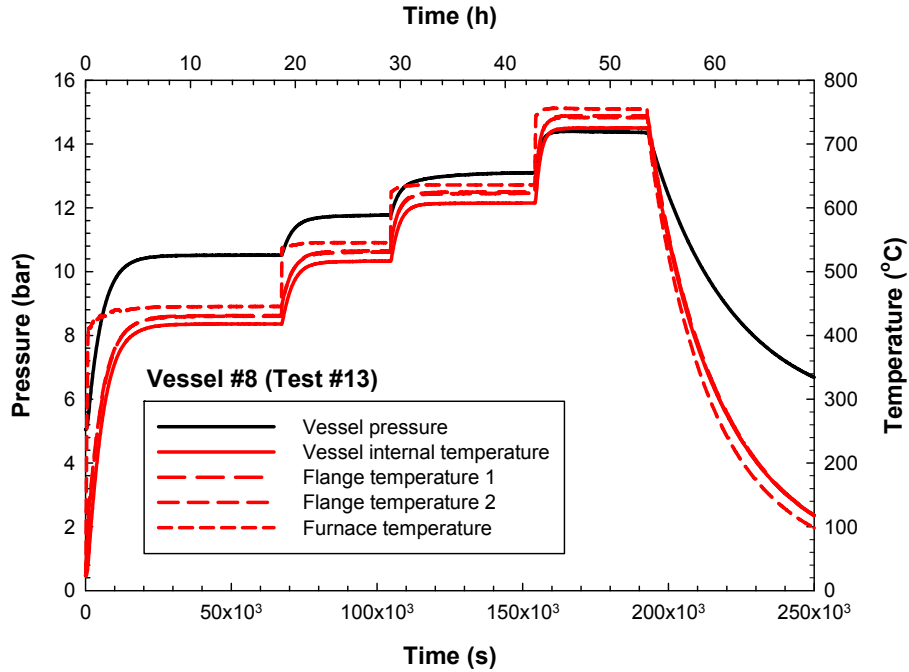
Figure 3-32. Temporal variations of vessel pressure and temperature in Test #13.

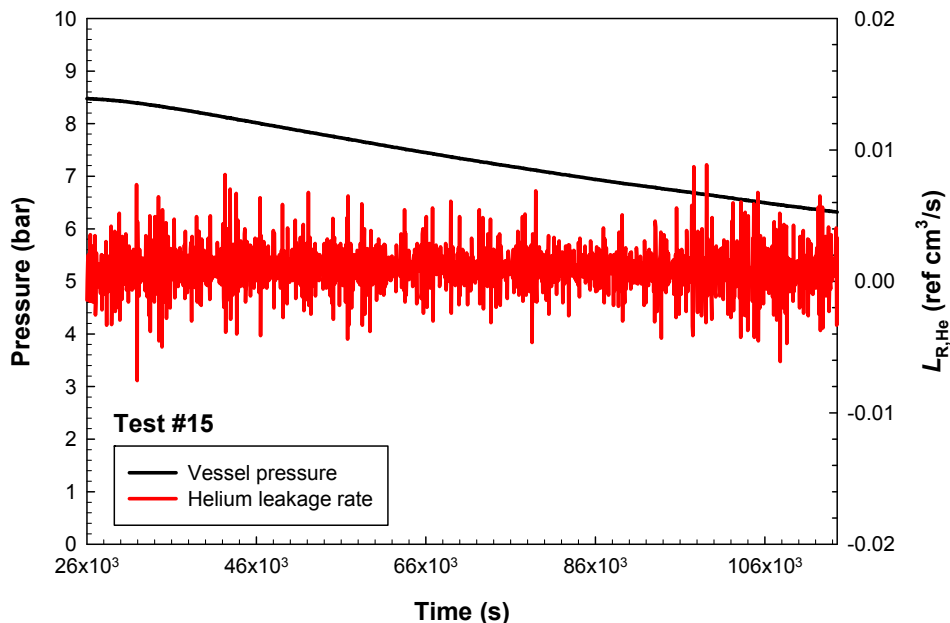
Figure 3-38. Isothermal reference helium leakage rate during the 25 h heating in Test #15.

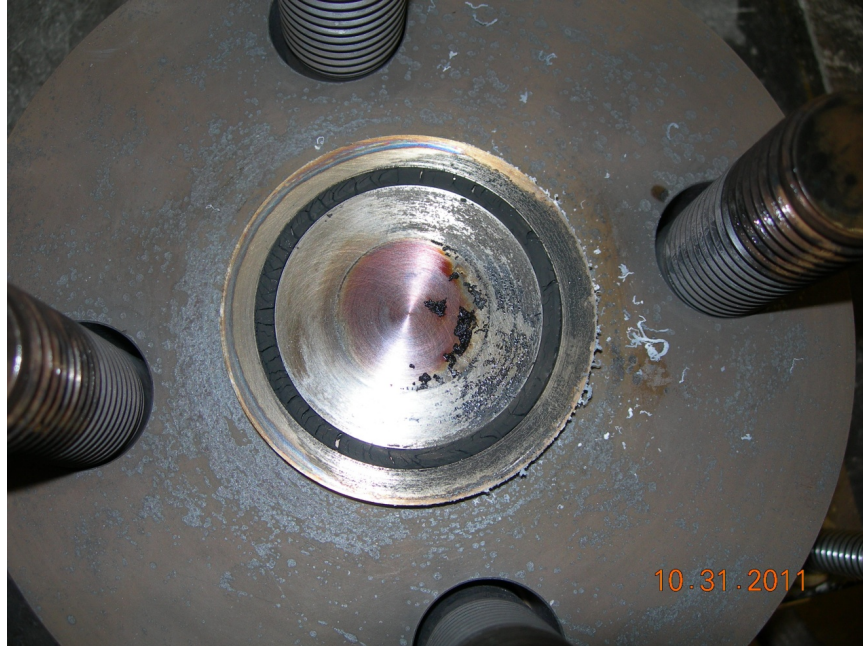
Figure 3-39. Photograph of the ethylene-propylene compound O-ring after thermal exposure.

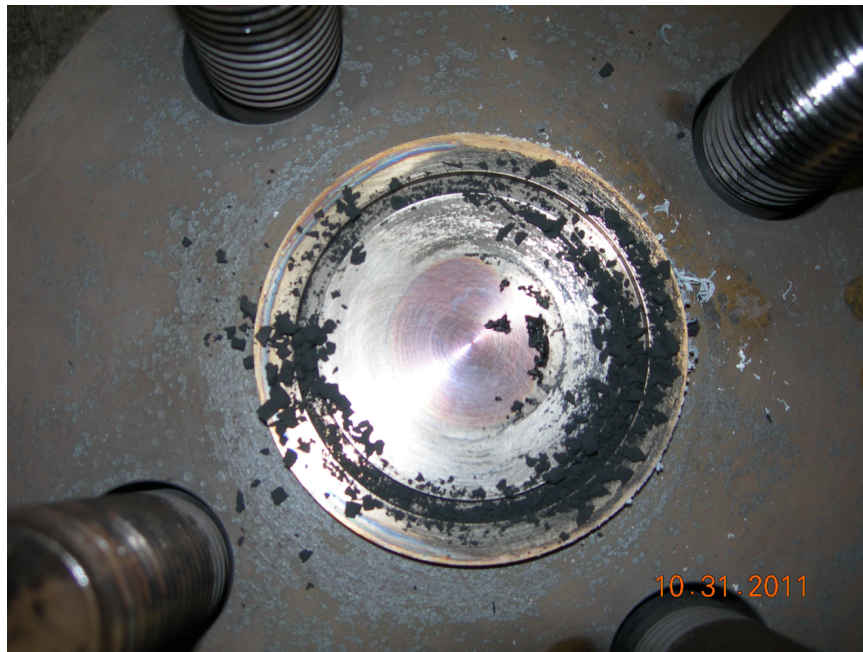
Figure 3-40. Photograph showing the disintegration of the tested ethylene-propylene compound O-ring when an attempt was made to remove the O-ring from the groove.
