NUREG/CR-7103, Vol. 2

Pacific Northwest National Laboratory Investigation of Stress Corrosion Cracking in Nickel-Base Alloys

The objective of this program is to evaluate the primary water stress corrosion cracking (PWSCC) susceptibility of high chromium alloy 690 and its weld metals, establish quantitative measurements of crack-growth rates and determine relationships among cracking susceptibility, environmental conditions and metallurgical characteristics. Stress-corrosion, crack-growth rates have been determined for 12 alloy 690 specimens, 11 alloy 152/52/52M weld metal specimens, 4 alloy 52M/182 overlay specimens and 2 alloy 52M/82 inlay specimens in simulated PWR primary water environments. The alloy 690 test materials included three different heats of extruded control-rod-drive mechanism (CRDM) tubing with variations in the initial material condition and degree of cold work for one heat. Two cold-rolled (CR) alloy 690 plate heats were also obtained and evaluated enabling comparisons to the CR CRDM materials. Weld metal, overlay and inlay specimens were machined from industry mock ups to provide plant-representative materials for testing. Specimens have been tested for one al

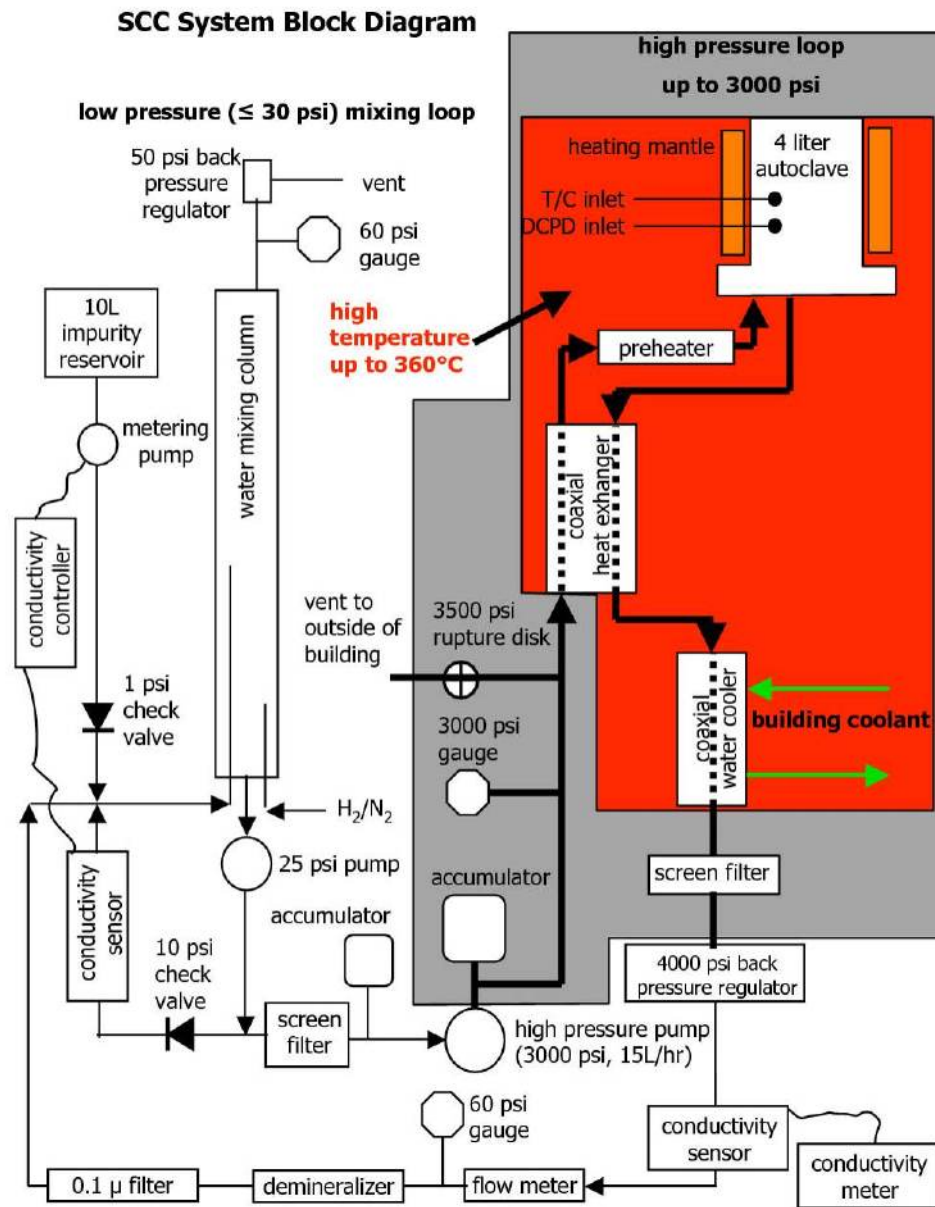
Figure 2.1 General water flow diagram for PNNL SCC crack-growth test systems.

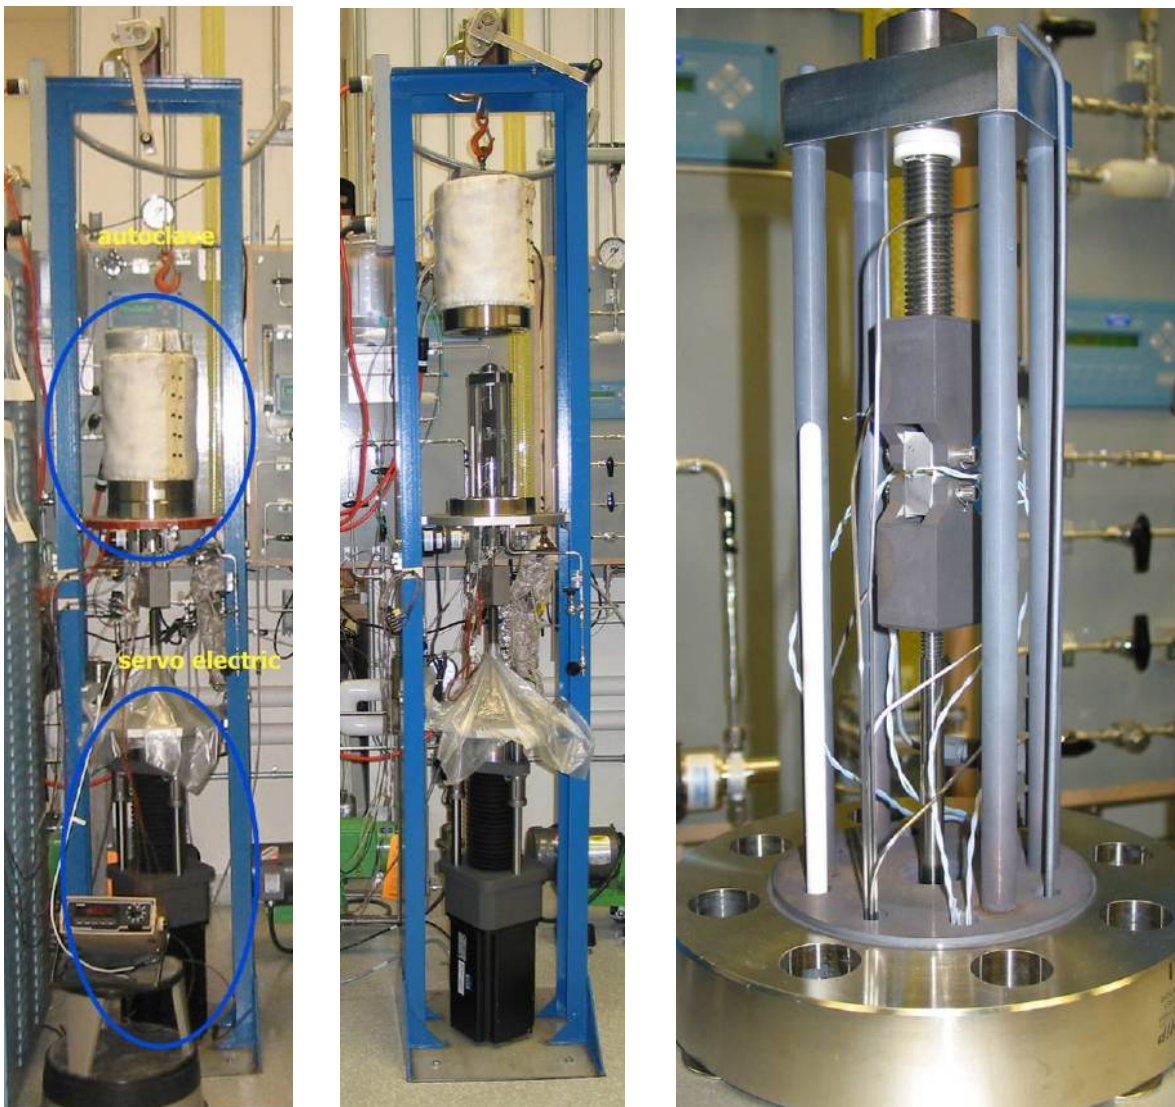
Figure 2.2 Typical crack-growth-rate test frame loading system used at PNNL.

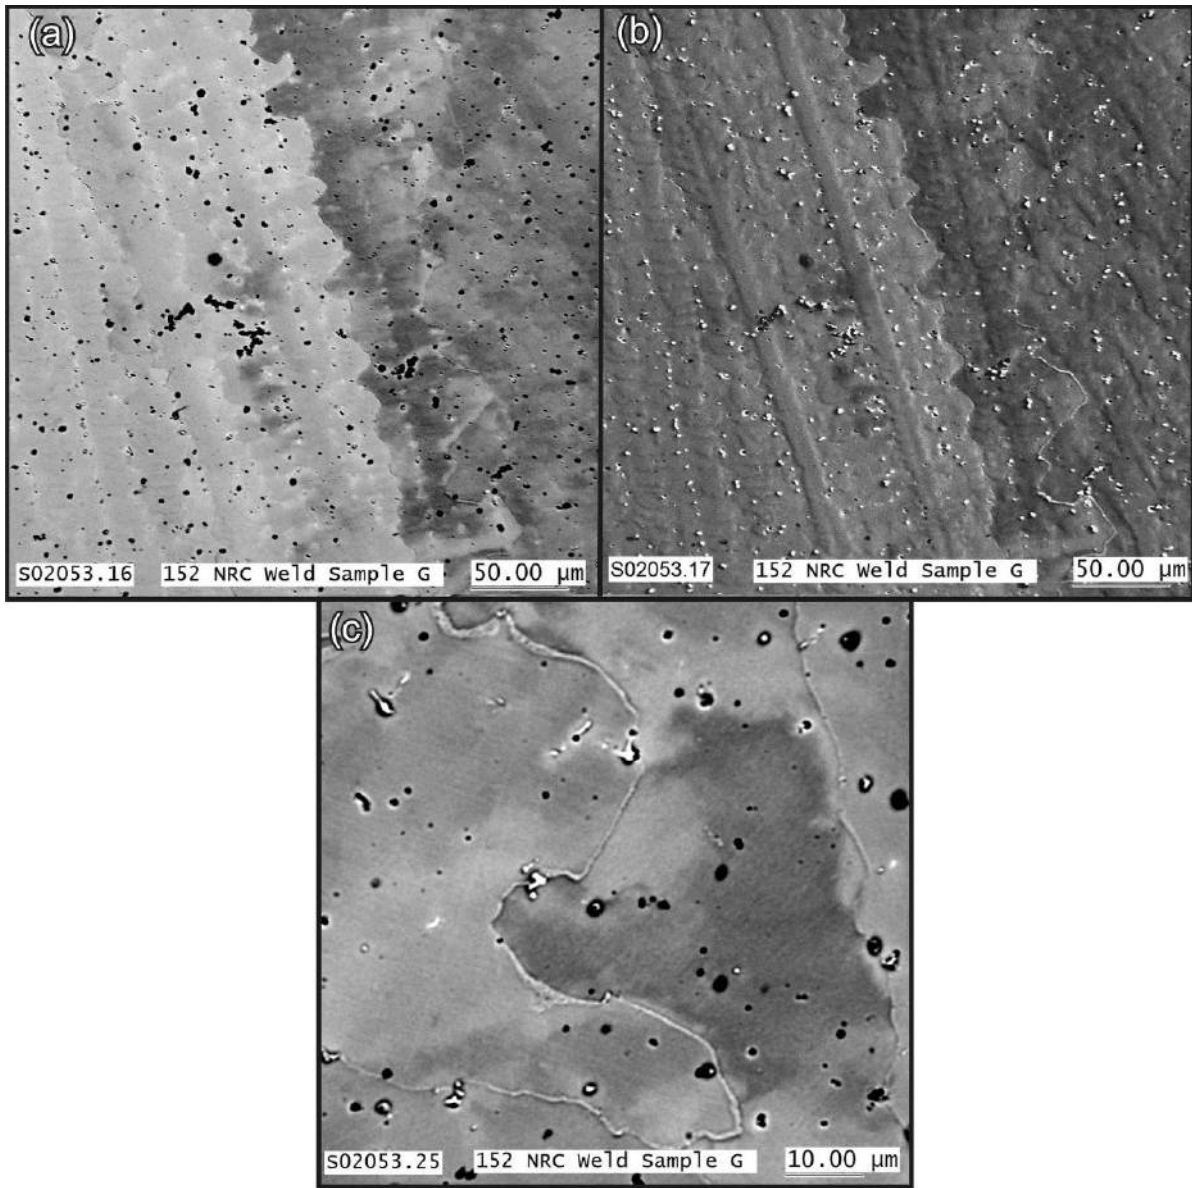
Figure 3.5 Scanning electron microscope images are shown from the alloy 152 weld metal. The image in (a) was taken using backscattered electrons, (b) and (c) were taken in secondary electron imaging mode.

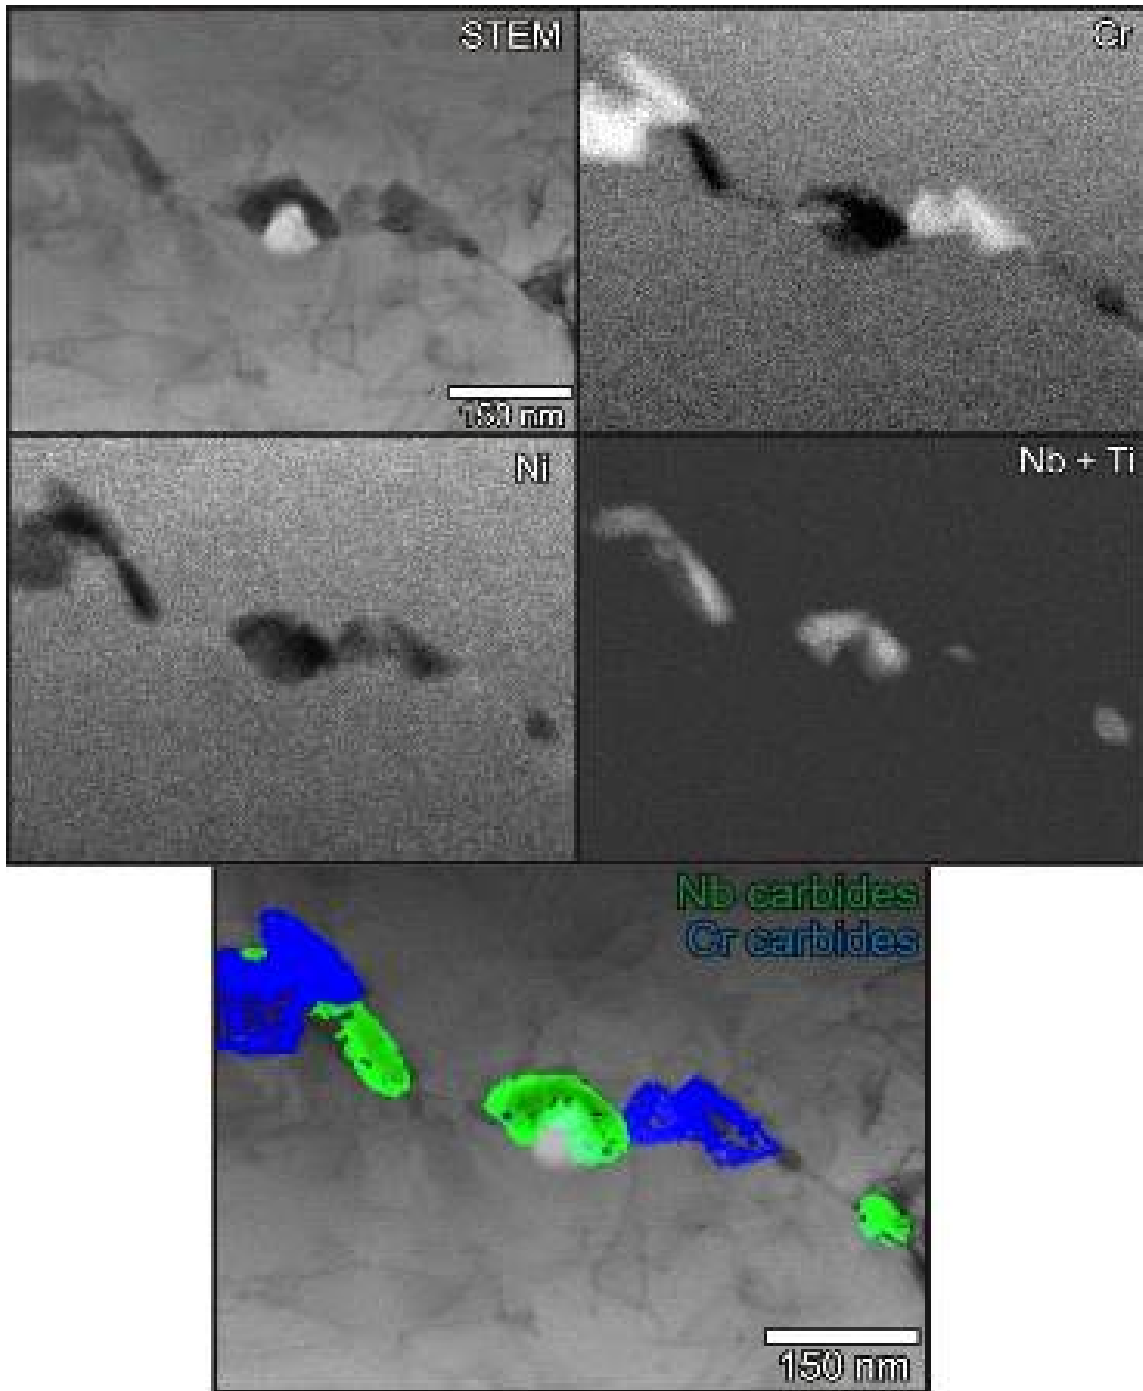
Figure 3.8 Compositional maps taken in STEM mode revealed that both Cr- and Nb-rich carbides are present on the boundary between two dendrites. The bottom image reveals that the two carbide phases can sometimes be superimposed with each other. In this example, Nb and Ti were associated with the same particles.

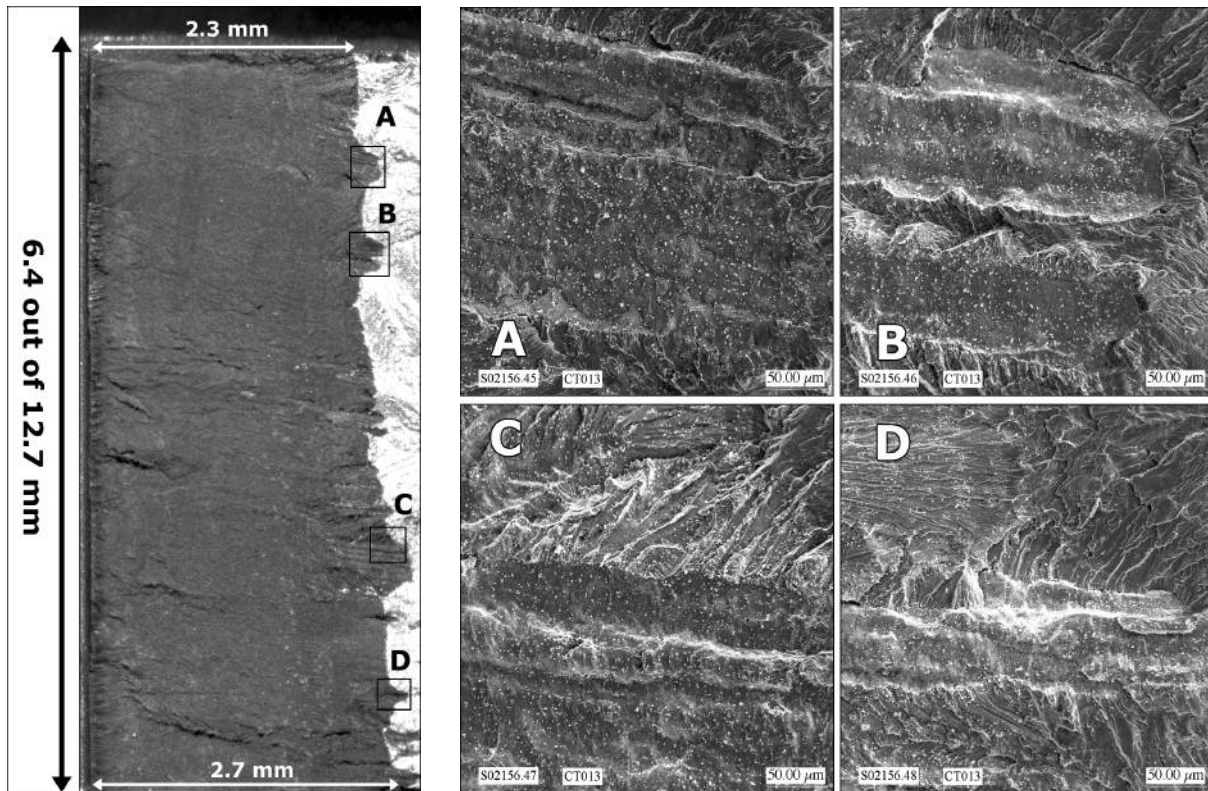
Figure 3.12 Crack growth surface of MHI alloy 152 specimen CT013. Optical image on left reveals local areas of SCC propagation and SEM images on right illustrate IG morphology.

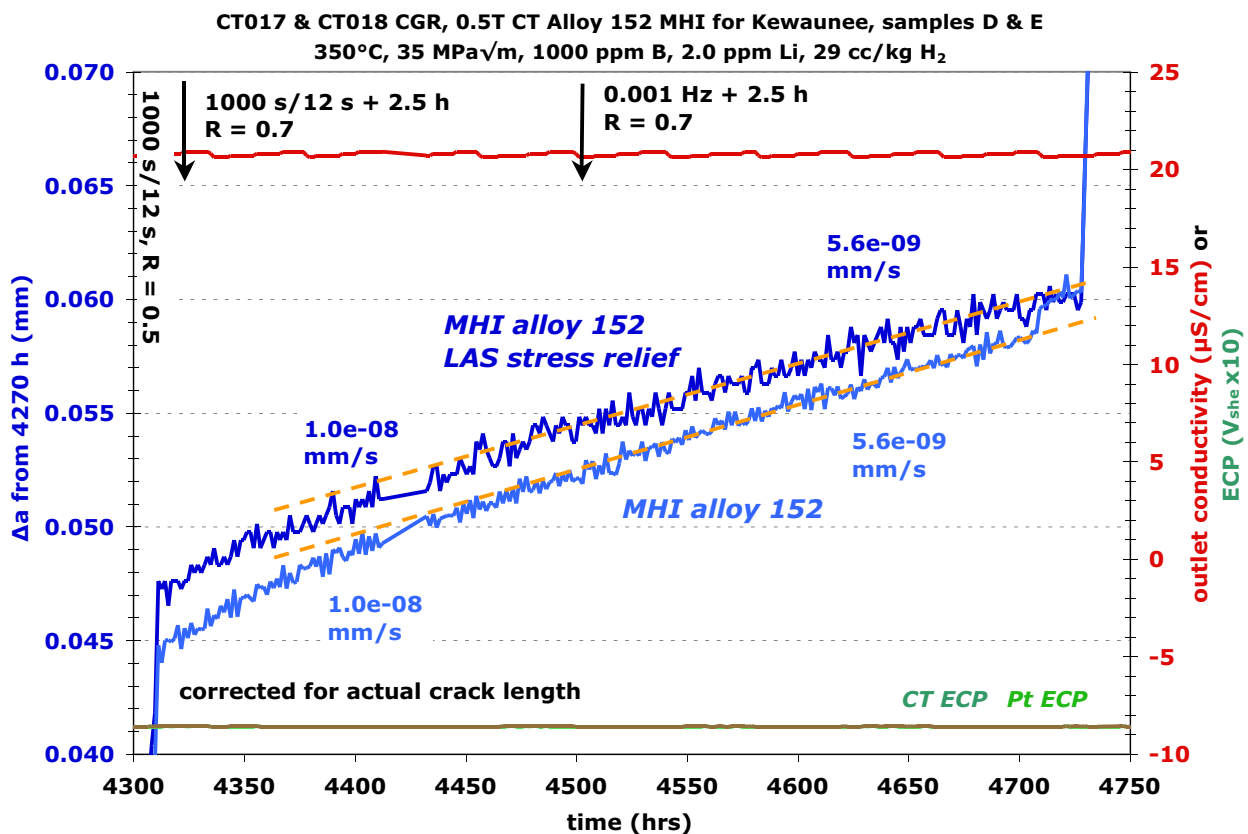
Figure 3.15 Crack growth response during cyclic loading conditions of MHI alloy 152 specimens CT017 & CT018 at $\sim 33 \text{ MPa}\sqrt{\text{m}}$ in the second microstructural region examined.

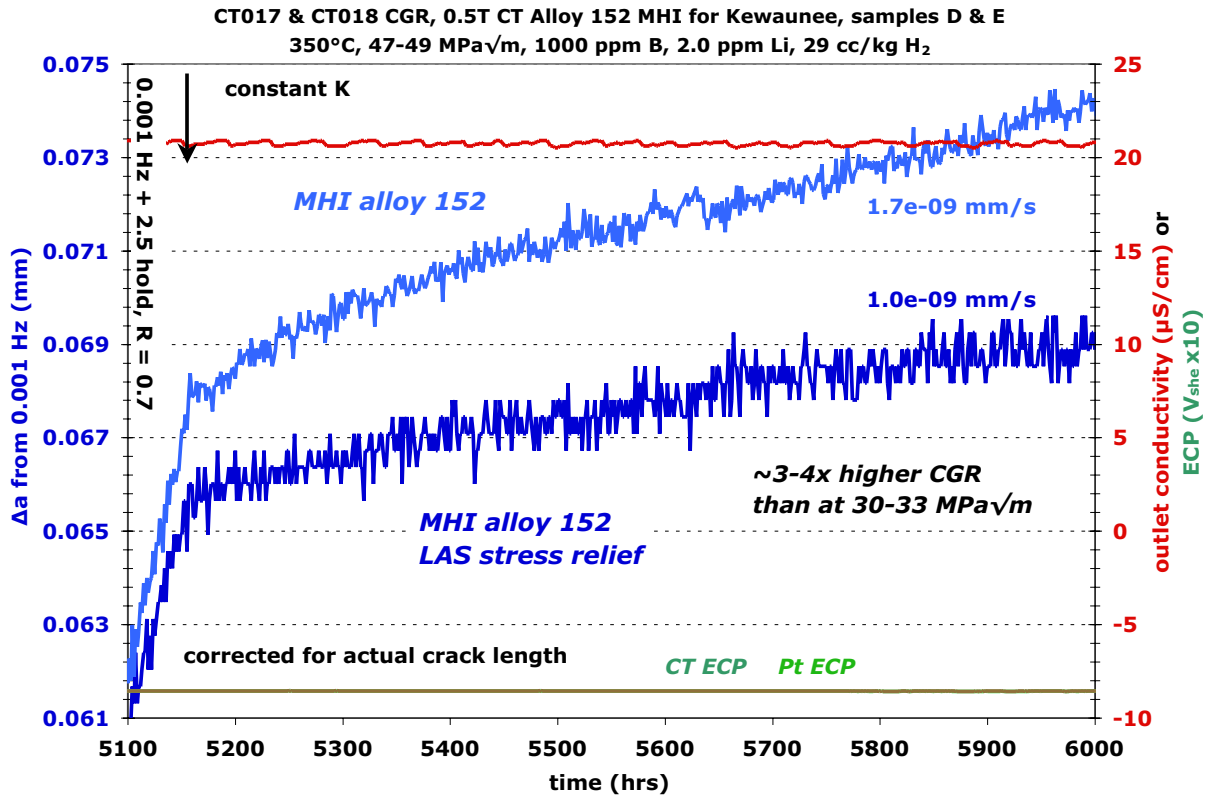
Figure 3.16 Constant K crack growth response of MHI alloy 152 specimens CT017 & CT018 at $\sim 48 \text{ MPa}\sqrt{\text{m}}$.

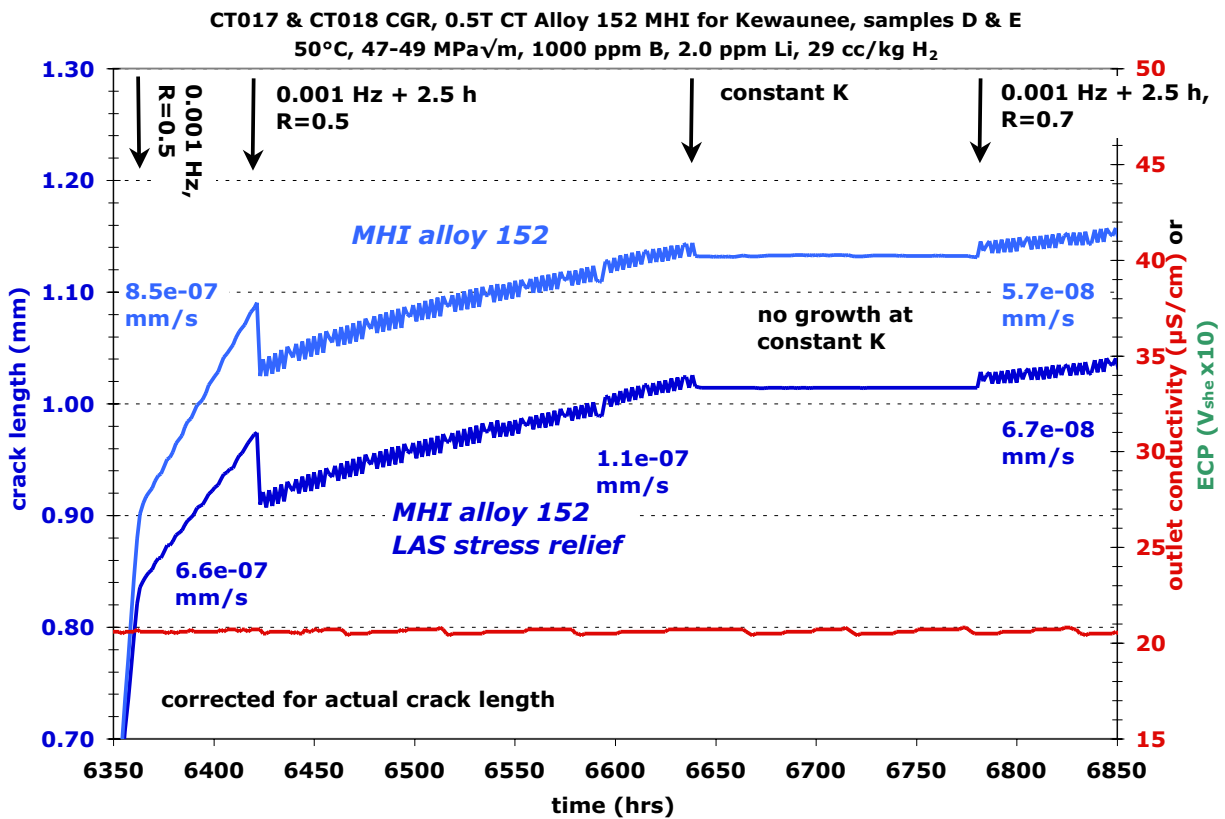
Figure 3.17 Crack growth response of MHI alloy 152 specimens CT017 & CT018 at 50°C in simulated PWR primary water.

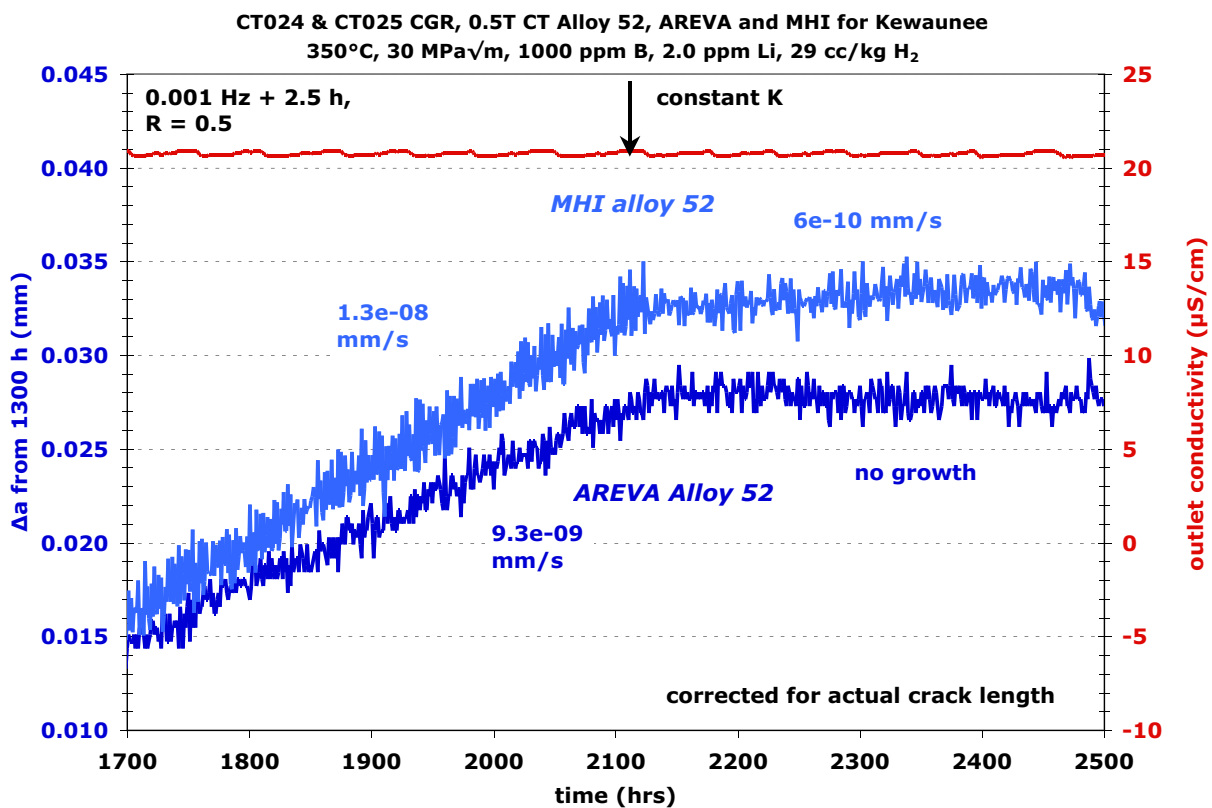
Figure 3.23 Cycle + hold and constant K response of the AREVA and MHI alloy 52 specimens (CT024 & CT025) in the second region of each specimen that was examined.

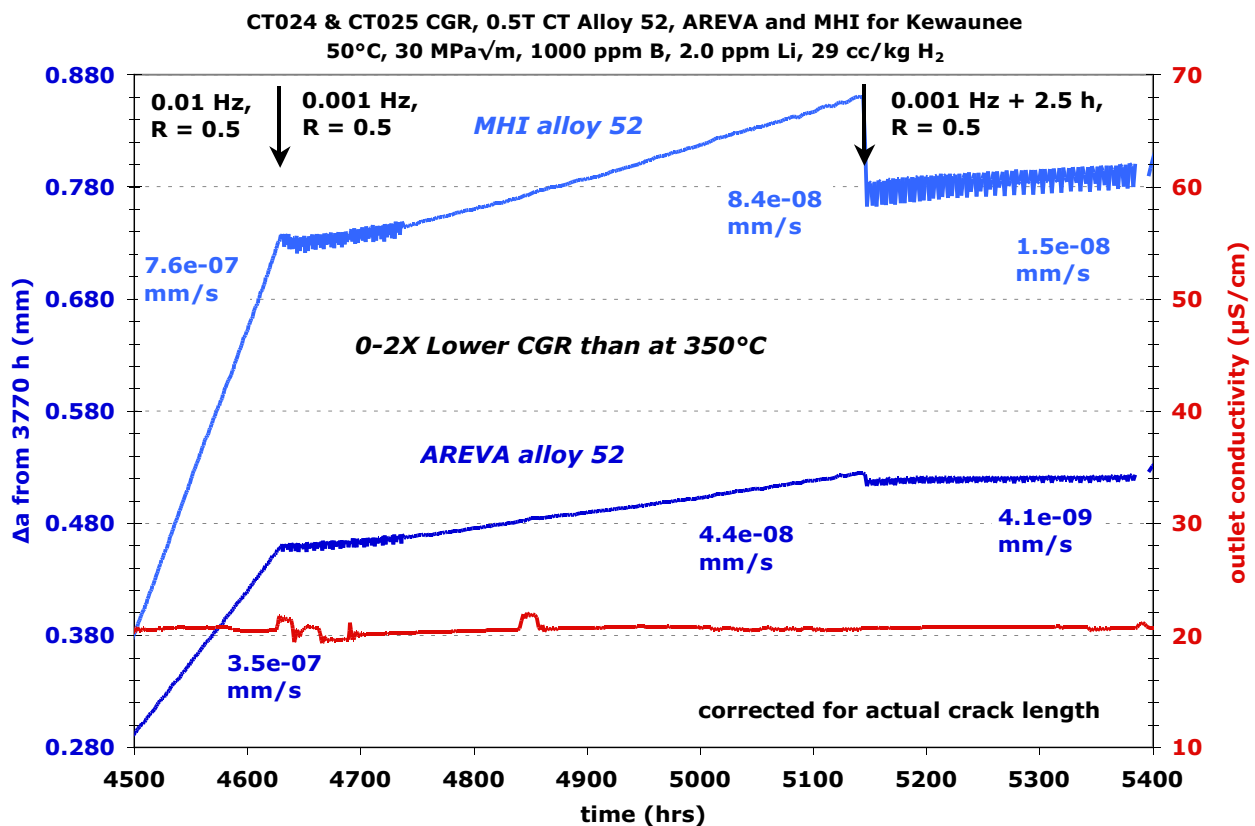
Figure 3.24 Overview of the crack growth response of the AREVA and MHI alloy 52 specimens (CT024 & CT025) during cyclic loading conditions at 50°C.

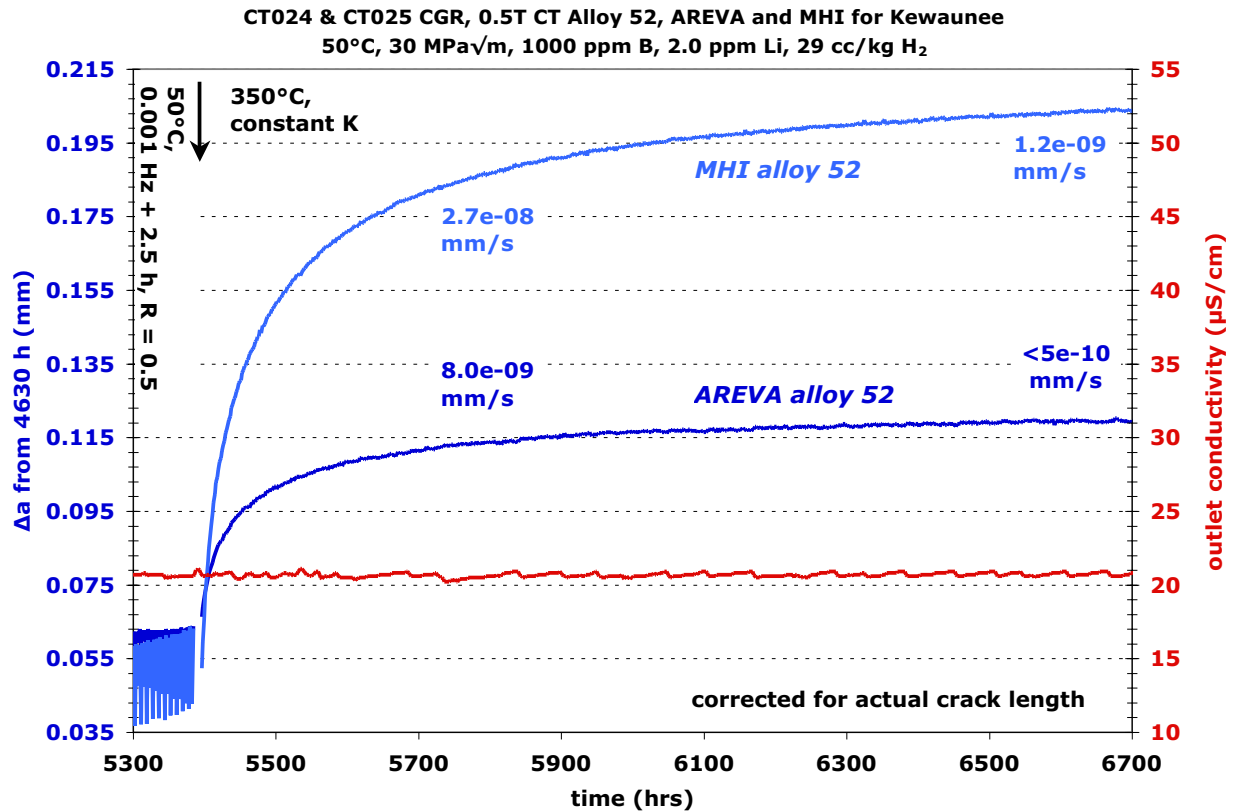
Figure 3.25 Constant K crack growth response of the MHI and AREVA alloy 52 specimens (CT024 & CT025) at 350°C after cyclic loading crack extension at 50°C.

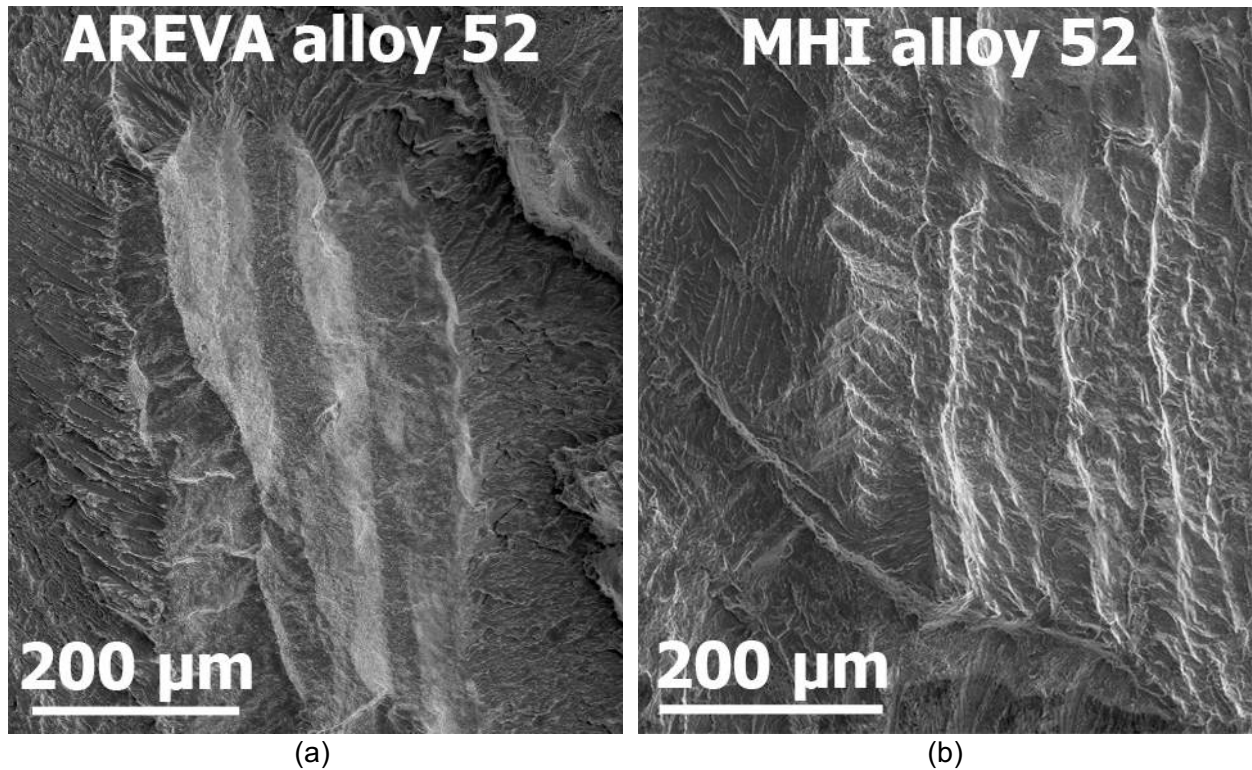
Figure 3.28 SEM images illustrating IG regions on the crack growth surface for the alloy 52 specimens: (a) isolated IG finger-like area in AREVA sample and (b) typical IG area in MHI sample. For both specimens, some IG cracking was initiated during final growth at 350°C and continued during cycling at 50°C.

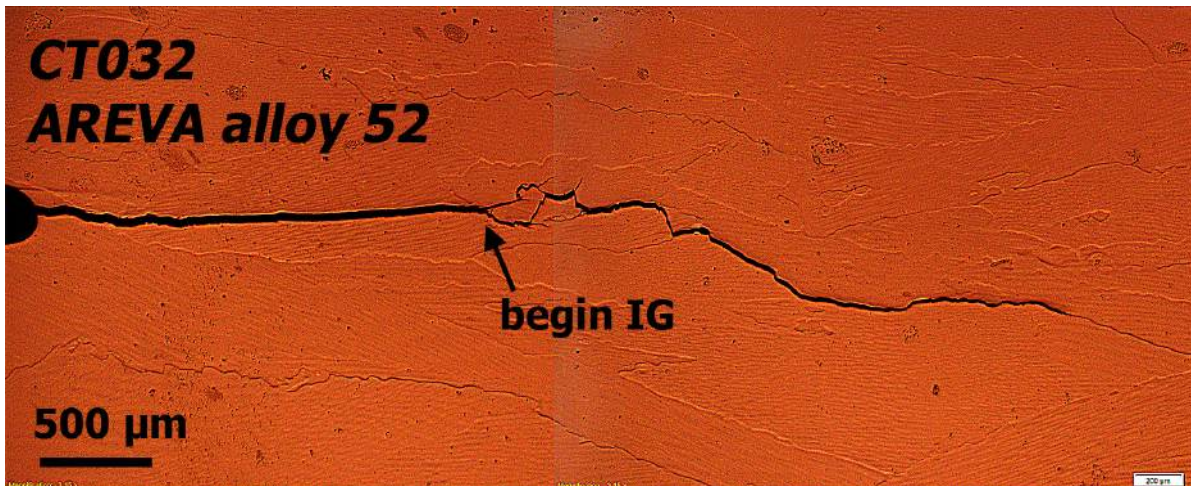
Figure 3.38 Side surface optical image of cracking in the AREVA alloy 52 specimen (CT032) showing both TG and IG growth.

After ending the test, the crack was sealed for crack-tip characterization by filling it with resin, and the specimens were each sectioned into two slices with one slice being fatigued open to reveal the crack growth surface, and the side of the other slice being polished to reveal the crack path through the material. The optical images of the crack growth surface, as shown in Figure 3.37, are somewhat difficult to discern because of resin coating the surface, but the large phases of the test are identifiable. It is also clear that there are regions of IG growth on the surface of both specimens. A side surface image of the AREVA (CT032) specimen is shown in Figure 3.38 revealing again that the material has very large grains. In this particular slice through the material, a significant amount of IG cracking was found; essentially the entire in-situ portion of the test appears to be IG along this section through the specimen. The side surface cut corresponds to a large protrusion on the crack growth surface in Figure 3.37. Several other protrusions are apparent indicating a higher degree of engagement than on the previous test (CT024). Figure 3.39 shows the side surface of the MHI (CT033) specimen with its smaller grains. Of interest in this photo is that while the crack eventually finds a grain boundary and cracks along it for some distance, it eventually turns off the boundary. Extensive cracking above and below the main crack is apparent. There is clearly some preference for IG cracking, but it appears that the grains must be well aligned for growth.

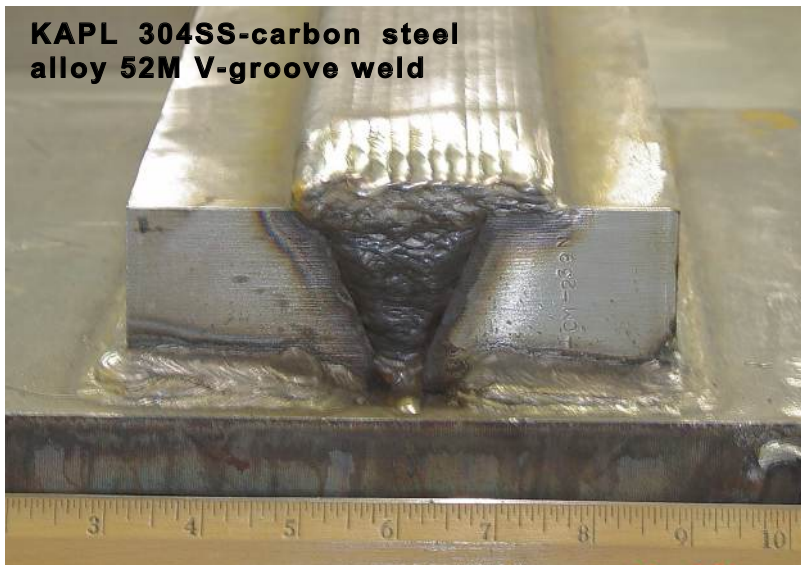
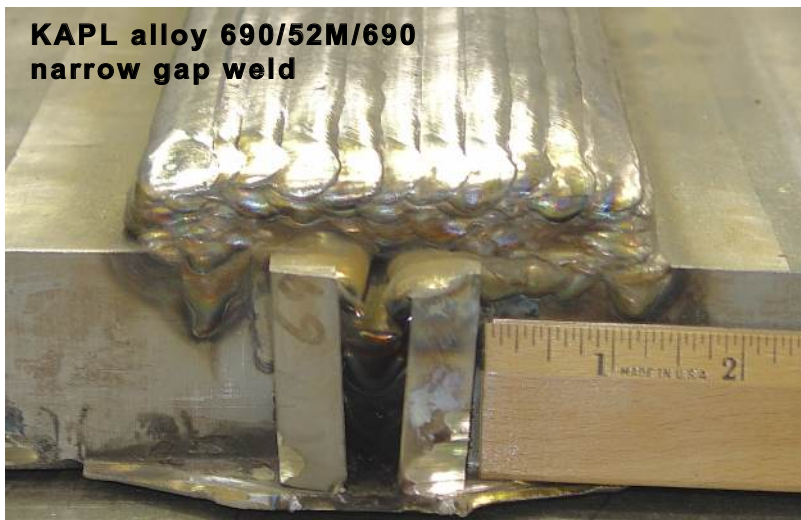
Figure 3.40 Alloy 52M welds from KAPL: (a) dissimilar metal V-groove weld of alloy EN52M joining 304 SS and carbon steel and (b) alloy EN52M narrow gap weld joining alloy 690. The thin rectangular bars at the front of the weld are run-off tabs to help start the weld. The weld itself is between the two large plates. Additional weldment was placed on top of the mockups to create sufficient size to cut CT specimens.

Characterizations, sample preparations and testing have been performed on three alloy 52M weldments received from KAPL. A brief description of the welds and weld metal compositions was given earlier in Table 3.1. Photographs of the V-groove and narrow gap mockups are presented in Figure 3.40. These welds were produced under prototypic best practice conditions and welding procedures. The third alloy 52M weldment was the same weld metal heat and narrow-gap configuration as the prototypic narrow gap weld, but re-fuse passes were applied between each weld pass to intentionally produce hot cracks. Based on metallographic examinations, the individual weld blocks were sectioned by electro-discharge machining to create blanks for CT and thin sheets for more detailed microstructural examinations. Most characterization effort was placed on the alloy 52M weld with known hot cracks.

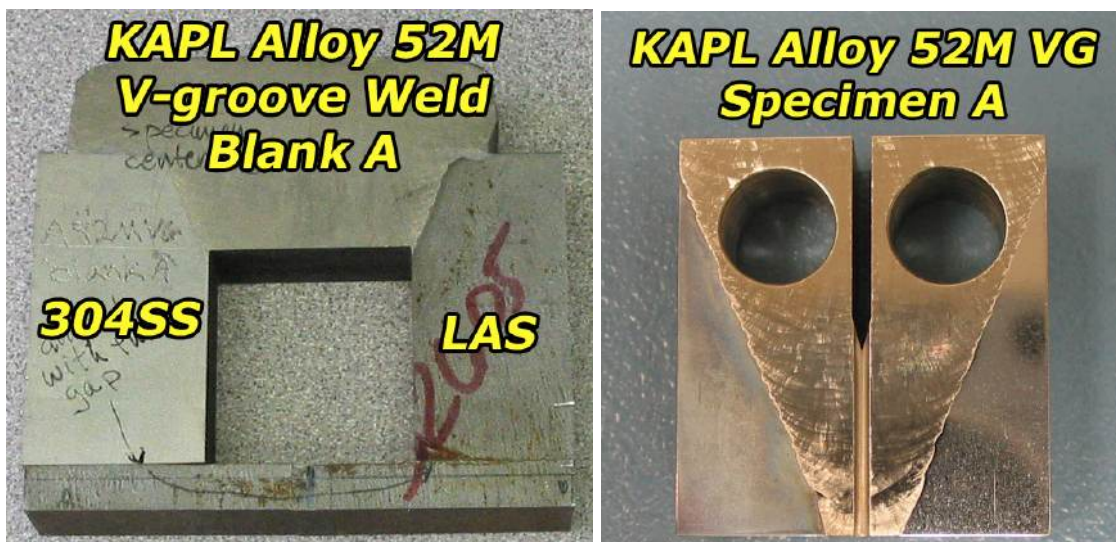
Figure 3.42 Photos of KAPL alloy 52M V-groove weld blank "A" and CT041 specimen machined from the blank.

Specimens CT040 and CT041 were machined from the center of the alloy 52M narrow-gap weld and alloy 52M V-groove weld, respectively. This is illustrated in Figures 3.41 and 3.42. Metallographic and SEM analyses were performed on the alloy 52M weld with hot cracks to determine the location of the hot cracks. Optical imaging was useful in mapping out the location of defects across entire width of the CT blanks while SEM was used to study the defects in greater detail. As shown in Figure 3.43, the majority of the defects were hot cracks along grain boundaries, and the density of these hot cracks was low. Because the cross-sectional area of the as-received weldment was only slightly larger than a 0.5T CT specimen, only a few regions of the weld could be selected for crack growth testing. Figure 3.44 shows the positioning of

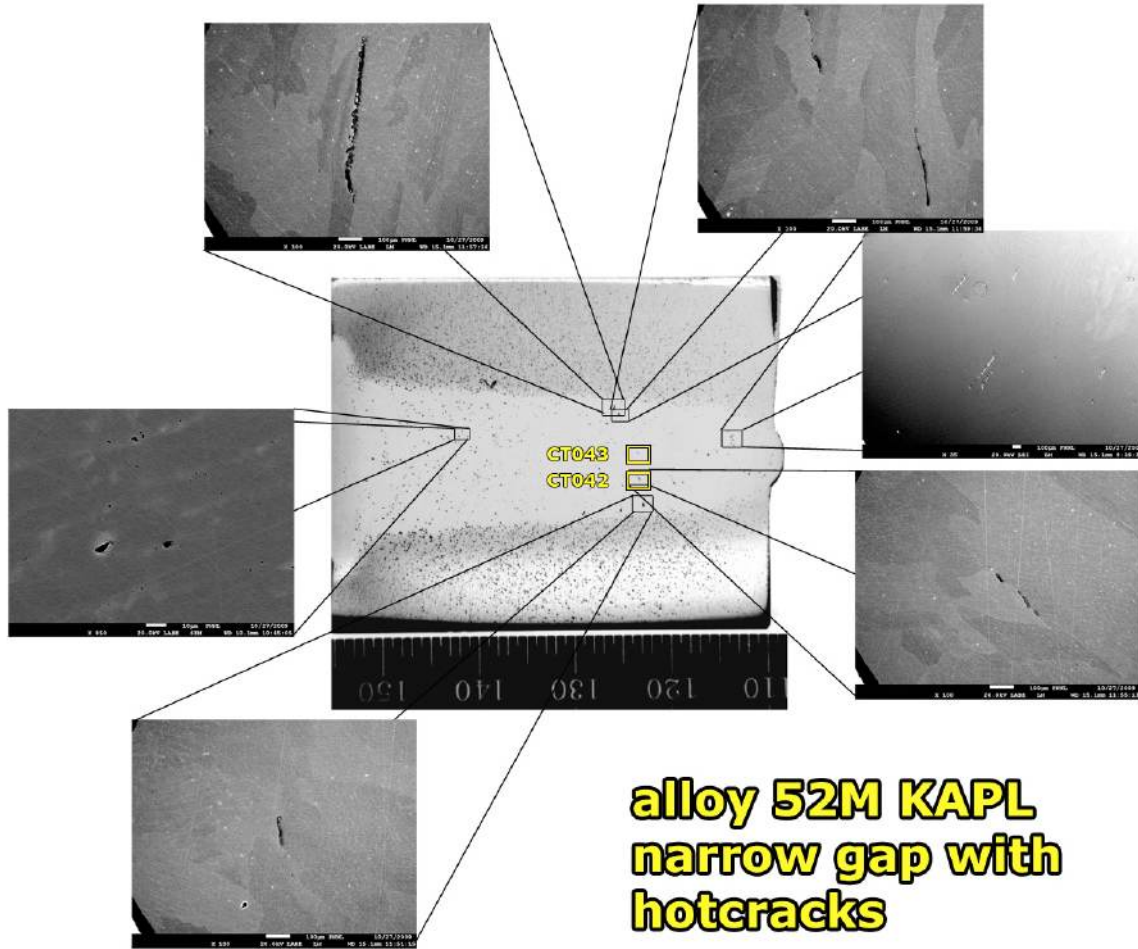
Figure 3.43 Overview of defects in the KAPL alloy 52M weld with known hot cracks.

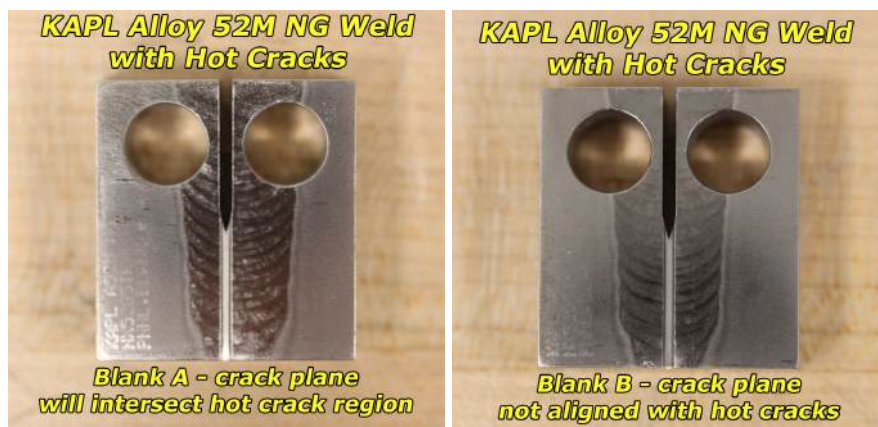
Figure 3.44 Photos of specimens cut from KAPL alloy 52M narrow gap weld containing hot cracks. Blank A (CT042) is positioned off-center and near the bottom of the weldment to intersect a high density of weld cracks, while blank B (CT043) is positioned near the center of the weld where no weld cracks were observed.

specimens CT042 and CT043 on the CT blanks while the yellow boxes in Figure 3.43 show the region of the weldment to be SCC tested relative to the observed weld defects in one of the metallography specimens. Specimen CT042 is positioned off-center to intersect a higher density of weld cracks, while CT043 is positioned near the center where fewer cracks were observed. All four alloy 52M specimens were pre-cracked in air to a depth of ~1.2 mm.

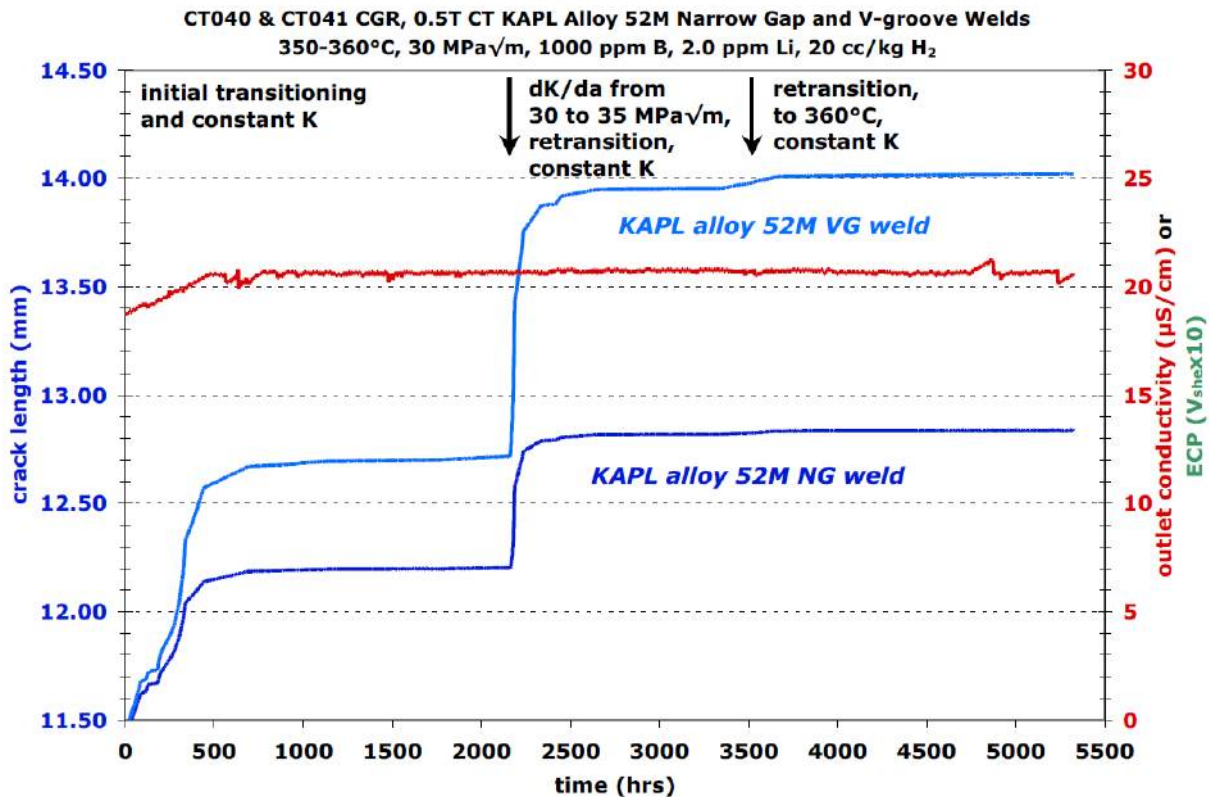
Figure 3.45 Overview of the entire test on the KAPL alloy 52M narrow gap (CT040) and V-groove (CT041) specimens.

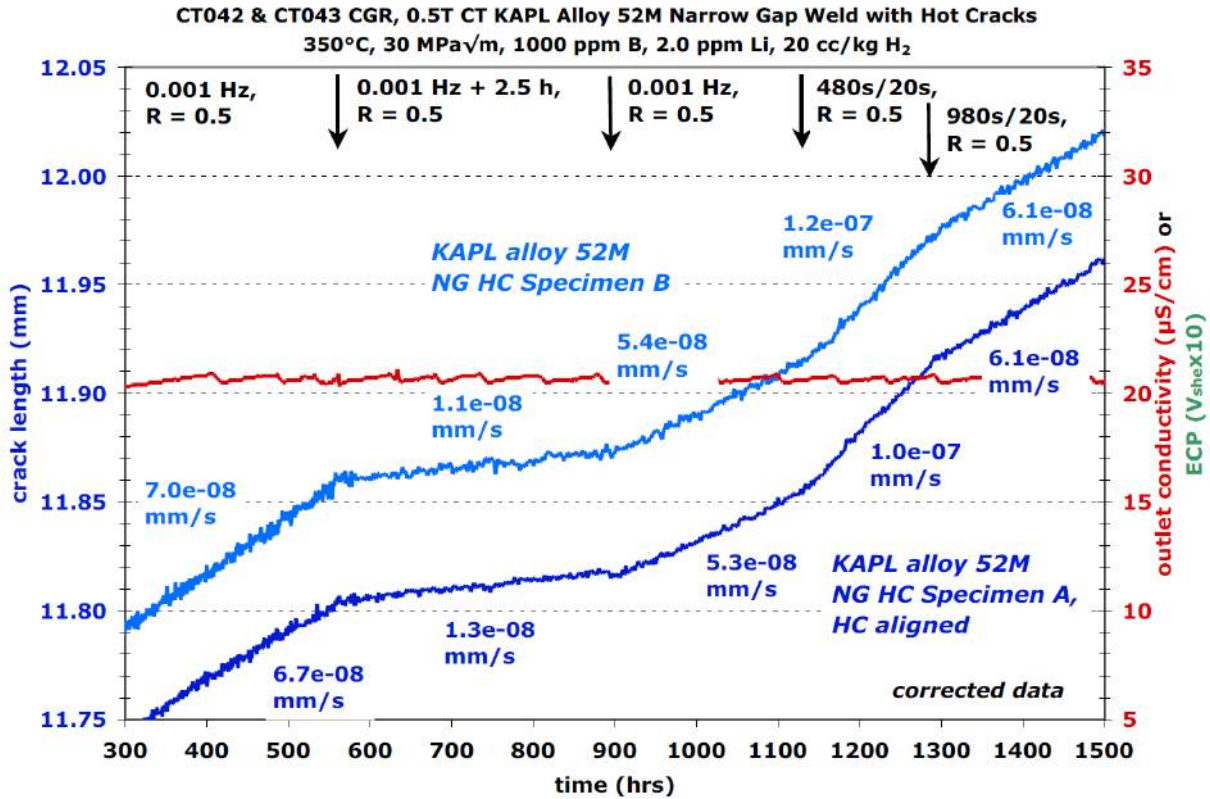
Figure 3.57 Continued transitioning steps performed on the KAPL alloy 52M narrow gap weld specimens (CT042 & CT043) with known hot cracks.

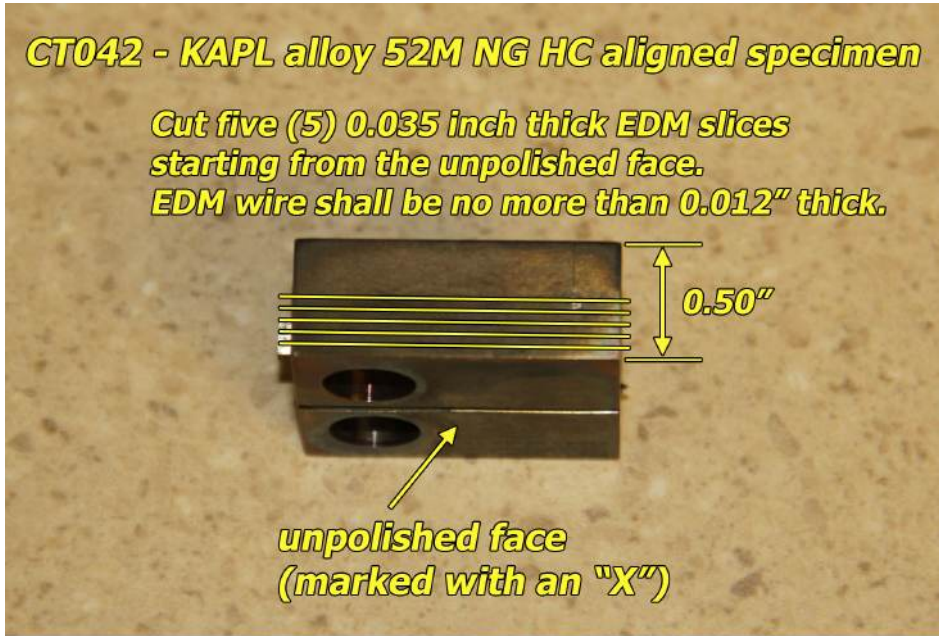
Figure 3.60 Post-test serial sectioning plan for KAPL alloy 52M NG weld specimens with hot cracks (CT042 & CT043).

Post-test examinations consisted of characterizing both the crack growth surface and a series of crack profile obtained from side surfaces of the crack. To accomplish this, both specimens were serially sectioned as shown in Figure 3.60 prior to air fatiguing open the specimens. Five slices were obtained from the CT042 (hot crack aligned), but due to a machining error, only four slices were obtained from CT043. The serial slices were placed in metallography mounts and polished to a high luster using colloidal silica as the final polishing agent. Crack profile images for CT042 and CT043 are shown in Figures 3.61 and 3.62, respectively. The crack profiles of CT042 show that the density of the hot cracks was too low and the distance from the SCC crack was too far for any hot cracks to be intersected by the SCC crack. In addition, the grain boundaries (and hot cracks) were at a steep angle to the geometric crack plane of the specimen, and the steep angle was not allowing the SCC crack to grow favorably along the grain boundaries. Somewhat surprisingly, the crack profile images of the specimen that was not supposed to be aligned with hot cracks shows that a few hot cracks were in the vicinity of the SCC crack. However, as with the hot crack-aligned specimen, only a few hot cracks were present, and they are fairly far from the SCC crack and at a steep angle to it. The grain boundaries are much better aligned with the geometric crack plane of the specimen. Instances of growth along dendrite and grain boundaries are apparent, and the more favorable alignment is likely responsible for the higher constant K crack growth rate in CT043.
