NUREG/CR-7103, Vol. 2

Pacific Northwest National Laboratory Investigation of Stress Corrosion Cracking in Nickel-Base Alloys

The objective of this program is to evaluate the primary water stress corrosion cracking (PWSCC) susceptibility of high chromium alloy 690 and its weld metals, establish quantitative measurements of crack-growth rates and determine relationships among cracking susceptibility, environmental conditions and metallurgical characteristics. Stress-corrosion, crack-growth rates have been determined for 12 alloy 690 specimens, 11 alloy 152/52/52M weld metal specimens, 4 alloy 52M/182 overlay specimens and 2 alloy 52M/82 inlay specimens in simulated PWR primary water environments. The alloy 690 test materials included three different heats of extruded control-rod-drive mechanism (CRDM) tubing with variations in the initial material condition and degree of cold work for one heat. Two cold-rolled (CR) alloy 690 plate heats were also obtained and evaluated enabling comparisons to the CR CRDM materials. Weld metal, overlay and inlay specimens were machined from industry mock ups to provide plant-representative materials for testing. Specimens have been tested for one al

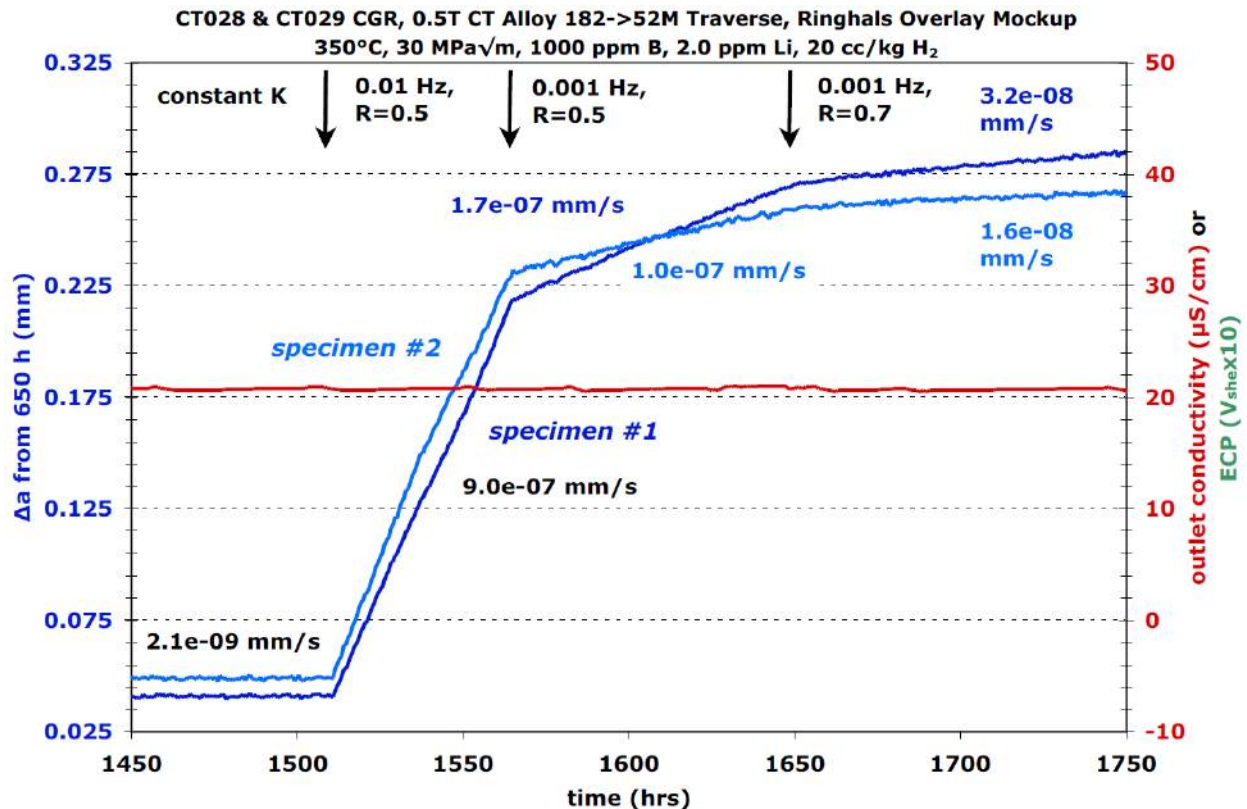
Figure 3.71 Crack extension into new microstructural region and growth response during cycle + hold loading with R = 0.7 and R = 0.5.

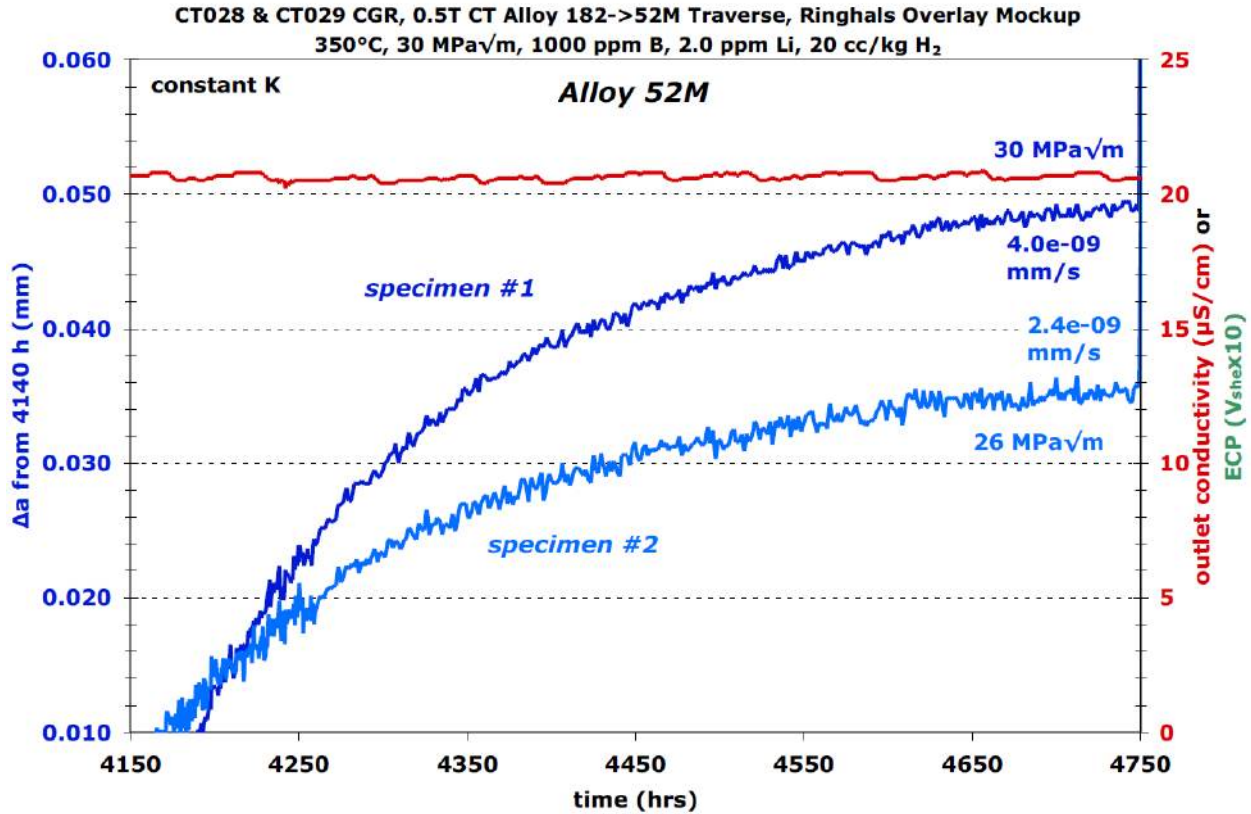
Figure 3.74 Constant K crack-growth response in the alloy 52M weld material after temperature increase from 50°C to 350°C.

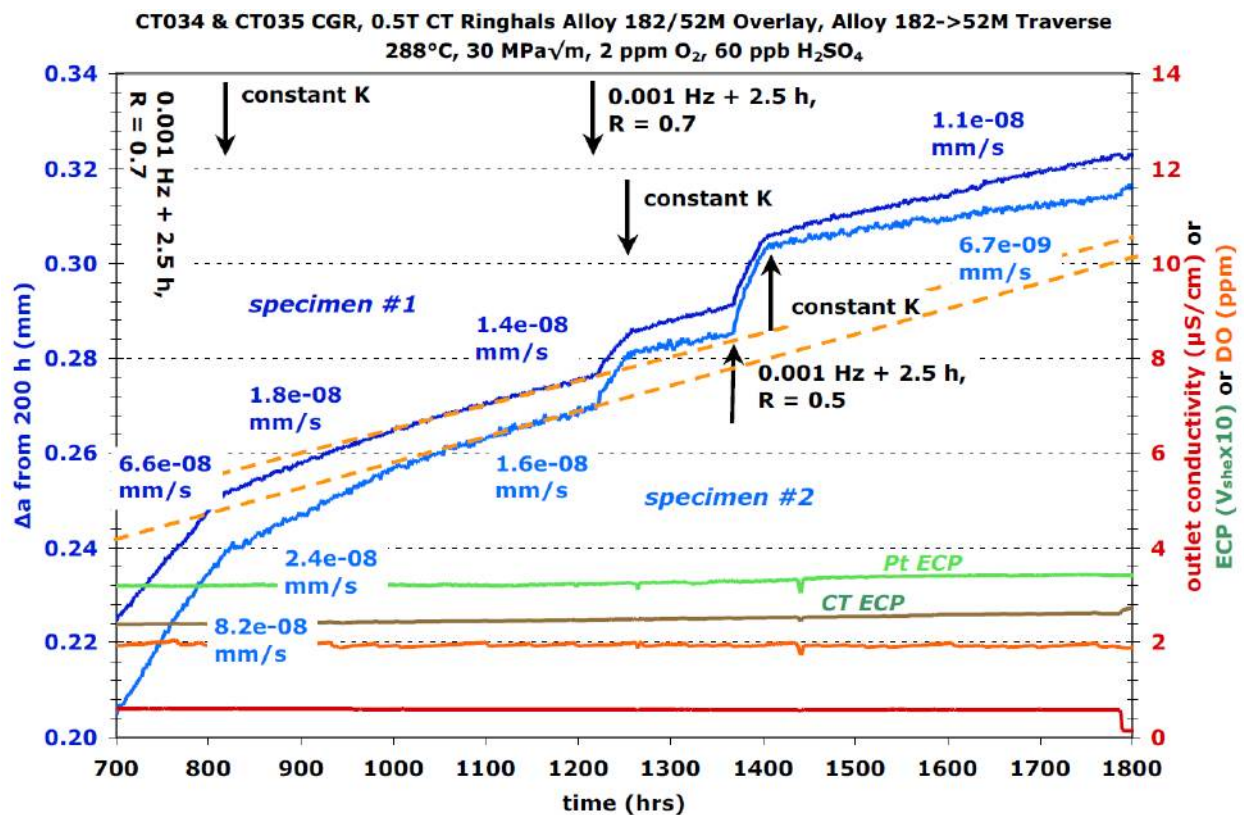
Figure 3.76 Transitioning steps to constant K response under BWR oxidizing conditions of the second pair of Ringhals alloy 52M/182 overlay specimens (CT034 & CT035).

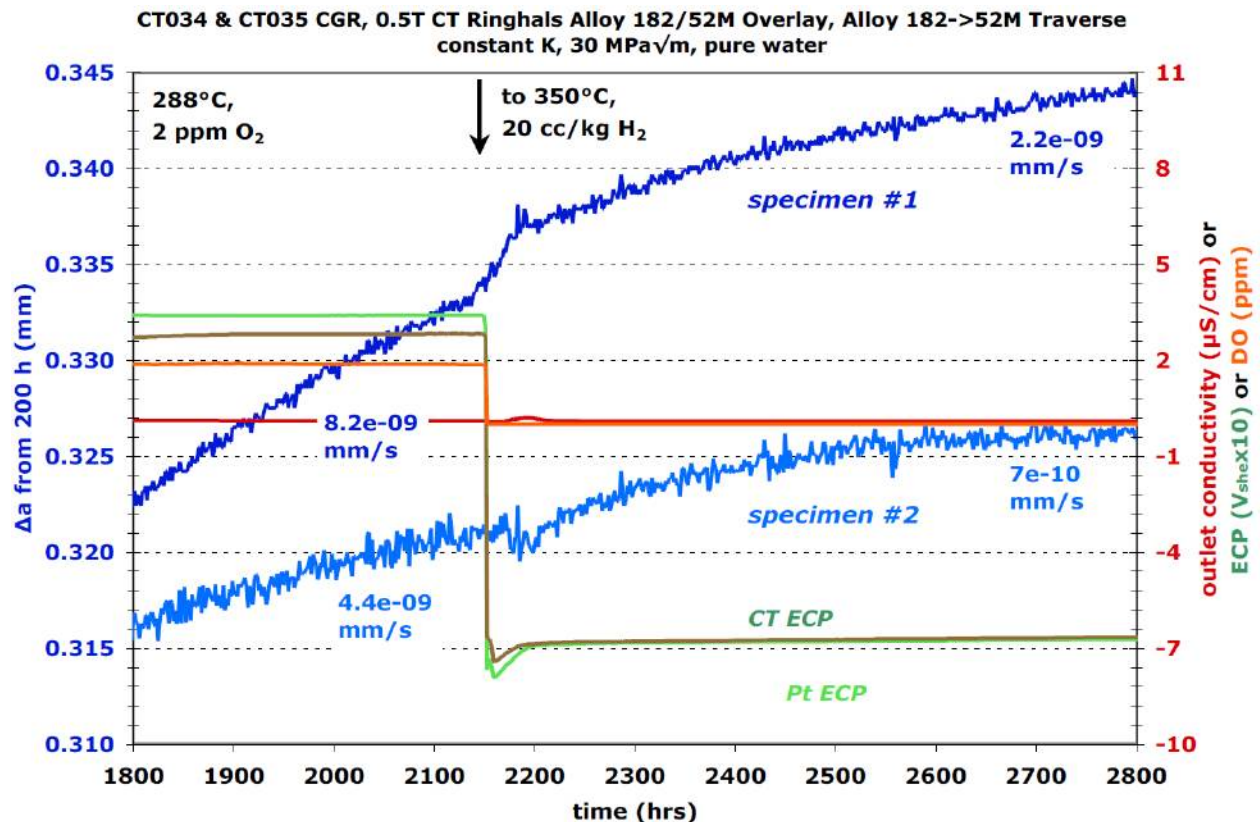
Figure 3.77 Crack growth response on switching from BWR oxidizing to hydrogenated water in the second pair of Ringhals alloy 52M/182 specimens (CT034 & CT035).

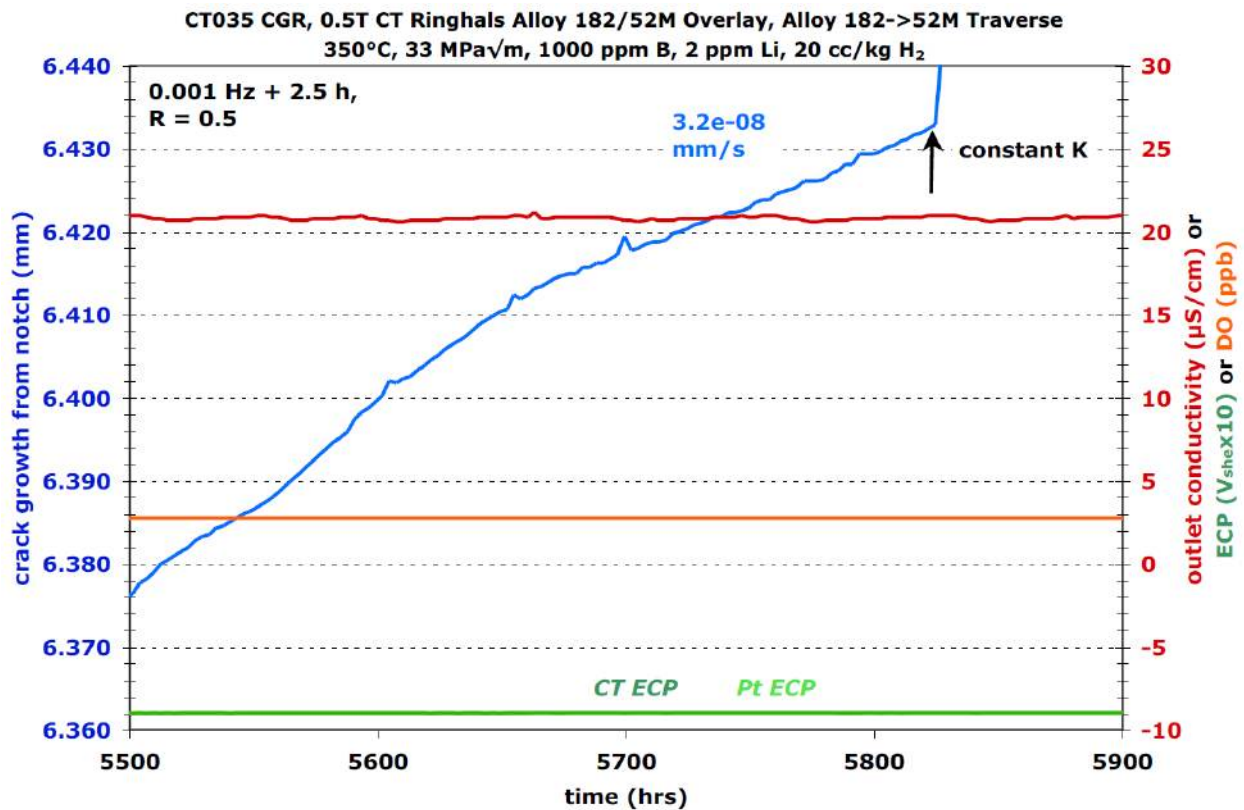
Figure 3.80 Final cycle + hold loading response of Ringhals alloy 52M/182 specimen CT035 showing a relatively high rate of 3.2×10^{-8} mm/s.

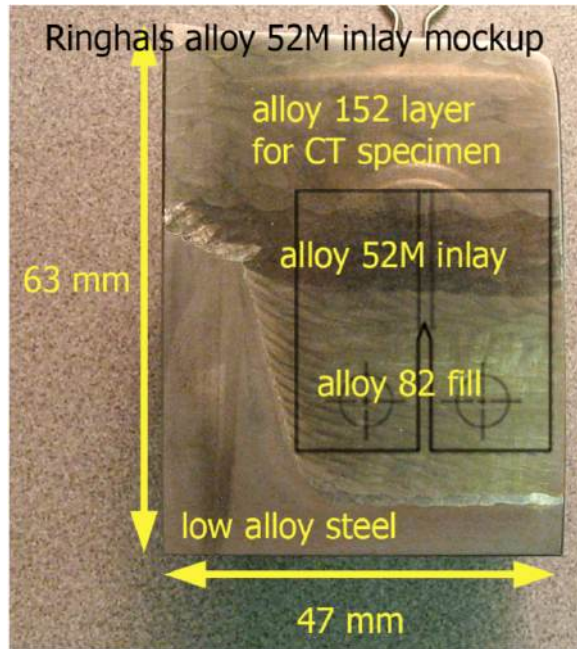
Figure 3.82 Profile of Ringhals alloy 52M inlay mockup weld received from Westinghouse. Alloy 52M inlay is 10 mm thick.

A section of an alloy 52M weld inlay mockup produced for Ringhals/Vattenfall was obtained from Rich Jacko of Westinghouse. As briefly described in Section 3.1, it consists of alloy 82 robotically deposited onto a low-alloy steel ring followed by a robotically deposited 10 mm thick inlay of alloy 52M. A layer of alloy 152 was manually welded on top of the inlay by Westinghouse to provide sufficient material to obtain CT specimens from the mockup. The approximate location of the 0.5T CT specimens (CT031 and CT032) is shown in the Figure 3.82. The notch was positioned to enable the precrack to be placed in the alloy 82 approximately 0.5 mm from the alloy 52M interface. Both sides of the machined samples were polished and etched to reveal the alloy 82 inlay and the alloy 52M interface. Examples of these regions are shown in Figure 3.83 along with specifics of the planned precrack locations.

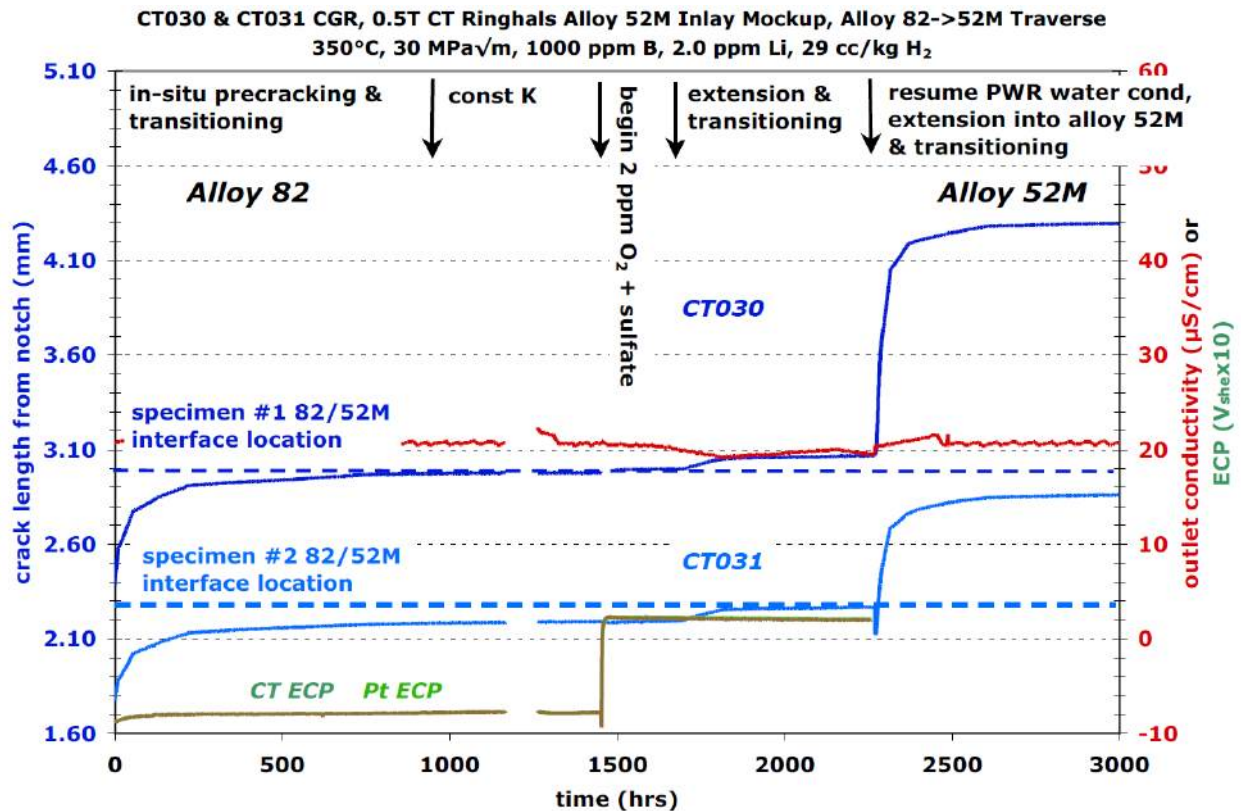
Figure 3.84 Overview of the entire test on the Ringhals alloy 52M/82 inlay mockups (CT030 & CT031).

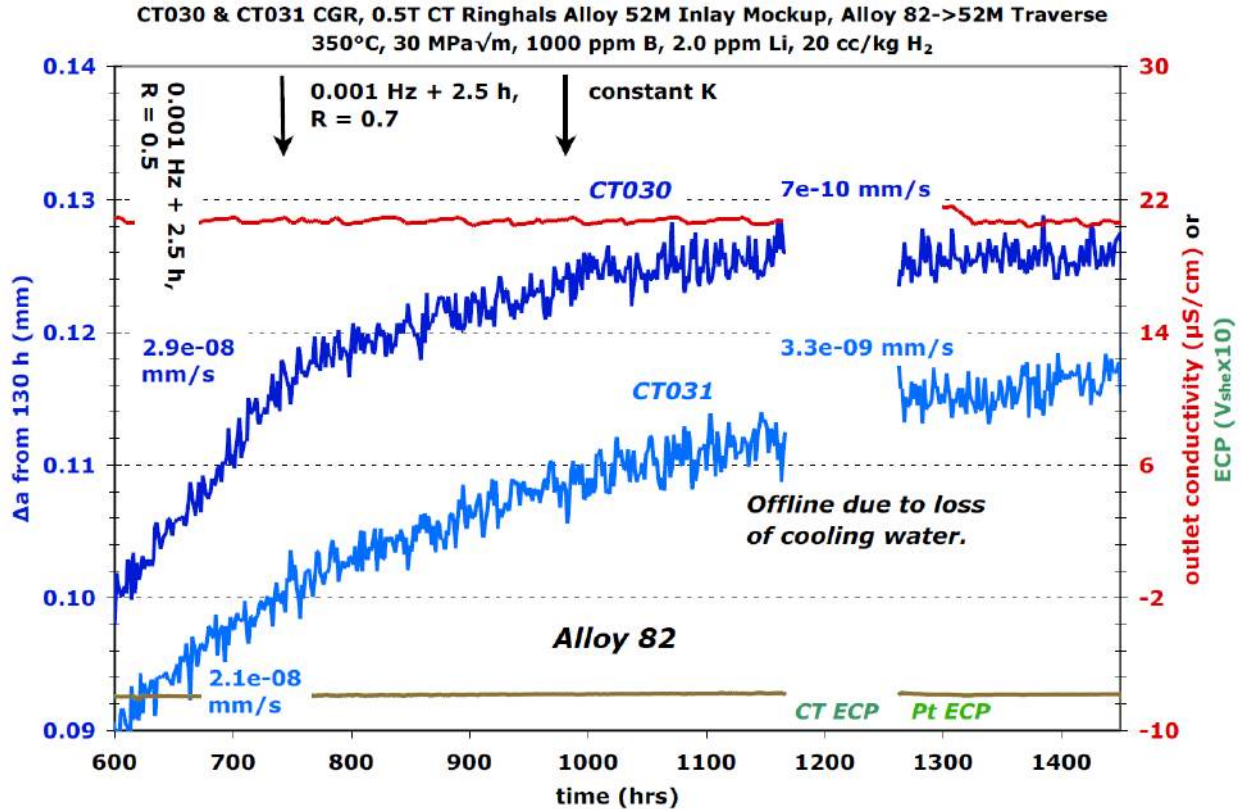
Figure 3.85 Initial cycle + hold and constant K response in PWR primary water of the Ringhals alloy 52M/82 inlay mockup (CT030 & CT031).

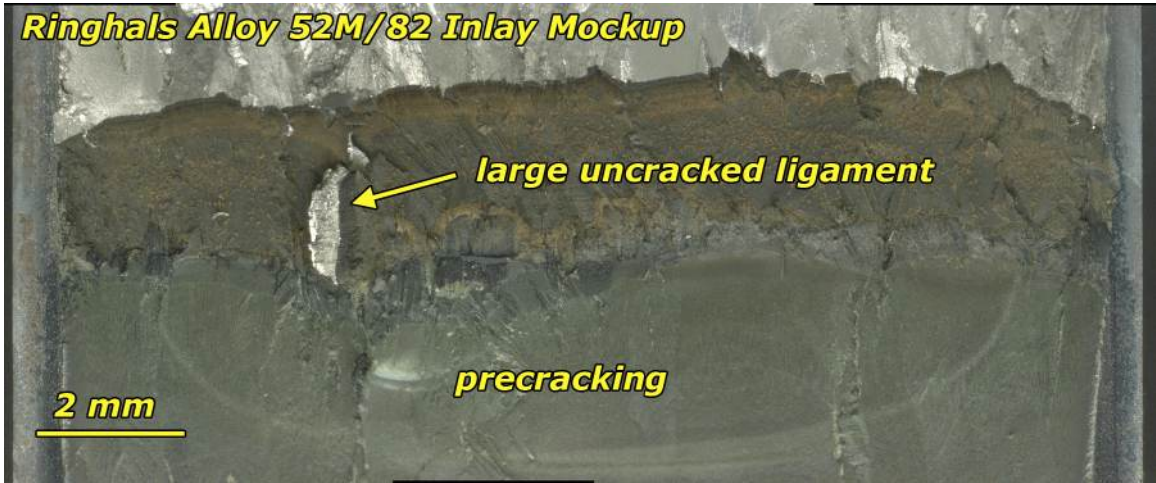
Figure 3.91 Crack growth surface of Ringhals alloy 52M/82 specimen CT030.

After ending the test, CT030 was fatigue fractured in air whereas CT031 was first backfilled with resin, sectioned into two pieces, and then one side was fatigue fractured in air while the other side was set aside for crack tip examinations. The most apparent feature of the crack growth surface of CT030 in Figure 3.91 is the very large uncracked ligament in the wake of the crack. This ligament formed at the onset of high temperature water testing, and was never broken during the entire test. Another feature of interest in the crack growth surface of CT030 is the rather uniform tan layer along the final crack front. This is likely representative of the final transitioning and constant K at $40 \text{ MPa}\sqrt{\text{m}}$. The jagged, uneven final crack front suggests a relatively high degree of engagement (but still with a very slow crack growth rate). The side surface image of the crack growing in the CT031 alloy 52M material in Figure 3.92 shows evidence of a large crack resulting from rapid extension with a narrower cracking extending out. The narrower crack, likely forming during cycle + hold and constant K, shows some preference for cracking along dendrites. This can be better seen in the SEM image of the same region in Figure 3.93.

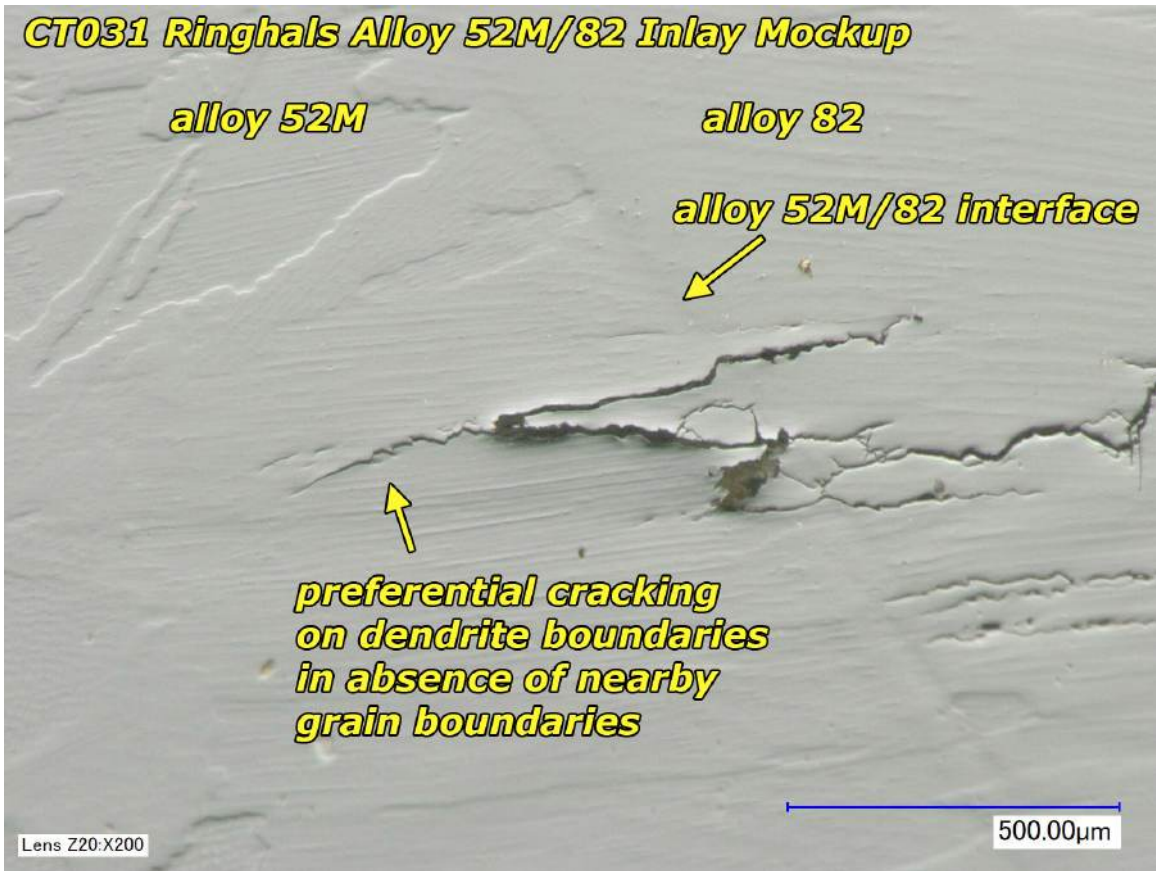
Figure 3.92 Optical image of side surface of crack growing into alloy 52M in the Ringhals alloy 52M/82 specimen CT031.

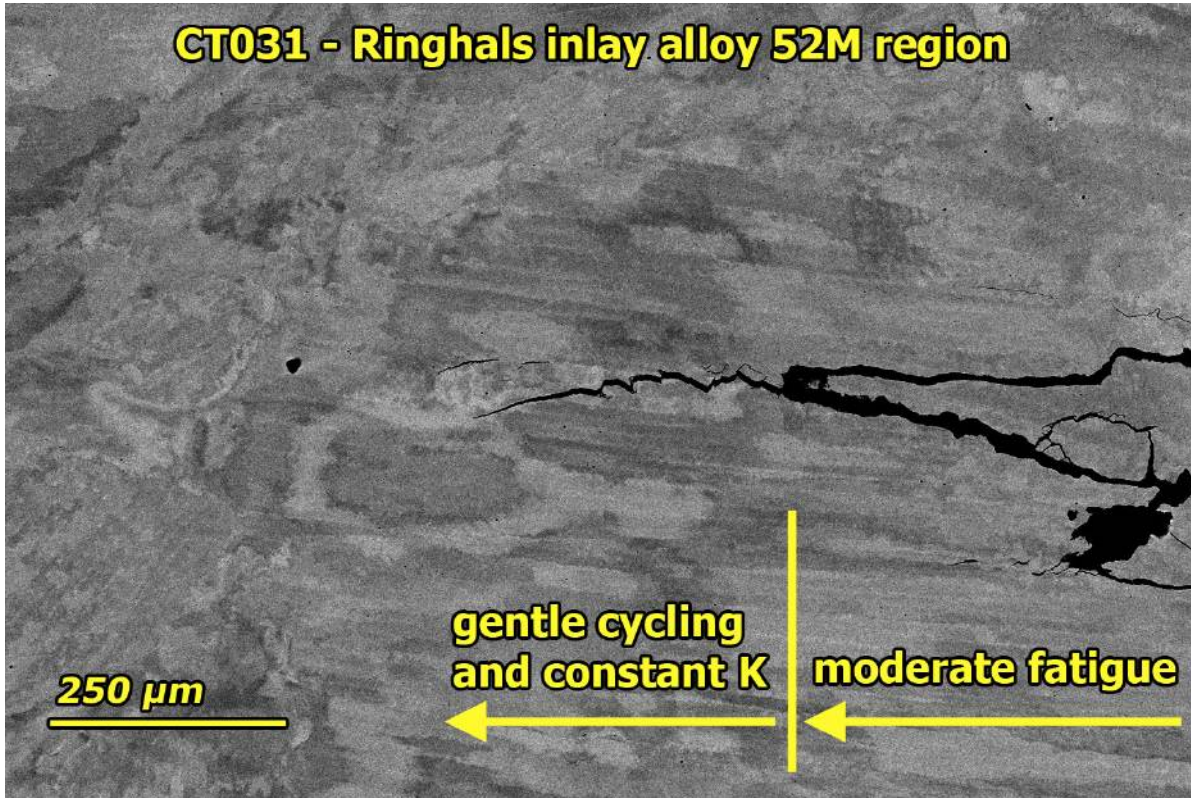
Figure 3.93 SEM image of side surface of crack growing into alloy 52M in the Ringhals alloy 52M/82 specimen CT031.

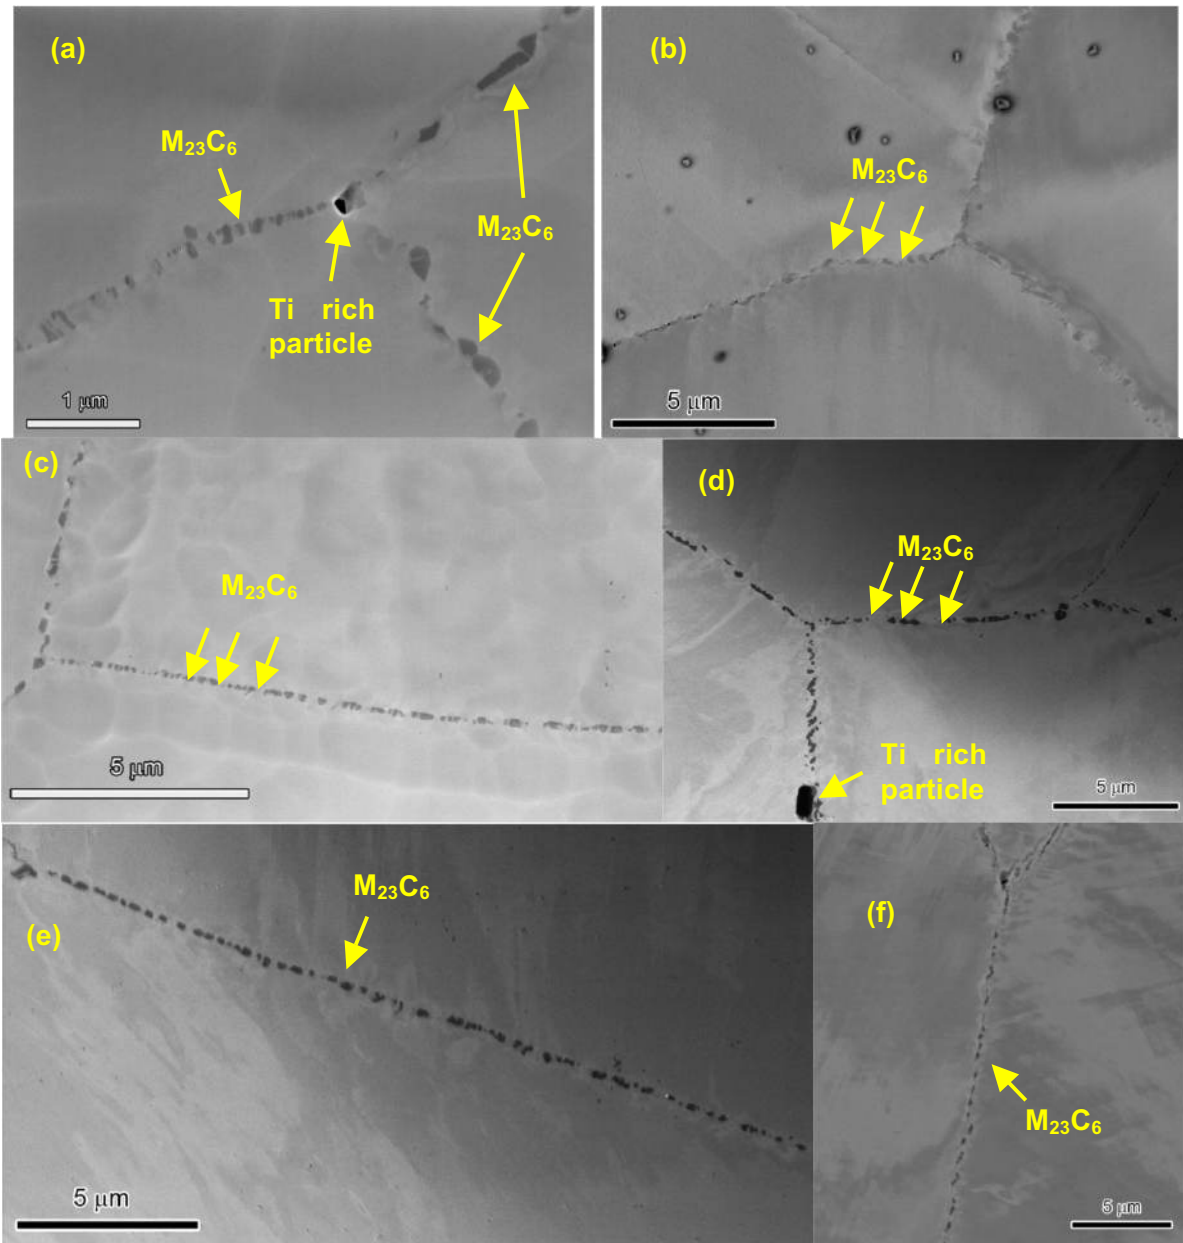
Figure 4.4 SEM micrographs (SE and backscatter) showing general carbide microstructure of the as received CRDM alloy 690TT heat RE243 material.

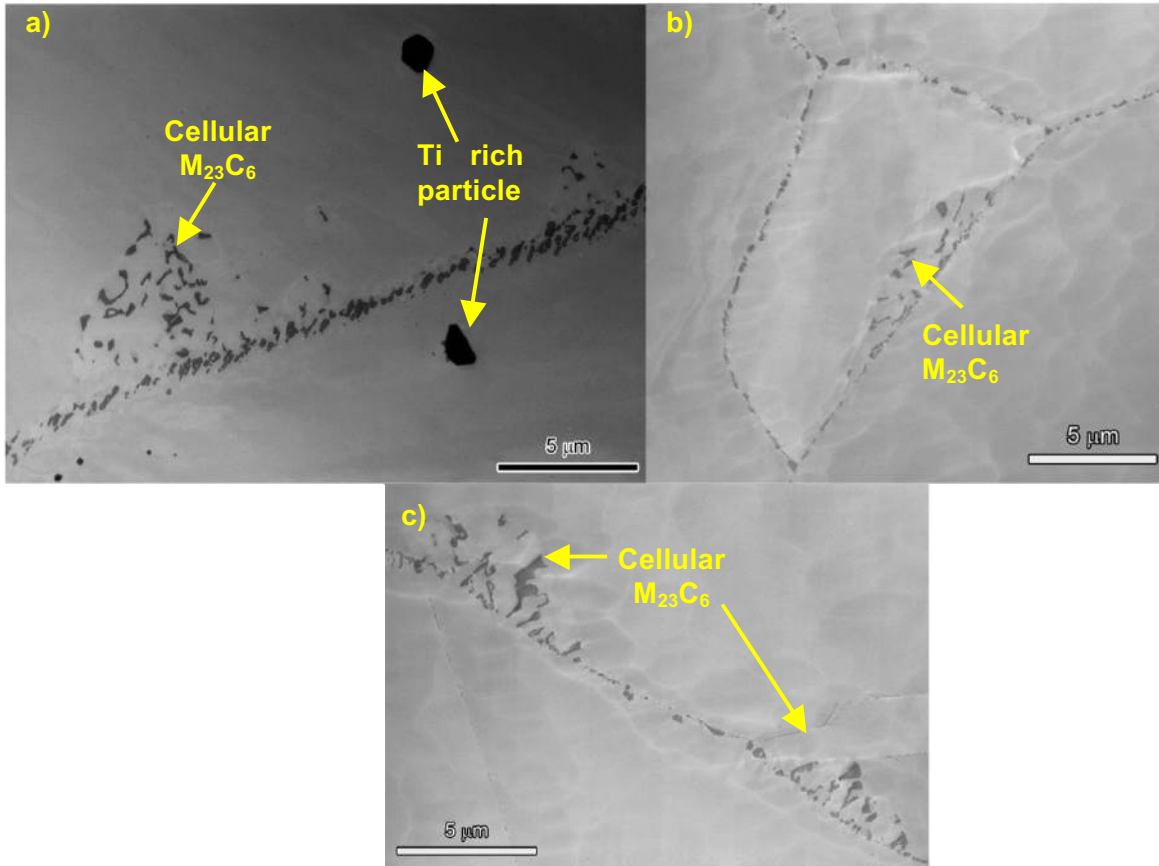
Figure 4.5 SEM micrographs (SE and backscatter) showing cellular carbide structure observed in the as received CRDM alloy 690TT heat RE243 material.

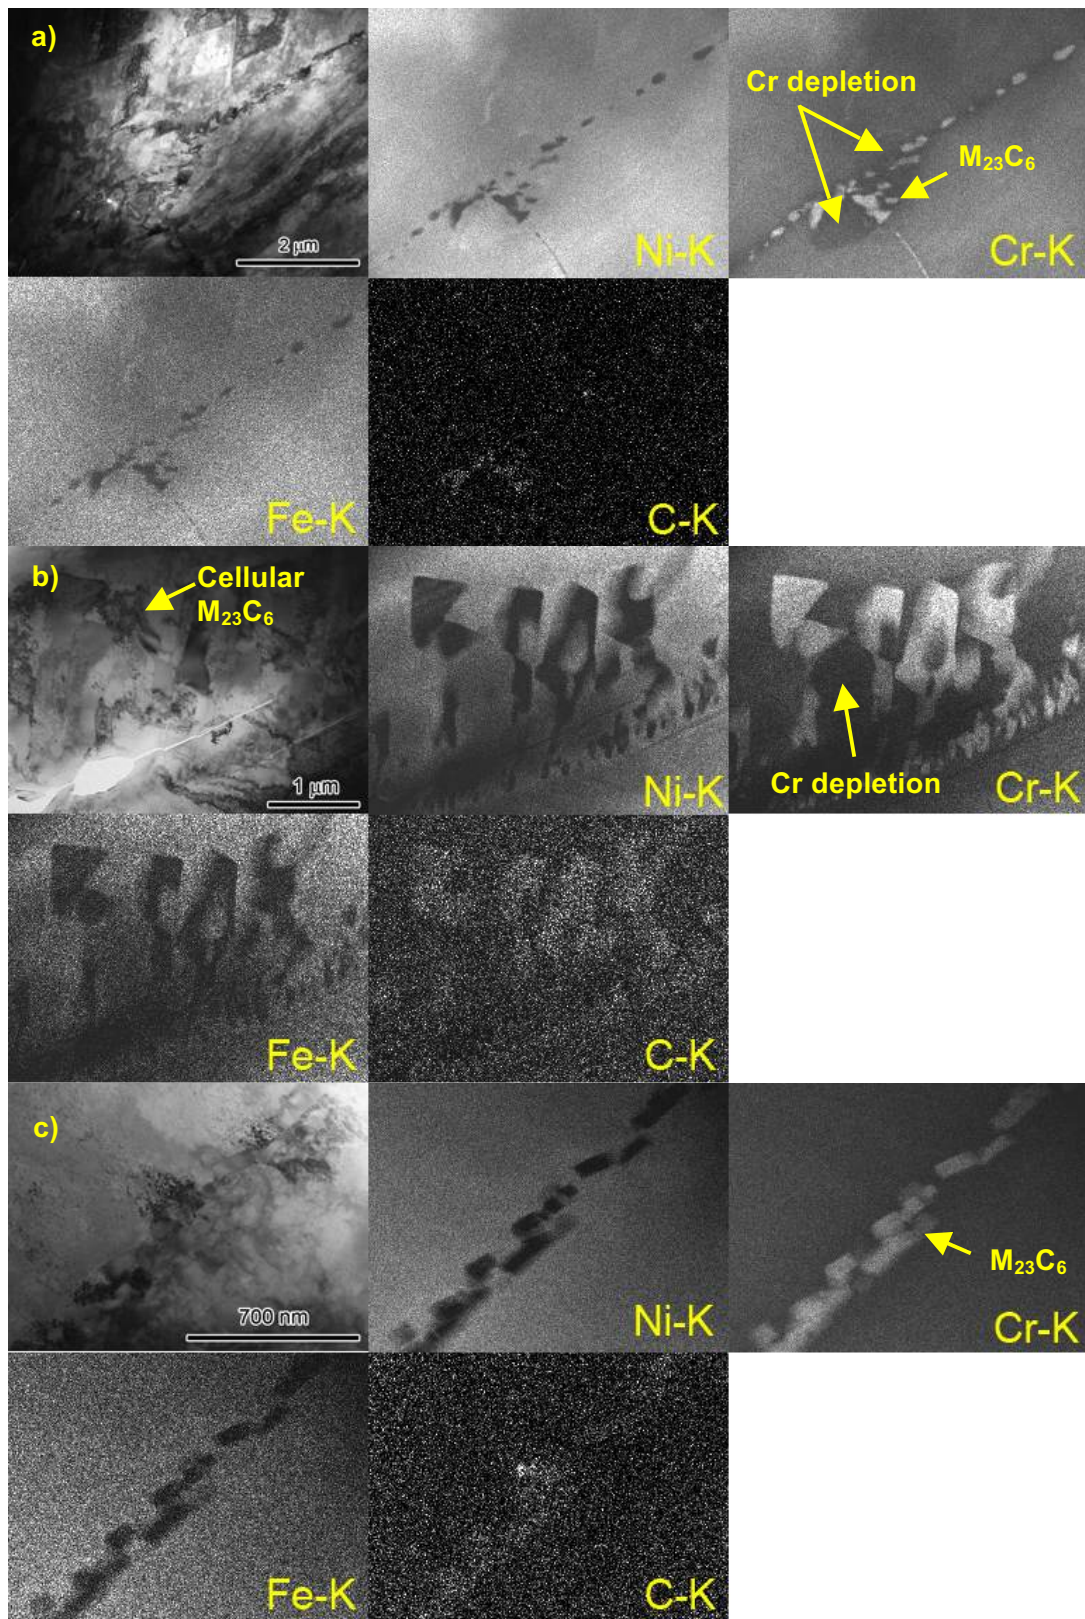
Figure 4.6 STEM/EDS elemental maps showing chemical distributions in various carbide structures in as-received CR CRDM alloy 690TT heat RE243.

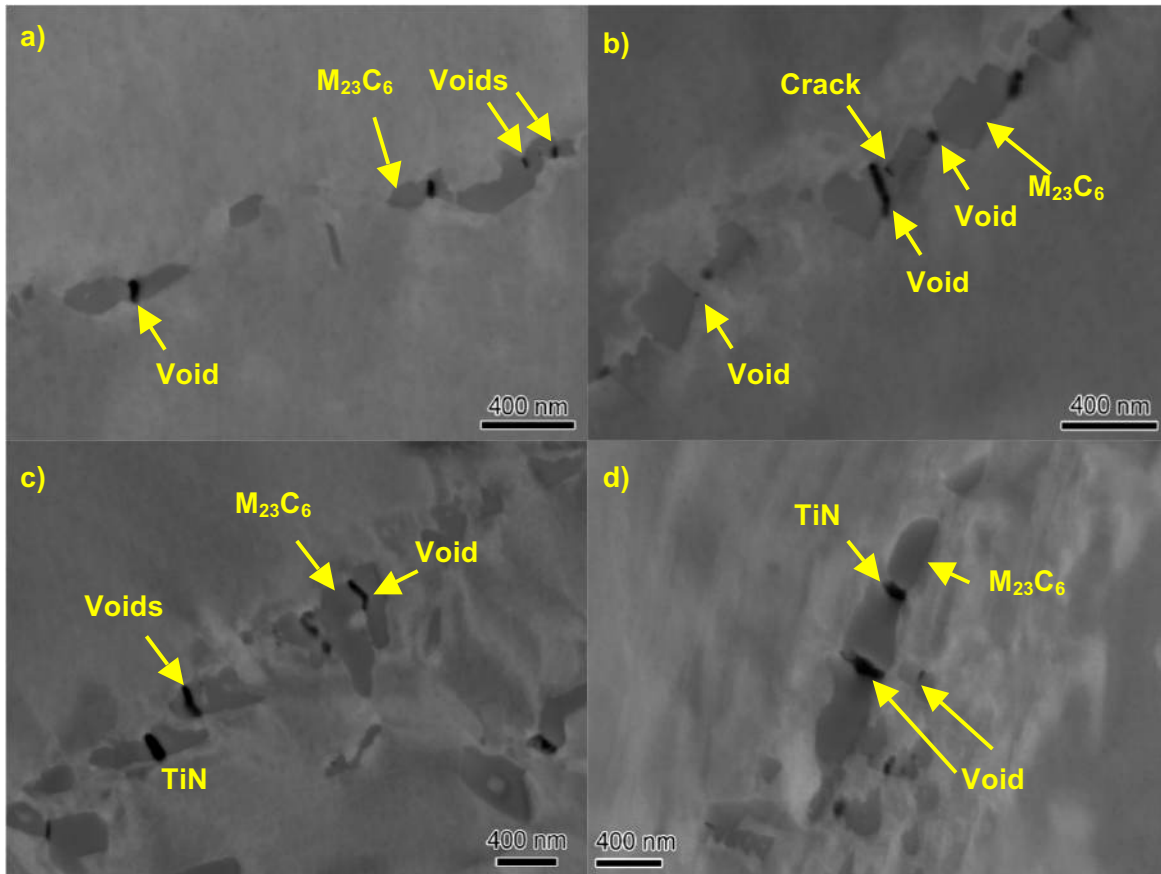
Figure 4.25 High magnification SEM backscatter micrographs illustrating IG carbide damage microstructures in 30%CR CRDM alloy 690TT (heat RE243).

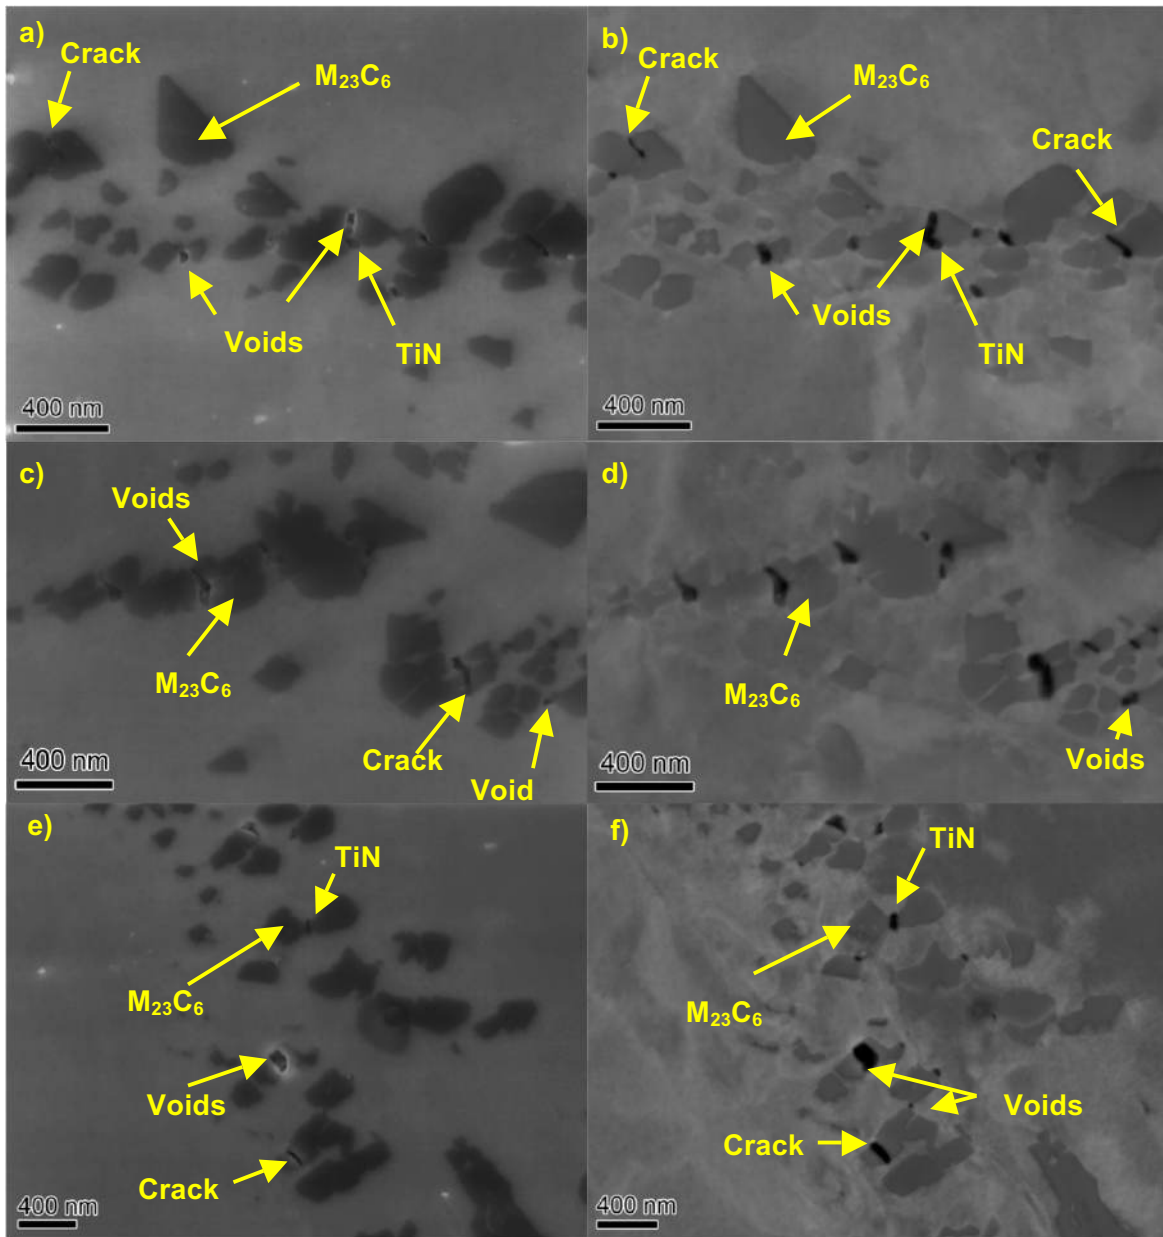
Figure 4.26 High magnification SEM backscatter/SE pair micrographs showing carbide damage microstructures in 30%CR CRDM alloy 690TT (heat RE243).

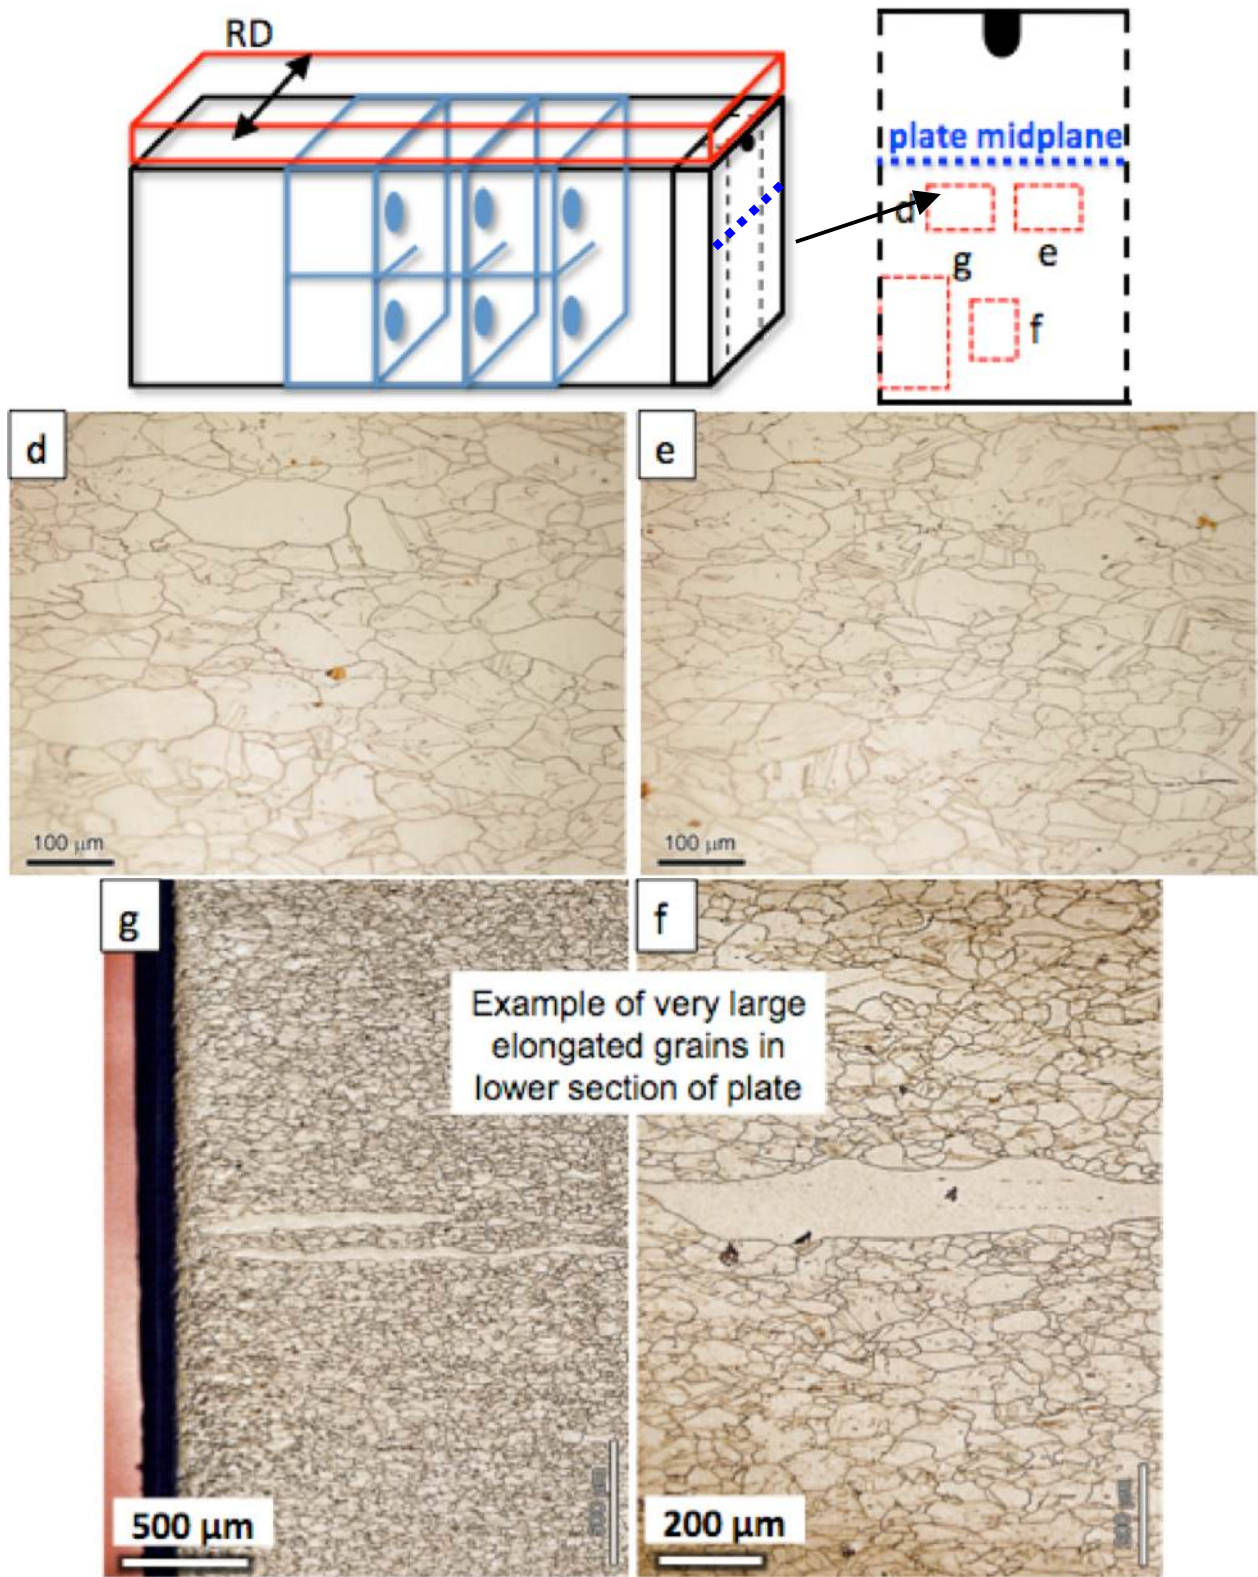
Figure 5.2 Optical micrographs illustrating microstructures in the lower section of the 26%CR ANL plate (heat NX3297HK12).

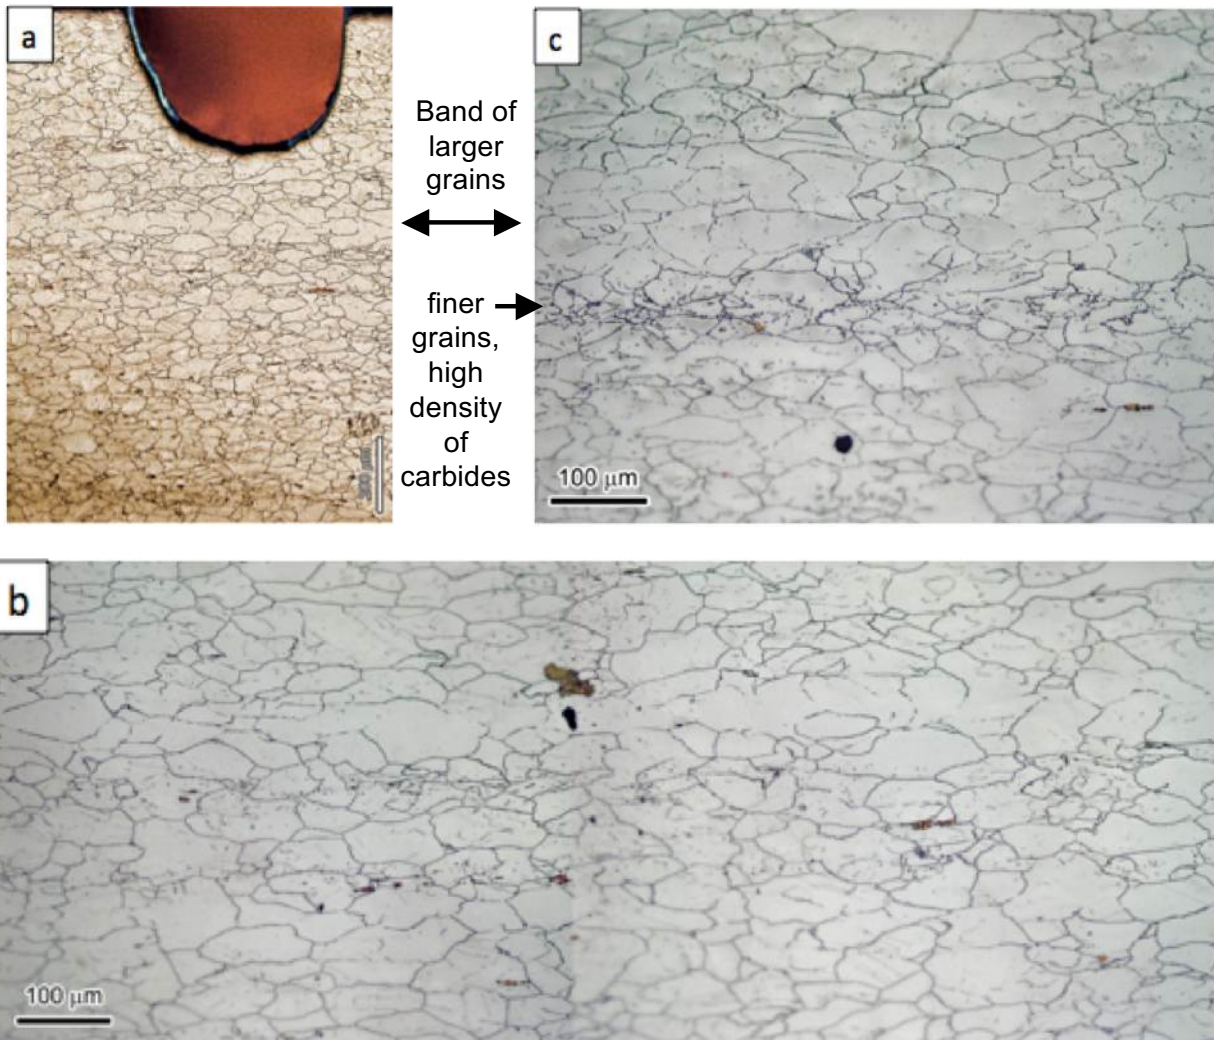
Figure 5.3 Optical micrographs illustrating microstructures in the upper section of the 26%CR ANL plate (heat NX3297HK12). Evidence of banded microstructure can be seen in selected regions (a, b and c) above the plate midplane.

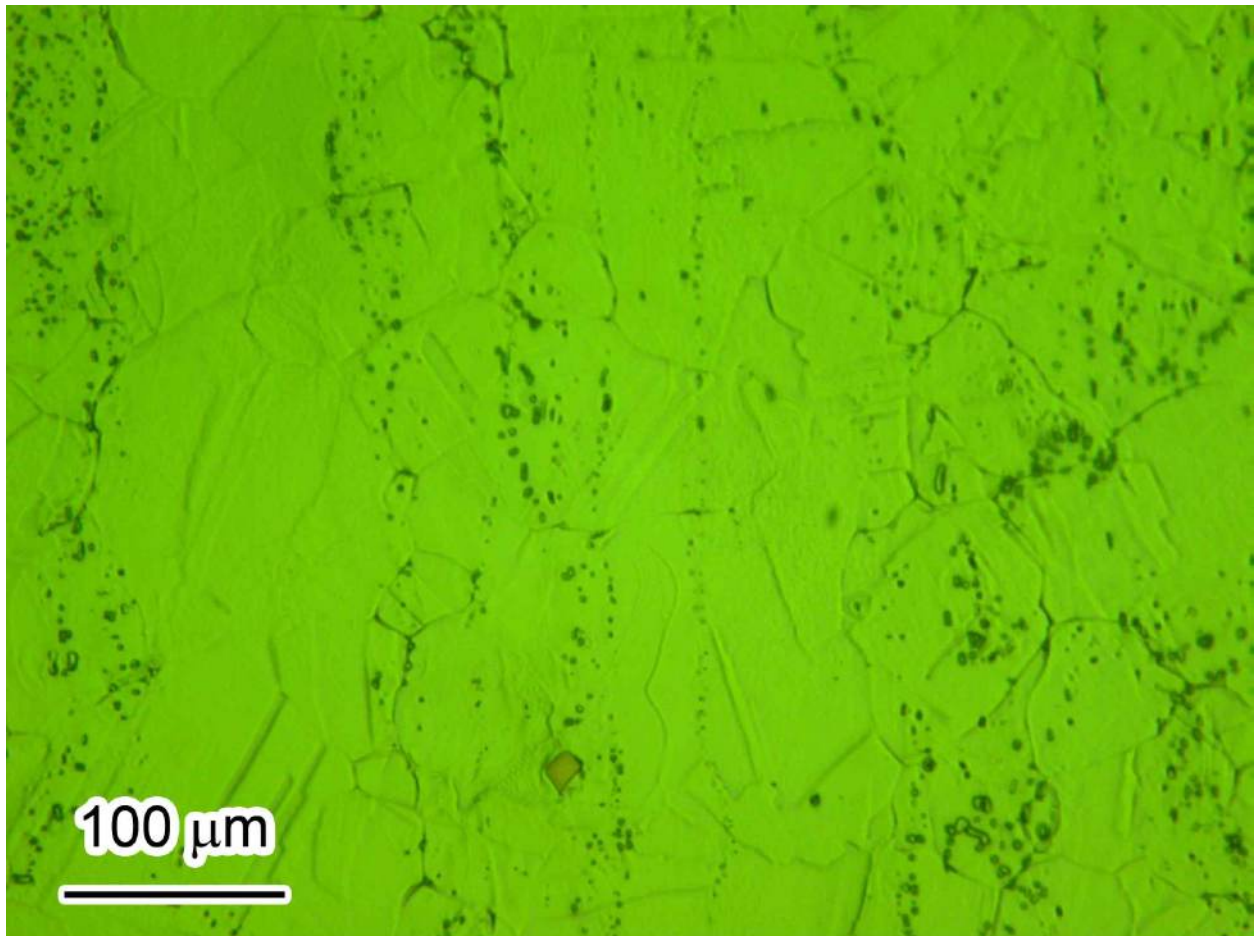
Figure 5.5 Optical micrograph showing high density of banded second-phase particles in the GEG 20%CR alloy 690 plate (heat B25K). The compositional bands in this material were oriented perpendicular to the rolling direction and SCC crack-growth direction for the plate.
