NUREG/CR-7103, Vol. 2

Pacific Northwest National Laboratory Investigation of Stress Corrosion Cracking in Nickel-Base Alloys

The objective of this program is to evaluate the primary water stress corrosion cracking (PWSCC) susceptibility of high chromium alloy 690 and its weld metals, establish quantitative measurements of crack-growth rates and determine relationships among cracking susceptibility, environmental conditions and metallurgical characteristics. Stress-corrosion, crack-growth rates have been determined for 12 alloy 690 specimens, 11 alloy 152/52/52M weld metal specimens, 4 alloy 52M/182 overlay specimens and 2 alloy 52M/82 inlay specimens in simulated PWR primary water environments. The alloy 690 test materials included three different heats of extruded control-rod-drive mechanism (CRDM) tubing with variations in the initial material condition and degree of cold work for one heat. Two cold-rolled (CR) alloy 690 plate heats were also obtained and evaluated enabling comparisons to the CR CRDM materials. Weld metal, overlay and inlay specimens were machined from industry mock ups to provide plant-representative materials for testing. Specimens have been tested for one al

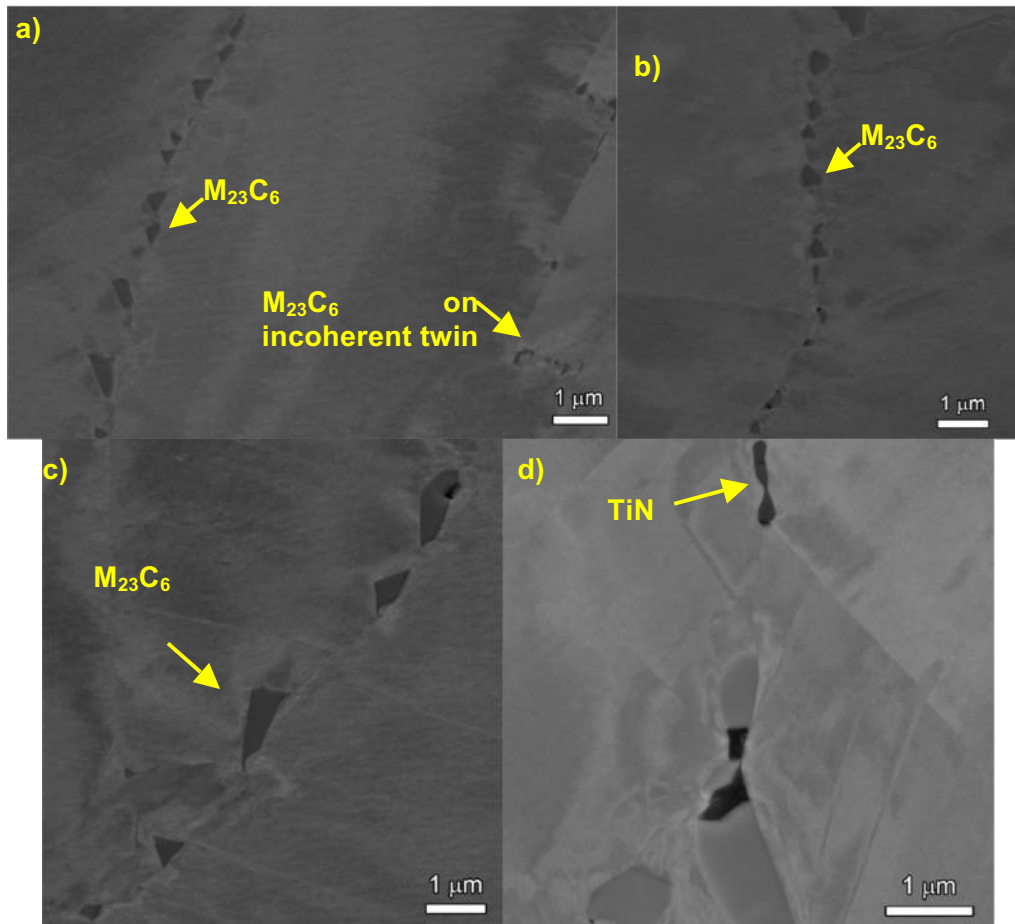
Figure 5.7 High magnification backscattered SEM images (a, b, c and d) illustrating typical grain boundary precipitate microstructures in 26%CR ANL alloy 690 plate (heat NX3297HK12).

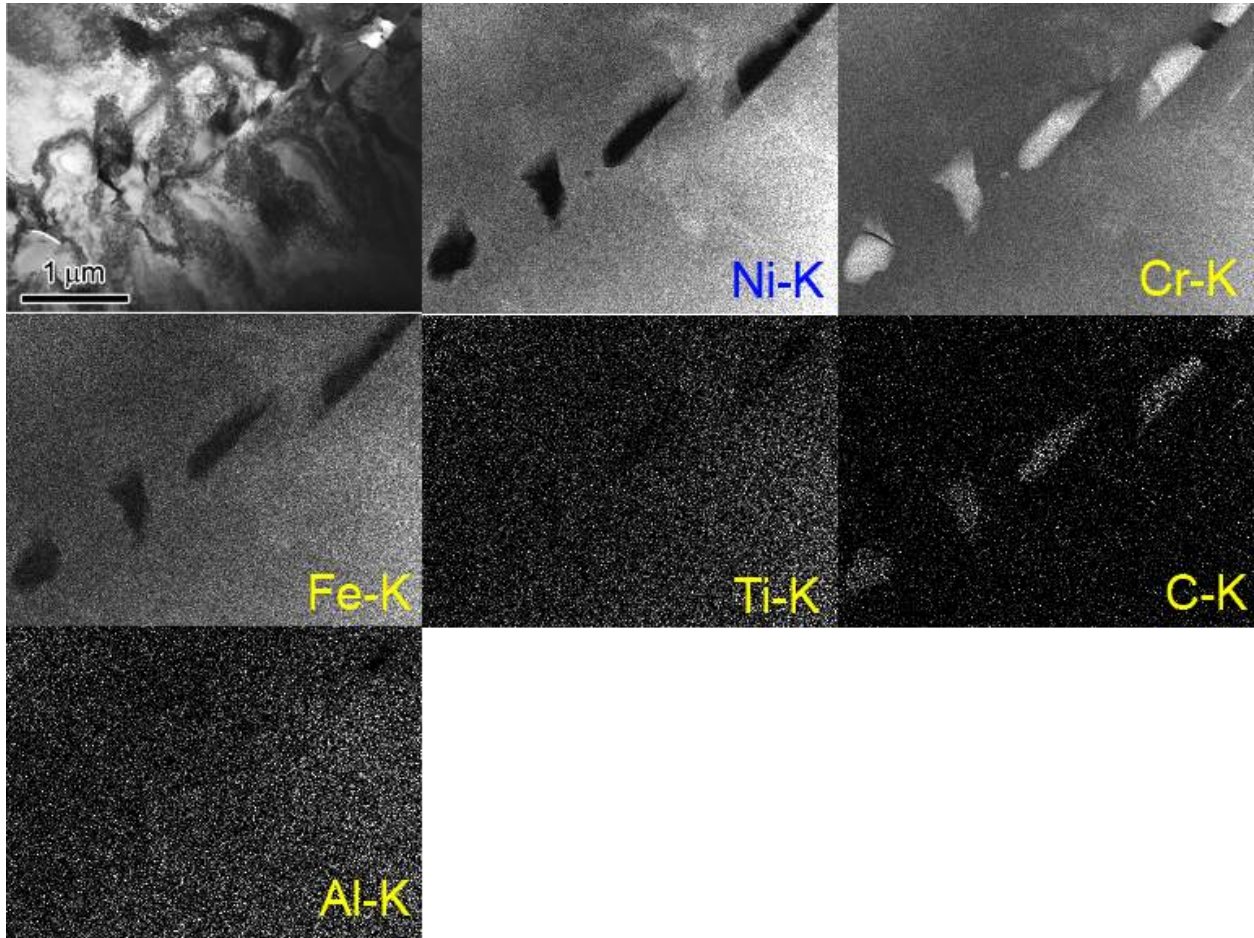
Figure 5.8 TEM EDS elemental maps illustrating the carbide microstructure in 26%CR ANL alloy 690 plate (heat NX3297HK12).

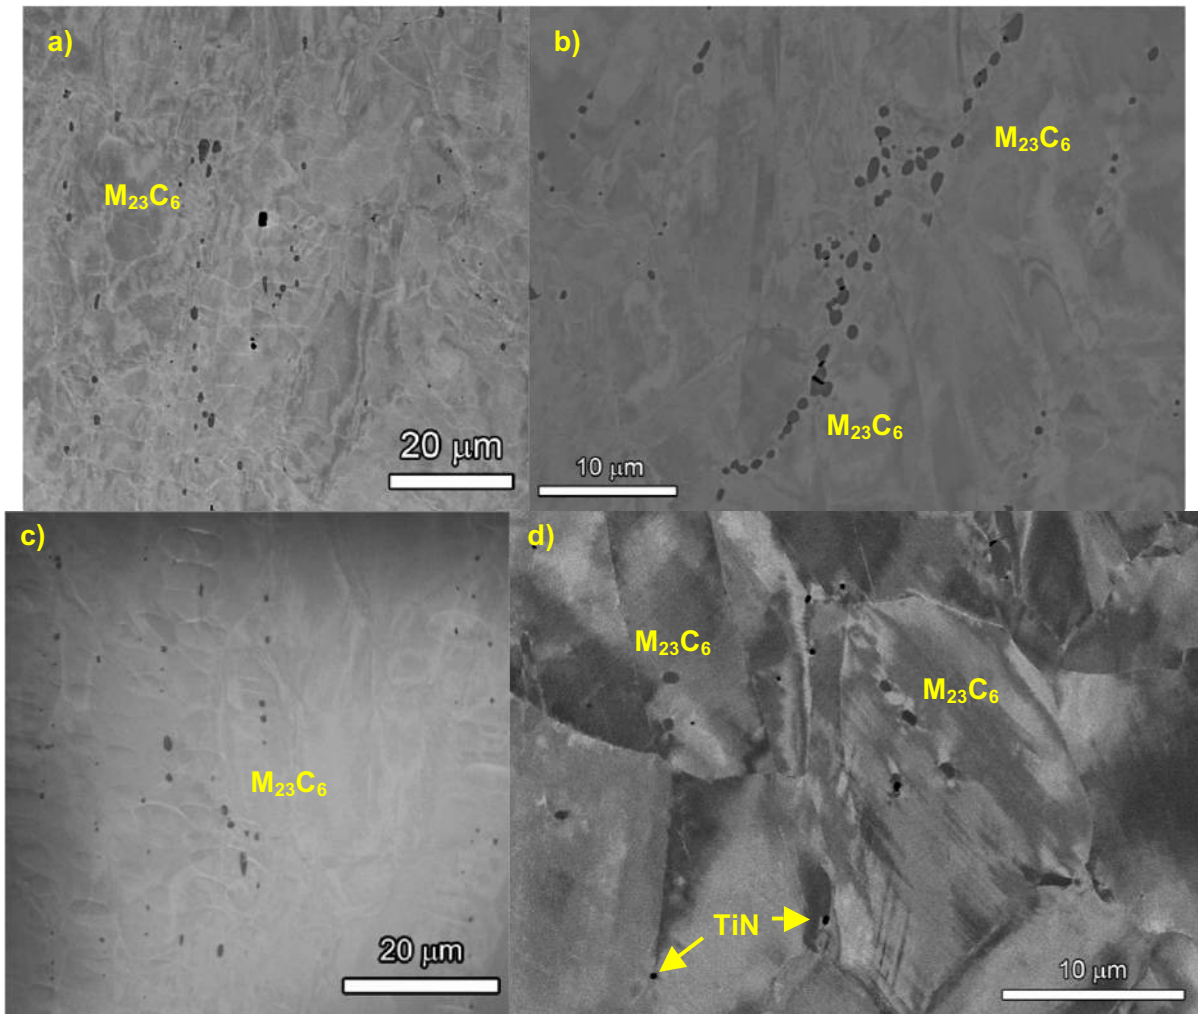
Figure 5.14 Low magnification SE and backscattered SEM images illustrating carbide distributions in 20%CR GEG alloy 690 plate (heat B25K): (a) mostly TG carbides, (b) high density of IG carbides, (c) and (d) low density of primarily TG carbides.

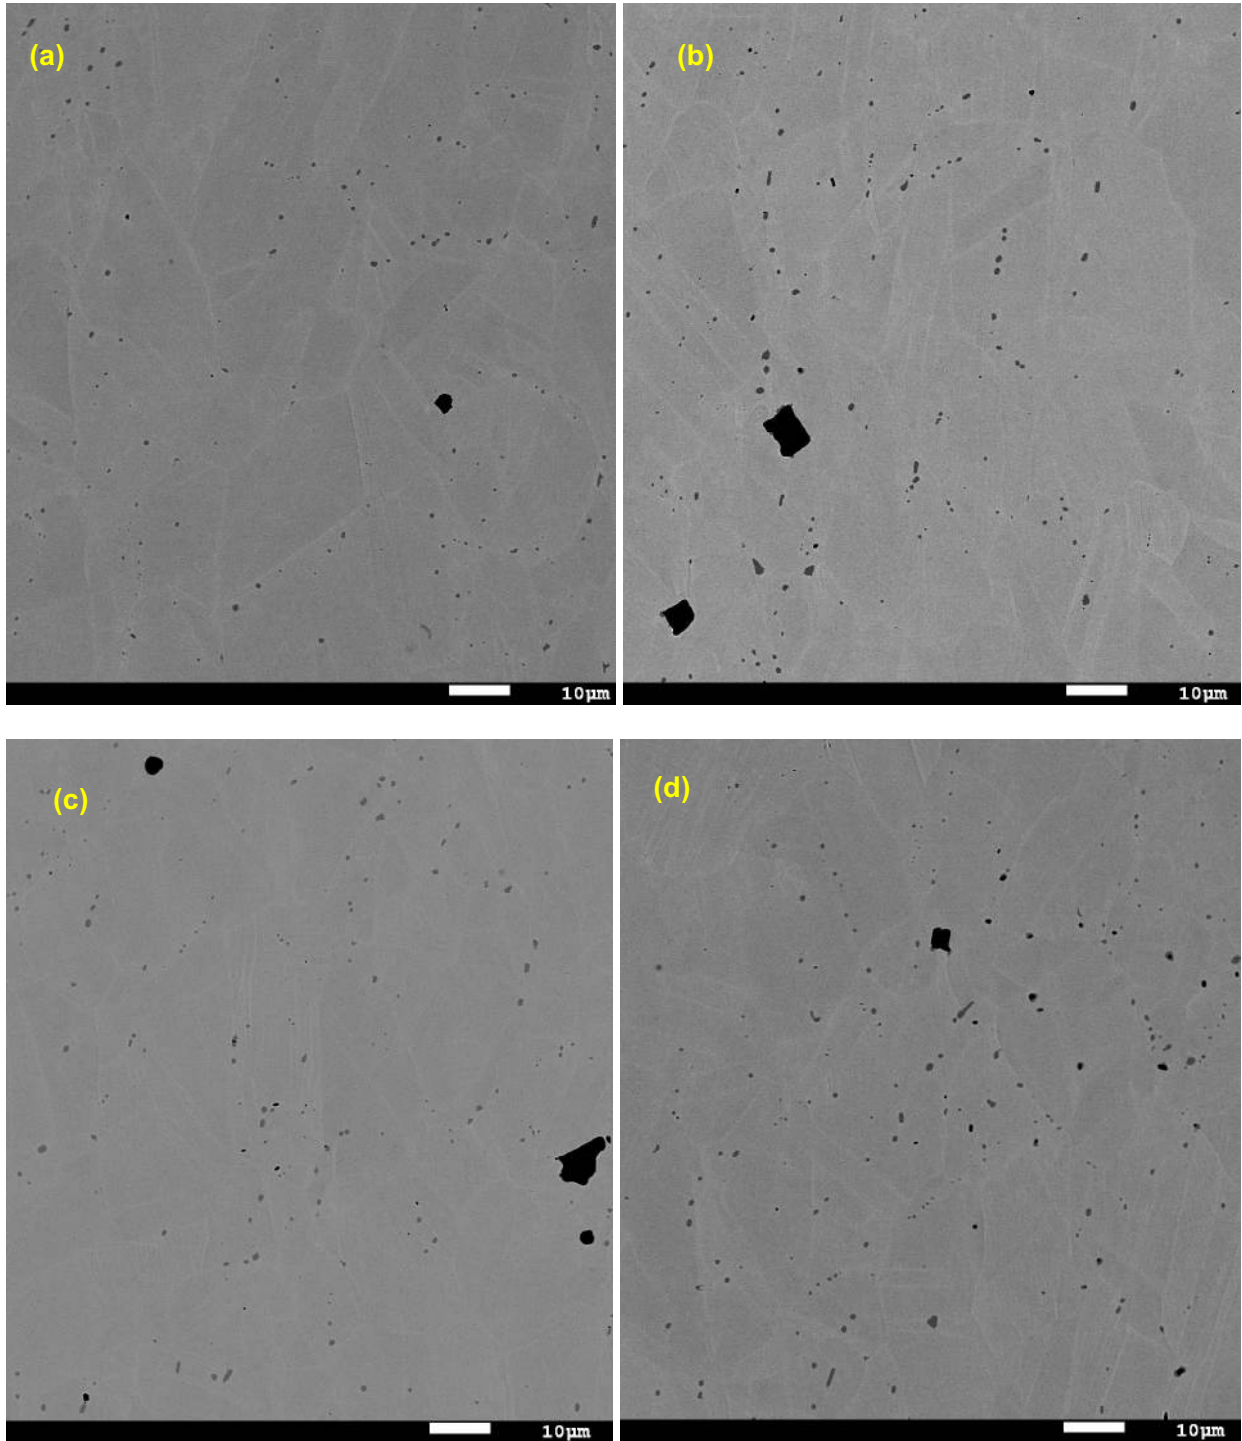
Figure 5.15 Low magnification backscattered SEM images illustrating carbide and nitride distributions in 20%CR GEG alloy 690 plate (heat B25K): (a,b,c) areas show mostly TG carbides with some aligned along prior grain boundaries and (d) area with a higher density of both TG and IG carbides. Larger Ti nitride particles can be seen in the matrix.

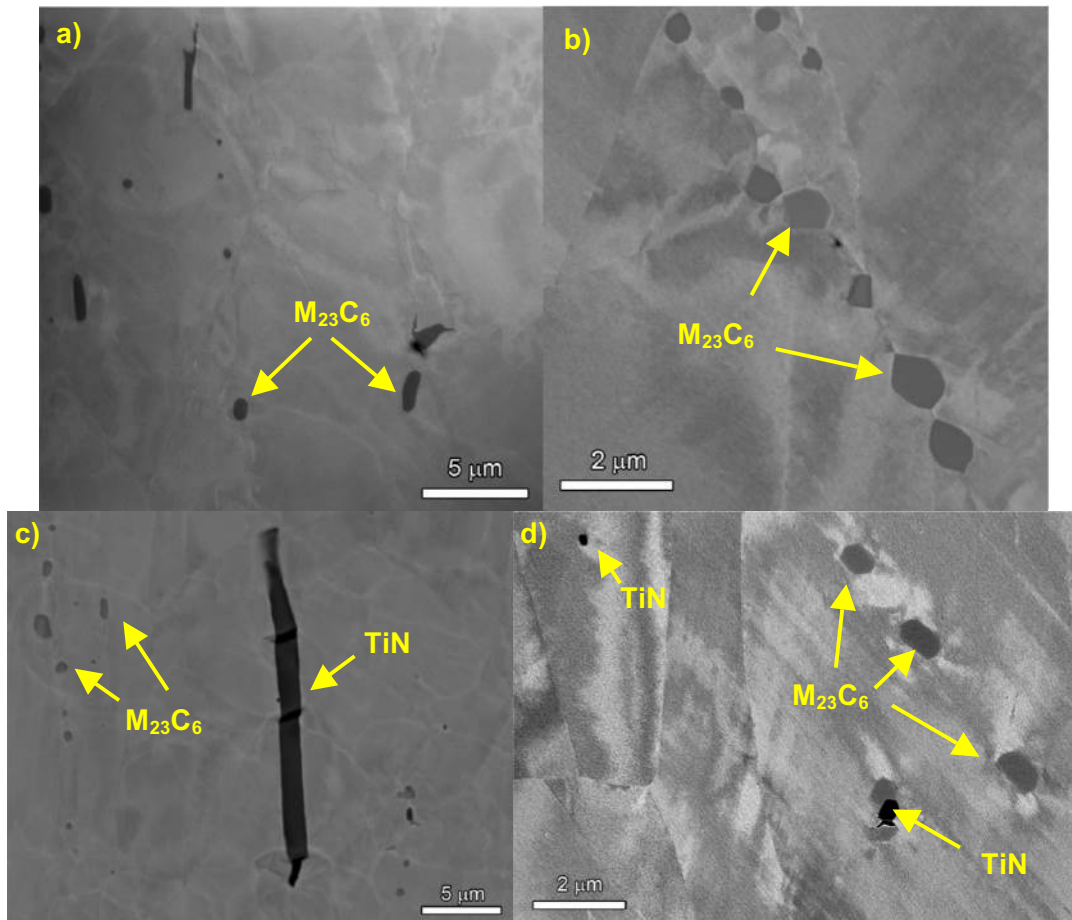
Figure 5.16 Higher magnification SE and backscattered SEM images illustrating general precipitation microstructure in 20%CR GEG alloy 690 (heat B25K): (a) well-spaced, TG carbides; (b) high density of IG carbides; (c) well-spaced TG carbides and an elongated TiN inclusion; (d) series of TG carbides apparently formed on a prior grain boundary along with a few small TiN matrix particles.

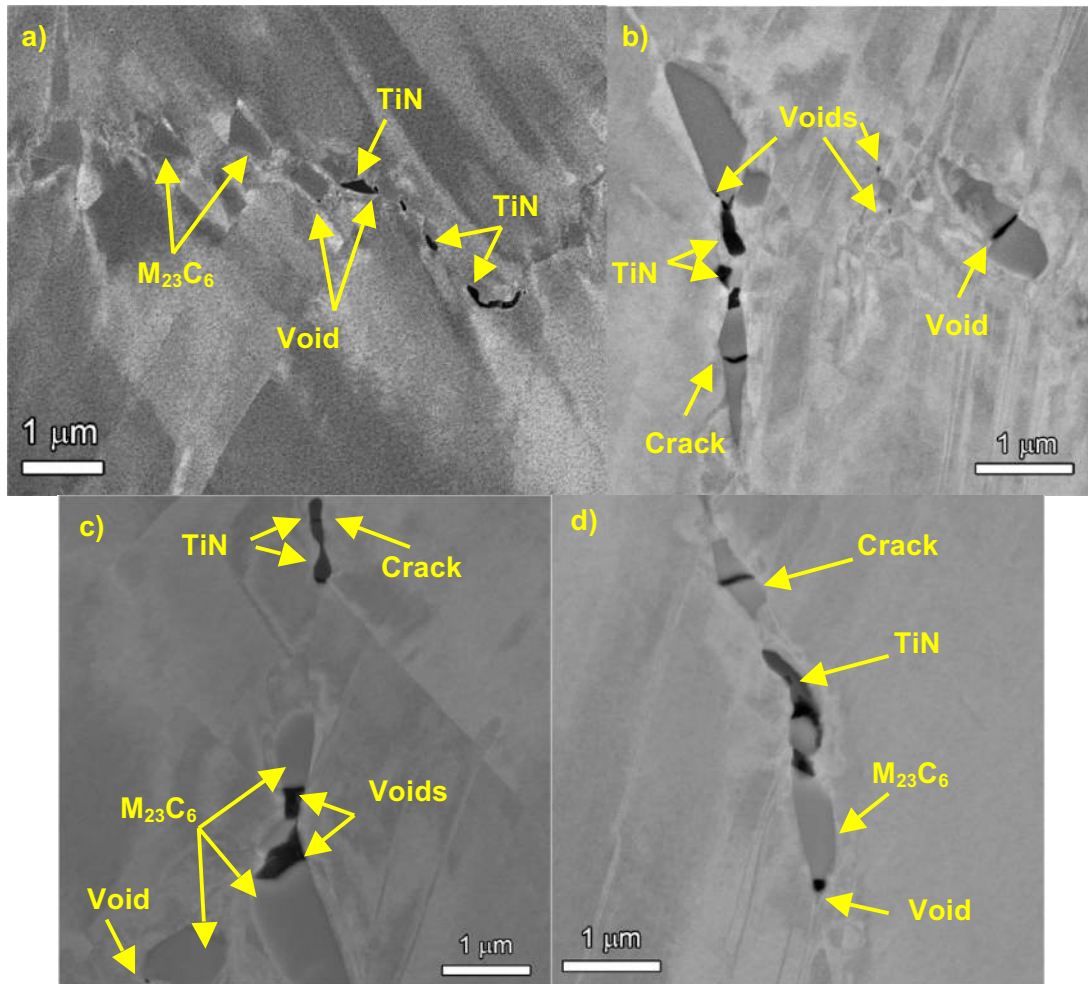
Figure 5.21 SEM backscatter micrographs illustrating grain boundary damage microstructure in 26%CR ANL alloy 690 (heat NX3297HK12).

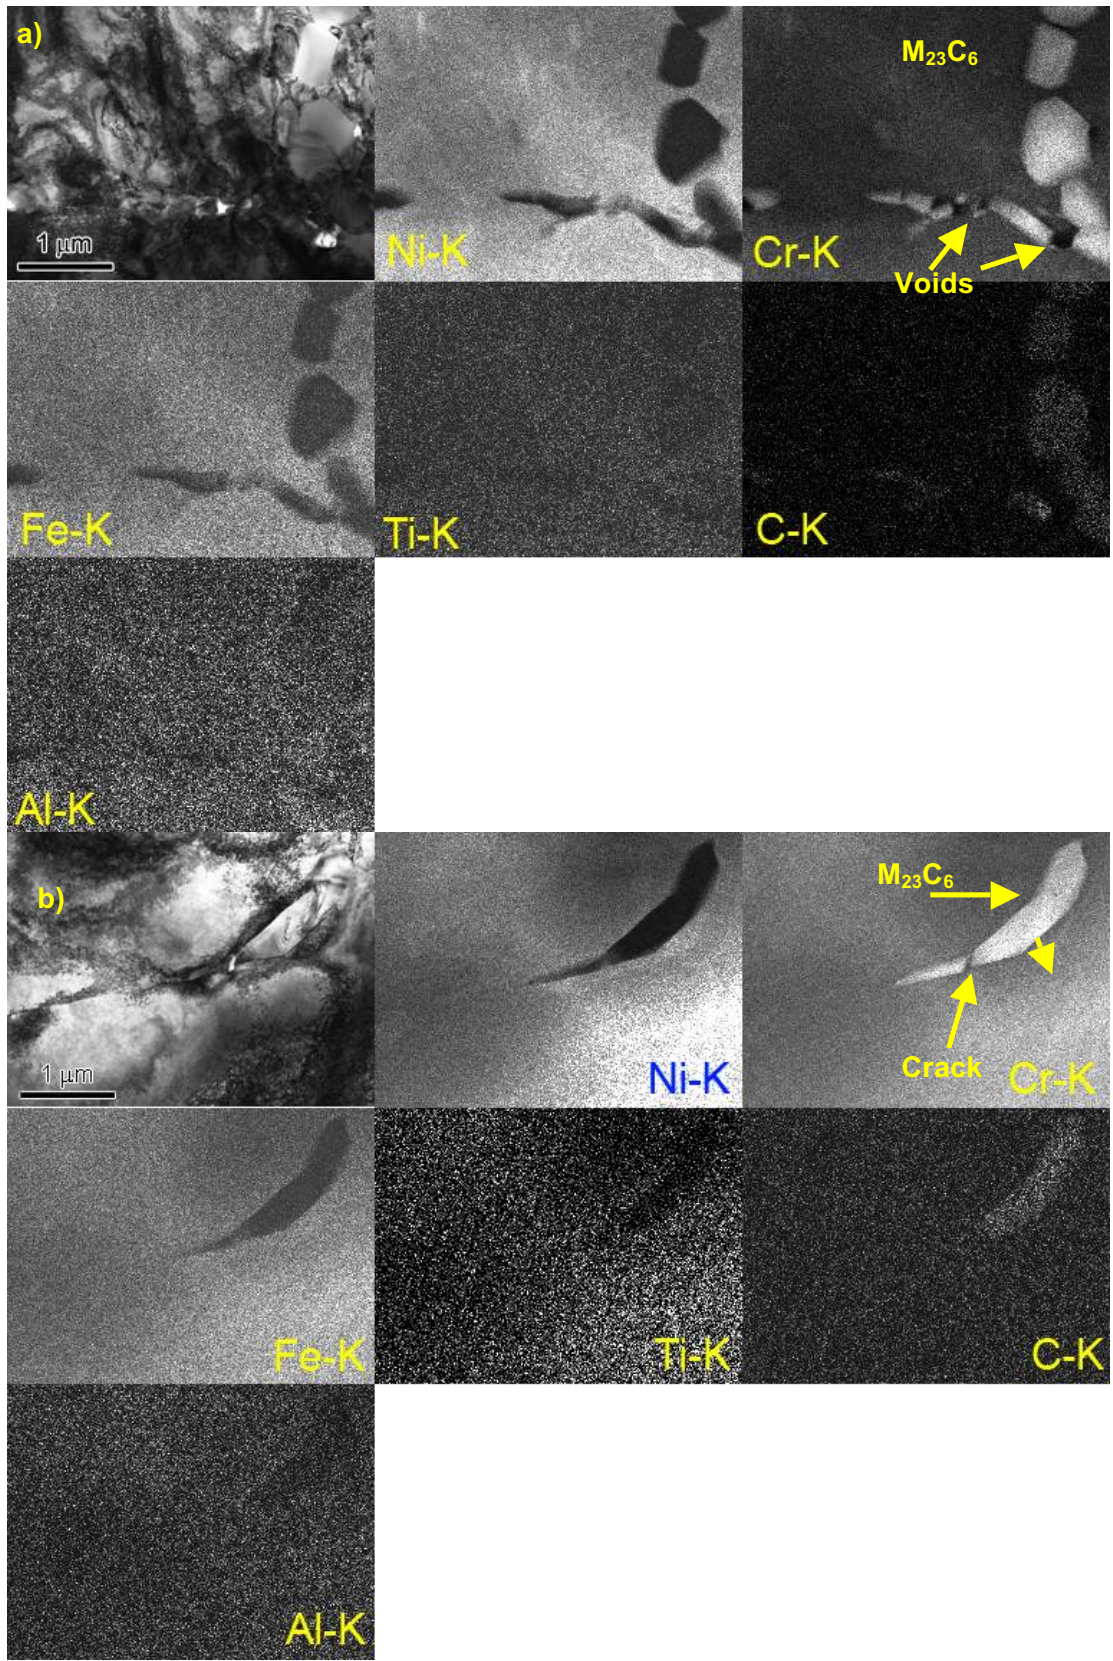
Figure 5.23 (a,b) SEM micrographs and EDS maps (a,b) illustrating general carbide microstructure in 26%CR ANL alloy 690 (heat NX3297HK12).

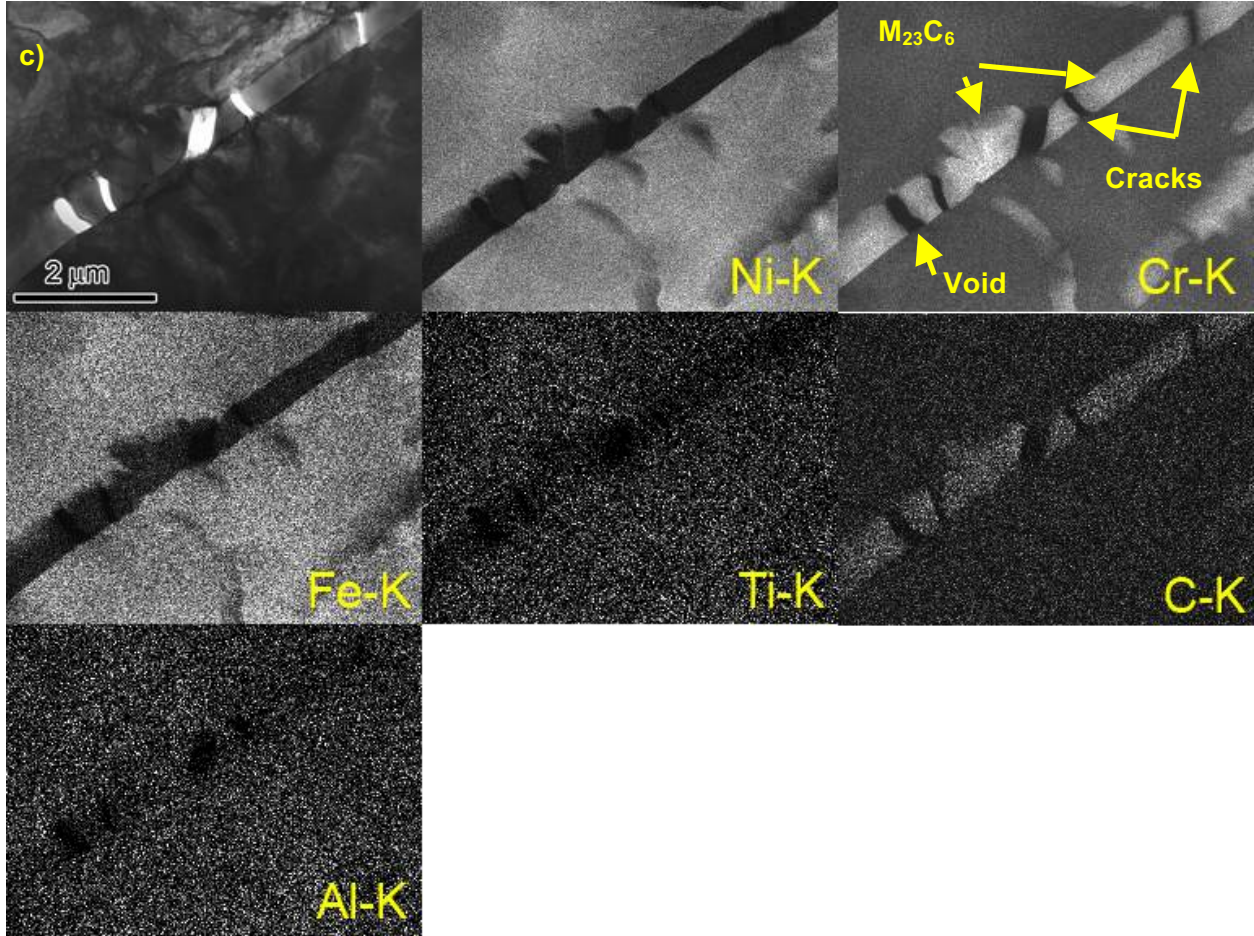
Figure 5.23 (c) SEM micrographs illustrating general carbide damage microstructure in 26%CR ANL alloy 690 (heat NX3297HK12).

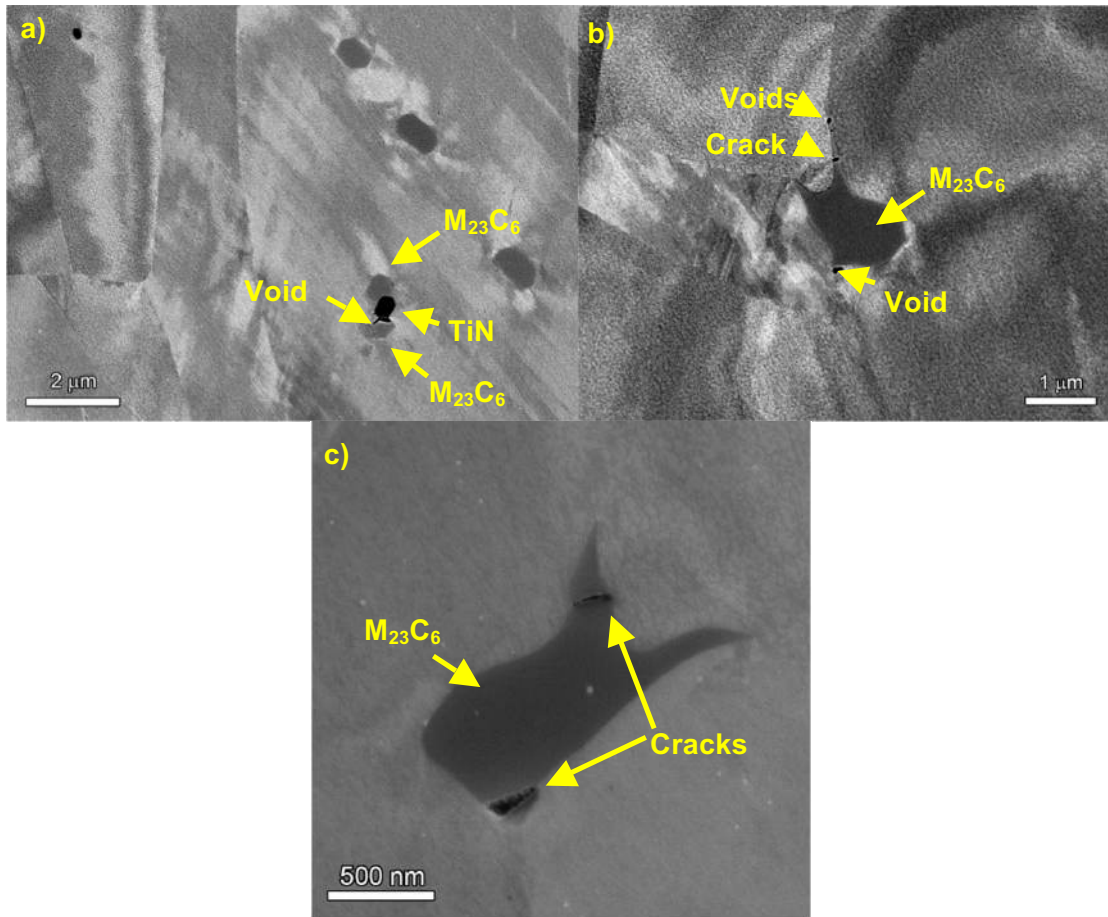
Figure 5.33 SEM micrographs illustrating general carbide damage microstructure in 20%CR GEG alloy 690 (heat B25K).

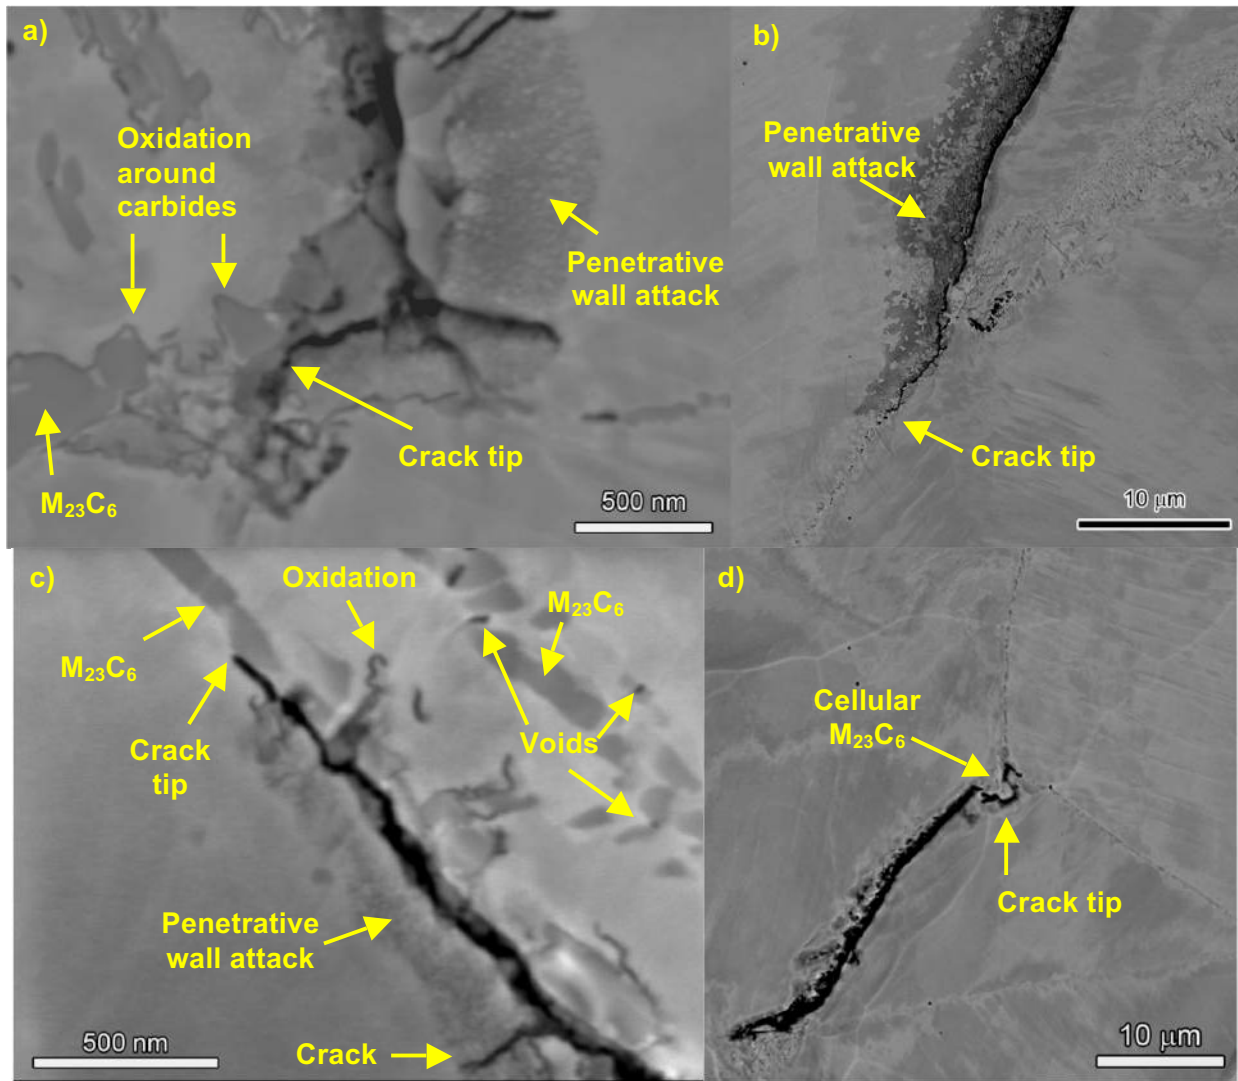
Figure 6.4 SEM backscatter micrographs of various SCC tips (secondary and primary) in 30%CR CRDM alloy 690TT specimen CT022.

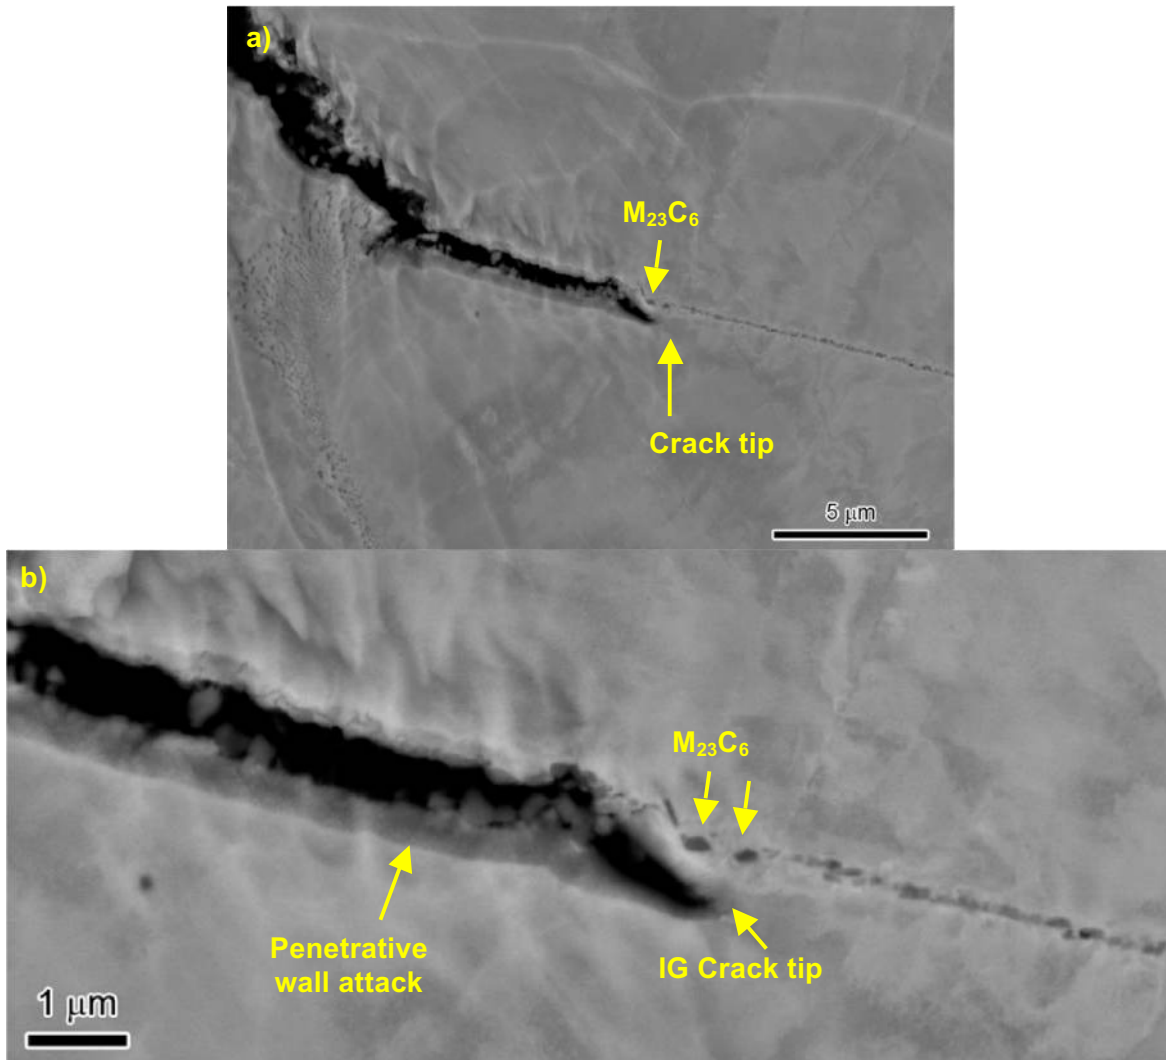
Figure 6.5 SEM backscatter micrographs of a leading SCC tip in 30%CR CRDM alloy 690TT specimen CT022.

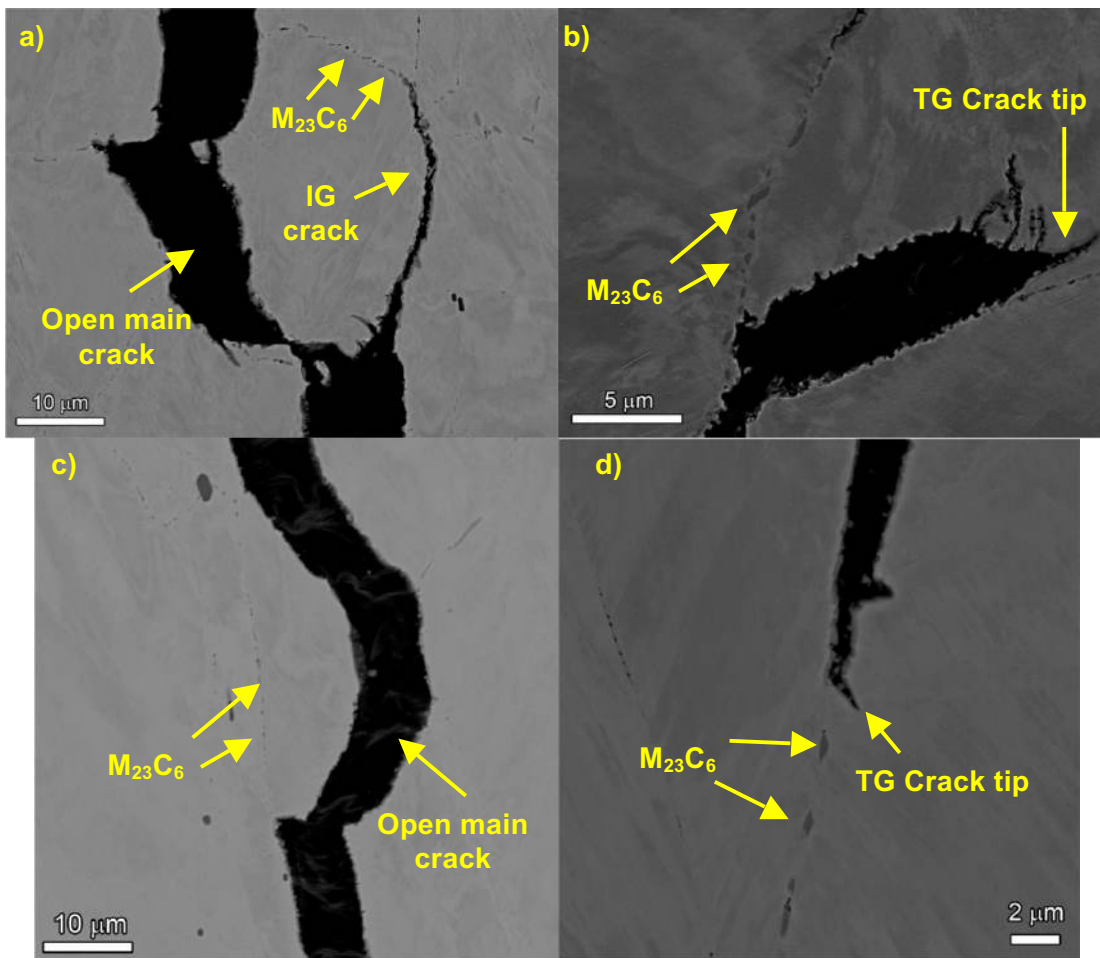
Figure 6.7 Low magnification SEM backscatter micrographs of various cracks and secondary crack tip regions in 26%CR ANL alloy 690 specimen CT036.

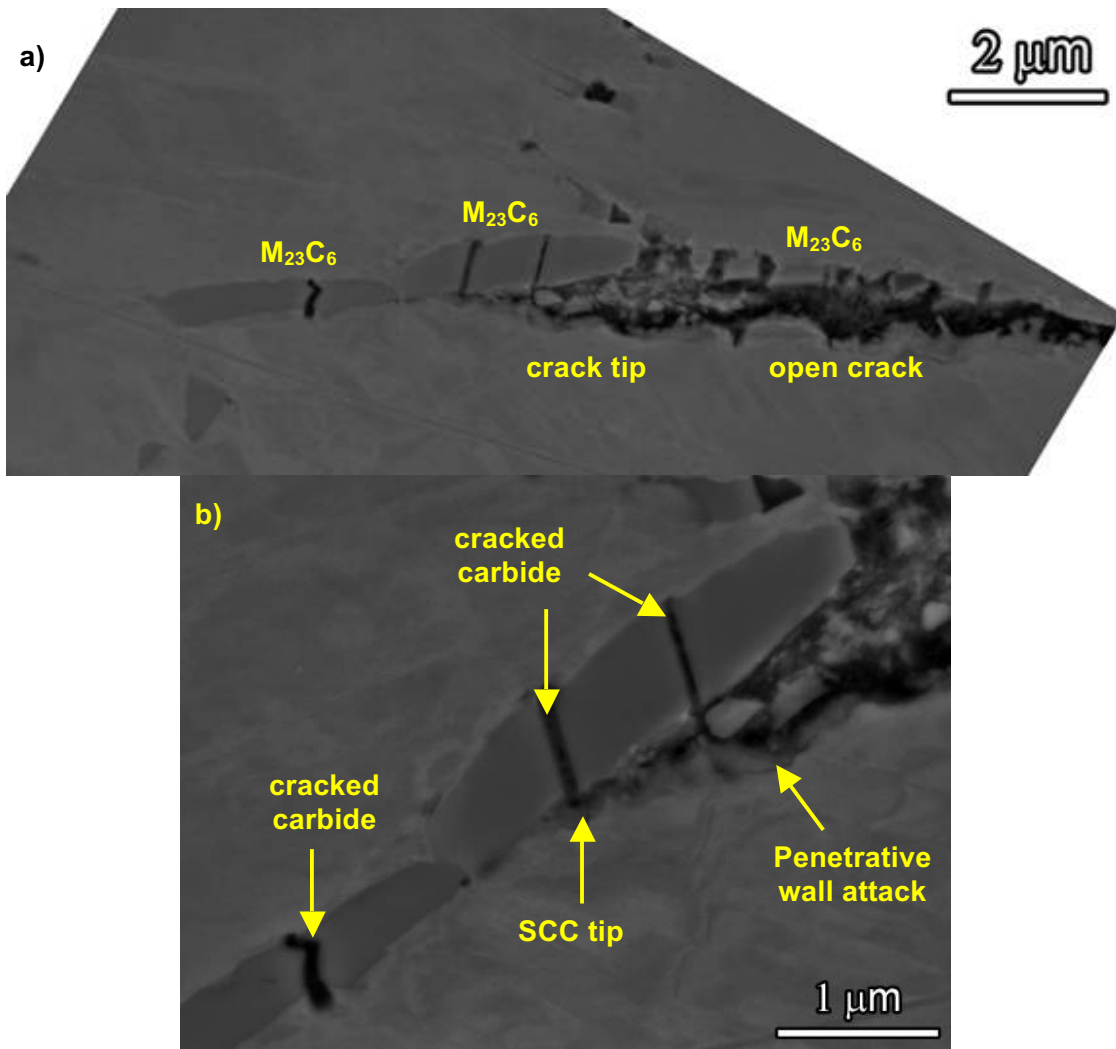
Figure 6.10 High magnification SEM backscatter micrographs of open crack walls in 26%CR ANL alloy 690 specimen CT036.

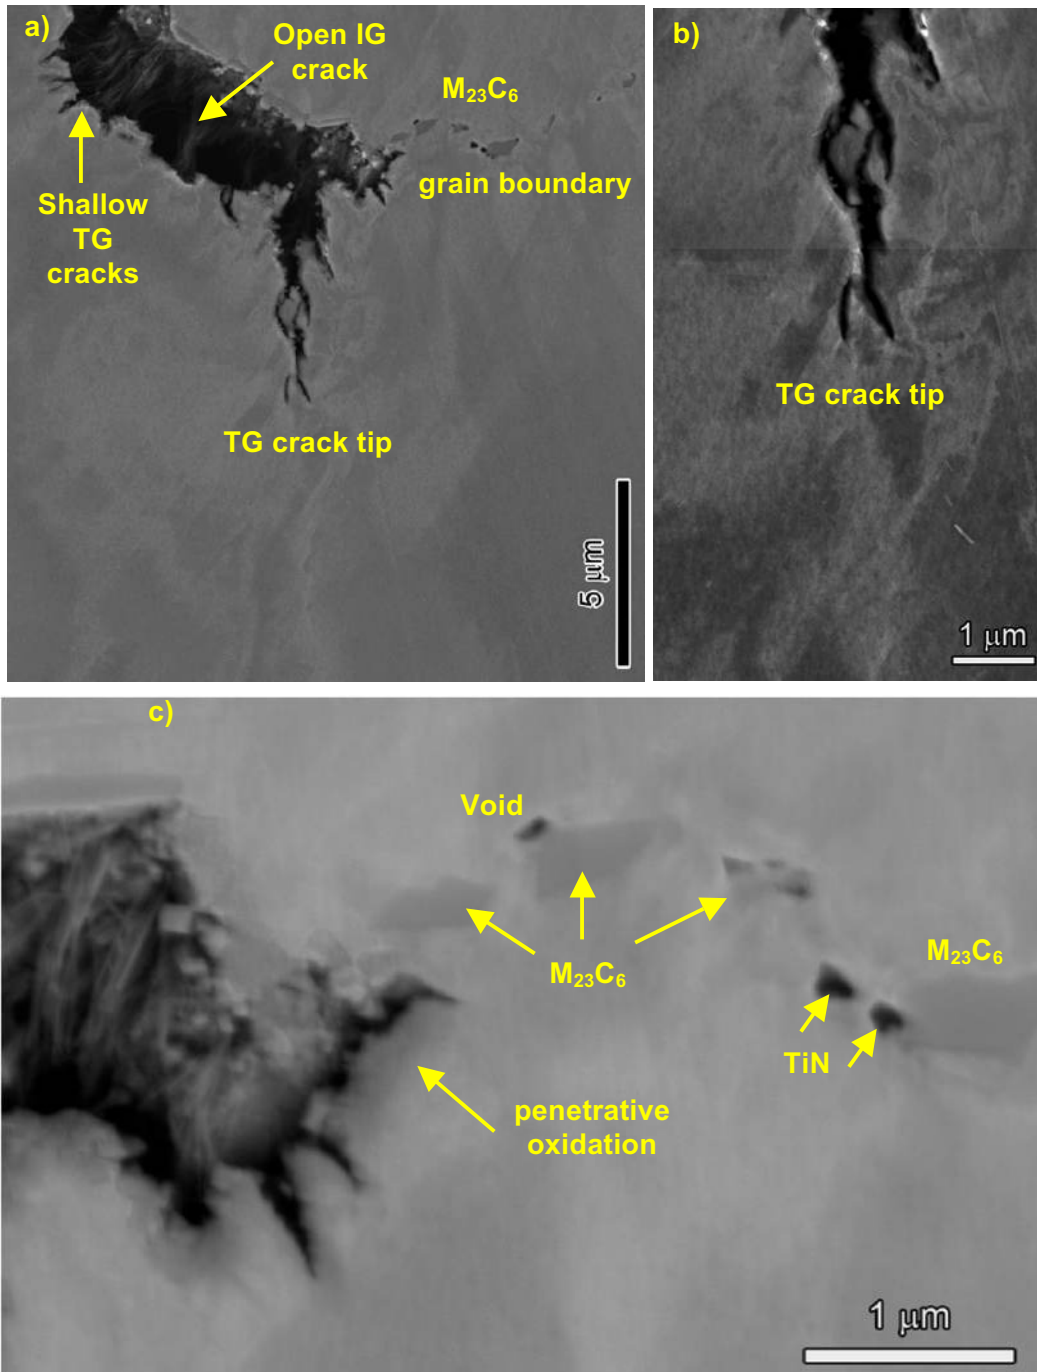
Figure 6.12 SEM backscatter micrographs of a SCC crack tip in the 26%CR ANL alloy 690 specimen CT036: (a) lower magnification showing an open IG crack ending in a highly branched tip region with a TG (b) and IG (c) characteristics.

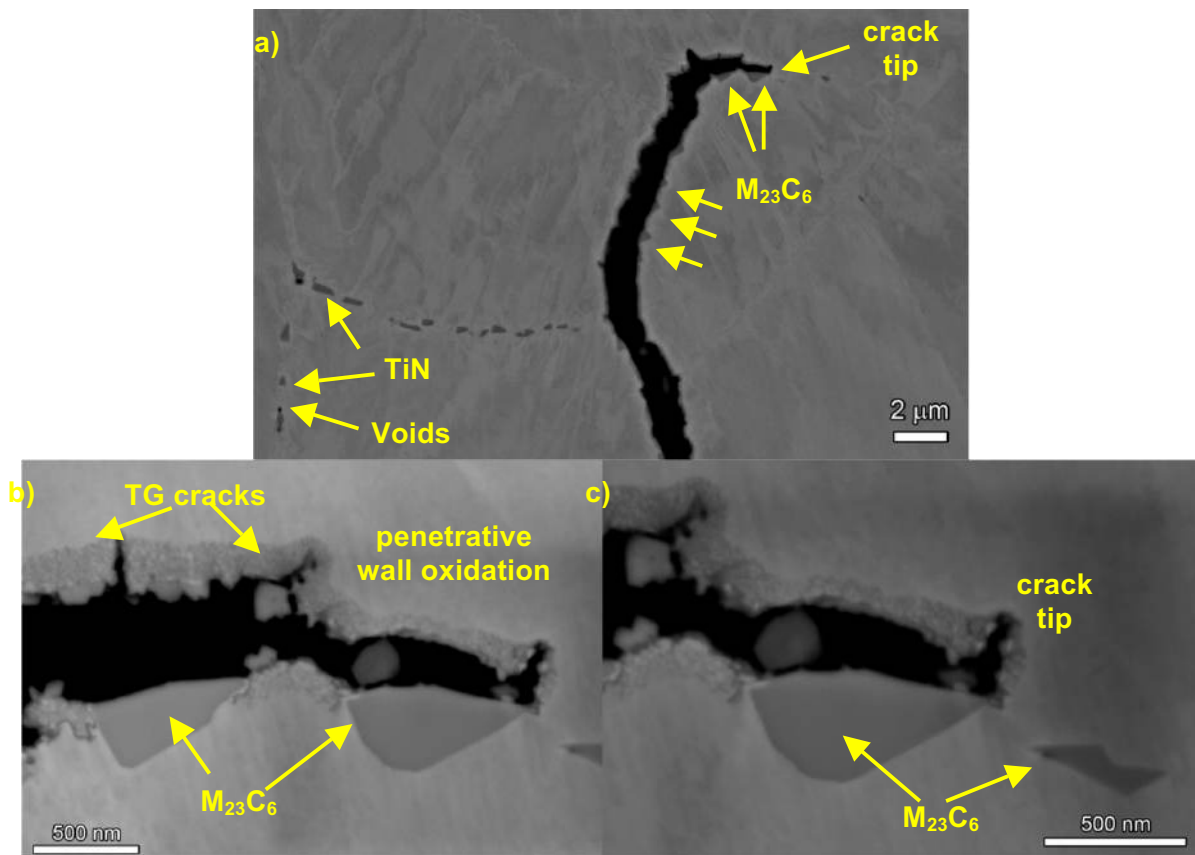
Figure 6.14 SEM backscatter micrographs of open IG crack (a) ending at a rather blunt IG crack tip (b,c) with penetrative wall oxidation in the 26%CR ANL alloy 690 specimen CT036.

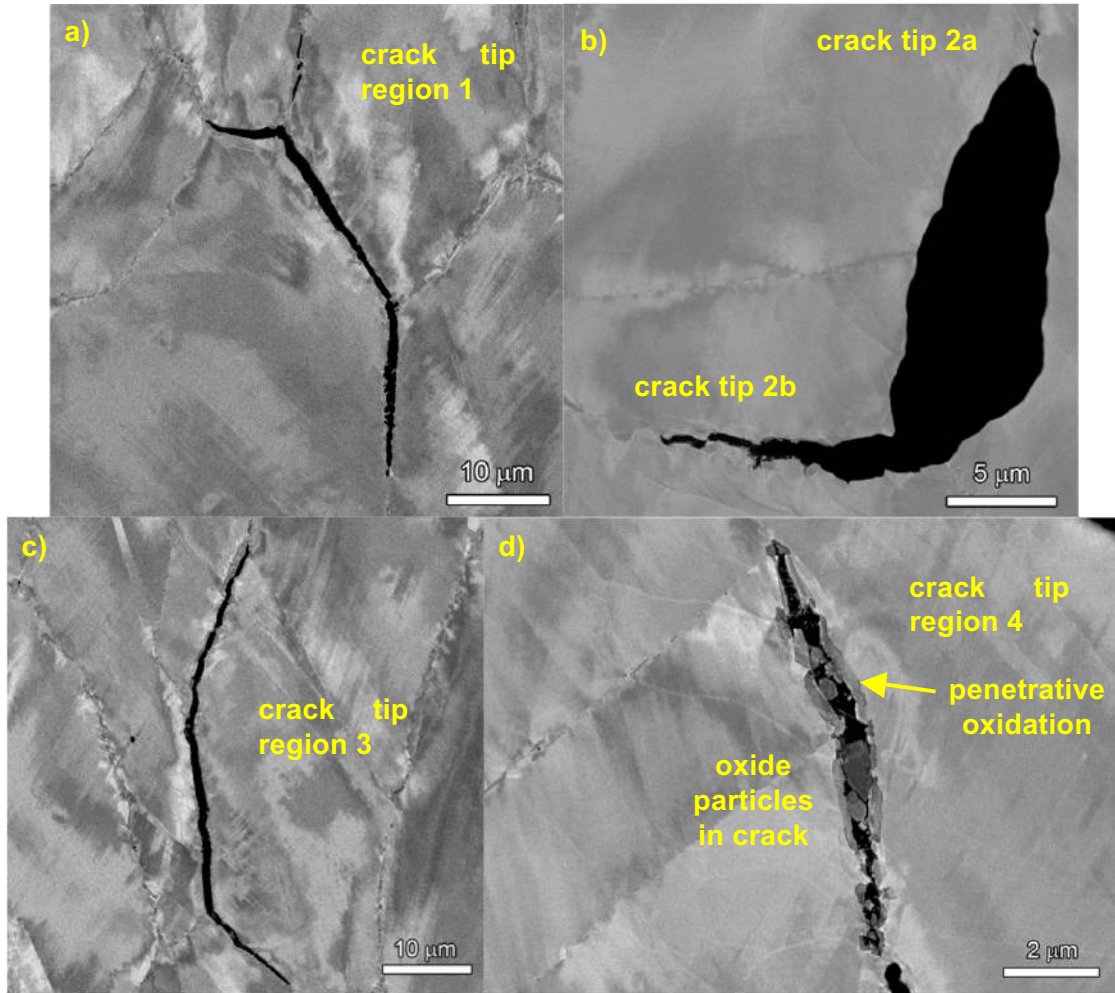
Figure 6.18 High magnification SEM backscatter micrographs of open crack walls in 26%CR ANL alloy 690 specimen CT036.

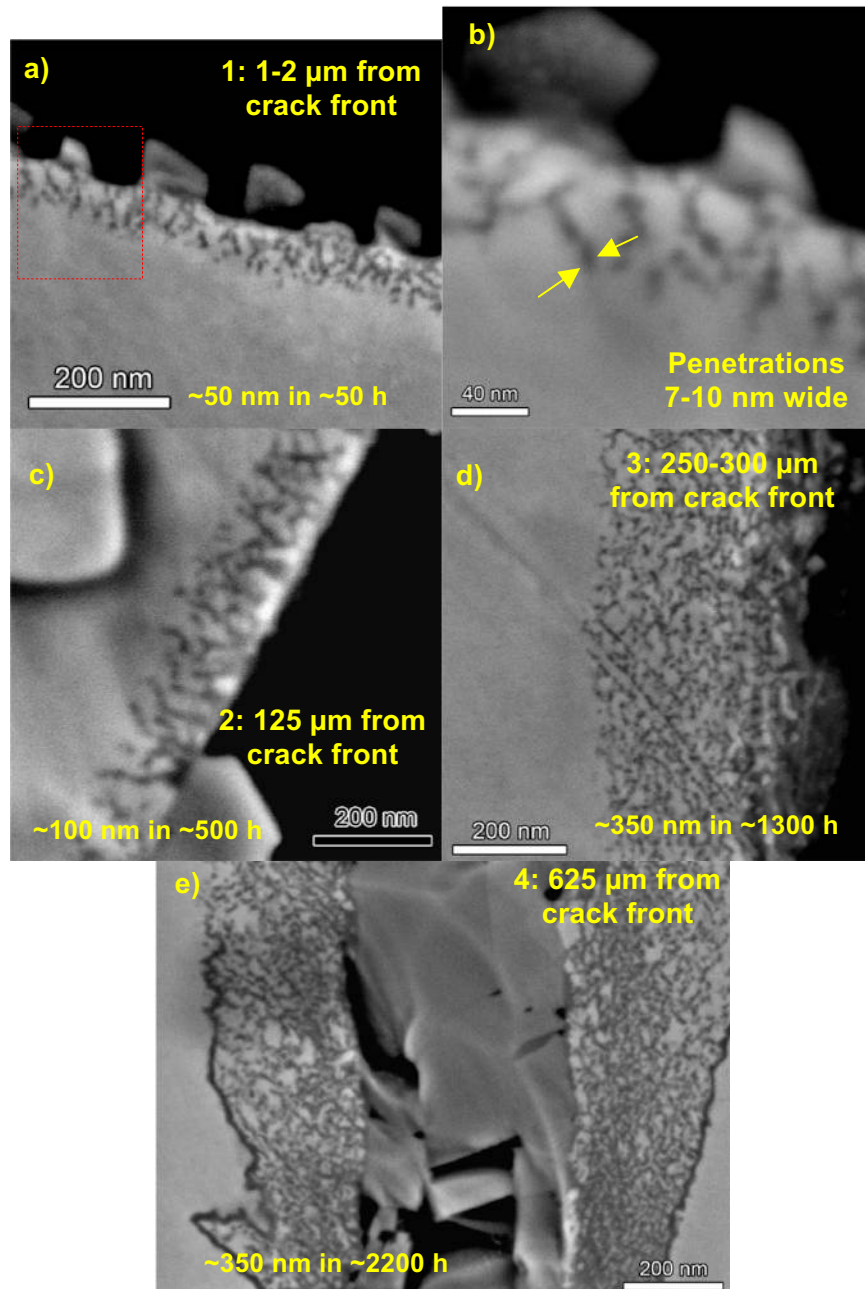
Figure 6.21 High magnification SEM backscatter micrographs of penetrative wall oxidation as a function of distance behind the SCC crack front in the 26%CR ANL alloy 690 specimen CT036.
