NUREG/CR-7103, Vol. 2

Pacific Northwest National Laboratory Investigation of Stress Corrosion Cracking in Nickel-Base Alloys

The objective of this program is to evaluate the primary water stress corrosion cracking (PWSCC) susceptibility of high chromium alloy 690 and its weld metals, establish quantitative measurements of crack-growth rates and determine relationships among cracking susceptibility, environmental conditions and metallurgical characteristics. Stress-corrosion, crack-growth rates have been determined for 12 alloy 690 specimens, 11 alloy 152/52/52M weld metal specimens, 4 alloy 52M/182 overlay specimens and 2 alloy 52M/82 inlay specimens in simulated PWR primary water environments. The alloy 690 test materials included three different heats of extruded control-rod-drive mechanism (CRDM) tubing with variations in the initial material condition and degree of cold work for one heat. Two cold-rolled (CR) alloy 690 plate heats were also obtained and evaluated enabling comparisons to the CR CRDM materials. Weld metal, overlay and inlay specimens were machined from industry mock ups to provide plant-representative materials for testing. Specimens have been tested for one al

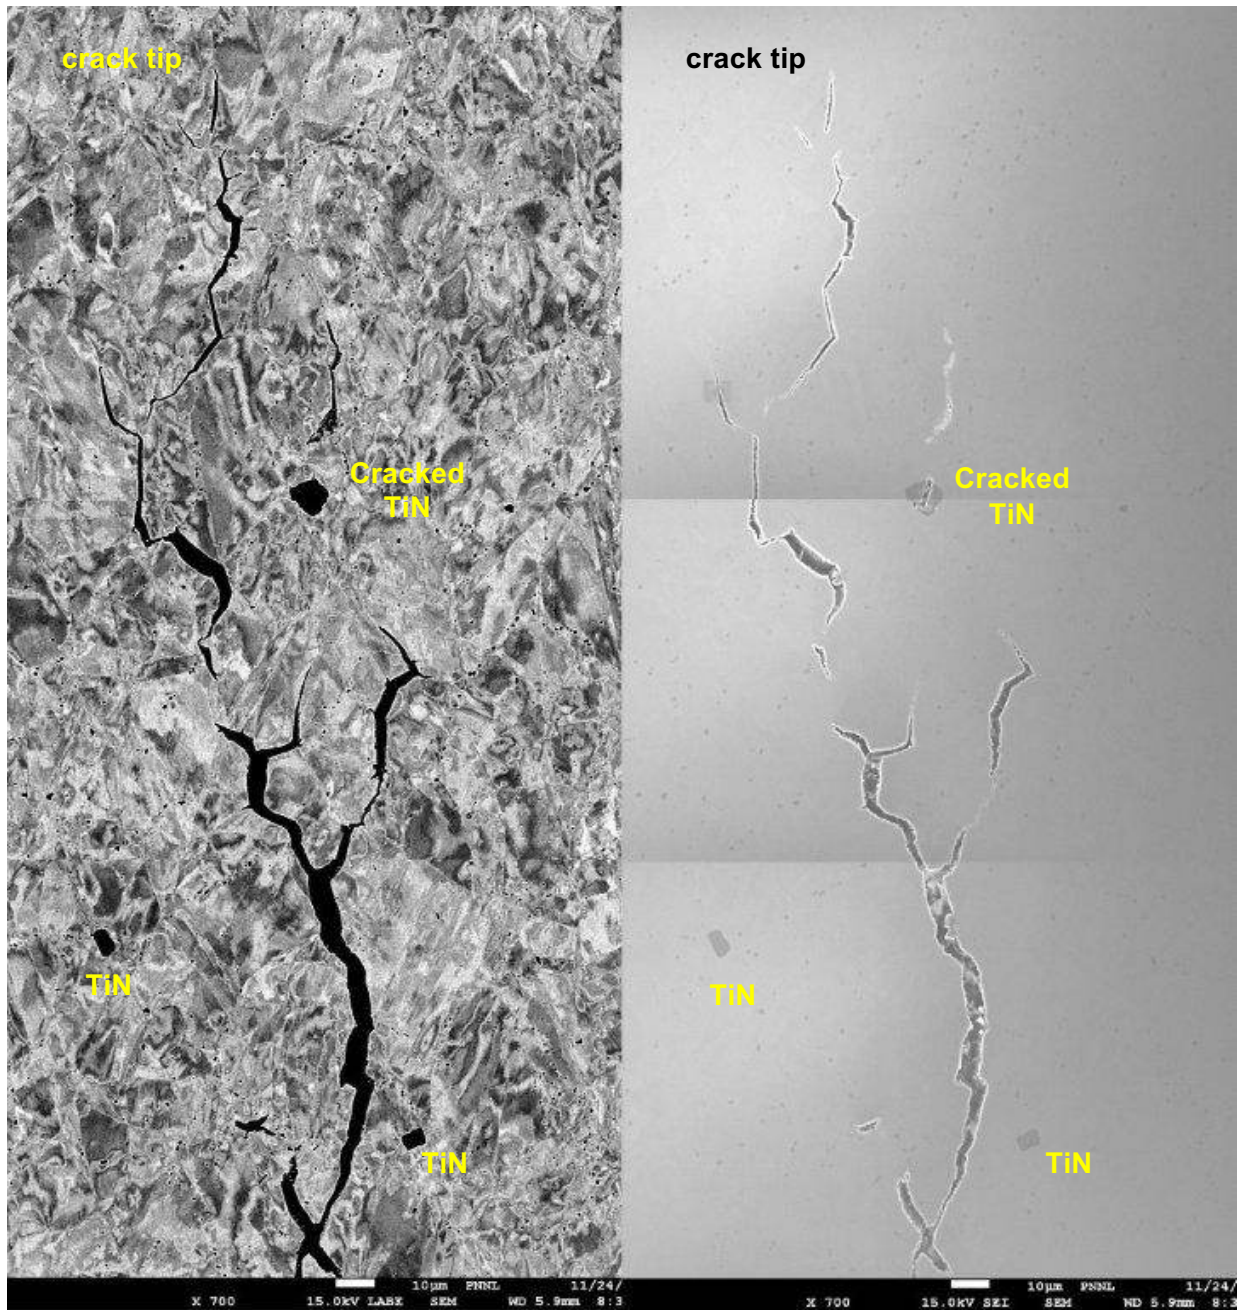
Figure 6.24 Montages of SEM backscatter (left) and secondary (right) electron micrographs at low magnifications showing the open SCC crack with branching (in and out of plane) to the crack tip in 20%CR GEG alloy 690 specimen CT037. Several larger matrix TiN particles are identified and careful examination of the backscatter image reveals much smaller TG and IG $M_{23}C_6$ precipitates.

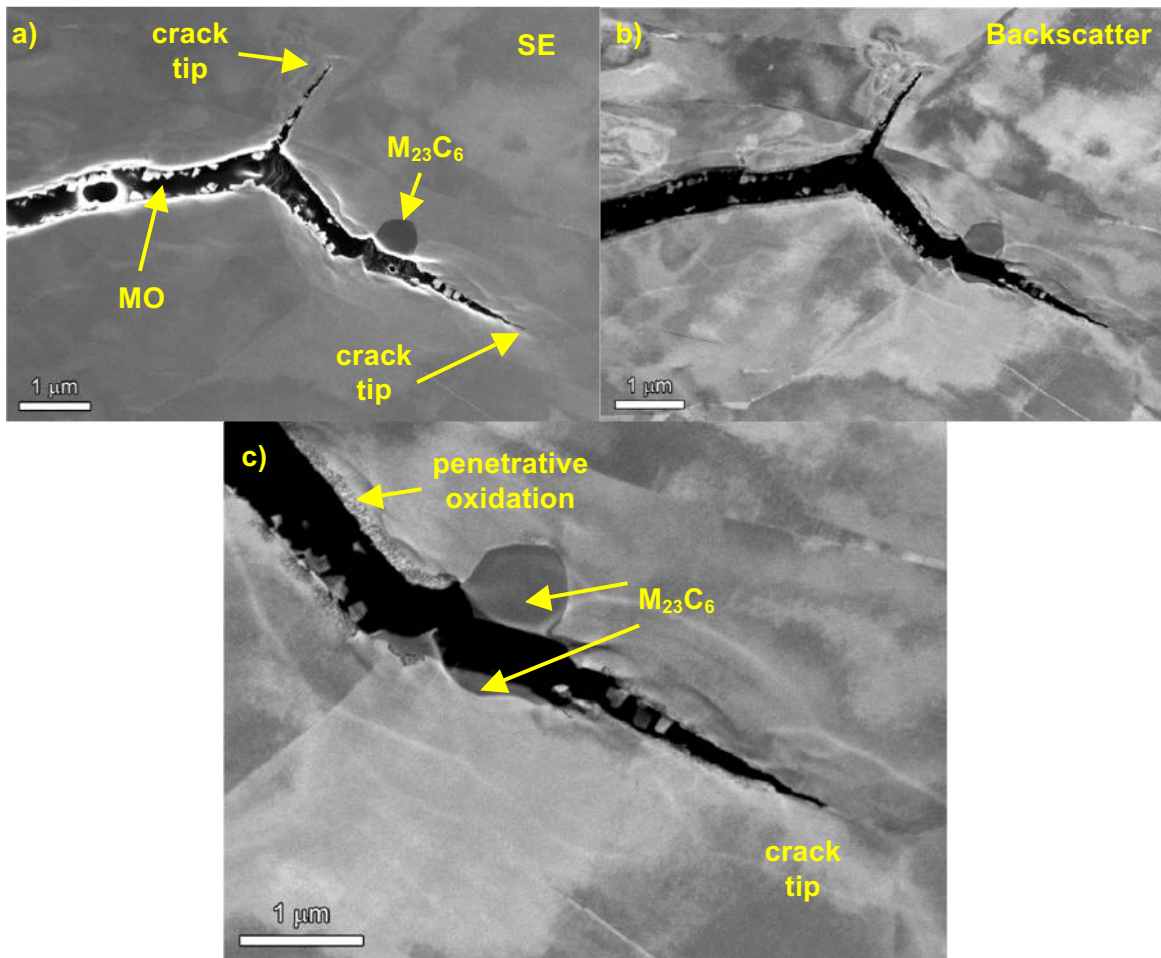
Figure 6.25 High magnification SEM SE (a) and backscatter (b,c) micrographs of open IGSCC crack ending with two IG crack tips in 20%CR GEG alloy 690 specimen CT037.

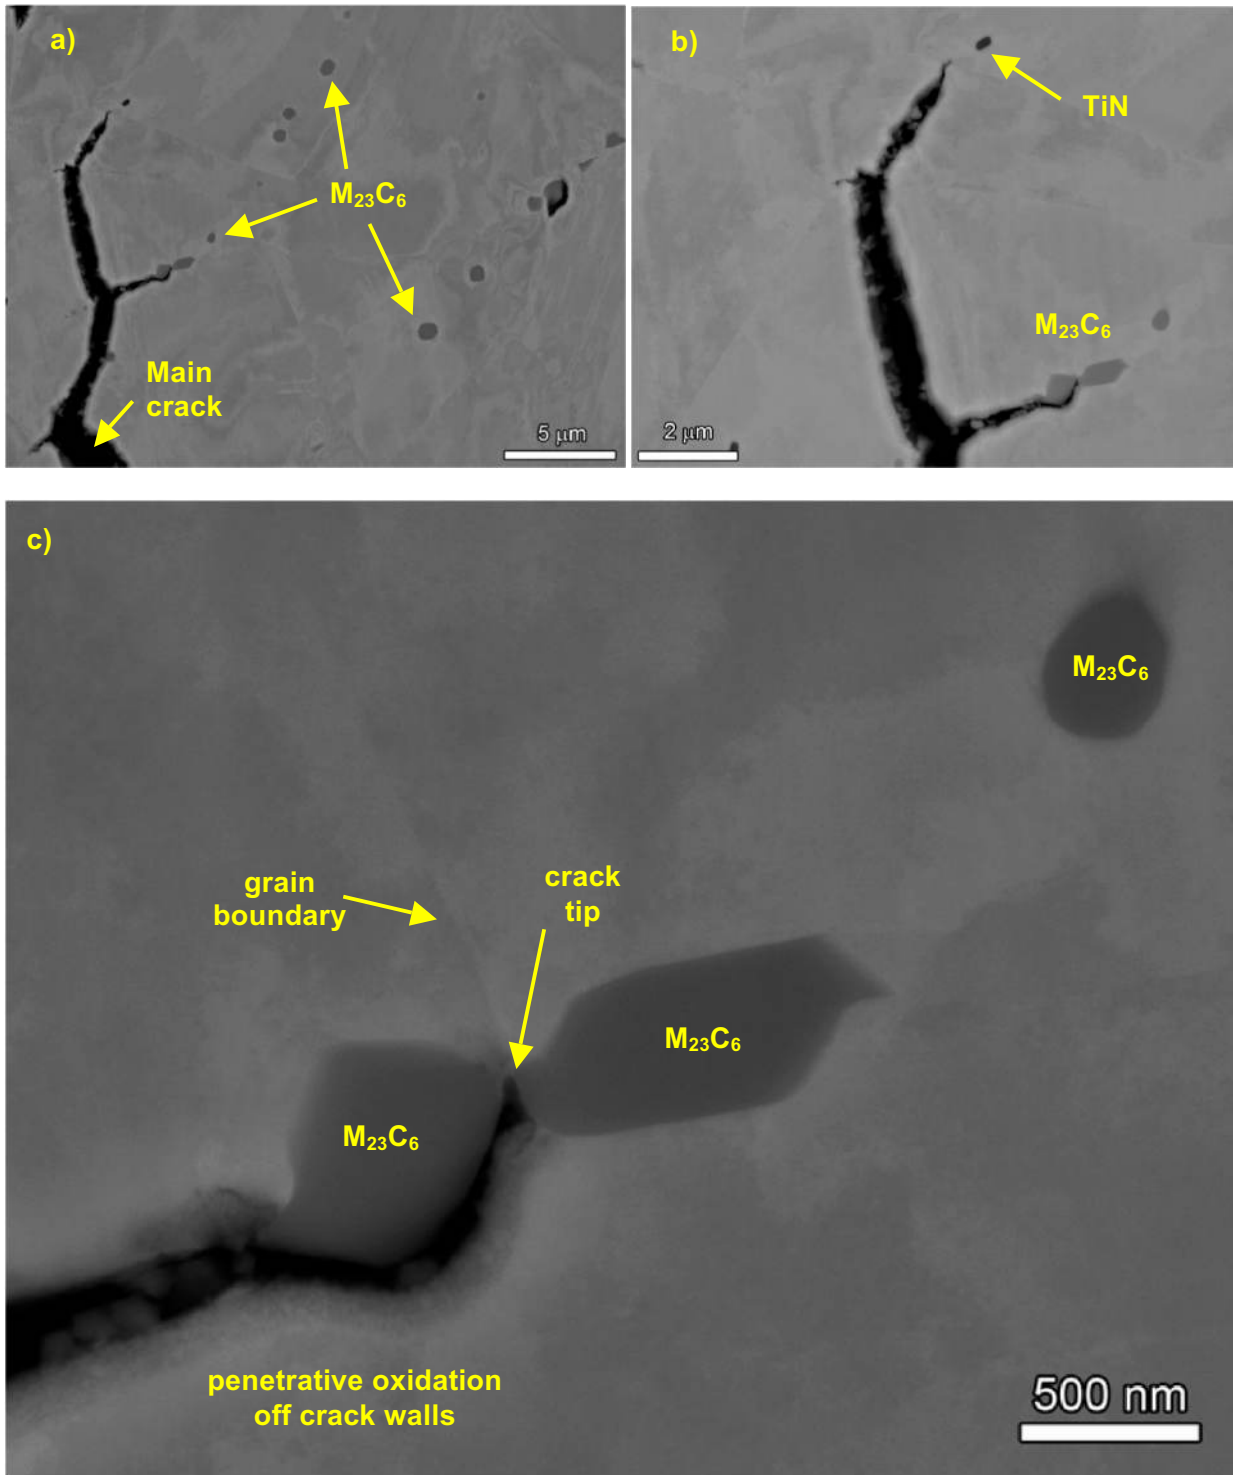
Figure 6.27 SEM backscatter micrographs of leading IGSCC crack tips in 20%CR GEG alloy 690 specimen CT037. Few grain boundary precipitates are seen off crack walls, however one of the crack branches ends at a grain boundary triple and a carbide interface.

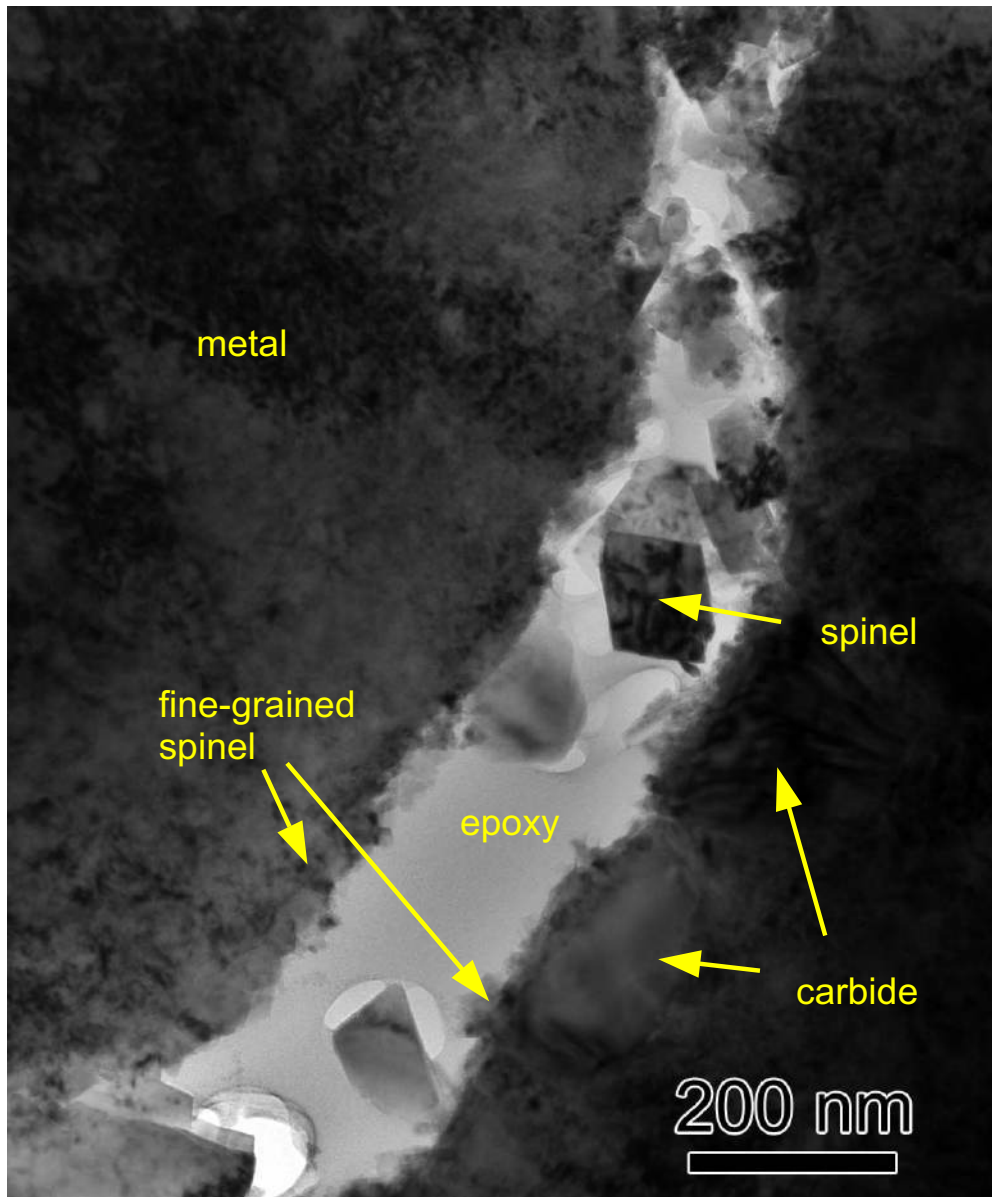
Figure 6.28 IGSCC crack partially filled with epoxy containing oxide corrosion products from 30%CR CRDM alloy 690TT specimen CT022.

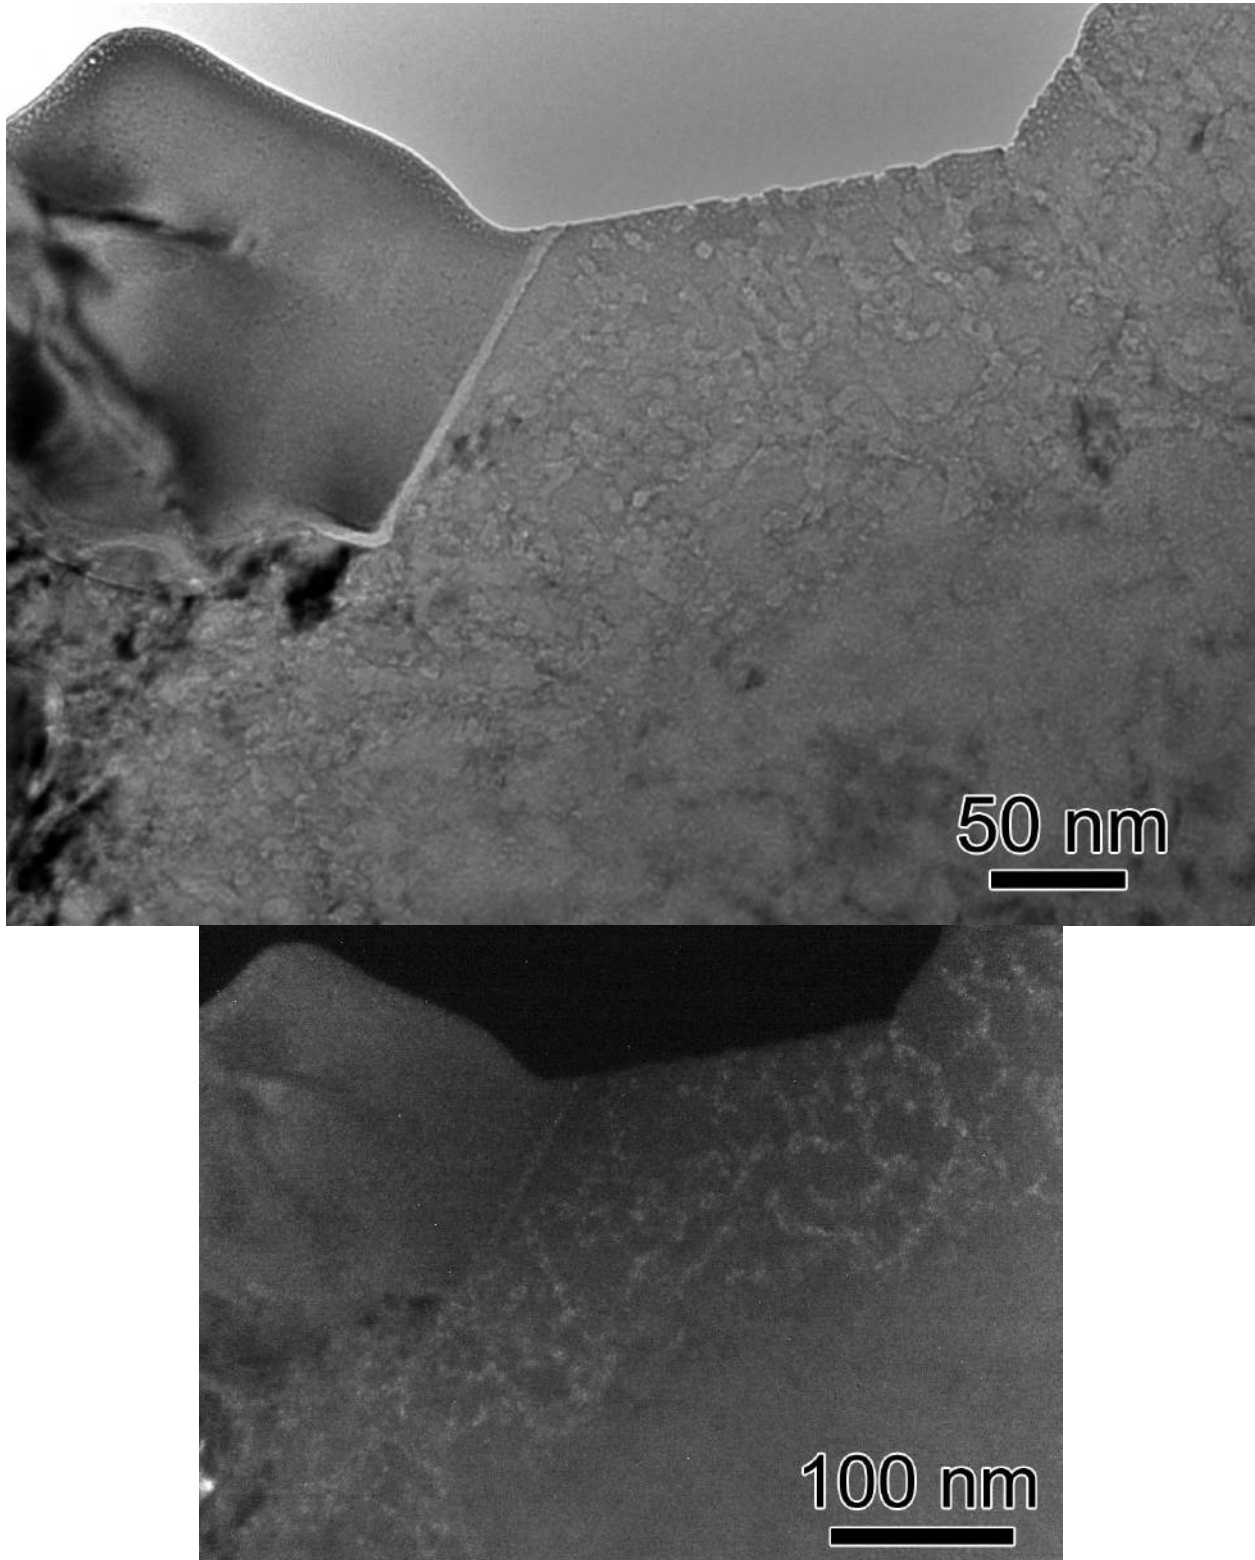
Figure 6.31 Attacked/oxidized region along edge of SCC crack in CT022. (a) brightfield underfocus image showing 'filaments' and interfacial oxidation of Cr-carbide particle. (b) oxide darkfield image taken with Cr_2O_3 reflection, showing oxide in filaments.

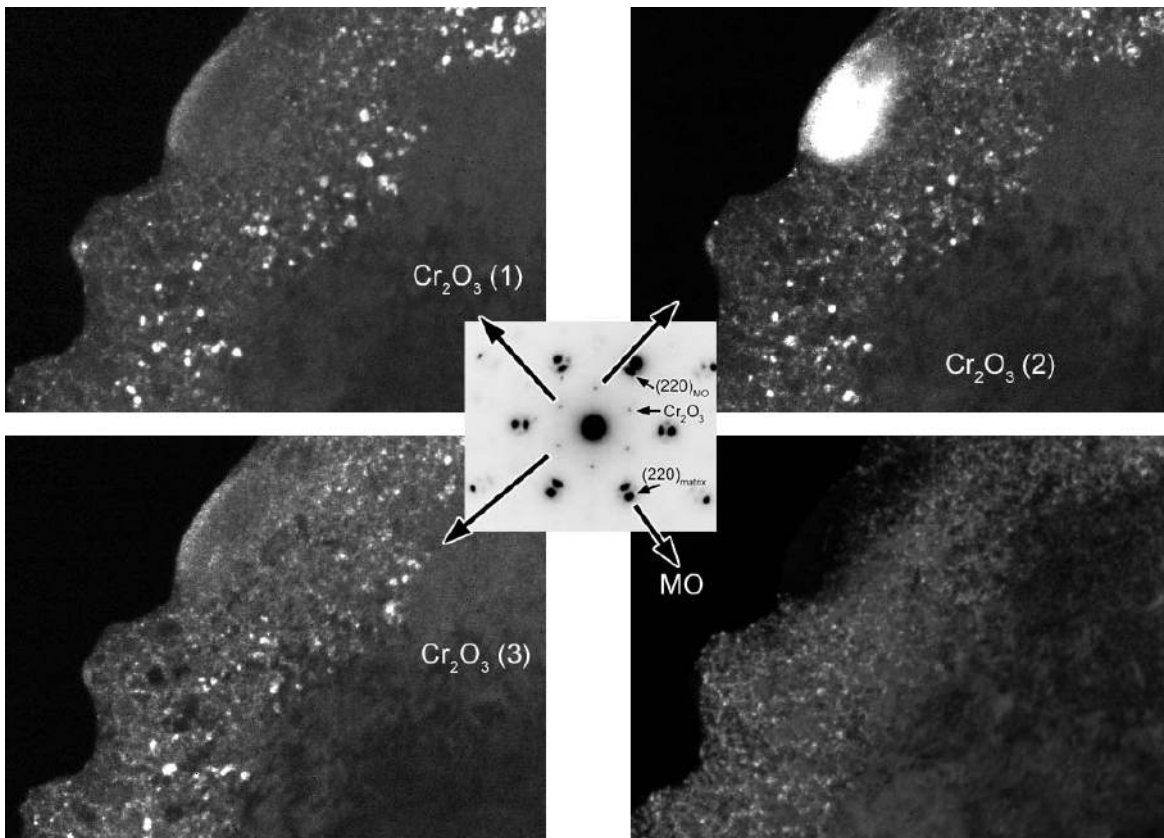
Figure 6.36 Oxide darkfield images showing particulate Cr_2O_3 and MO-type oxide in filaments along crack wall. Different Cr_2O_3 spots appear to highlight different orientation variants.

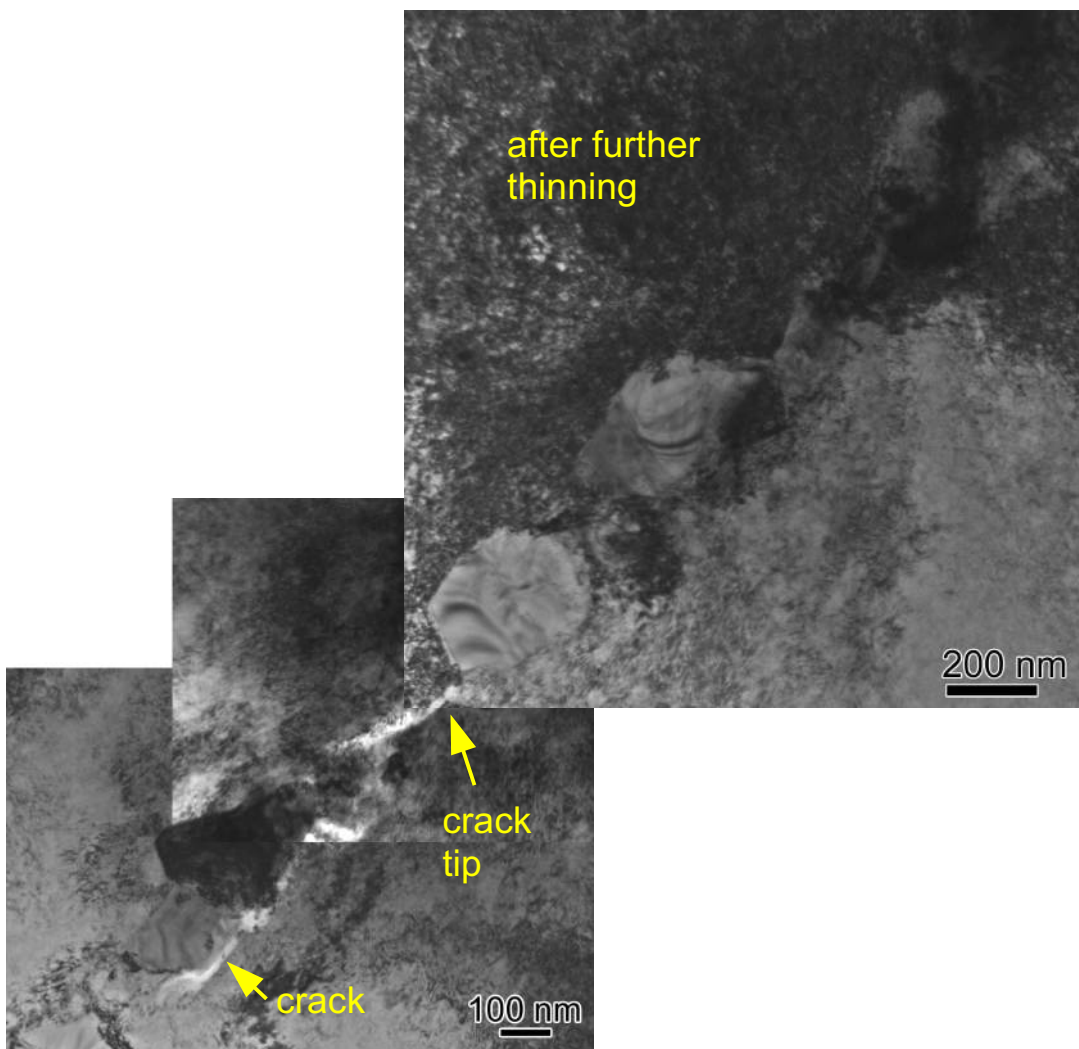
Figure 6.37 Crack-tip area in the 30%CR CRDM alloy 690TT specimen CT022. Photo at upper right was taken after thinning was continued. Note very high dislocation density in region. No porosity is observed along grain boundary ahead of crack tip.

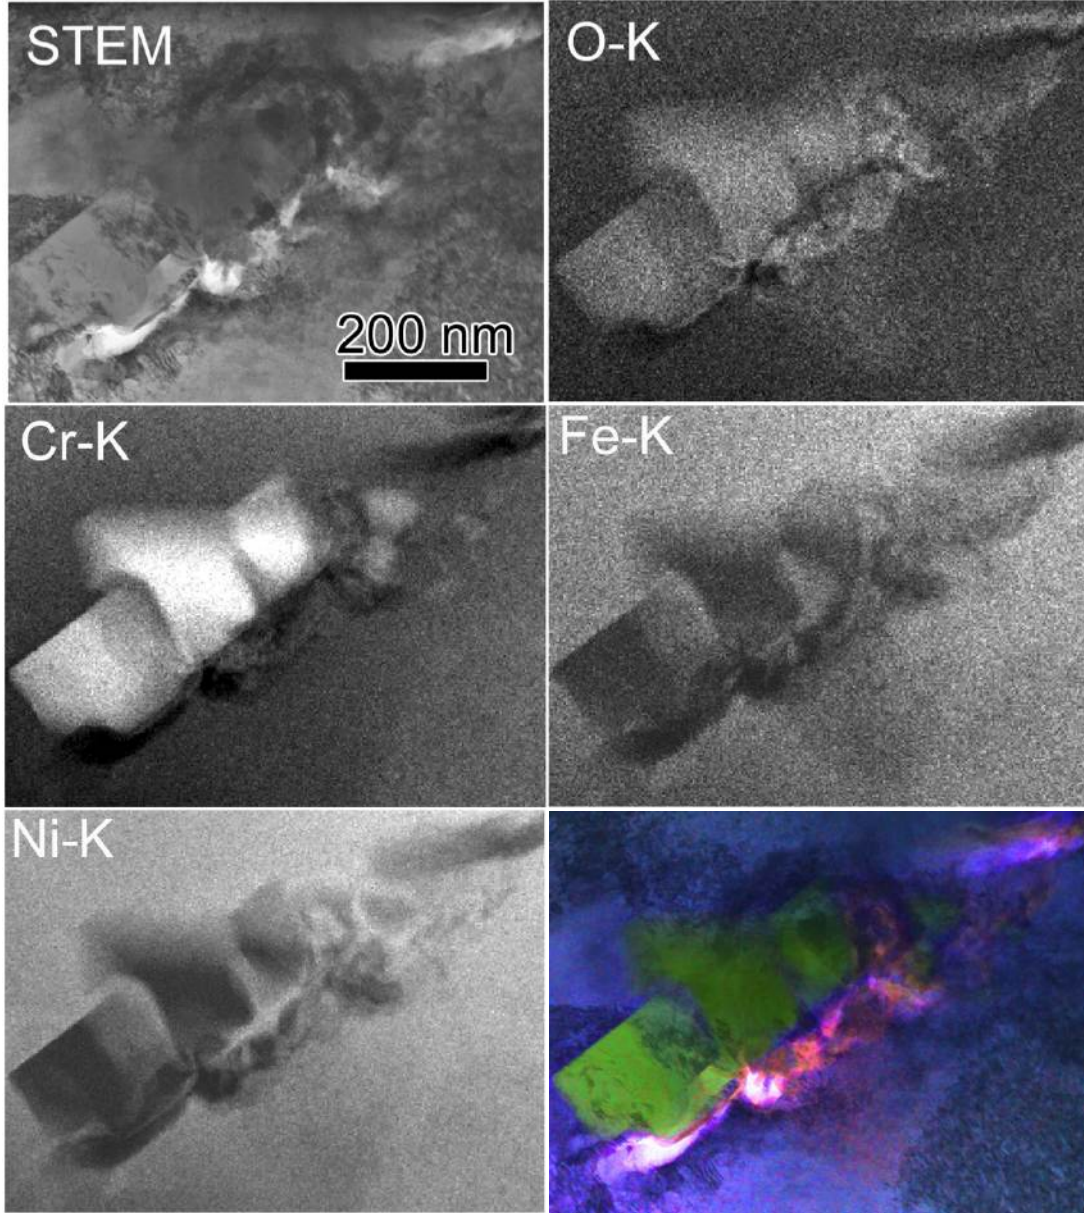
Figure 6.38 STEM/EDS maps of CT022 specimen crack tip region shown in Figure 6.36. Color composite of O (red), Cr (green) and Ni (blue) maps shows blocky Cr-carbide particles (green), and Cr-rich oxide (pink-orange). White is open area of crack. Also note Ni-rich regions (dark blue) between carbide particles.

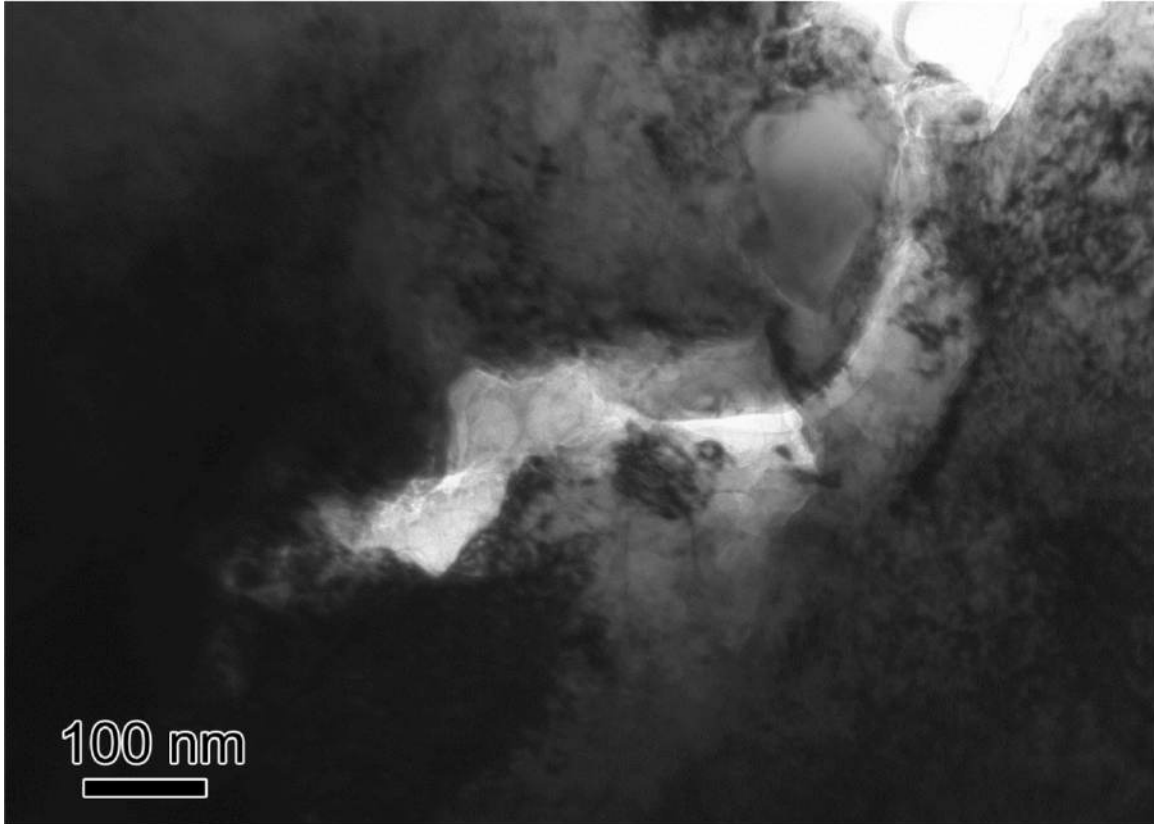
Figure 6.39 TEM brightfield image of an additional crack tip in 30%CR alloy 690 CRDM specimen CT022.

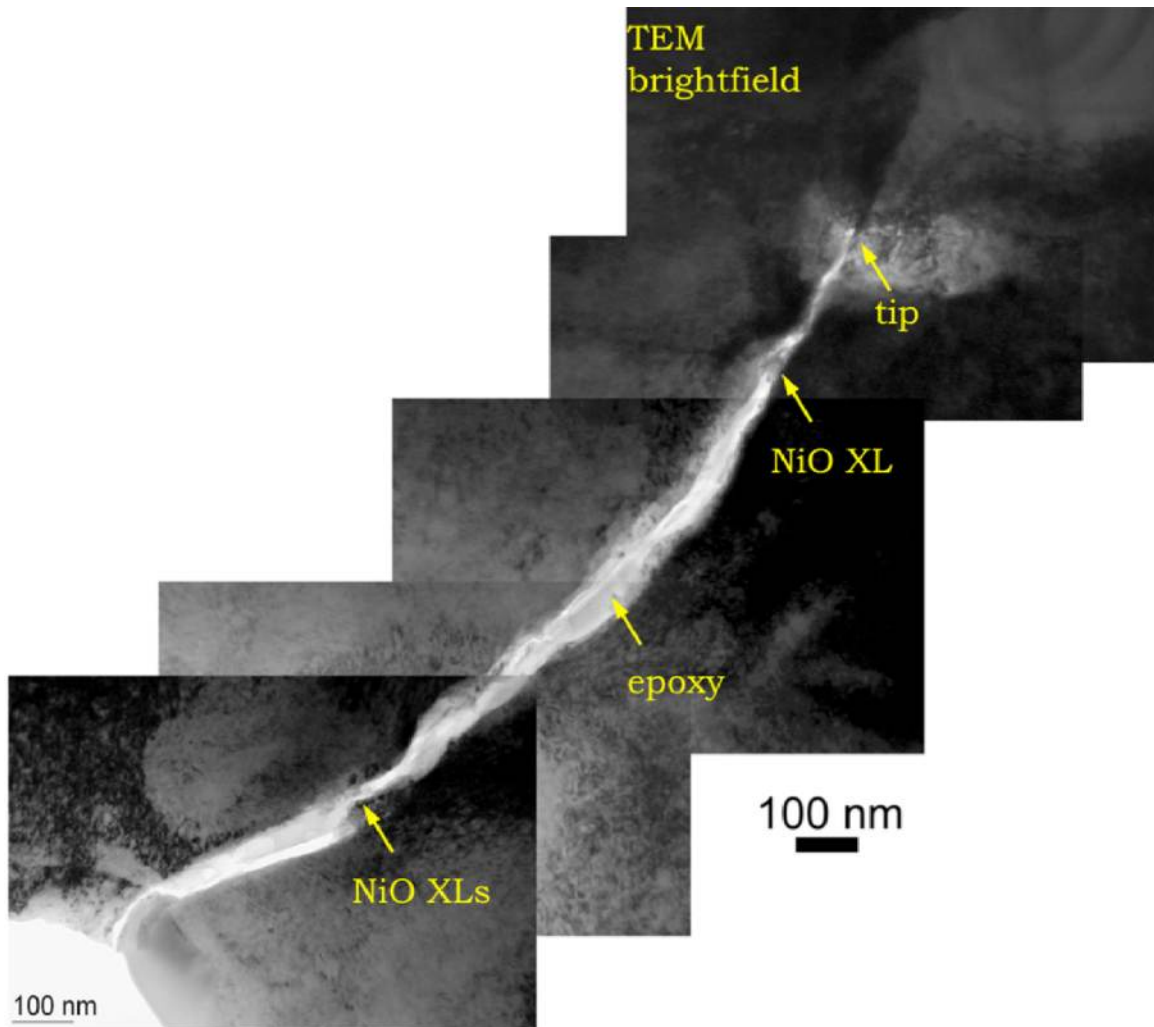
Figure 6.40 TEM image of a crack tip in the ANL 26%CR alloy 690 specimen CT036.

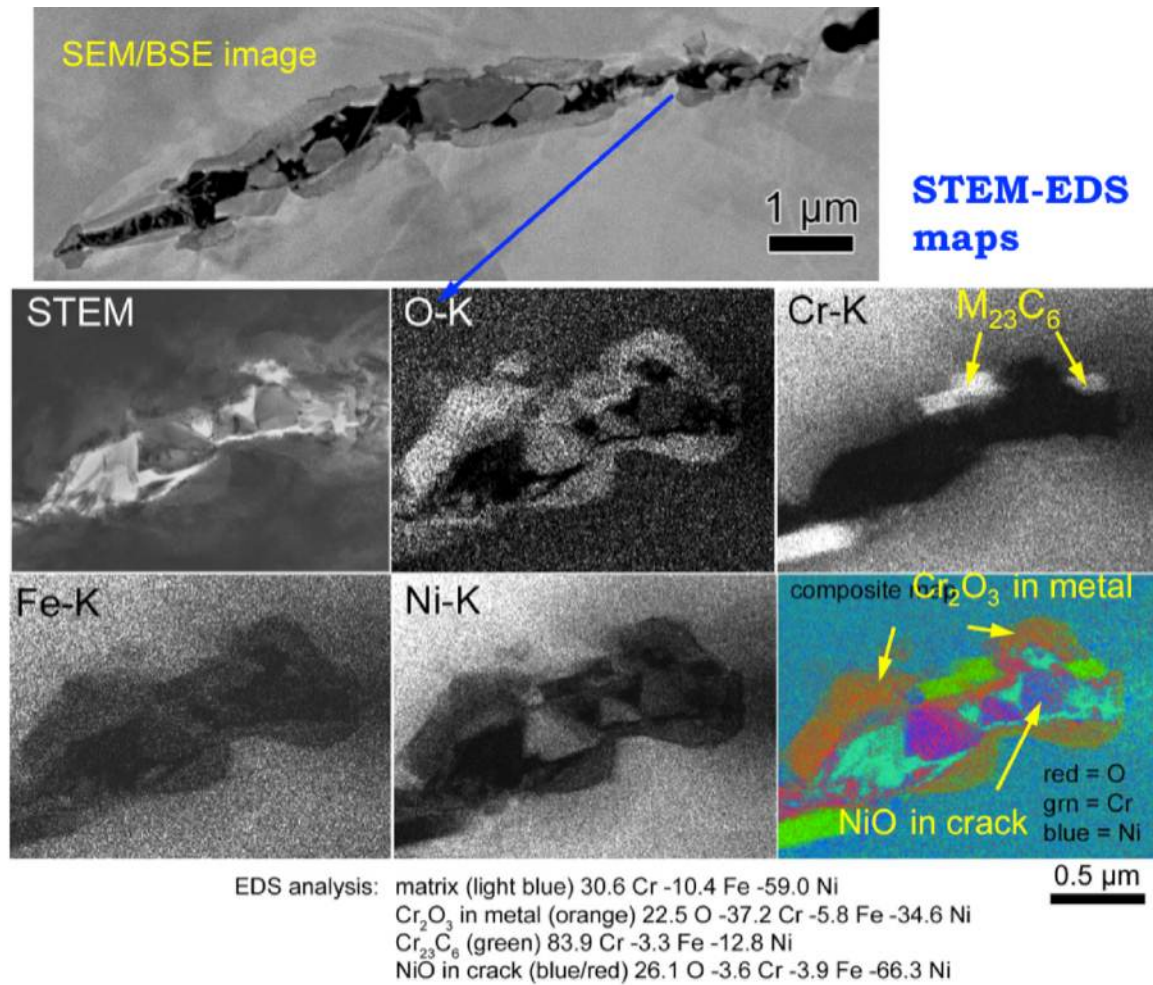
Figure 6.41 SEM and STEM images from a secondary crack region in the CT036 specimen (ANL 26%CR alloy 690). This region is behind the SCC crack front and EDS composition maps are shown illustrating the corrosion microstructure that has developed.

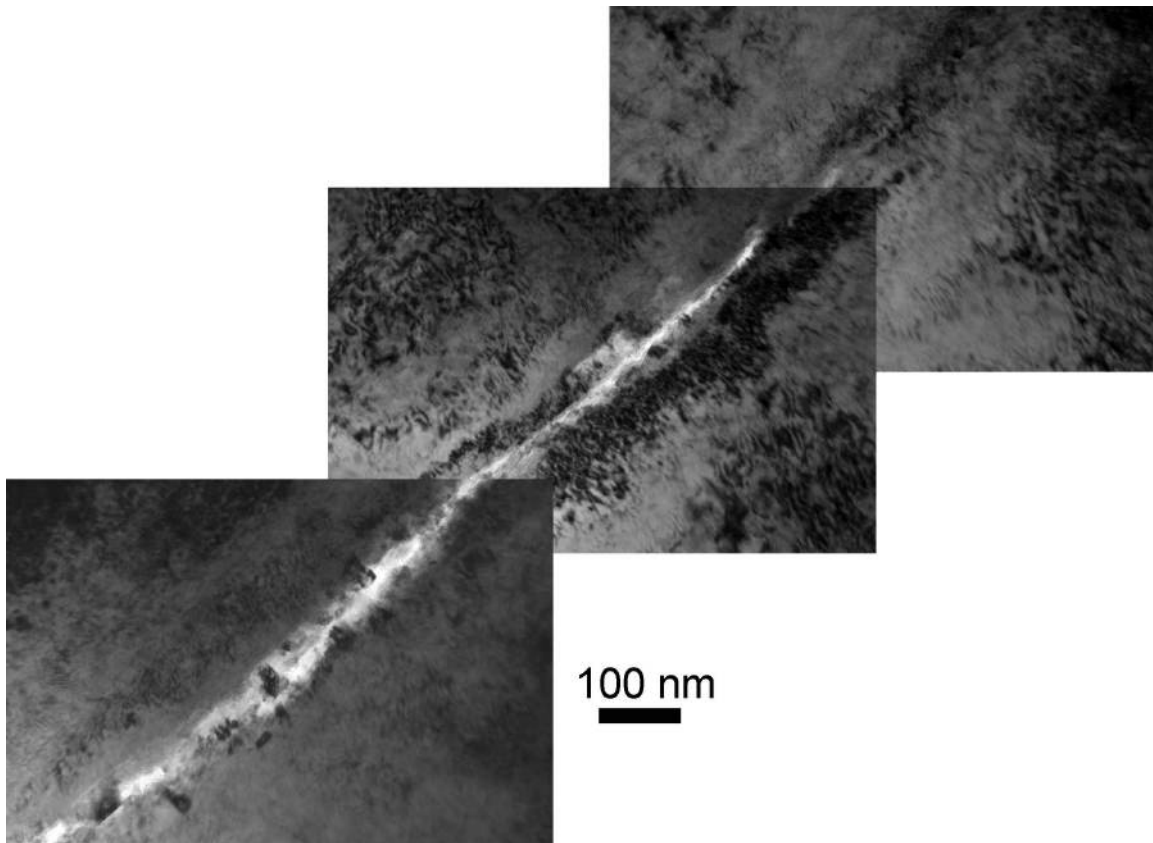
Figure 6.42 SEM (above) and TEM (below) images of a crack tip in the GEG 20%CR alloy 690 specimen CT037.

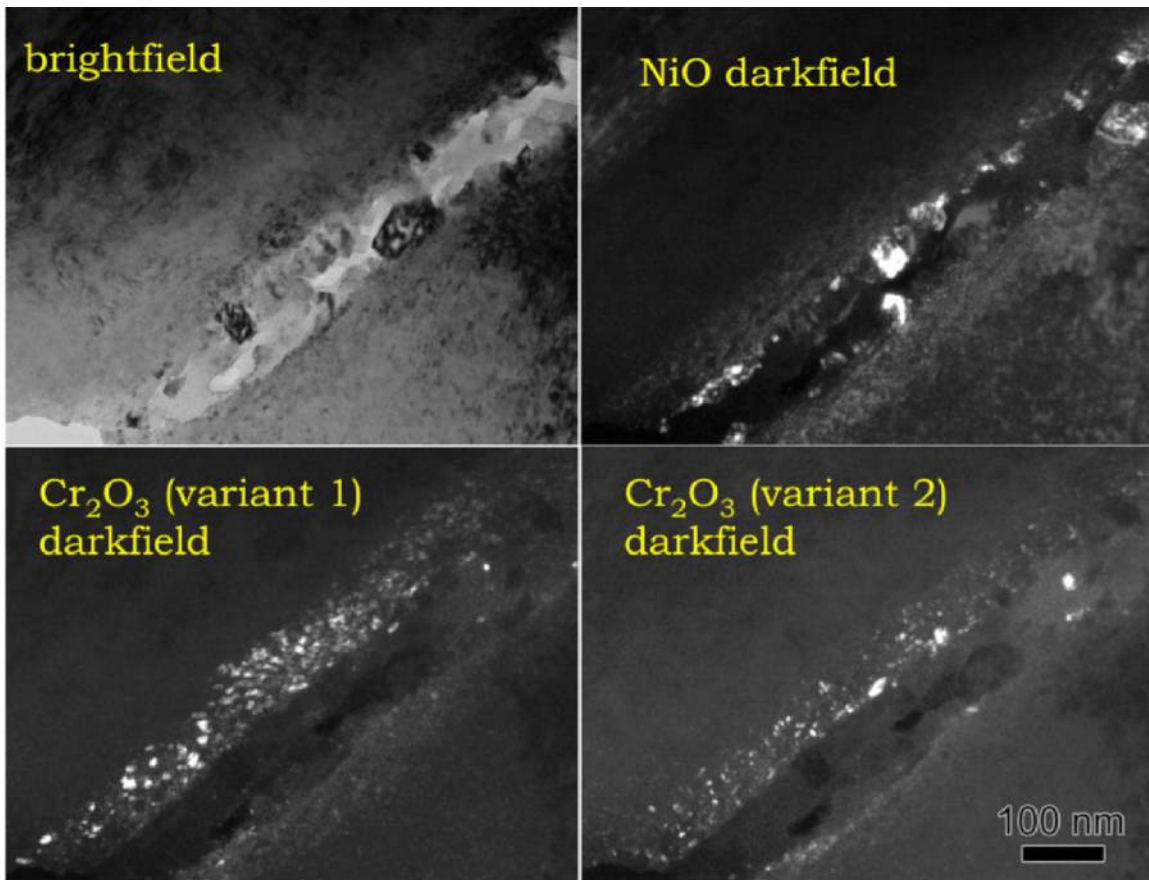
Figure 6.43 TEM brightfield and oxide darkfield images indicating wall oxidation in the crack-tip region from Figure 6.42.
