NUREG/CR-7100
SAND2012-0323P

Direct Current Electrical Shorting in Response to Exposure Fire (DESIREE-Fire): Test Results

Final Report

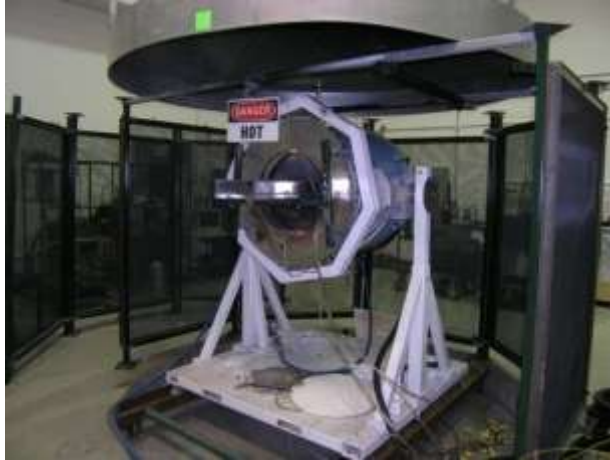
Figure 3-1 The Penlight apparatus

The Penlight apparatus is placed beneath a ventilation hood as shown in Figure 3-1 and uses computer-controlled, water-cooled quartz lamps to heat a stainless steel shroud. The shroud is painted flat-black and acts as a grey-body radiant heating source, re-radiating heat to a test sample located within the shroud. The exposure temperature is controlled and monitored based on thermocouples mounted on the inner surface of the shroud. Penlight creates a primarily radiant heating environment that is analogous to that seen by an object enveloped in a fire-induced hot gas layer. That is, the hot gas layer thermal exposure environment is dominated by radiant heat exchange between the hot, smoke-filled gases and any immersed objects. The hot, smoke-filled gases act largely as a gray-body radiator. Penlight simulates these conditions with the shroud temperature being analogous to the hot gas layer or smoke temperature. From Volume 2 of CAROLFIRE, Table 3-1 provides a summary of the temperatures and corresponding heat fluxes. Additional insights may be gleaned from that report.

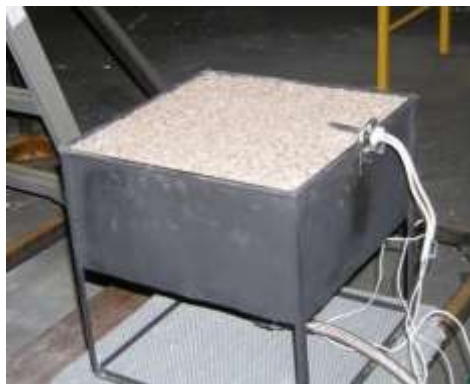
Figure 3-4 Photo of “sand box” diffusion burner

The fires in all intermediate-scale tests were initiated using the same gas burner setup as was used in CAROLFIRE. The fuel in all cases was propene (propylene, C_3H_6). The burner used was a square “sand box” diffusion burner. Figure 3-4 provides a photograph of the burner. The top surface of the burner measured 40cm (15.75in) on a side (outside dimensions).

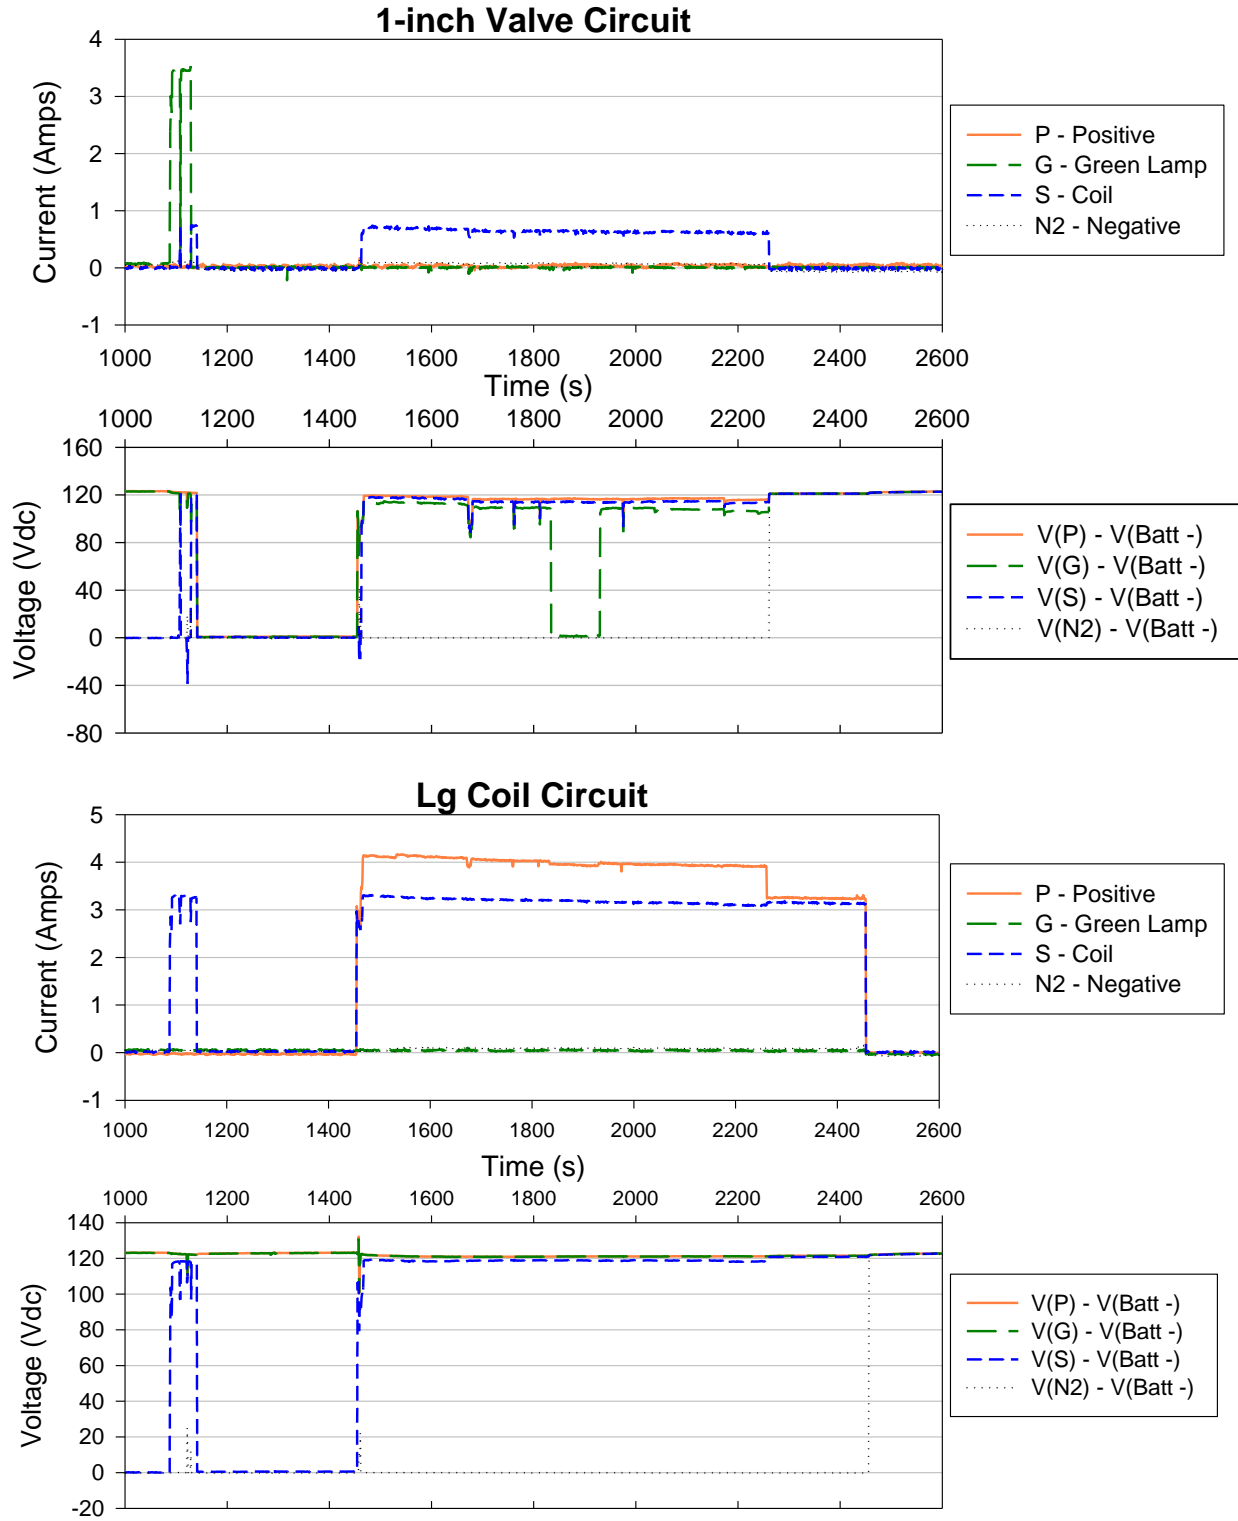
Figure 6-6 Penlight Test #11 1-inch SOV and large coil voltage/current plots

Figure 6-5 through Figure 6-7 provide the temperature profile during Penlight Test #11, the current and voltage response of both circuits during the test, and the behavior of the nominal 125Vdc battery ground monitoring system.

Of the 13 large coil circuit cables tested, five resulted in an initial SA failure while seven were characterized by initially clearing of one or both circuit fuses; no failures occurred during Pre-1 (IS). The longest duration of a spurious large coil actuation occurred during Test IS8, where the event lasted for just less than two minutes. Circuits with an asterisk (*) may have experienced multiple SAs; however, the appropriate appendices should be reviewed for more detailed information on the number of operations and duration of each operation. Additional insights may be gained from Appendix D.

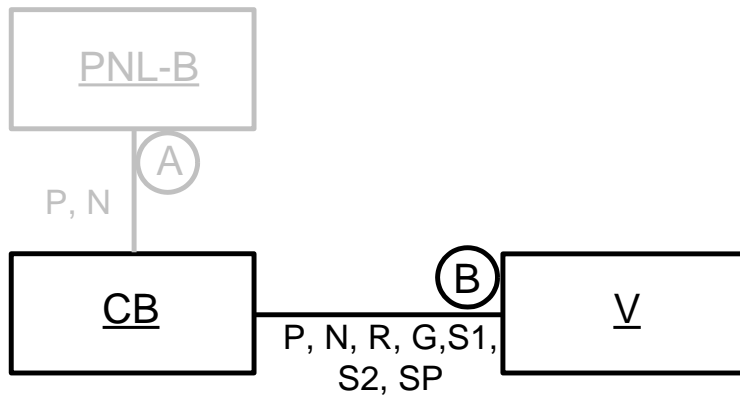
Figure A-10 Block diagram of a small SOV

It is also worthwhile noting that no immediate discernible effect occurs if conductors P, N, S1, S2, or R experience an open circuit failure (conductor break) as the initial failure mode.

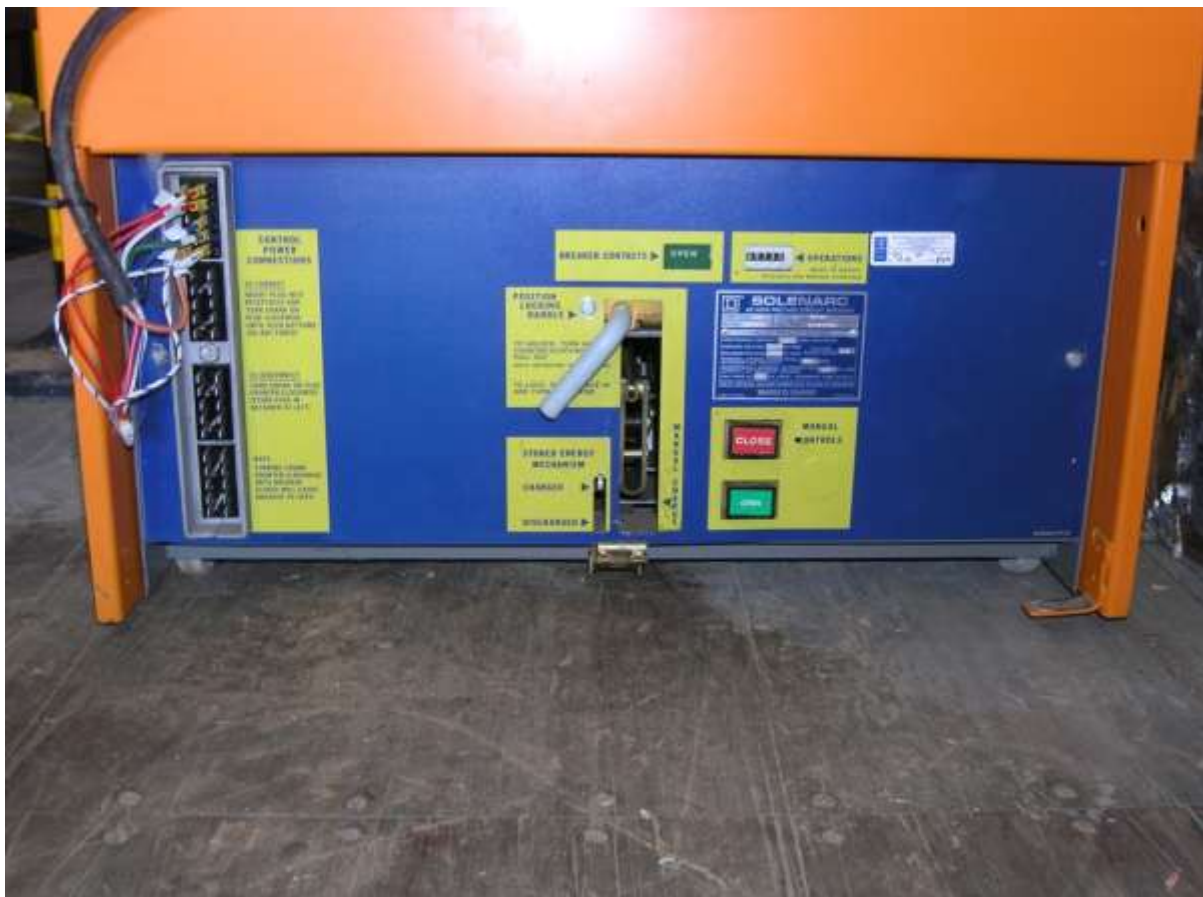
Figure A-41 Front of the switchgear unit. The return cable connections are being made at the left side.

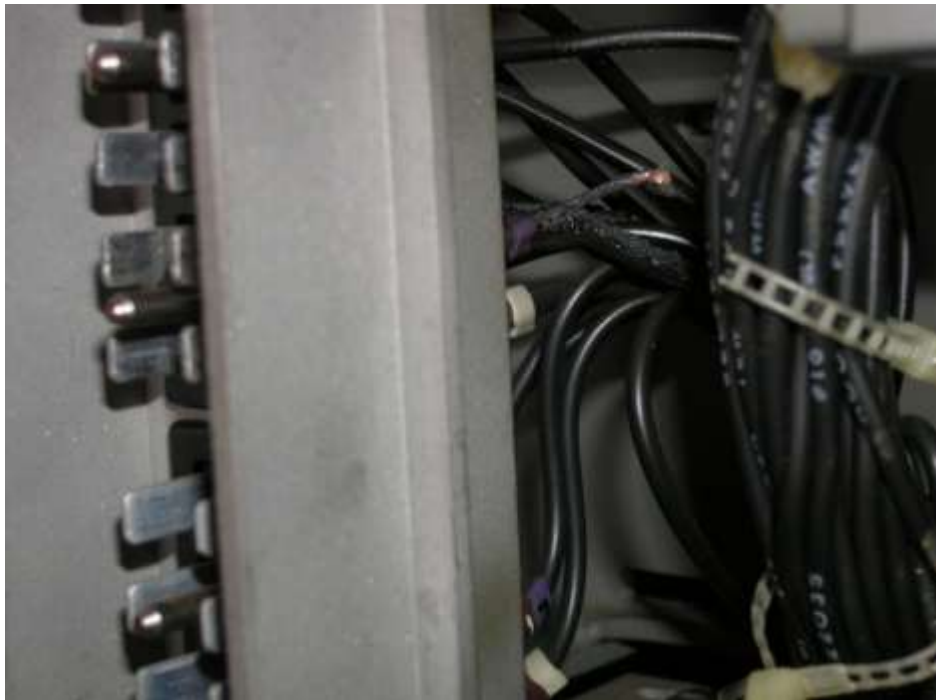
Figure A-42 Damaged panel wires immediately behind the connector block

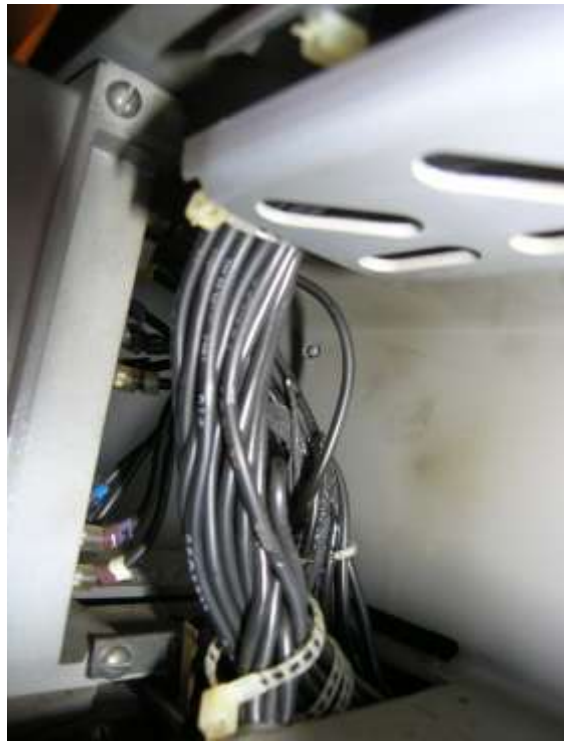
Figure A-44 Damage to some of the wires inside the bundle behind the connector block

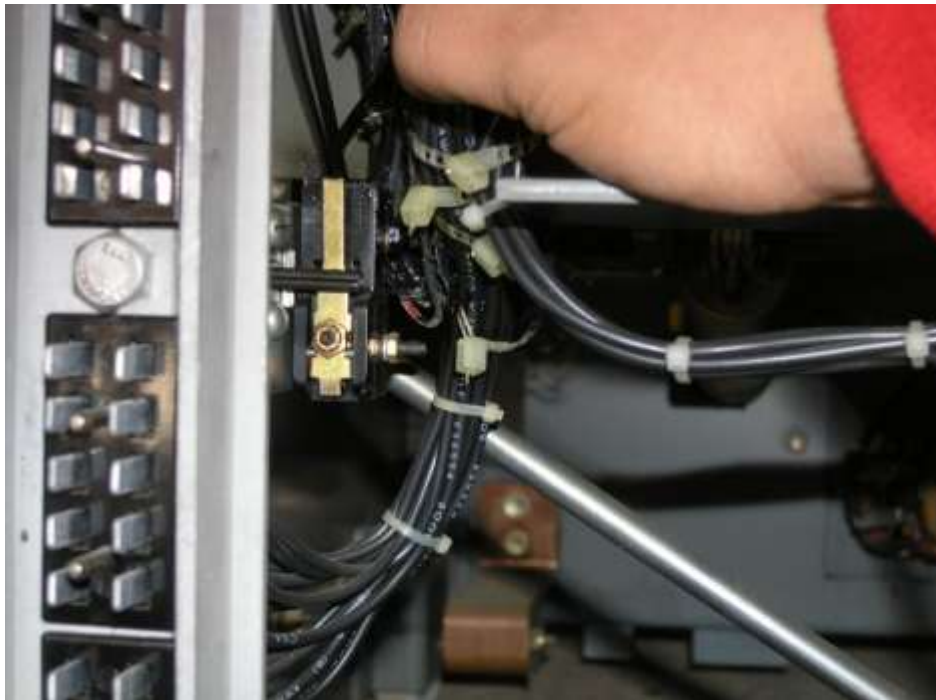
Figure A-46 Another view of damage to the wires located in the wireway between the connector block and the auxiliary contacts

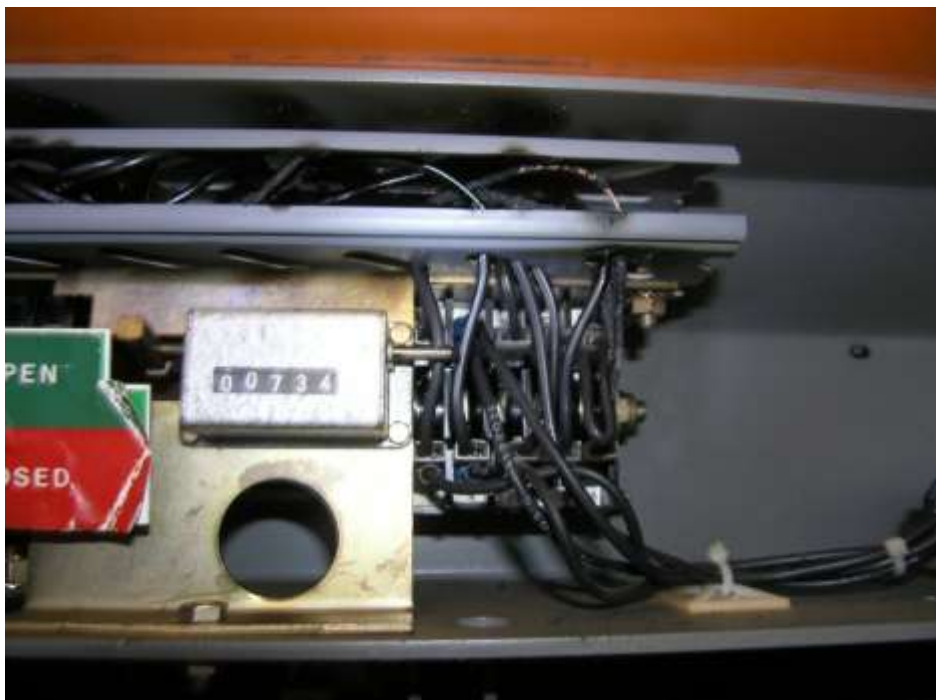
Figure A-47 Panel wire damage near the auxiliary contacts

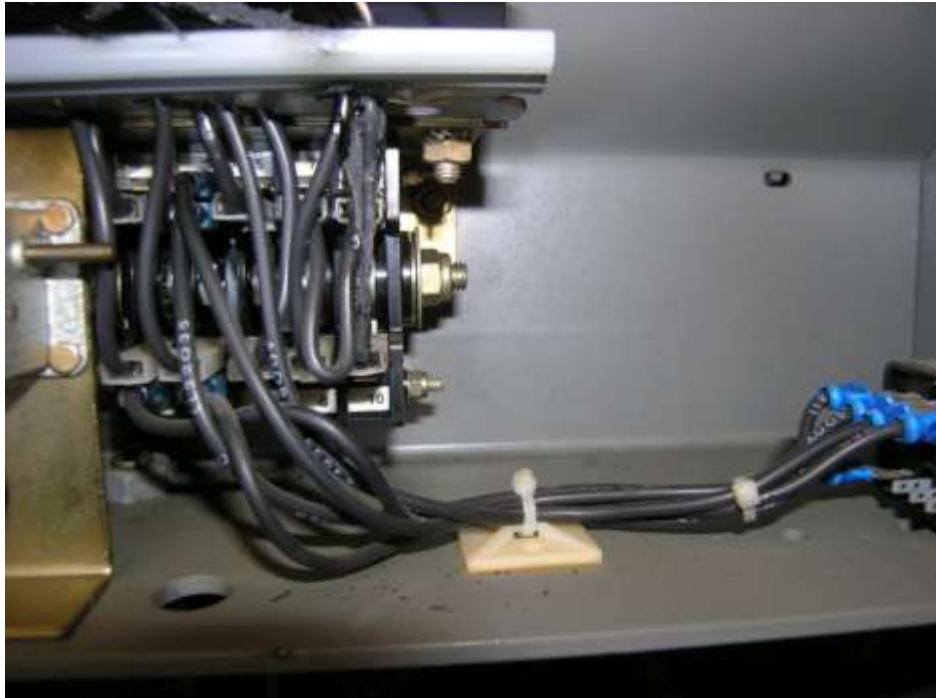
Figure A-48 Panel wire damage at the auxiliary contacts

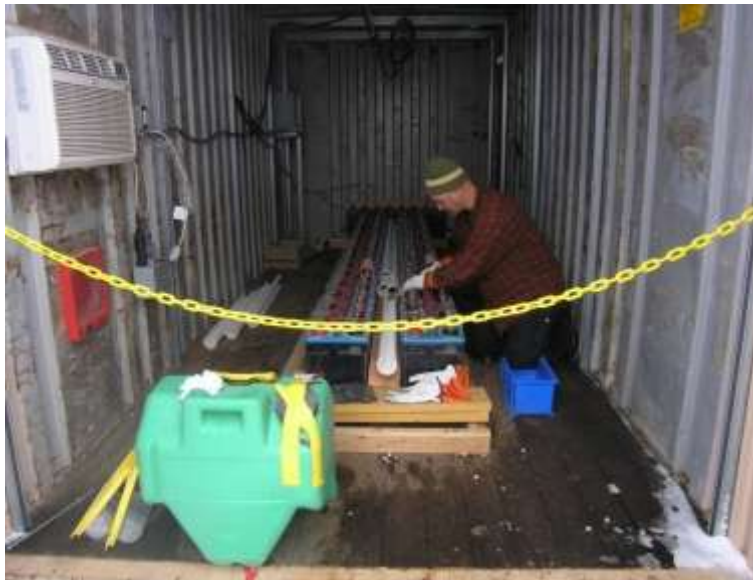
Figure A-66 Photo of the battery assembly

An automatic charging system capable of recharging the cells over night was also installed. The charger was capable of providing both a freshening charge and float charging. All cells received a freshening charge when they arrived at SNL. Once installed, the battery bank also received a freshening charge. The bank was then recharged periodically throughout the course of testing. In general, the bank would be recharged at least weekly during the small-scale tests where the loads on the cells were relatively modest. During the larger--scale tests, the cells would be charged as a minimum after completion of two tests. The charger was secured and disconnected from the battery bank during testing.
