Seismic Walkdown Checklist (SWC)

Equipment ID No.: 1CV02SB

Equipment Description: 1B CENTRIFUGAL CHARGING PUMP GEAR COOLER

Project: Braidwood 1 SWEL

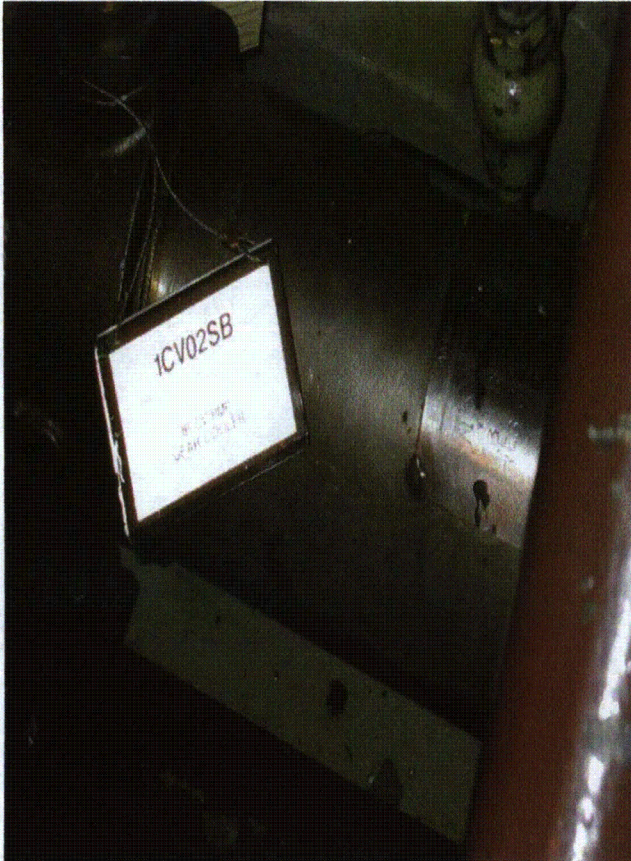
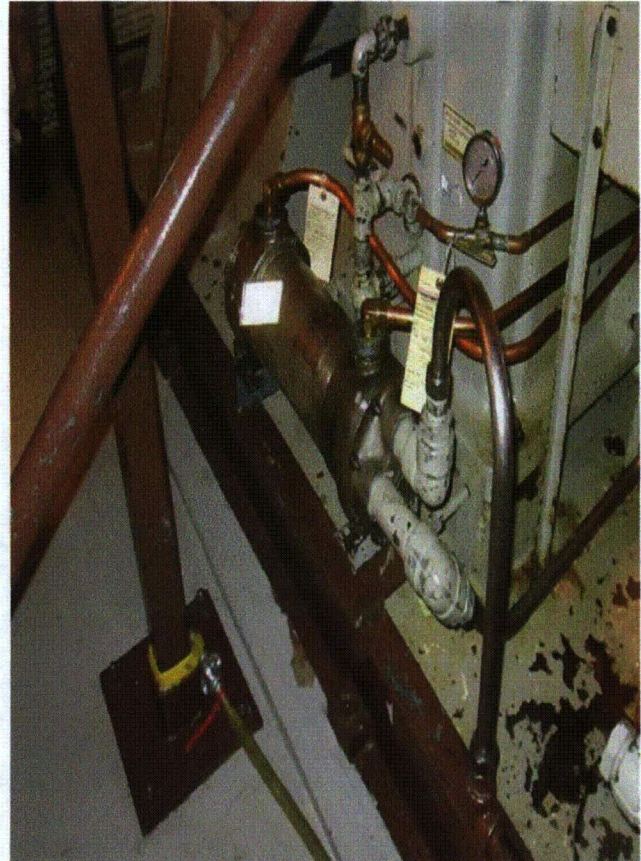
1CV02SB 7-19-12 022

6. Based on the above anchorage evaluations, is the anchorage free of potentially adverse seismic conditions? Yes
*Detail for skid mounting shown on Drawing 5-162-06-018-003 Revision 4.
Well-secured to skid.*

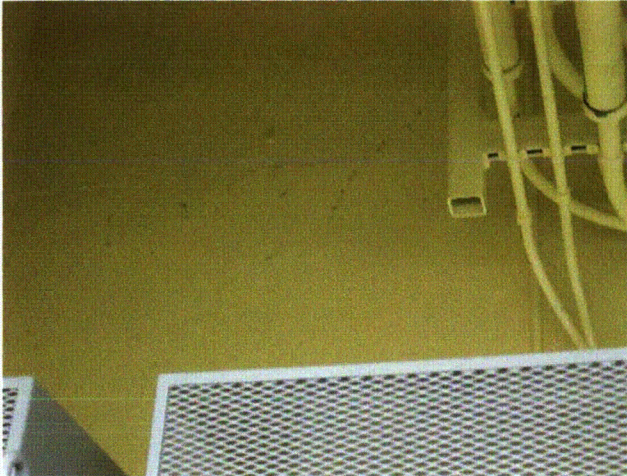
1DC04E (NP 6695 crack) 7-16-12 063

11. Have you looked for and found no adverse seismic conditions that could adversely affect the safety functions of the equipment? Yes
See AWC 8 for discussion on small crack in wall near equipment.

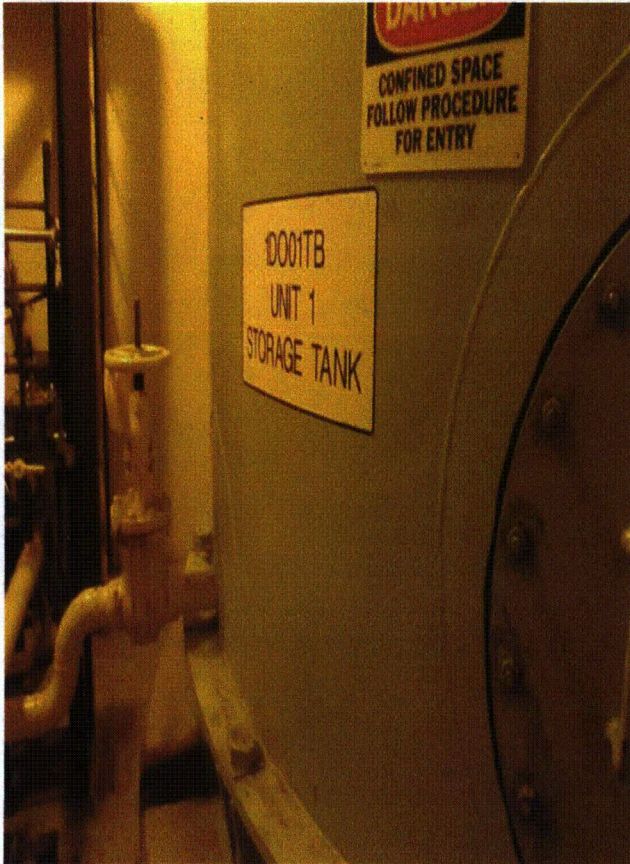
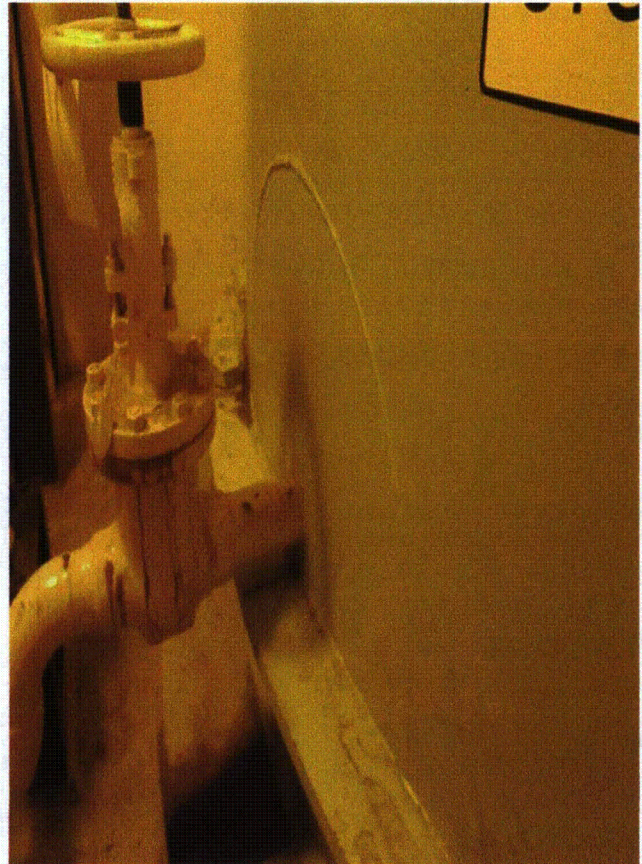
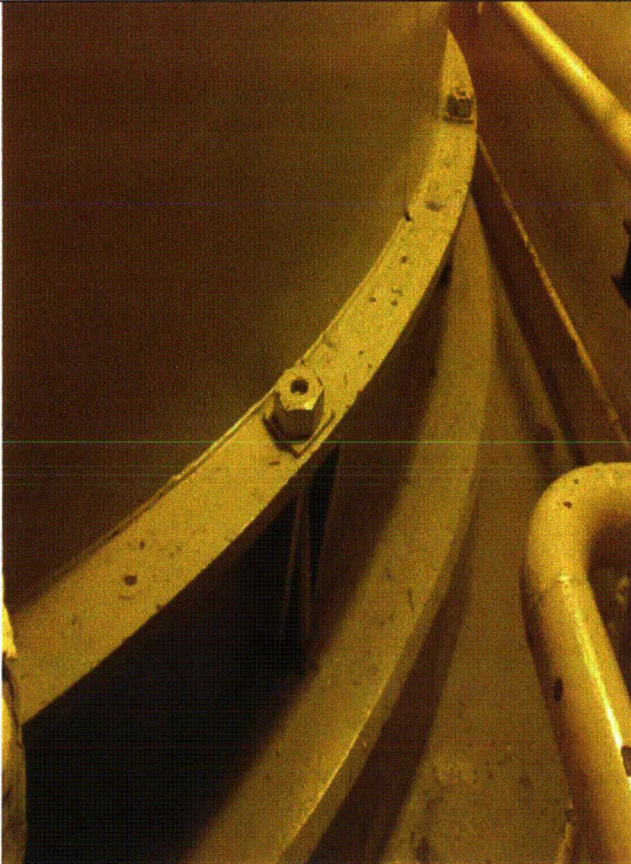
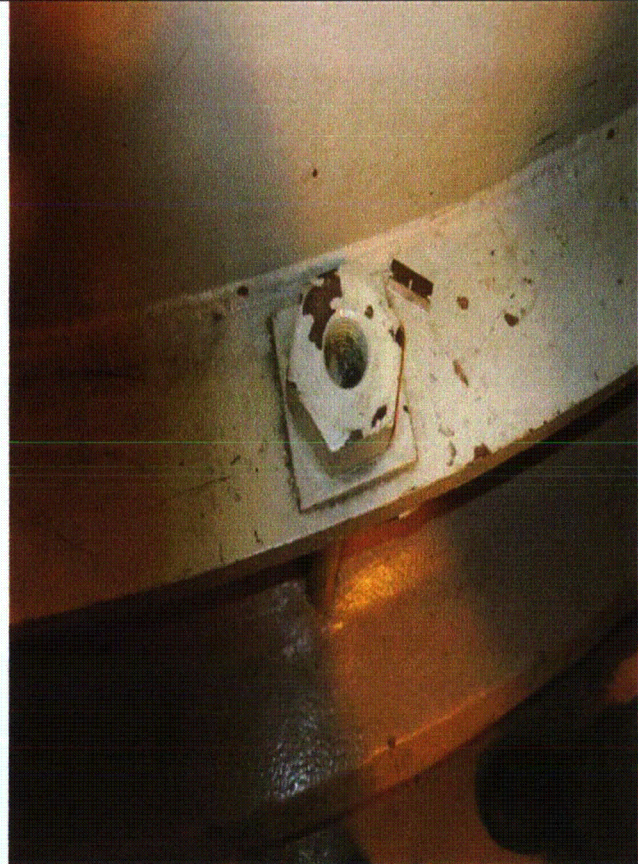
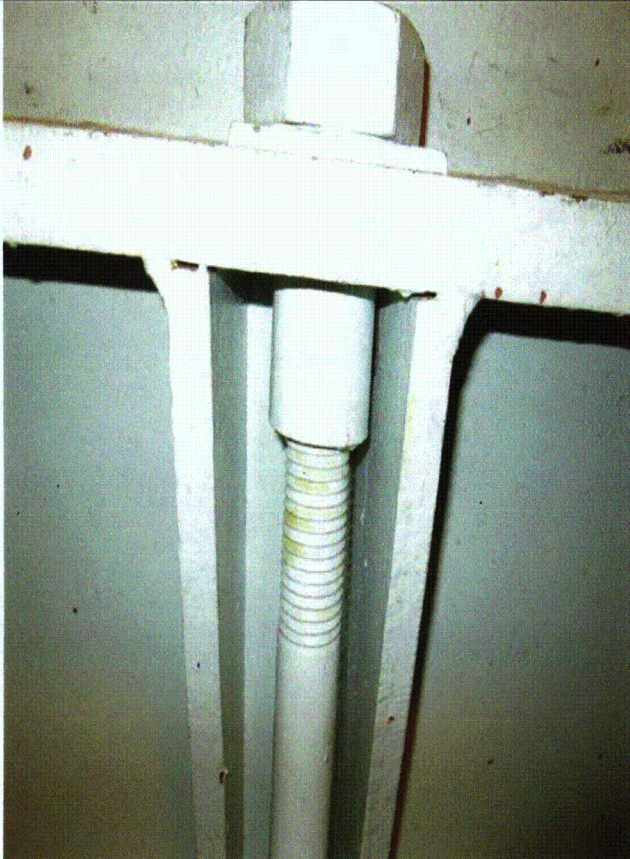
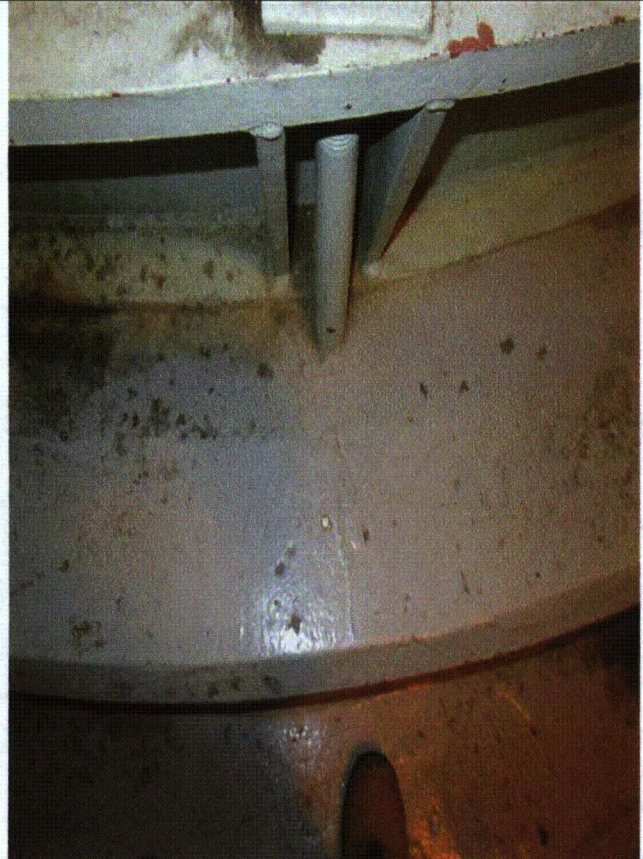
1DO01TB 7-16-12 091

4 of 12 anchor bolts have hairline cracks in the 1'thick foundation pad that do not extend into the base slab. A review of the design drawings was performed. The tank locations are shown on Drawing M-1216 Sheet 1 Revision W. The anchor bolt locations and details are shown on Drawing M-1214 Sheet 3 Revision Z. The anchor bolts are embedded 1'-3 1/2" in the base slab. The approximate total length of the anchor bolts is 3'-9". The pad is shown on section G-G shows a #6 reinforcing bar outside of the anchor bolt that will provide confinement to the anchor.

Since the anchor bolt is founded in the base slab and the pad has reinforcing across the hairline cracks, this cracking is judged to not impact the strength of the anchors. IR 1389743 was written.

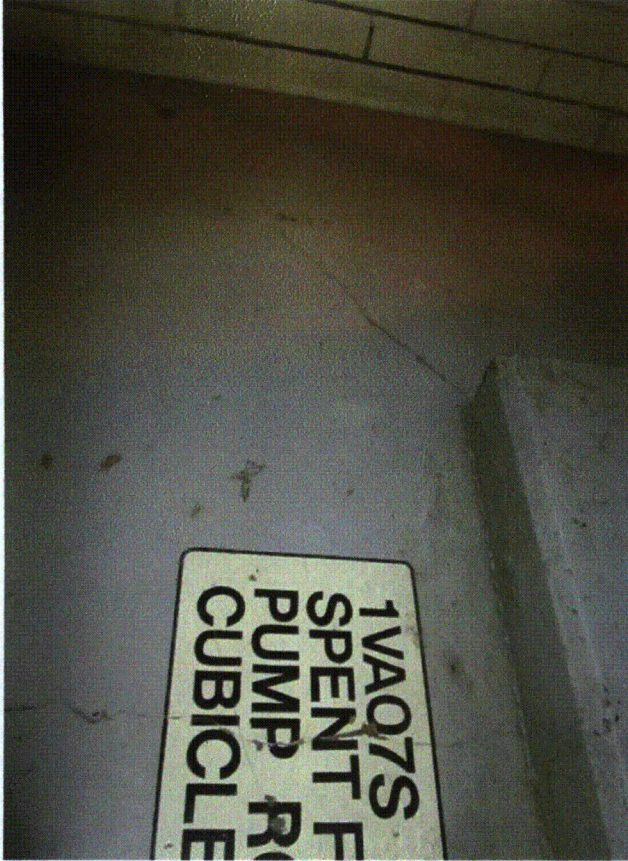
1FC01P (6695 - cracked concrete) 7-18-12 077

11. Have you looked for and found no adverse seismic conditions that could adversely affect the safety functions of the equipment?
Crack in slab - not a structural/seismic issue. Yes
