**ATTACHMENT 3**  
**WALKDOWN CHECKLISTS**

**Seismic Walkdown Checklist (SWC)**

Project: CCNPP 2 SWEL

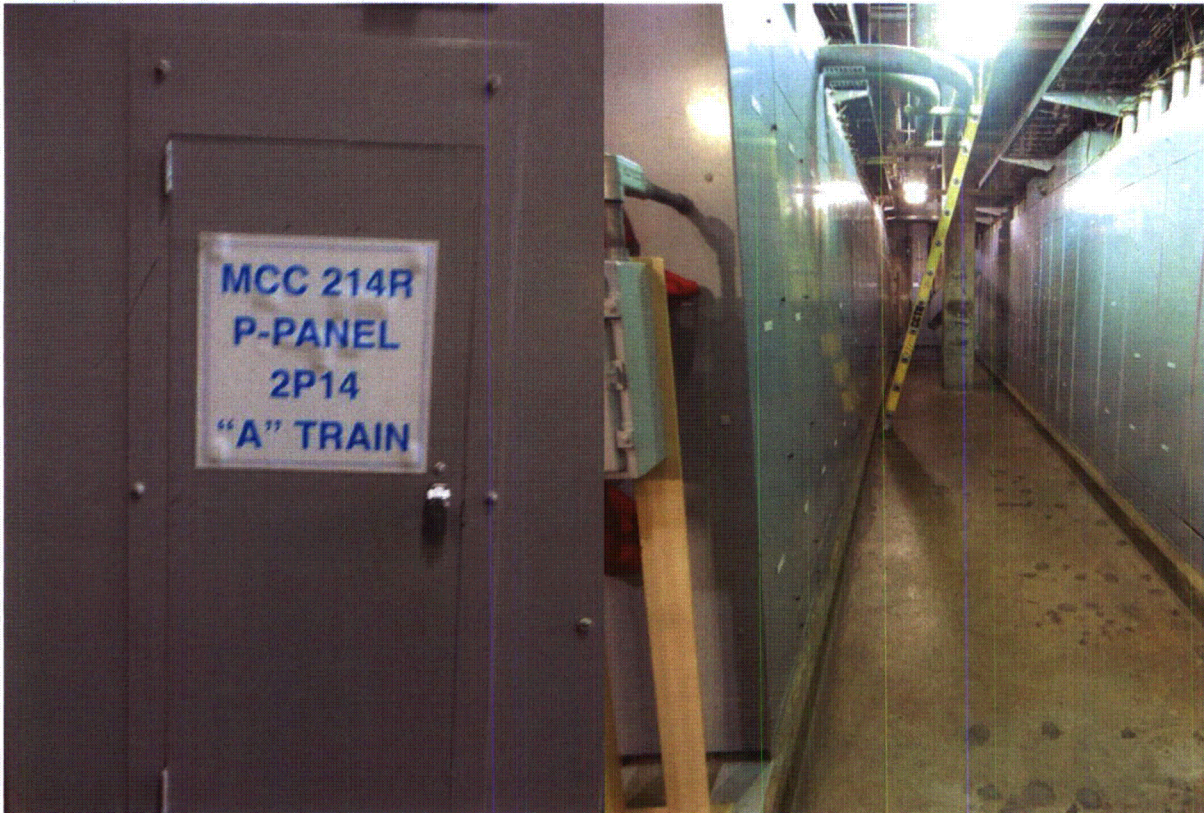
2MCC214R 8-9-12 095

*According to CCNPP personnel, the MCC is also unknown as MCC-2B004 and the walkdown noted panel 2P14 within the MCC. Anchorage is consistent with calculation CA02066 Section 21.*

*There are heaters that are 6' and 8' from MCC. Their valves have sufficient gap approximately 2" from any impact hazard and the heaters have adequate vertical support, therefore judged not to be a seismic concern.*
