ATTACHMENT 3
WALKDOWN CHECKLISTS

Seismic Walkdown Checklist (SWC)

Project: CCNPP 2 SWEL

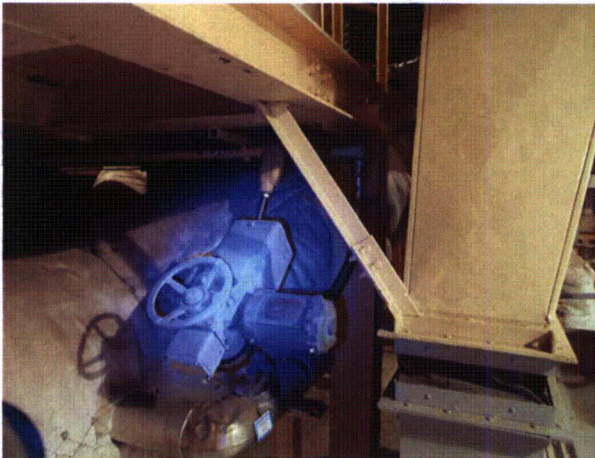
6. Based on the above anchorage evaluations, is the anchorage free of potentially adverse seismic conditions? Yes
Tubing support approximately 5' from valve
Valve 1/2" from steel pipe well supported in subject direction
Floor crack, dented jacket on floor piping

7. Are soft targets free from impact by nearby equipment or structures? Yes
There is a 1/2" gap between the valve and nearby steel, the pipe is adequately supported in the subject direction, judged not to be a seismic hazard.
8. Are overhead equipment, distribution systems, ceiling tiles and lighting, and masonry block walls not likely to collapse onto the equipment? Yes
9. Do attached lines have adequate flexibility to avoid damage? Yes
Tubing is supported 5' from valve and is judged to have adequate flexibility.
10. Based on the above seismic interaction evaluations, is equipment free of potentially adverse seismic interaction effects? Yes
-

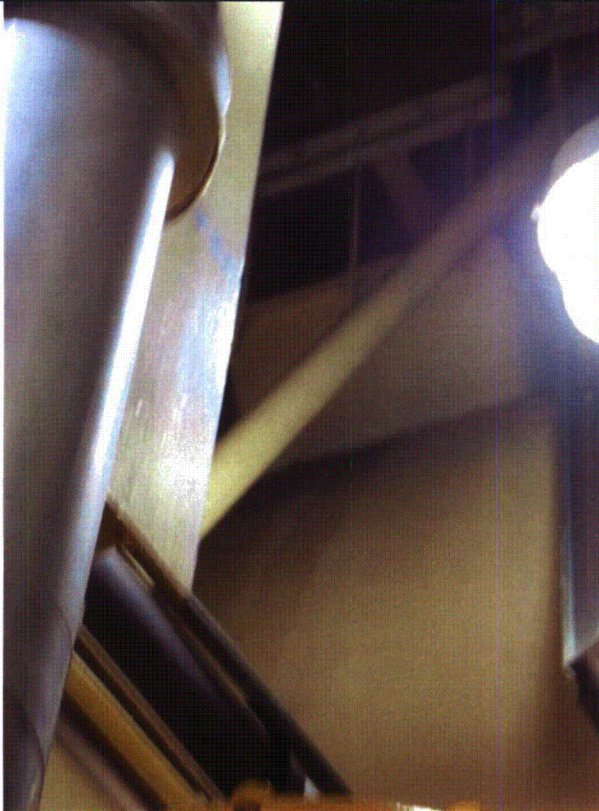
2FANHVACEDGS2A 8-13-12 216

2. Is the anchorage free of bent, broken, missing or loose hardware? Yes
Fan is on vibration isolator (springs). Isolator is judged not to be a seismic concern.
