WALKDOWN CHECKLISTS

Seismic Walkdown Checklist (SWC)

Project: CCNPP 2 SWEL

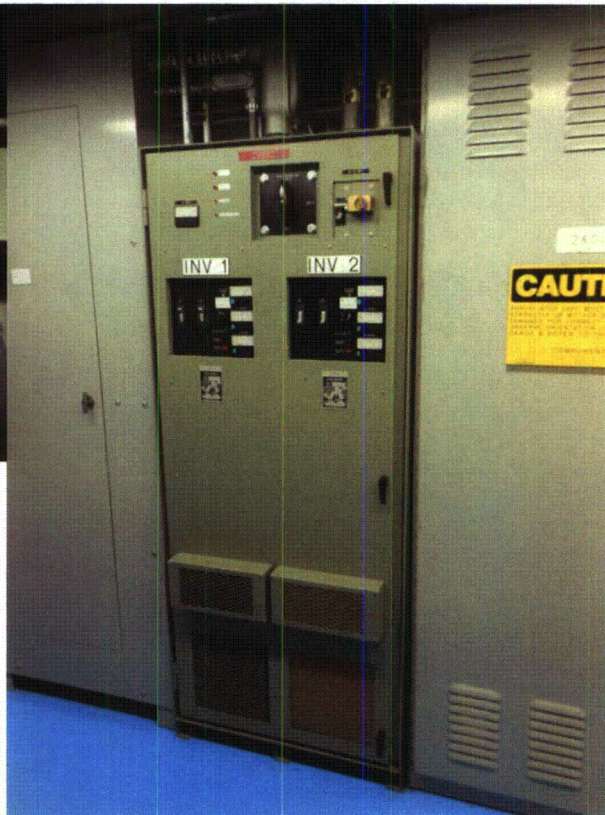
2RY2Y03A#64#B23 8-14-12 030

11. Have you looked for and found no adverse seismic conditions that could adversely affect the safety functions of the equipment? No
- Cabinet is inaccessible for internal inspection.*
-
