ATTACHMENT 3
WALKDOWN CHECKLISTS

Seismic Walkdown Checklist (SWC)

Project: CCNPP 2 SWEL

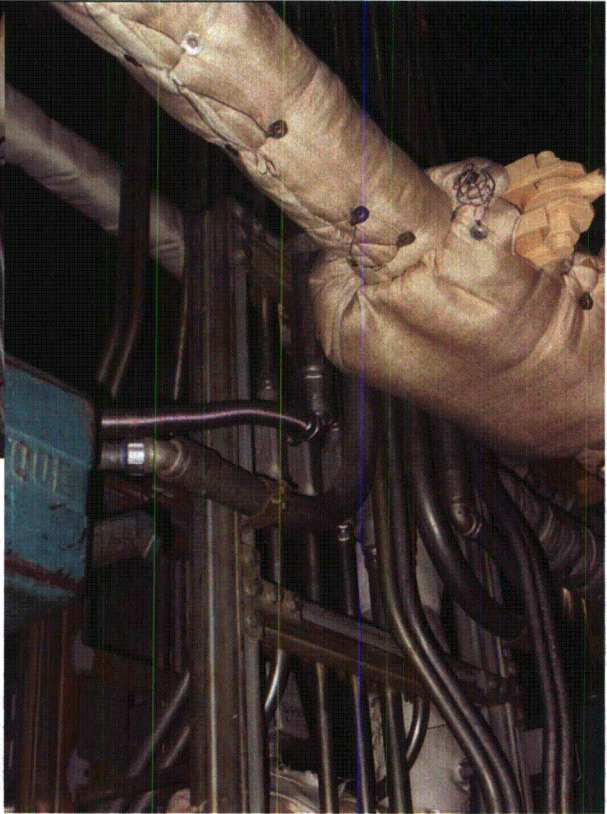
2MOV508 8-6-12 072

7. Are soft targets free from impact by nearby equipment or structures? Yes
- Operator is in close proximity to pipe, i.e. touching insulation. The pipe is part of valve's piping system, therefore minimal differential motion expected. Judged not a seismic concern.*
- Also, a unistrut frame is touching the top of a horizontal valve component, the condition may cause some scrapping, but judged not a seismic concern.*
8. Are overhead equipment, distribution systems, ceiling tiles and lighting, and masonry block walls not likely to collapse onto the equipment? Yes
9. Do attached lines have adequate flexibility to avoid damage? Yes
10. Based on the above seismic interaction evaluations, is equipment free of potentially adverse seismic interaction effects? Yes
-

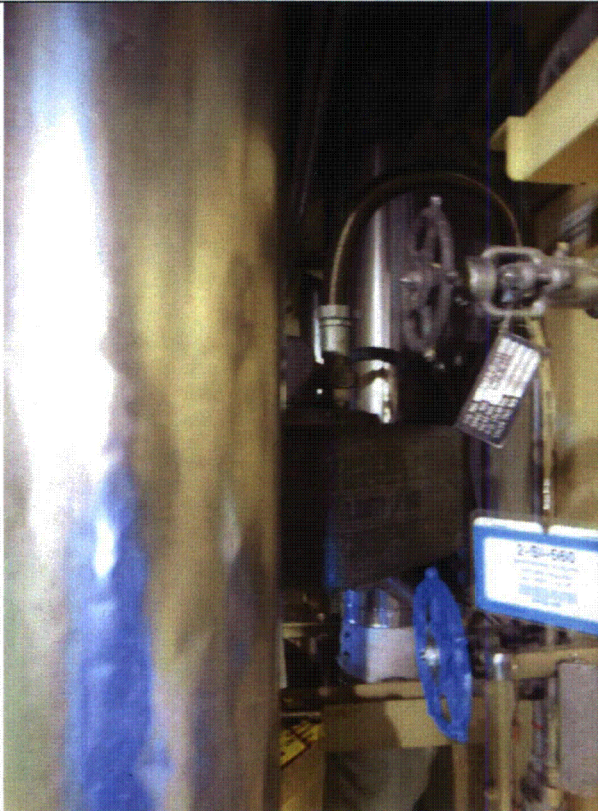
2MOV615 8-7-12 135

7. Are soft targets free from impact by nearby equipment or structures? Yes
Flexible hose is behind the pipe and in direct contact with the isolation jacket. Piping is restrained from movement by lugs, therefore judged not a seismic concern.
8. Are overhead equipment, distribution systems, ceiling tiles and lighting, and masonry block walls not likely to collapse onto the equipment? Yes
9. Do attached lines have adequate flexibility to avoid damage? Yes
10. Based on the above seismic interaction evaluations, is equipment free of potentially adverse seismic interaction effects? Yes
-

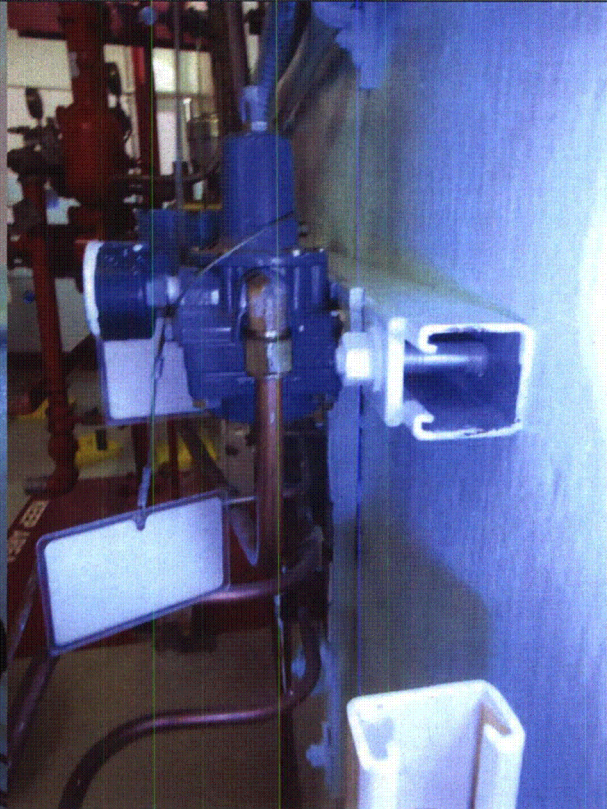
2PCV3939A 8-8-12 127

6. Based on the above anchorage evaluations, is the anchorage free of potentially adverse seismic conditions? Yes
Device is mounted to unistrut by 2-7/16 F-F bolts head and the unistrut stitch-welded to steel pipe support.

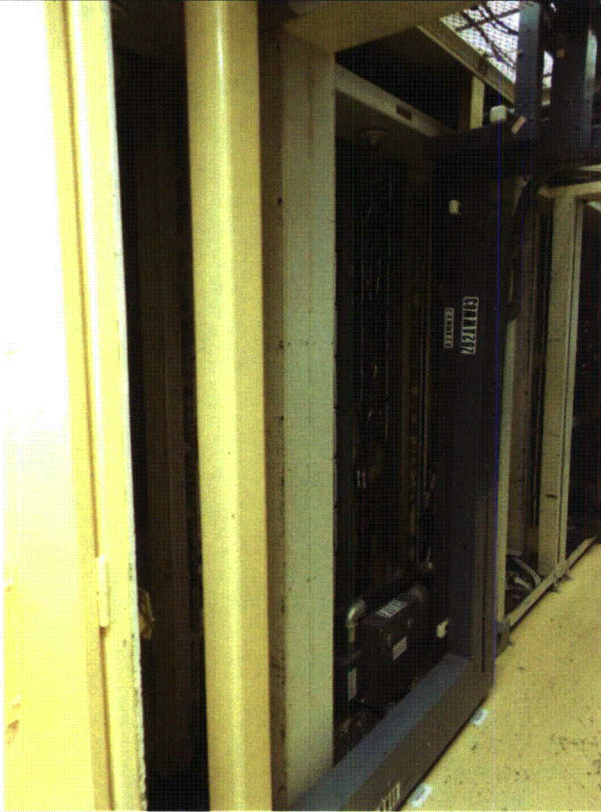
2PNL2C08 8-14-12 178

7. Are soft targets free from impact by nearby equipment or structures? Yes
8. Are overhead equipment, distribution systems, ceiling tiles and lighting, and masonry block walls not likely to collapse onto the equipment? Yes
Observed a drop ceiling and light diffuser ceiling.
10/3/12 - The control room ceiling has been previously evaluated by CCNPP and was determined to not be a credible seismic concern.

Observed a masonry block wall behind the panels. The block wall, identified as AA on drawing A-259, is safety-related and thus seismically rated per IE Bulletin 80-11.
9. Do attached lines have adequate flexibility to avoid damage? Yes
10. Based on the above seismic interaction evaluations, is equipment free of potentially adverse seismic interaction effects? Yes
-

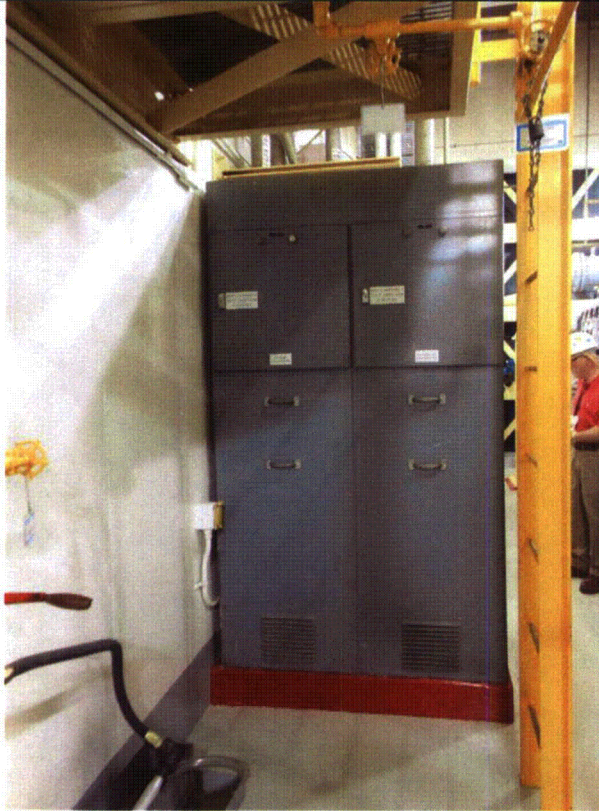
2PNL2C61B 8-13-12 059

2. Is the anchorage free of bent, broken, missing or loose hardware? No
Anchorage is inaccessible.
