ATTACHMENT 3
WALKDOWN CHECKLISTS

Seismic Walkdown Checklist (SWC)

Project: CCNPP 2 SWEL

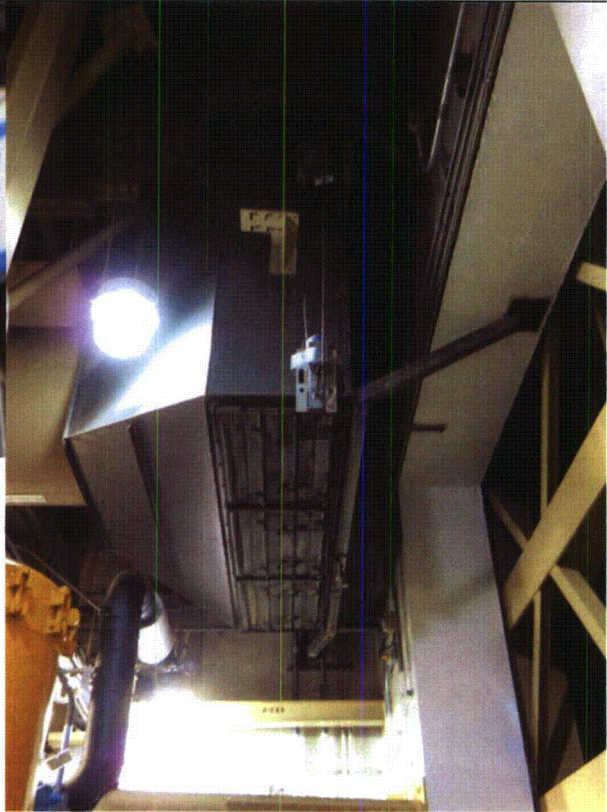
2PO5430 8-13-12 228

5. Is the anchorage configuration consistent with plant documentation? (Note: This question only applies if the item is one of the 50% for which an anchorage configuration verification is required.) No
Need plant documentation to determine if anchorage is consistent with as-built sketch. CR-2012-009778

6. Based on the above anchorage evaluations, is the anchorage free of potentially adverse seismic conditions? No
Need plant documentation to determine if anchorage is consistent with as-built sketch.

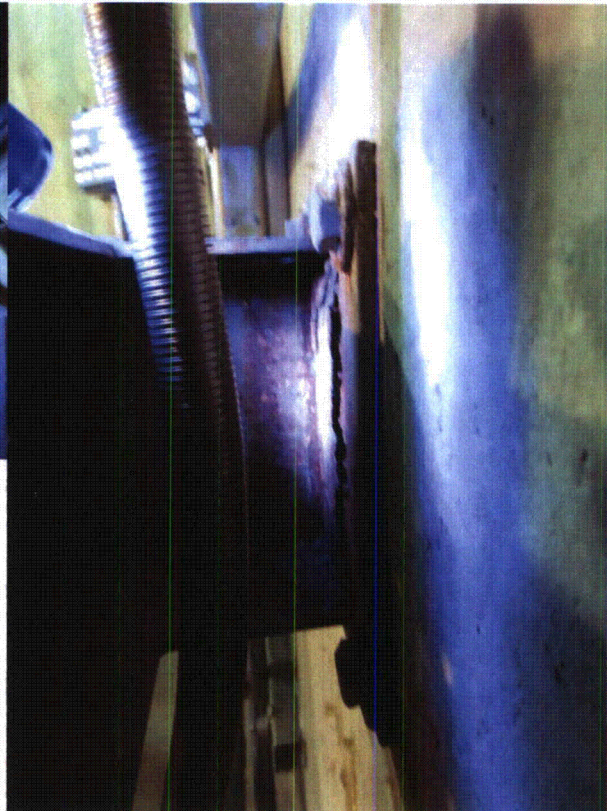
2PT5313A 8-7-12 035

2. Is the anchorage free of bent, broken, missing or loose hardware? No
Missing anchor bolt washer. CR-2012-009624

3. Is the anchorage free of corrosion that is more than mild surface oxidation? No
*Corrosion and oxidation on Anchor Bolt and plate.
Base plate is flaking on both sides. CR-2012-009622*

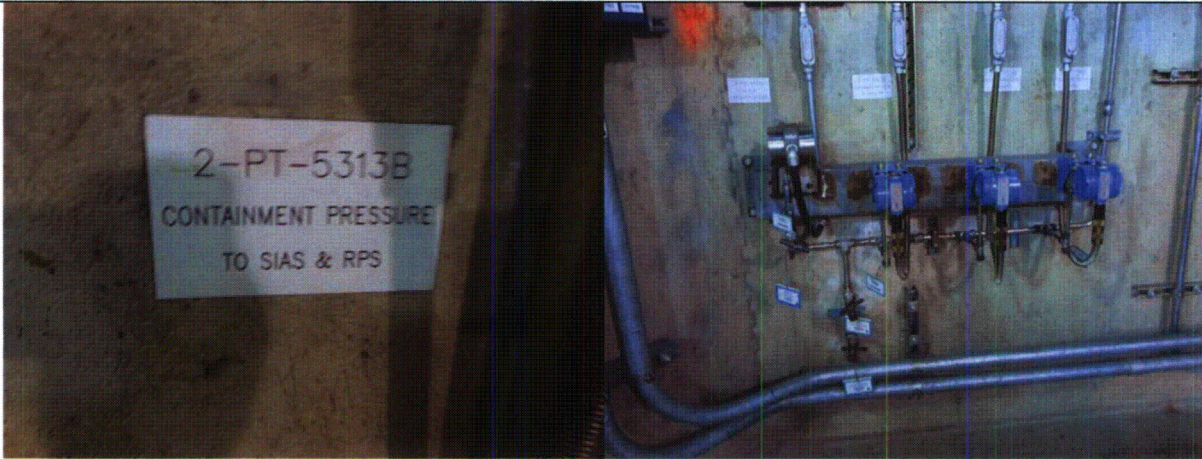
2PT5313B 8-7-12 037

2. Is the anchorage free of bent, broken, missing or loose hardware? No
*Bottom bolts on right side not engaged.
Only 3" long weld on vertical side of channel, not fully welded as shown on typical detail. CR -2012-009754*
3. Is the anchorage free of corrosion that is more than mild surface oxidation? Yes

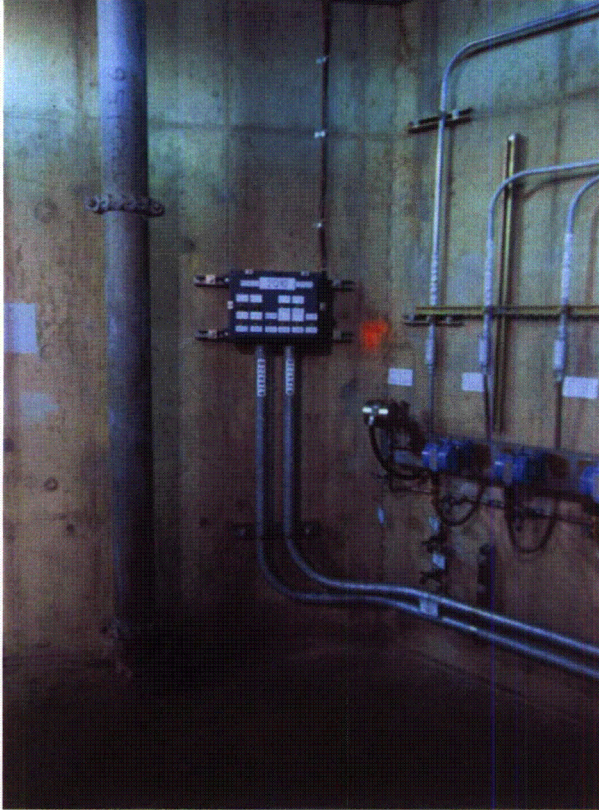
2PT5313B 8-7-12 047

6. Based on the above anchorage evaluations, is the anchorage free of potentially adverse seismic conditions? No

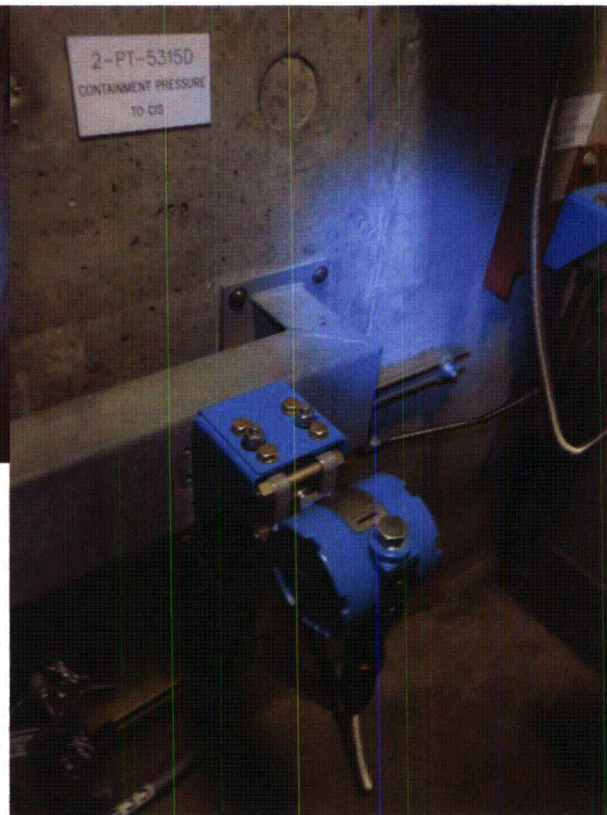
2PT5315D 8-7-12 069

4. Is the anchorage free of visible cracks in the concrete near the anchors? Yes
There are no cracks in concrete, but there are cracks and chips in grout. This condition is judged not to adversely affect the anchorage.
