**Seismic Walkdown Checklist (SWC)**

Project: Byron 1 SWEL

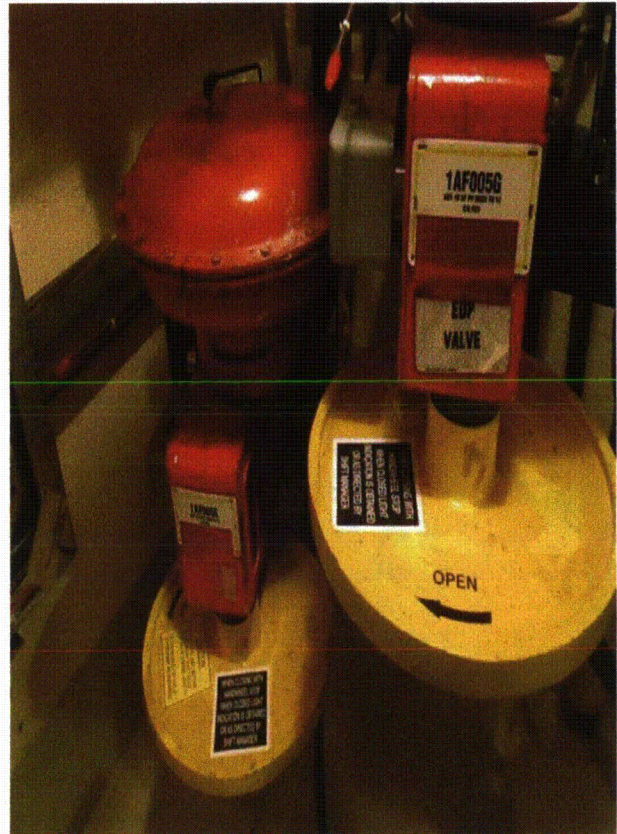
1AF005E Byron 1 & 2 8-10-12 001

7. Are soft targets free from impact by nearby equipment or structures? Yes  
*Clearance between Valve 1AF005E diaphragm enclosure and adjacent Valve 1AF005G is relatively large and not an issue (~3/4" horizontal and 1 1/2" vertical).*
8. Are overhead equipment, distribution systems, ceiling tiles and lighting, and masonry block walls not likely to collapse onto the equipment? Yes
9. Do attached lines have adequate flexibility to avoid damage? Yes
10. Based on the above seismic interaction evaluations, is equipment free of potentially adverse seismic interaction effects? Yes

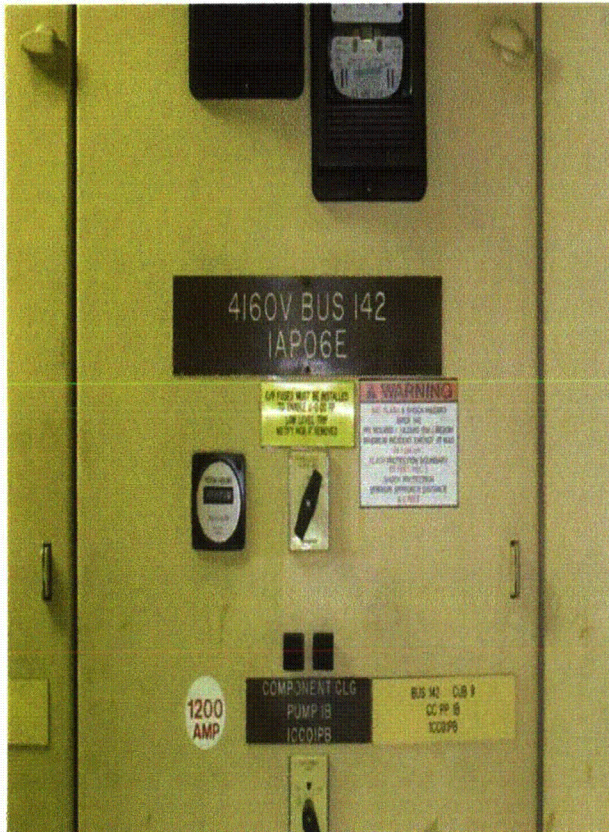
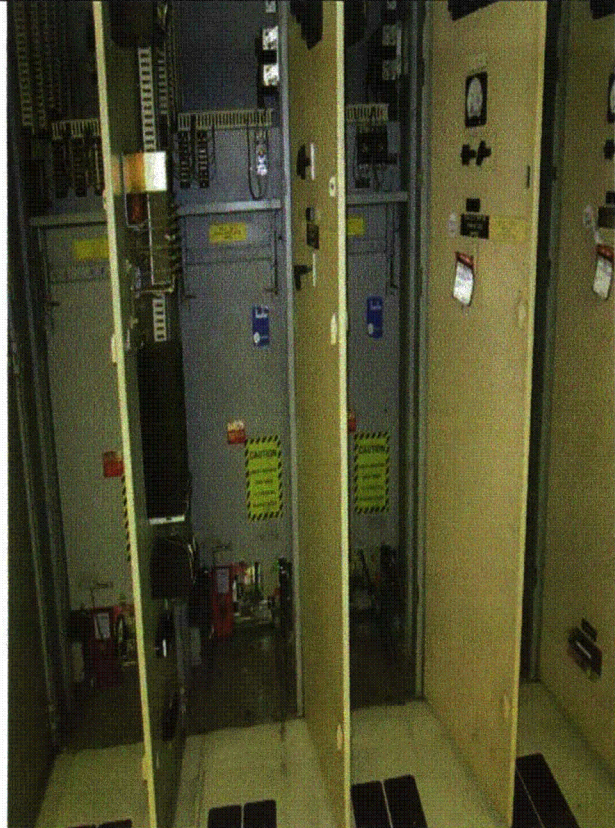
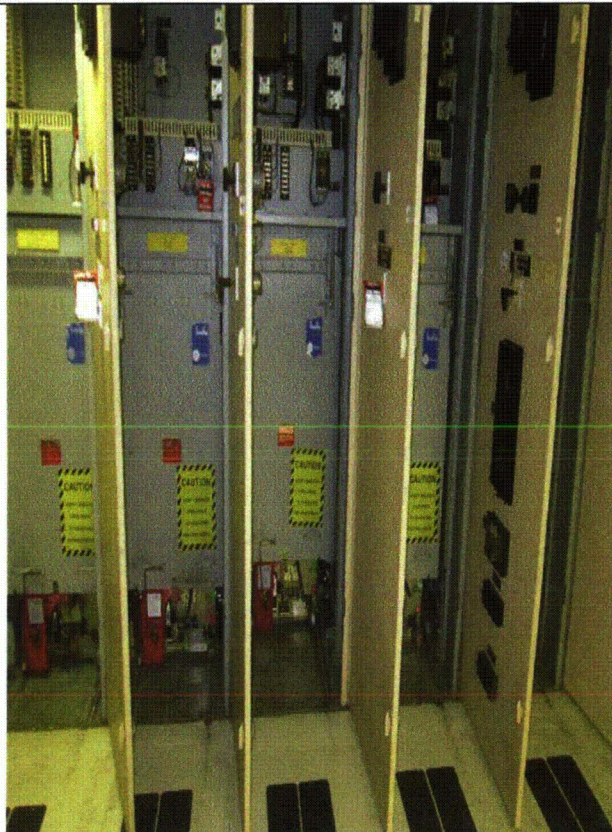
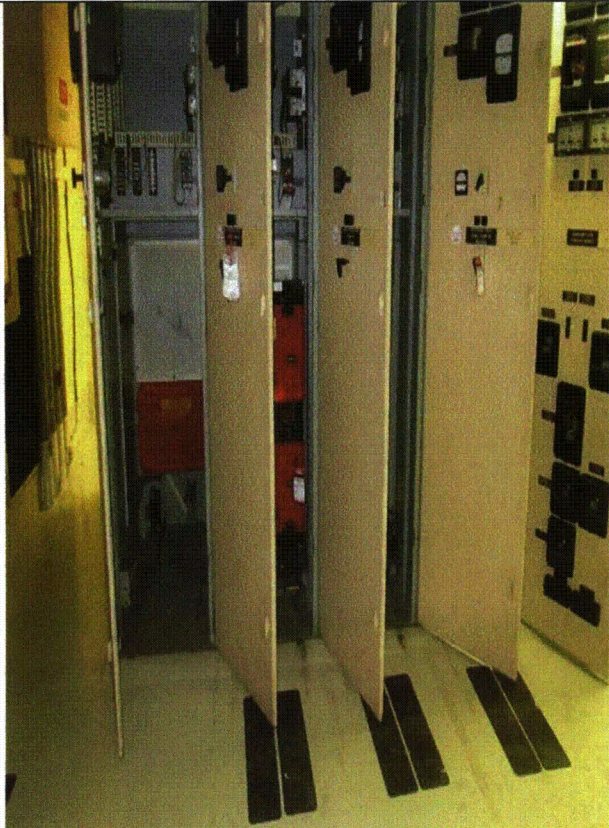
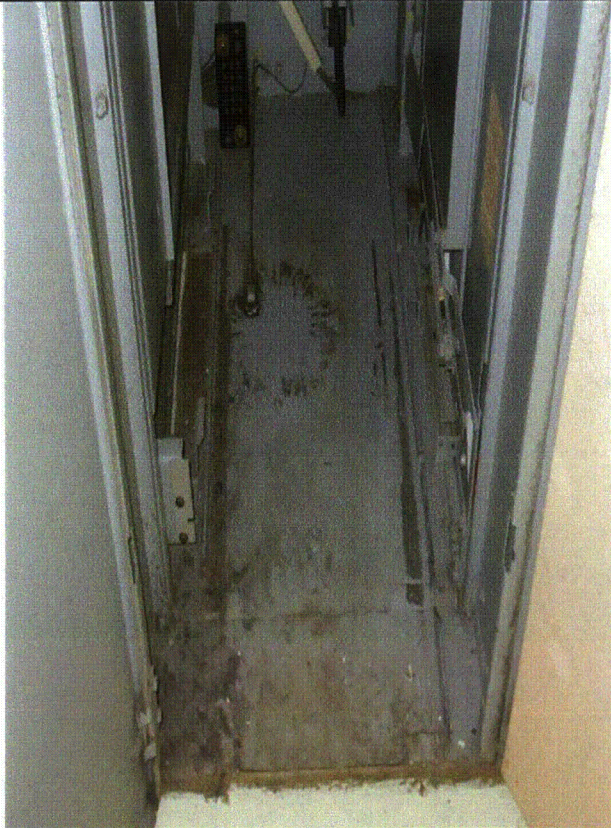
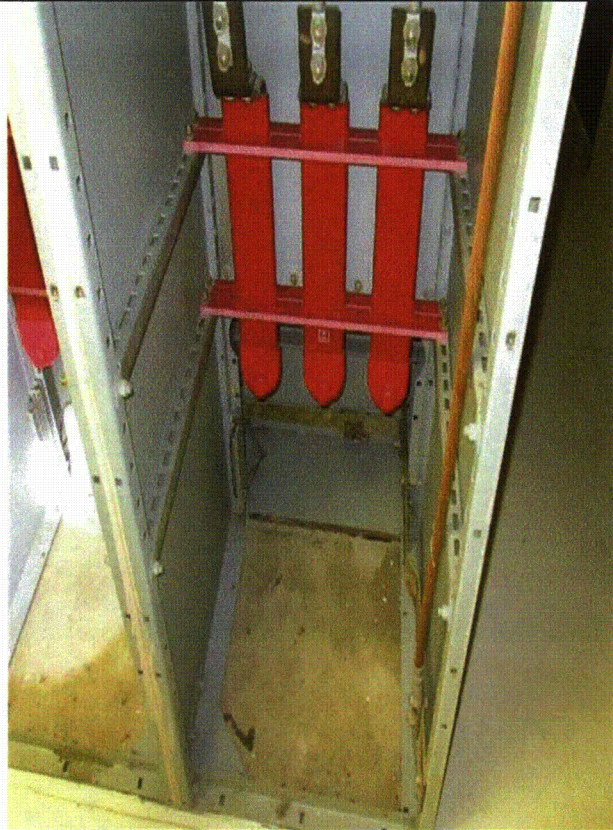
1AP06E Byron - de-energized Equip 9-22-12 001

4. Is the anchorage free of visible cracks in the concrete near the anchors? Yes  
*Minor shrinkage cracking in floor judged to be acceptable.*

*19 total cubicles. All front doors were opened. All front anchorages were observed.*

*All lower back panels were opened except for 5 cubicles due to electrical limitations. All back anchorages for the 14 opened cubicles were observed.*

*The middle anchorages at 5 cubicles were observed.*

- 11. Have you looked for and found no adverse seismic conditions that could adversely affect the safety functions of the equipment? Yes  
*All front cubicle doors were opened. All rear back panels except for 5 were opened. No other adverse conditions were observed.*

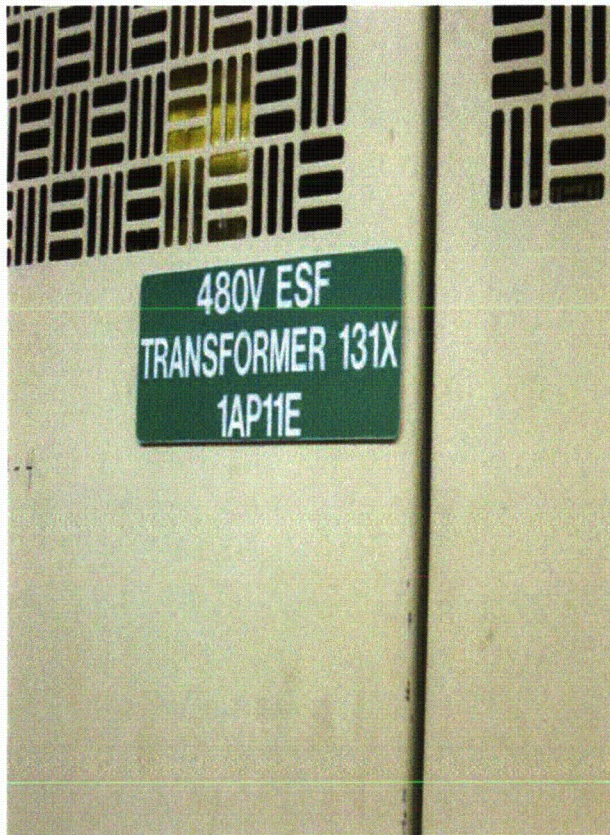
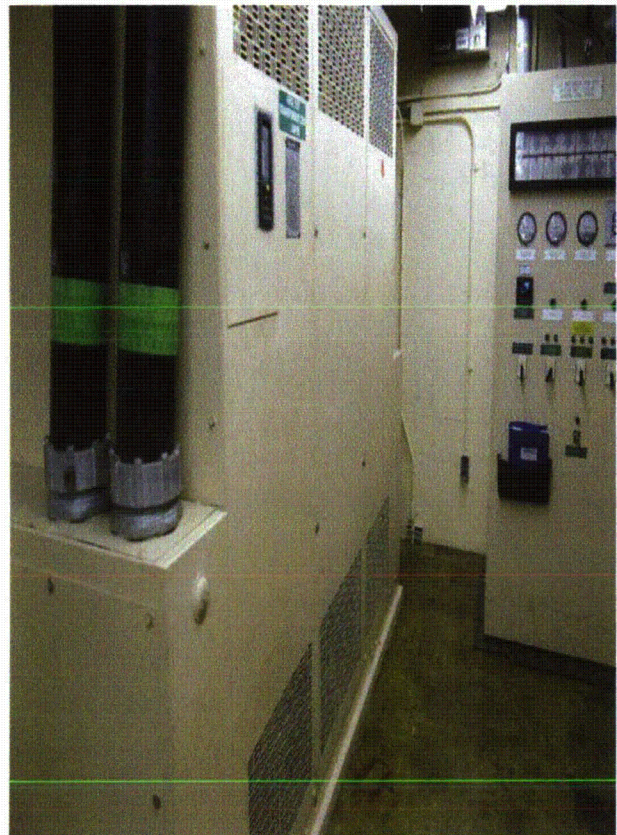
1AP11E Byron 1 & 2 8-8-12 032

11. Have you looked for and found no adverse seismic conditions that could adversely affect the safety functions of the equipment? Yes  
*Front panel bent due to equipment configuration and is not a structural/seismic concern*  
*Missing bolts (2) on panel cover - IR 1398659 written. Not a structural/seismic issue since adequate bolts in place*

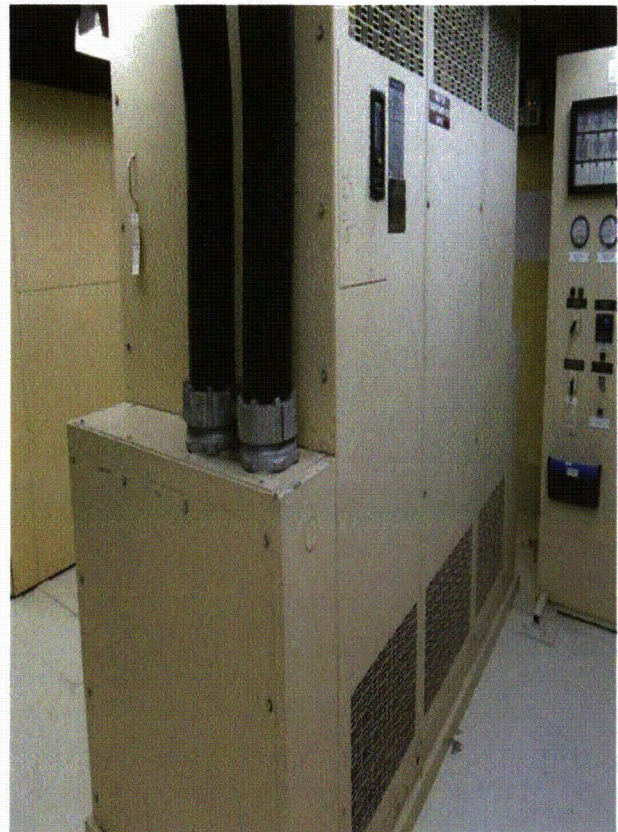
1AP13E Byron 1 & 2 8-8-12 029

4. Is the anchorage free of visible cracks in the concrete near the anchors? Yes  
*Minor shrinkage cracking in floor judged to be acceptable.*

*5 total cubicles. All doors were opened. All rear anchorages were observed.*

*All front anchorages were observed except for 2 cubicles due to electrical limitations.*

*The middle anchorages at 1 cubicle were observed.*

*Open S-hooks addressed in IR 1398568. Lights are not directly over equipment so damage is unlikely and S-hooks are partially open - judged to be acceptable.*

*All cubicle doors were opened. No other adverse conditions were observed.*
