Seismic Walkdown Checklist (SWC)

Equipment ID No.: 1DC11J

Equipment Description: 125V DC FUSE PANEL - DIV. 12

Project: Byron 1 SWEL

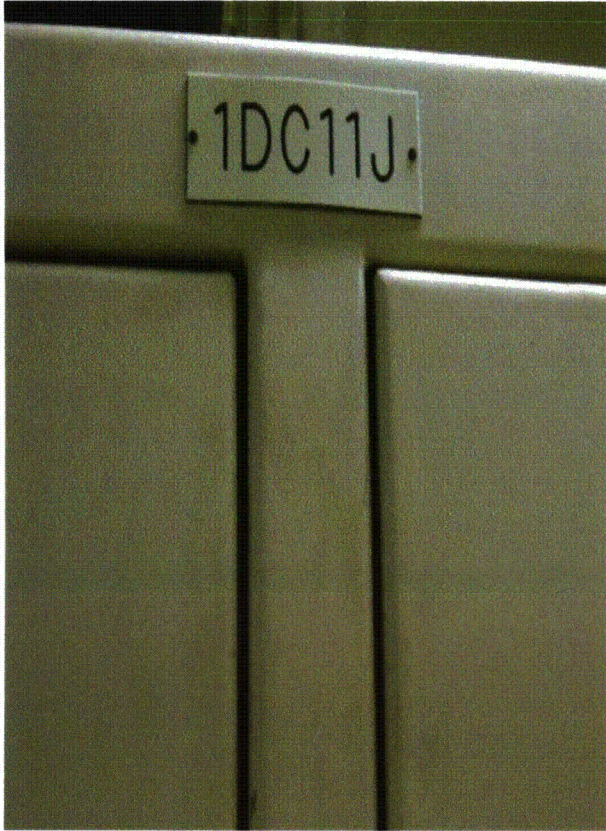
1DC11J Byron 1 & 2 8-8-12 016

6. Based on the above anchorage evaluations, is the anchorage free of potentially adverse seismic conditions? Yes

11. Have you looked for and found no adverse seismic conditions that could adversely affect the safety functions of the equipment? Yes
No structural/seismic issues

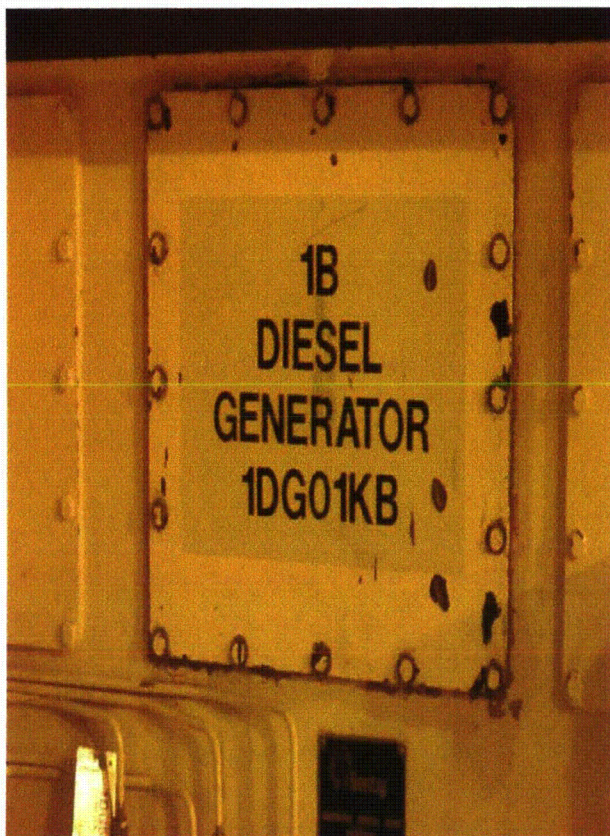
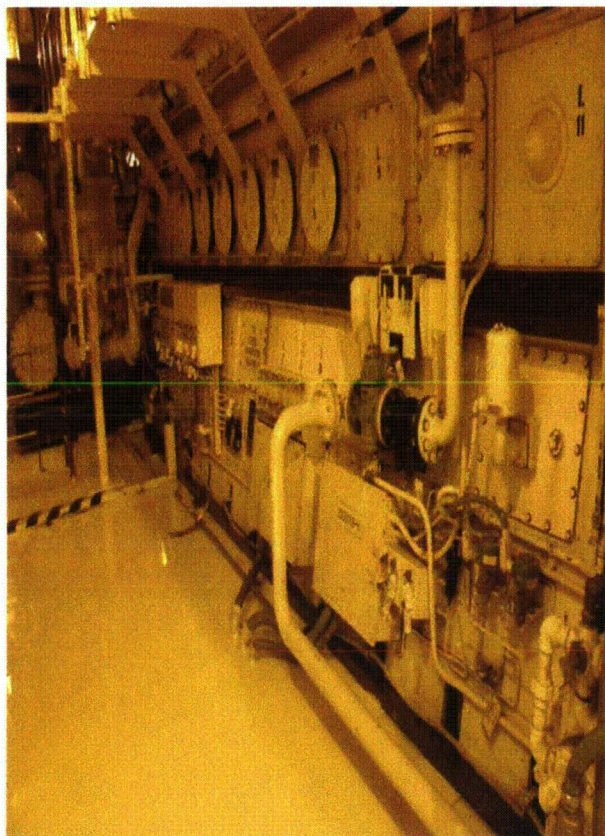
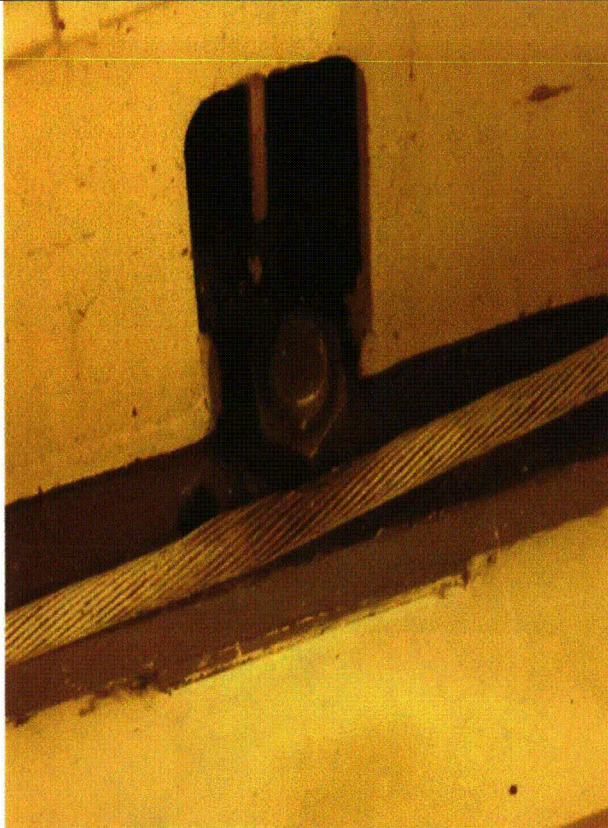
1DG01KB Byron 1 & 2 206

4. Is the anchorage free of visible cracks in the concrete near the anchors? Yes
Crack at anchor in pad that does not extend to base slab. Drawing M-1214 Sheet 3 indicate adequate embedment in base slab (1'-3 1/2") so small crack has no structural/seismic issue. IR 1398190 was written to document acceptability
5. Is the anchorage configuration consistent with plant documentation? (Note: This question only applies if the item is one of the 50% for which an anchorage configuration verification is required.) Yes
Drawing M-1214 Sheet 3 Revision W

6. Based on the above anchorage evaluations, is the anchorage free of potentially adverse seismic conditions? Yes

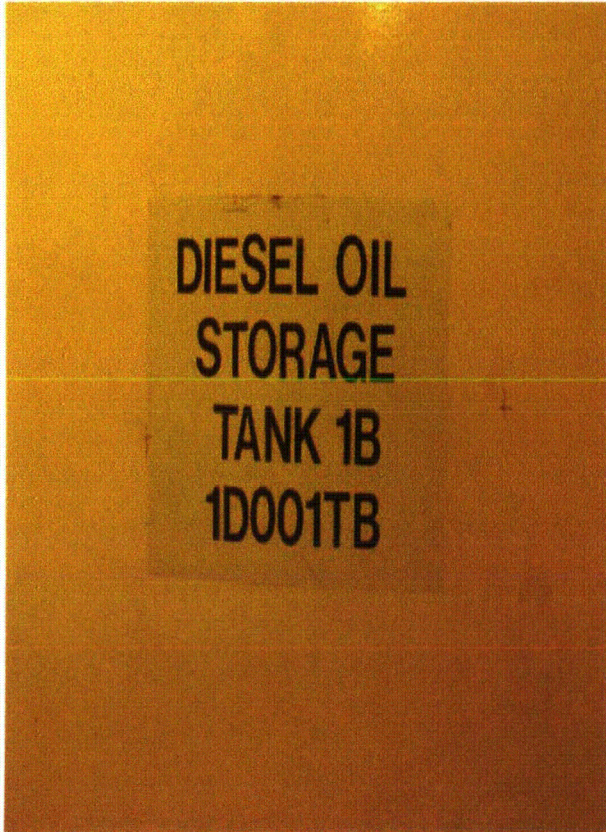
1DO01TB Byron 1 & 2 227

11. Have you looked for and found no adverse seismic conditions that could adversely affect the safety functions of the equipment? Yes
No structural/seismic issues

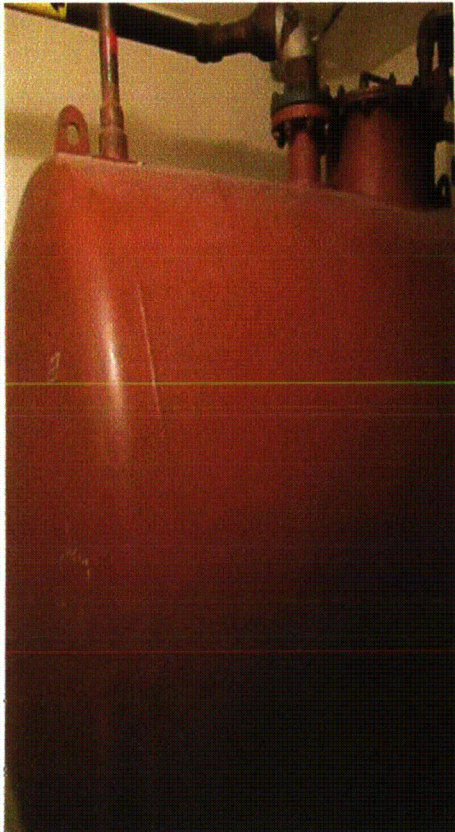
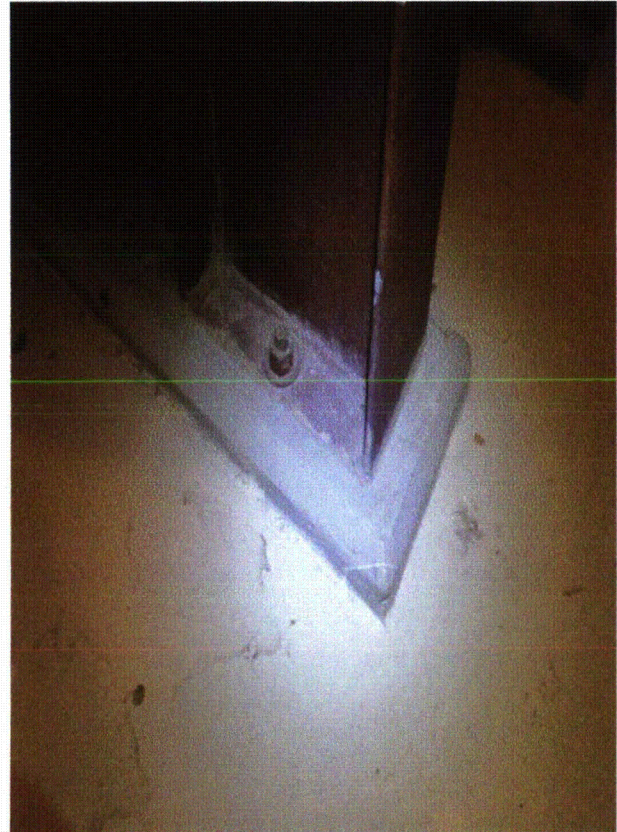
1DO10T Byron 1 & 2 8-20-12 018

11. Have you looked for and found no adverse seismic conditions that could adversely affect the safety functions of the equipment? Yes
No structural/seismic issues

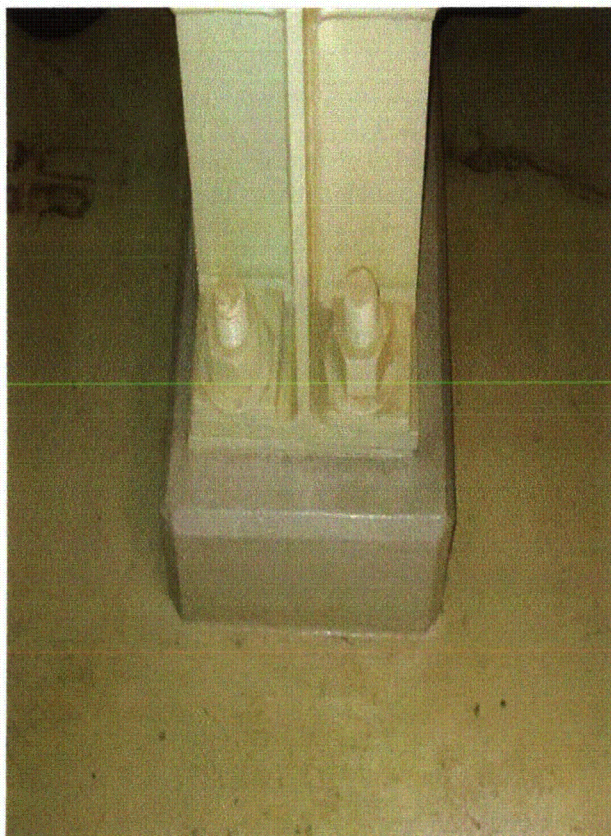
1FC01A Byron 1 & 2 8-9-12 011

7. Are soft targets free from impact by nearby equipment or structures? Yes
8. Are overhead equipment, distribution systems, ceiling tiles and lighting, and masonry block walls not likely to collapse onto the equipment? Yes
Masonry walls are seismic and would not collapse on equipment
9. Do attached lines have adequate flexibility to avoid damage? Yes
10. Based on the above seismic interaction evaluations, is equipment free of potentially adverse seismic interaction effects? Yes

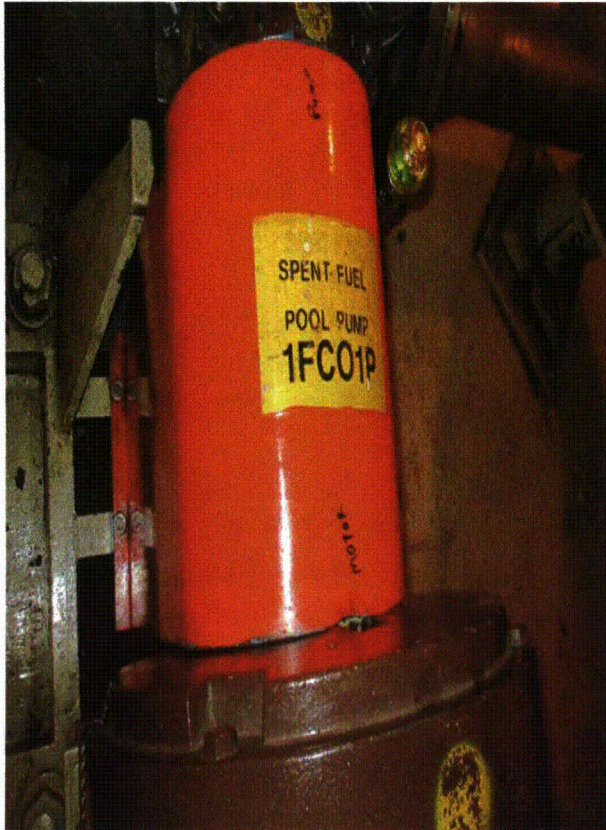
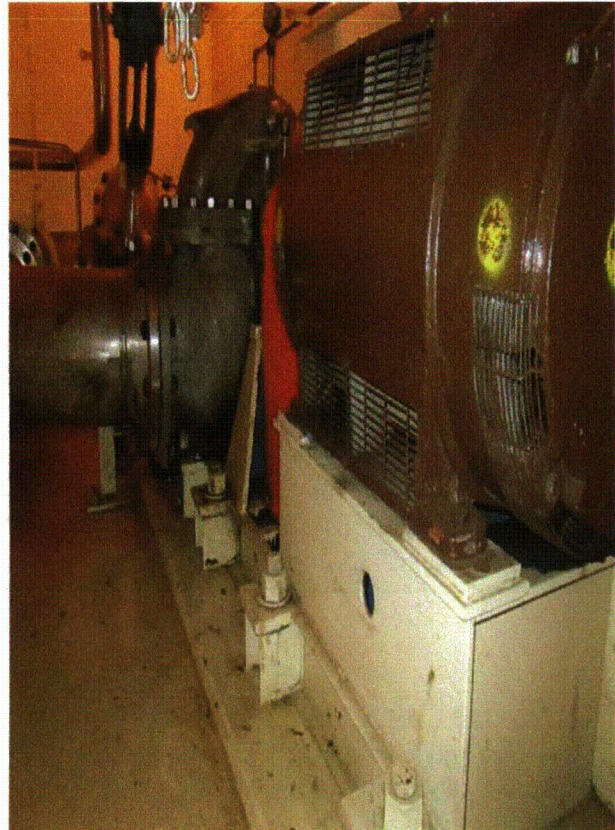
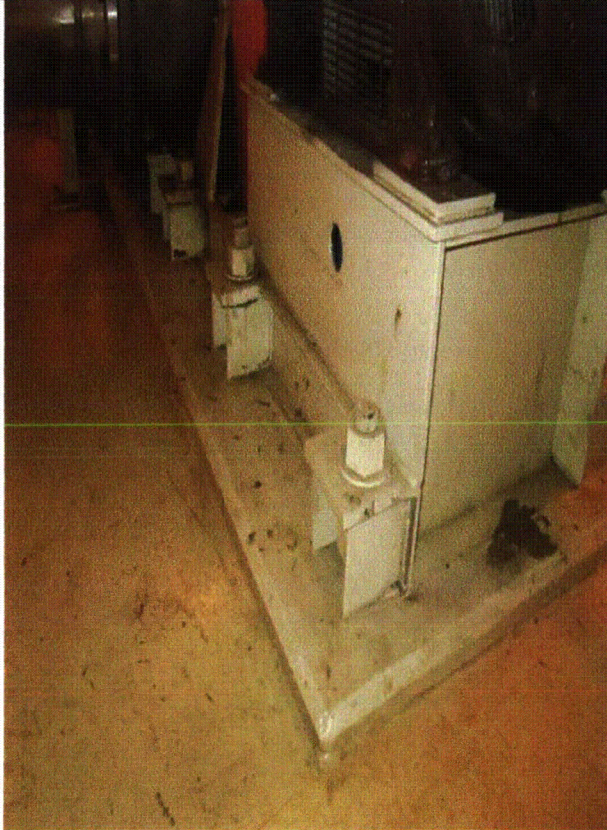
1FC01P Byron 1 & 2 8-9-12 020

11. Have you looked for and found no adverse seismic conditions that could adversely affect the safety functions of the equipment? Yes

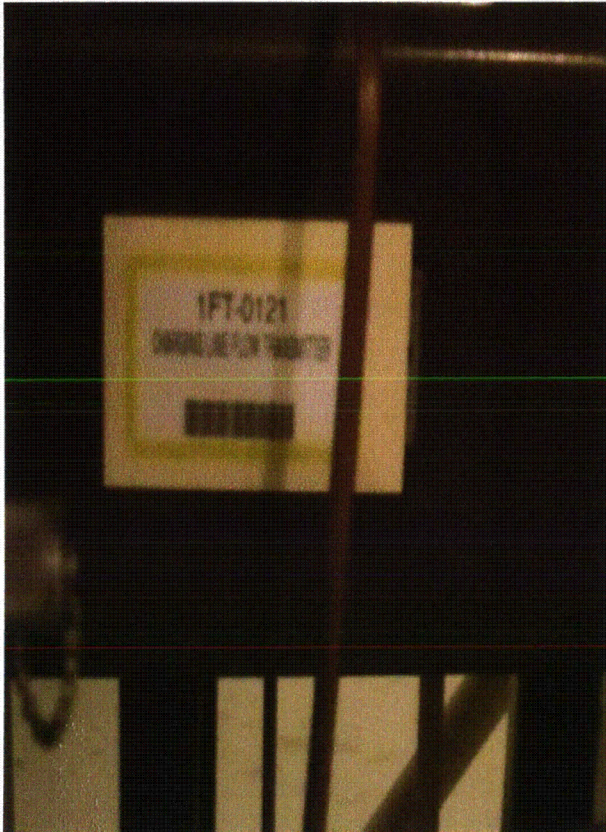
1FT-0121 Byron 1 & 2 8-20-12 060

6. Based on the above anchorage evaluations, is the anchorage free of potentially adverse seismic conditions? Yes
Instrument securely mounted to rack that is well-anchored to seismic block wall that would not collapse on equipment

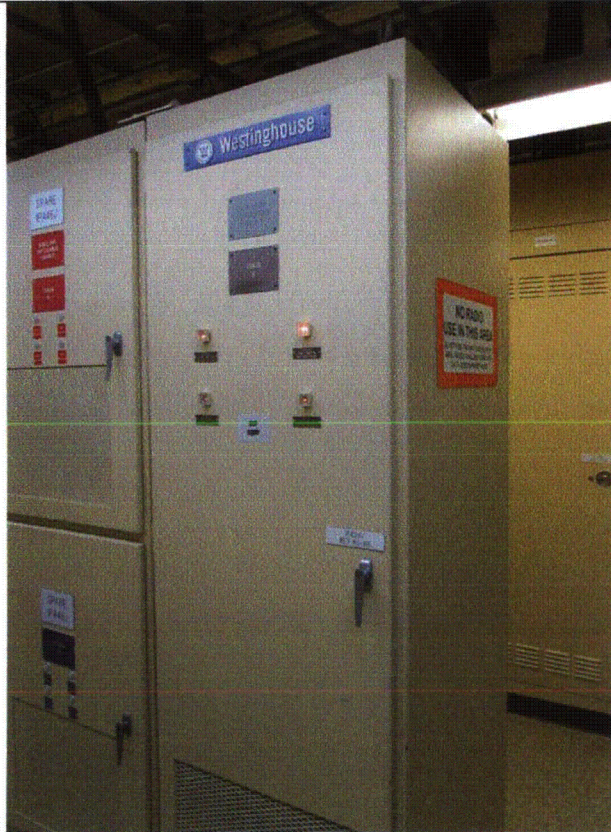
1PA28J Byron 1 & 2 116

6. Based on the above anchorage evaluations, is the anchorage free of potentially adverse seismic conditions? Yes
See discussion in Section 5 of report to address cove molding at anchorage detail. Anchorage is judged to be acceptable.

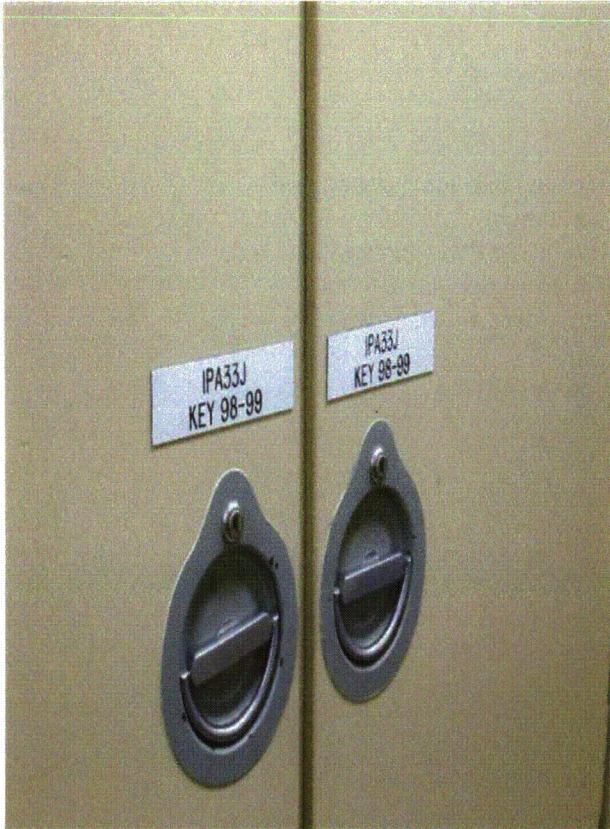
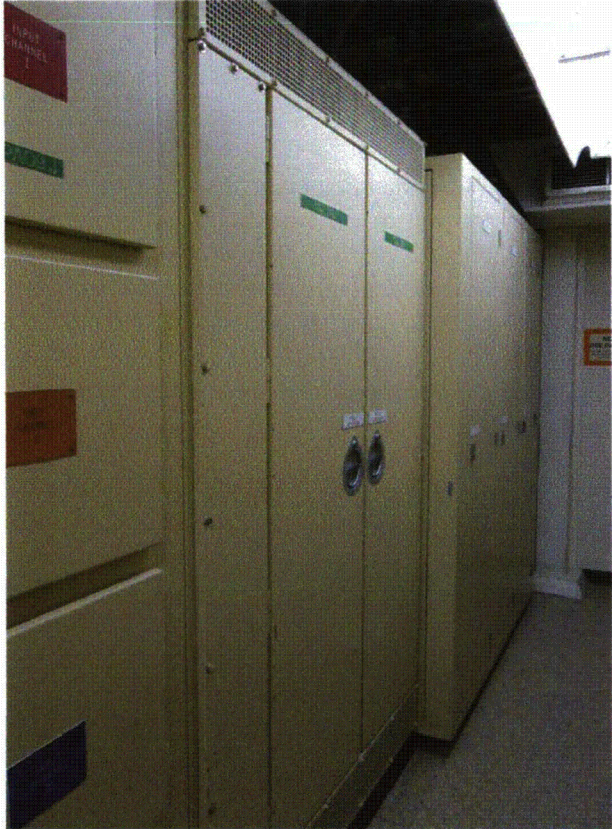
1PA33J Byron 1 & 2 117

6. Based on the above anchorage evaluations, is the anchorage free of potentially adverse seismic conditions? Yes
See discussion in Section 5 of report to address cove molding at anchorage detail. Anchorage is judged to be acceptable.

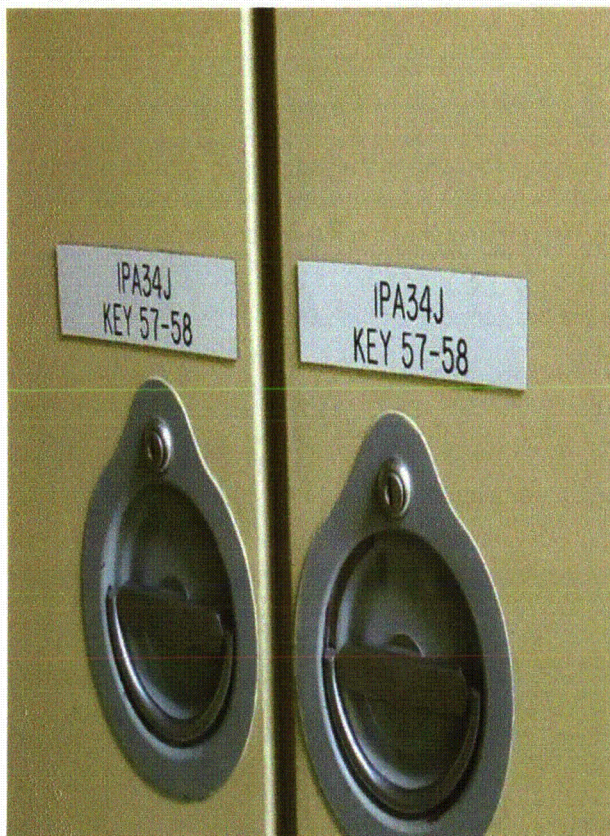
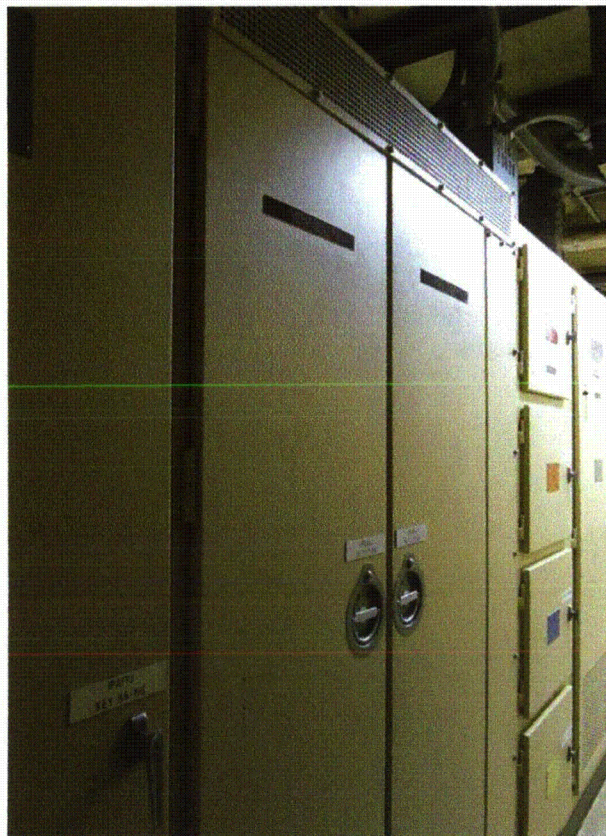
1PA34J Byron 1 & 2 119

6. Based on the above anchorage evaluations, is the anchorage free of potentially adverse seismic conditions? Yes
Anchorage on front of panel inspected since a panel ventilation grate prevented installation of cove molding. Weld is 2 1/4" in length at approximately 9" spacing. Drawing 6E-0-3391AJ Revision AF specified 1 1/2" at 9". Back was not visible. See discussion in Section 5 of report to address cove molding at anchorage detail. Anchorage is judged to be acceptable.
