Seismic Walkdown Checklist (SWC)

Equipment ID No.: 2CC01PA

Equipment Description: 2A COMPONENT COOLING WTR PUMP ASMBLY

Project: Byron 2 SWEL

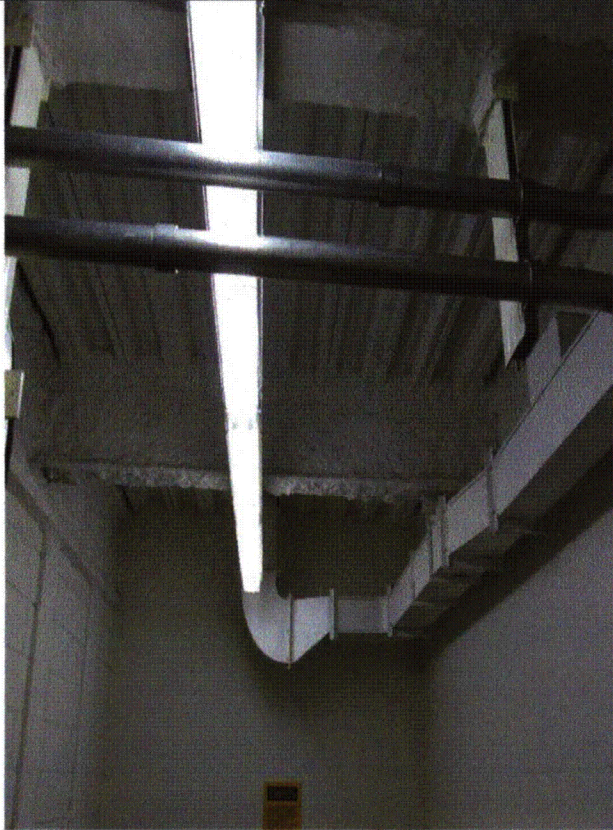
2DC02E Byron 1 & 2 038

4. Is the anchorage free of visible cracks in the concrete near the anchors? Yes
Adjacent small crack (northwest corner) - not a structural/seismic issue

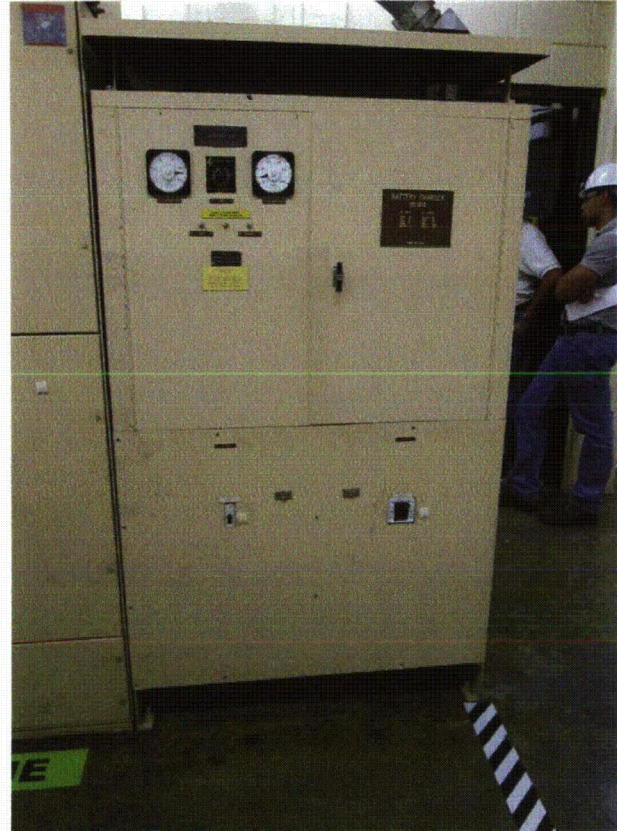
2DC04E Byron 1 & 2 031

3. Is the anchorage free of corrosion that is more than mild surface oxidation? Yes
Only mild corrosion - not a structural/seismic issue since anchorage configuration is maintained.

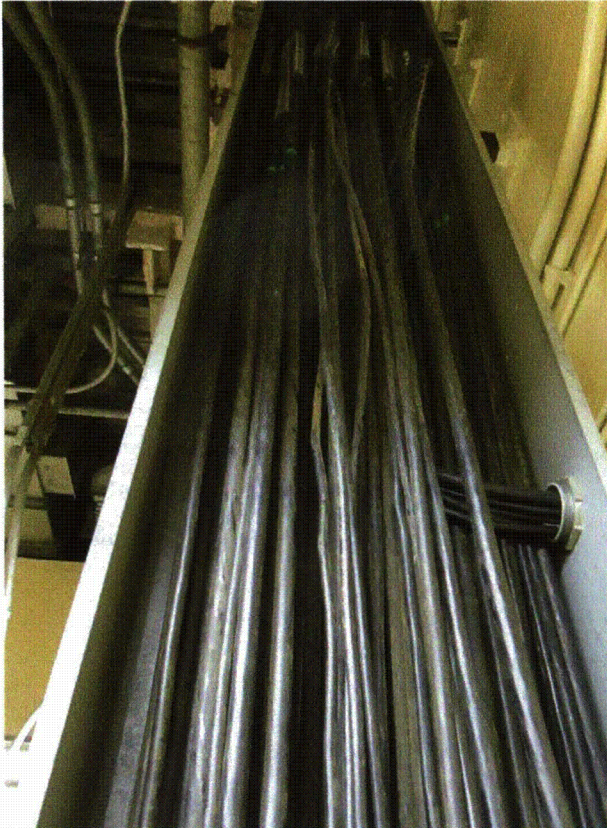
2DC10J (AWB - VERTICAL CABLE TRAY OK) Byron
1 & 2 020

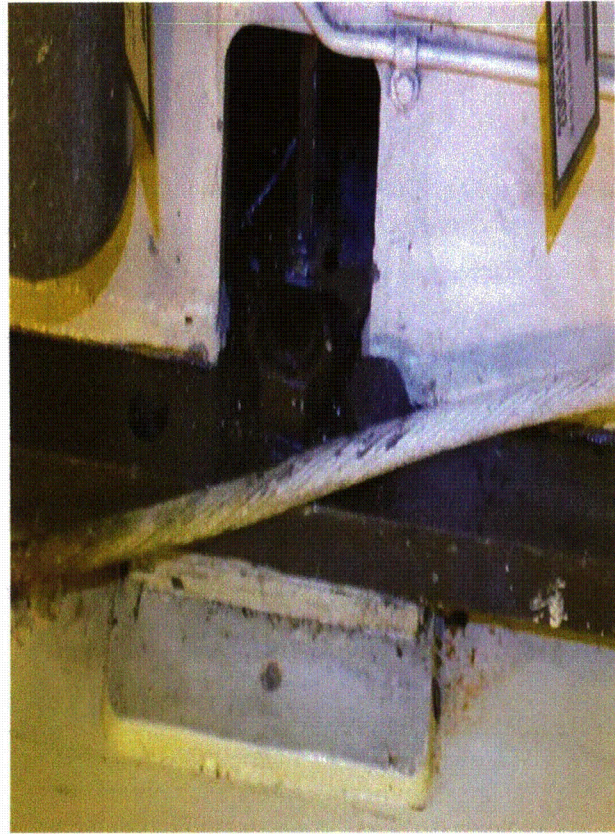
2DG01KA Byron 1 & 2 219

4. Is the anchorage free of visible cracks in the concrete near the anchors? Yes
*Very minor cracks in grout wash does not penetrate into grout or base slab.
Not a structural/seismic issue.*

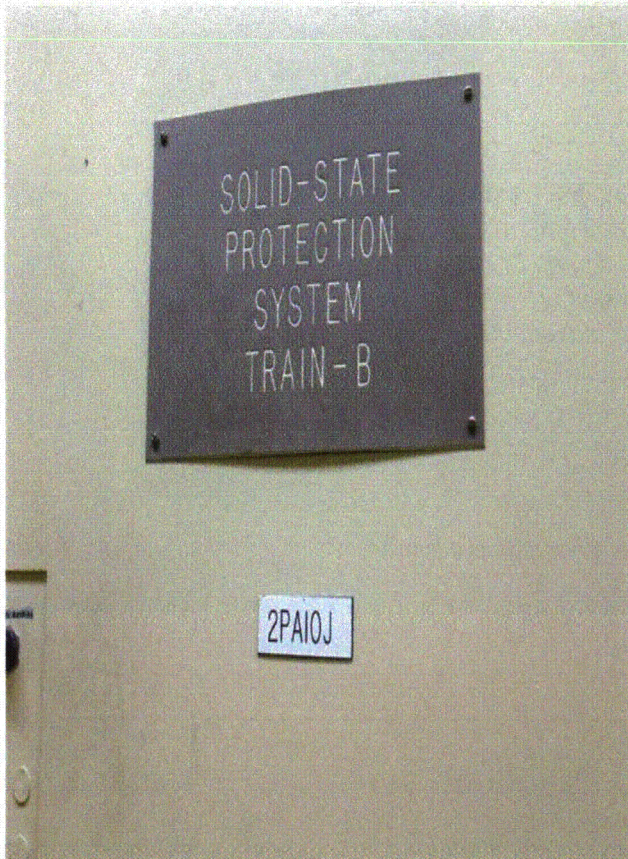
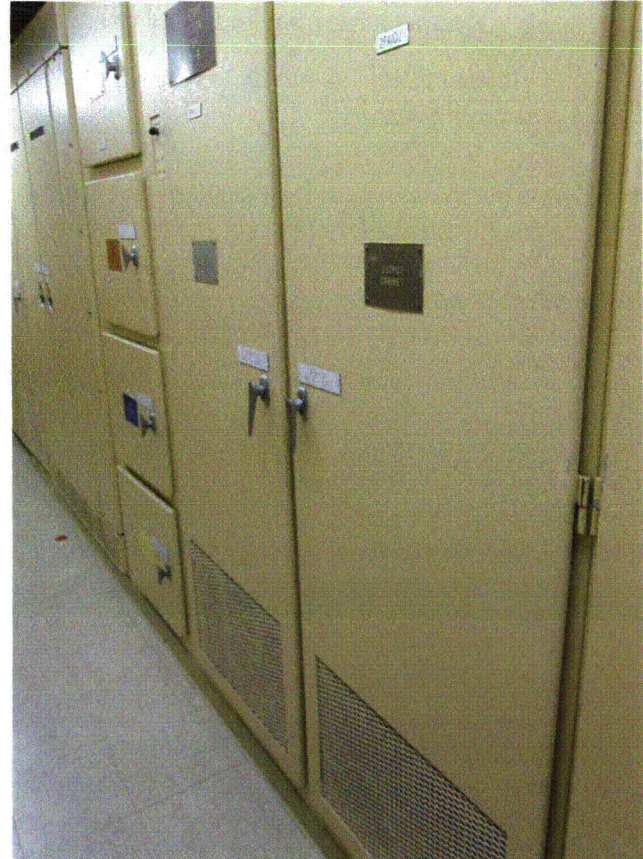
2PA10J Byron 1 & 2 066

6. Based on the above anchorage evaluations, is the anchorage free of potentially adverse seismic conditions? Yes
See discussion in Section 5 of report to address cove molding at anchorage detail. Anchorage is judged to be acceptable.

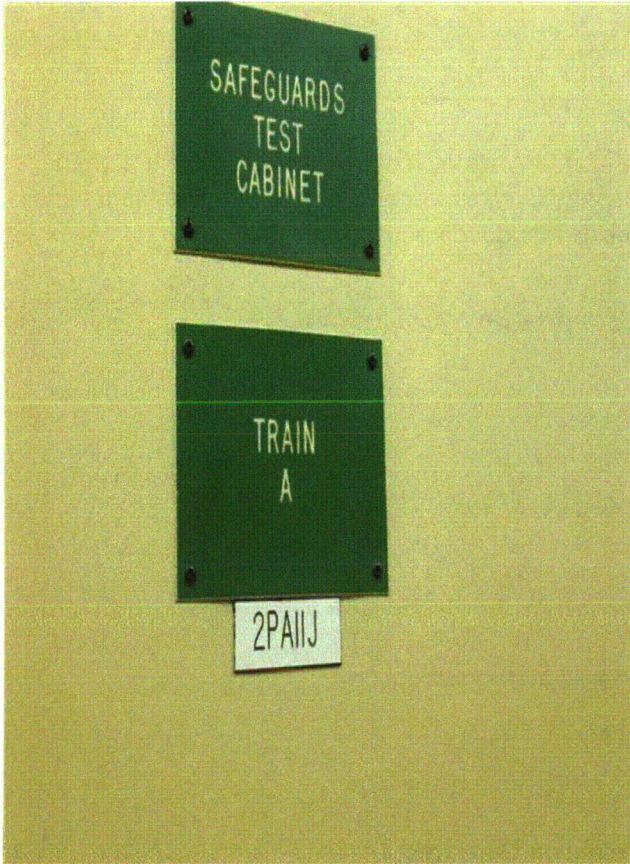
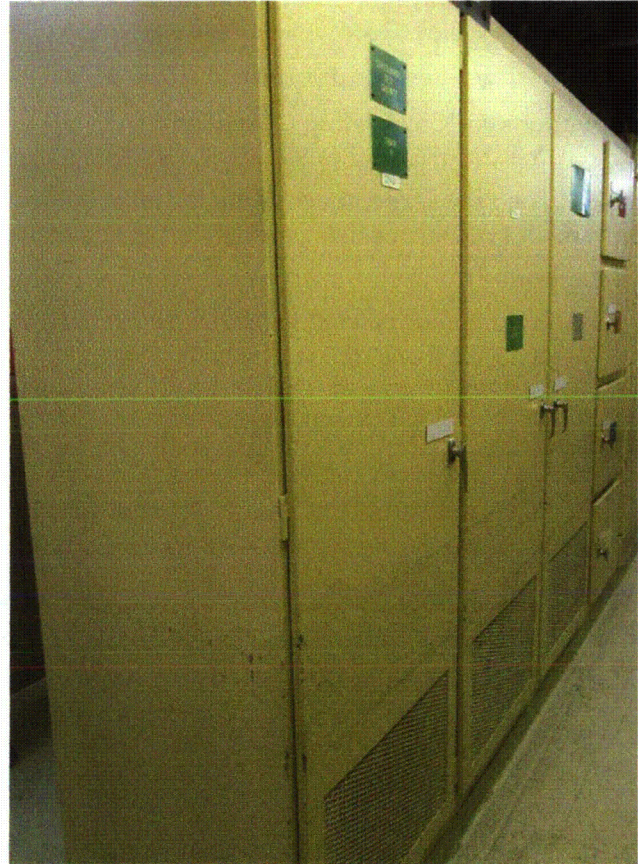
2PA11J Byron 1 & 2 068

6. Based on the above anchorage evaluations, is the anchorage free of potentially adverse seismic conditions? Yes
See discussion in Section 5 of report to address cove molding at anchorage detail. Anchorage is judged to be acceptable.

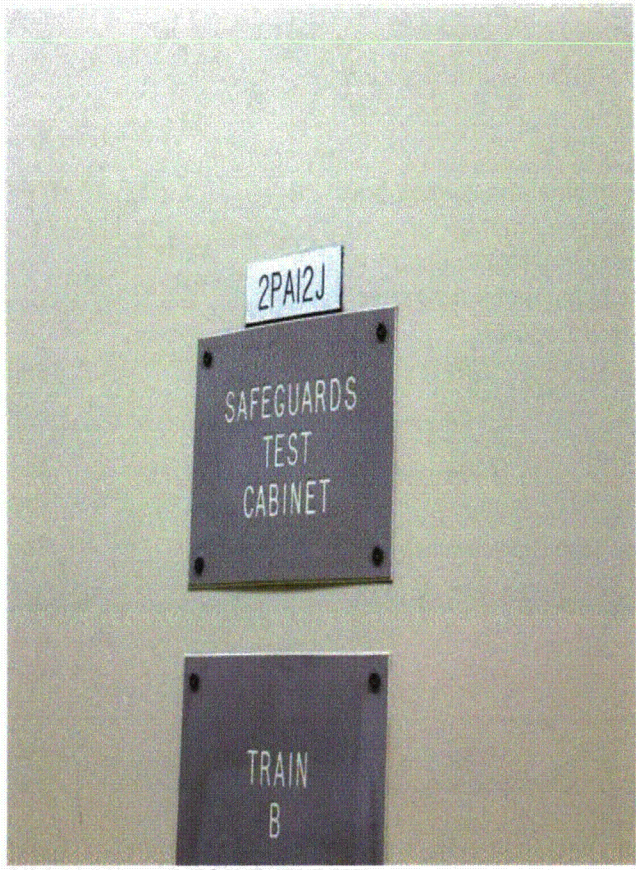
2PA12J Byron 1 & 2 070

6. Based on the above anchorage evaluations, is the anchorage free of potentially adverse seismic conditions? Yes
See discussion in Section 5 of report to address cove molding at anchorage detail. Anchorage is judged to be acceptable.

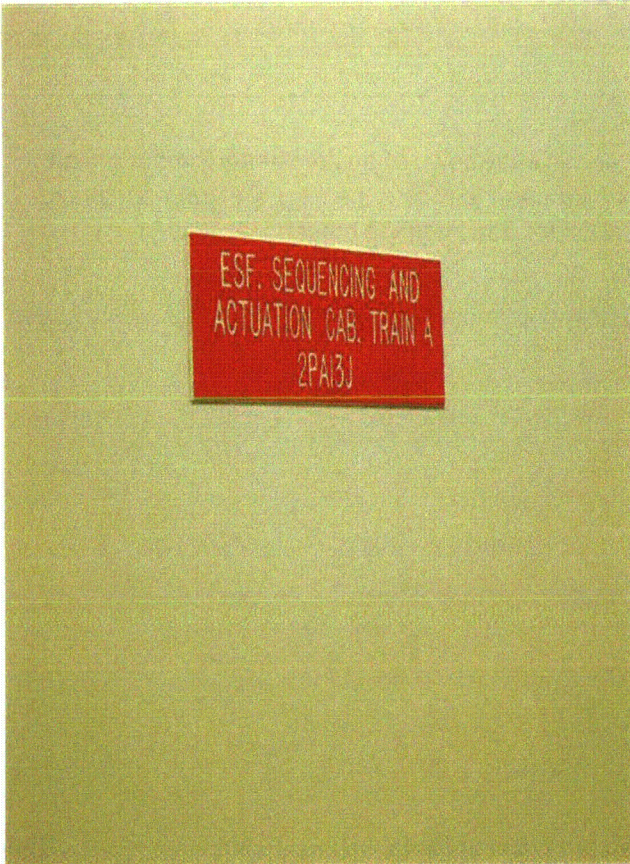
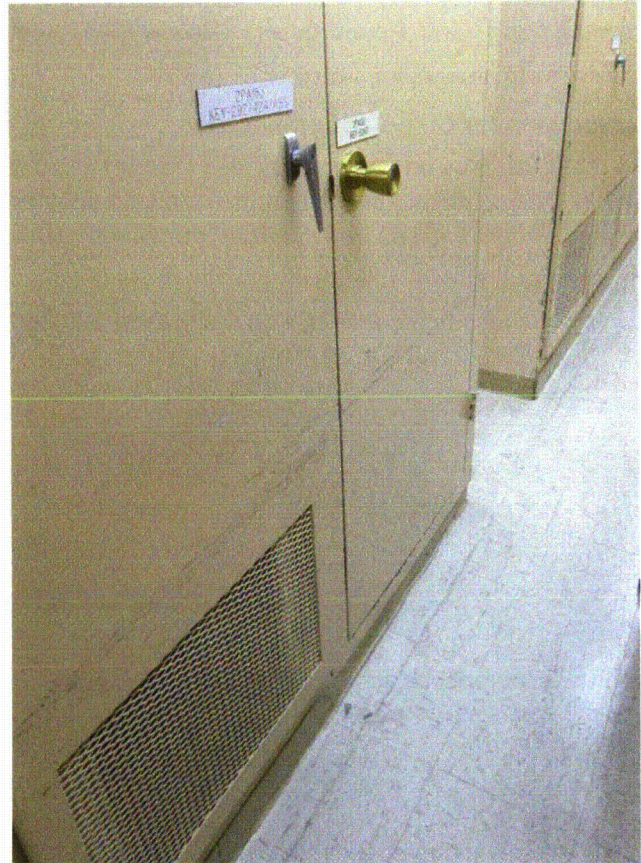
2PA13J Byron 1 & 2 072

6. Based on the above anchorage evaluations, is the anchorage free of potentially adverse seismic conditions? Yes
See discussion in Section 5 of report to address cove molding at anchorage detail. Anchorage is judged to be acceptable.
