Fermi 2 Seismic Walkdown Guidance Document  
Seismic Walkdown Checklist

Seismic Walkdown Checklist (SWC)

Equipment Description H21-P624 Div. 1 Bus 64C Dedicated Shutdown Panel

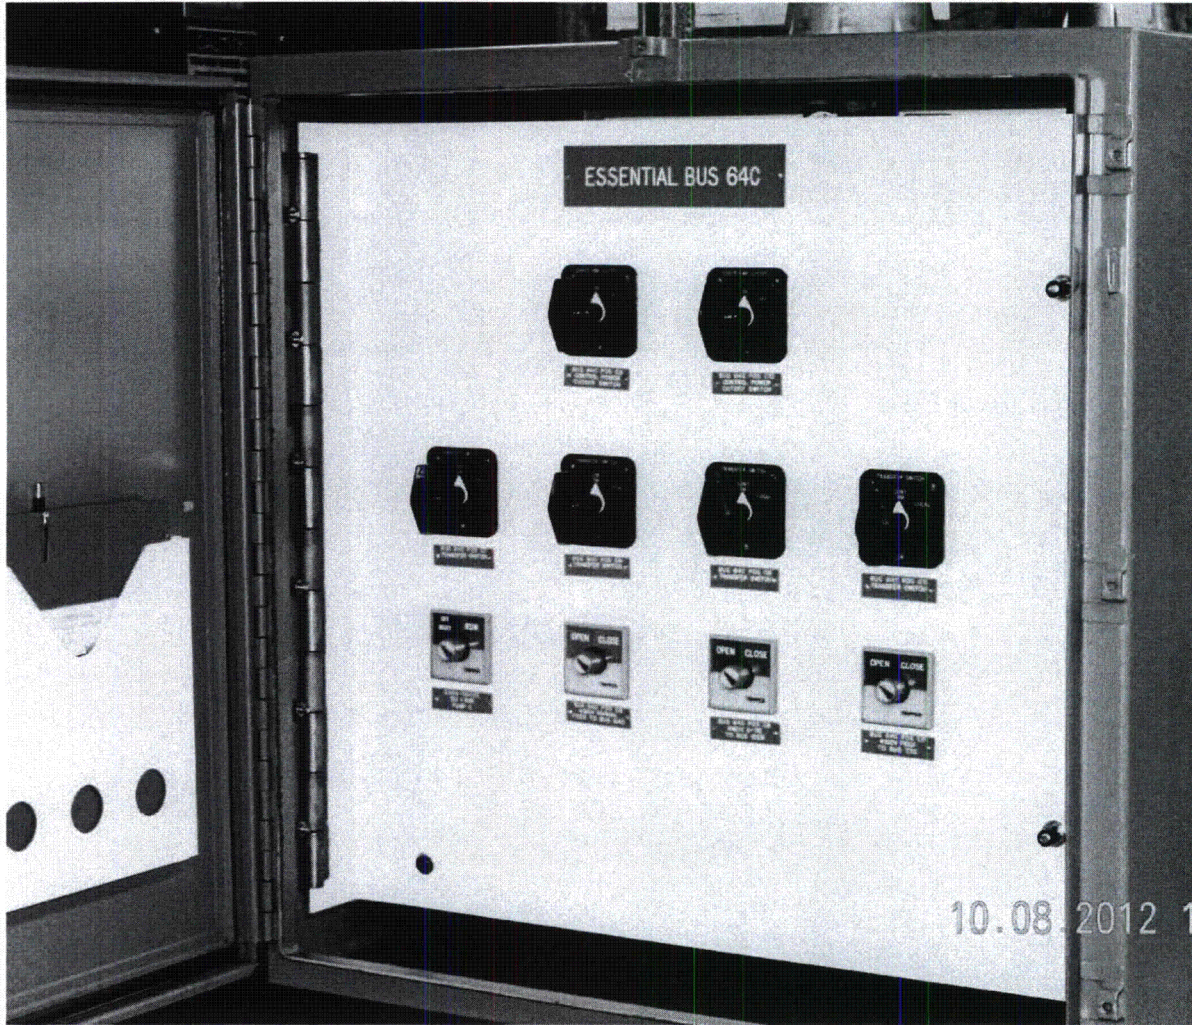
Photo 1, Close-Up View of Inside of Shutdown Panel

11. Have you looked for and found no other seismic conditions that could adversely affect the safety functions of the equipment?  Y  N  U  
*The door on the instrument panel was opened to permit evaluating the adequacy of fasteners securing components mounted inside. None of the components weighed more than two pounds. No adverse conditions were identified. See Photo 1, attached.*

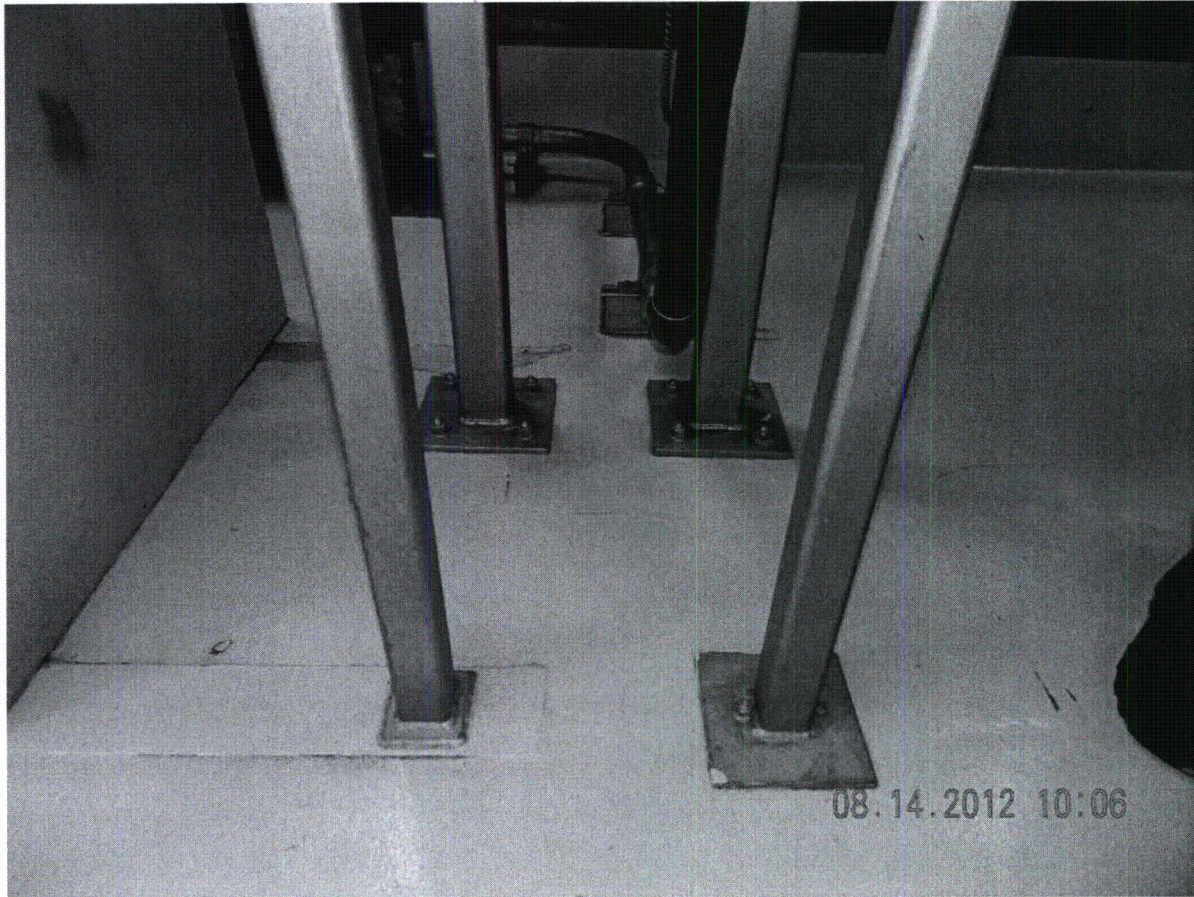
(DSCN0303)

2. Is the anchorage free of bent, broken, missing or loose hardware?  Y  N  U  N/A  
*All base anchorage connections complete. See question No. 5 for configuration control issue.  
(SEE PICTURES DSCN0303, DSCN0305, DSCN0306, DSCN0309) ~ DJK 10/9/12*

3. Is the anchorage free of corrosion that is more than mild surface oxidation?  Y  N  U  N/A  
*Welds painted. Anchor bolts free of corrosion.  
(SEE PICTURE DSCN0303) ~ DJK 10/9/12*

Drawing has configuration error – Section G-G is incorrect for the front right leg – As-built condition is as shown on section D-D from H21P626. Verification and drawing update required (ref. Dwg. E-2998-05). CARD 12-26837 has been issued to track drawing configuration error. Welds of unistrut are consistent with drawing and welding of front legs to equipment is consistent with drawing. SEE COMMENTS ~ DJK 10/12/12  
(SEE PICTURES DSCN0303, DSCN0305, DSCN0306, DSCN0309) ~ DJK 10/9/12*

General Mounting Configuration

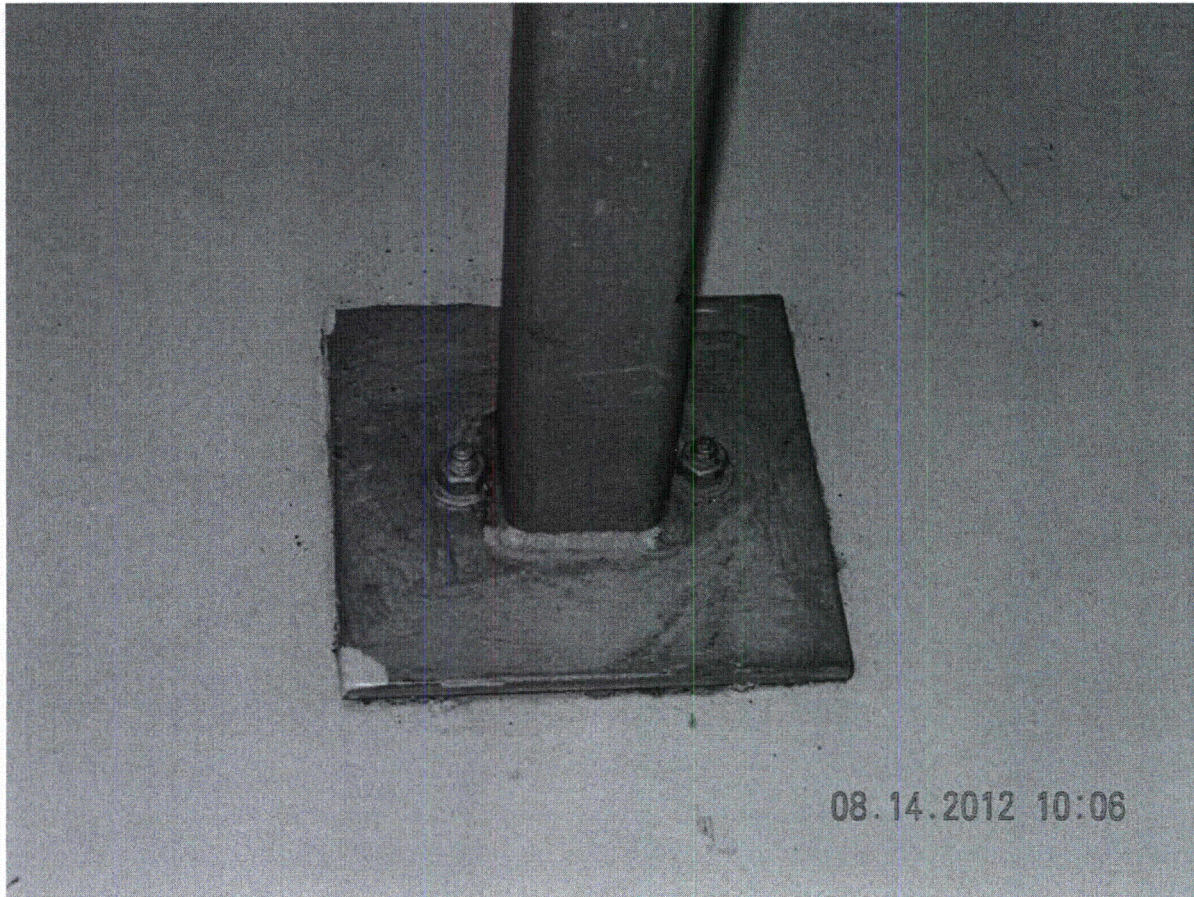
(DSCN0305)

Bolting Configuration to Concrete Floor

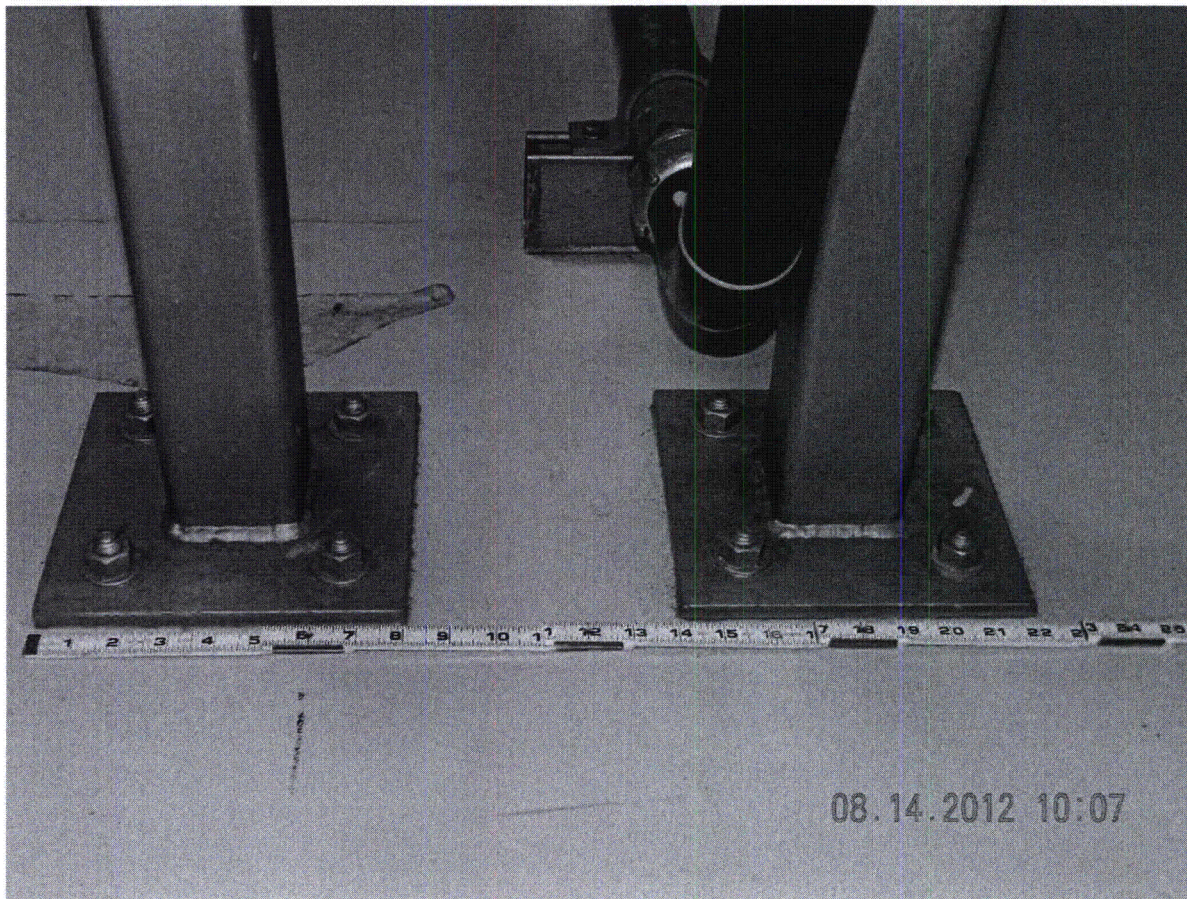
(DSCN0306)

Bolting Configuration to Concrete Floor (Rear)

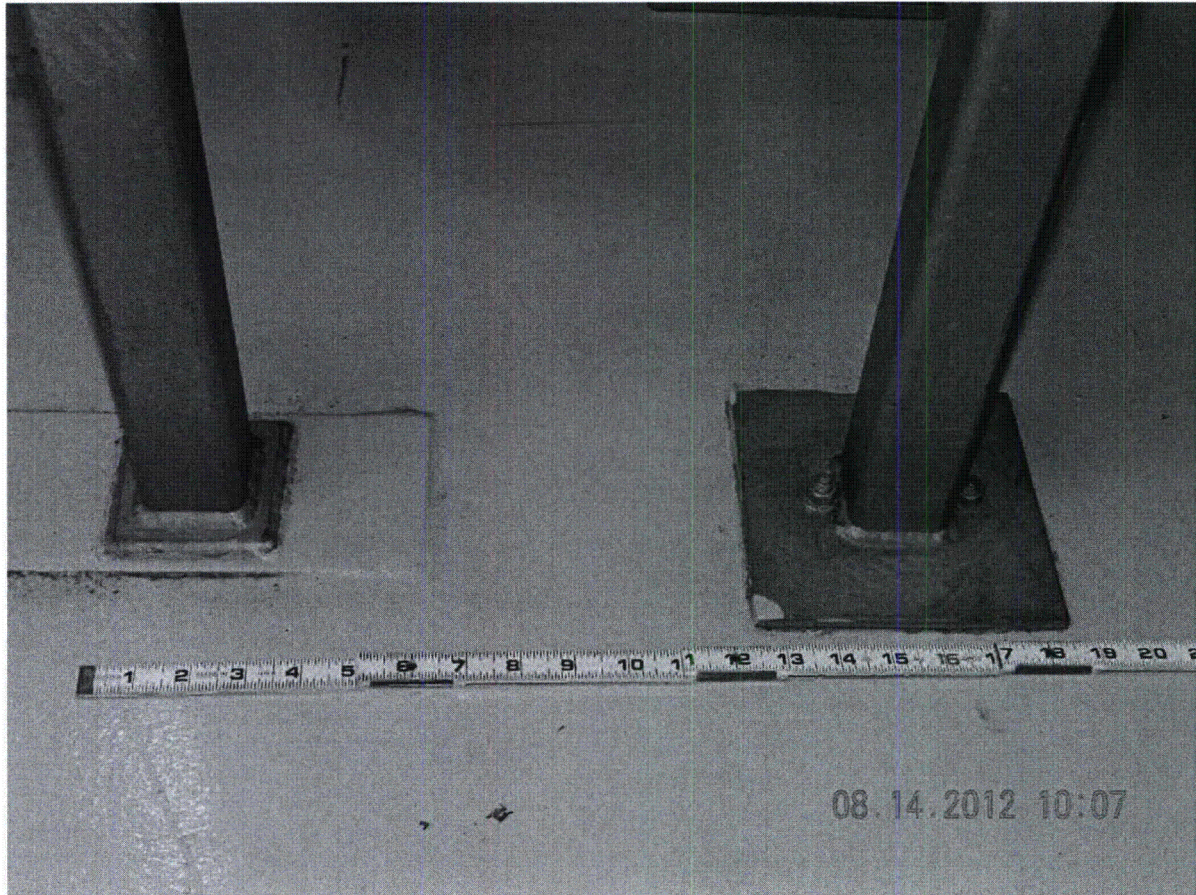
(DSCN0309)

Bolting Configuration to Concrete Floor (Front)

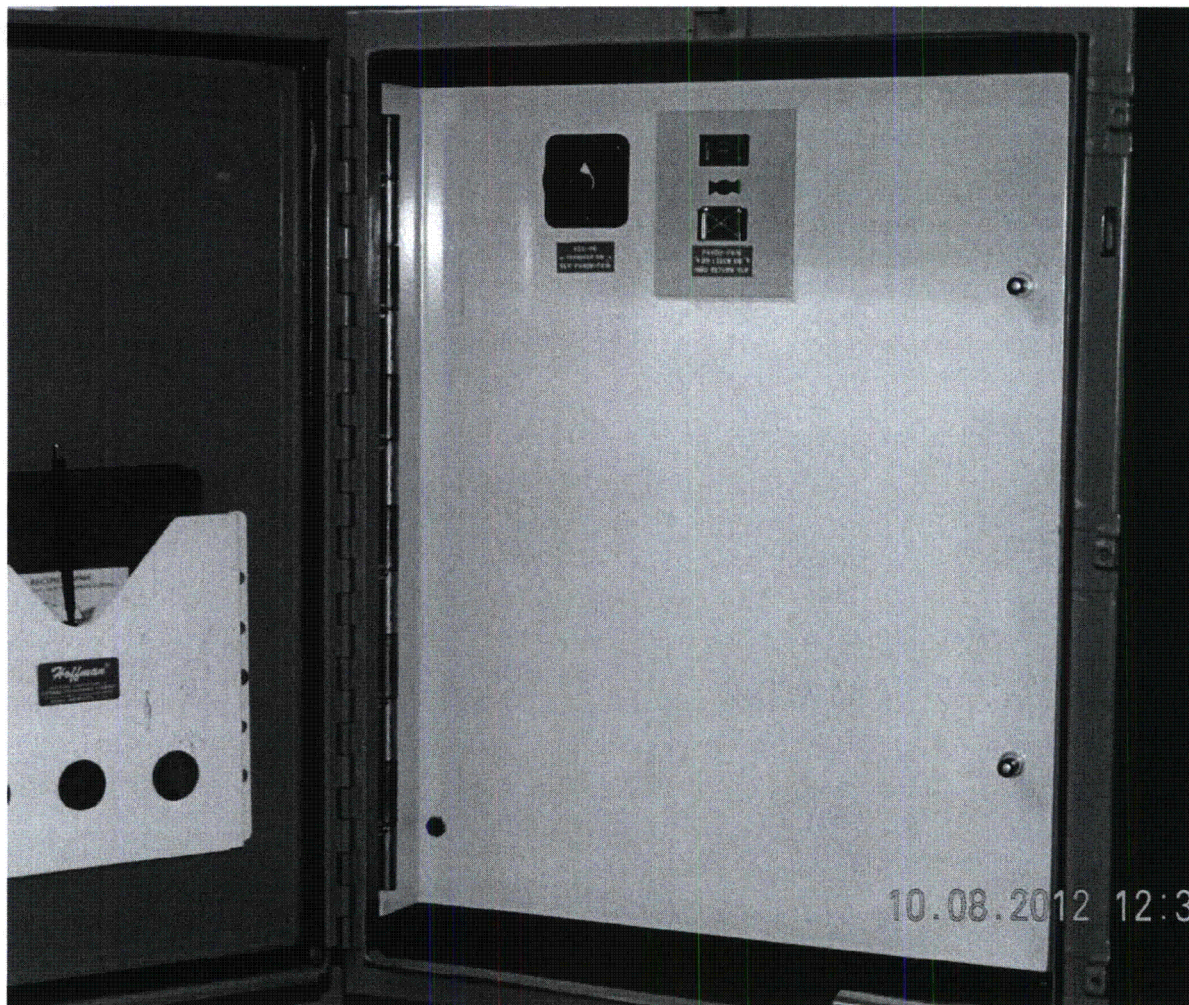
Photo 1, Close-Up View of Inside of Panel

11. Have you looked for and found no other seismic conditions that could adversely affect the safety functions of the equipment?  Y  N  U  
*The door on the instrument panel was opened to permit evaluating the adequacy of fasteners securing components mounted inside. None of the components weighed more than two pounds. No adverse conditions were identified. See Photos 1, 2 & 3 attached.*

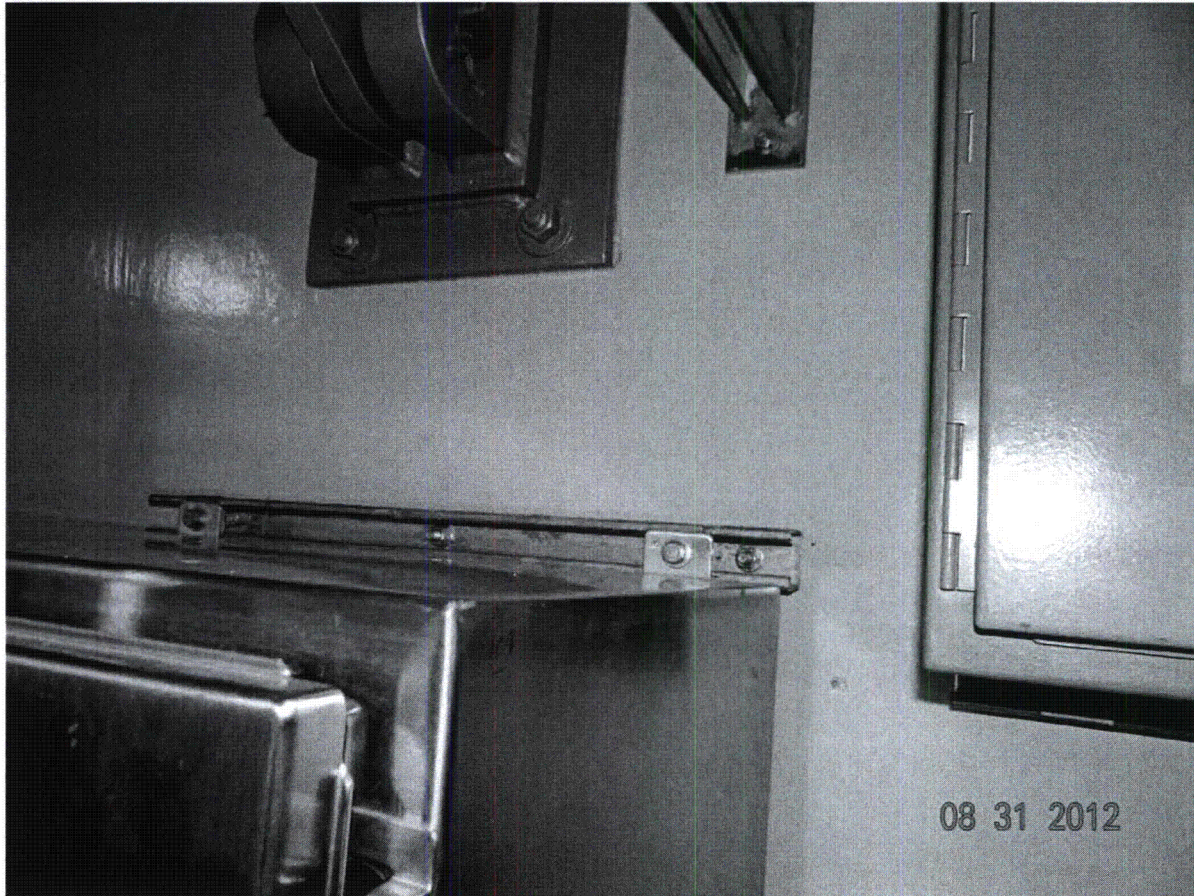
(PICTURE # 11)

2. Is the anchorage free of bent, broken, missing or loose hardware?  Y  N  U  N/A  
*All anchorage is present and secure. See pictures 11 and 19.*

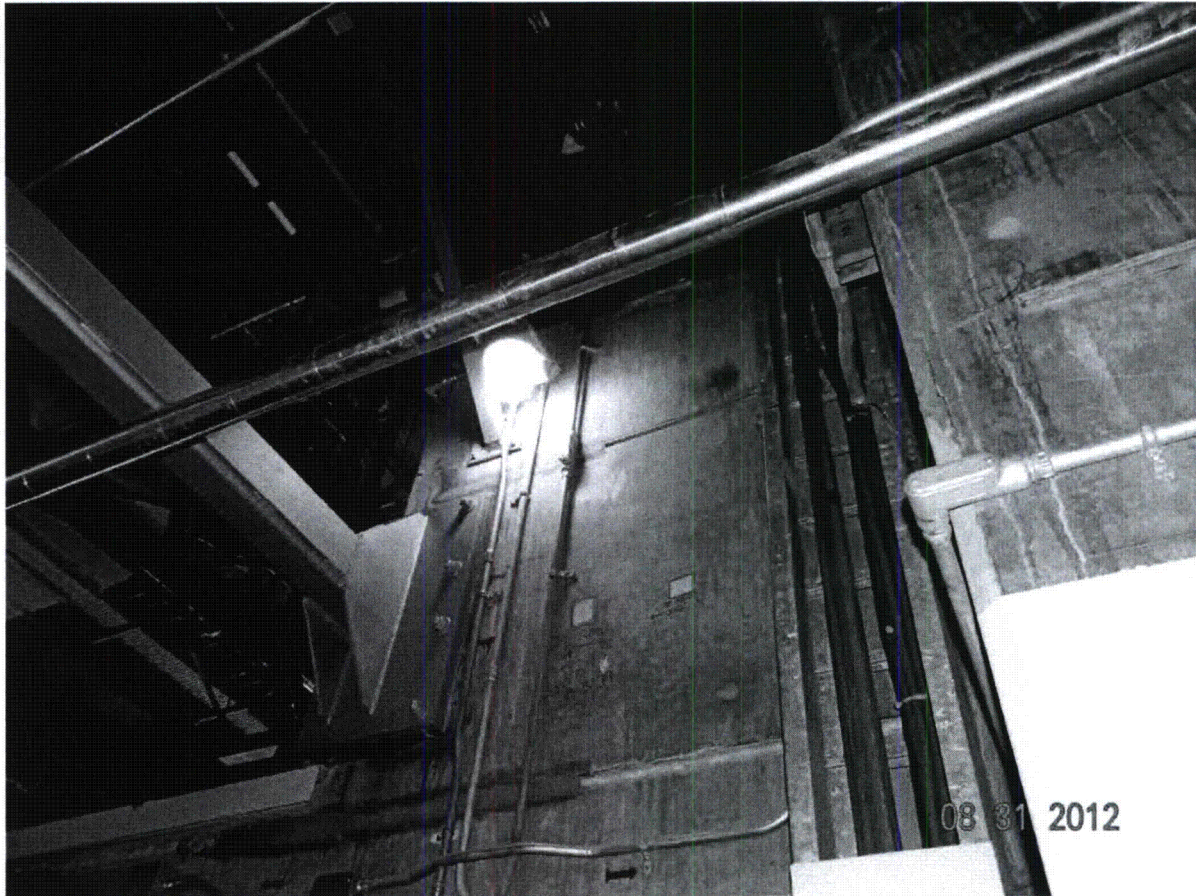
(PICTURE # 13)

Equipment ID No. H21P632 Equipment Class: 20, Instrumentation & Control Panel

Equipment Description Dedicated Shutdown MCC 72F-4A Local Ctrl Panel

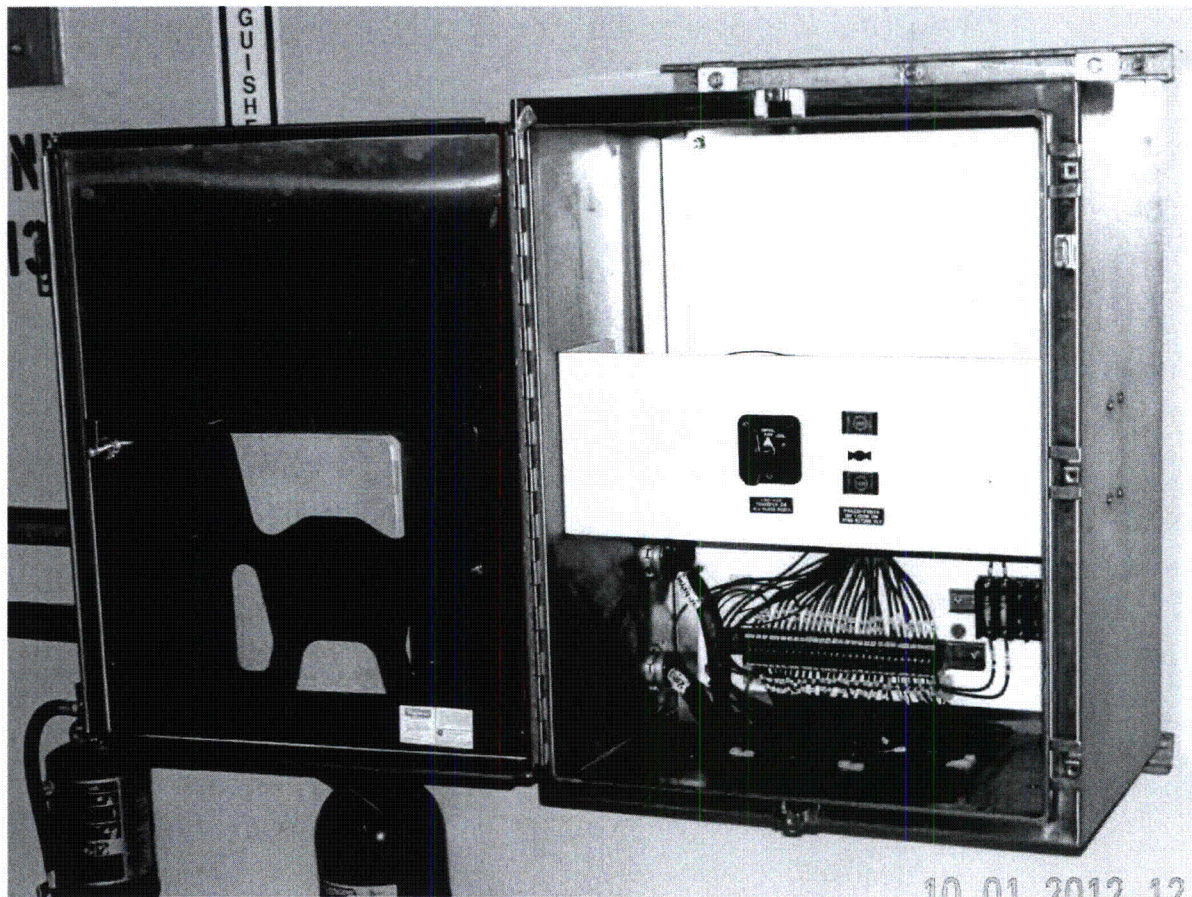
Photo 1, *Components Mounted Inside Instrument Panel*

11. Have you looked for and found no other seismic conditions that could adversely affect the safety functions of the equipment?  Y  N  U  
*The door on the instrument panel was opened to permit evaluating the adequacy of fasteners securing components mounted inside. Only one of the components weighed more than two pounds. No adverse conditions were identified. See Photos 1, 2 & 3 attached.*

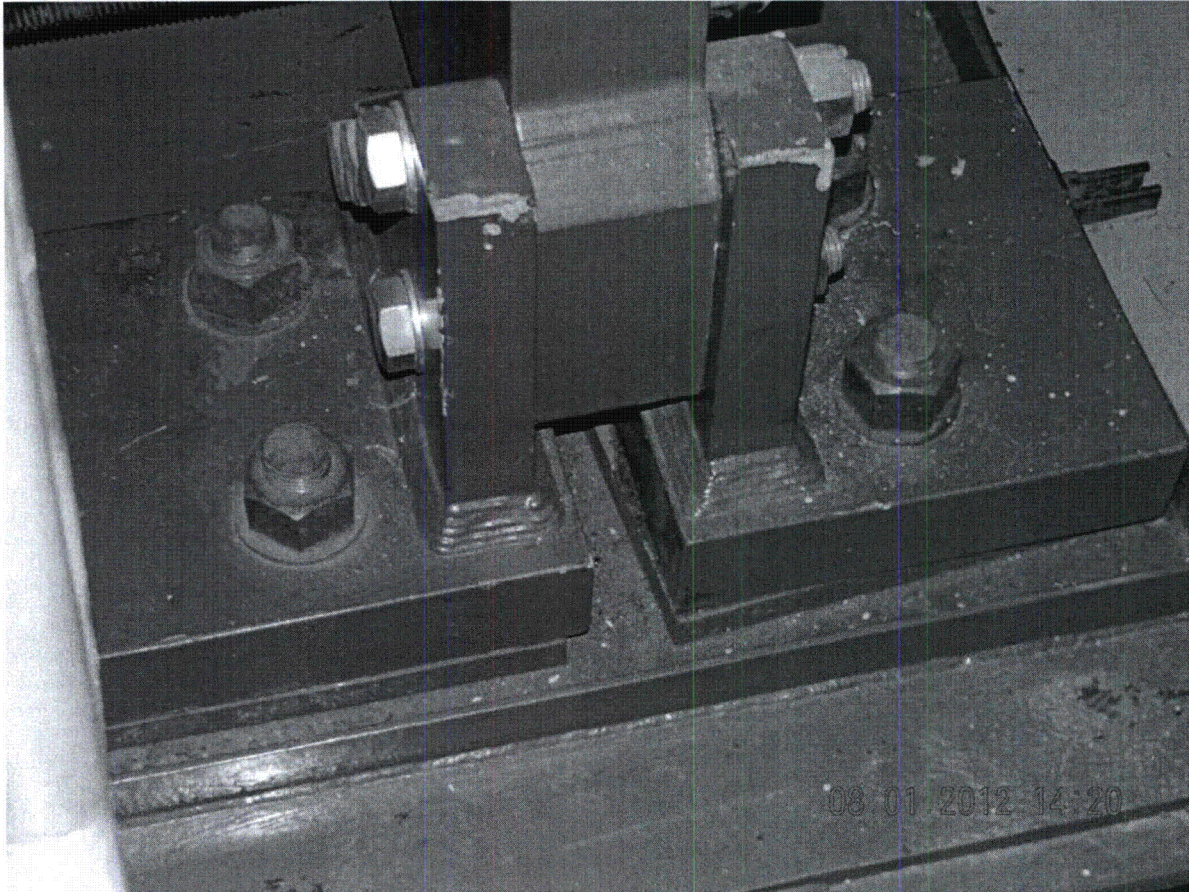
(DSCN 0043)

3. Is the anchorage free of corrosion that is more than mild surface oxidation? Y  N  U  N/A   
*Surface oxidation on some bolts is very minor and acceptable. (see Photos DSC0035 & DSC0043)*

"Bolt Configuration"

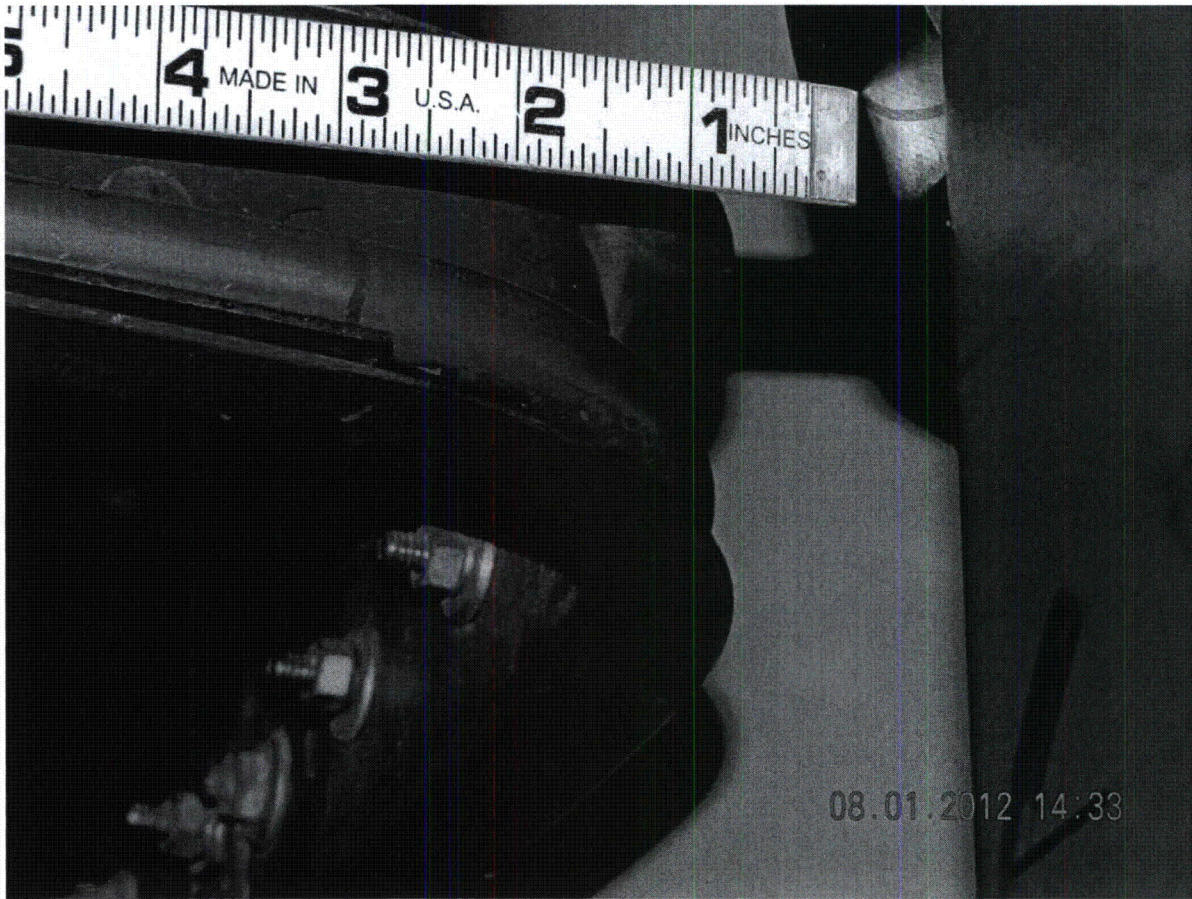
(DSCN 0046)

11. Have you looked for and found no other seismic conditions that could adversely affect the safety functions of the equipment?  Y  N  U  
*1/2" ~ 3/4" clearance between heat exchanger and TubeTrack was evaluated and found not to be a concern. Because TubeTrack is well supported and the heat exchanger is rigid, during a seismic event there will not be enough movement to cause the two components to come into contact with each other. See Photos DSC0046 & DSC0048.*

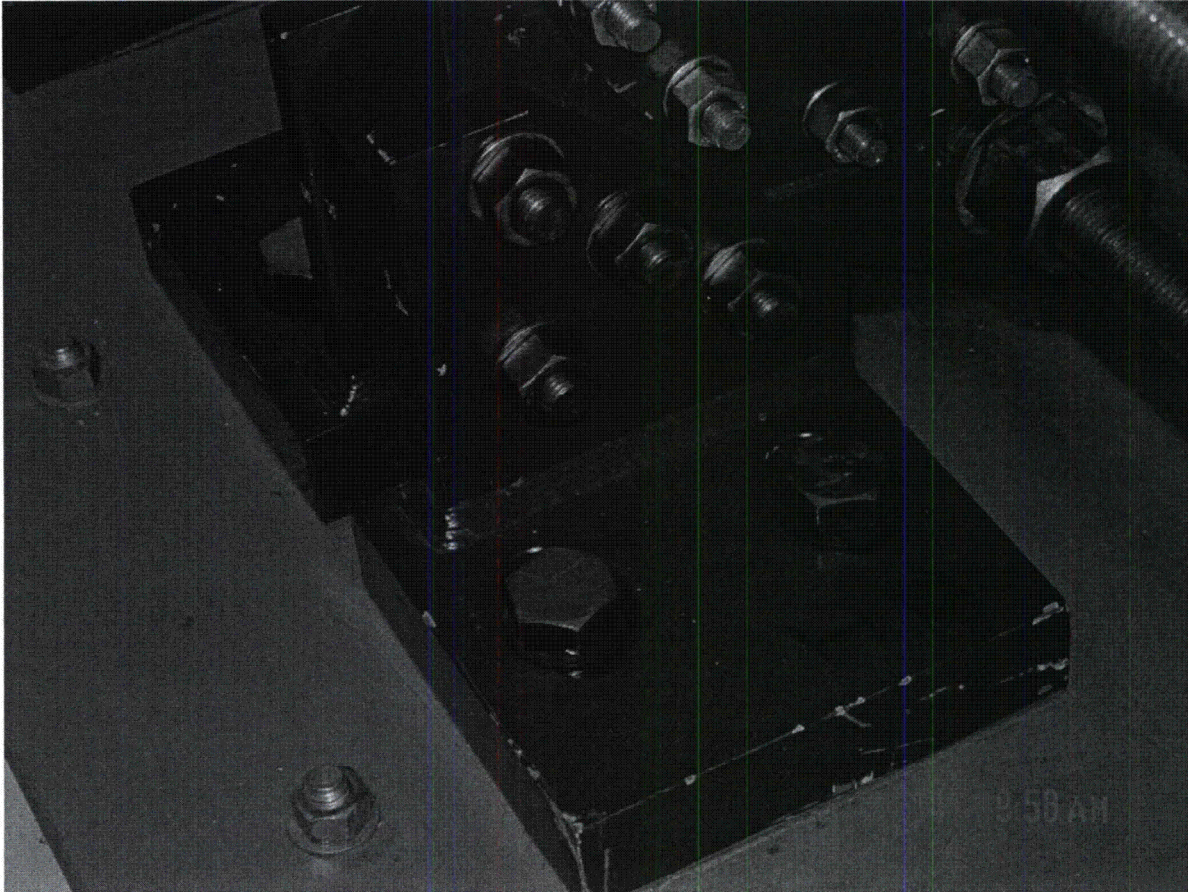
(DSC 01345)

3. Is the anchorage free of corrosion that is more than mild surface oxidation?  Y  N  U  N/A  
*Some anchorage has mild surface oxidation, see photo DSC 01345.*

Bolt Configuration

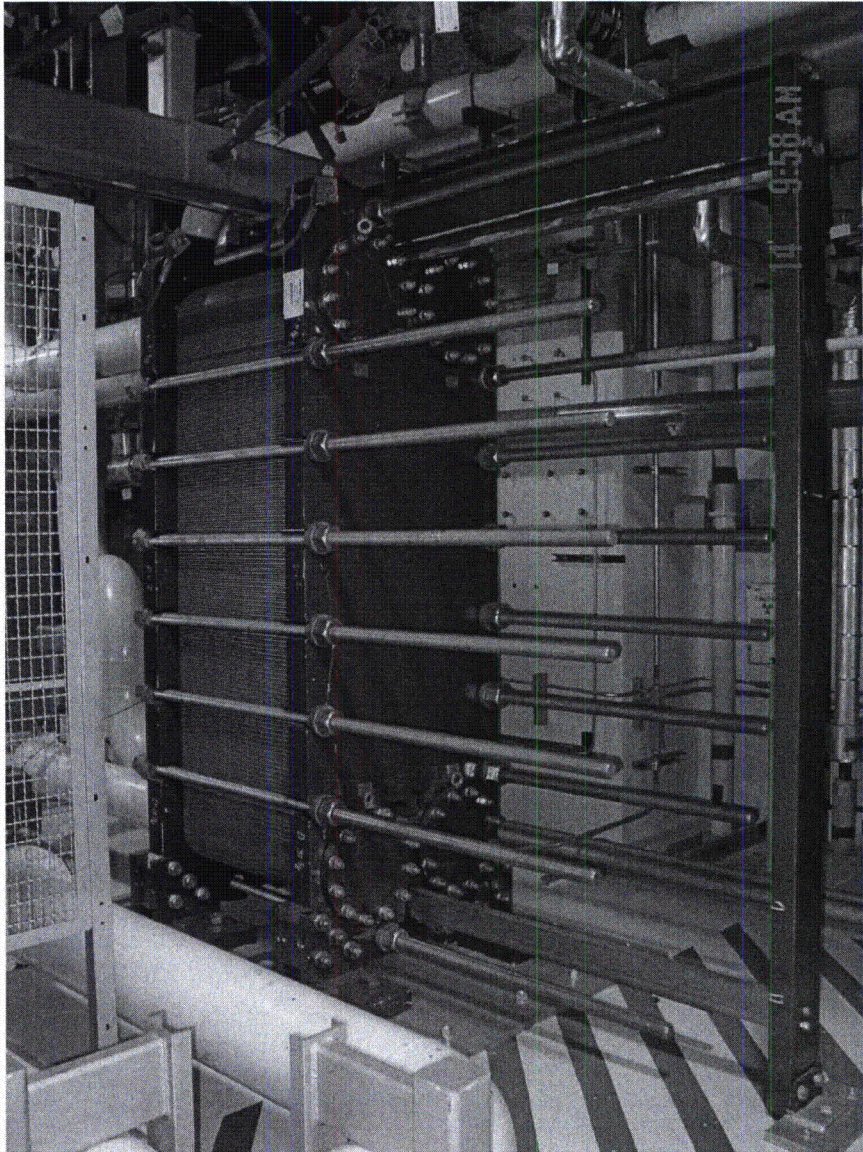
(DSC 01346)

7. Are soft targets free from impact by nearby equipment or structures?  Y  N  U  N/A  
*No soft targets identified on heat exchanger. Nearby piping, conduits are adequately supported.*
8. Are overhead equipment, distribution systems, ceiling tiles and lighting, and masonry block walls not likely to collapse onto the equipment?  Y  N  U  N/A  
*No ceiling tiles, lighting or masonry block walls over this equipment. All other commodities are adequately supported.*
9. Do attached lines have adequate flexibility to avoid damage?  Y  N  U  N/A  
*Attached lines to heat exchanger have adequate flexibility.*
10. Based on the above seismic interaction evaluations, is equipment free of potentially adverse seismic interaction effects?  Y  N  U  
*The equipment is free of potentially adverse seismic interaction. See photo DSC 01346.*
-

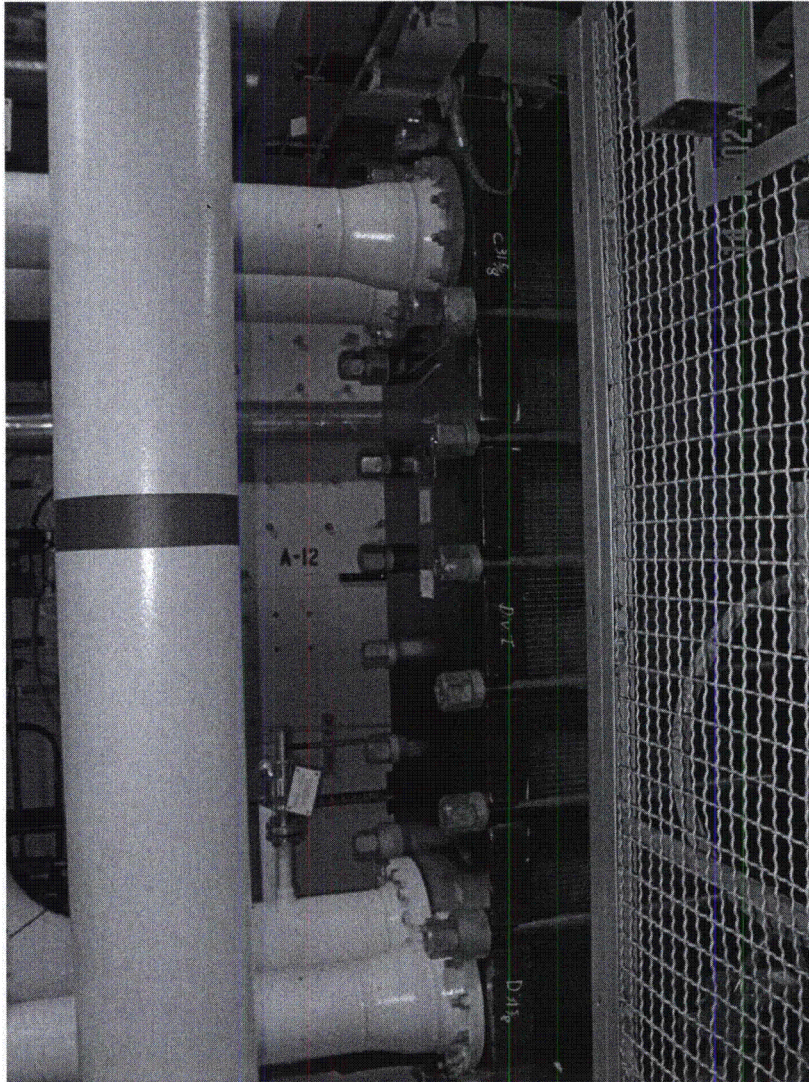
(DSC 01348)

6. Based on the above anchorage evaluations, is the anchorage free of potentially adverse seismic conditions?  Y  N  U  
*The anchorage is free of potentially adverse seismic conditions, see photo DSC 01348.*

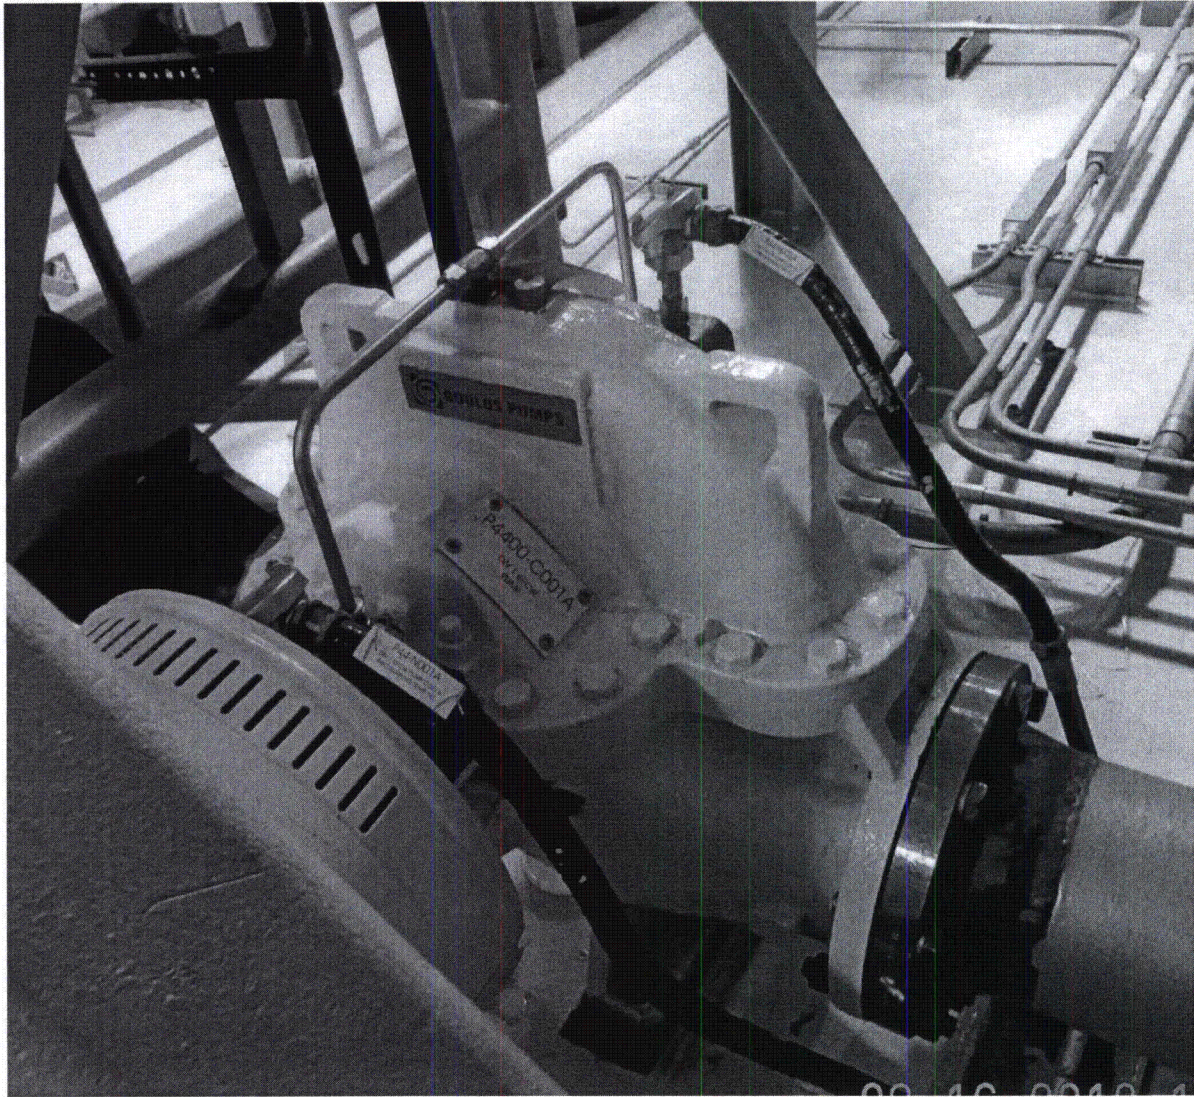
(016.JPG)

9. Do attached lines have adequate flexibility to avoid damage?  Y  N  U  N/A  
*Attached lines have adequate flexibility to avoid damage during seismic event. See Photo 016.JPG for condition of pump's flex hoses.*

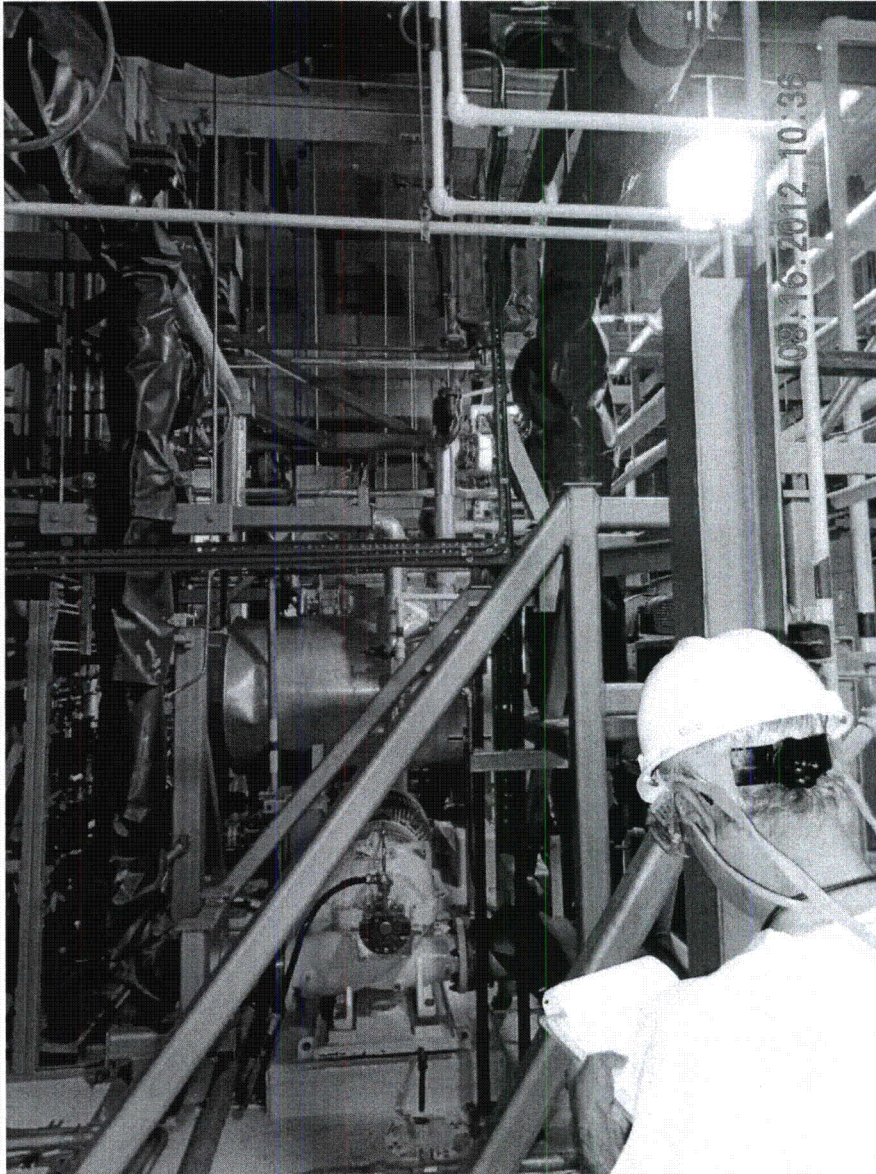
(017.JPG)

10. Based on the above seismic interaction evaluations, is equipment free of potentially adverse seismic interaction effects?  Y  N  U  
*Equipment and adjacent commodities are adequately supported and free of potentially adverse seismic interaction conditions. See Photo 017.JPG for overall view of nearby commodities.*

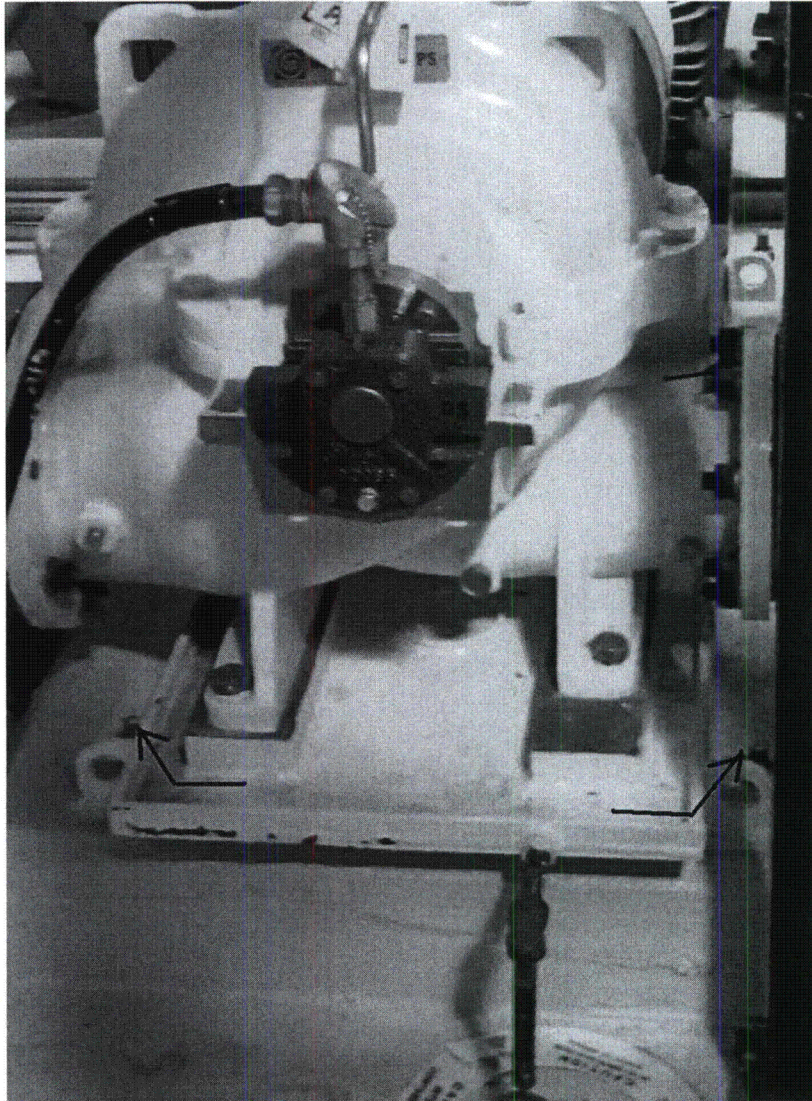
(015.JPG, Bolt to Concrete Pad)

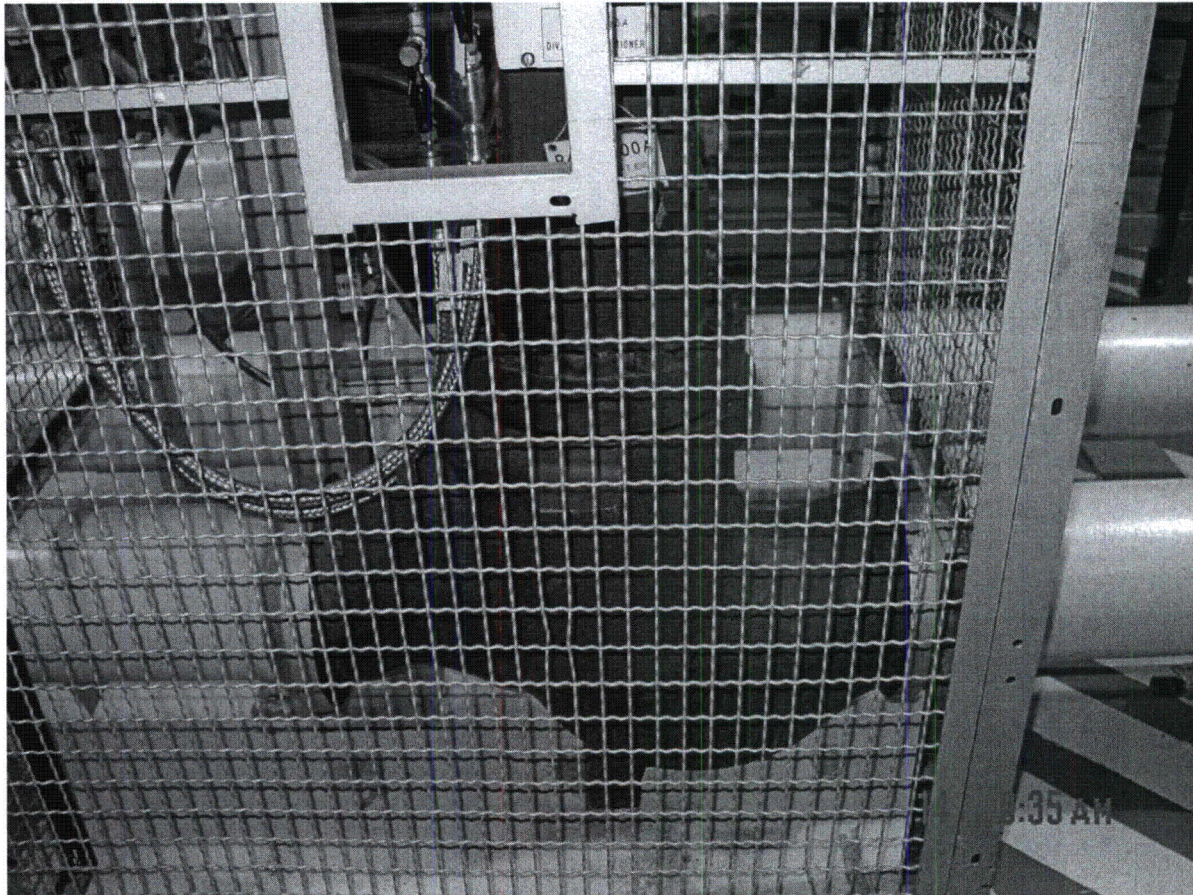
(DSC 01338)

Equipment ID No. P44F400A Equipment Class: 7, Pneumatic Operated Valves

Equipment Description EECW Div. I HX Outlet Temp Ctrl AOV (valve)

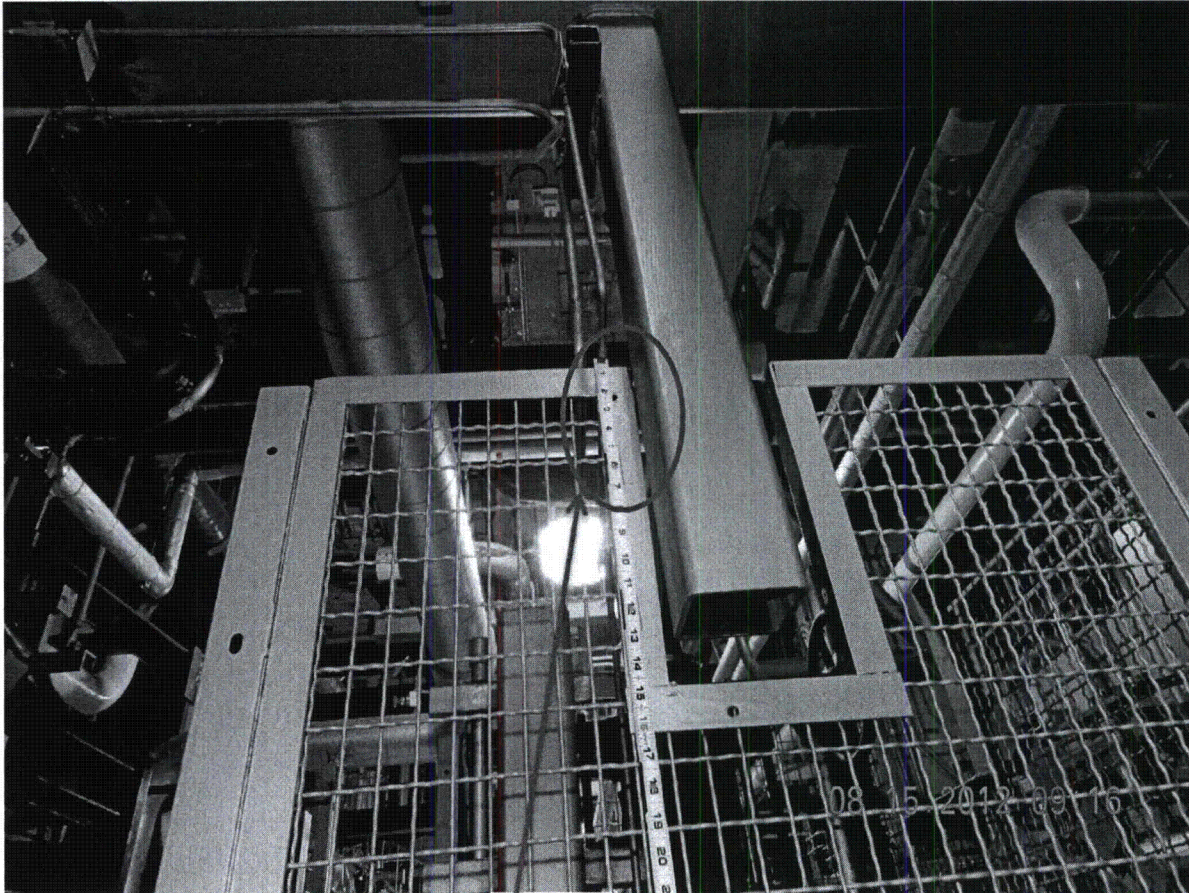
(Photo 2)

Tubing Close to Cage

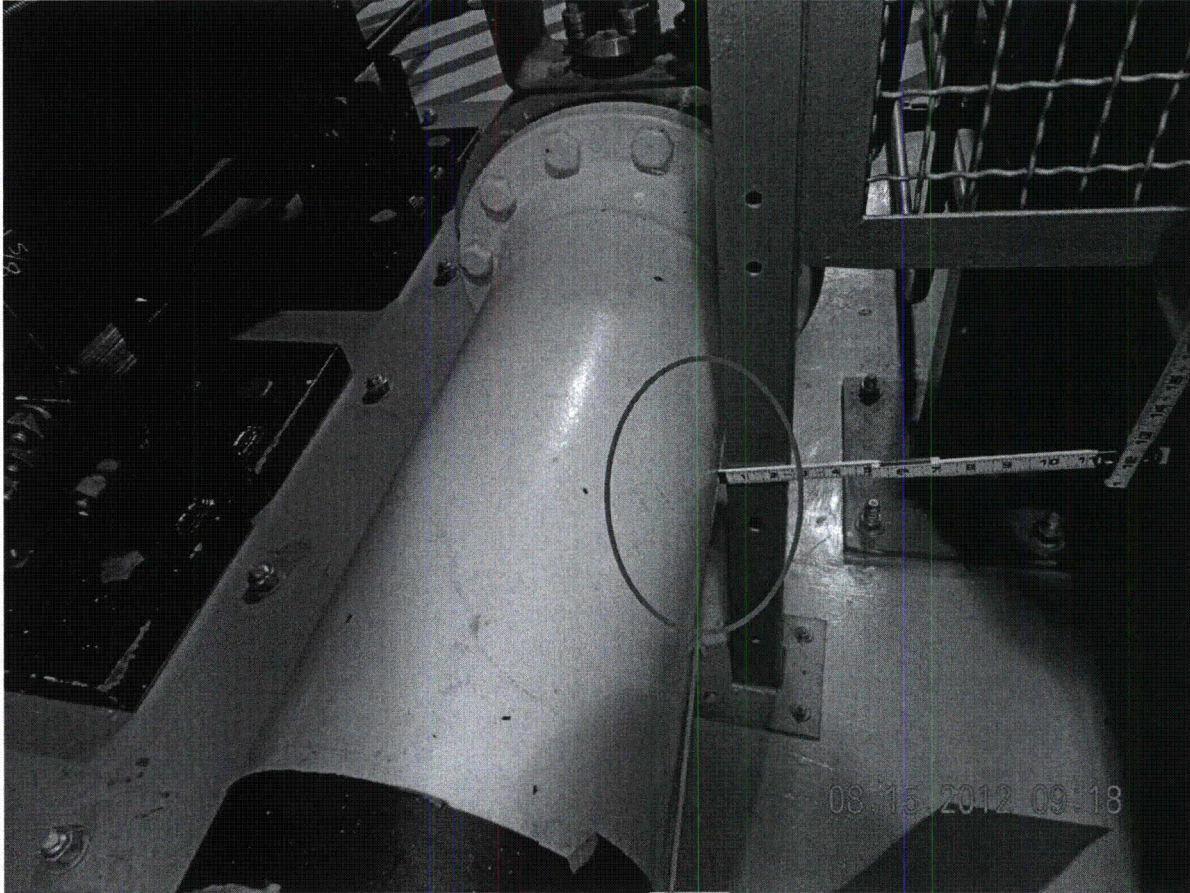
(Photo 1)

Pipe Close to Cage
