Fermi 2 Seismic Walkdown Guidance Document  
Seismic Walkdown Checklist

Seismic Walkdown Checklist (SWC)

Equipment Description H21-P624 Div. 1 Bus 64C Dedicated Shutdown Panel

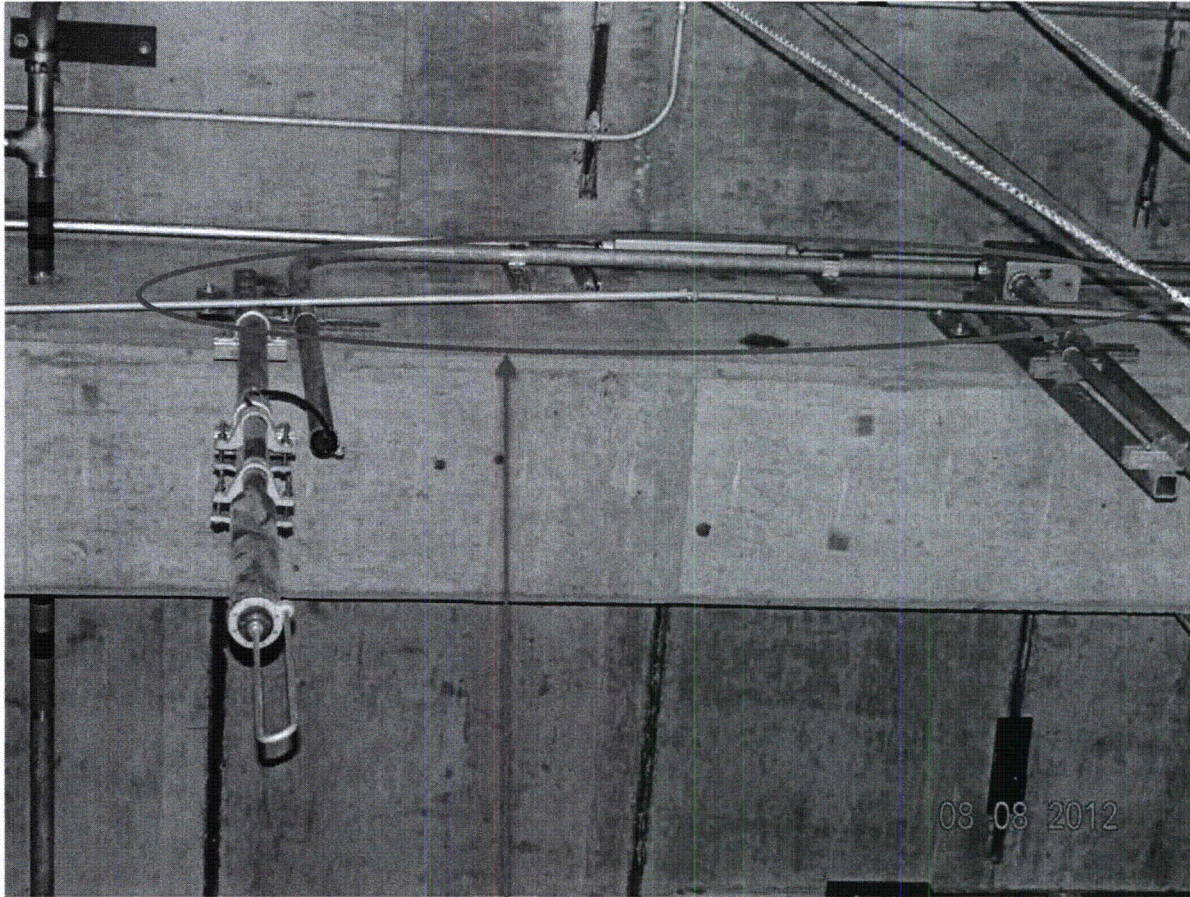
(DSC 00296)

Conduit "Unsupported"

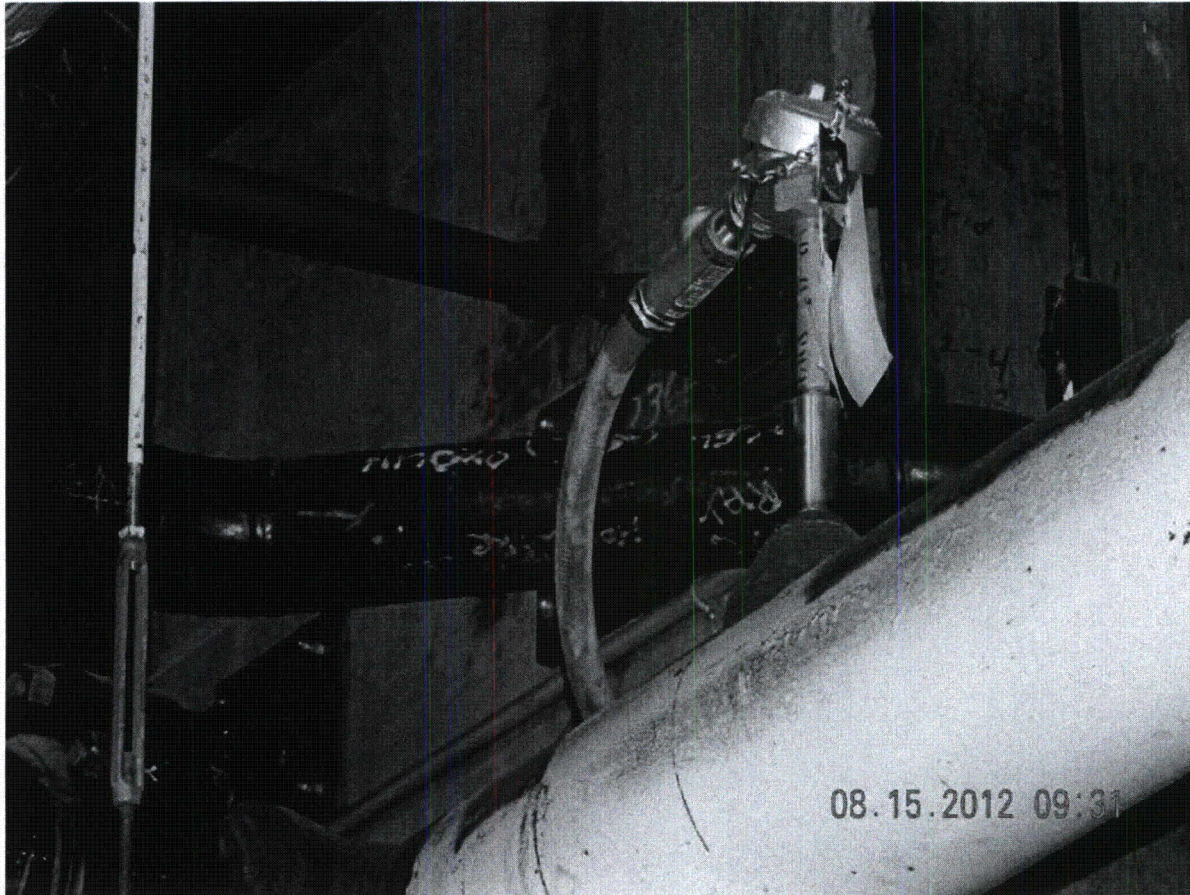
(Photo 004)

7. Are soft targets free from impact by nearby equipment or structures?  Y  N  U  N/A  
*No overhead objects are nearby that could impact the sensor (see Photo 004). Strut and pipe in photo are closest objects and well supported.*
8. Are overhead equipment, distribution systems, ceiling tiles and lighting, and masonry block walls not likely to collapse onto the equipment?  Y  N  U  N/A  
*No ceiling tiles, lighting or masonry block walls. All other systems are adequately supported (see Photo 005).*
9. Do attached lines have adequate flexibility to avoid damage?  Y  N  U  N/A  
*Conduit lines attached to thermocouple have adequate flexibility.*
10. Based on the above seismic interaction evaluations, is equipment free of potentially adverse seismic interaction effects?  Y  N  U

Equipment ID No. P44N401A    Equipment Class: 19, Temperature Sensors

Equipment Description EECW HX B001A/B001C Rtrn T/C (Thermocouple)

9. Do attached lines have adequate flexibility to avoid damage?  Y  N  U  N/A    
*Since attached lines have adequate flexibility, seismic interaction is not a concern (see Photo 004.jpg).*
