Fermi 2 Seismic Walkdown Guidance Document  
Seismic Walkdown Checklist

NJPR-12-0043

**Seismic Walkdown Checklist (SWC)**

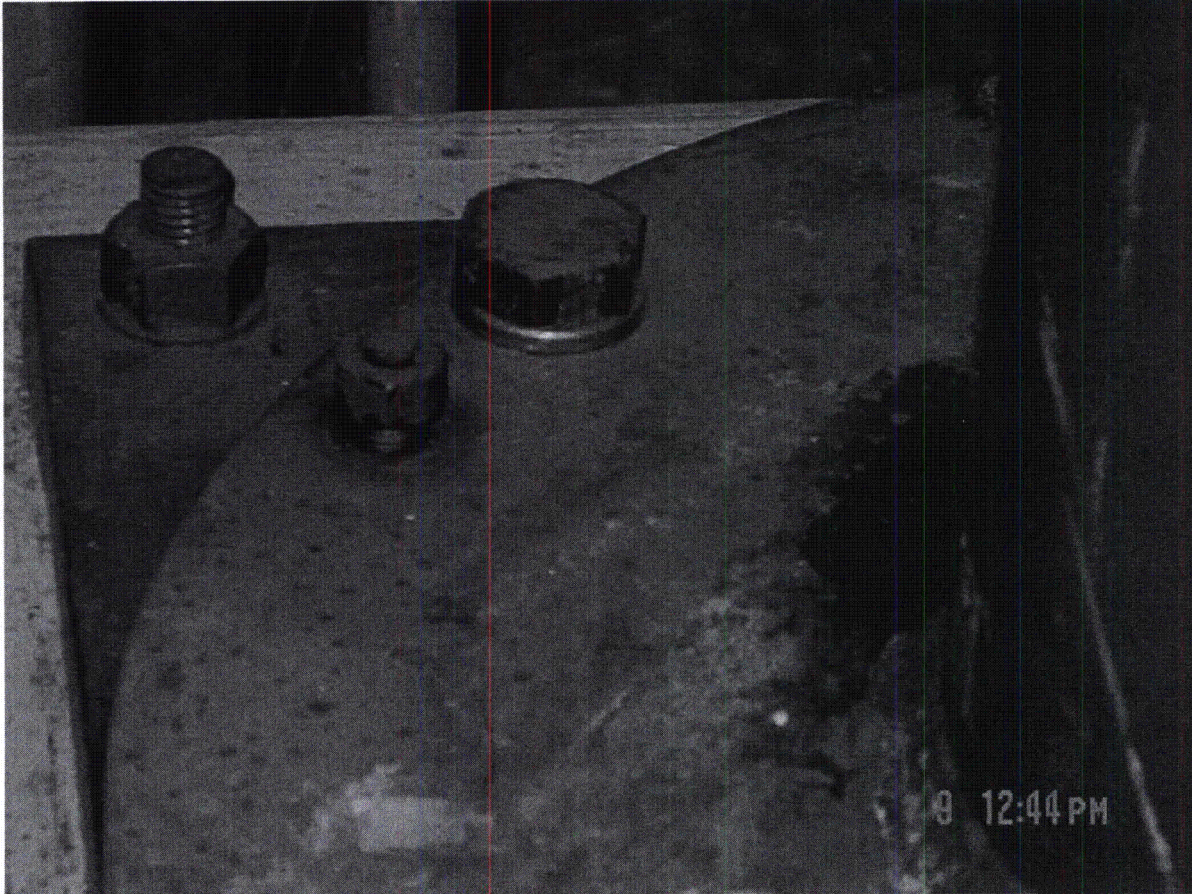
(Picture #2)

3. Is the anchorage free of corrosion that is more than mild surface oxidation?  Y  N  U  N/A  
*There is only mild surface oxidation. (See Picture 2.)*

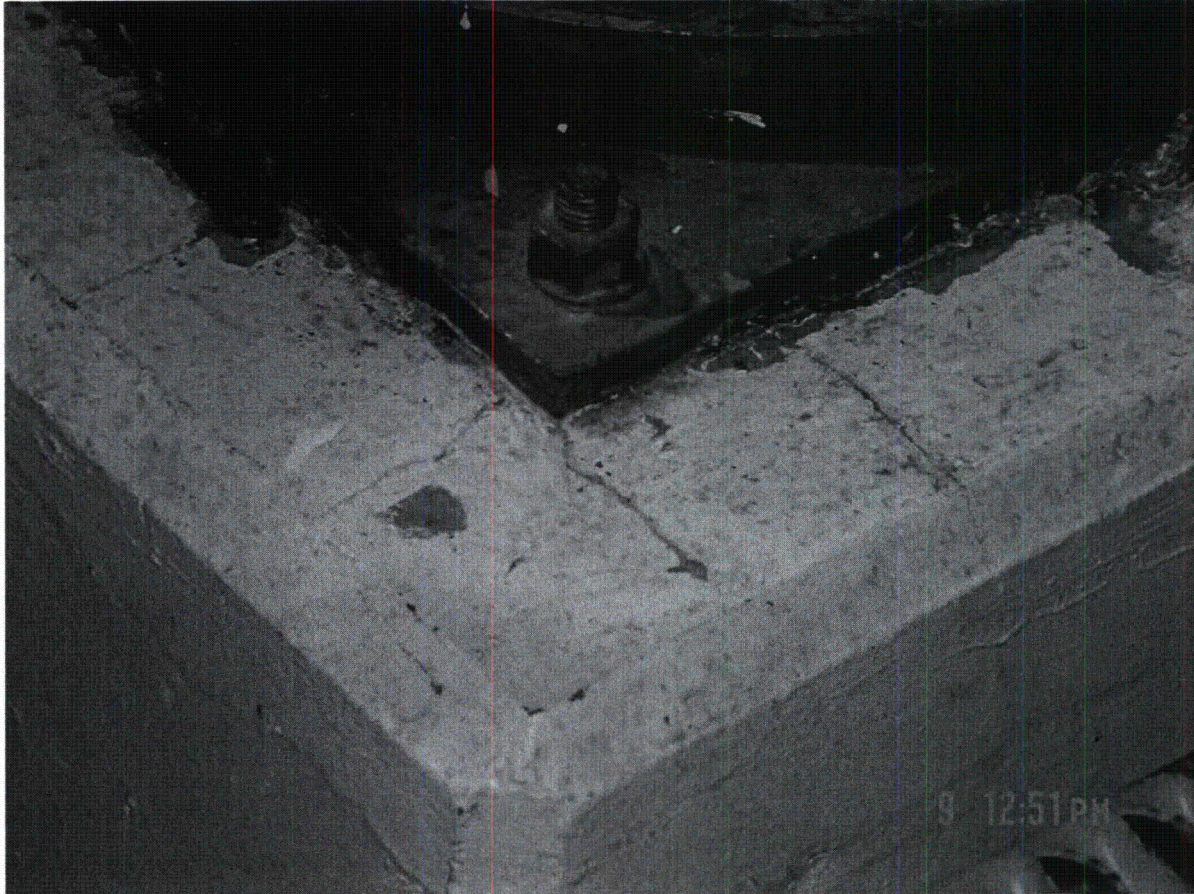
(Picture #3)

4. Is the anchorage free of visible cracks in the concrete near the anchors?  Y  N  U  N/A  
*There are some surface cracks at the top of the concrete pedestal, but these would not affect the seismic integrity of the asset (NW quadrant and East face of pedestal). (See Picture 3.)*

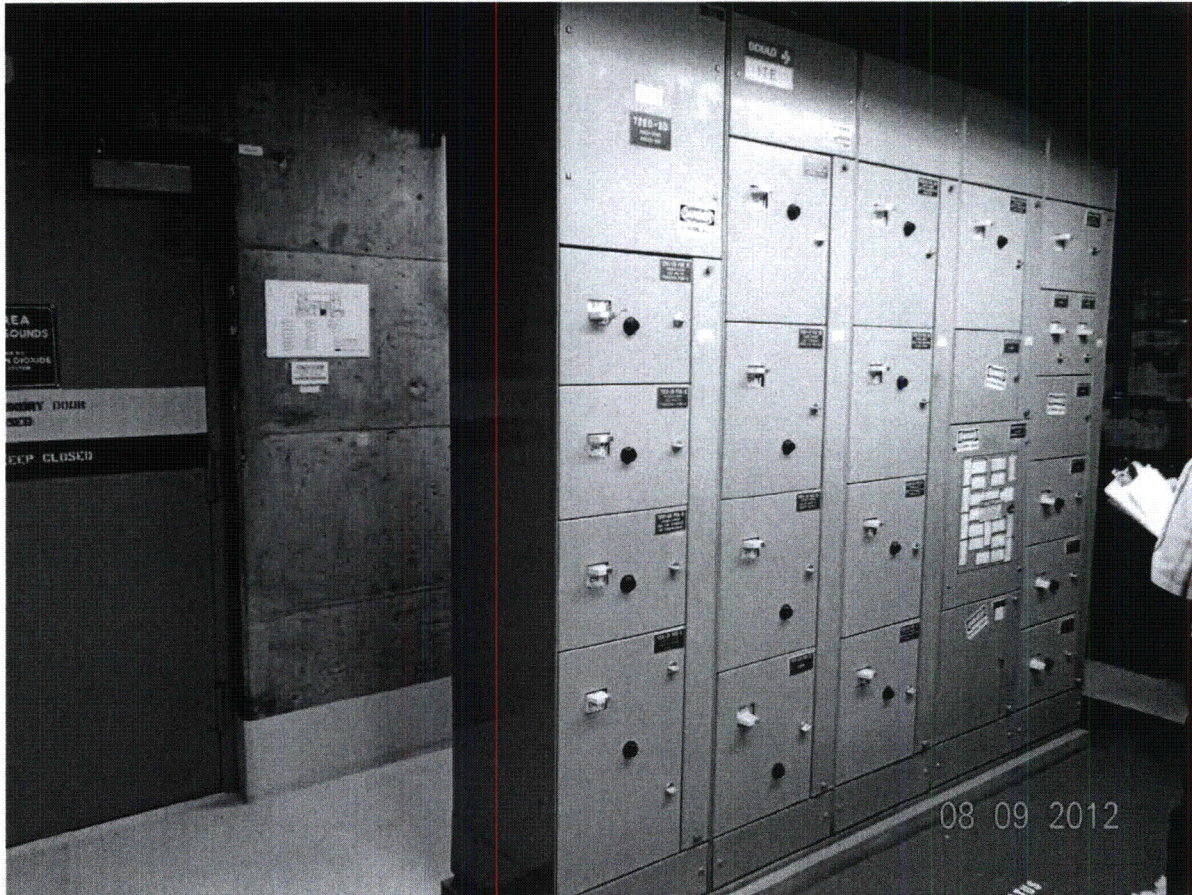
(DSC 00338)

11. Have you looked for and found no other seismic conditions that could adversely affect the safety functions of the equipment?  Y  N  U  
*Missing 1 out of 4 fasteners on panel at Position 4C (see Photo DSC 00338). Initiated CARD 12-27475 to install missing fastener.*

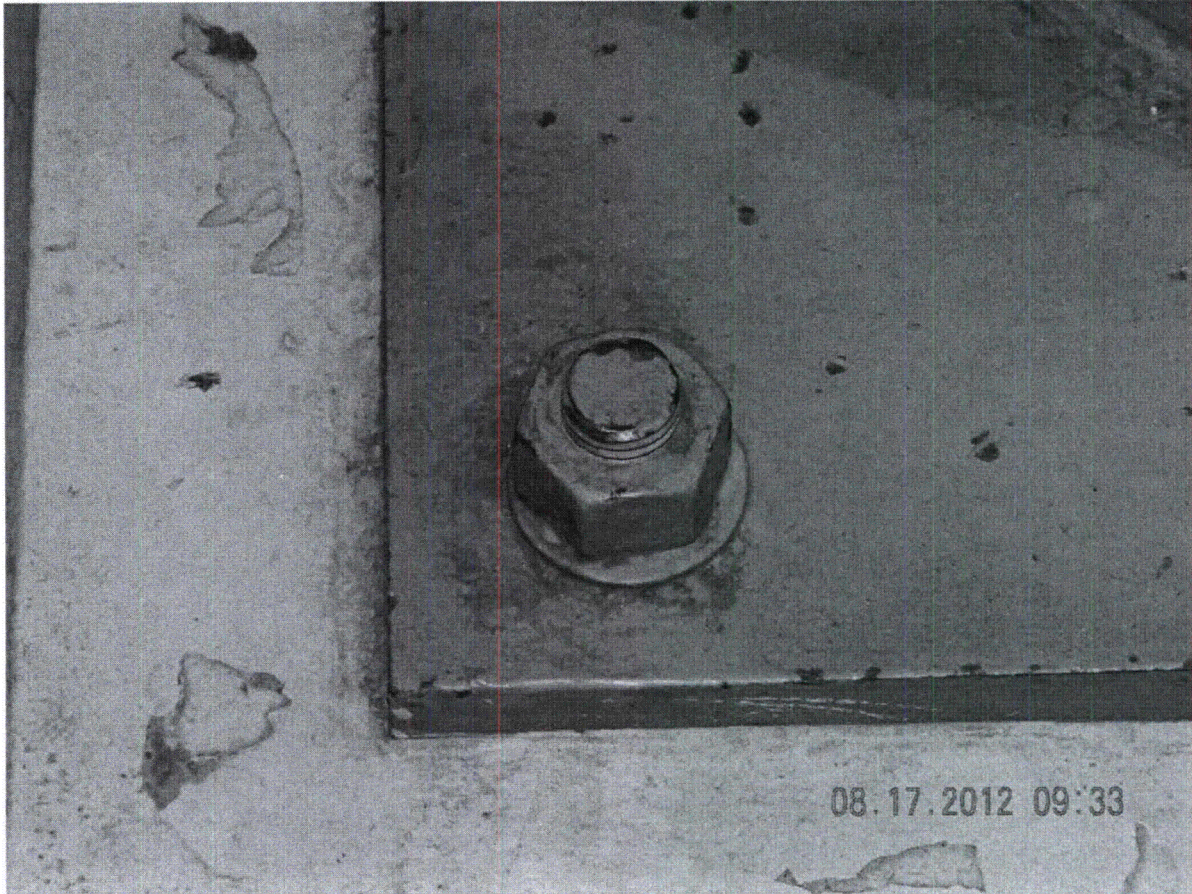
2. Is the anchorage free of bent, broken, missing or loose hardware? Y  N  U  N/A   
*Anchorage is in good condition. (See Photo DSCN 0522 and 0524).*

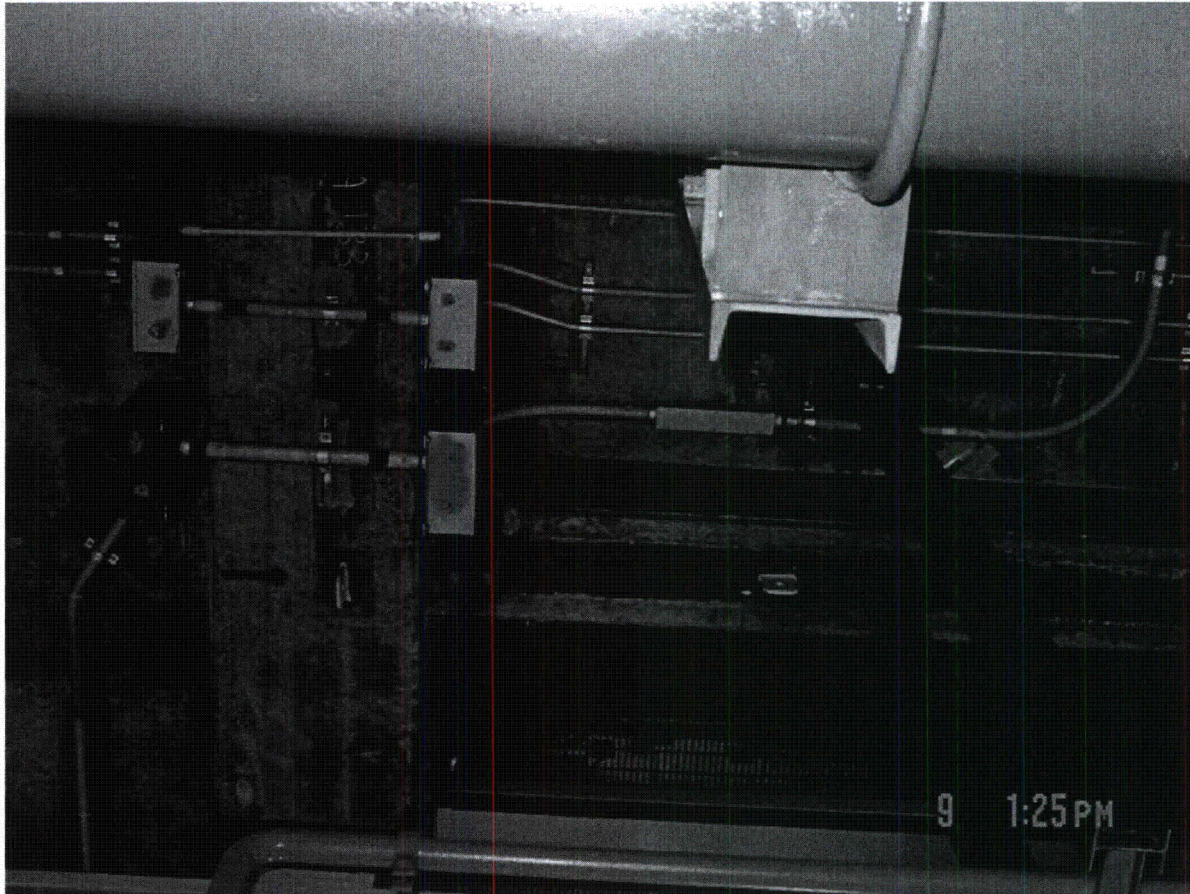
(Picture 9)

8. Are overhead equipment, distribution systems, ceiling tiles and lighting, and masonry block walls not likely to collapse onto the equipment?  Y  N  U  N/A   
*All overhead equipment and piping are adequately restrained from movement. See picture 9 showing the view above the asset. There are no masonry black walls in the vicinity.*
