Seismic Walkdown Checklist (SWC)

Equipment ID No. R30P320 Equip. Class¹ 20, Instrumentation and Control Panel

Equipment Description EDG 12 – Engine Gauge Panel

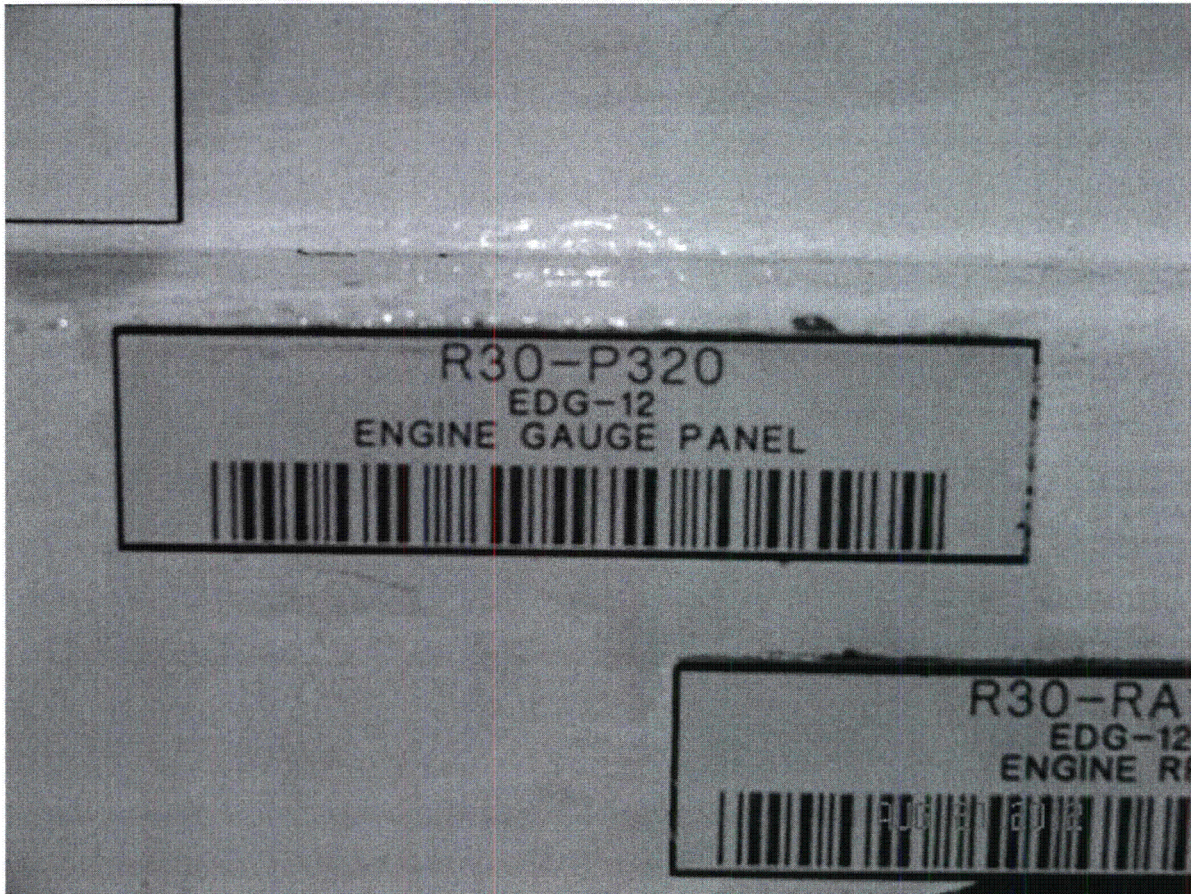
(DSC00095)

7. Are soft targets free from impact by nearby equipment or structures? Y N U N/A
All soft targets adjacent to this panel are robustly supported, and will not impact the panel
8. Are overhead equipment, distribution systems, ceiling tiles and lighting, and masonry block walls not likely to collapse onto the equipment? Y N U N/A
There are no ceiling tiles or block walls in the area. All light fittings hung from rigid conduit and have a redundant wire cable. During a seismic event the lights will not impact equipment
9. Do attached lines have adequate flexibility to avoid damage? Y N U N/A
Attached lines are flexible, and are acceptable
10. Based on the above seismic interaction evaluations, is equipment free of potentially adverse seismic interaction effects? Y N U

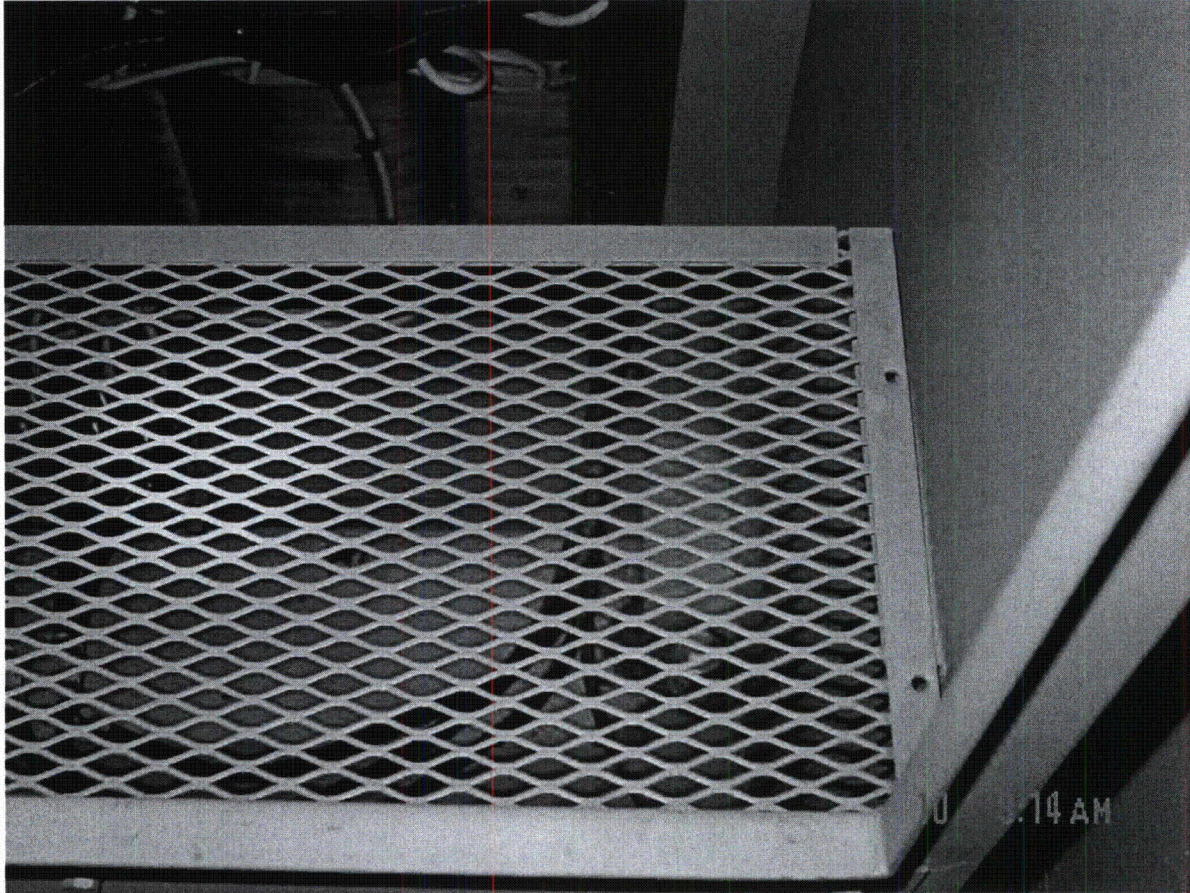
(Picture 3)

11. Have you looked for and found no other seismic conditions that could adversely affect the safety functions of the equipment? Y N U
During the walkdown it was noticed that 4 screws were missing from the panel's interior protective grate. The existing condition was evaluated by the SWE's by calculation and determination acceptable during a seismic event. See CARD 12-27360 for resolution.
(SEE PICTURE 3) ~ DJR 10/11/12

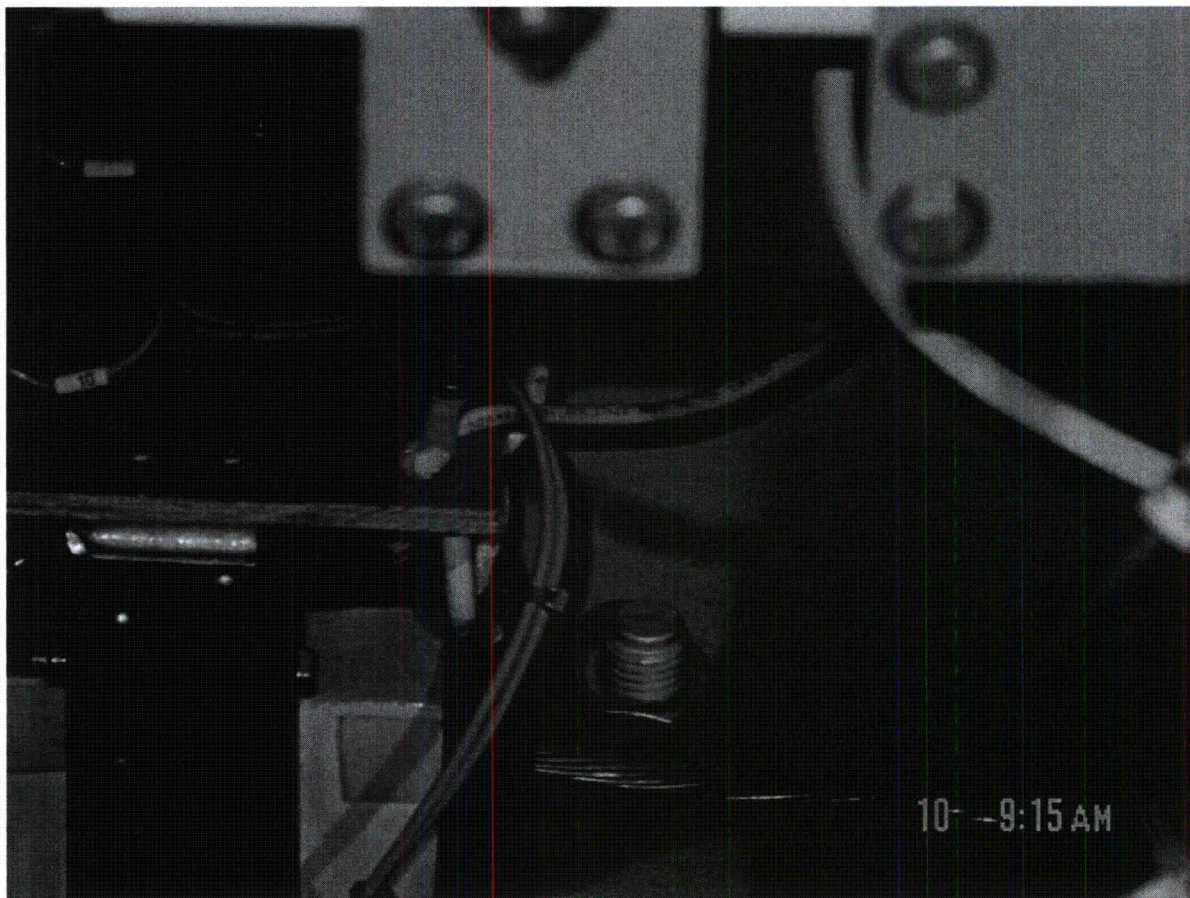
(Picture 4)

2. Is the anchorage free of bent, broken, missing or loose hardware? Y N U N/A
Anchorage was viewed from outside the panel and was in good condition. (See Picture 4.)

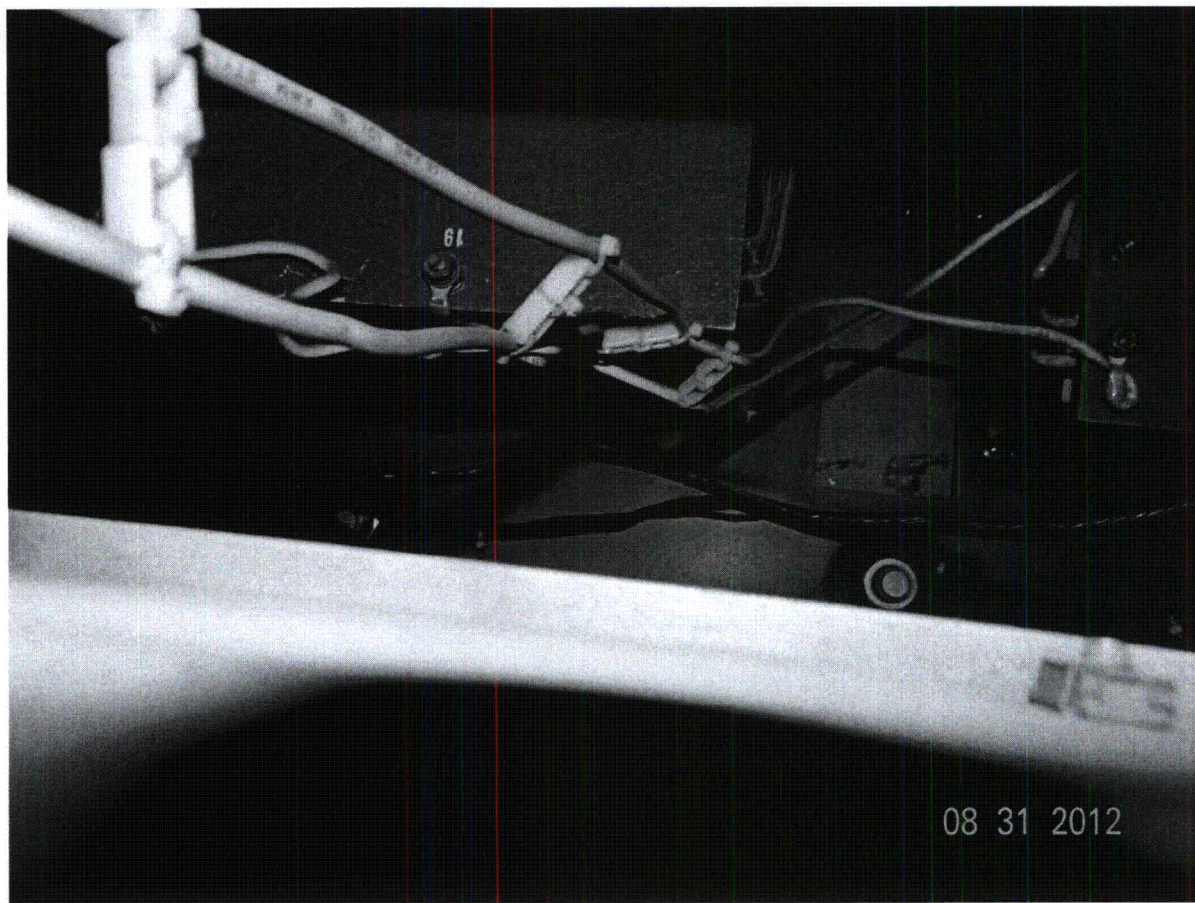
(Picture 6)

5. Is the anchorage configuration consistent with plant documentation? Y N U N/A
(Note: This question only applies if the item is one of the 50% for which anchorage configuration verification is required.)
*All anchors observed to be in the proper layout and conform to Calc. DC-6037 VOL I, Rev. C. One anchor was not immediately visible, but it was confirmed to be in place during a follow-up inspection. * See Comments and Picture 6. DC-6037 VOL. I, Rev. C HAS NO APPLICABLE POSTINGS.*

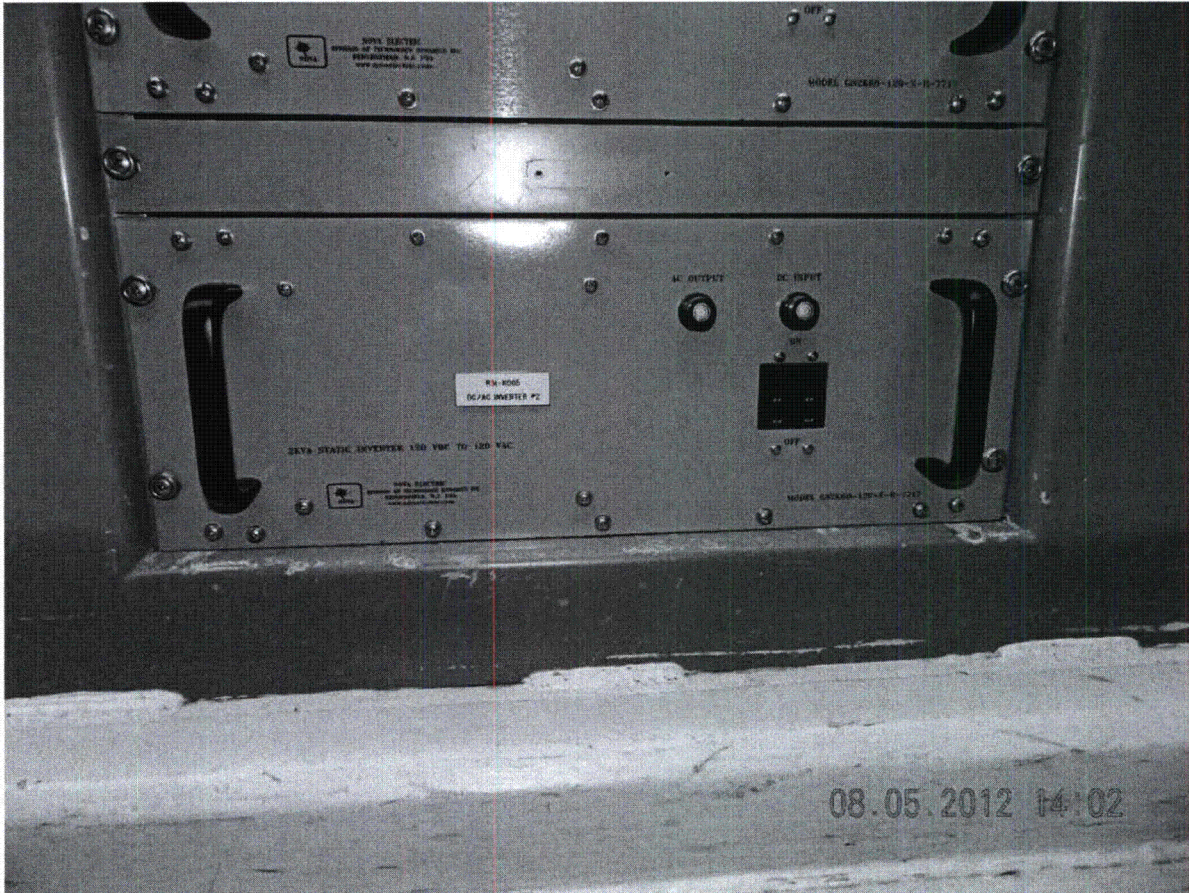
(DSCN0051)

1. Is the anchorage configuration verification required (i.e., is the item one of the 50% of SWEL items requiring such verification)? Y N U
*Equipment mounted in cabinet. Cabinet missing plug weld. Welds exterior to cabinet confirmed to be correct. No plug welds required.
Ok as is. (SEE PICTURE D5CN0051) ~ DJK 10/11/12*

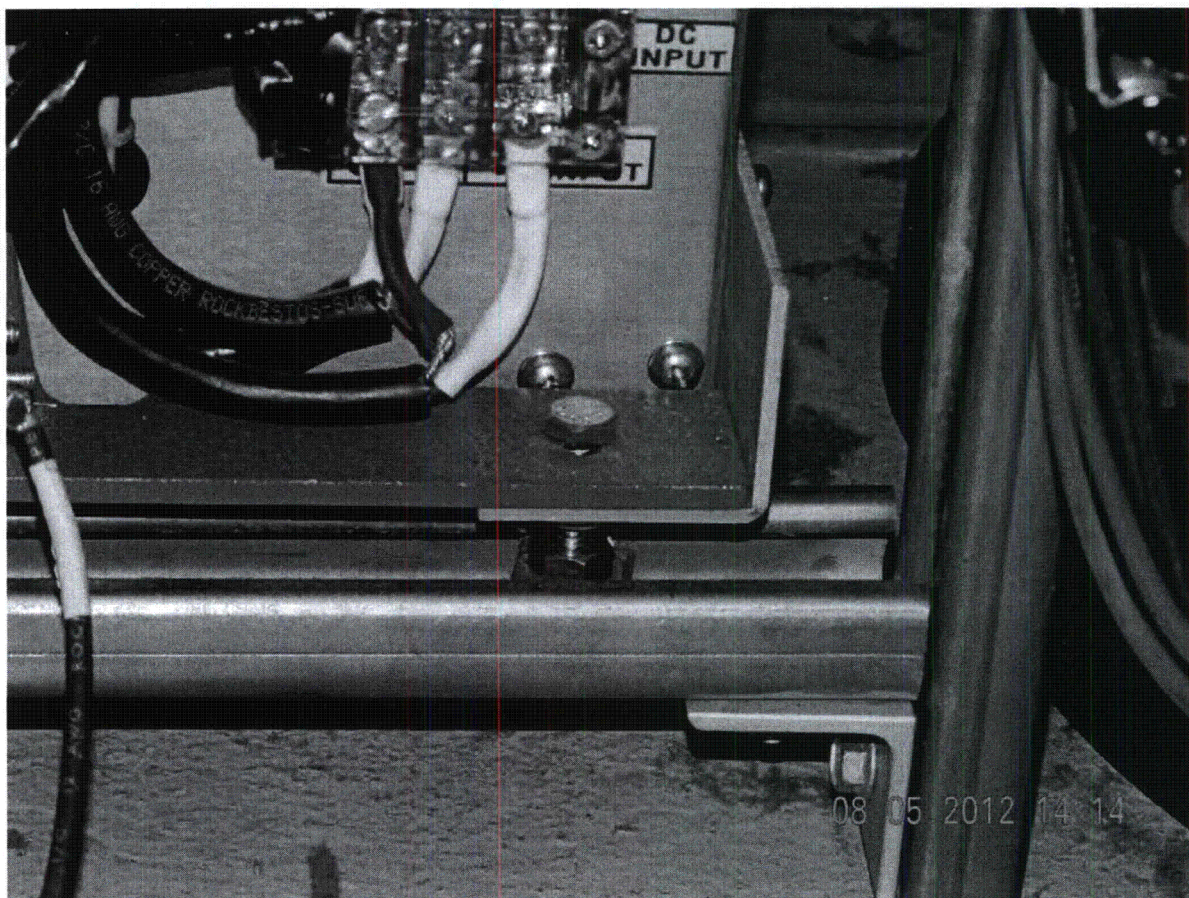
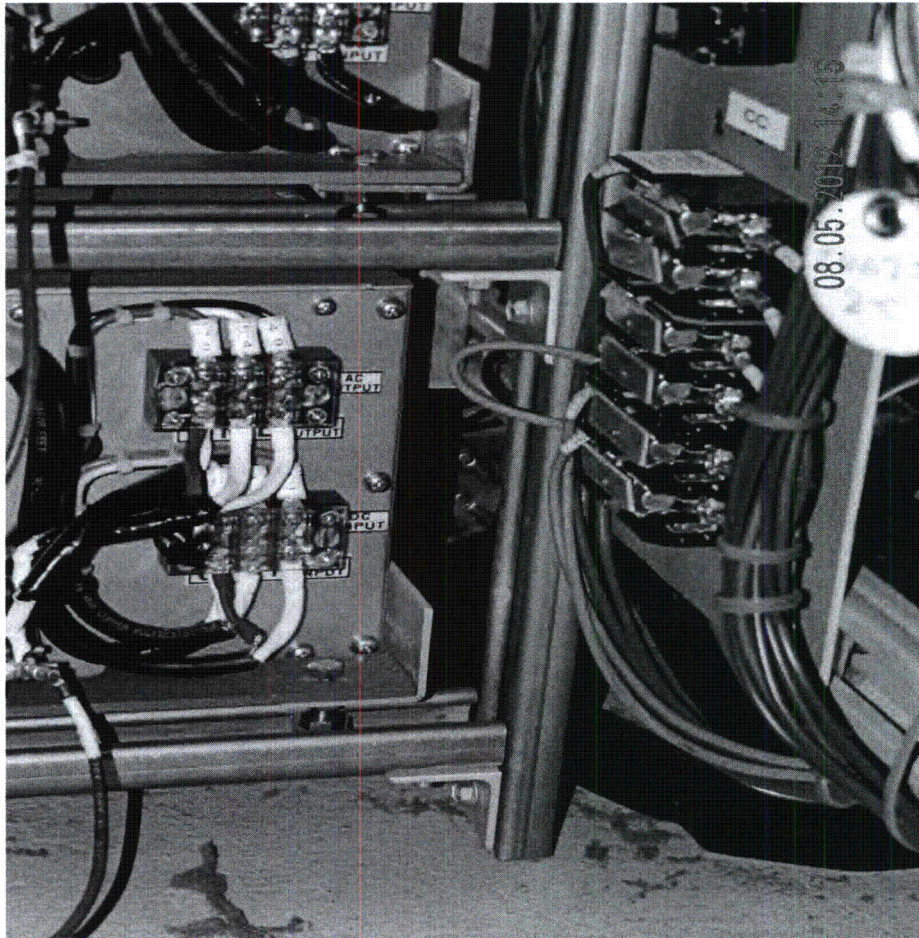
4. Is the anchorage free of visible cracks in the concrete near the anchors? Y N U N/A
*Equipment is mounted in a cabinet, not to concrete.
(SEE PICTURES D5CN0055, D5CN0057) ~ DJK 10/11/12*

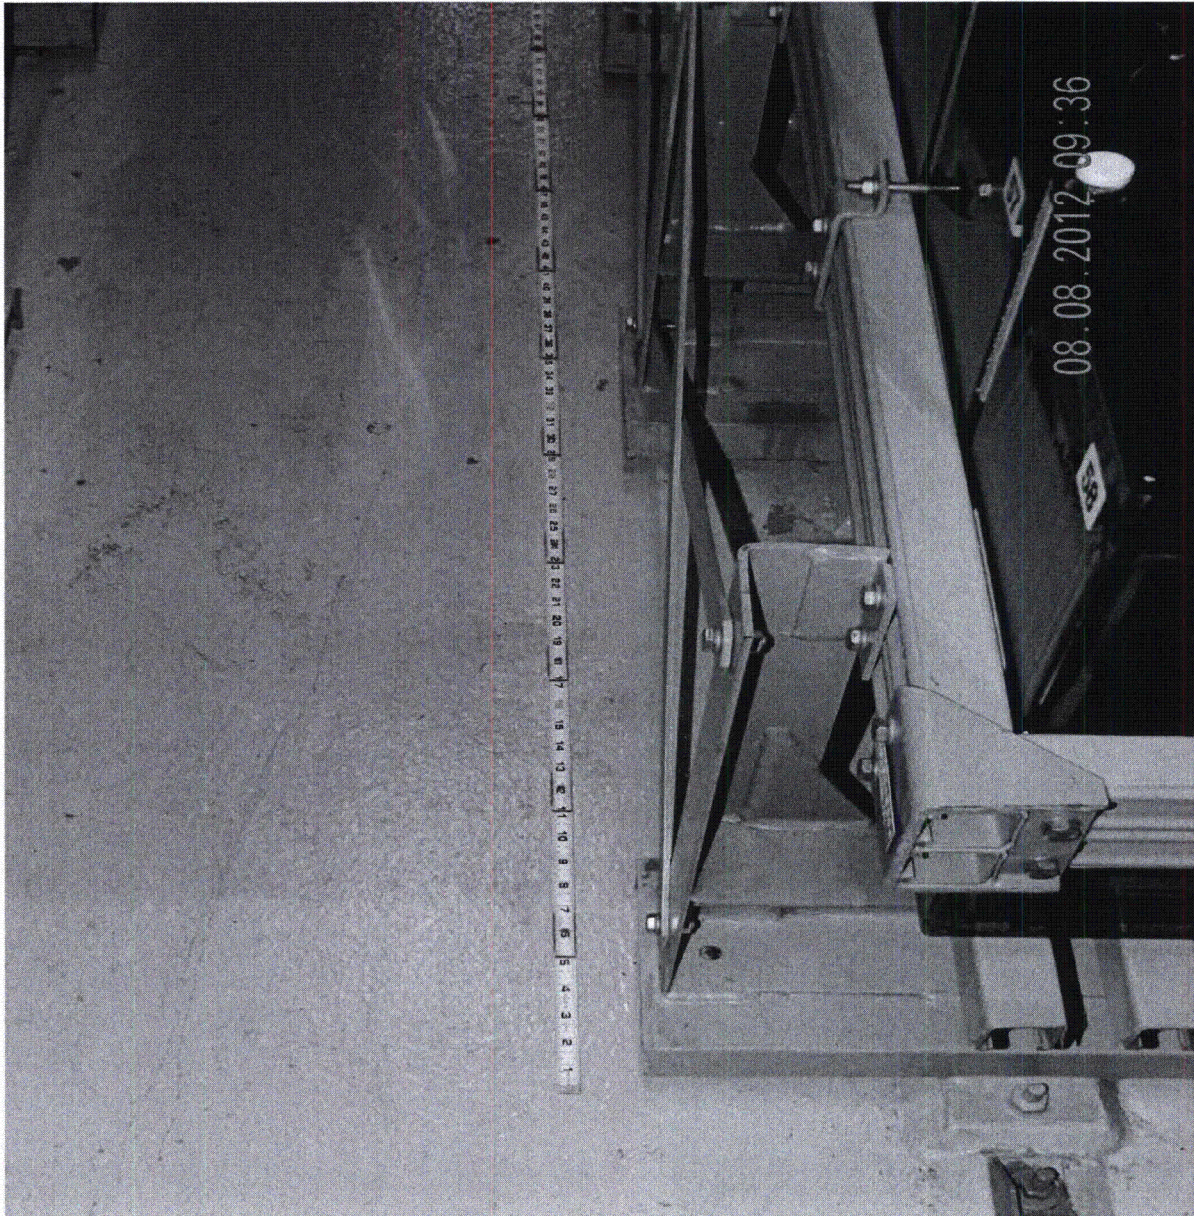
(DSCN0119)

3. Is the anchorage free of corrosion that is more than mild surface oxidation? Y N U N/A
No corrosion visible.
(SEE PICTURES DSCN0119, DSCN0126, DSCN0129, DSCN0135) ~ DJK 10/11/12

4. Is the anchorage free of visible cracks in the concrete near the anchors? Y N U N/A
No cracks in concrete.
(SEE PICTURES DSCN0119, DSCN0126, DSCN0129, DSCN0135) ~ DJK 10/11/12

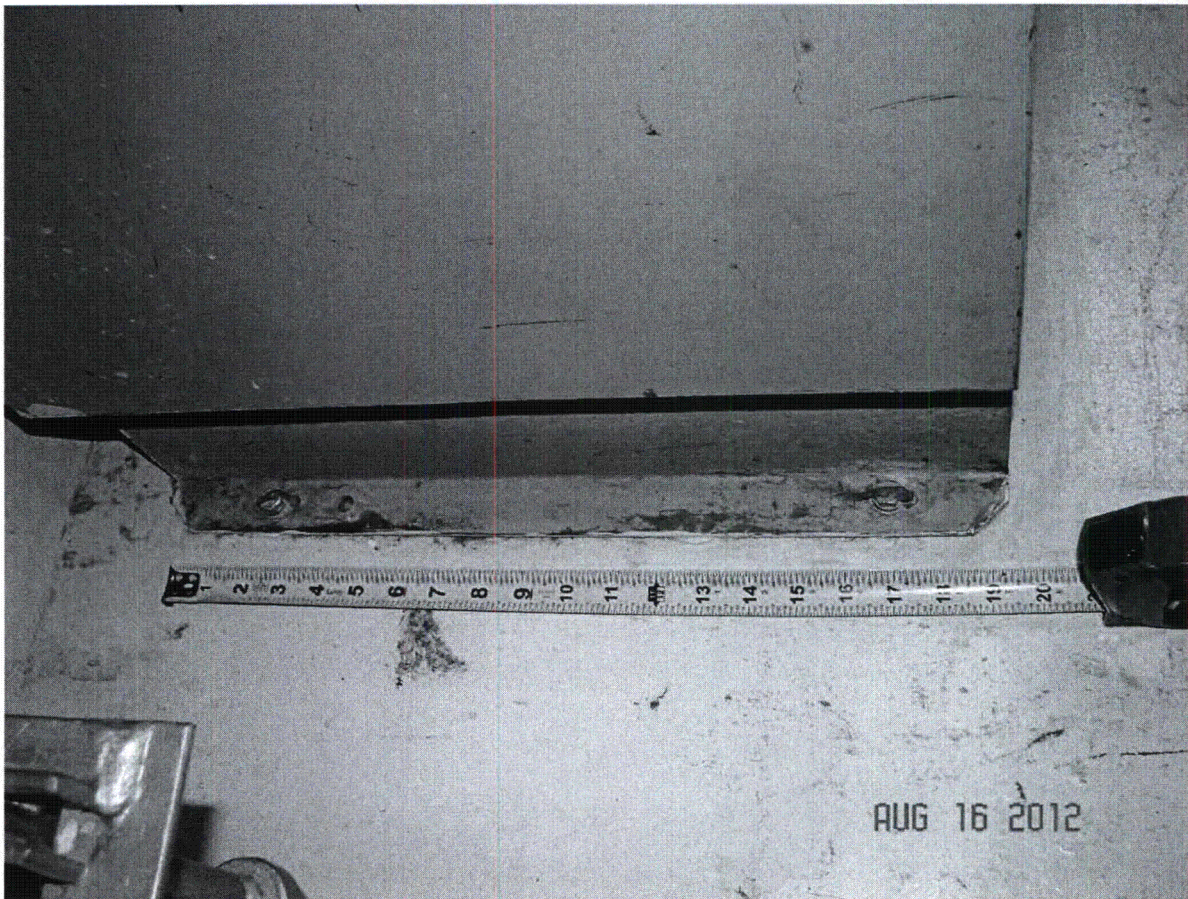
(DSC0071)

2. Is the anchorage free of bent, broken, missing or loose hardware? Y N U N/A
All 4 bolts installed properly. (SEE PICTURES DSC0068, DSC0071) DSK 10/9/12

3. Is the anchorage free of corrosion that is more than mild surface oxidation? Y N U N/A
Clean, no oxidation. (SEE PICTURES DSC0068, DSC0071) DSK 10/9/12

Bolting Configuration to Concrete Floor

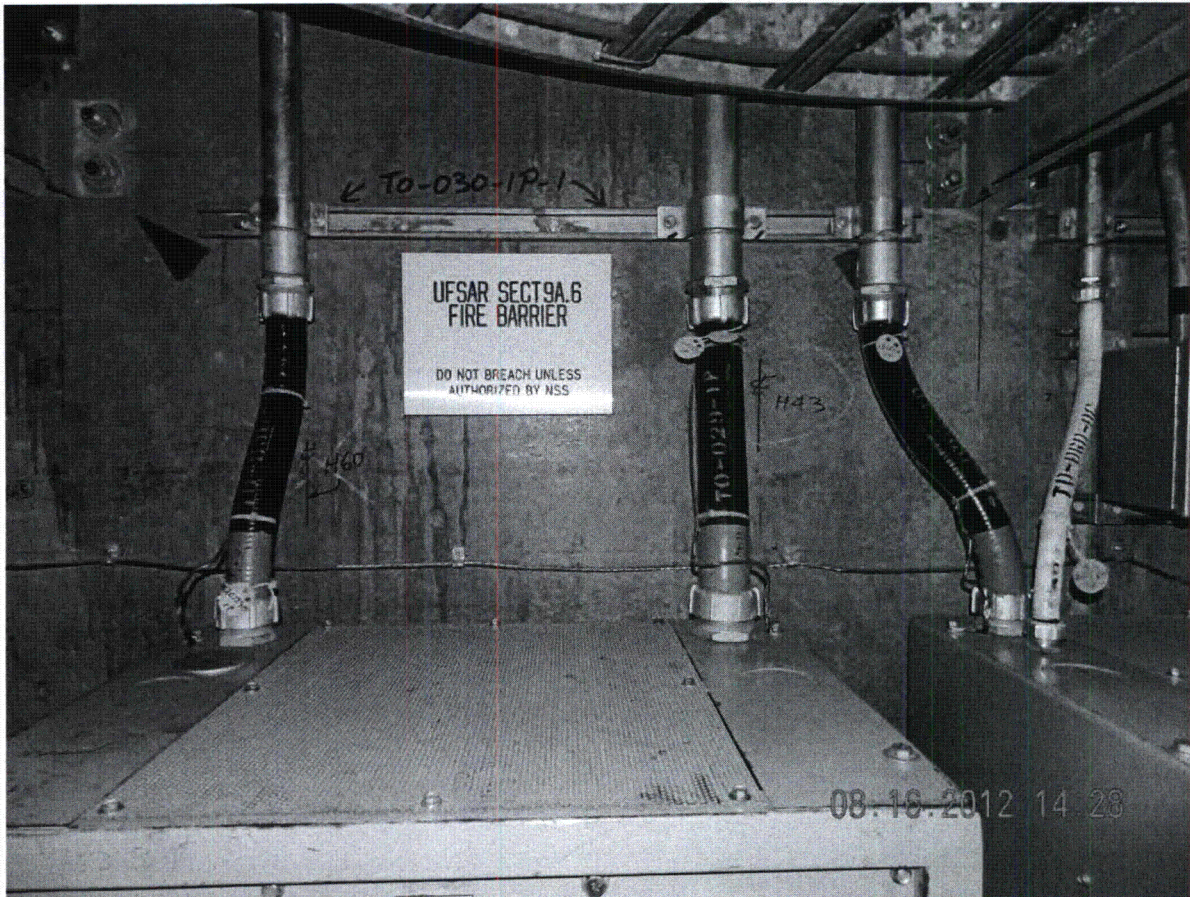
(DSCN0481)

Overhead Cable Tray and Flexible Conduits to Battery Charger
