NJPR-12-0043

**Missing Seismic Walkdown Checklist (SWC)**

Equipment ID No. T4100B009 Equip. Class<sup>1</sup> 11, Chillers

Equipment Description CCHVAC North Div 1 Air Conditioner Chiller

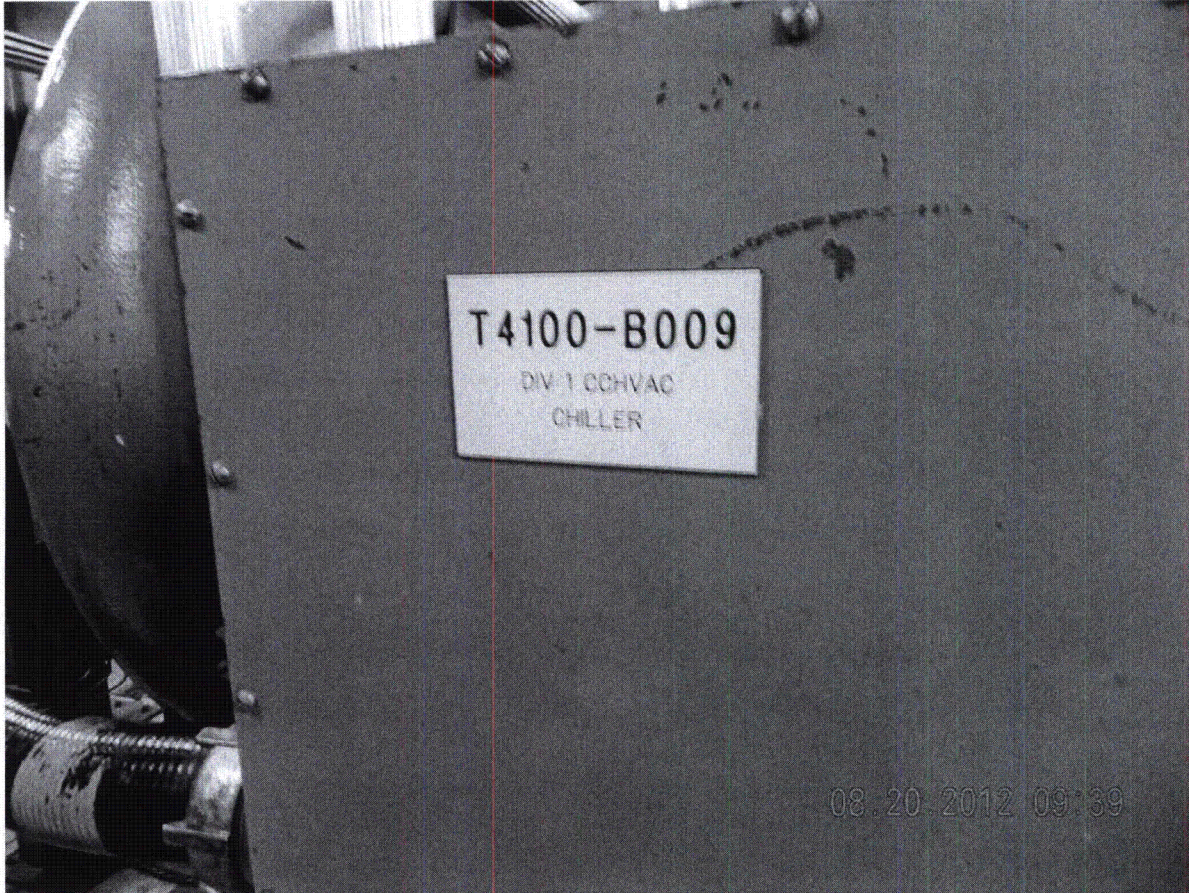
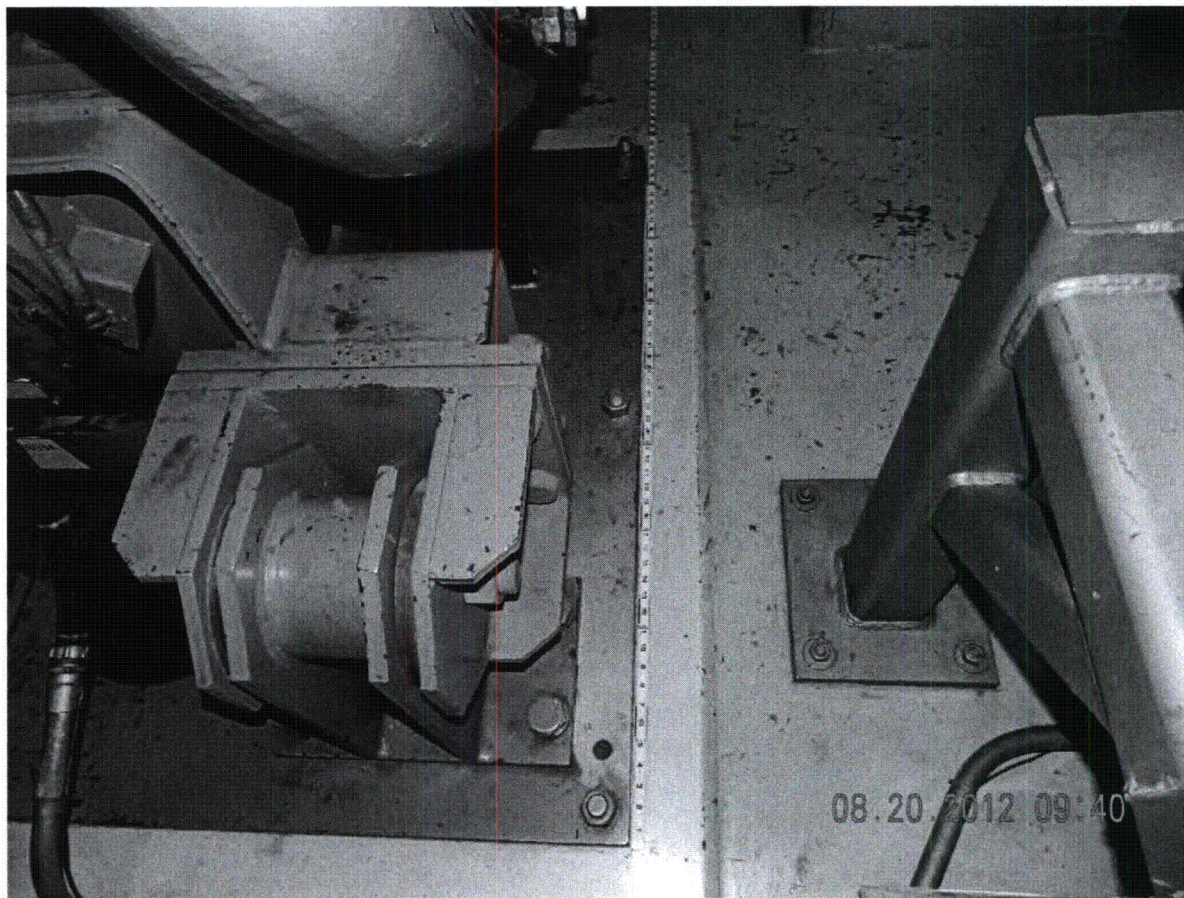
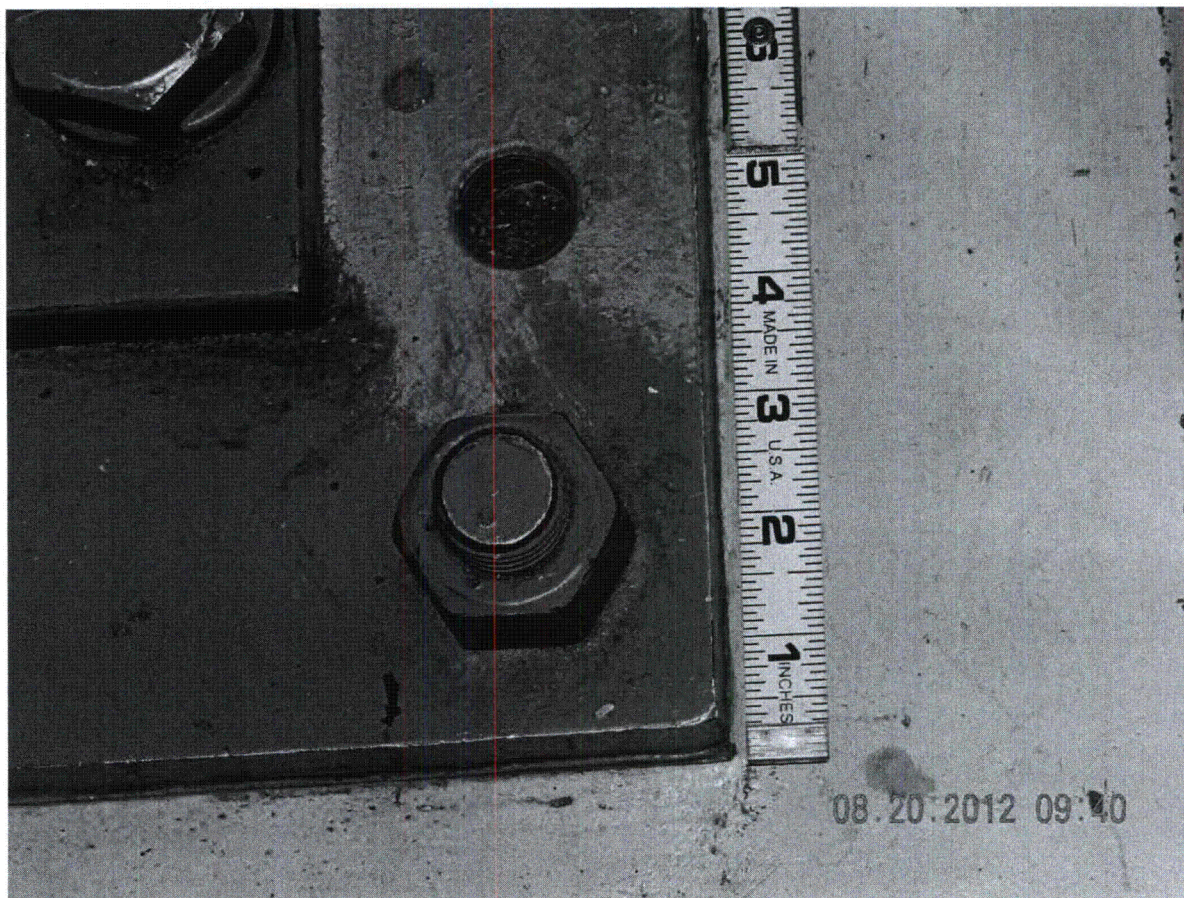
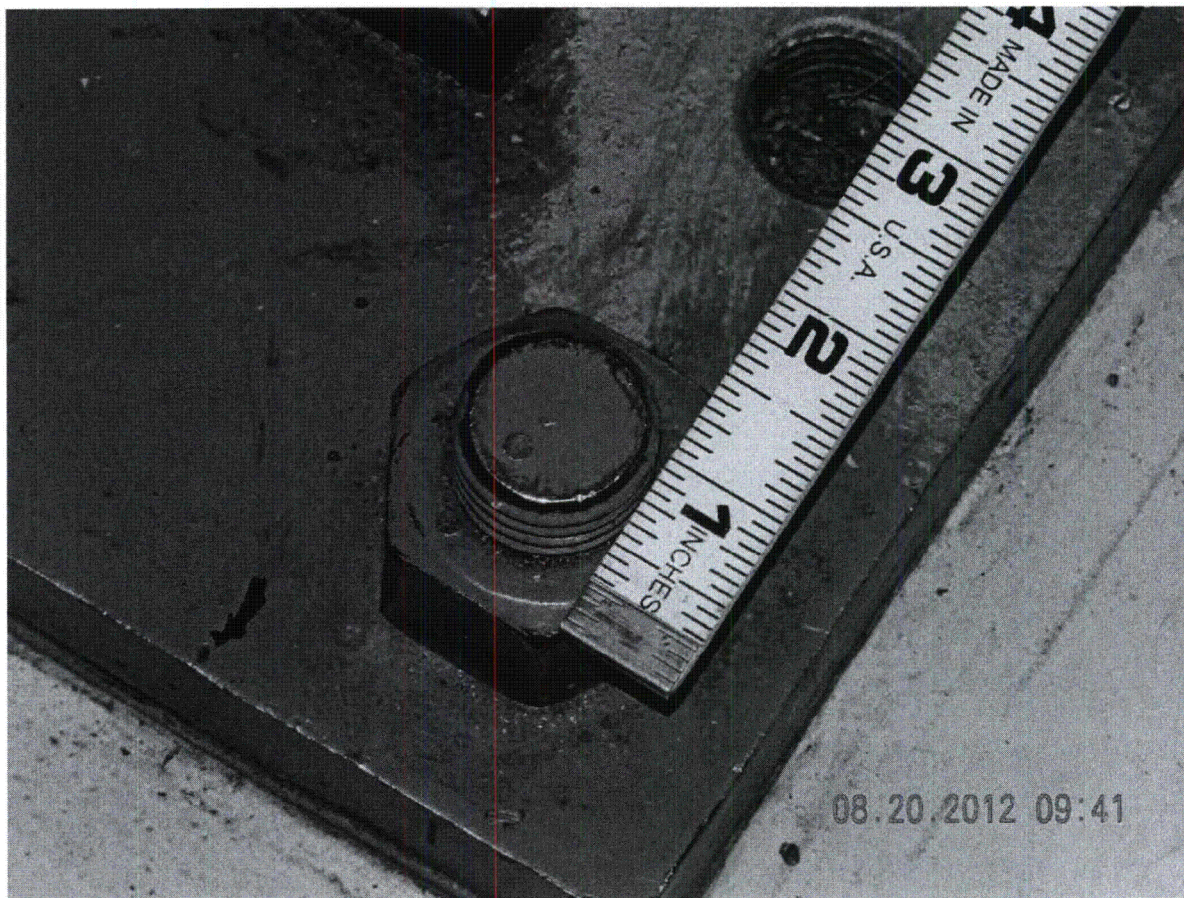
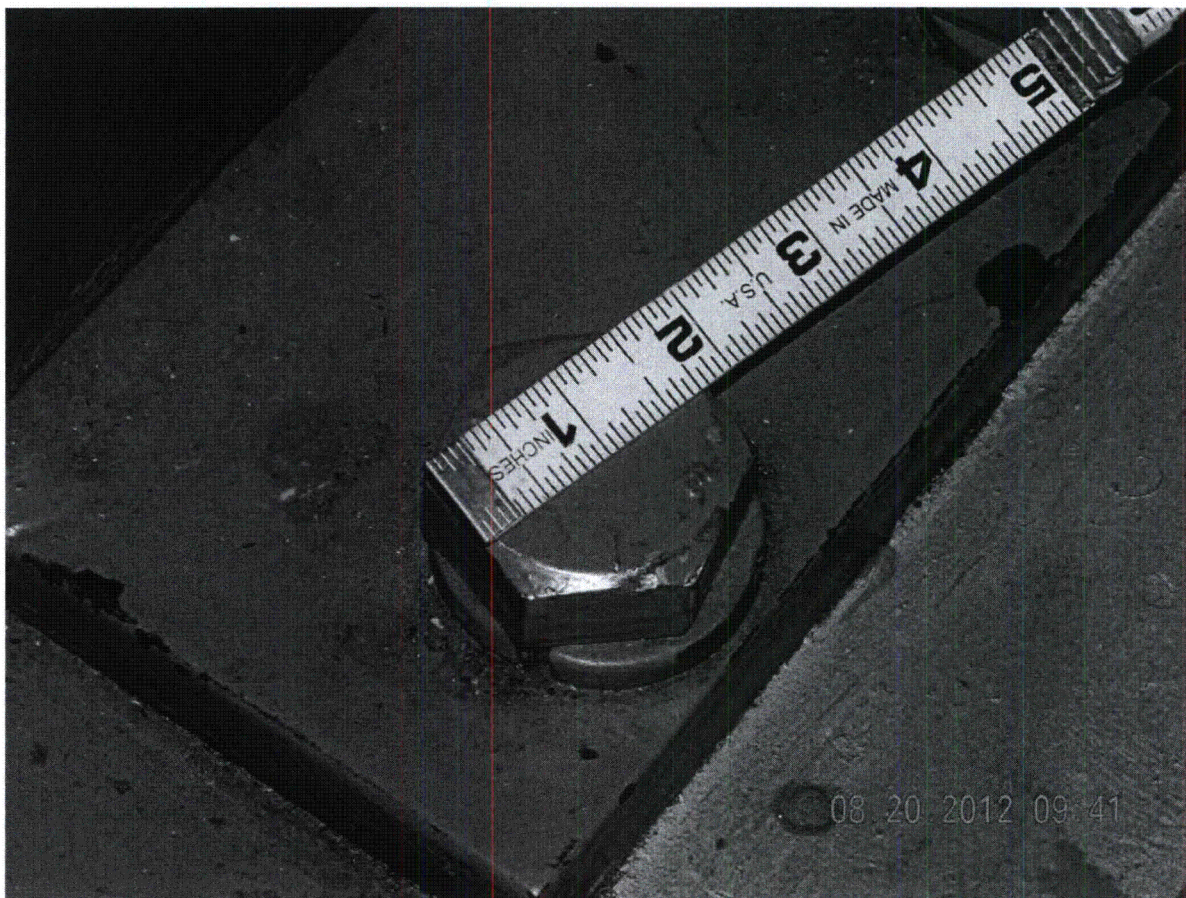
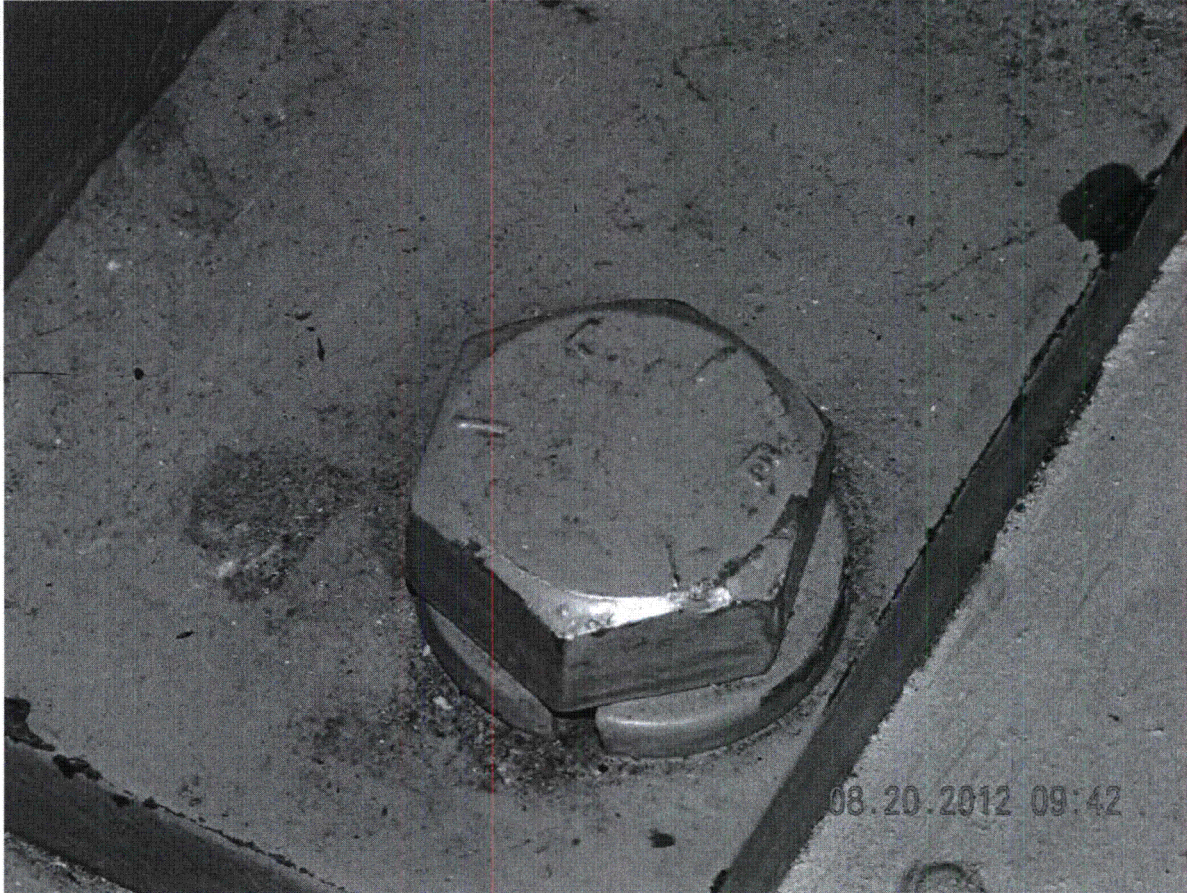
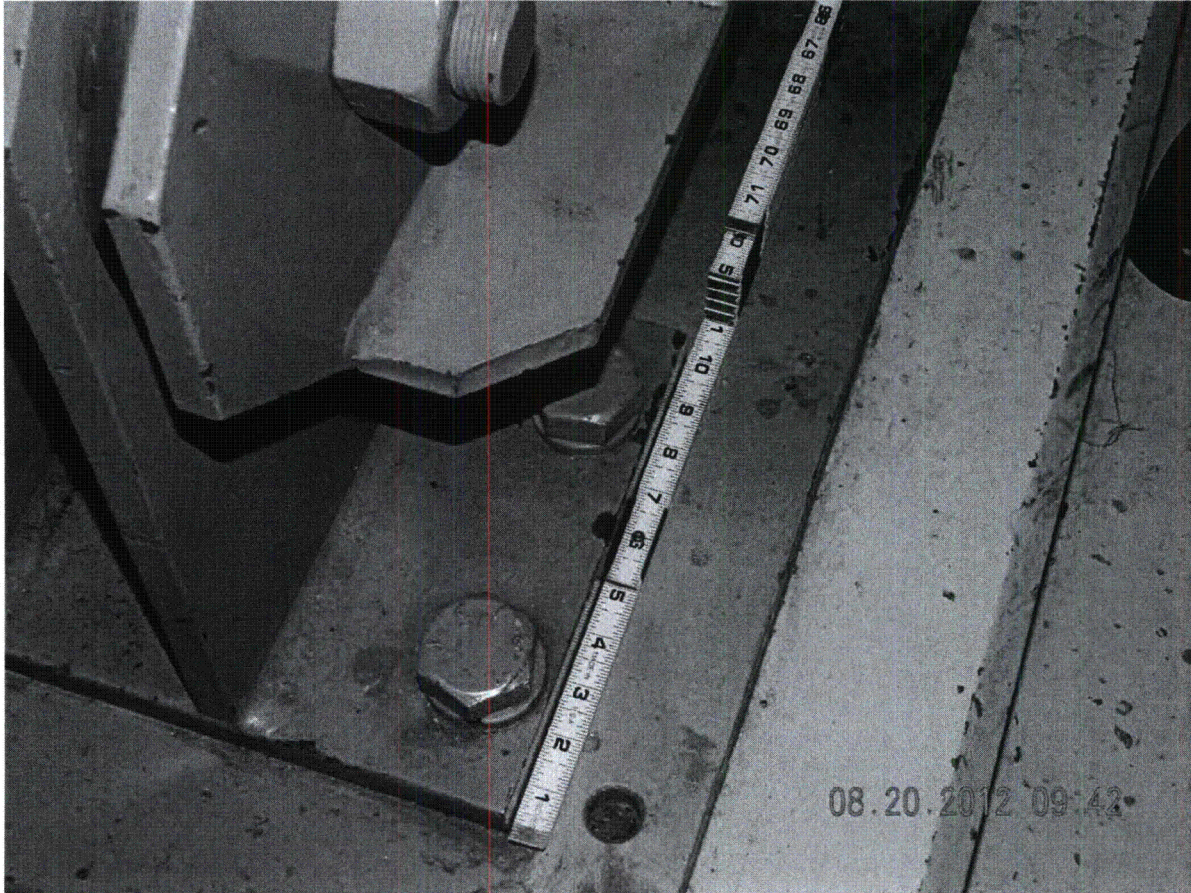
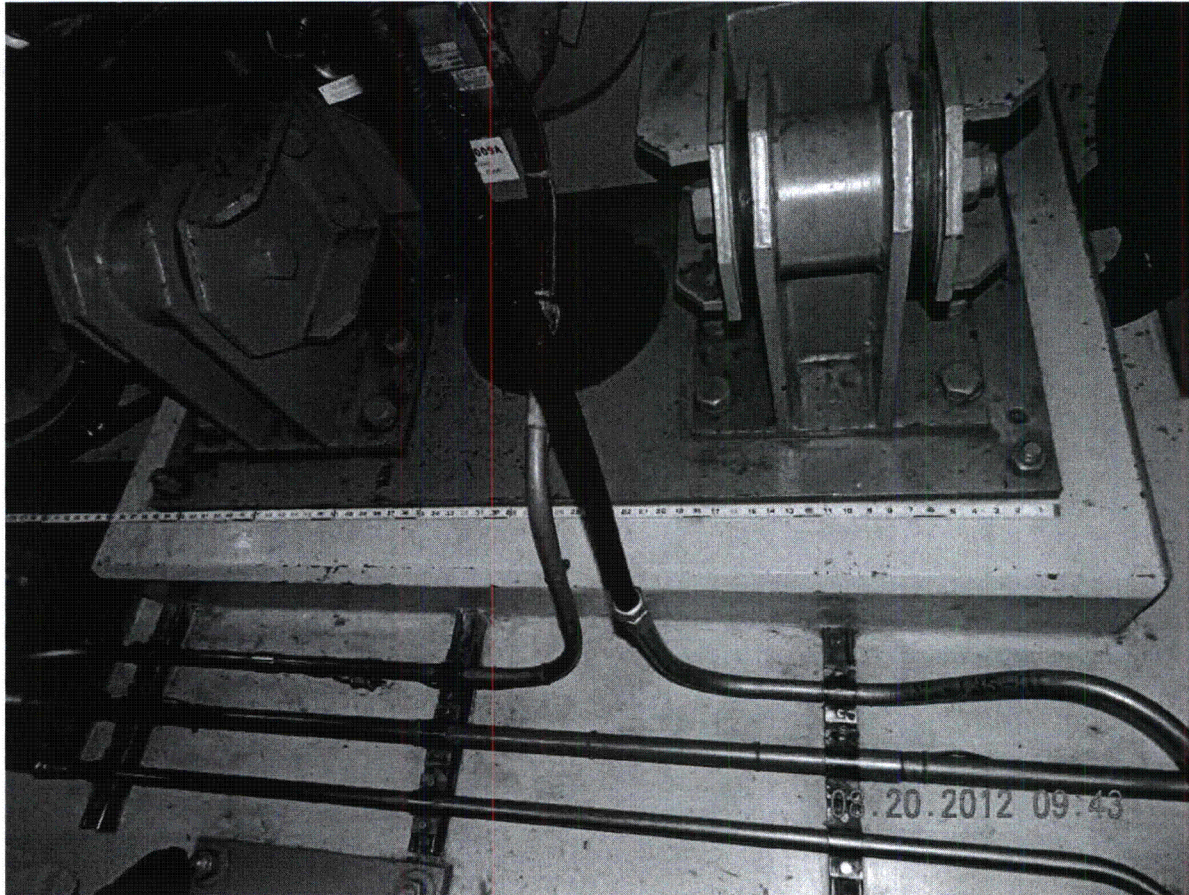
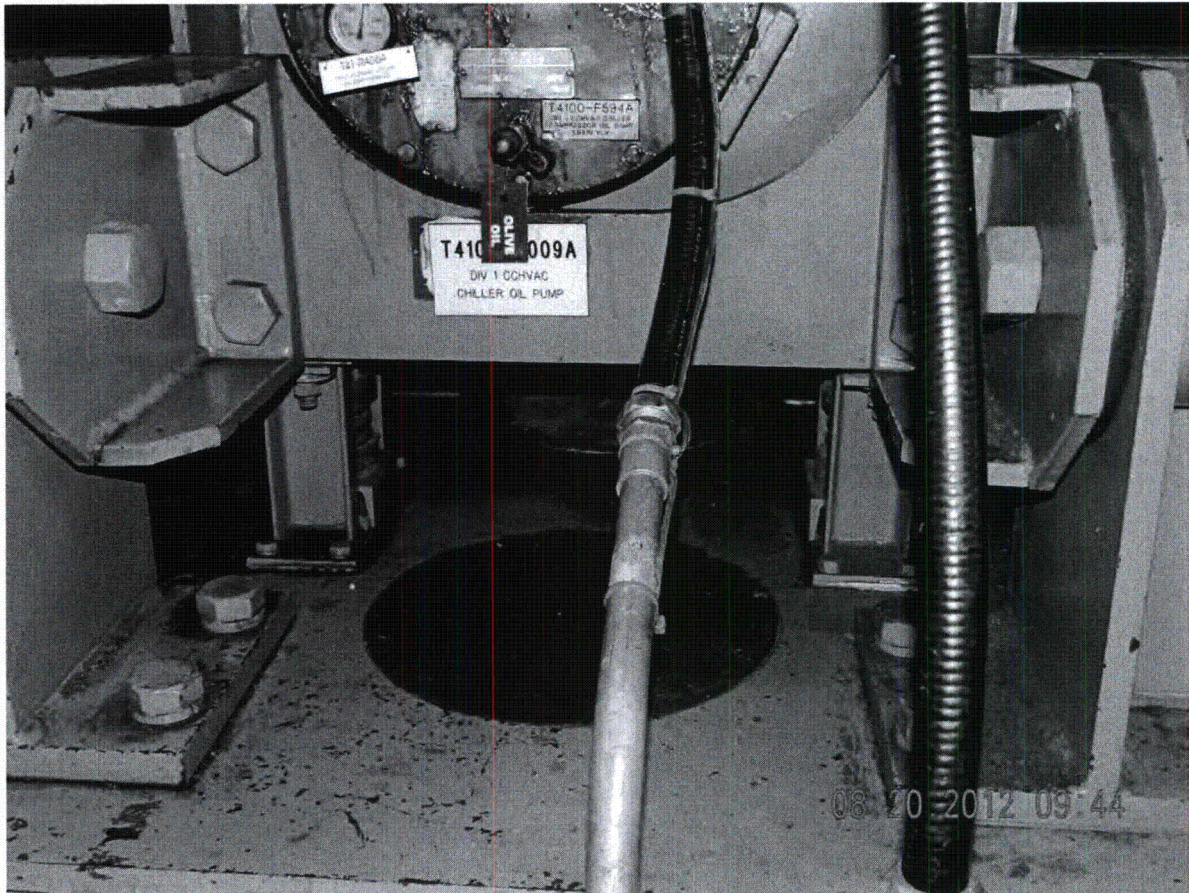
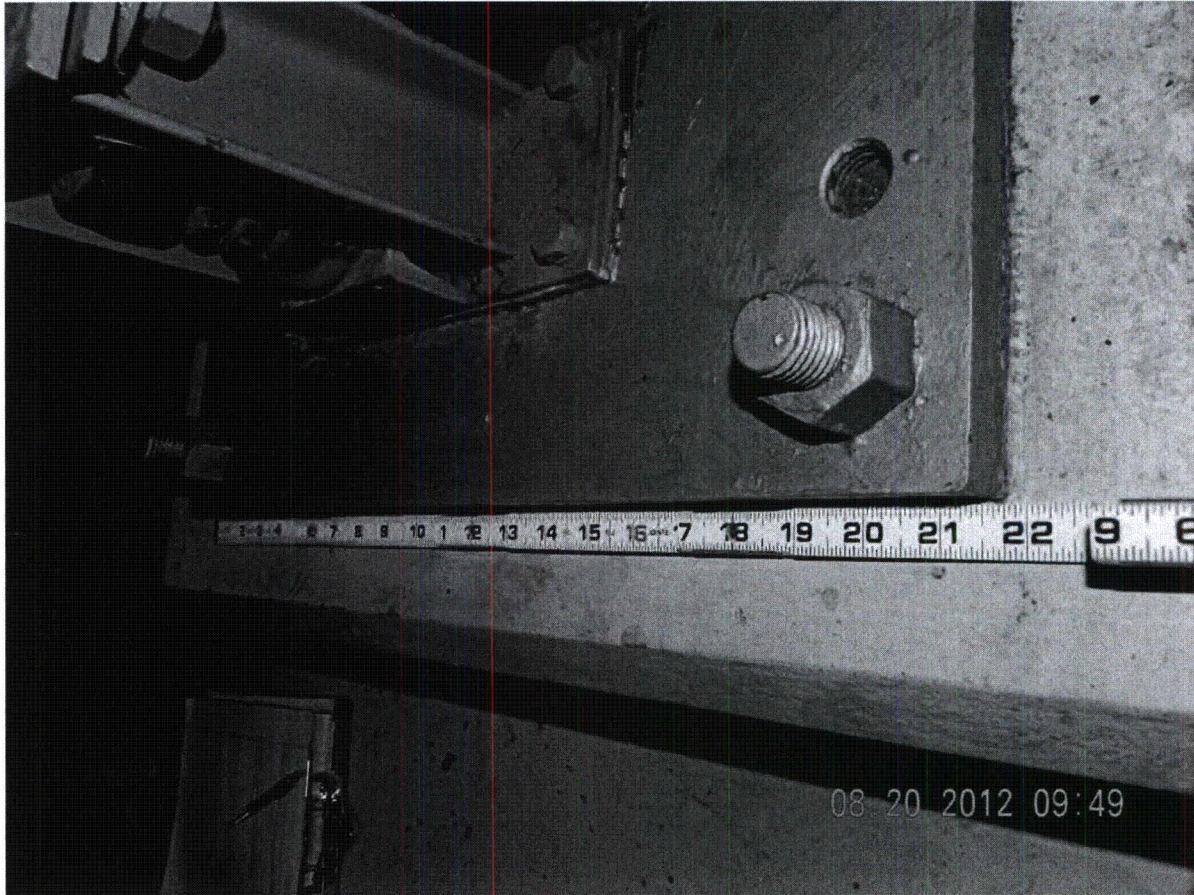
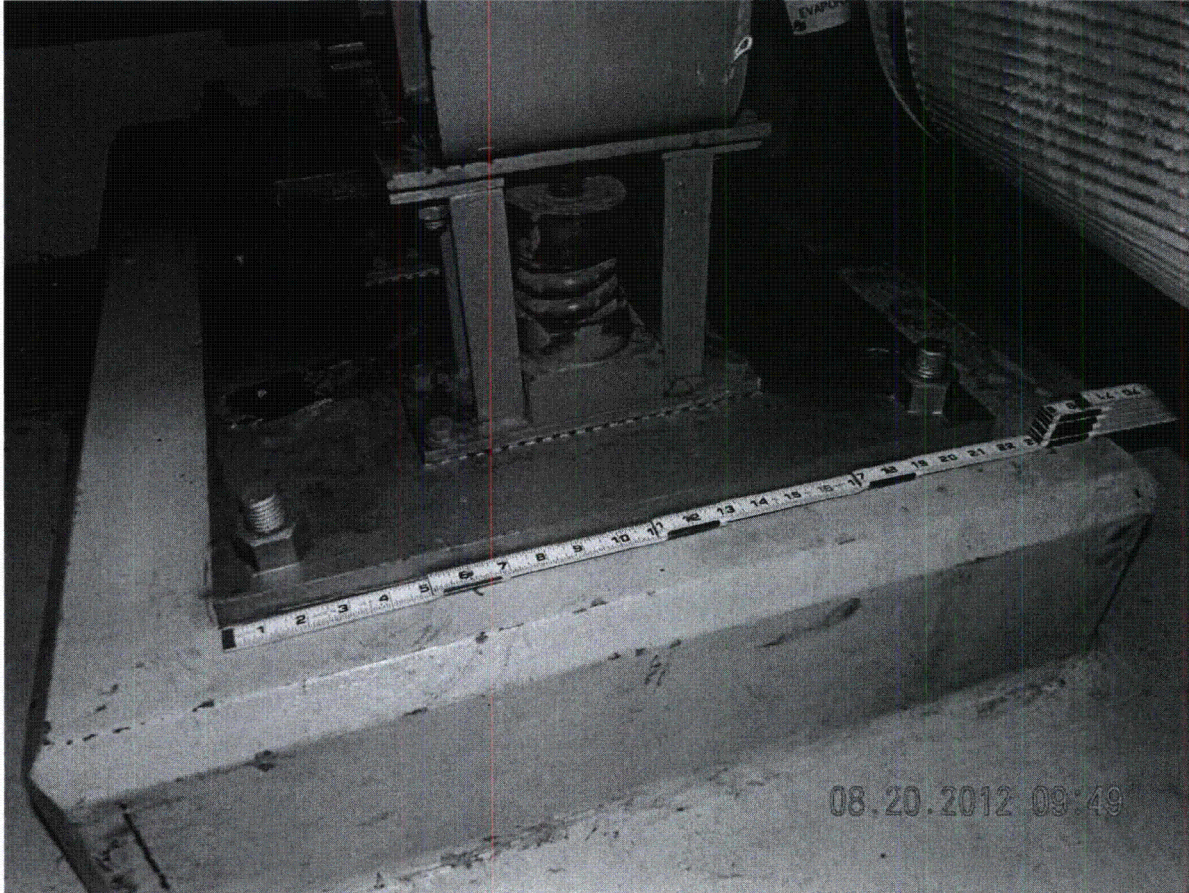
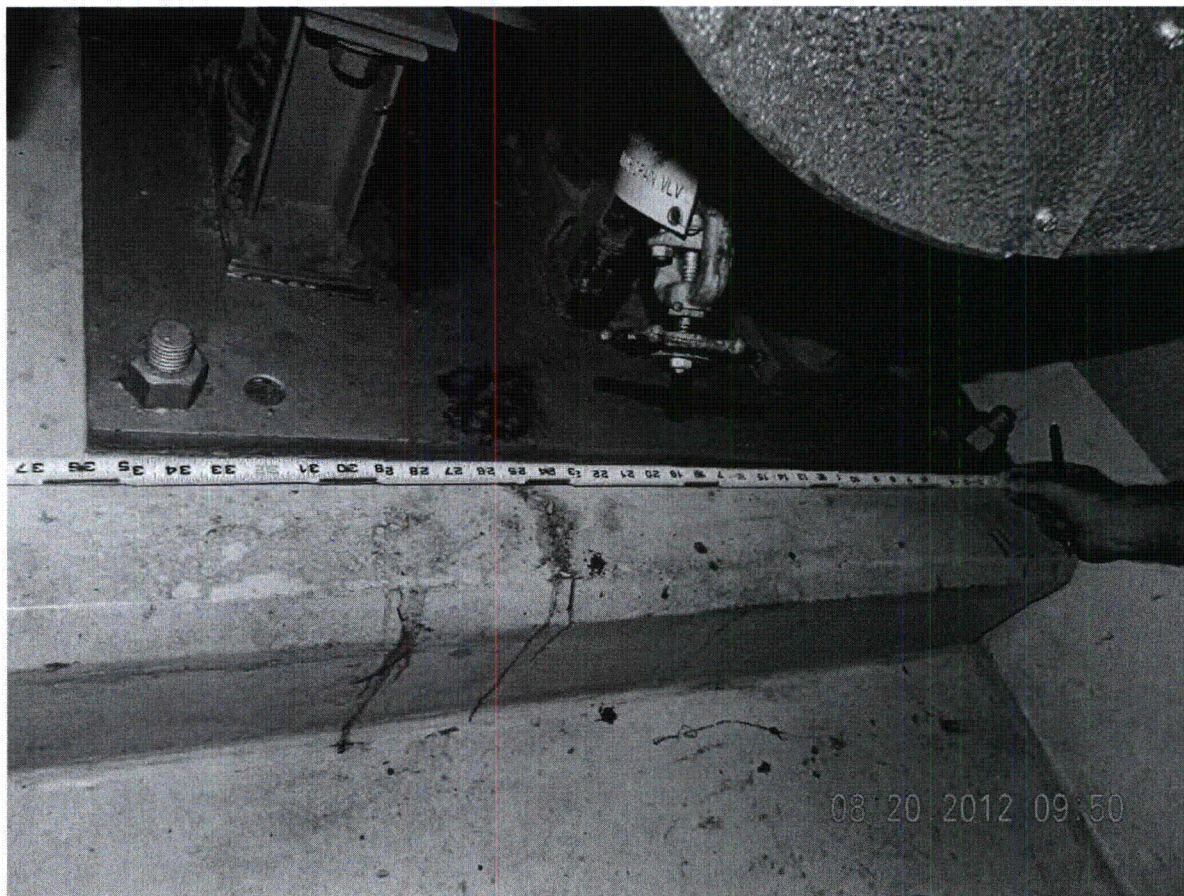
2. Is the anchorage free of bent, broken, missing or loose hardware?  Y  N  U  N/A  
*All bolts installed properly. Missing spring isolator bolt at SE spring isolator; See CARD 12-28245 for action. See photos DSCN0558-0569 and DSCN0576-0579.*

5. Is the anchorage configuration consistent with plant documentation?(Note: This question only applies if the item is one of the 50% for which an anchorage configuration verification is required.)  Y  N  U  N/A  
*Anchorage is consistent with drawing M-4007. Missing spring isolator bolt at SE spring isolator (See question No. 2)*

6. Based on the above anchorage evaluations, is the anchorage free of potentially adverse seismic conditions?  Y  N  U  
*The missing spring isolator bolt and questionable clearance at spring isolators are potentially adverse seismic conditions. Refer to CARDS 12-28245 and 12-28393 for resolution of the conditions.*

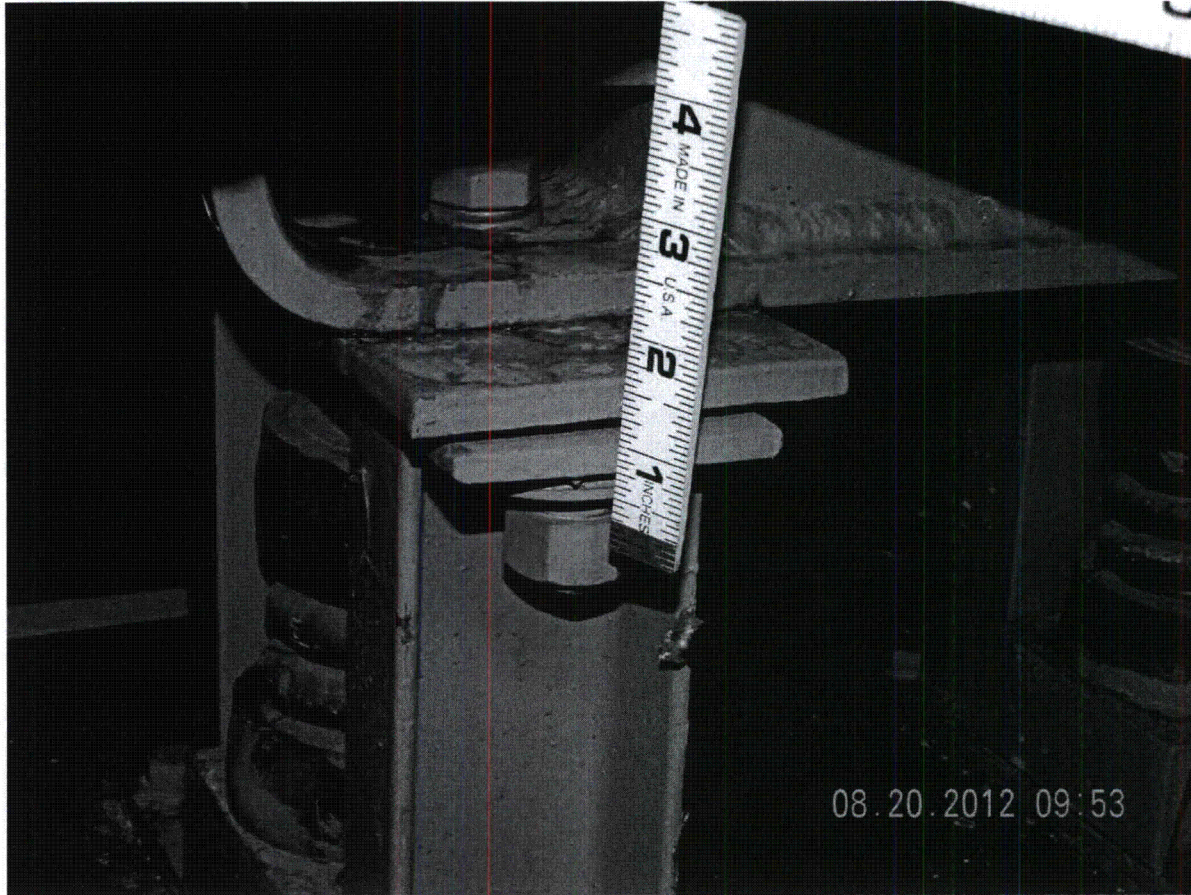
(DSCN0571)

3. Is the anchorage free of corrosion that is more than mild surface oxidation?  Y  N  U  N/A  
*Bolts are clean with no corrosion. Chiller isolators exhibit some rusting. The corrosion is mild and will not impact seismic performance. See CARD 12-28246 for action. See Photo DSCN0571.*

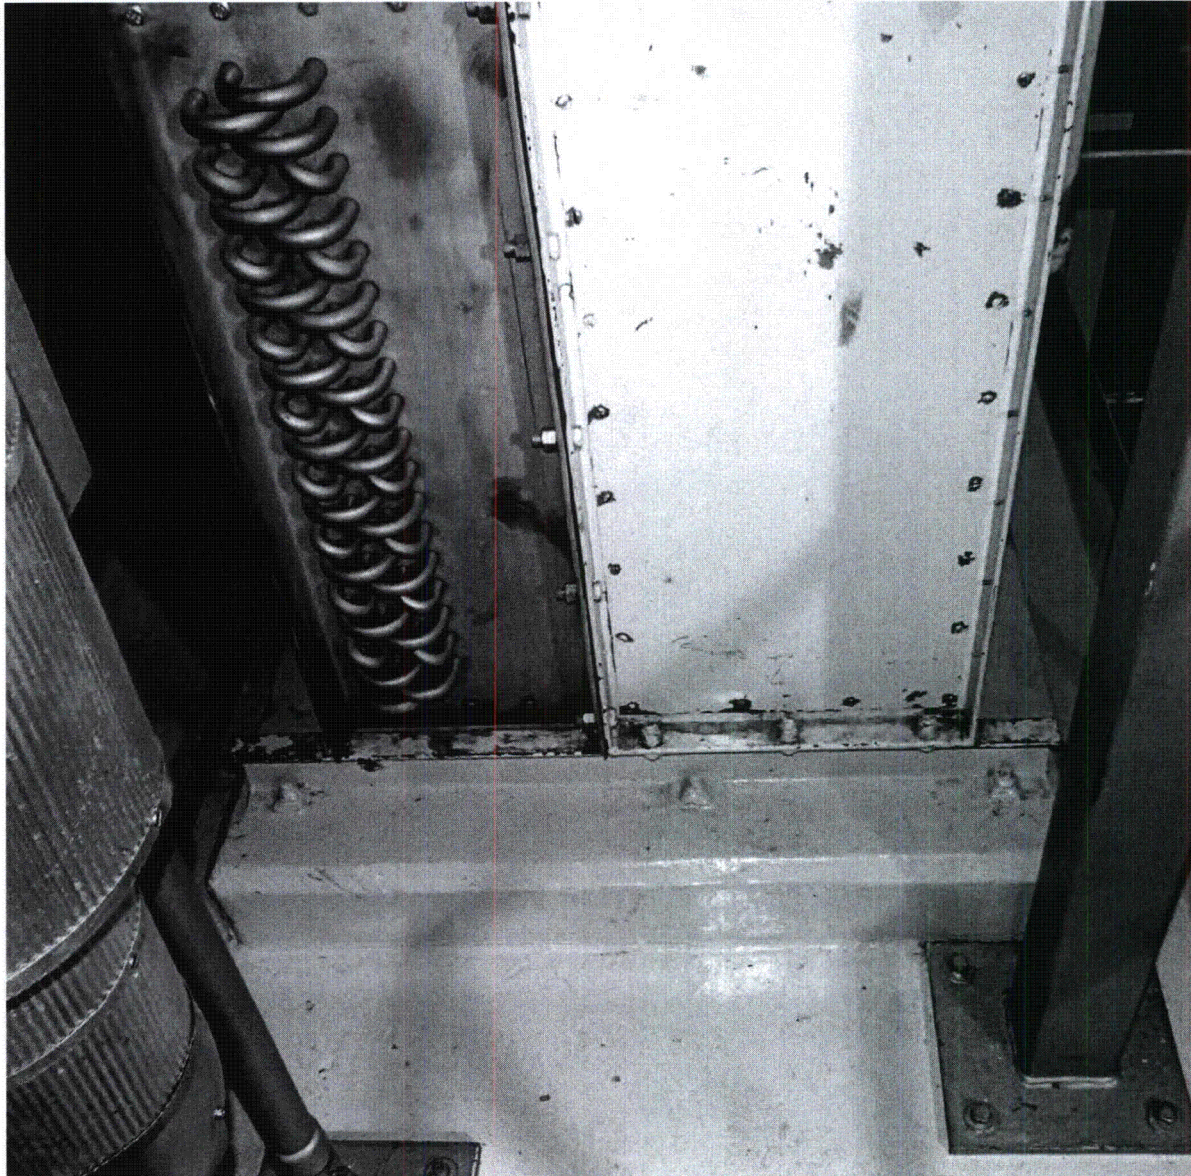
(DSC001025)

2. Is the anchorage free of bent, broken, missing or loose hardware?  Y  N  U  N/A  
*All bolts present and in good condition. See Photo DSC01025 for example of condition.*

BOLT CONFIGURATION

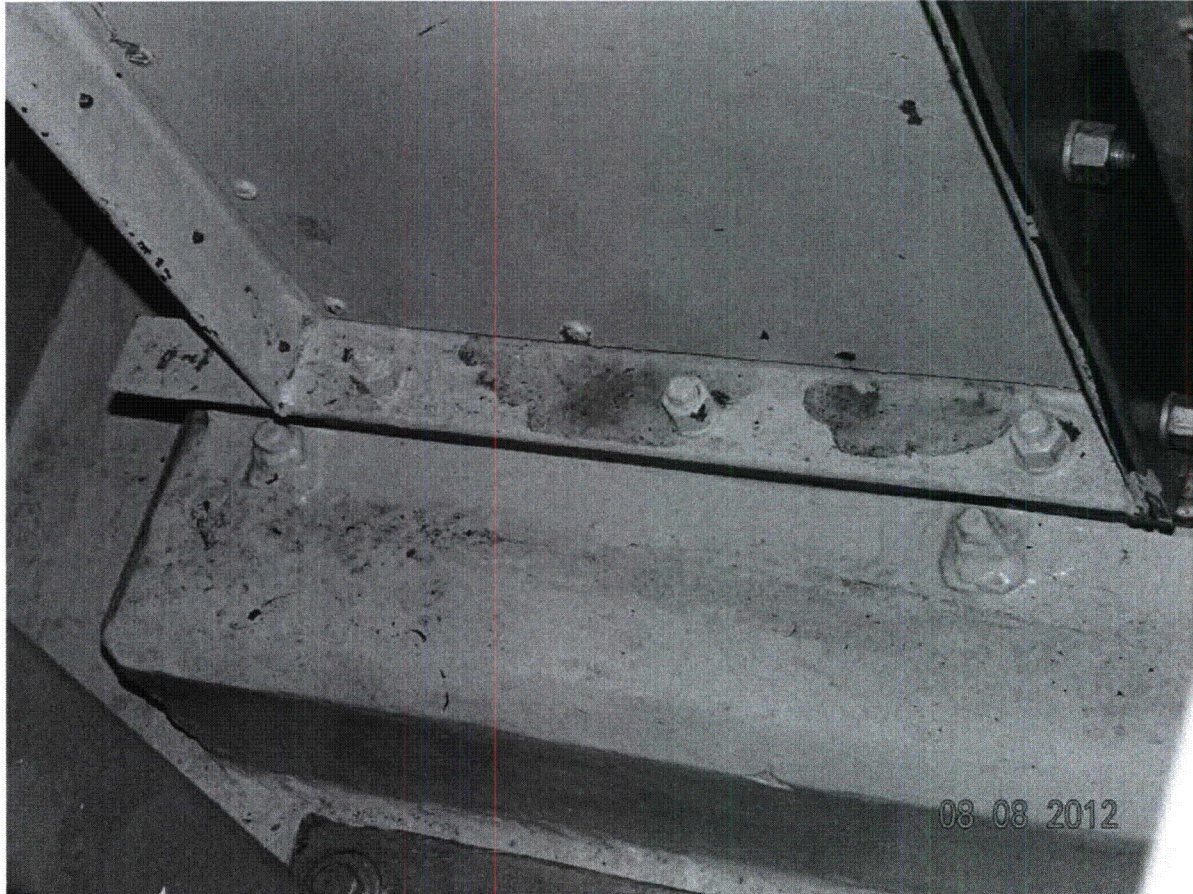
(DSC00304)

3. Is the anchorage free of corrosion that is more than mild surface oxidation?  Y  N  U  N/A  
*Bolts are painted. No corrosion evident. (See Photos DSC00304 & 00309)*

BOLT CONFIGURATION (REF DWG. M-3515)

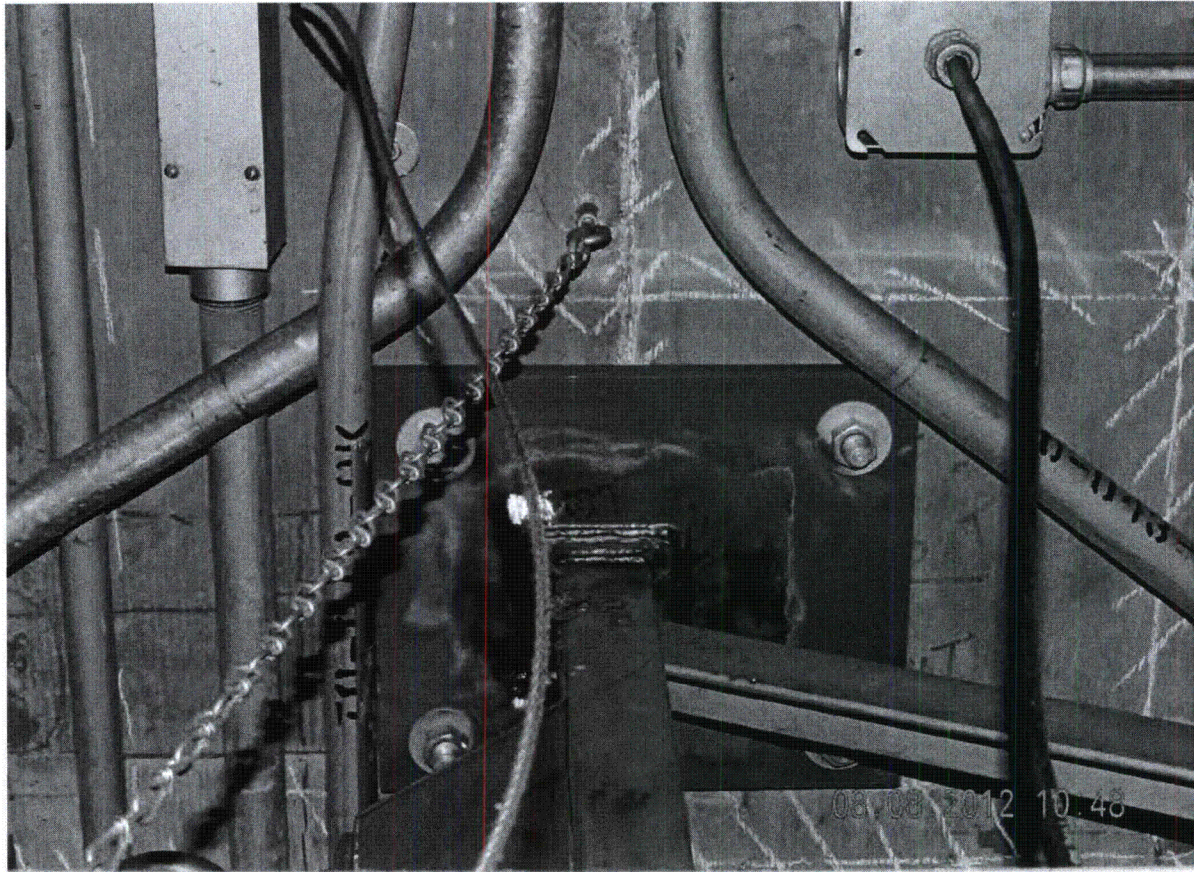
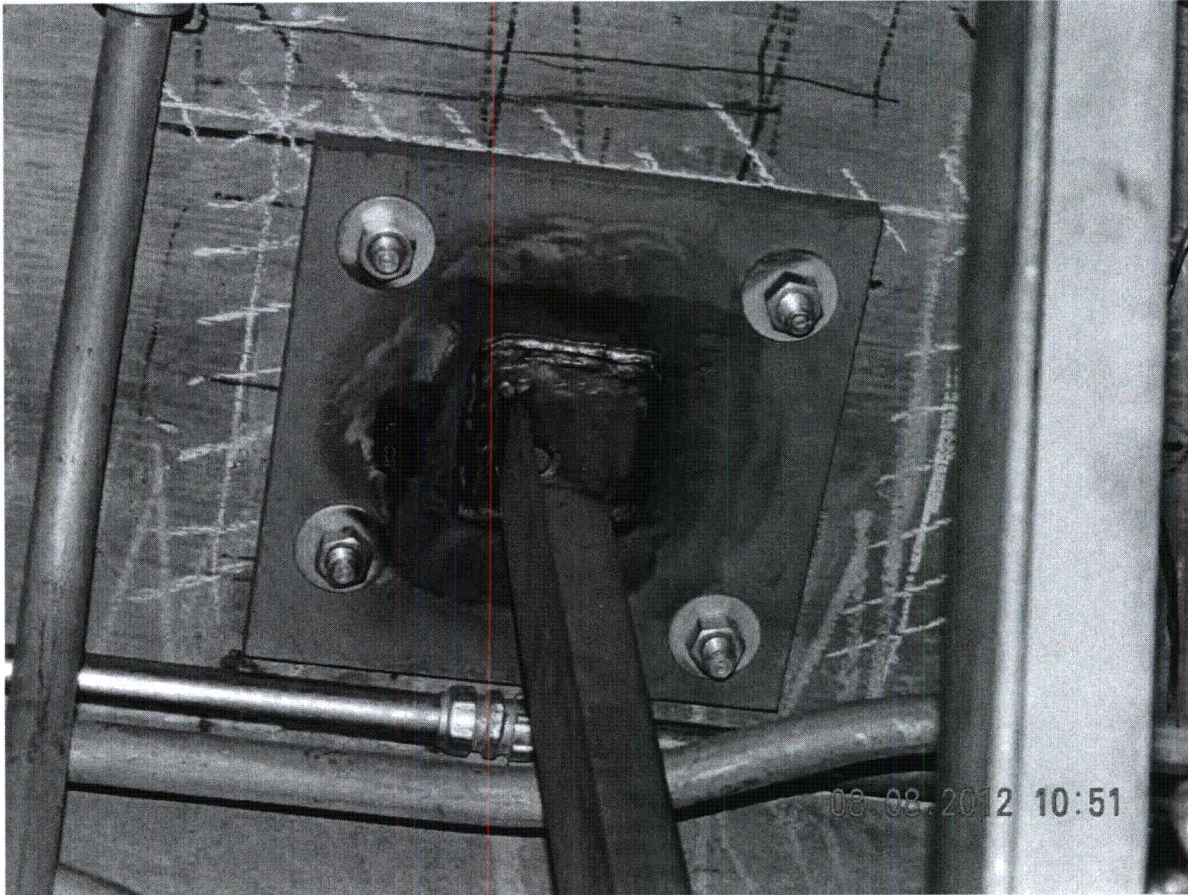
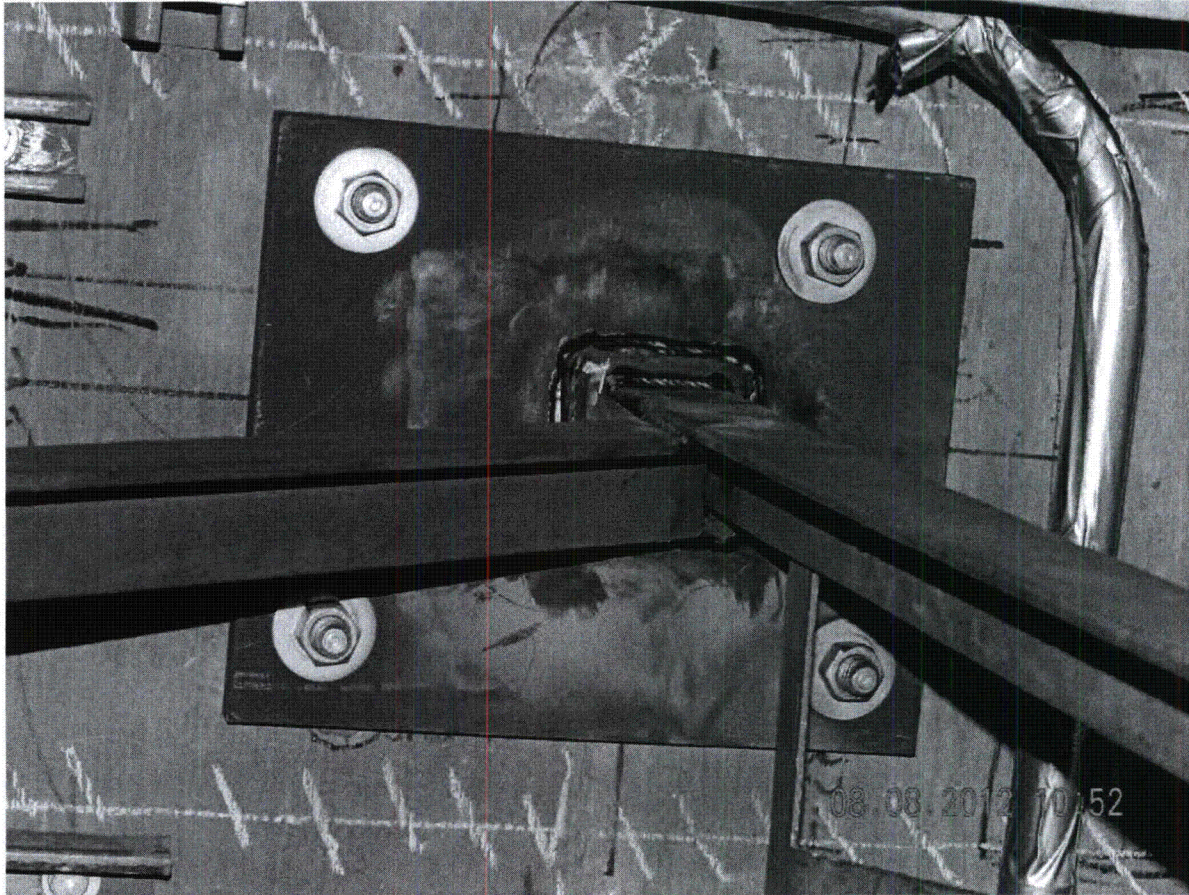
2. Is the anchorage free of bent, broken, missing or loose hardware?  Y  N  U  N/A   
*All anchor bolts visible and in good condition. No bent, broken or missing hardware evident.*  
(SEE PICTURES DSCN0159, DSCN0163, DSCN0166, DSCN0167) ~ DJK 10/11/12

3. Is the anchorage free of corrosion that is more than mild surface oxidation?  Y  N  U  N/A   
*Anchorage is free of corrosion.*  
(SEE PICTURES DSCN0159, DSCN0163, DSCN0166, DSCN0167) ~ DJK 10/11/12

4. Is the anchorage free of visible cracks in the concrete near the anchors?  Y  N  U  N/A   
*The concrete at the anchorage is in serviceable condition. No cracks observed.*  
(SEE PICTURES DSCN0159, DSCN0163, DSCN0166, DSCN0167) ~ DJK 10/11/12

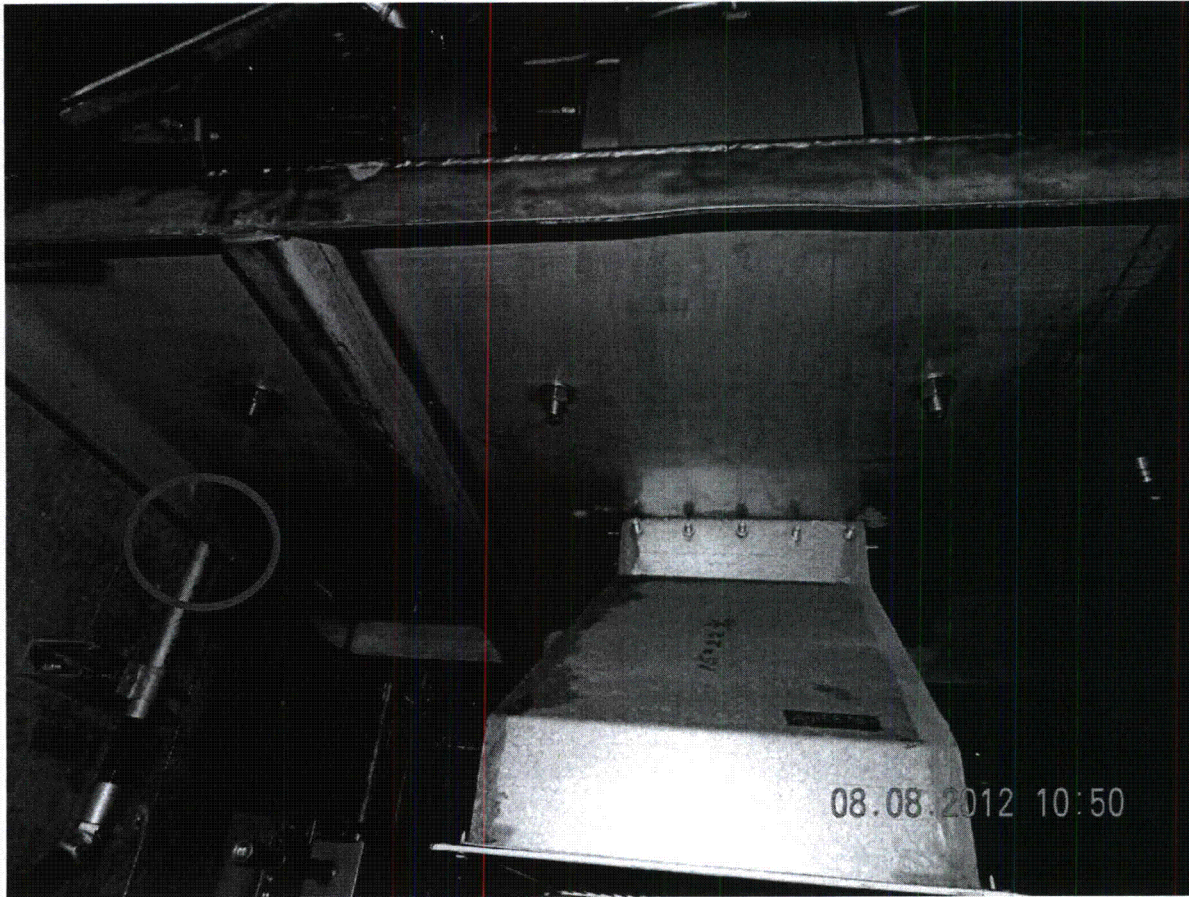
(DSCN0163)

6. Based on the above anchorage evaluations, is the anchorage free of potentially adverse seismic conditions?  Y  N  U   
*Possible rattle space violation with 1"Ø conduit to TSE-T41-N452 (see photo DSCN0163). Note: See attached hand calculation for resolution. Rattle space is sufficient.*  
(SEE PICTURE DSCN0169) ~ DJK 10/11/12

11. Have you looked for and found no other seismic conditions that could adversely affect the safety functions of the equipment?  Y  N  U  
*Possible rattlespace violation with 1"Ø conduit to TSE-T41-N452 (see photo DSCN0163). Note: See attached hand calculation of maximum frame deflection. Rattlespace is sufficient.*
