NJPR-12-0043

**Missing Seismic Walkdown Checklist (SWC)**

Equipment ID No. T4100B009 Equip. Class<sup>1</sup> 11, Chillers

Equipment Description CCHVAC North Div 1 Air Conditioner Chiller

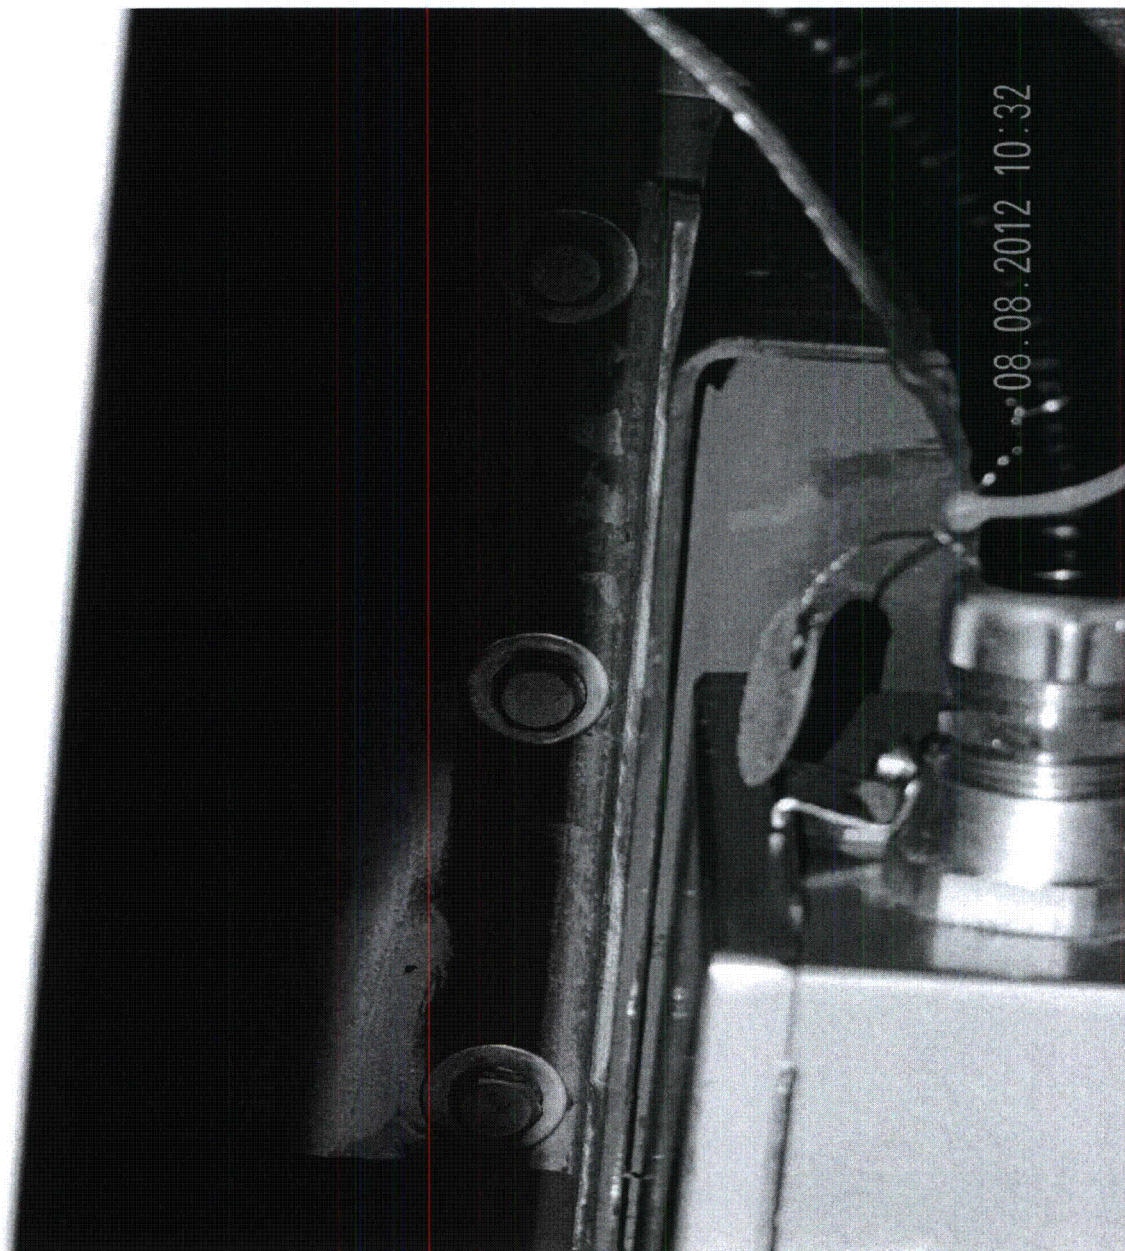
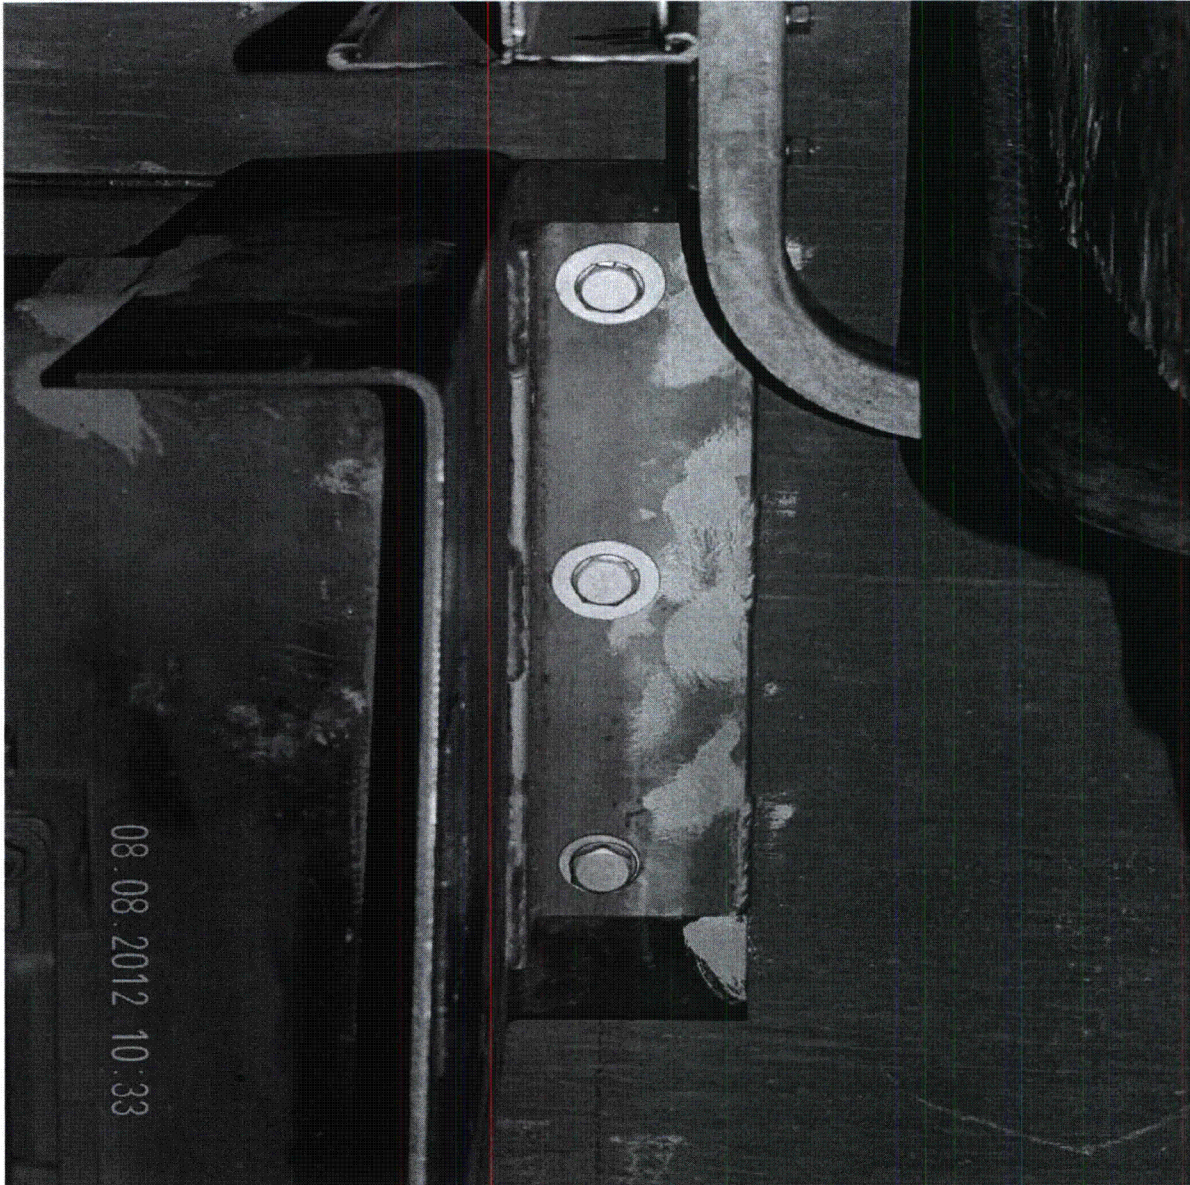
2. Is the anchorage free of bent, broken, missing or loose hardware?  Y  N  U  N/A  
*Anchorage is in good condition and is free of bent, broken, missing or loose hardware.*  
*(SEE PICTURE DSCN0146, DSCN0147) ~ DJK 10/11/12*

3. Is the anchorage free of corrosion that is more than mild surface oxidation?  Y  N  U  N/A  
*Bolts look new and are free of corrosion and oxidation.*  
*(SEE PICTURE DSCN0146, DSCN0147) ~ DJK 10/11/12*

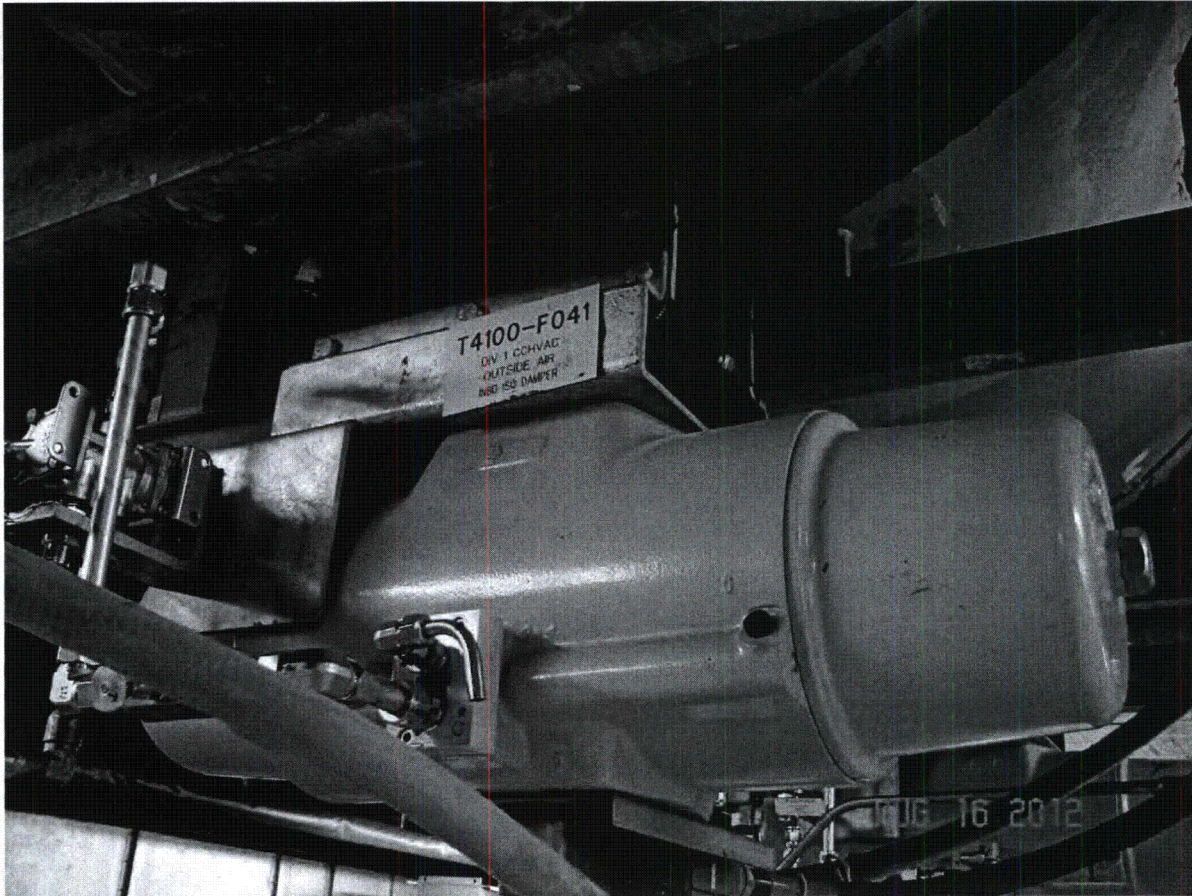
(DSC00076)

Equipment ID No. T4100F041 Equipment Class: 7, Pneumatic-Operated Valves

Equipment Description Div. I CCHVAC Outside Air Damper

2. Is the anchorage free of bent, broken, missing or loose hardware?  Y  N  U  N/A  
*Anchorage is in good condition and is free of bent, broken, missing or loose hardware.*

3. Is the anchorage free of corrosion that is more than mild surface oxidation?  Y  N  U  N/A  
*Bolts in good condition and are free of corrosion and oxidation.*

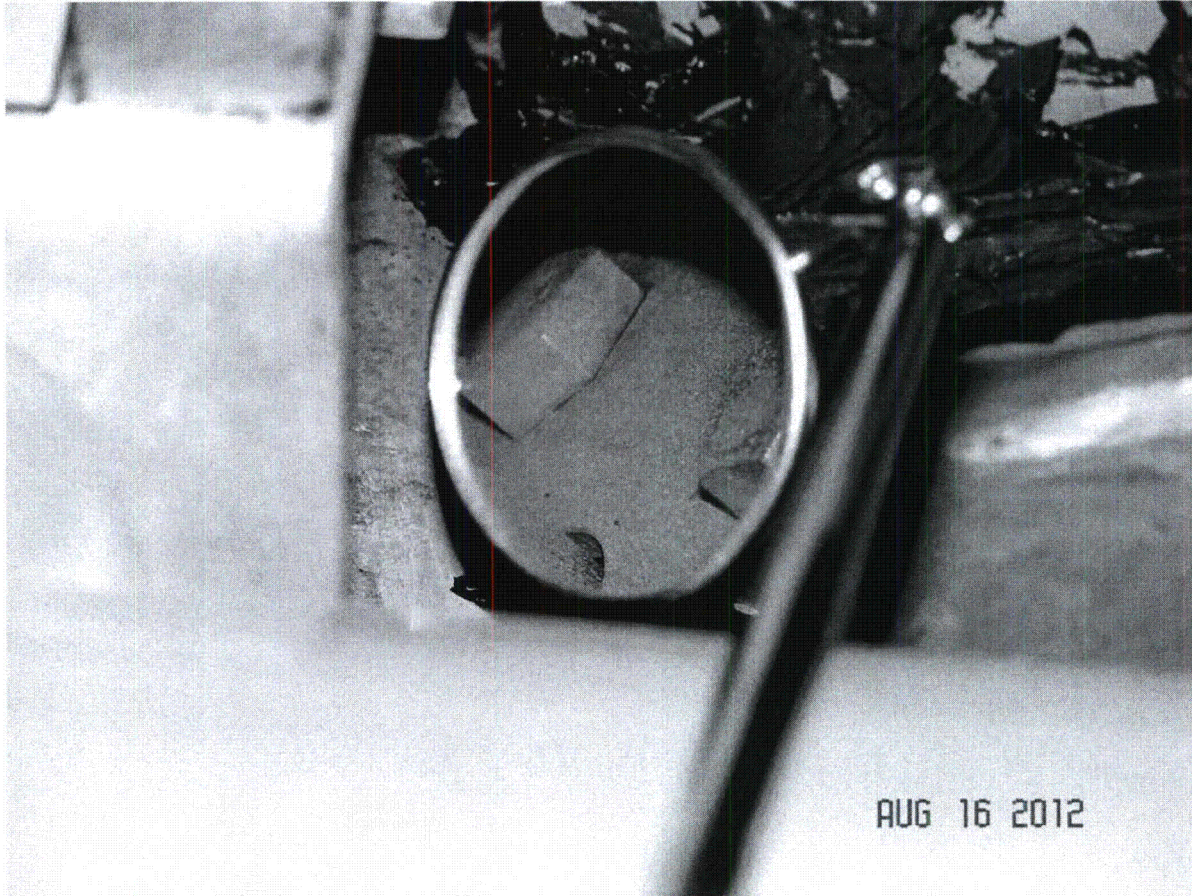
(DSC00078)

2. Is the anchorage free of bent, broken, missing or loose hardware?  Y  N  U  N/A   
*Anchorage is in good condition and is free of bent, broken, missing or loose hardware. (SEE PICTURE DSC00078) - DJK 10/11/12*

3. Is the anchorage free of corrosion that is more than mild surface oxidation?  Y  N  U  N/A   
*Bolts in good condition and are free of corrosion and oxidation. (SEE PICTURE DSC00078) - DJK 10/11/12*

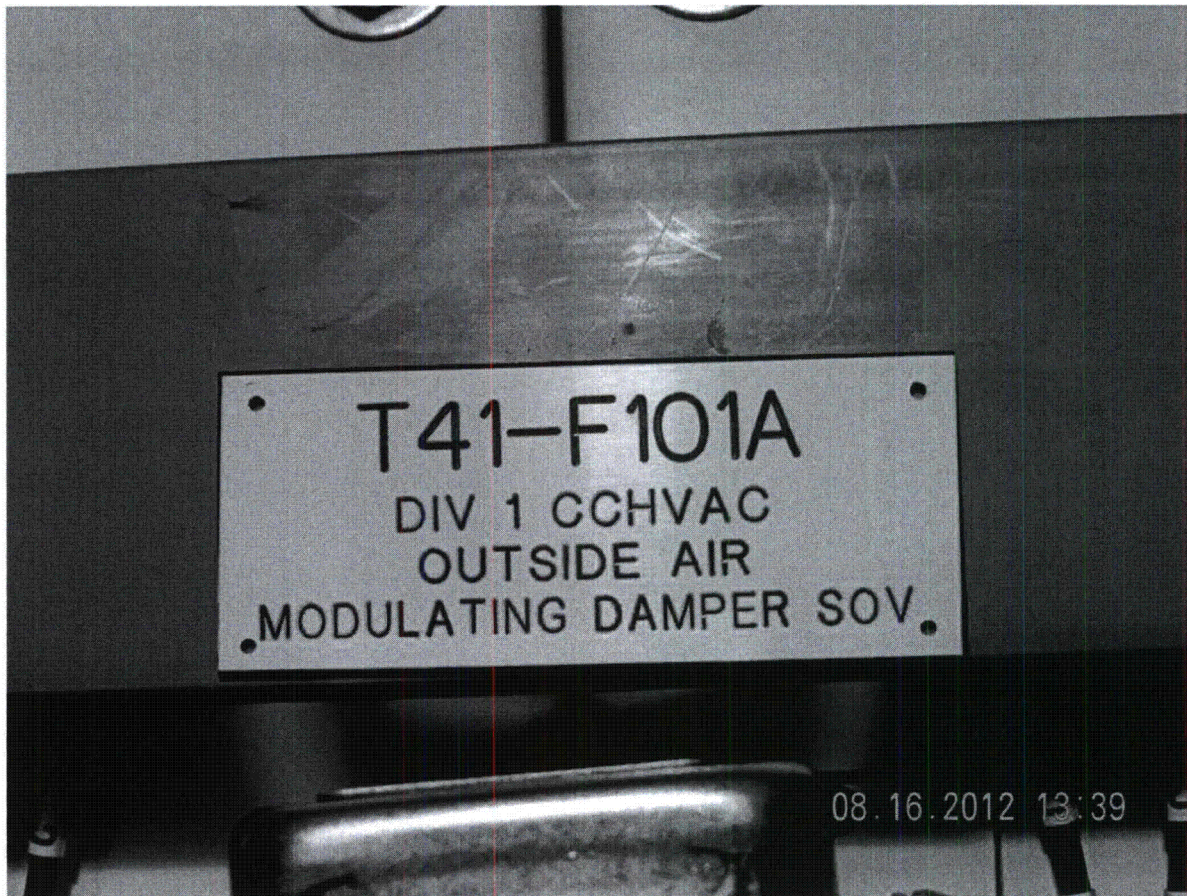
(DSCN0473)

Equipment ID No. T41F101A Equipment Class: 8, Motor/Solenoid-Operated Valves

Equipment Description Div. I - CCHVAC Air Modulation Damper SOV

2. Is the anchorage free of bent, broken, missing or loose hardware? Y  N  U  N/A   
*Valve is attached to piping, not to building. Bolts securing valve to piping are in good condition (see Photo DSC00222).*

3. Is the anchorage free of corrosion that is more than mild surface oxidation? Y  N  U  N/A   
*Flange bolts are free of corrosion.*

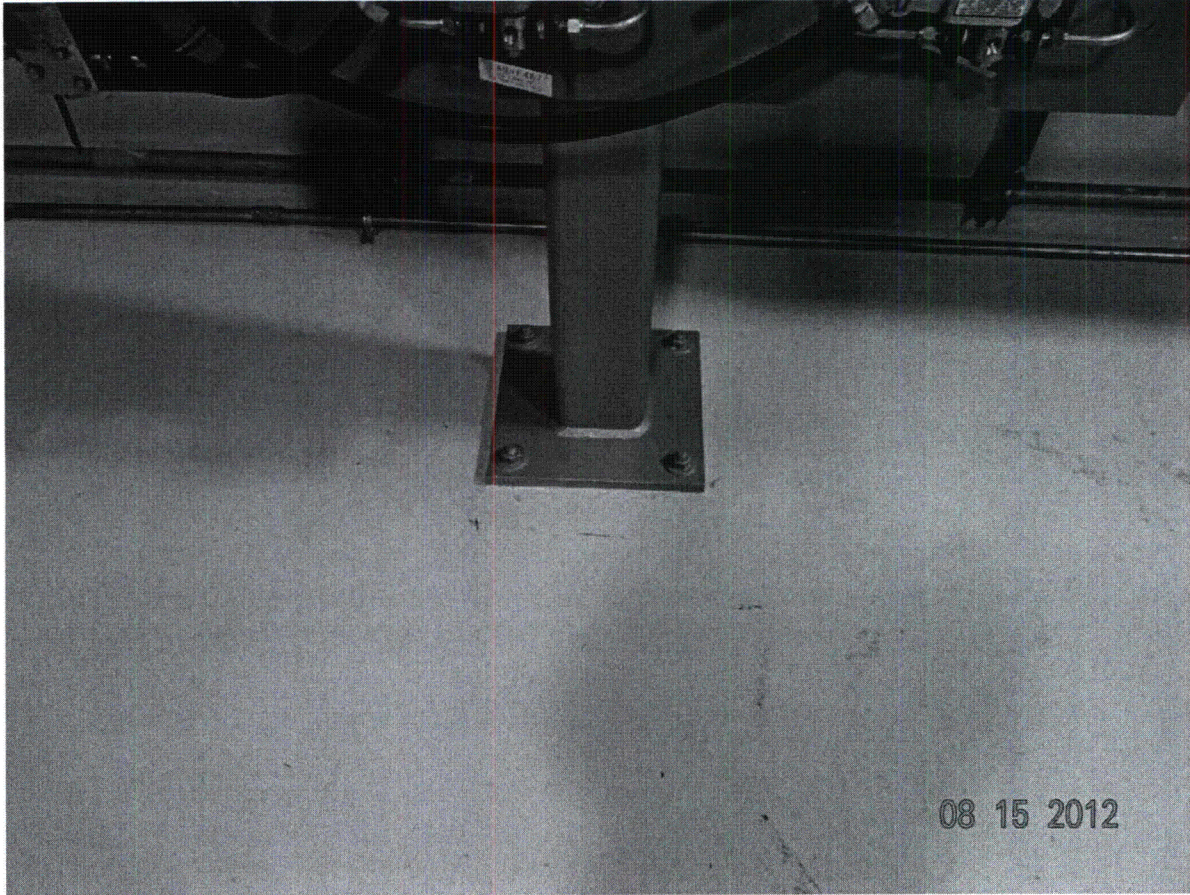
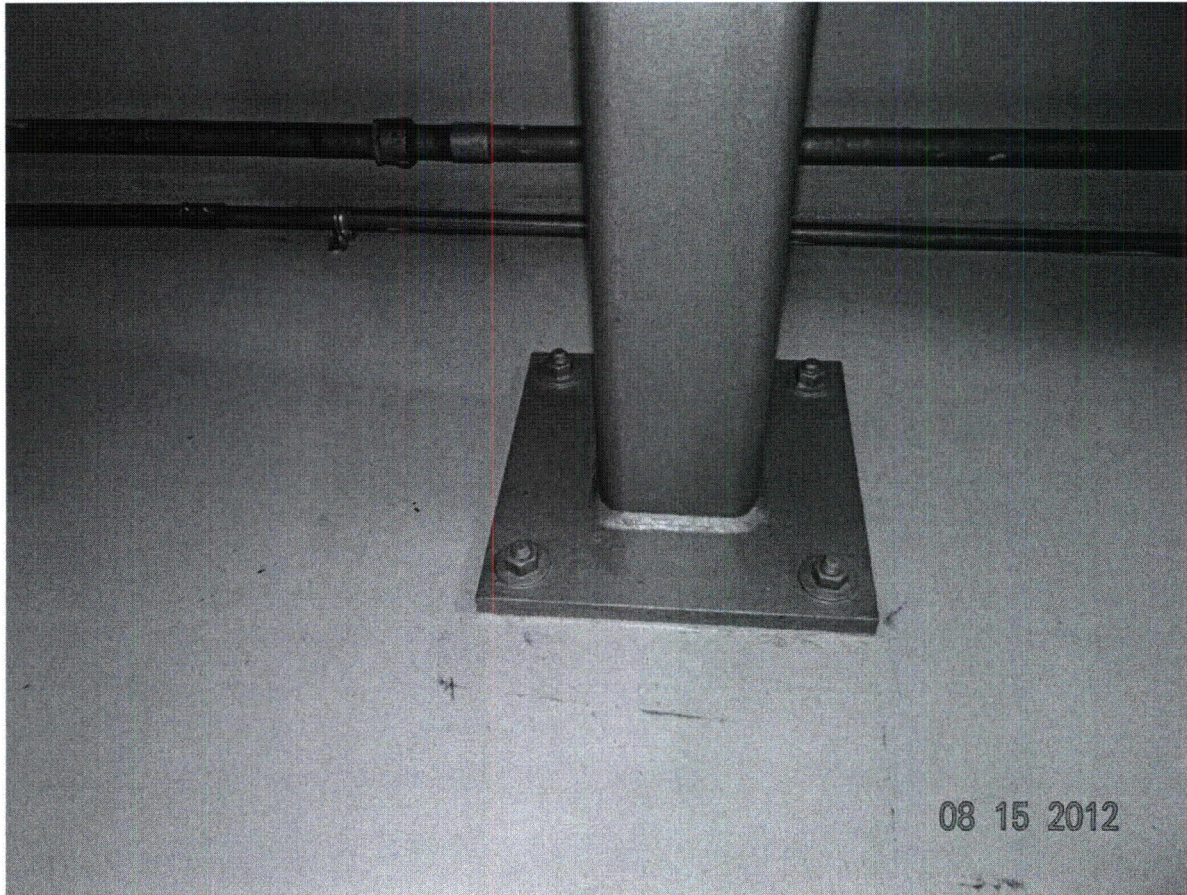
2. Is the anchorage free of bent, broken, missing or loose hardware?  Y  N  U  N/A  
*All anchorage is present and securely fastened. (See pictures 3 and 4.)*

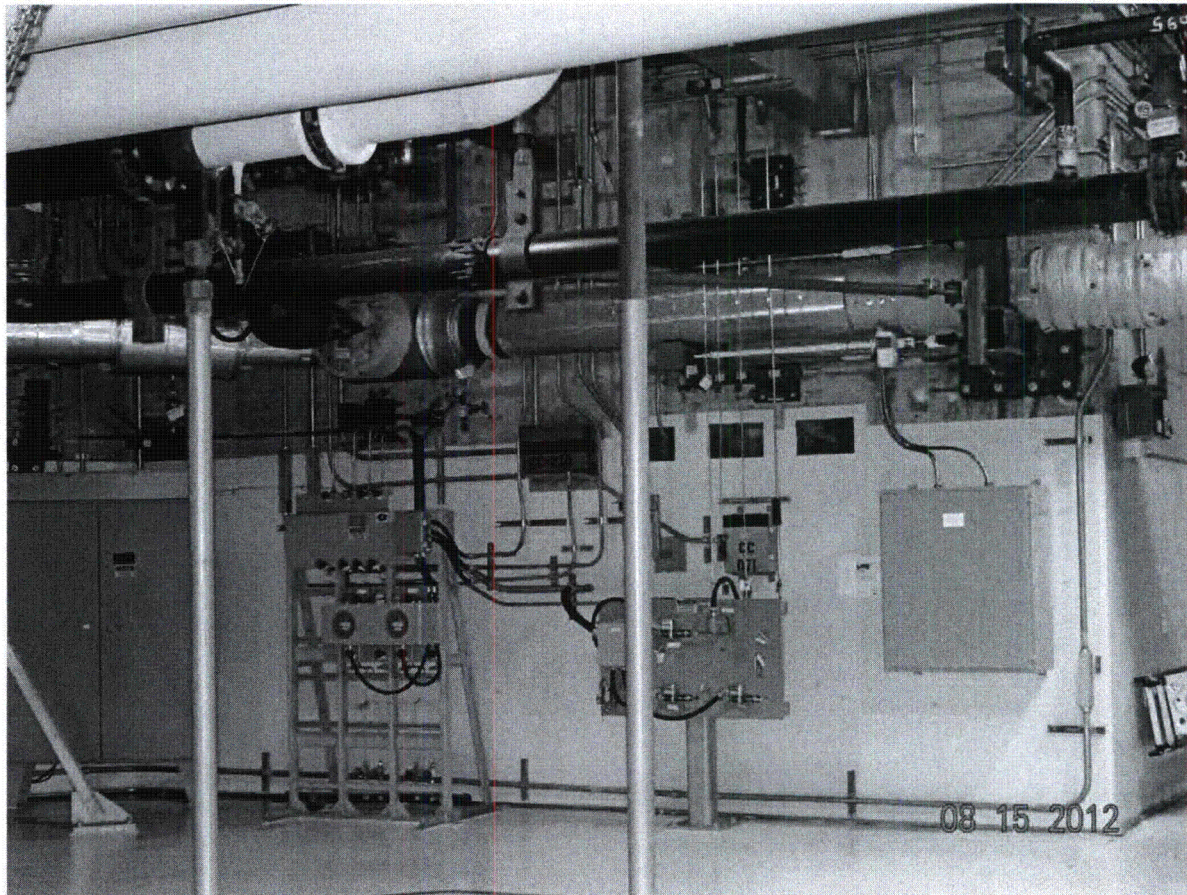
(Picture 11)

7. Are soft targets free from impact by nearby equipment or structures?  Y  N  U  N/A  
*There is no observed seismic proximity interaction or danger of falling overhead hazards. (See picture 11.)*

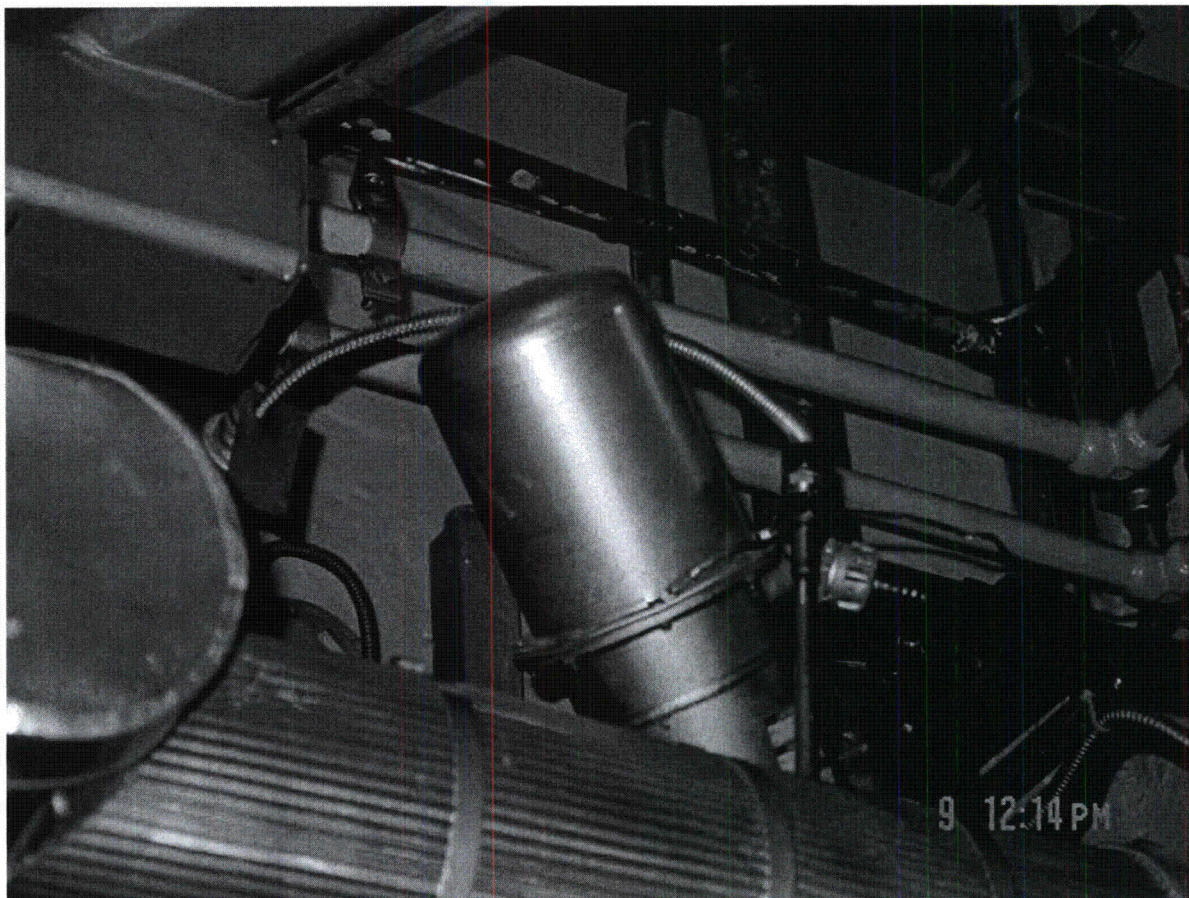
Picture1

9. Do attached lines have adequate flexibility to avoid damage?  Y  N  U  N/A  
*All attached lines have adequate flexibility. (See picture 1.)*

Equipment Description PC RAD MON SYST INLET ISO VLV

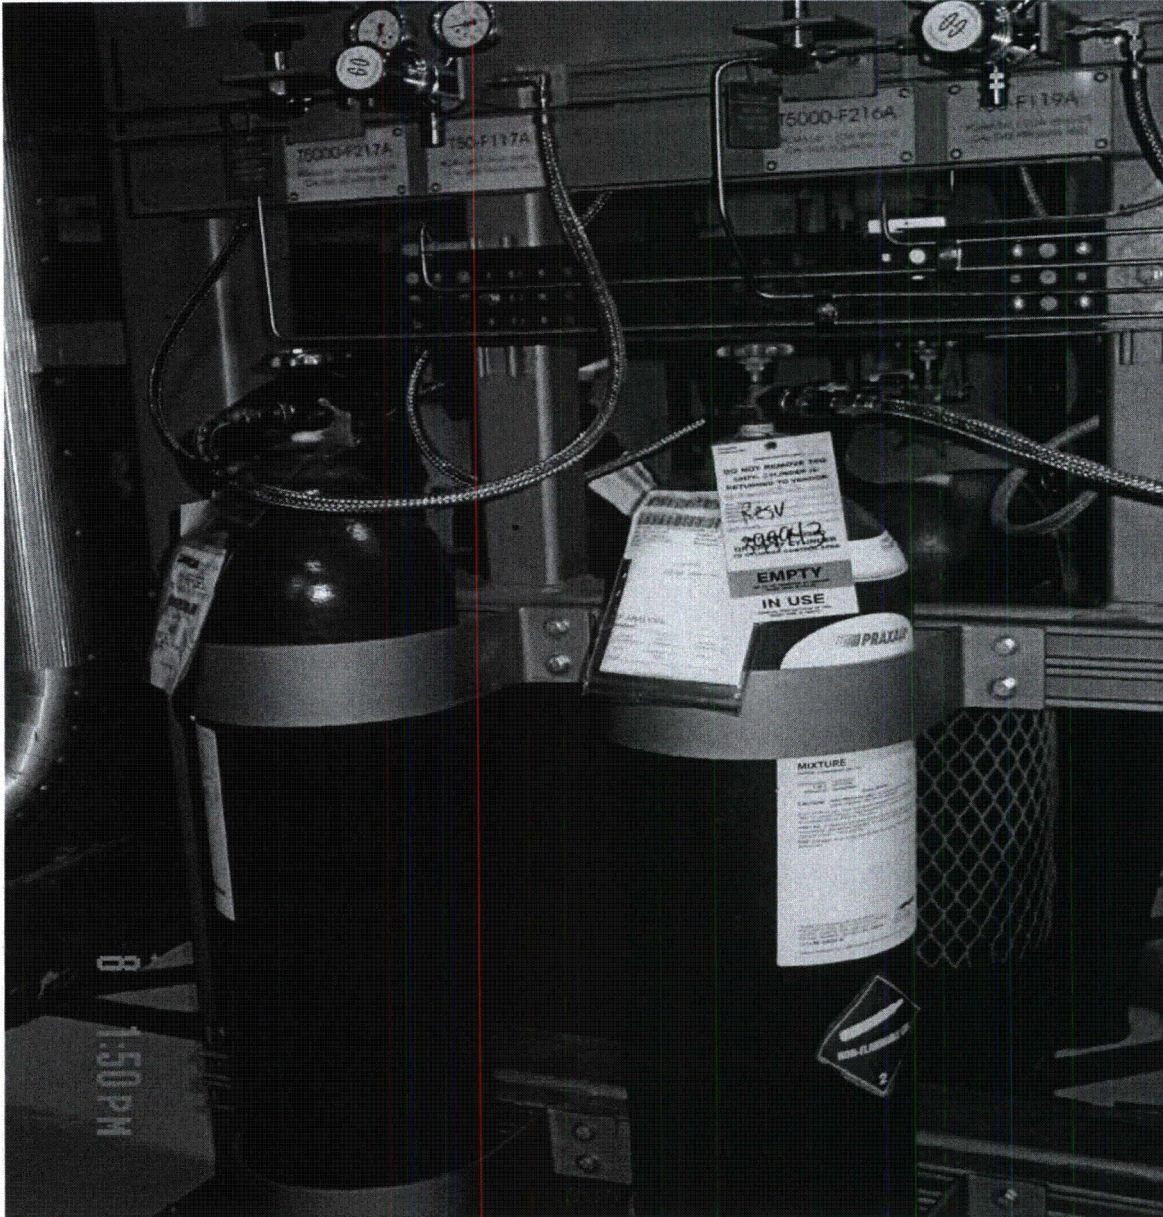
Picture 2

7. Are soft targets free from impact by nearby equipment or structures?  Y  N  U  N/A  
*The nearby Nitrogen tanks are restrained so that they do not impact equipment. (See Picture 2.)*
8. Are overhead equipment, distribution systems, ceiling tiles and lighting, and masonry block walls not likely to collapse onto the equipment?  Y  N  U  N/A  
*All overhead equipment and conduit is restrained.*
9. Do attached lines have adequate flexibility to avoid damage?  Y  N  U  N/A  
*All attached lines are flexible. (SEE PICTURE 1) ~ DSK 10/11/12*
10. Based on the above seismic interaction evaluations, is equipment free of potentially adverse seismic interaction effects?  Y  N  U  
*There are nearby items, but they either are far enough away ( $\geq 2'$  for rigid items) or they do not have enough mass to cause damage to the asset.*

Equipment Description PC RAD MON SYST INLET ISO VLV

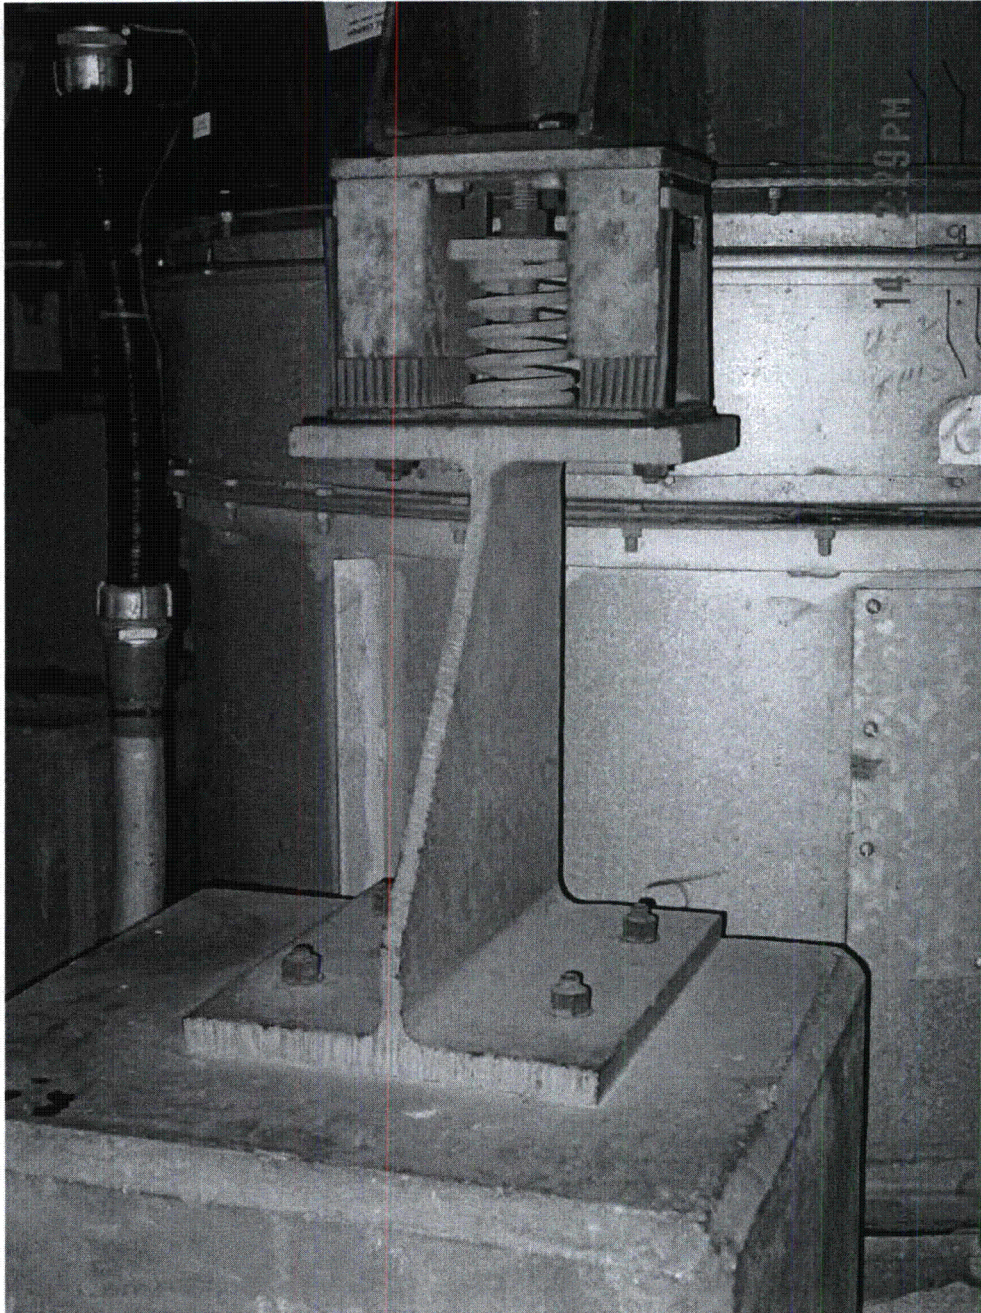
(DSC01367)

"Bolt attached to Concrete"

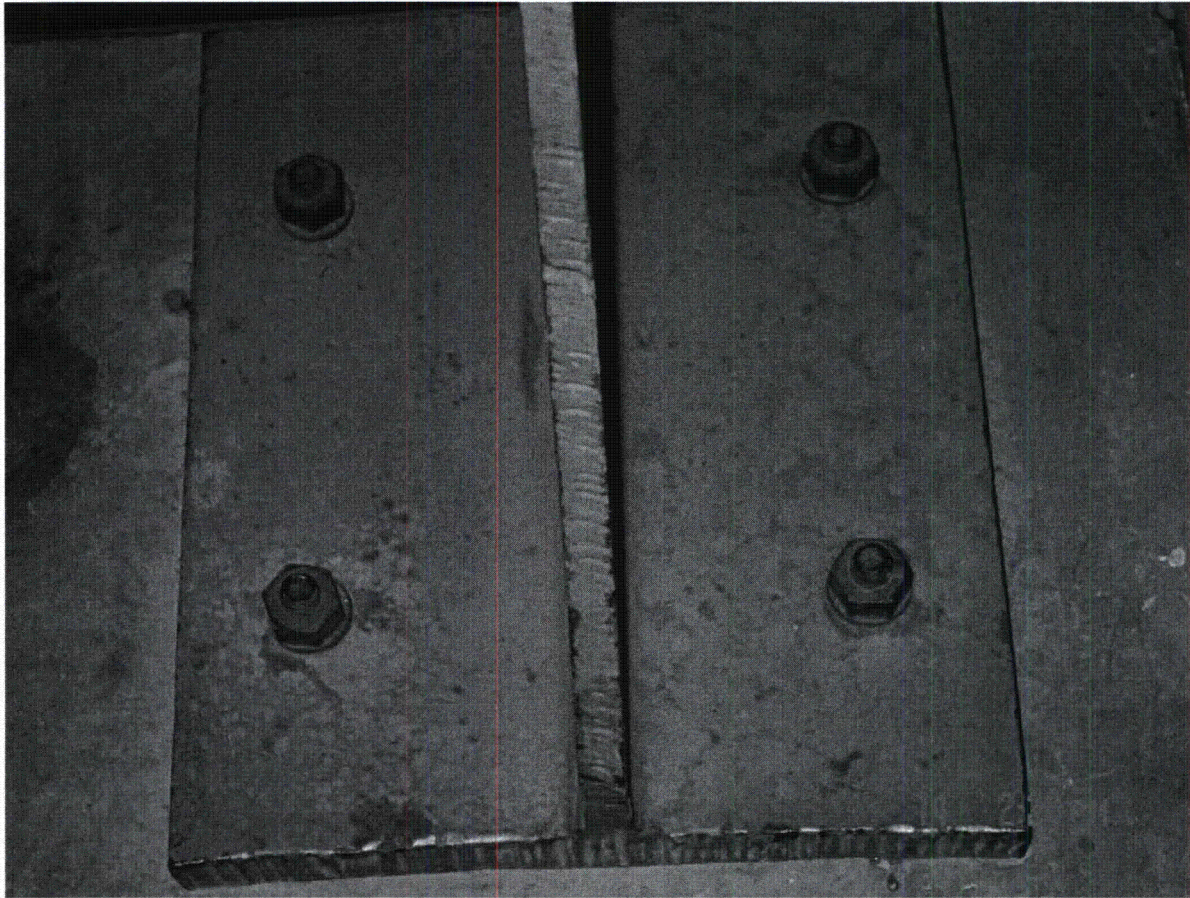
(DSC01365)

“Bolt Pattern”

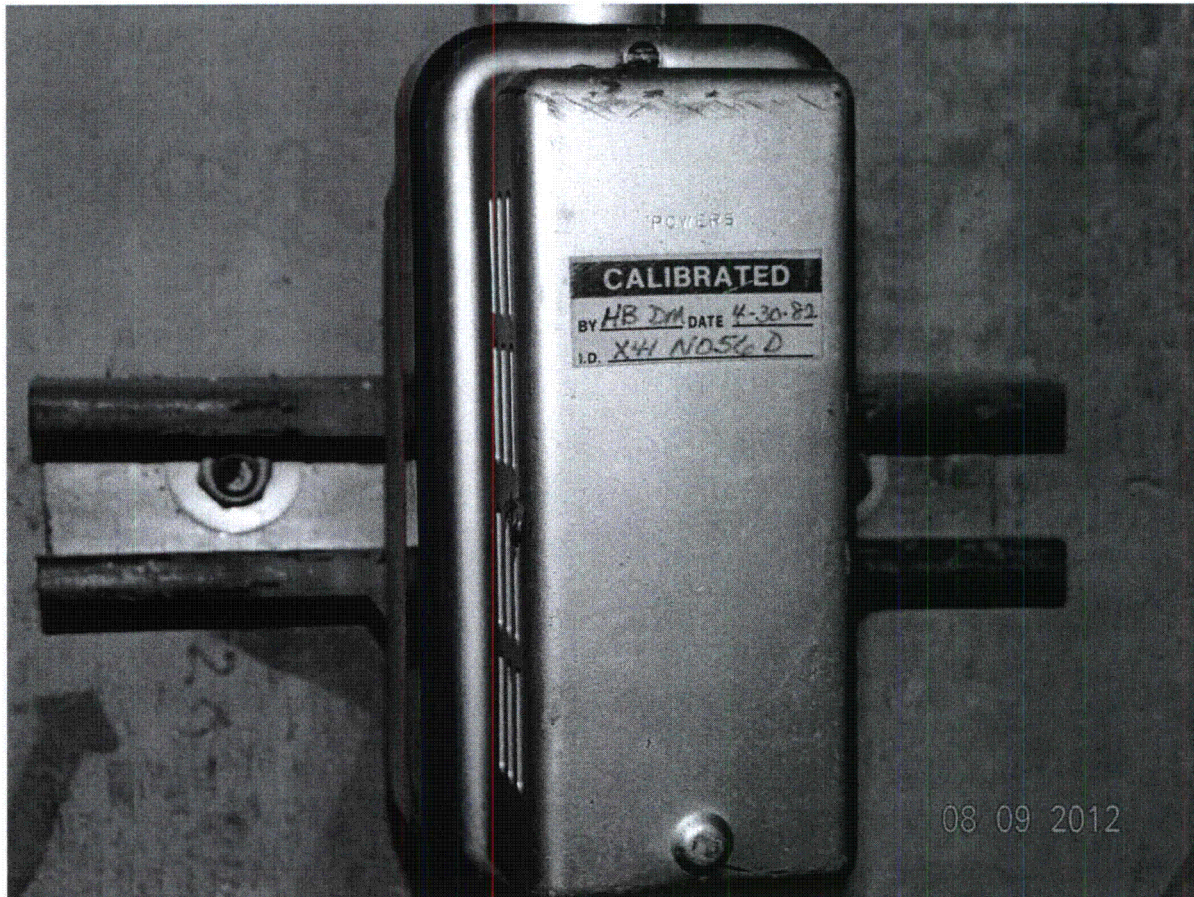
Picture DSC00340  
"Bolt Configuration"

Equipment ID No. X41N056D Equipment Class: 19-Temperature Sensors

Equipment Description HVAC RHR EDG Swgr. Rm. Air Damper Temperature Sensors (EL. 622'-00")

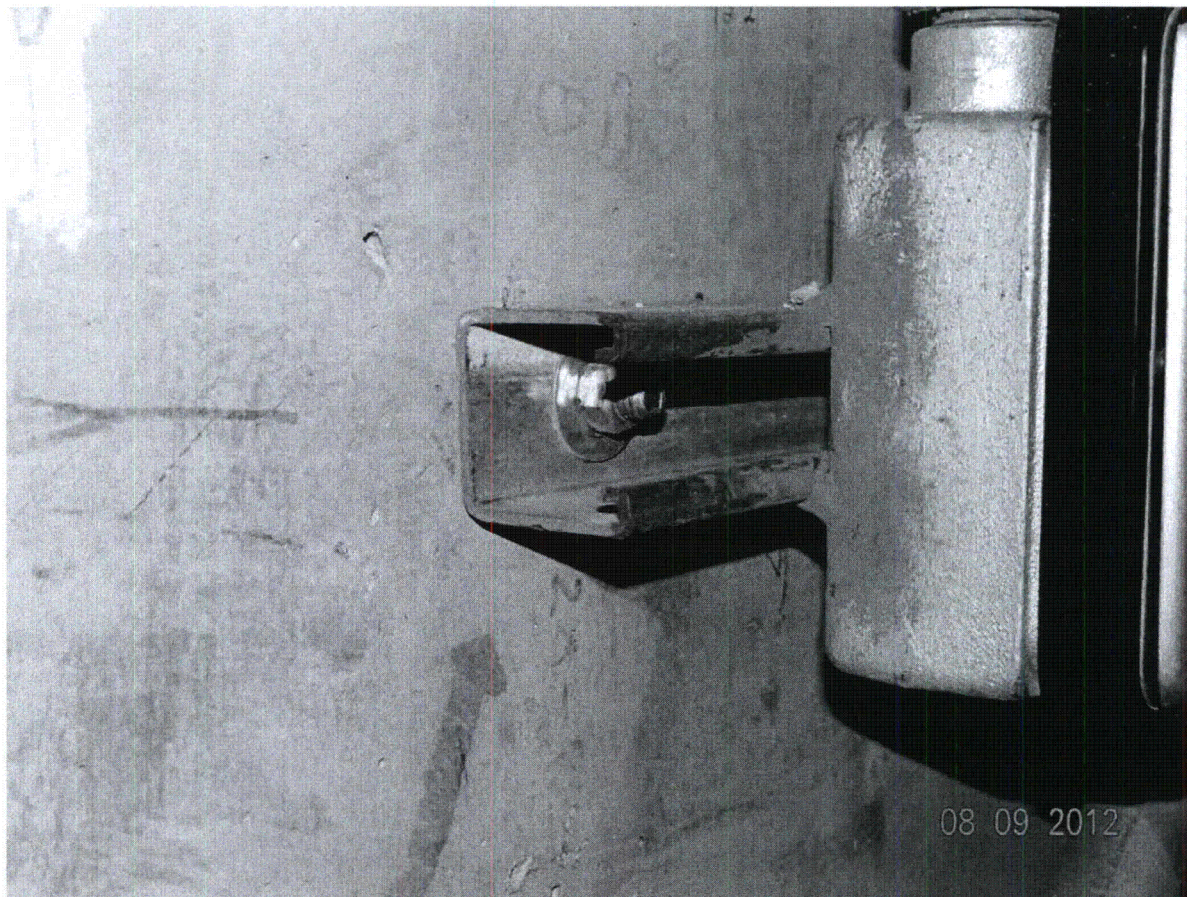
Picture DSC00342  
"Bolt Configuration"

Equipment ID No. X41N056D Equipment Class: 19-Temperature Sensors

Equipment Description HVAC RHR EDG Swgr. Rm. Air Damper Temperature Sensors (EL. 622'-00")

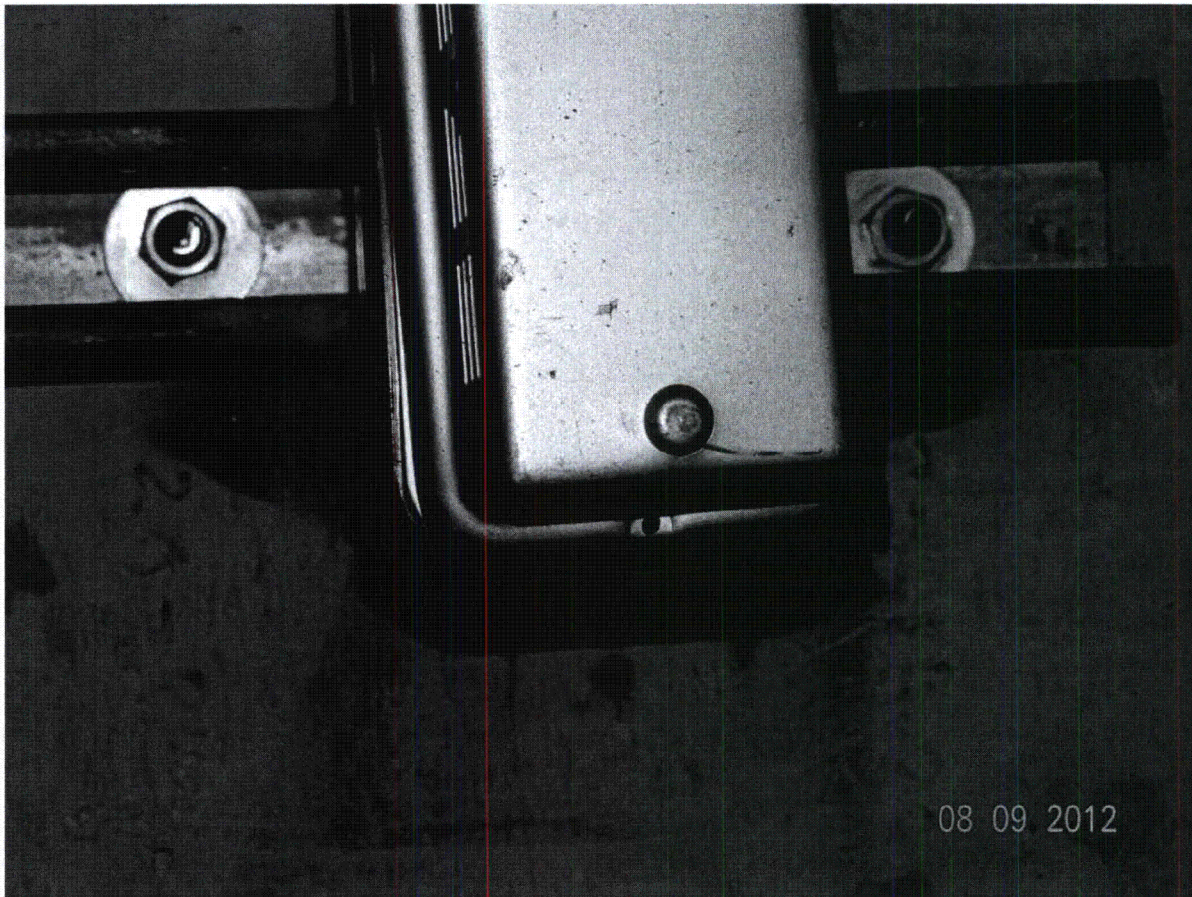
Picture DSC00346  
"Missing Cover Screw"
