**Arkansas Nuclear One Unit 1 Seismic Walkdown Report
for Resolution of Fukushima Near-Term Task Force Recommendation 2.3: Seismic**

Arkansas Nuclear One Unit 1 Seismic Walkdown Report

for Resolution of Fukushima Near-Term Task Force Recommendation 2.3: Seismic

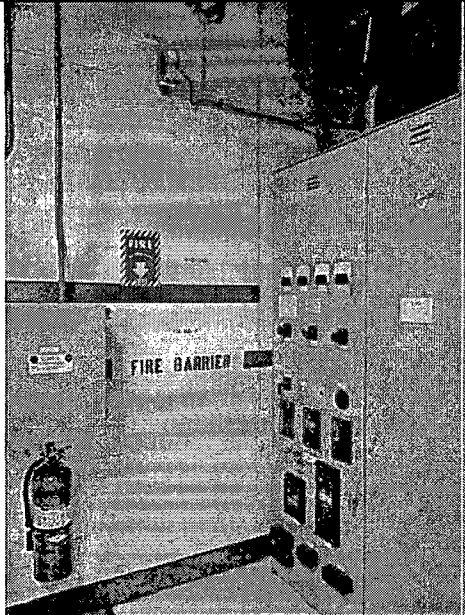
Note: E-21 Cabinet, 6 1/4" spacing between RC wall. Transition between seismic masonry block and RC wall in front of cabinet (vertical gray line.)

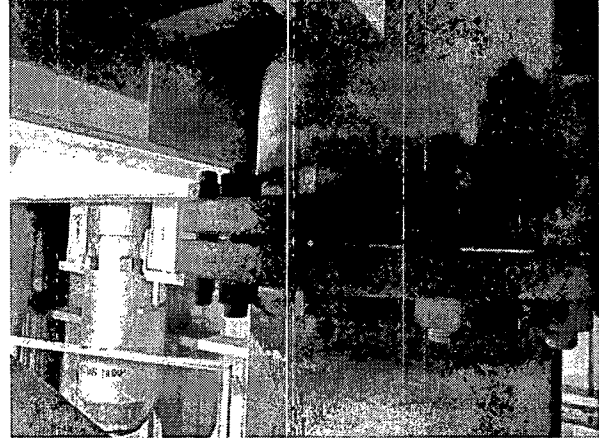
Note: This image shows a section of the bolt connection. Mild surface oxidation was observed.

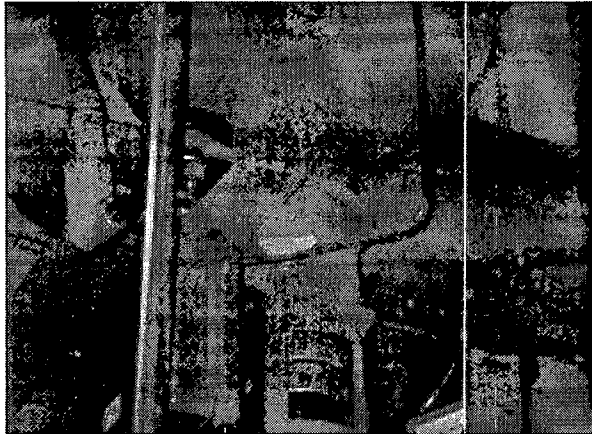
Note: *Since the component appears to be securely anchored to the adjacent steel frames, the small pipe found next to the item is free from impact.*

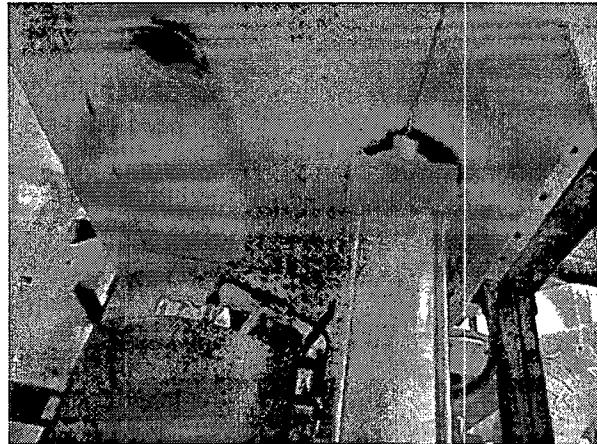
Note: Based on the inspection of the clearance between Item CV-2214 and the steel plate above, the corrective action stated in the SEWS has been verified and no adverse seismic interaction effects have been found.

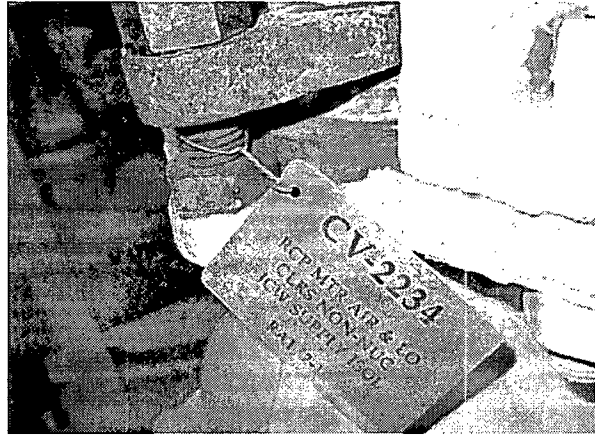
Note: Tag ID number of Item CV-2234. Note also the minor corrosion on the anchor. This has been ruled not to be severe.

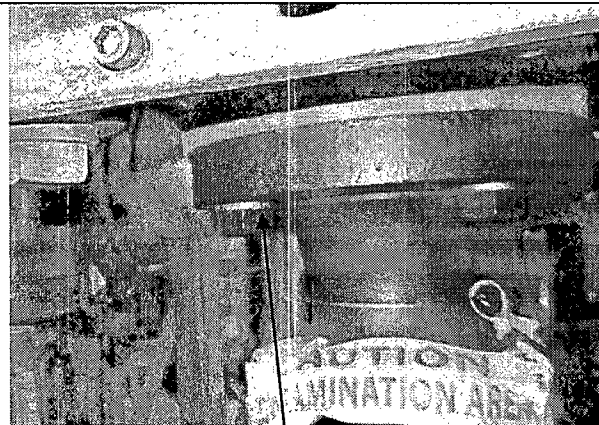
Crack in washer

Note: The washer on the bolt to the left of the image has a small crack. This crack was determined to be insignificant.

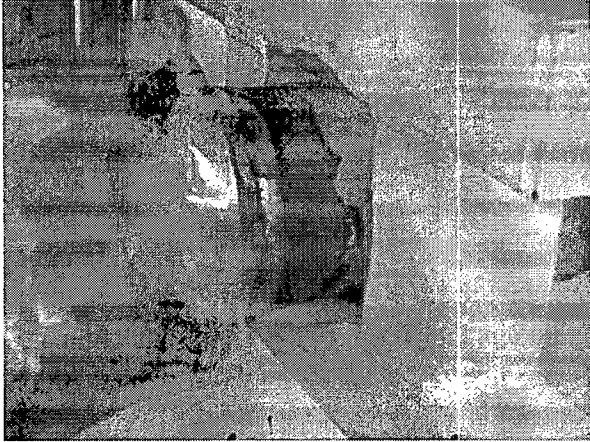
Note: *This image shows the mild corrosion that appears near the anchorage of the pipe leading into the valve, CV-3850.*

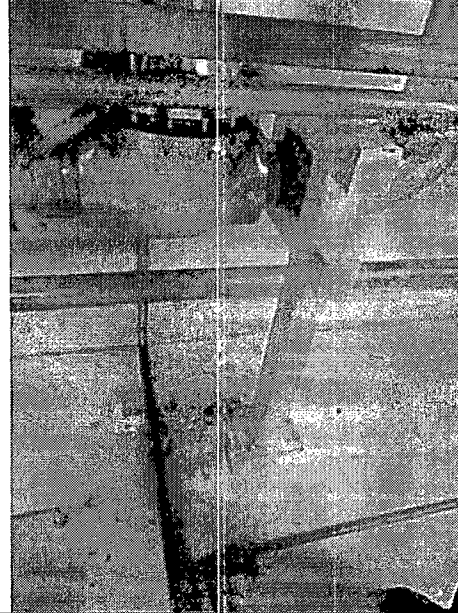
Note: *This image shows the residuals of the mild corrosion on the pipe.*

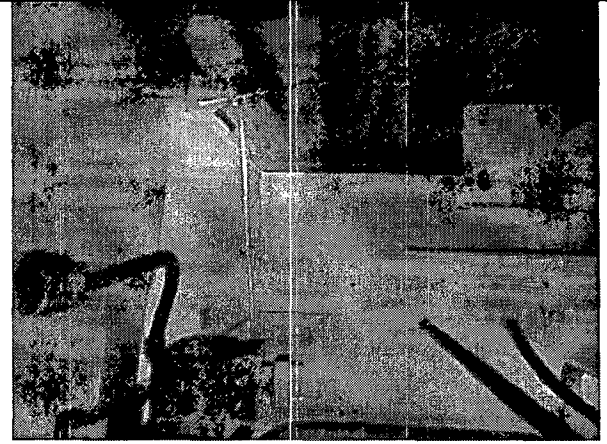
Note: The moveable louver is visible in the top of the picture. The rod seen is the coupling between the damper motor and the louver.

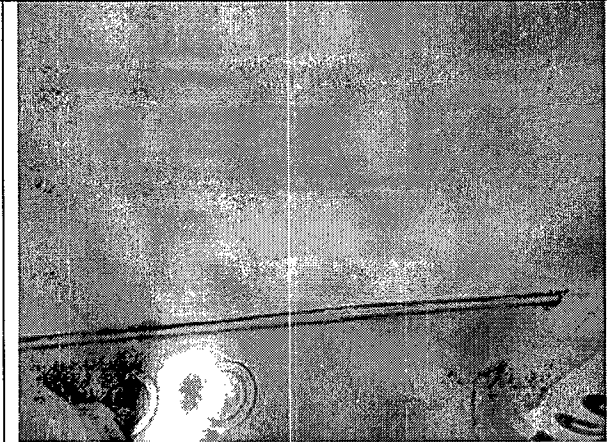
Note: View from above panel RS-2. The expansion anchors are not visible since the panel is mounted flush against the wall.
