Seismic Walkdown Checklist (SWC)

Equipment ID No.: 1DO01P

Equipment Description: PUMP, DIESEL OILTRANSFER

Project: LaSalle 1 SWEL

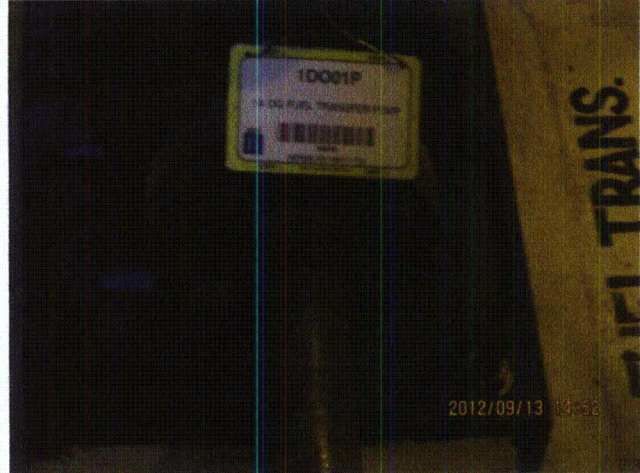
20120913-Lasalle 265

4. Is the anchorage free of visible cracks in the concrete near the anchors? Yes
Approximately 12" of sloped portion of grout pad past edge of pump base has been chipped away. All anchorage still engaged; judged to be acceptable.

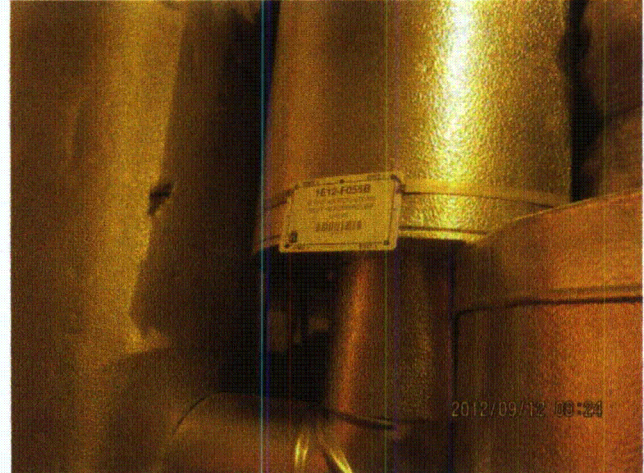
20120912-Lasalle 005

11. Have you looked for and found no adverse seismic conditions that could adversely affect the safety functions of the equipment? Yes
Valve located near insulated pipe. Pipe insulation is flexible; therefore, there is no interaction concern.

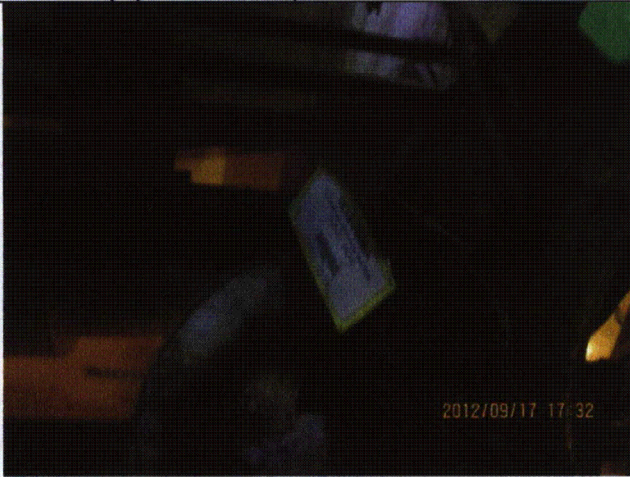
20120917-Lasalle 336

Equipment Description: A RHR HX SERVICE WATER OUTLET VALVE

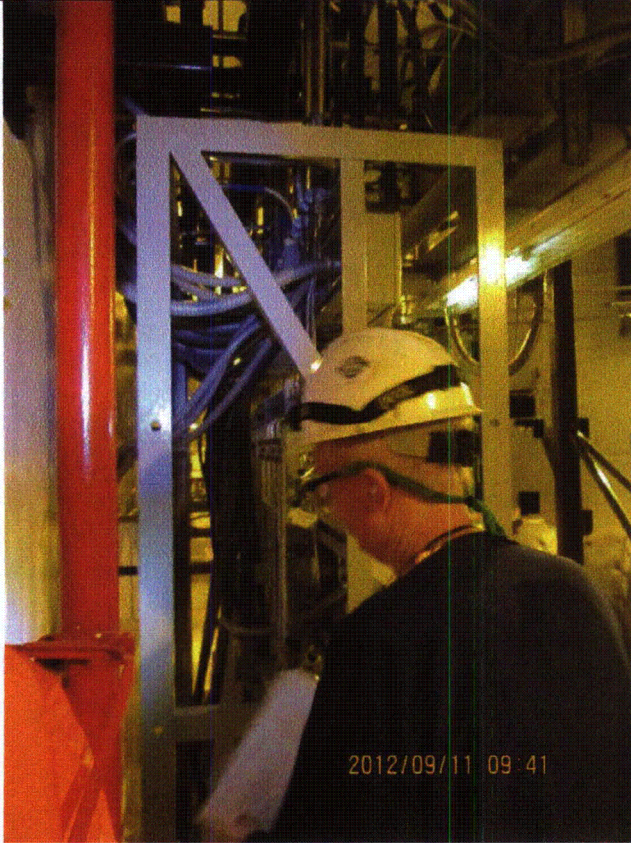
20120911-Lasalle 064

Equipment Description: B RHR HX SERVICE WATER INLET FLOW

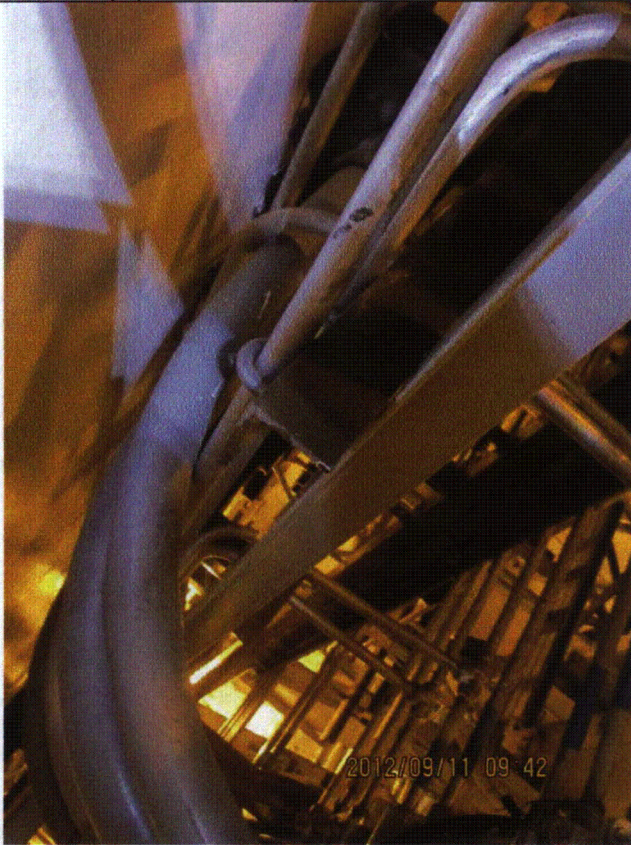
20120911-Lasalle 066

Equipment Description: B RHR HX SERVICE WATER INLET FLOW
