VIRGINIA ELECTRIC AND POWER COMPANY RICHMOND, VIRGINIA 23261

VIRGINIA ELECTRIC AND POWER COMPANY
NORTH ANNA POWER STATION UNITS 1 AND 2
REPORT IN RESPONSE TO MARCH 12, 2012 INFORMATION REQUEST
REGARDING SEISMIC ASPECTS OF RECOMMENDATION 2.3

Resolution of Fukushima Near-Term Task Force Recommendation 2.3: Seismic

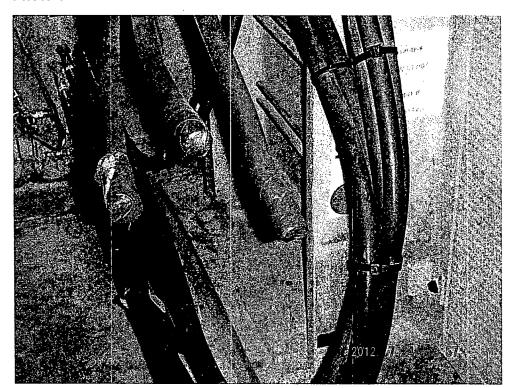
AWC#: NA1-WB-007

SWC / AWC	Equipment ID	CAP	Description	Resolution	Status
NA1-WB-007	N/A	CR482689	Anchor bolt missing in multiple conduit unistrut supports in the Unit 1 Cable Vault. The anchor bolt missing in all supports is the northern most hole located under a cable tray (3 out of 4 are installed).	Engineering review determined that due to the robustness of the support, existing additional lateral support, and the low seismic accelerations in this location of the plant that these supports are acceptable as-is.	Corrective action initiated to document the conduit support configuration.
NA1-WD-SWEL- 013	1-FW-P-3B	CR482723	Two u-bolt supports with loose nuts on non-safety related AFW pump bearing seal leak-off drain piping.	The condition results in a minor loss of support function because the lateral restraint function is still retained and the existing nuts will prevent large vertical displacements. The support spans are also very short. Therefore, functionality of the pump is not affected.	Work Order initiated to correct the loose support condition.

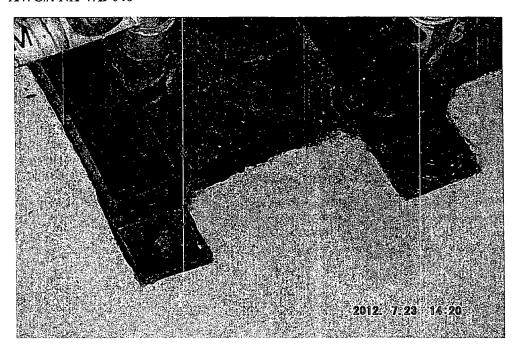
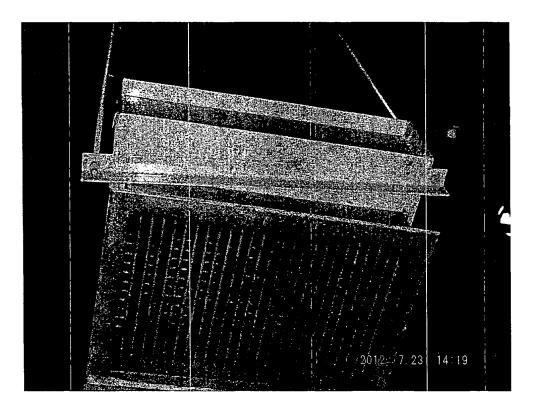
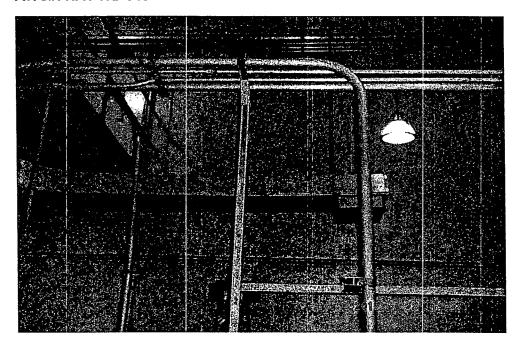
AWC#: NA-WB-046

NA1-WB-046	N/A	CR482589	Angle support for ductwork is currently attached to structural steel with beam clamps and should be a welded attachment.	The support is fully functional in its current clamped condition, however should be a welded attachment as a permanent installation.	Work Order initiated to weld the support.
NA1-WB-007	1TL018P	CR482686	Cable tray 1TL018P support anchor nut lack of full thread engagement.	Engineering review determined that the anchor bolt thread engagement condition is acceptable due to the robustness of the support and the low seismic accelerations in this location, and the bolt has its full shear capacity and additional lateral supports exist.	CLOSED

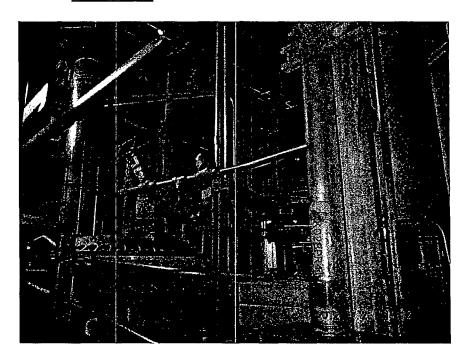
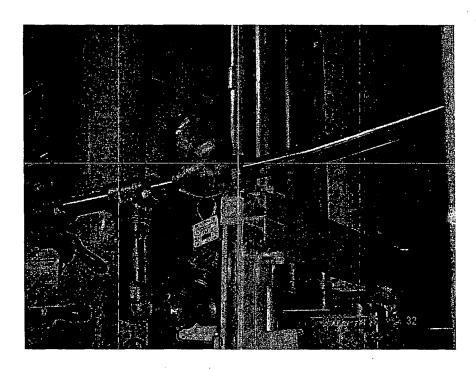
AWC # NA2-WB-004

8.	Have you looked for and found no other seismic conditions that could adversely affect the safety functions of the equipment in the area?	Y⊠ N□ U□
	Noted that lines 1"-SI-413-602-Q2 and 1"-SI-412-1502-Q3 were supported at valve 2-SI-45 by a piece of unistrut. This was not a designed support, the piping was just resting on the unistrut being used to support some conduits. CR 482917 was generated to document this issue. This will not affect the ability of the pipe to perform its design function. See Photos 1 and 2.	
Comr	nents (Additional pages may be added as necessary)	*
	Associated Seismic Walkdown Checklists: NA2-WD-SWEL-054	
	Area consisted of Unit 2 Penetration Area south of Column J to the wall east.	at Column Line 10 ½ to the
Evalu	ated by: Dave DeMello David Do Nollo	Date: 7/25/2012
Evalu	nated by: Tim Knoebel	Date: 7/25/2012
