Seismic Walkdown Checklist (SWC)Equipment ID No. 2R43-C006C Equip. Class¹ 12Equipment Description DG 2C AIR COMPRESSORLocation: Bldg. DIESEL Floor El. 130 Room, Area DIESEL GEN ROOM 2C

Seismic Walkdown Checklist (SWC)Equipment ID No. 2R43-C005A Equip. Class¹ 12Equipment Description DG 2A AIR COMPRESSORLocation: Bldg. DIESEL Floor El. 130 Room, Area 2A

Status: Y N U **Seismic Walkdown Checklist (SWC)**Equipment ID No. 2C71-S001A Equip. Class¹ 13Equipment Description RPS MG Set A Motor GeneratorLocation: Bldg. CONTROL Floor El. 130 Room, Area C124

Seismic Walkdown Checklist (SWC)Equipment ID No. 2R42-S001A Equip. Class¹ 15Equipment Description 125/250V Station Battery 2ALocation: Bldg. CONTROL Floor El. 112 Room, Area Unit 2 Station Battery Room 2A

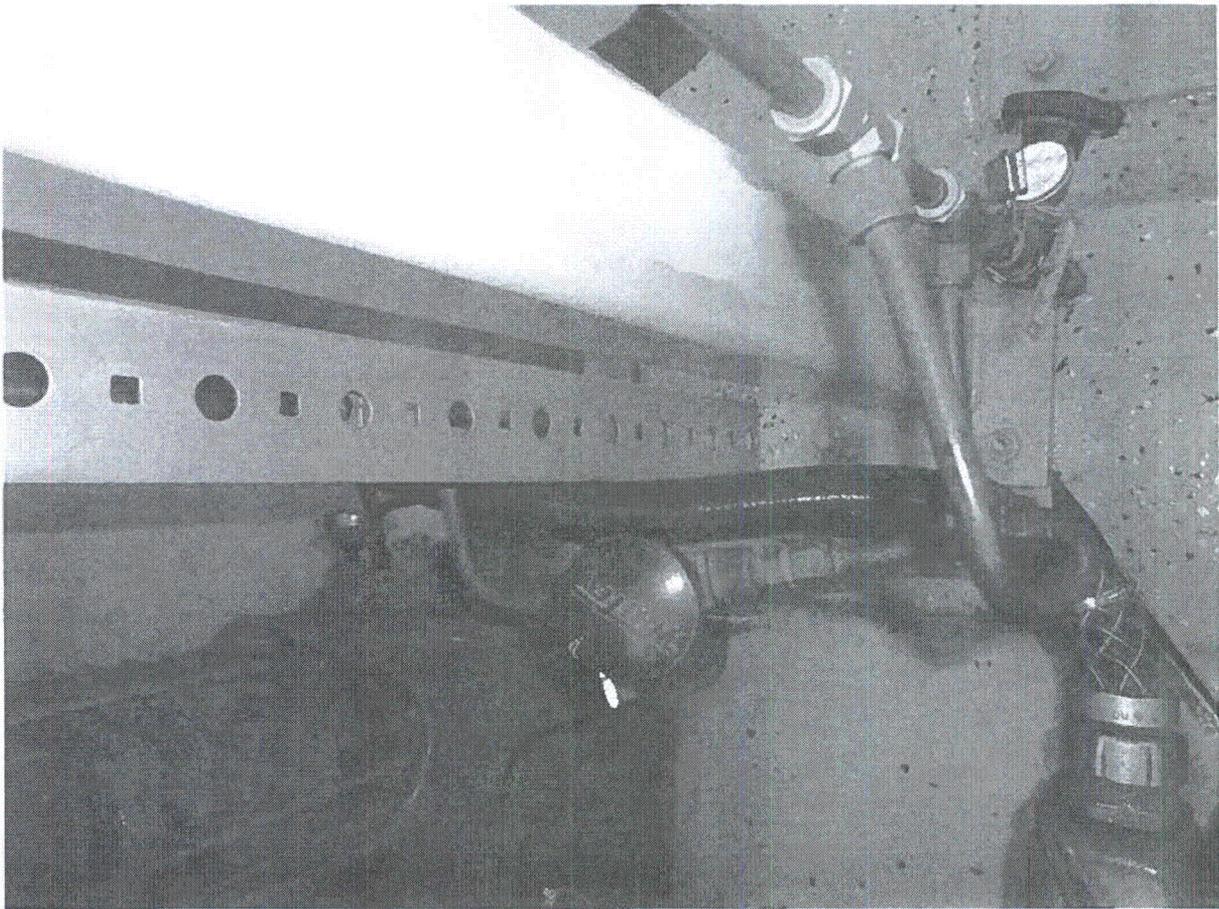
3: Flex Conduit Bearing on Angle (2R43-C006C)

9. Do attached lines have adequate flexibility to avoid damage? Y N U N/A
The flex conduit attached to the equipment as shown in photograph 3 is in contact with the sharp edge of a supporting angle. This condition is not considered adverse in a seismic event, due to the relative small duration of vibration. Long term fretting on the conduit may occur during operation when high frequency vibrations are constantly present. CR 515119 was created to address this condition.

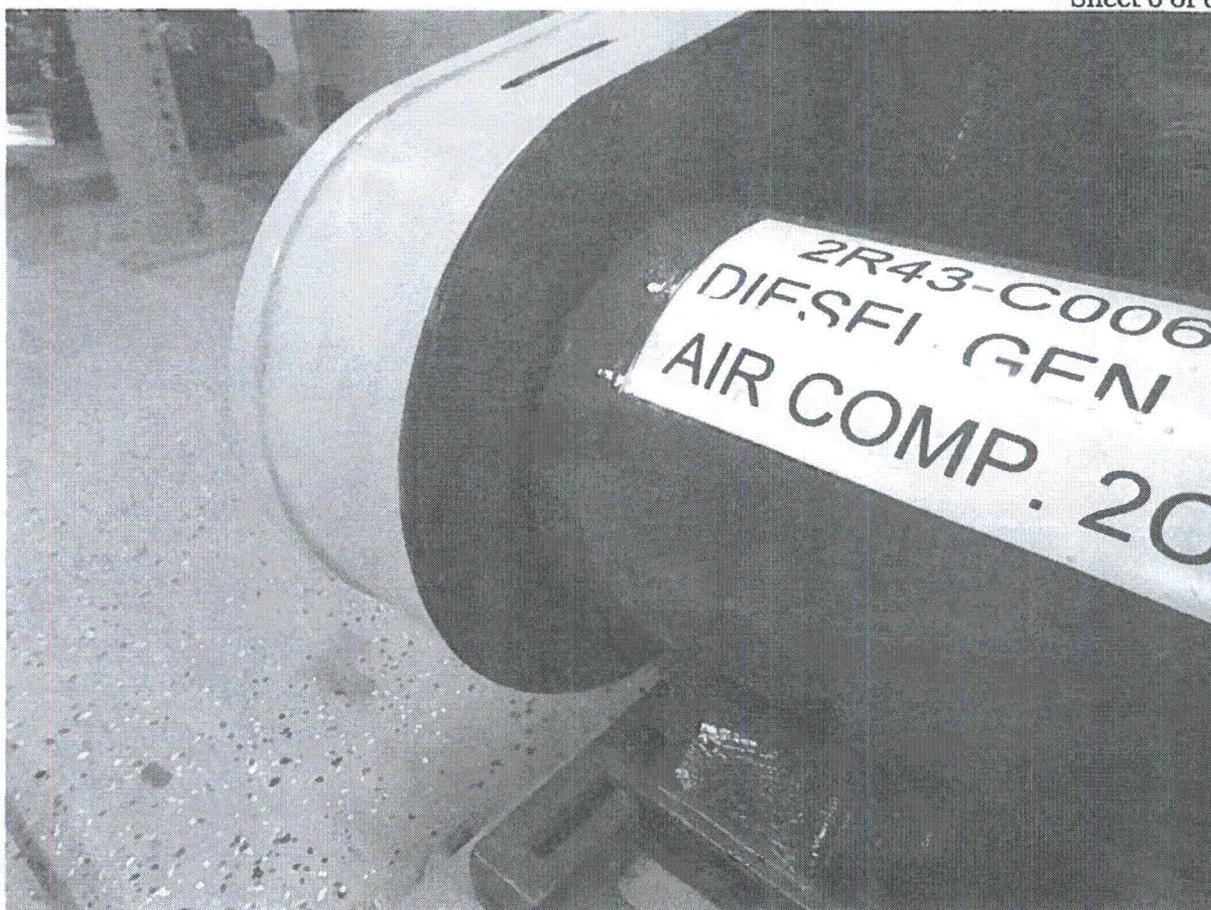
4: Housing Screw Missing (2R43-C006C)

There is a missing screw in the equipment housing as shown in picture 4. CR 515119 was created to address this issue.

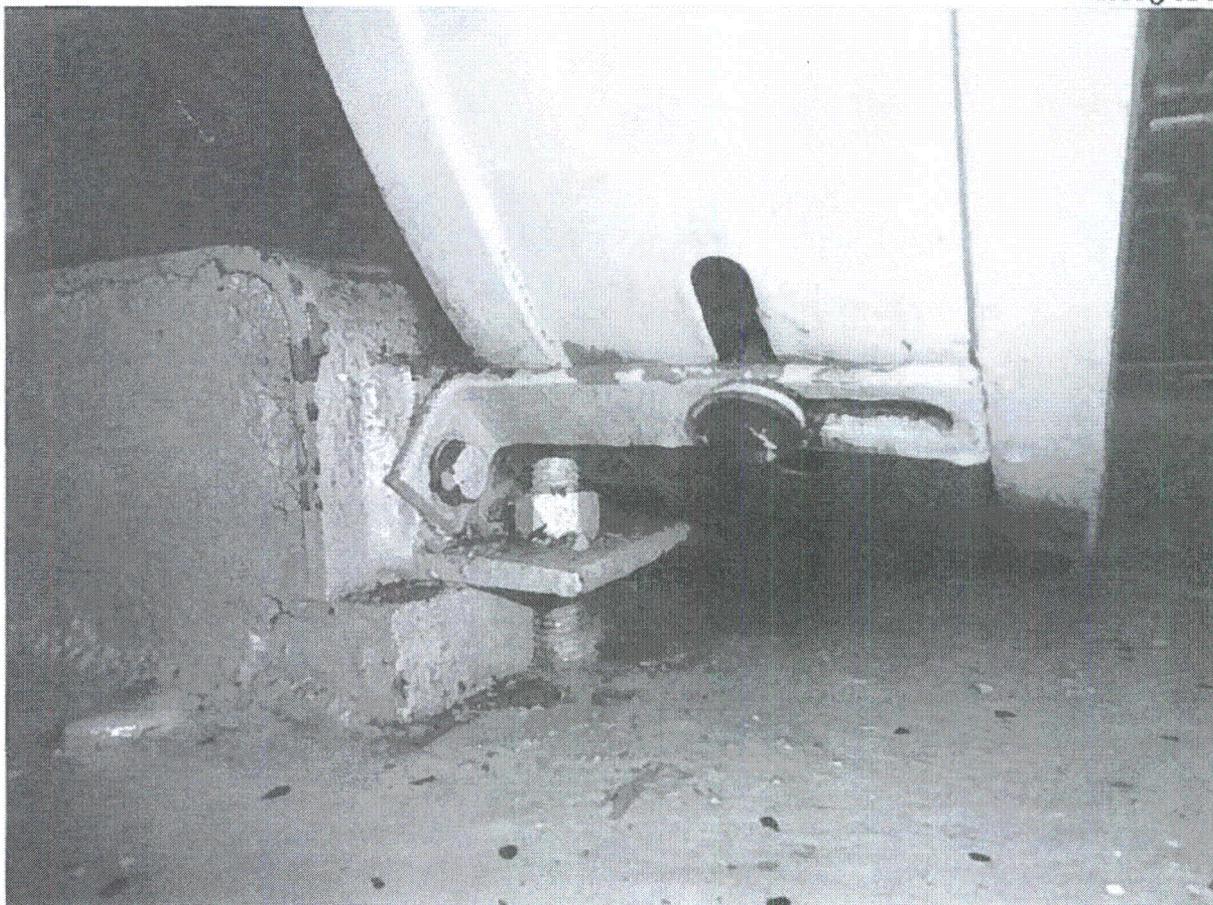
3: Missing Grout Condition (2R43-C005C)

4. Is the anchorage free of visible cracks in the concrete near the anchors? Y N U N/A
A potential seismic condition was observed. Grout is missing from under the southeast anchor of the component pad (see photograph 3). CR 515115 was written to address this condition.

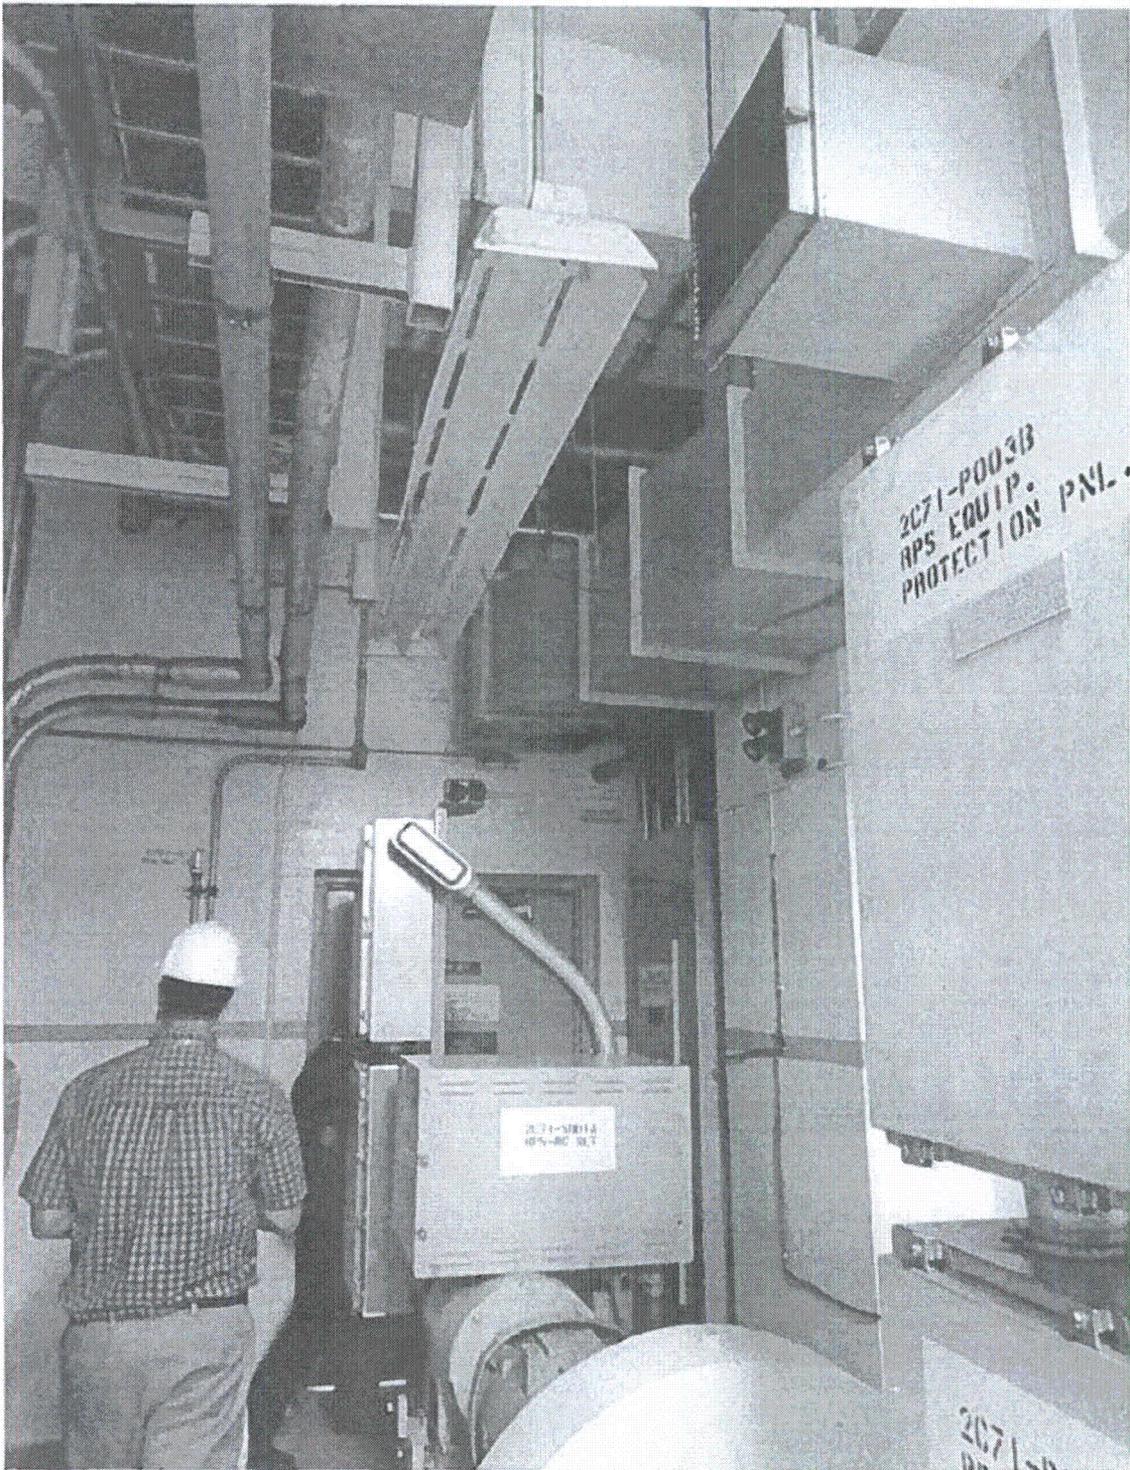
Figure 3 -- Light Fixture Above Motor Generator (2C71-S001A)

There is a fluorescent light fixture without a cover located over the component. The light is tied to the ceiling, so during a seismic event, only the bulb could fall. The motor generator is very rugged and is judged to have sufficient strength as to make a possible impact between the motor generator and the bulb will be insignificant. Therefore, it is judged to be seismically adequate by the SWE's.

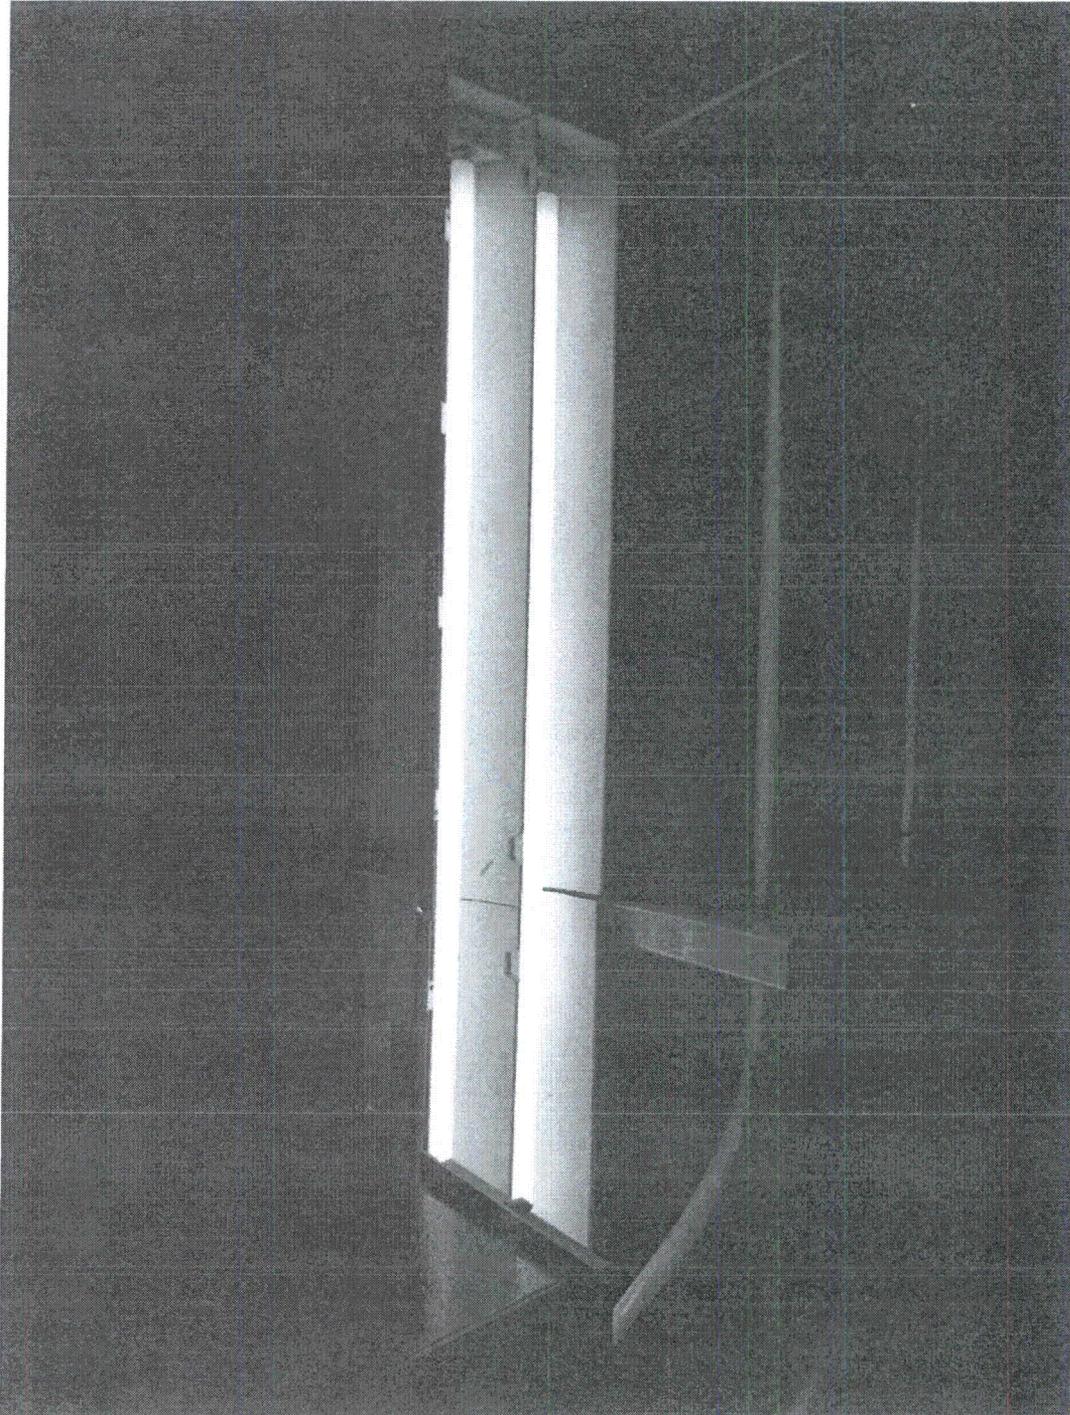
Figure 3 – Flourescent Light over Equipment (2C71-S001B)

Table 3.8-20. There is a fluorescent light fixture without a cover located over the component. The light is tied to the ceiling, so during a seismic event, only the bulb could fall. The motor generator is very rugged and is judged to have sufficient strength as to make a possible impact between the motor generator and the bulb insignificant. Therefore, it is judged to be seismically adequate.

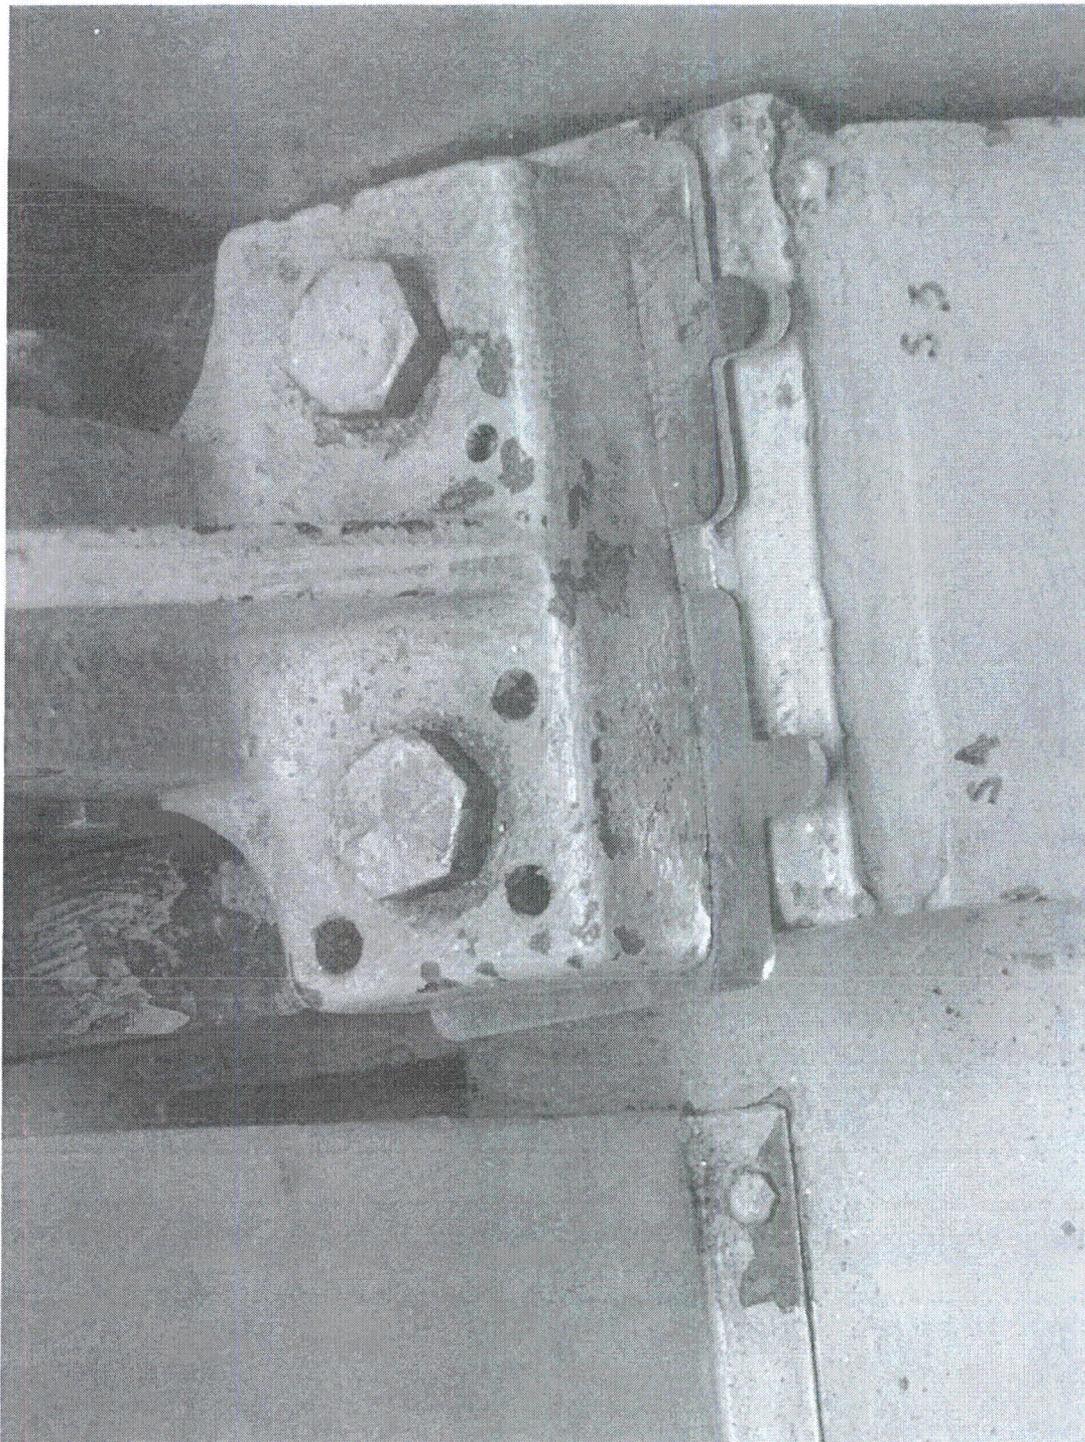
Figure 4 – Drilled Holes in Motor Casing (2C71-S001B)

There are a number of drilled holes in the casing of the motor, particularly at anchorage locations. These holes appear to have been drilled to alter the balance of the motor and are clearly unrelated to component anchorage. Their presence does not indicate missing anchors or screws. Therefore, there is no potentially adverse seismic condition.
