<b>PROJECT REPORT COVER SHEET</b>	<b>NO. SNCH082-RPT-02</b>
		<b>VERSION 1.0</b>
		Page 1 of 60

Edwin I. Hatch Unit 2 SEISMIC WALKDOWN REPORT, RER SNC425082

Resolution of Fukushima Near-Term Task Force Recommendation 2.3: Seismic

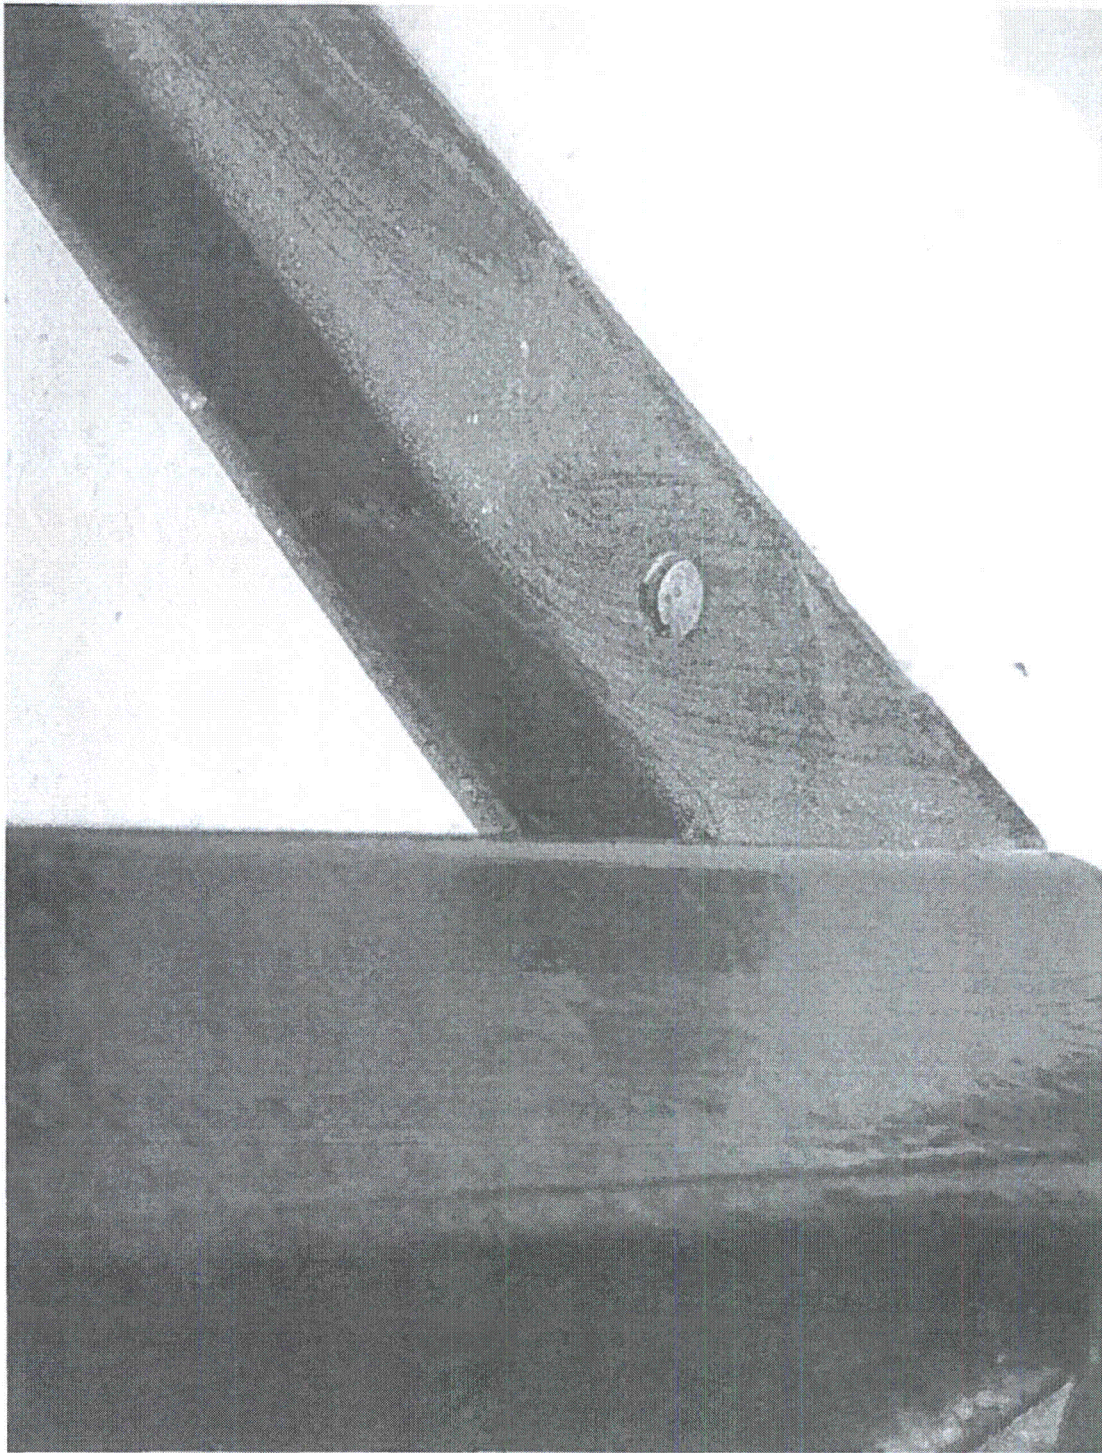
Figure 3 – Empty Anchor Hole (2R42-S001B)

2. Is the anchorage free of bent, broken, missing or loose hardware? Y  N  U  N/A   
*There is one anchor missing from the support. Review of SEWS package 2R42-S001B shows that this anchor is noted to be missing and is not accounted for in the evaluation, so there is no potentially adverse seismic condition.*

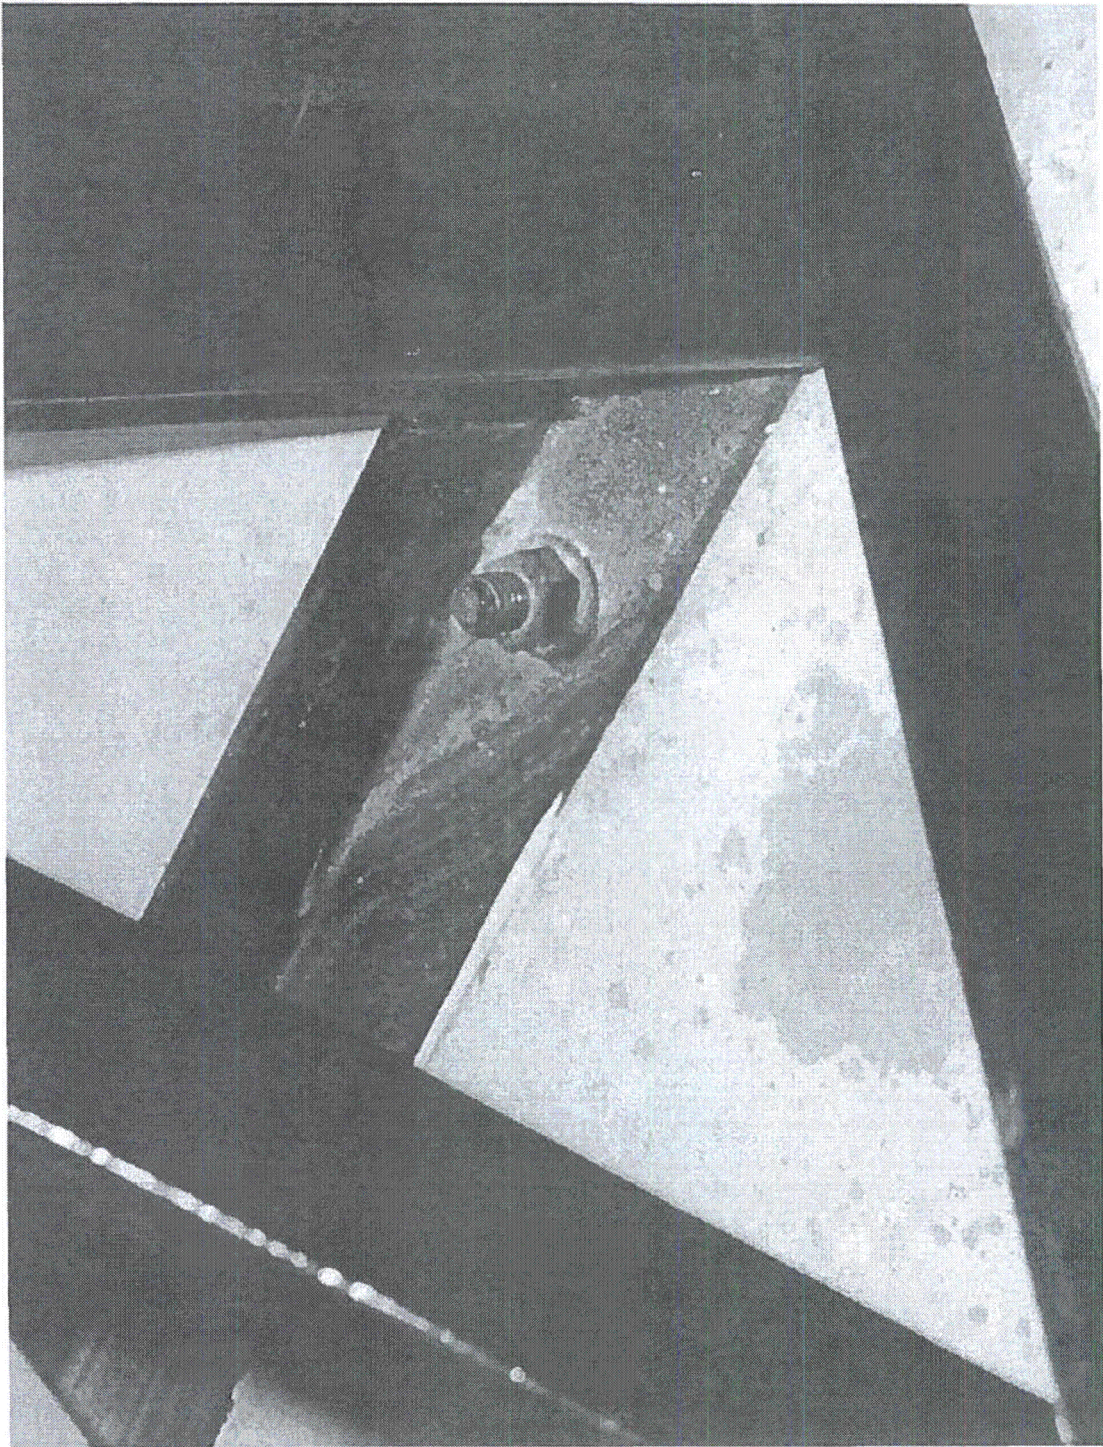
Figure 4 – Mild Acid Residue on Bolts (2R42-S001B)

3. Is the anchorage free of corrosion that is more than mild surface oxidation? Y  N  U  N/A   
*There is some acid residue on the bolts from the batteries, but the paint has prevented any significant corrosion of the bolts. Since the corrosion is only on the surface, there is no potentially adverse seismic condition.*

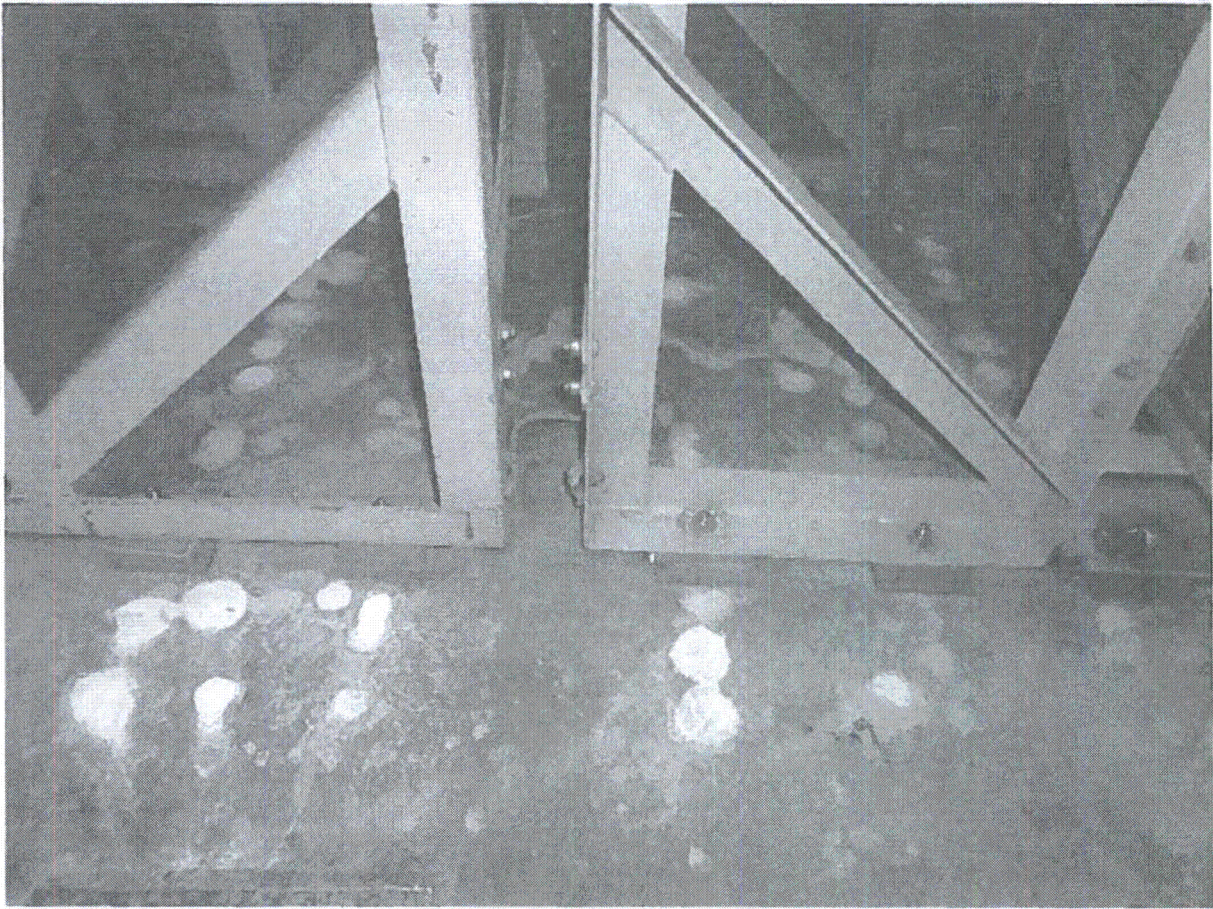
3: Stains on Concrete Below Batteries (2R42-S002C)

11. Have you looked for and found no other seismic conditions that could adversely affect the safety functions of the equipment? Y N U  
*The concrete surface below the batteries exhibited stains from some substance leaking in the area (see photograph 3). This is not a seismic concern.*

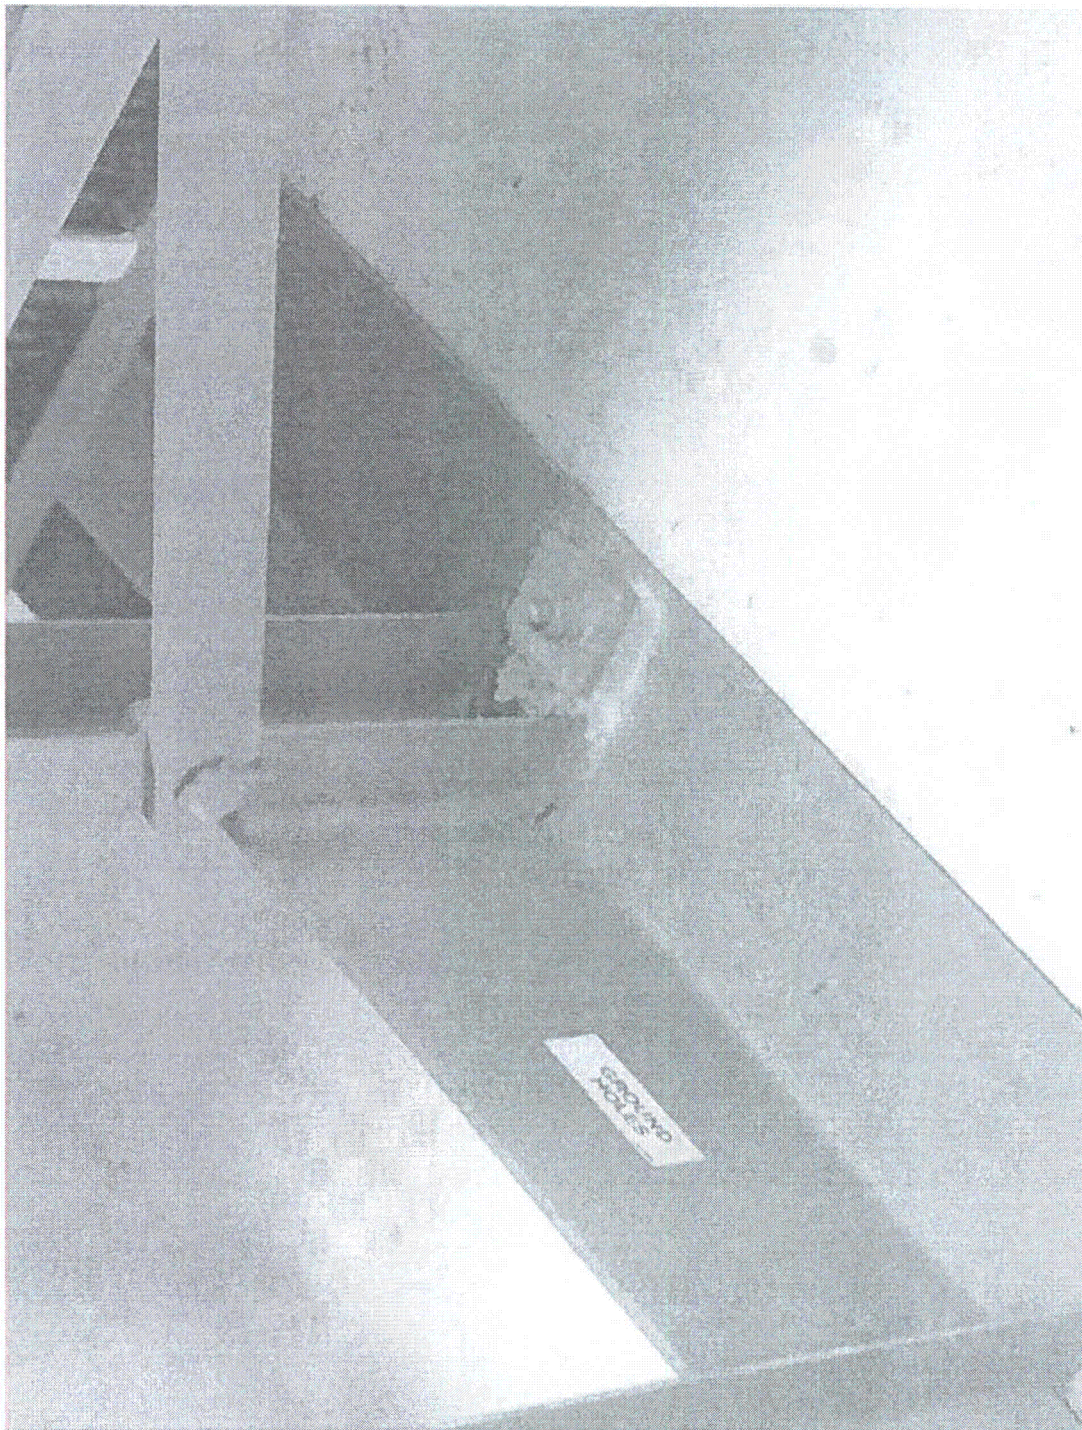
Figure 3 – Surface Oxidation on Middle Anchor (2R42-S017A)

3. Is the anchorage free of corrosion that is more than mild surface oxidation? Y  N  U  N/A   
*There is mild surface oxidation on the middle anchor bolts. Since oxidation is only on the surface, the bolts are not degraded. Therefore, judged not to be a concern.*

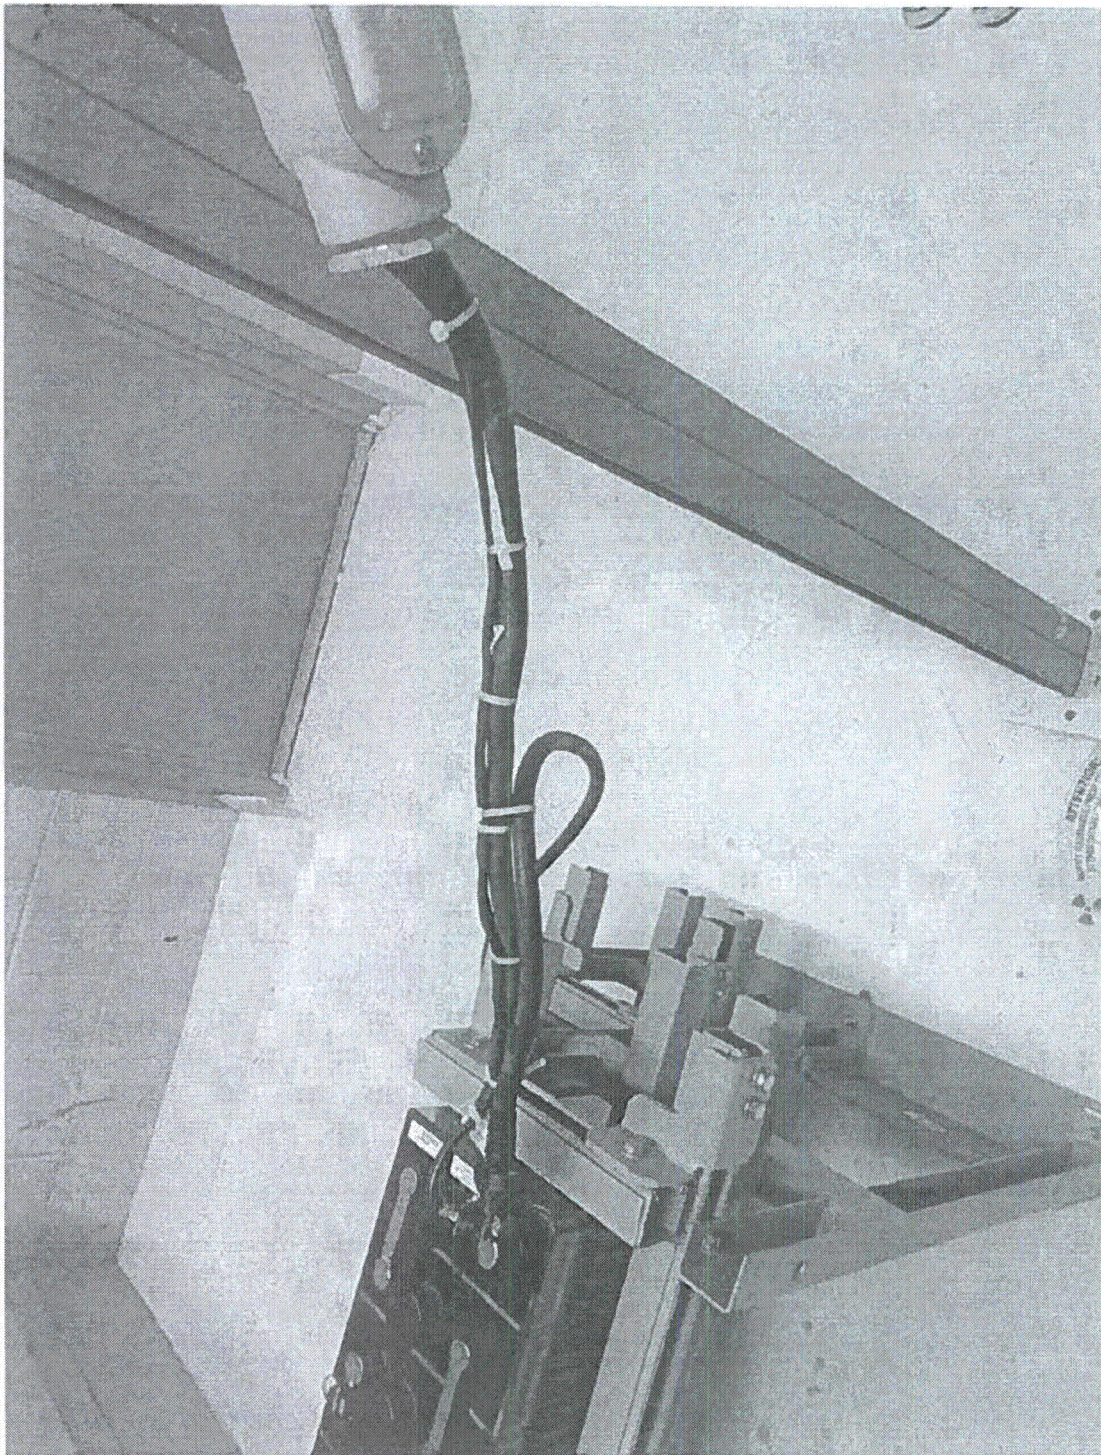
Figure 4 – Attached Battery Line (2R42-S017A)

9. Do attached lines have adequate flexibility to avoid damage? Y  N  U  N/A   
*The line between the battery rack and the adjacent junction box support has relatively little slack. The battery and box supports are fairly rigid and the seismic acceleration at that elevation will be relatively low, so the differential movement between the components will be small. The slack in the conduit is judged sufficient to prevent any damage to the cables, so there is no potentially adverse seismic condition.*

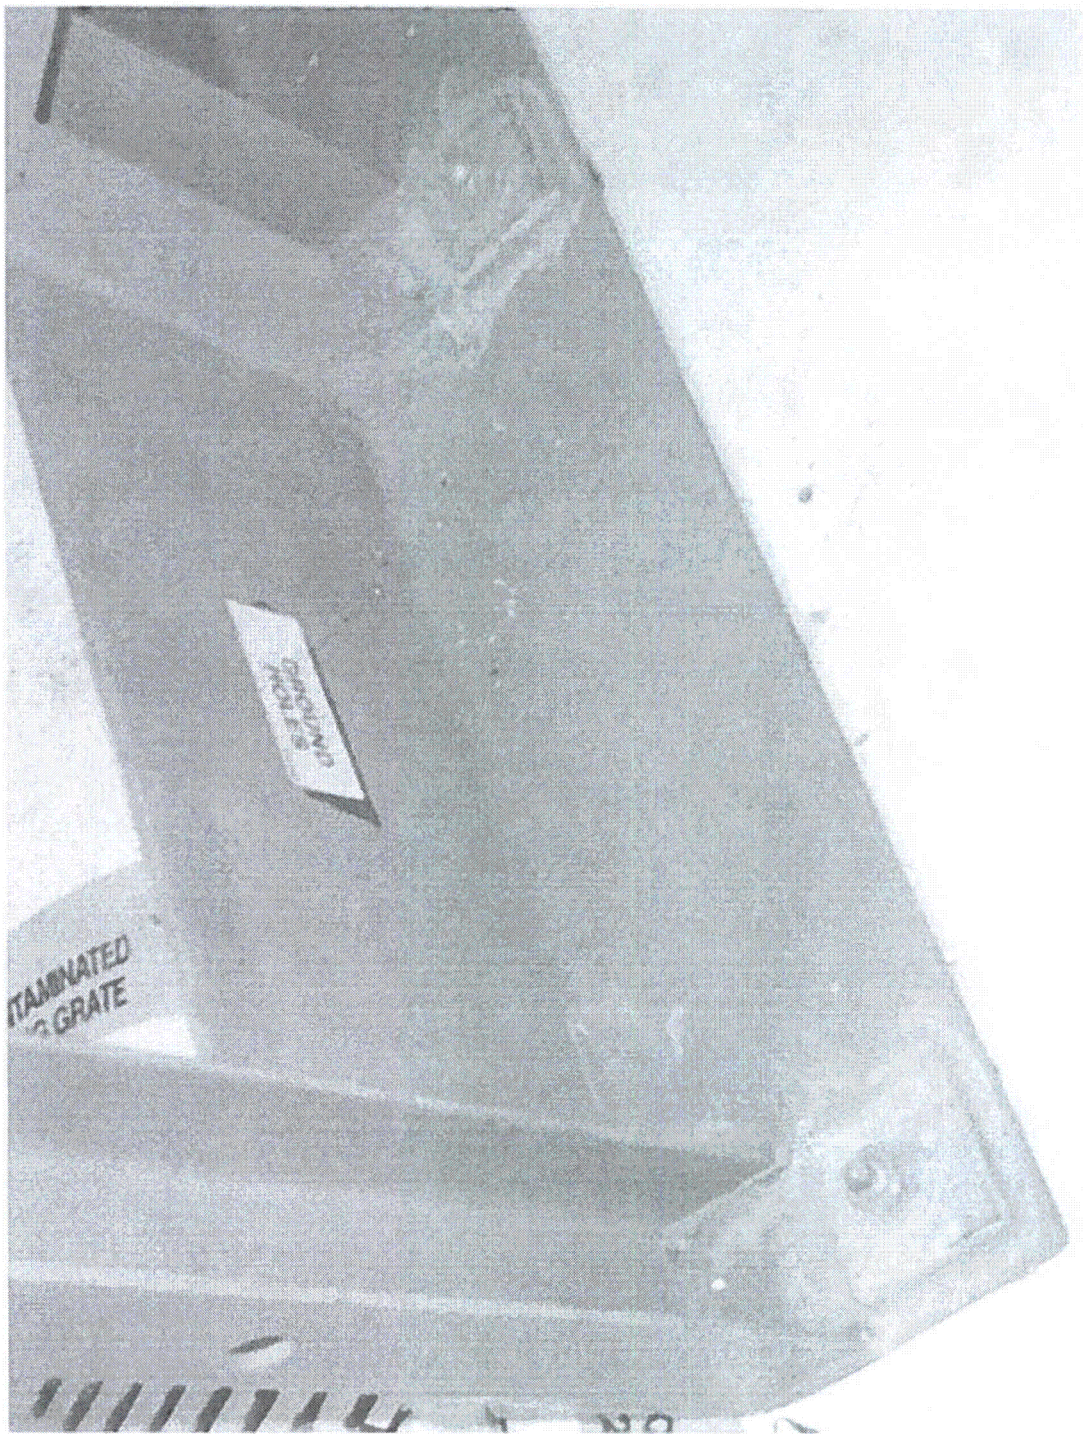
Figure 3 – Surface Oxidation on Washer Plates (2R42-S017B)

3. Is the anchorage free of corrosion that is more than mild surface oxidation? Y  N  U  N/A   
*There is mild surface oxidation on the component washer plates. Since oxidation is only on the surface, the bolts are not degraded. Therefore, judged not to be a concern.*

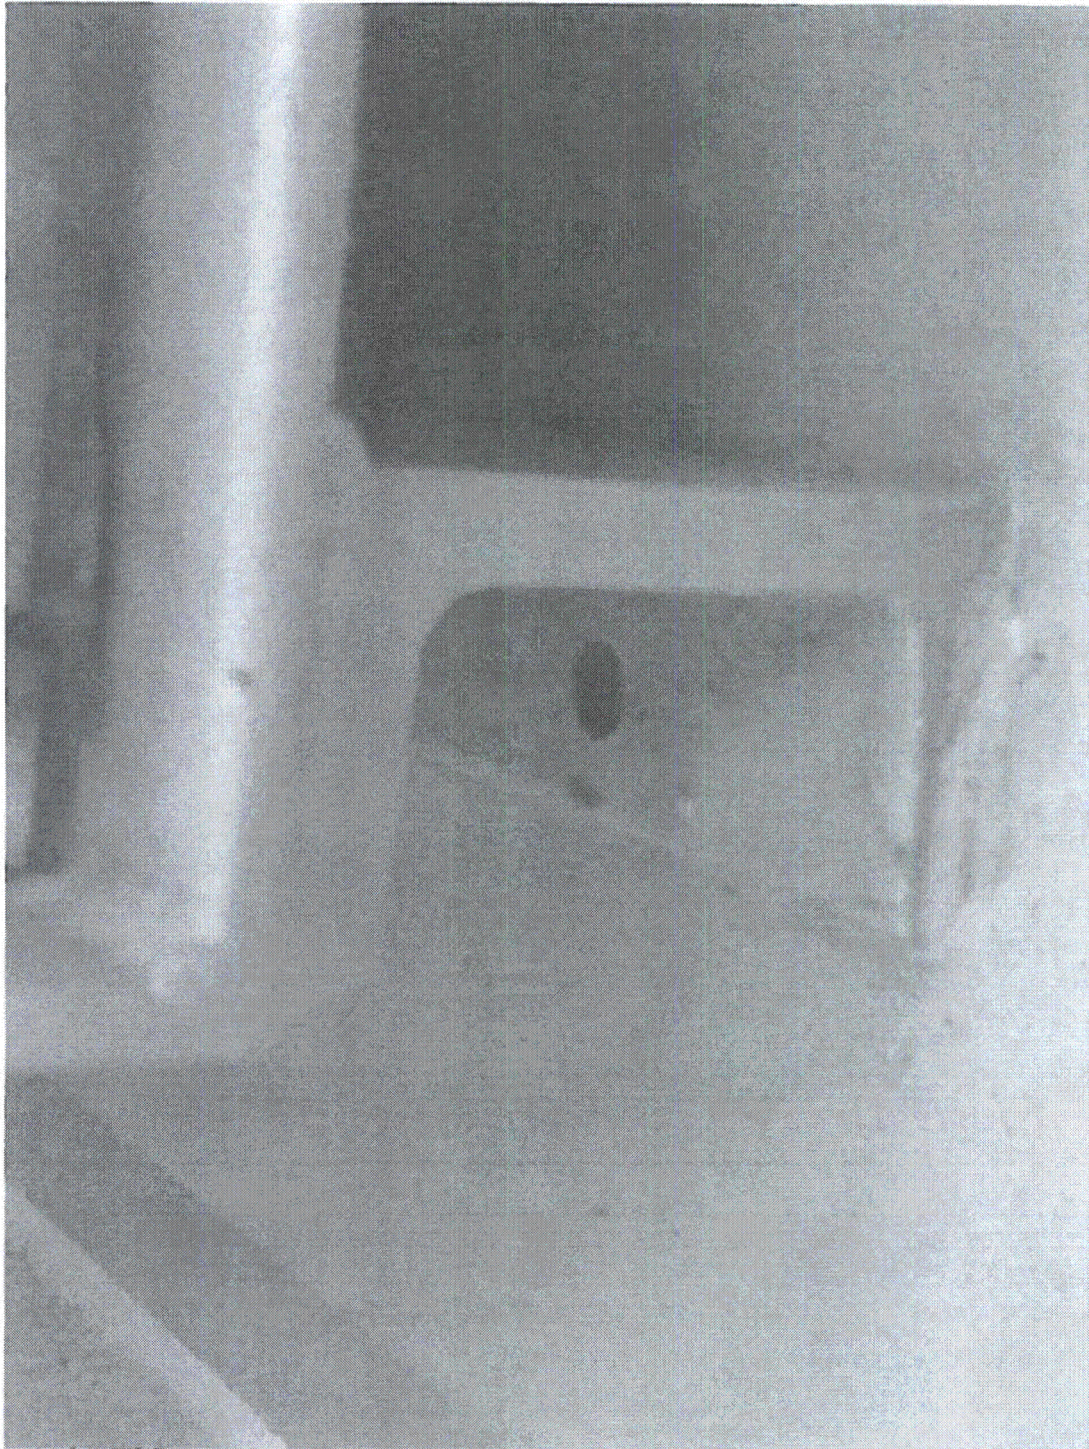
Figure 3 – Replaced Anchor Bolts (2R42-S026)

2. Is the anchorage free of bent, broken, missing or loose hardware? Y  N  U  N/A   
*There are two anchor bolt holes without anchor bolts. However, review of SEWS packages 2R42-S026 and S029 show that the anchors were replaced with welds, so there are no missing anchors. The existing welds have been verified against the SEWS packages and found to be in compliance. Therefore, there is no potentially adverse seismic condition.*

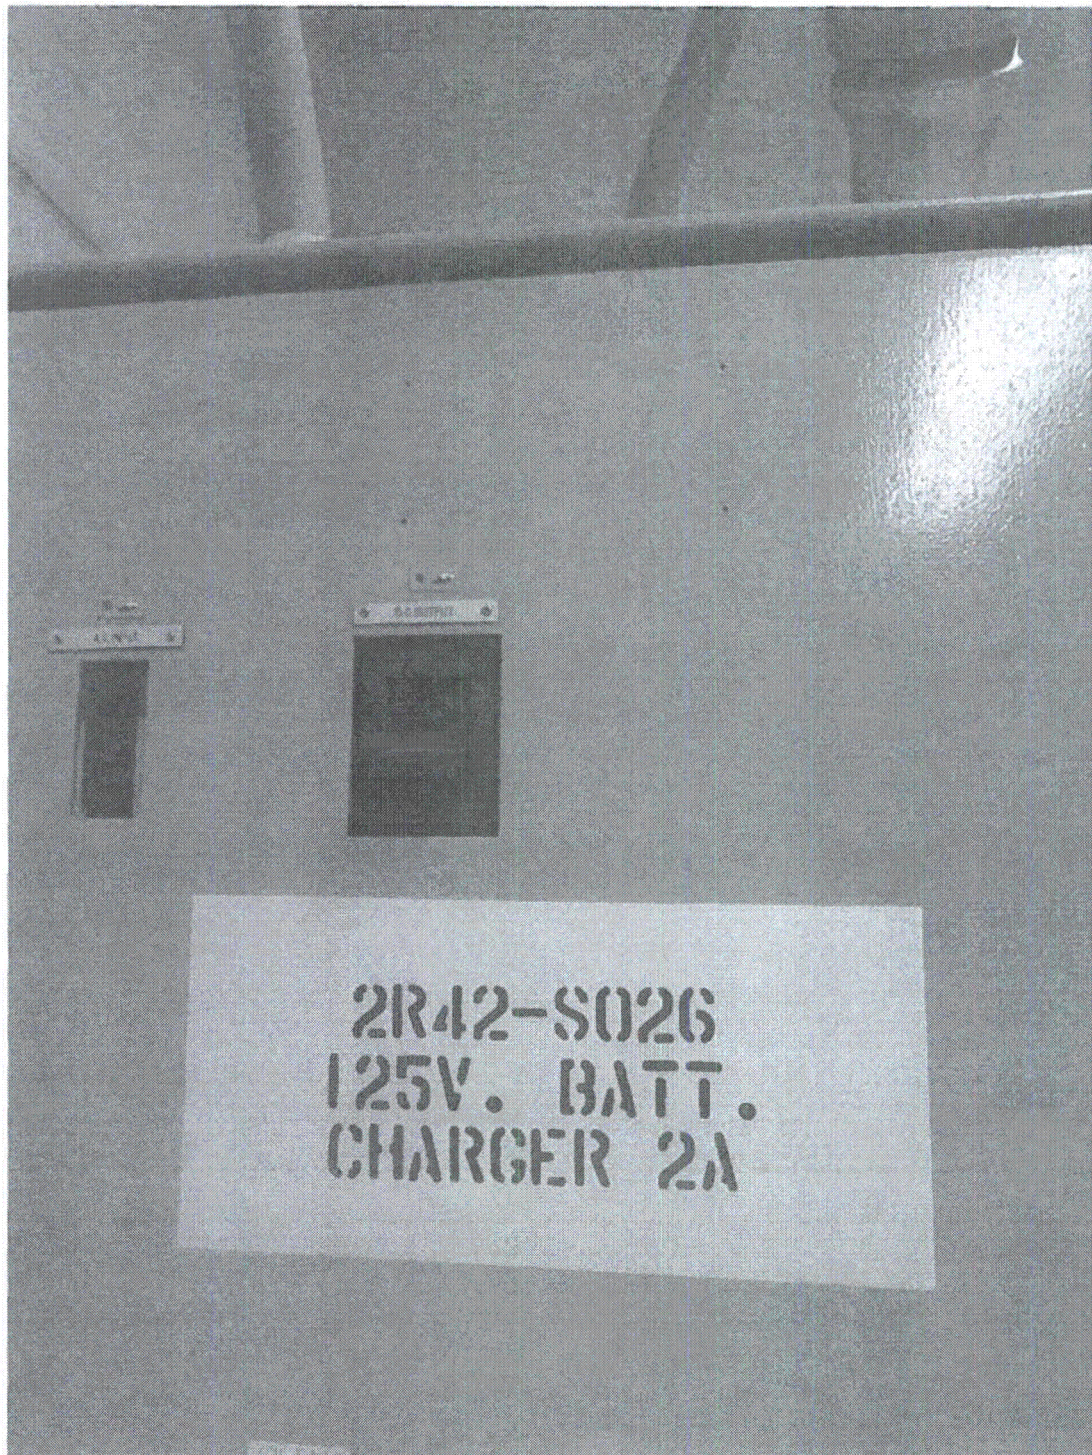
Figure 4 –Empty Holes on Panel Front (2R42-S026)

*There are four holes on the front of the battery charger without screws. The holes are for an internal attachment or grounding configuration that is not being utilized, so there are no screws missing. Therefore, there is no potentially adverse seismic condition.*

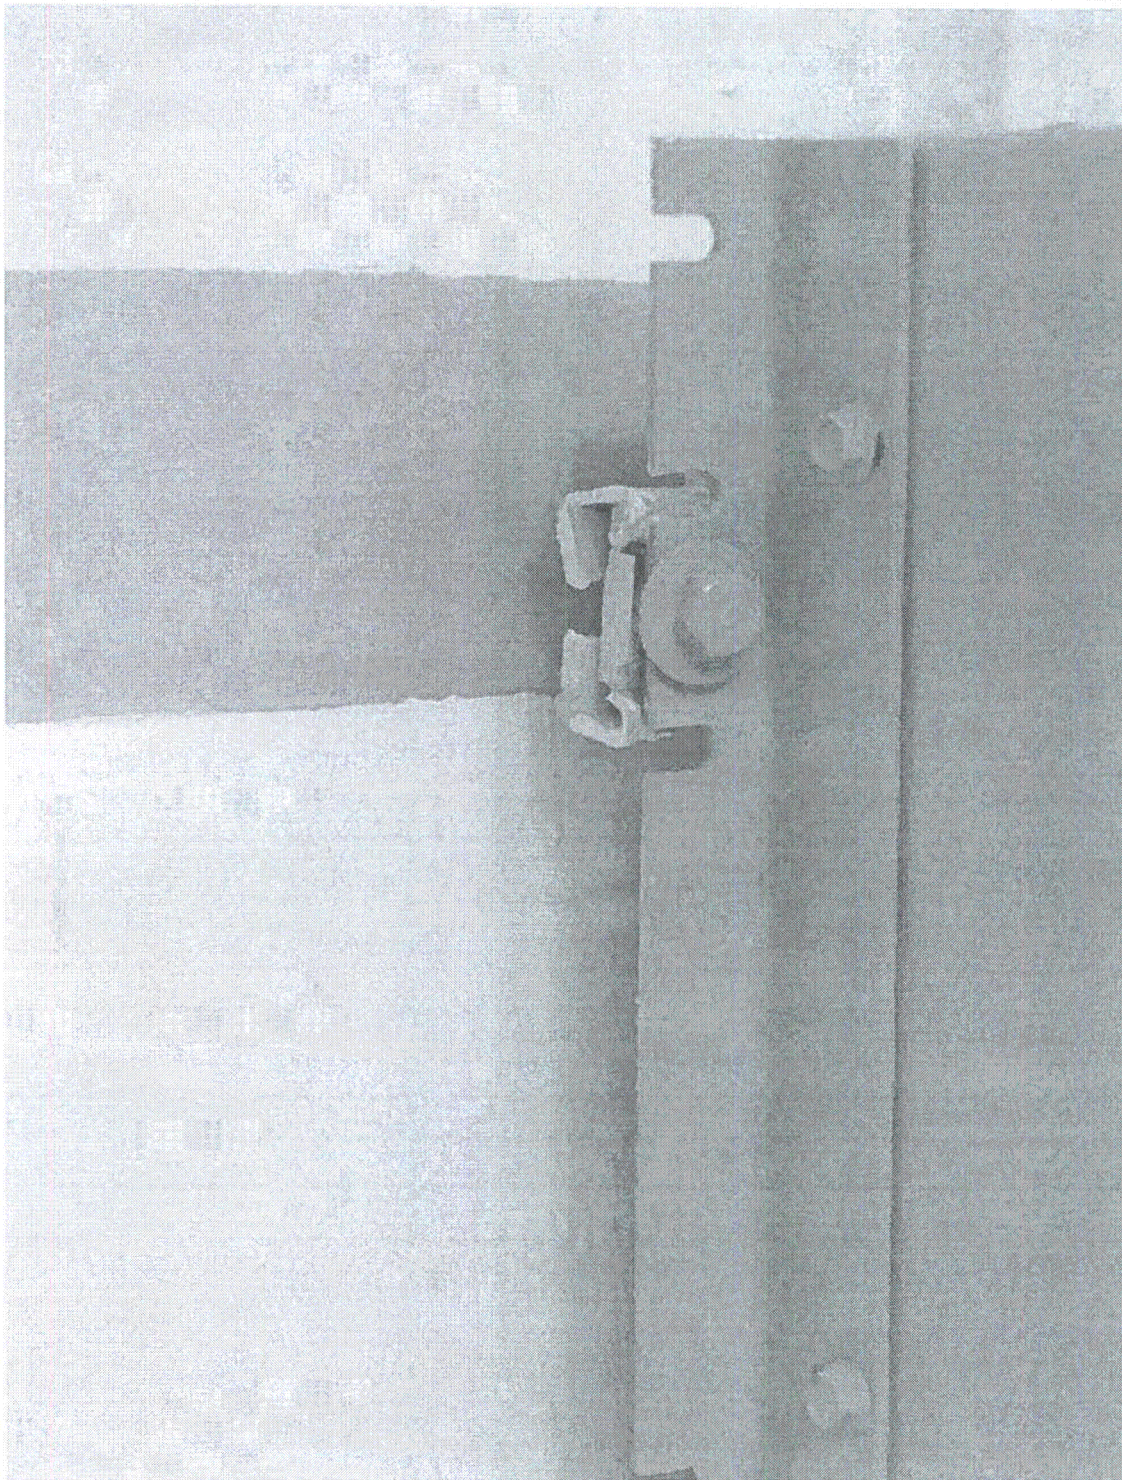
Figure 3 – Gap Between Unistrut and Wall (2R42-S052)

*The Unistrut member supporting the battery charger is bent out from the wall at the far end of the member. The gap between the wall and the member is less than 1/4", so the gap is not significant. In addition, the bolt attaching the charger to the unistrut channel at that location appeared to be over tightened to the point that the unistrut is sprung and the lower edge of spring nut no longer makes proper contact with the inner edge of the unistrut channel (See Figure 3). This condition reduces the connection's strength compared to a properly installed spring nut connection. The current battery charger is supported by 3 additional unistrut bolts and a vertical conduit which also provides additional support to the battery charger in the vertical direction. However CR 520297 has been generated to correct this condition.*

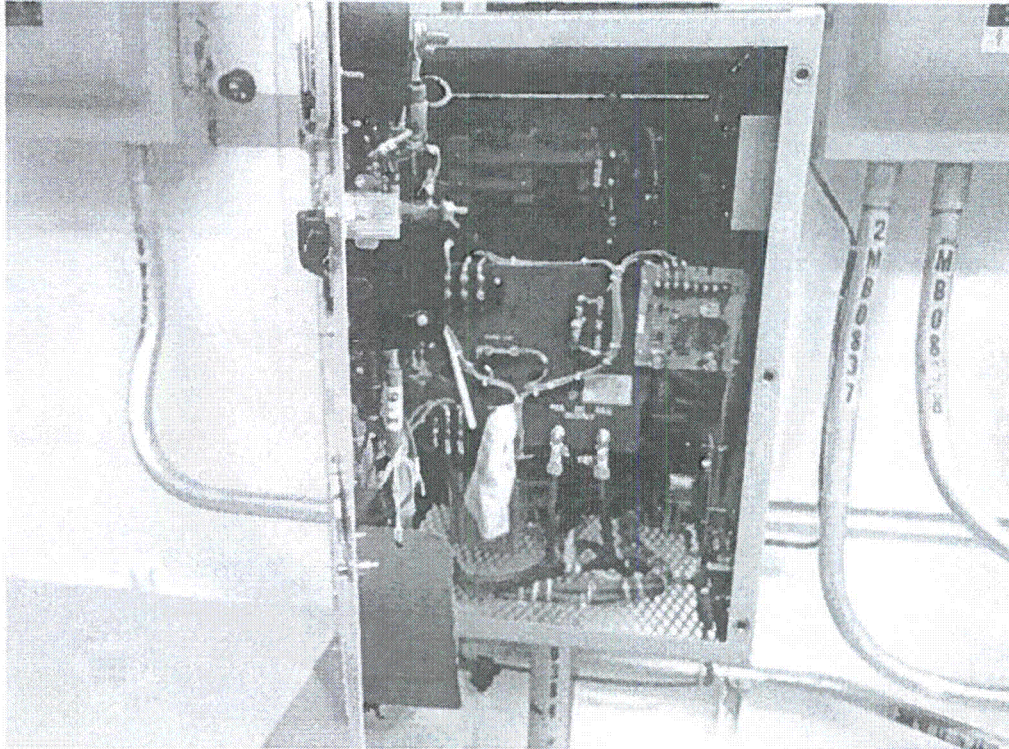
Figure 4 – Interior of the panel (2R42-S052)

*Components inside the panel were inspected visually in accordance with the direction provided in the FAQ related to opening panels. The panel was opened under WO# SNC436331. No potentially adverse seismic conditions were found.*

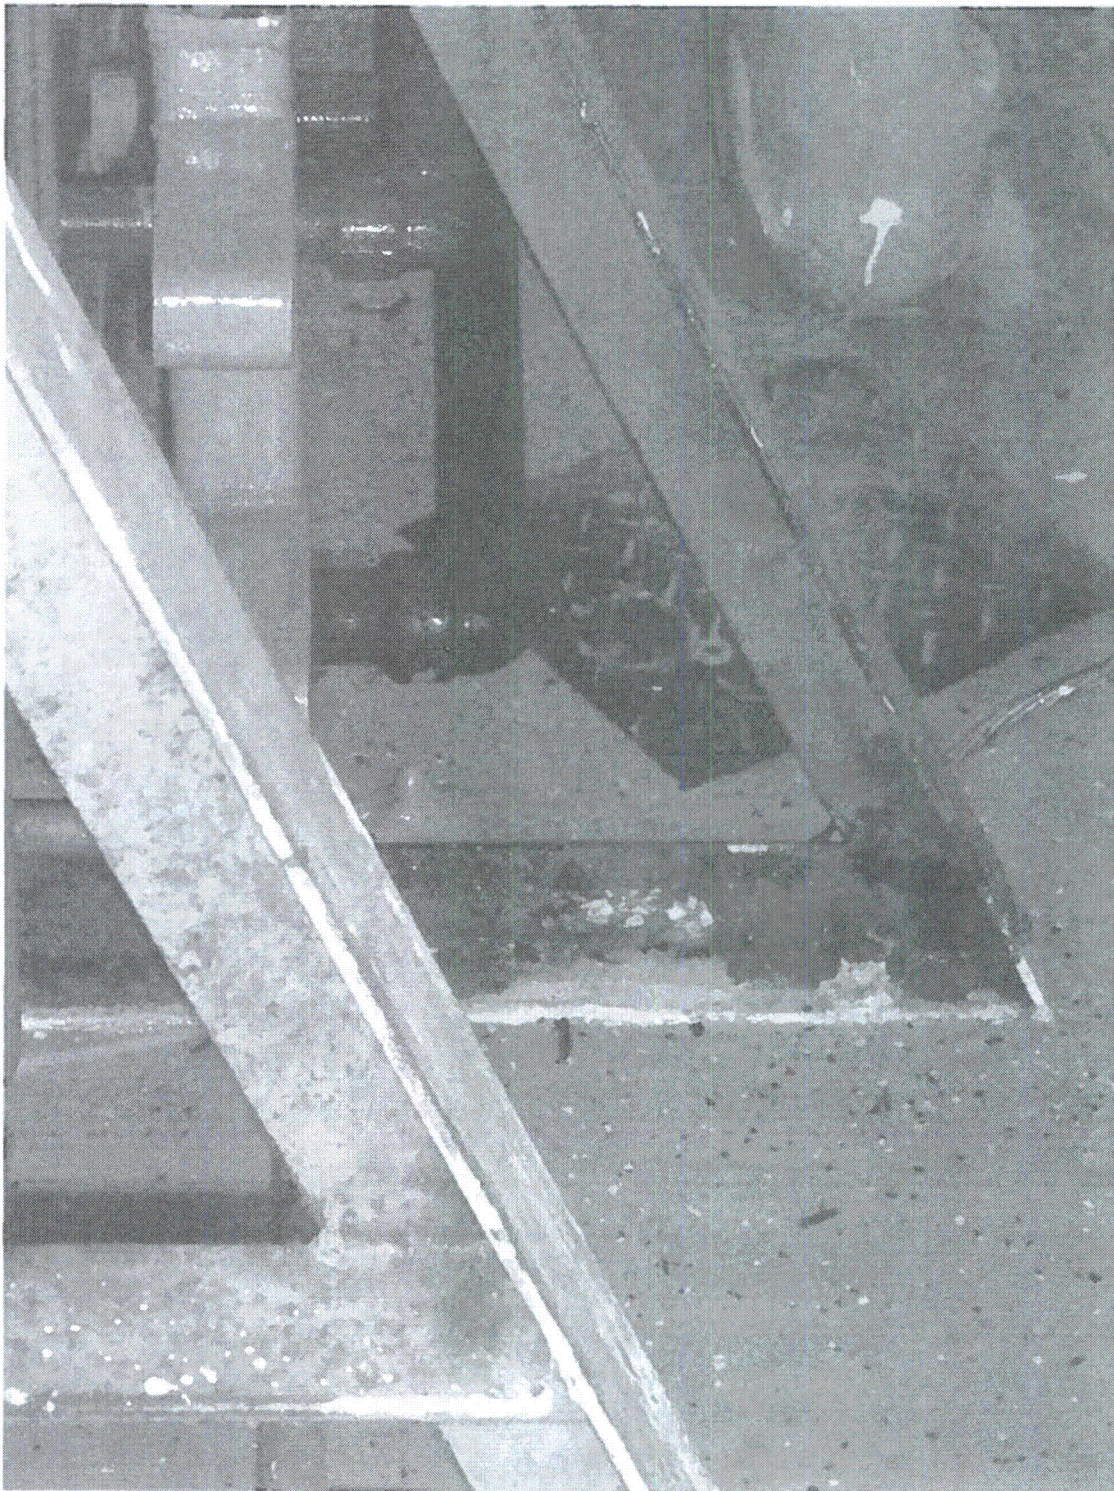
Figure 3 – Mild Oxidation on Anchor Bolts (2H21-P018)

3. Is the anchorage free of corrosion that is more than mild surface oxidation? Y  N  U  N/A   
*There is mild surface oxidation on two of the anchor bolts. Since oxidation is only on the surface, the bolts are not degraded. Therefore, judged not to be a concern.*

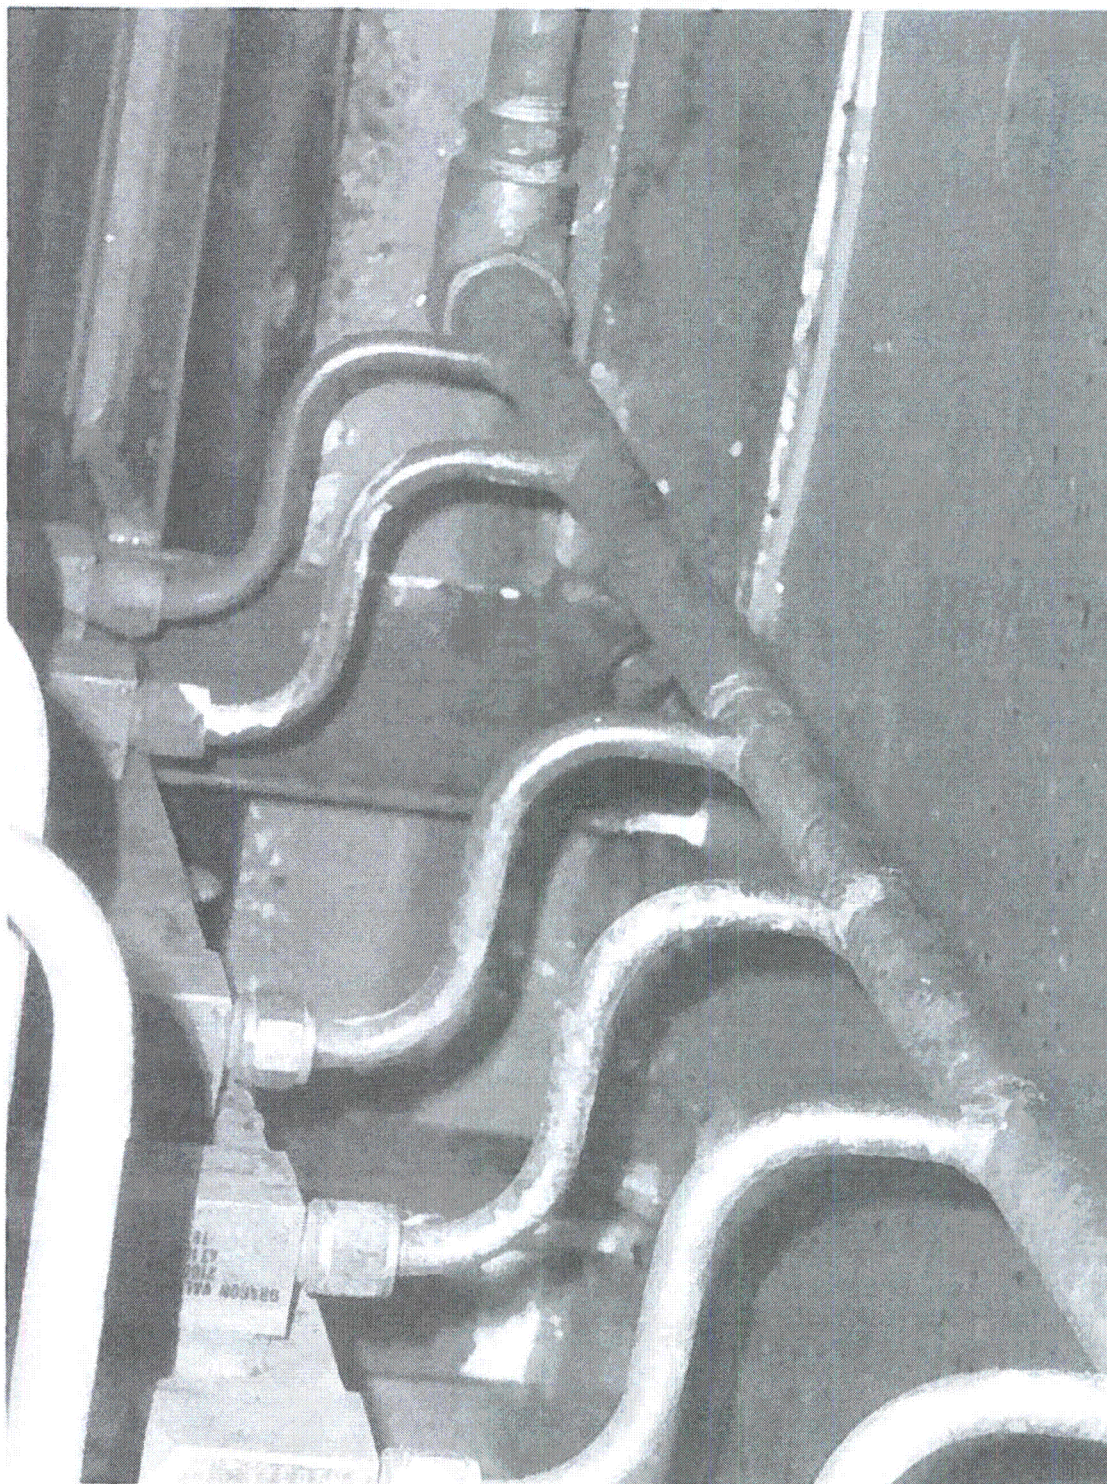
Figure 4 – Nut Next to Anchor Bolt (2H21-P018)

11. Have you looked for and found no other seismic conditions that could adversely affect the safety functions of the equipment? Y  N  U   
*There is a small nut lying on the floor next to one of the anchor bolts. The nut is light and not capable of impacting any sensitive equipment, so there is no potentially adverse seismic condition.*
