**Seismic Walkdown Checklist (SWC)**

Equipment ID No.: 2-MCM-221

Equipment Description: MAIN STEAM LEAD #2 TO AUXILIARY FEED PUMP TURBINE

Project: DC Cook 2 SWEL

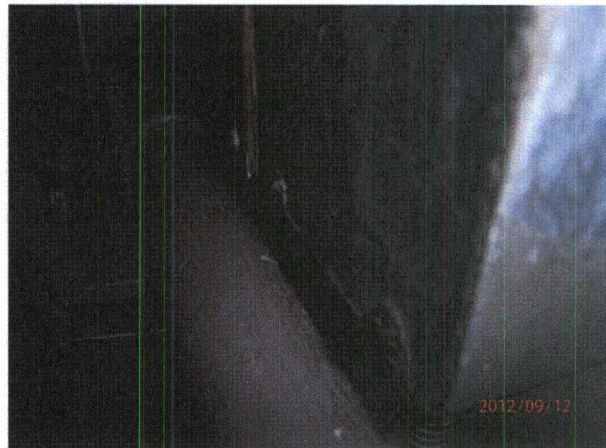
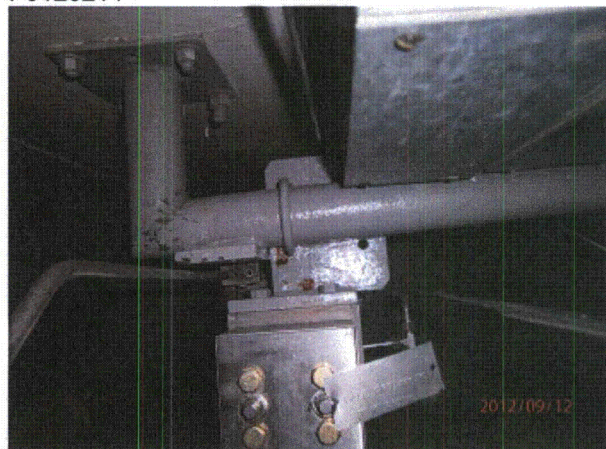
| 2. Is the anchorage free of bent, broken, missing or loose hardware?<br><br><i>Only one U-bolt around pipe verify with dwgs - Pictures show that a single U-bolt in conjunction with a weld are used - OK - Documents FCN 49030-006, 2-5581J-E049030.</i> | Yes |
