**Seismic Walkdown Checklist (SWC)**

Project: DC Cook 1 SWEL

Location (Bldg, Elev, Room/Area): TB1, 591.00 ft, 51

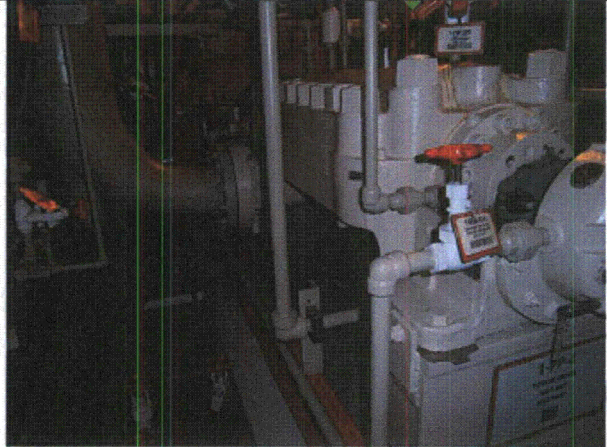
P9170917

- 2. Is the anchorage free of bent, broken, missing or loose hardware? Yes  
*Can only see 7 out of 8 bolts, 1 bolt not visible because of other equipment in area*

11. Have you looked for and found no adverse seismic conditions that could adversely affect the safety functions of the equipment? No  
*Wet fire protection, rod hung threaded pipe - may develop leakage at threaded joints post seismic event*
