ATTACHMENT (3)

AREA WALK-BY CHECKLISTS

Area Walk-By Checklists

**SWCs FOR SUPPLEMENTAL INTERNAL INSPECTIONS OF
ELECTRICAL CABINETS**

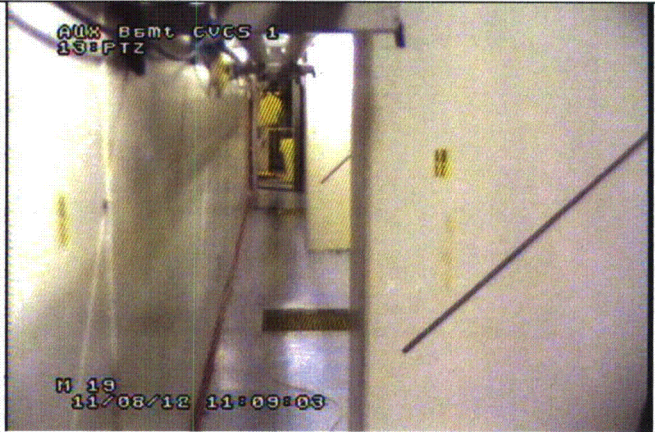
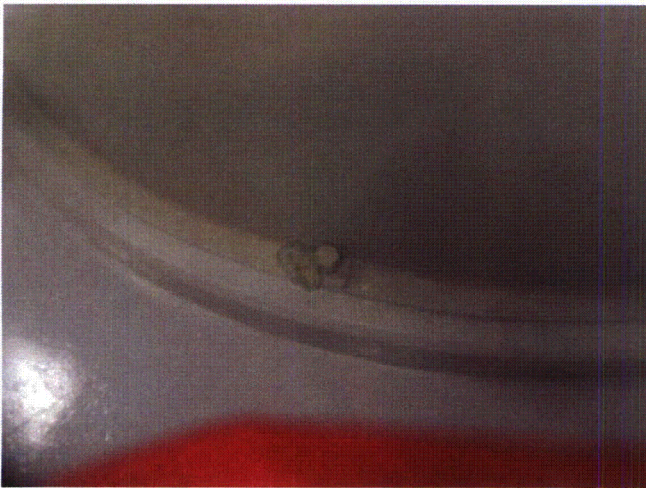
Location (Bldg, Elev, Room/Area): CVCS Waste Tank Room, Auxiliary Building, 235', Area 17

Inspected anchorage of B CVCS waste hold-up tank only. Dose from other 2 tanks prevents complete inspection of anchorage

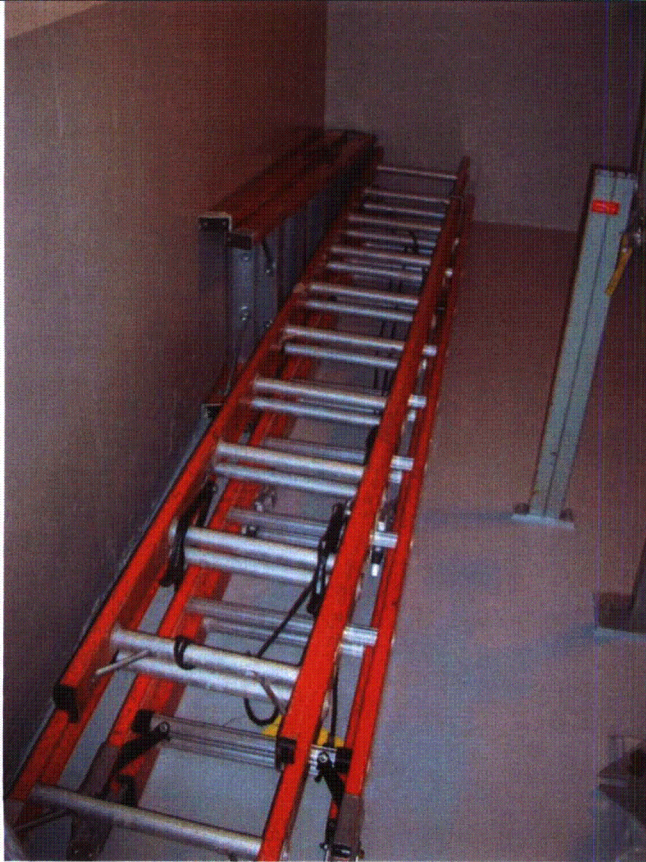
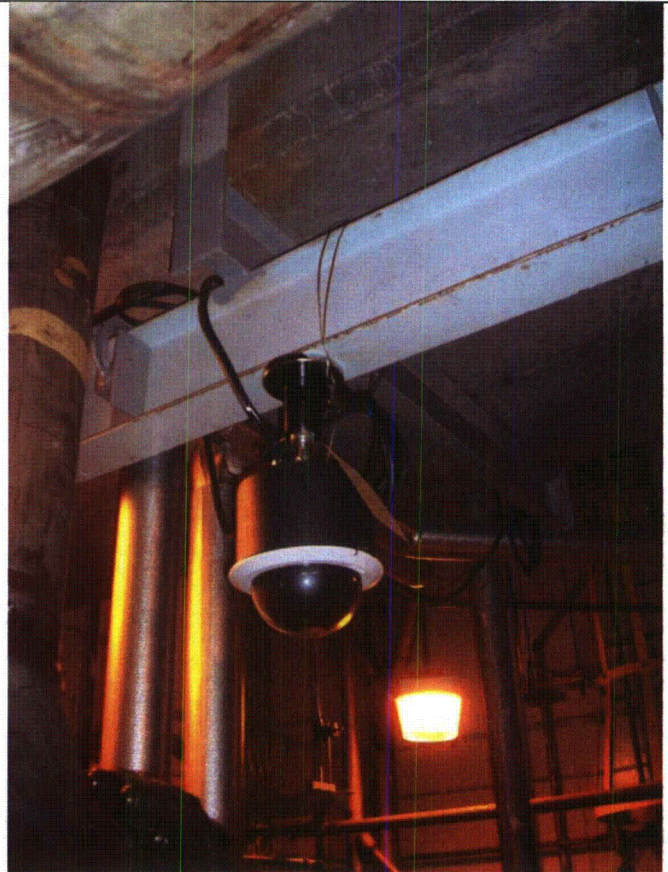
Location (Bldg, Elev, Room/Area): Auxiliary Building Sub-Basement, 219', Area 25

More than minor surface corrosion on Unistrut mounted on floor, CR-2012-008409

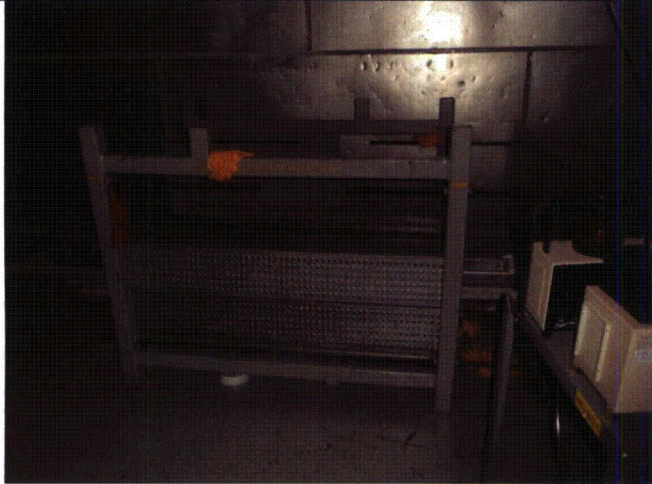
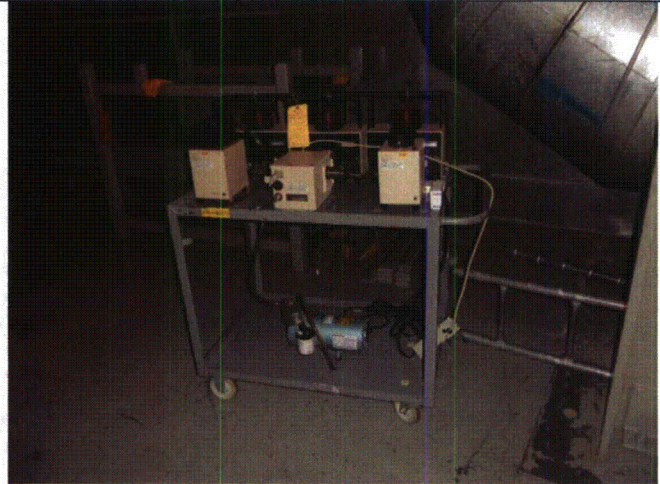
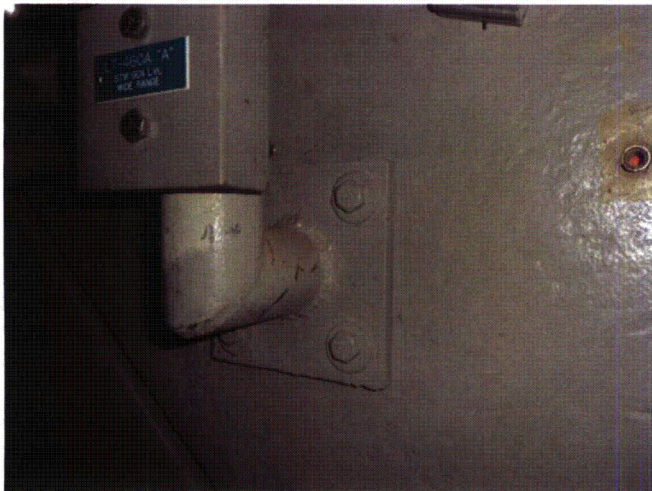
Location (Bldg, Elev, Room/Area): Containment, 235', Area 26c, Basement Level, North

4. Does it appear that the area is free of potentially adverse seismic spatial interactions with other equipment in the area (e.g., ceiling tiles and lighting)? Y N U N/A
Abandoned heating unit, identified under SWC for 8608A. No adverse condition noted

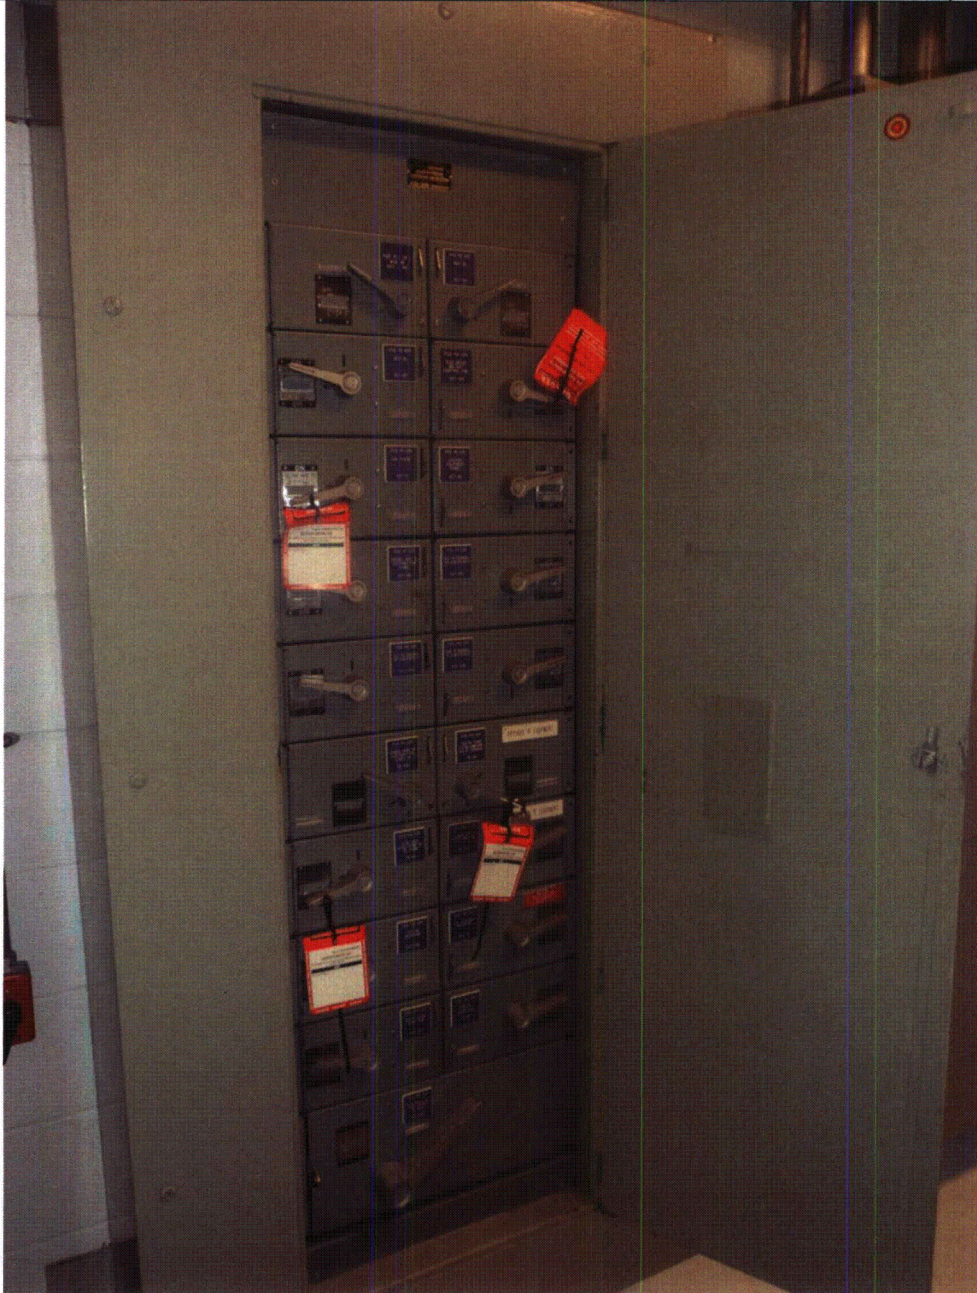
Equipment Description: DC POWER DISTRIBUTION PANEL CB 02 A (MAIN FUSE CAB A)

Supplemental internal inspection: Recently replaced, well-routed cabinet, no internal modifications noted. Inspected live, maintenance performed on unit during inspection

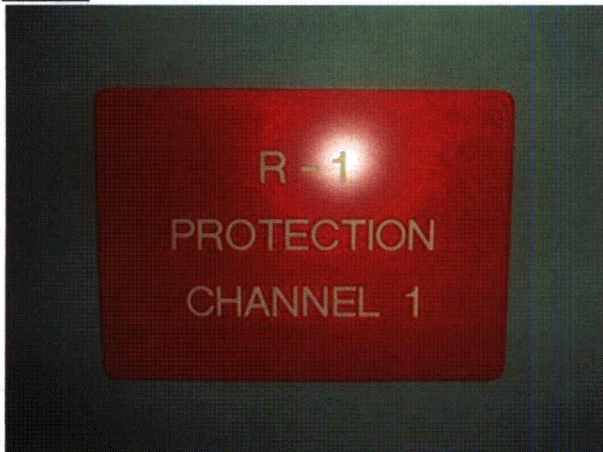
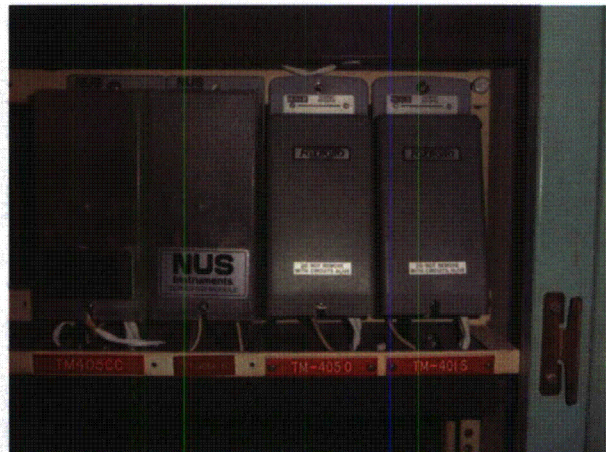
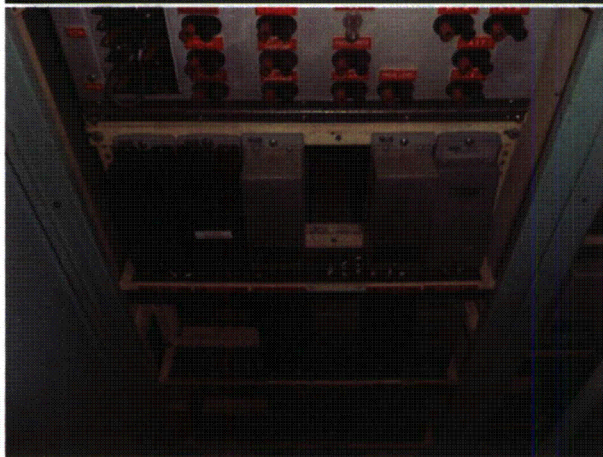
Equipment Description: REACTOR PROTECTION INSTRUMENT RACK CHANNEL 1 RED 1

Supplemental internal inspection: Inspected live, no adverse conditions noted.
