Seismic Walkdown Checklist (SWC)

Peach Bottom Atomic Power Station Unit 2
MPR-3815, Revision 3
Correspondence No. RS-12-173

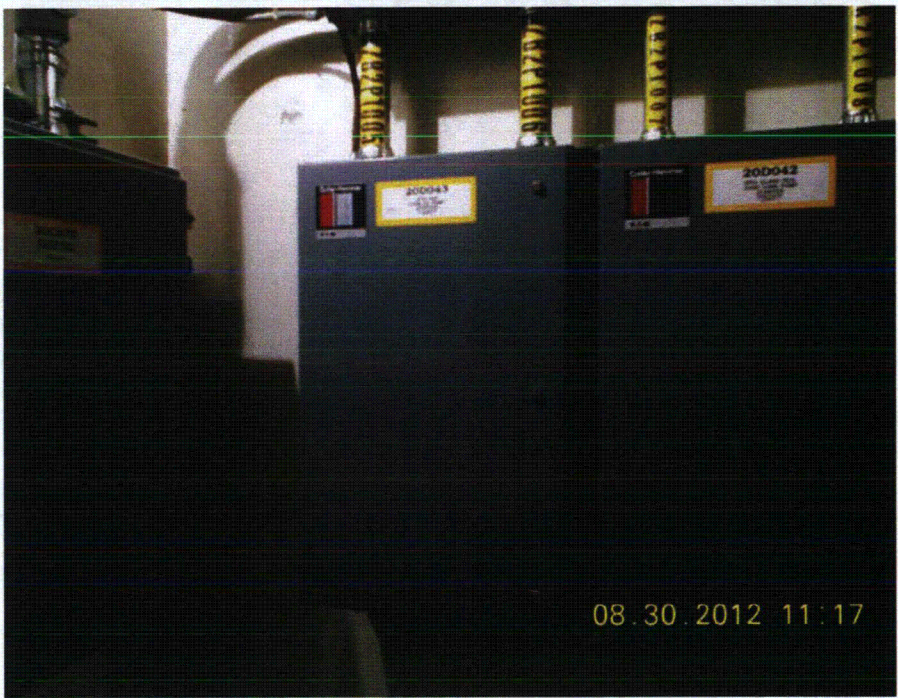
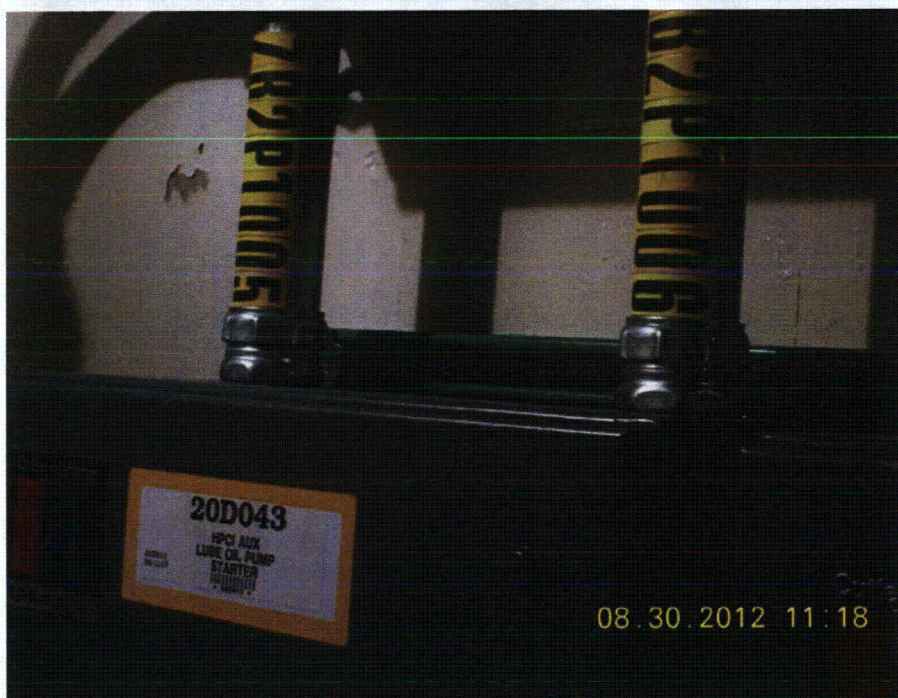
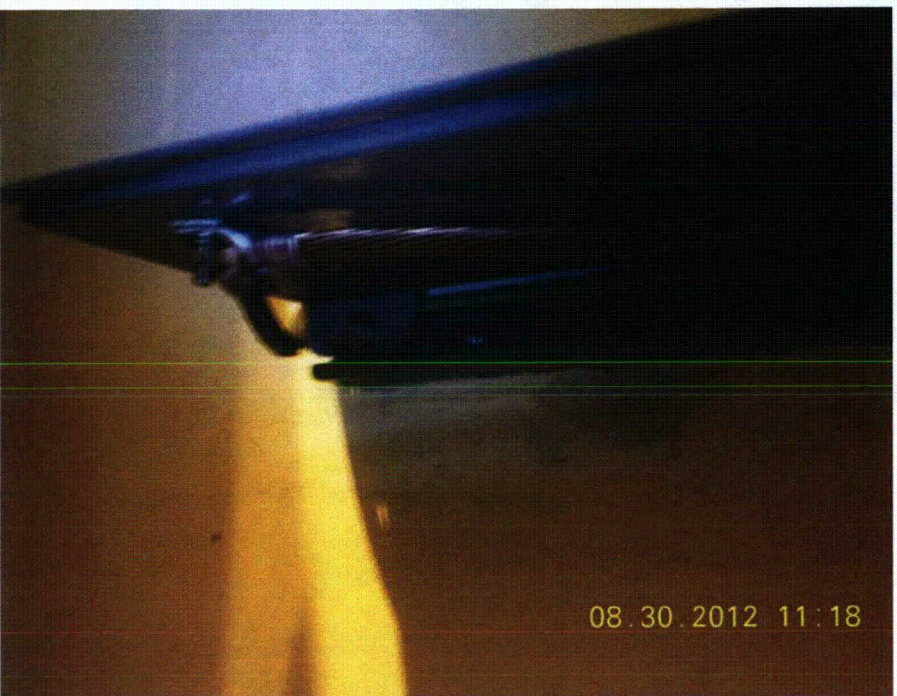
Equipment ID: 20D043

N/A

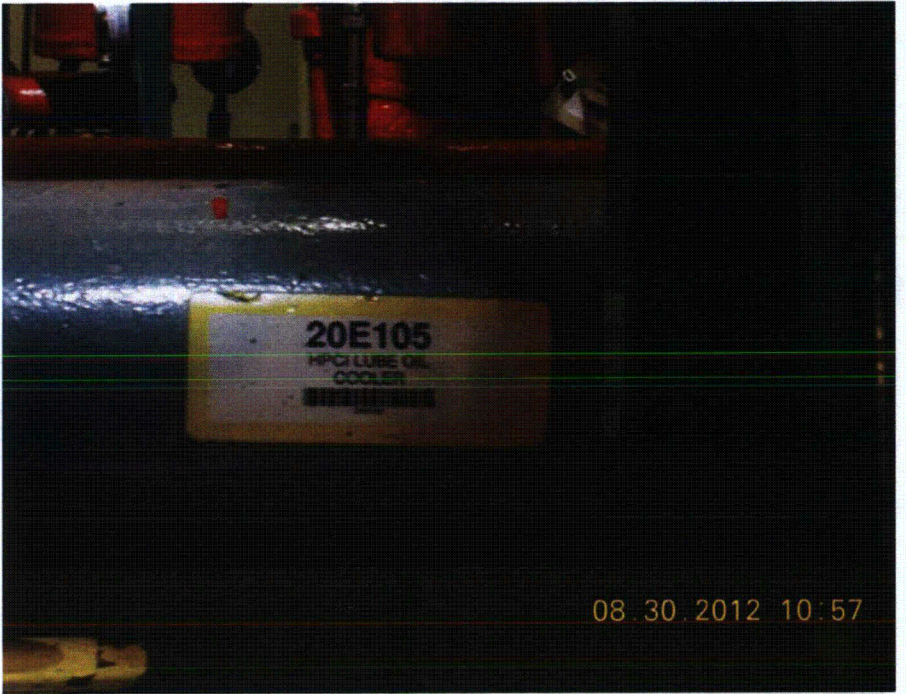
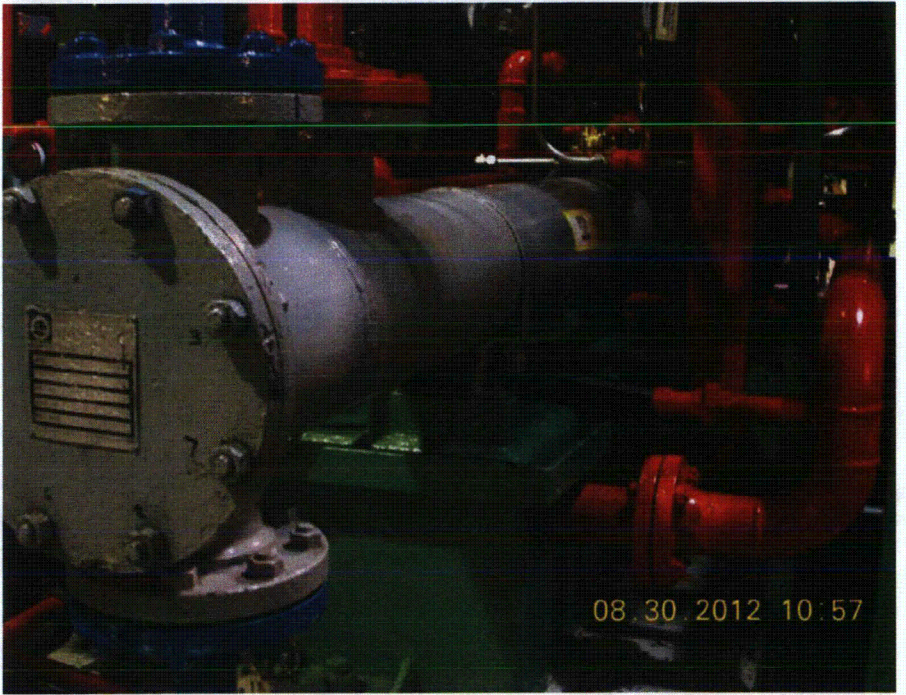
Equipment ID: 20E105

N/A

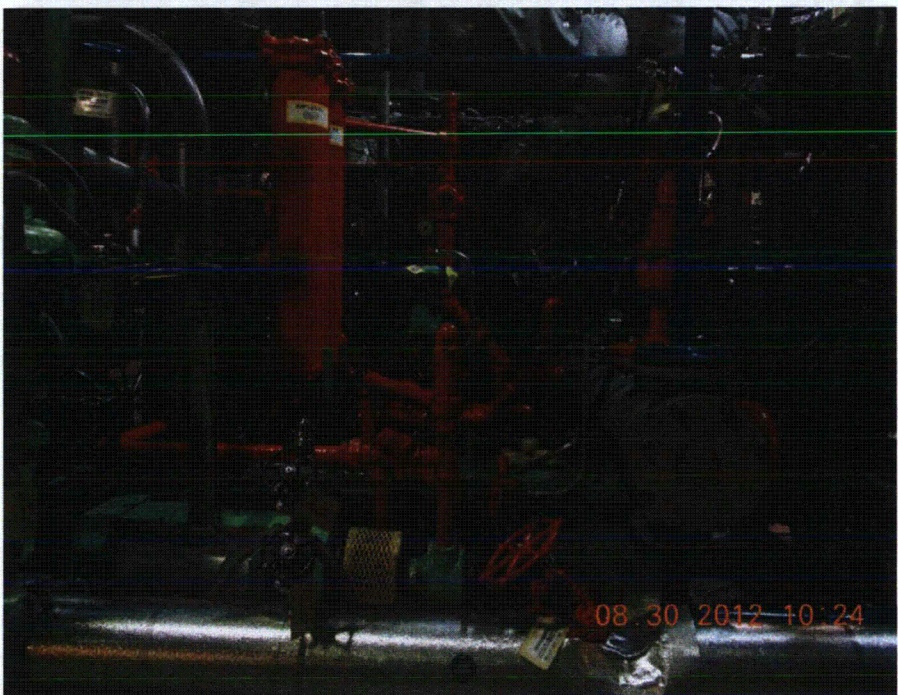
Equipment ID: 20S037

N/A

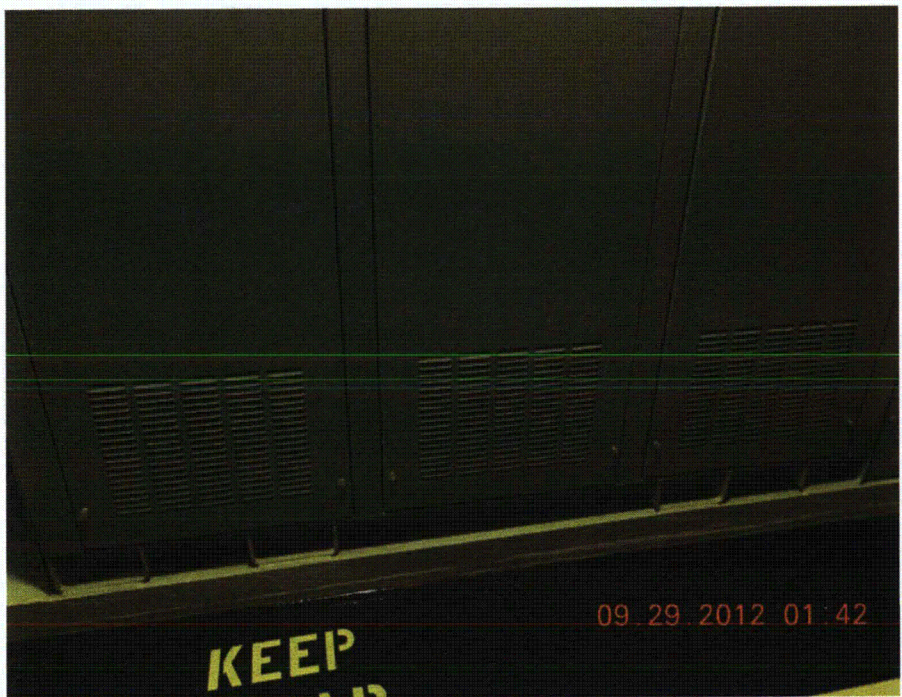
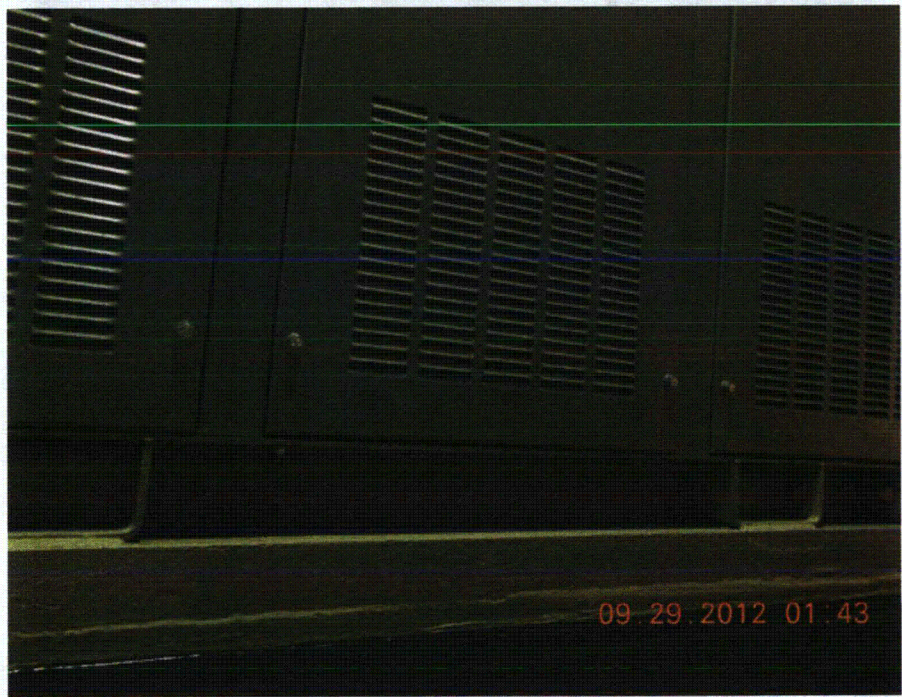
2. Is the anchorage free of bent, broken, missing or loose hardware? Y N U N/A
Anchorage is in good condition

Cabinets not opened because it requires disassembly w/ hand tools.
IPEEE - Confirmed transformer is ABB type and properly anchored. MO 10/10/2012

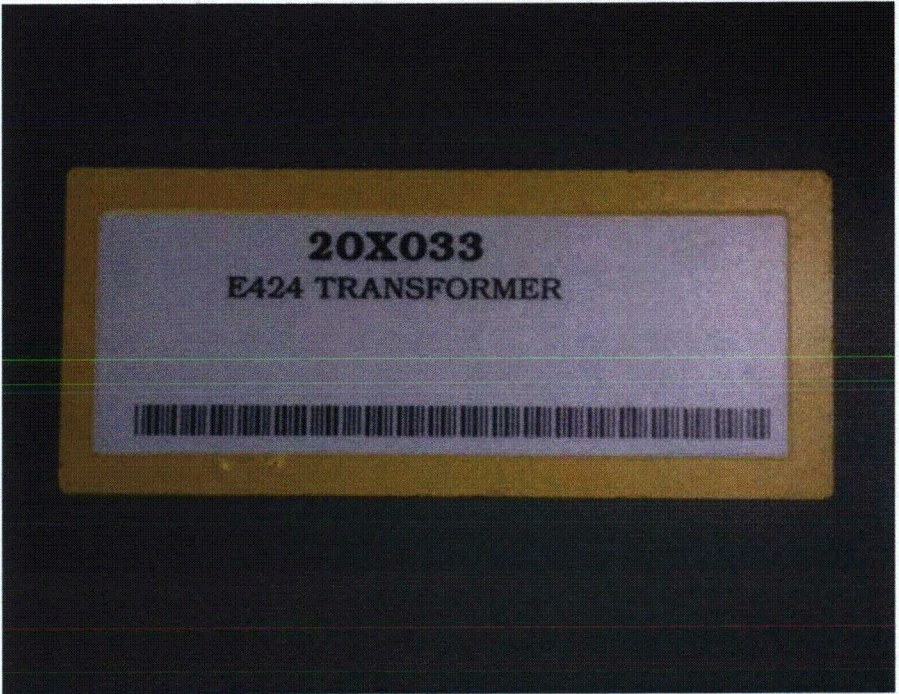
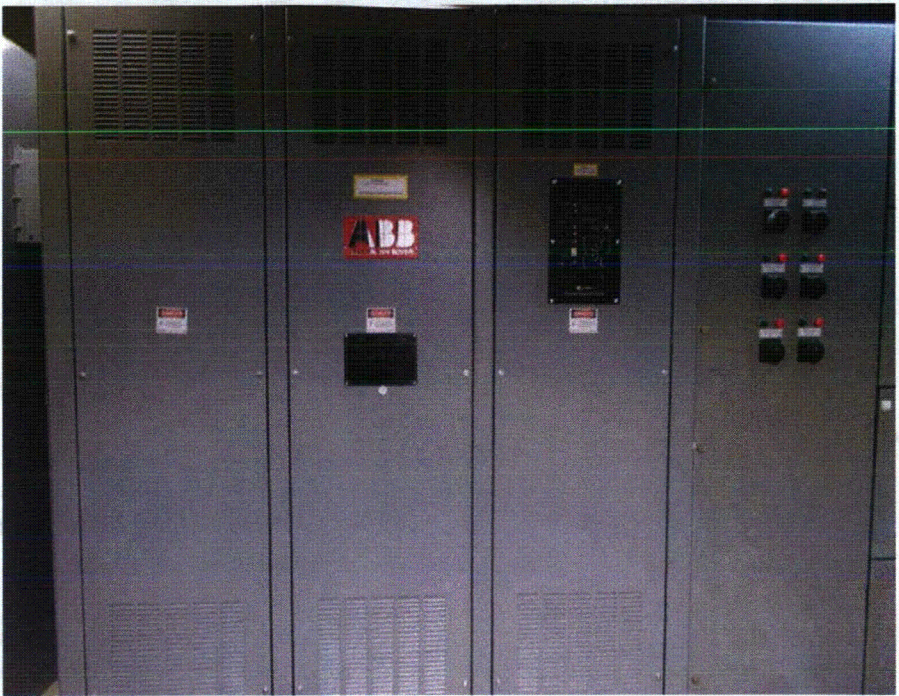
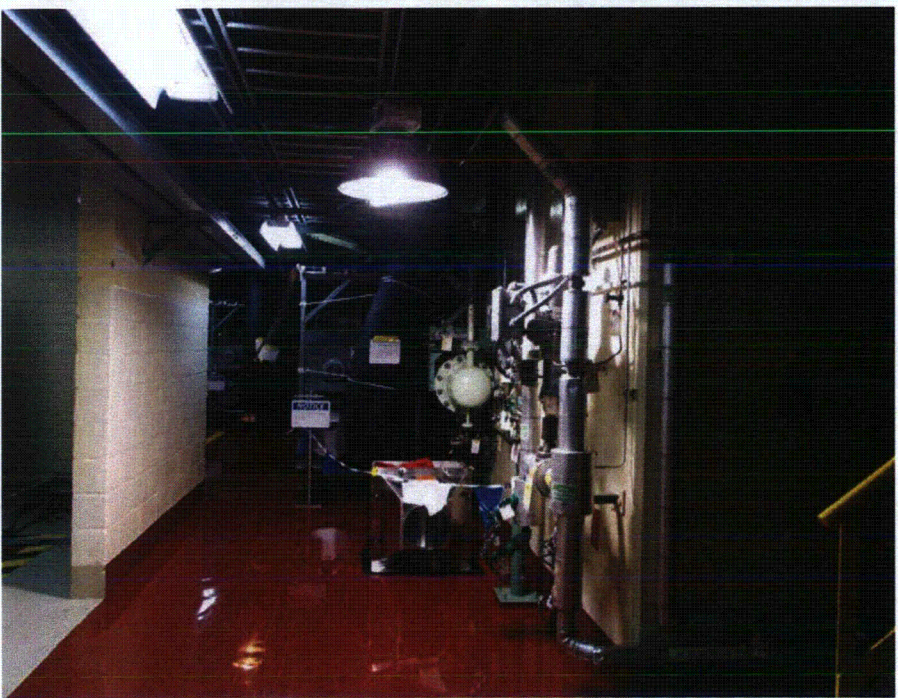
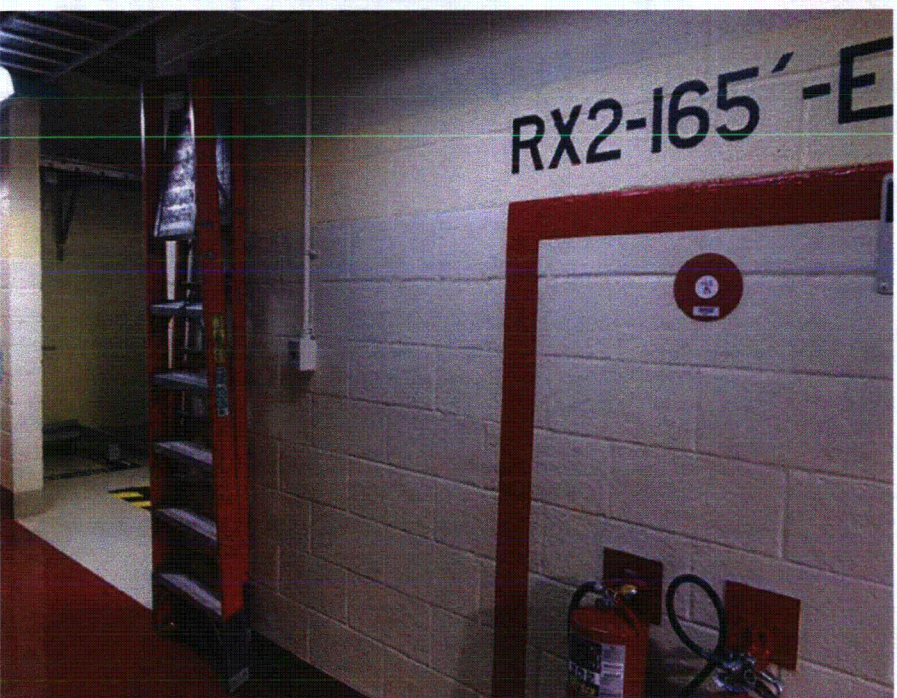
Equipment ID: 20X033

*Flourescent light fixtures - all observed S-hooks are closed.
masonry block walls - see below.
Damage from falling light bulbs not credible.*

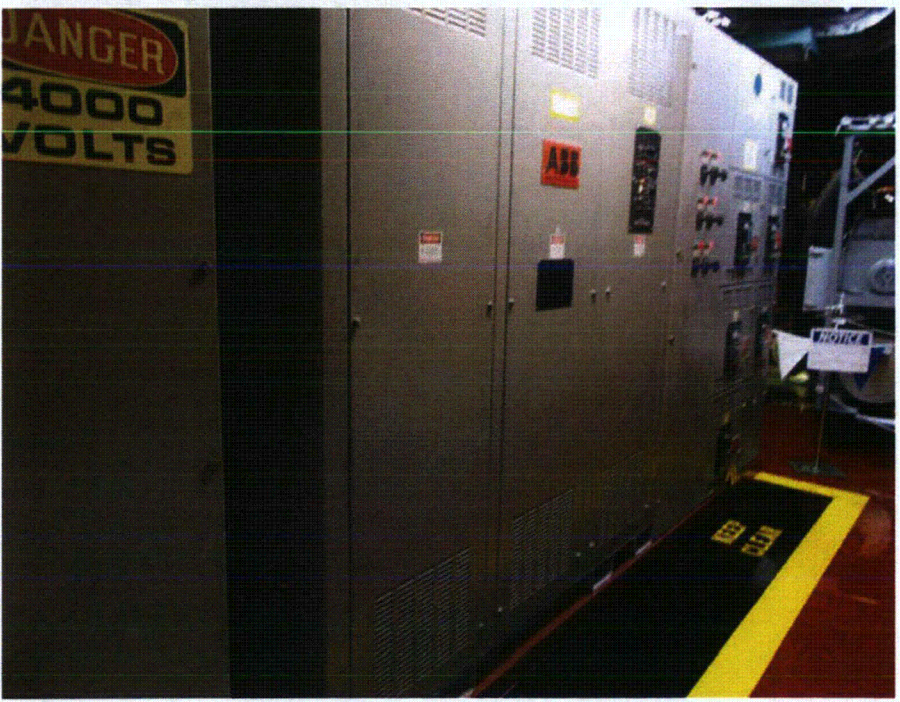
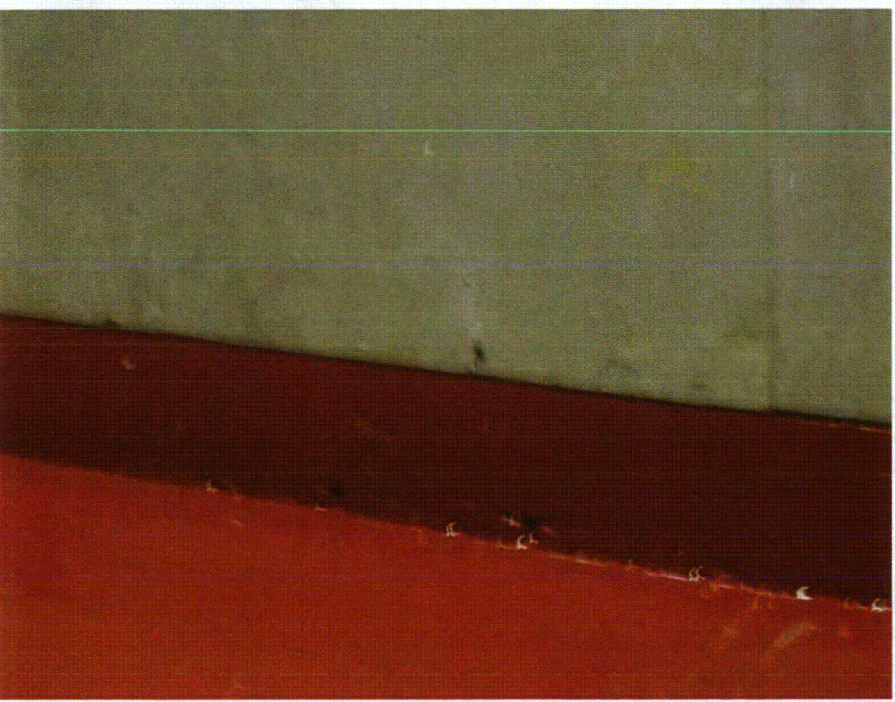
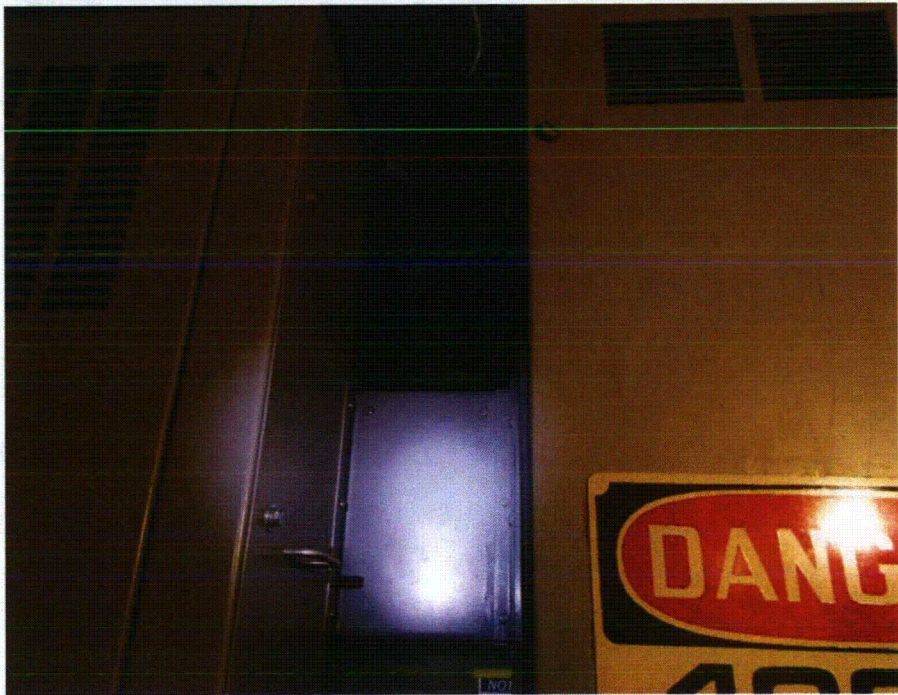
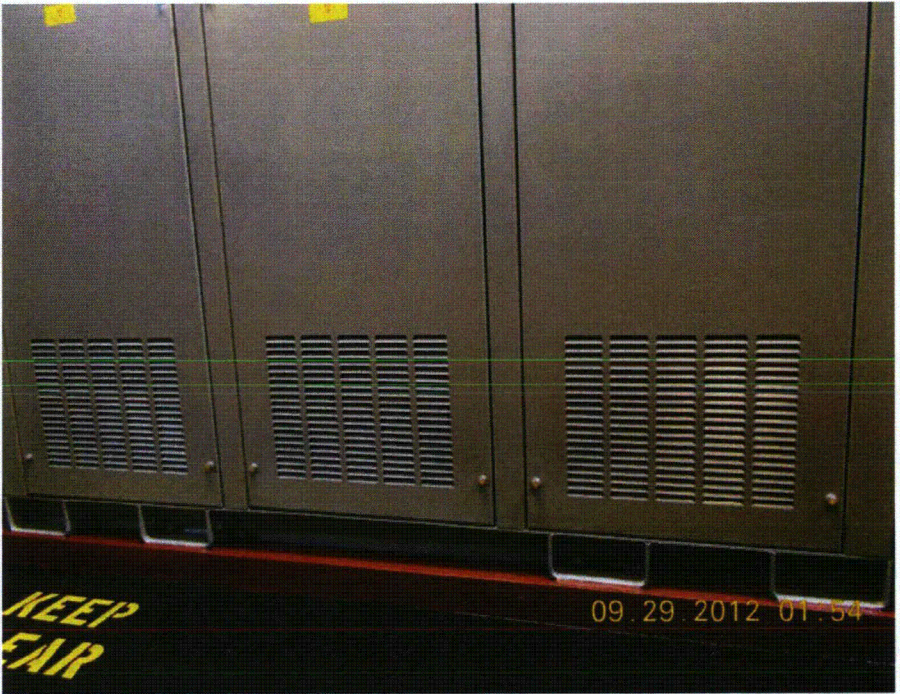
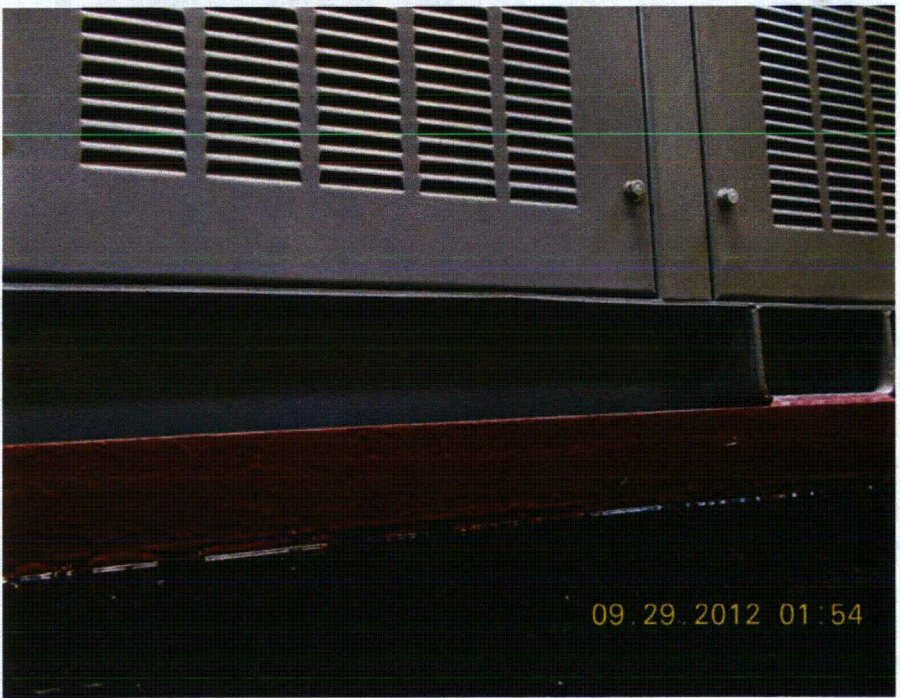
Equipment ID : 20X030

2. Is the anchorage free of bent, broken, missing or loose hardware? Y N U N/A
4 feet welded to channel in floor on each side (front + back)

4. Is the anchorage free of visible cracks in the concrete near the anchors? Y N U N/A
- Minor honeycombing of concrete at south end of pad. No structural impact.

No ceiling tiles, Damage from falling light bulbs not credible. Masonry walls - Component surrounded by block walls 76-6, 76-8, 76-9, 76-10 per PBAPS Drawing S-76 Revision 4. These walls are safety related per PBAPS specification M-701 Revision 1.

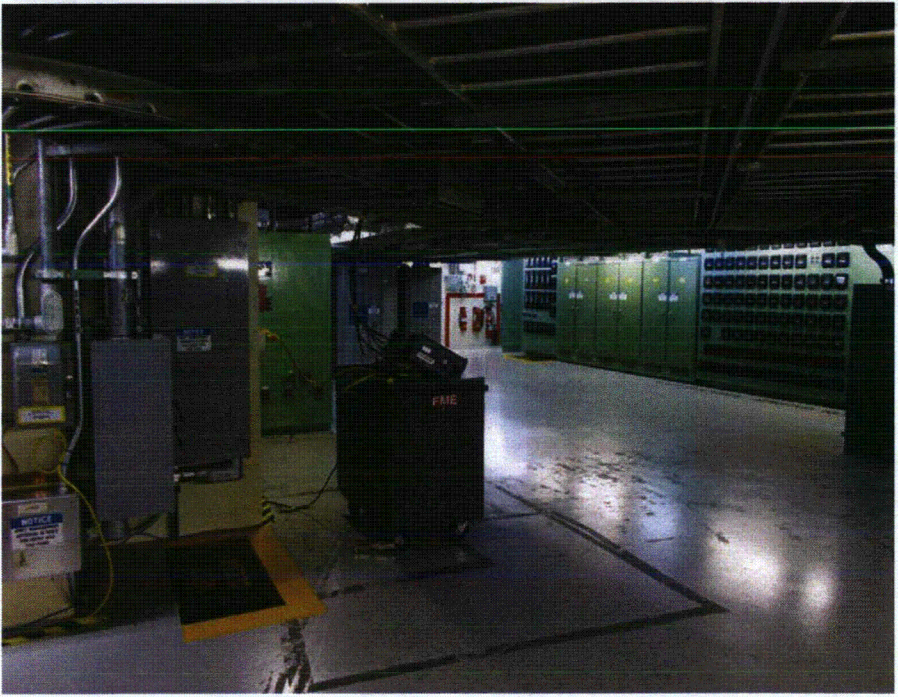
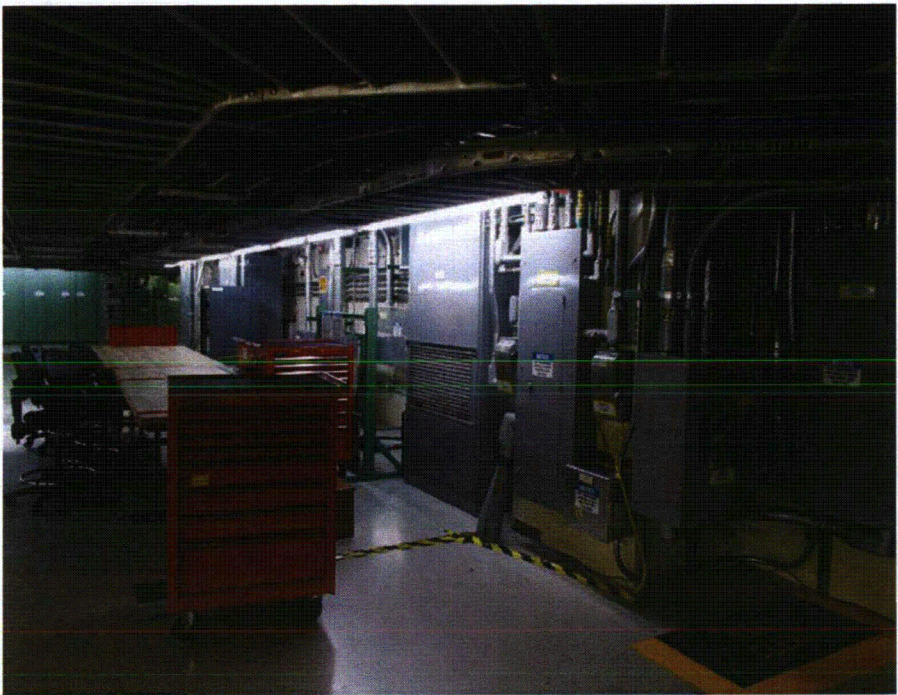
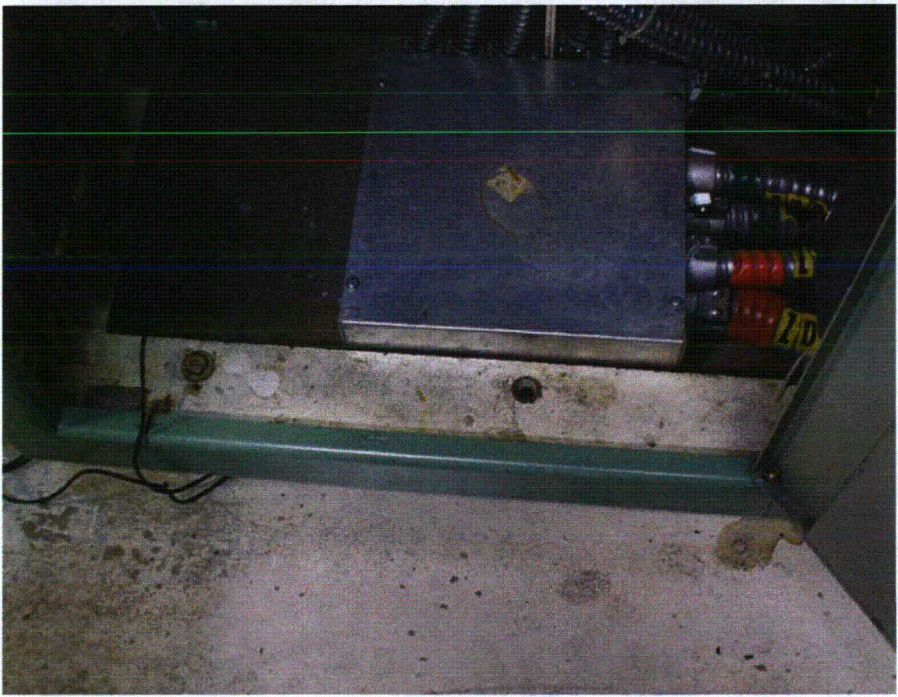
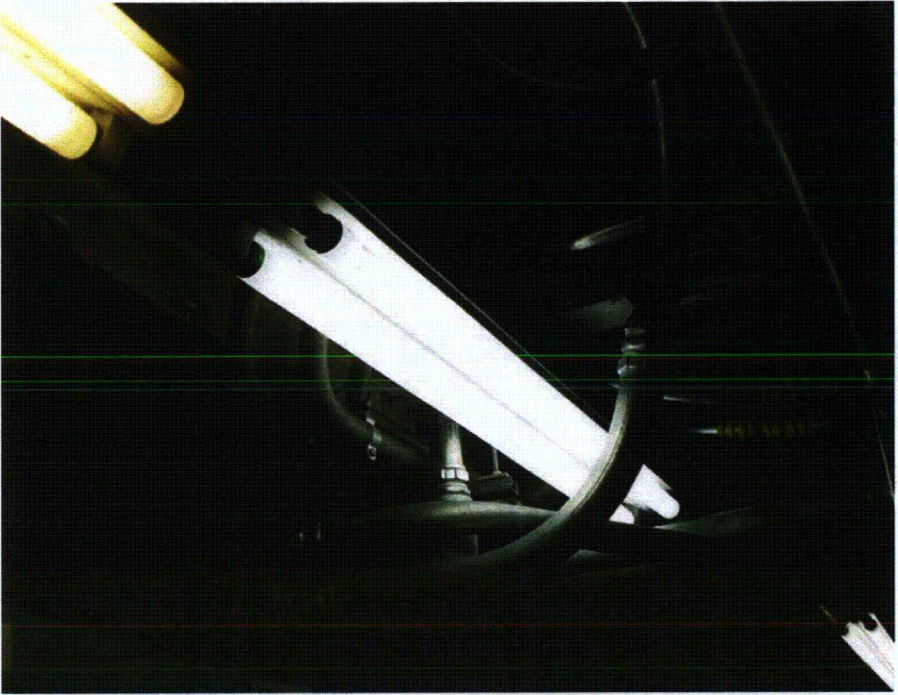
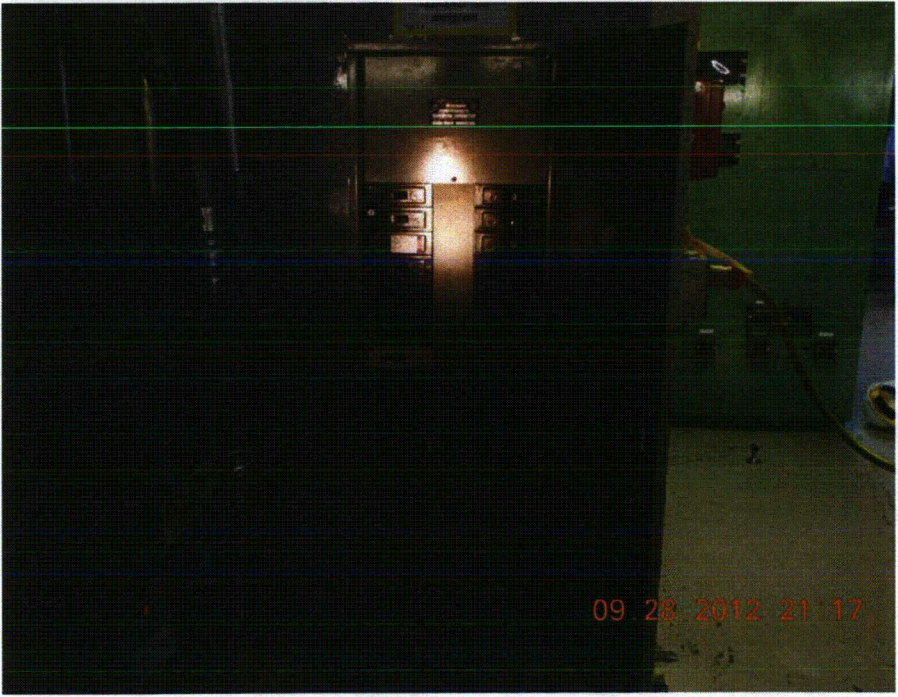
Equipment ID: 20Y050

4. Is the anchorage free of visible cracks in the concrete near the anchors? Y N U N/A
Attached to masonry block wall.

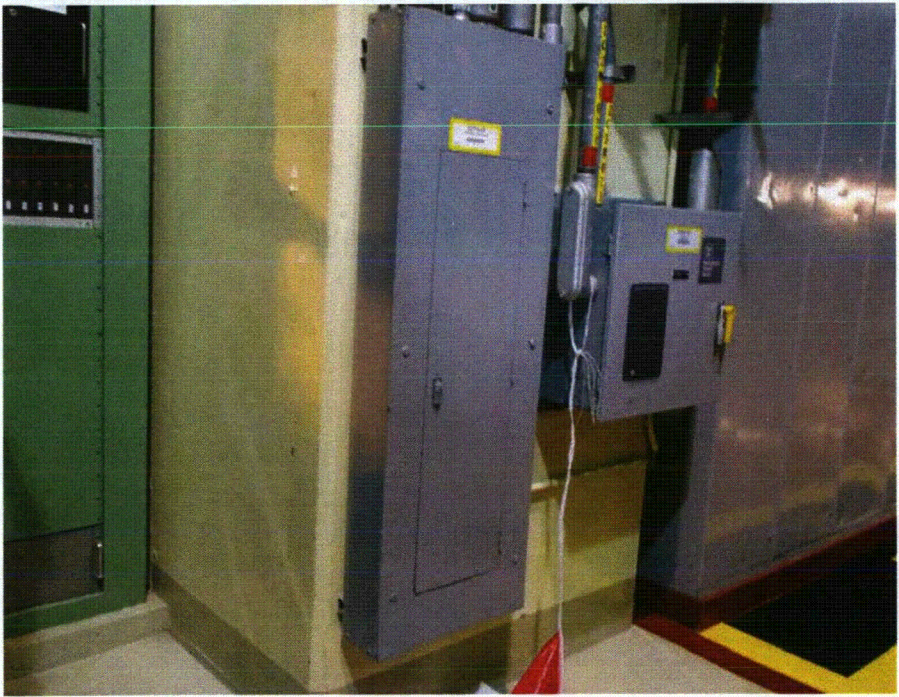
Equipment ID: 20Y035

4. Is the anchorage free of visible cracks in the concrete near the anchors? Y N U N/A
Wall mounted to poured concrete wall.

*Damage from falling light bulbs not visible,
No masonry block walls, no ceiling tiles.*

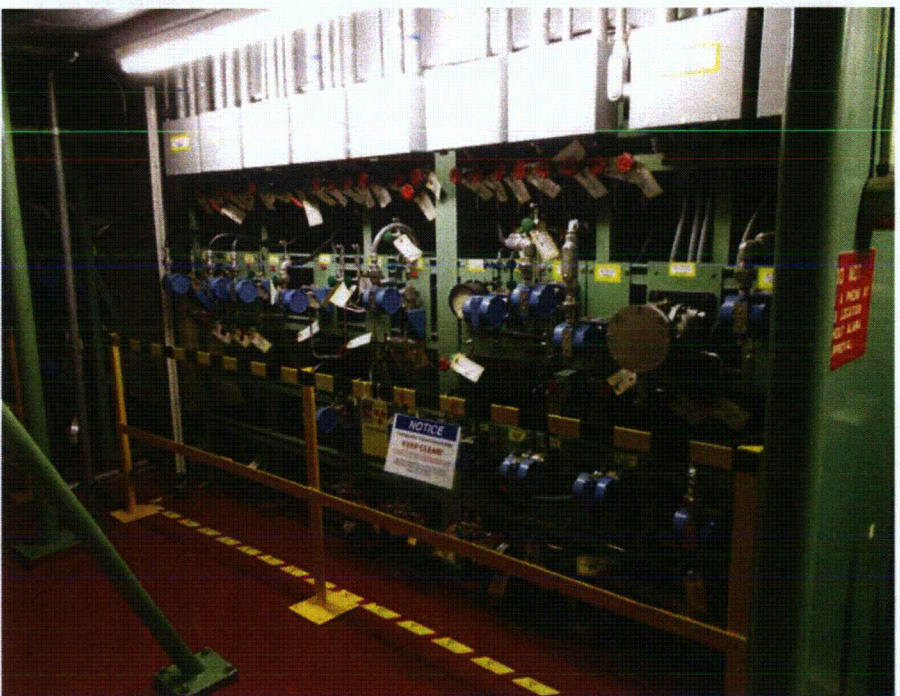
Equipment ID: 2AC065

2. Is the anchorage free of bent, broken, missing or loose hardware? Y N U N/A
See comments. No 10/22/12

5. Is the anchorage configuration consistent with plant documentation? Y N U N/A
 (Note: This question only applies if the item is one of the 50% for which an anchorage configuration verification is required.)
Missing anchor bolts on legs 2, 3, 5, 6.

6. Based on the above anchorage evaluations, is the anchorage free of potentially adverse seismic conditions? Y N U
The anchorage configuration analyzed in Calc. PS-0930, Rev 0, is not consistent with the existing anchorage shown on the field sketch (on back). The Calc does not account for the missing anchor bolts or for the restraint from the large divider plate that is bolted to the rack structure. As-installed configuration is judge acceptable for resolution, see IRT# 0149745.

*Fluorescent fixture mounted to channel.
Damage from falling light bulbs not credible.
No ceiling tiles or masonry walls.*

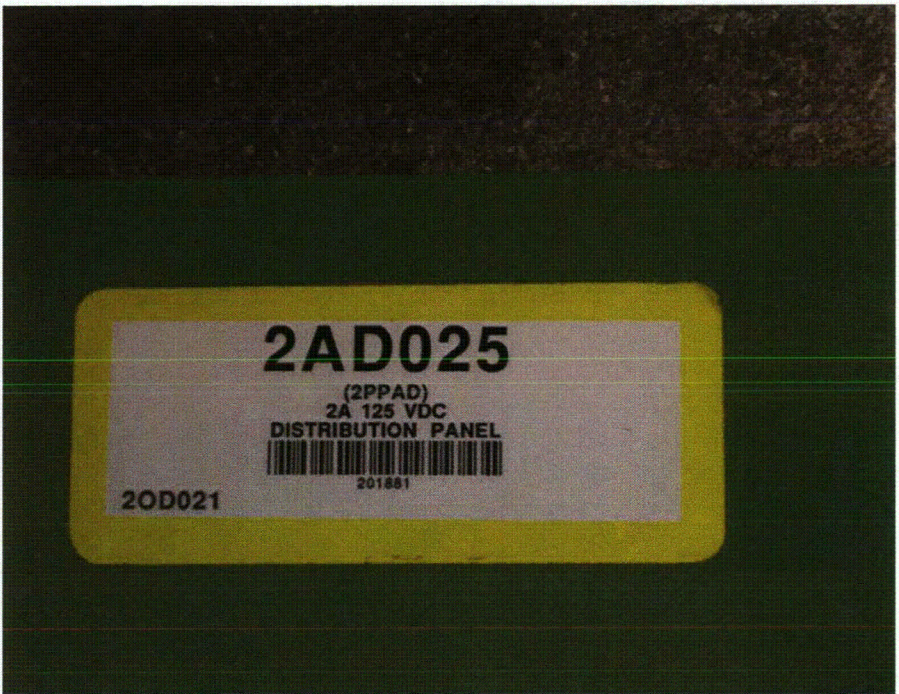
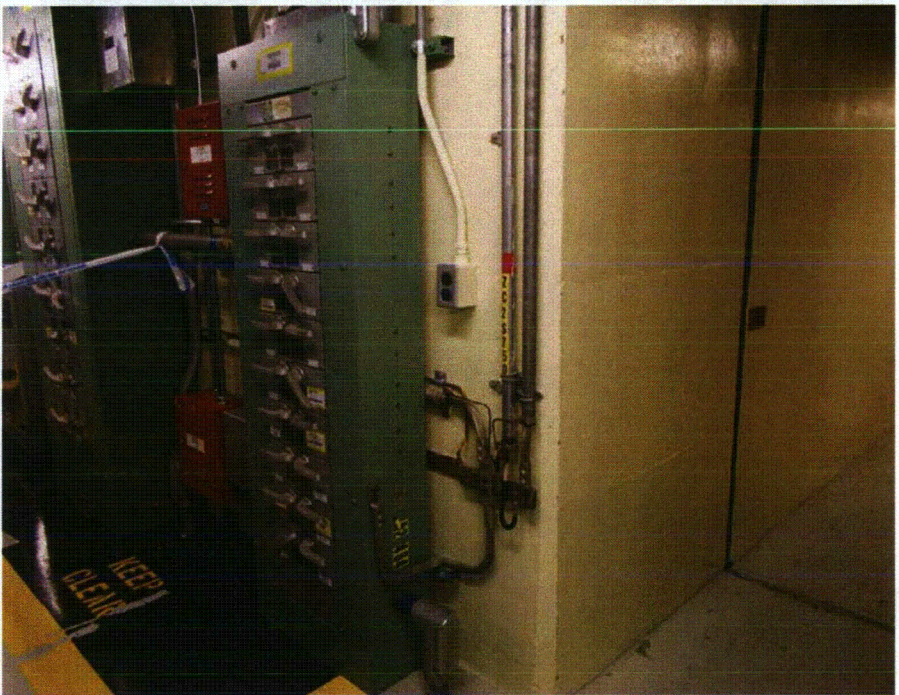
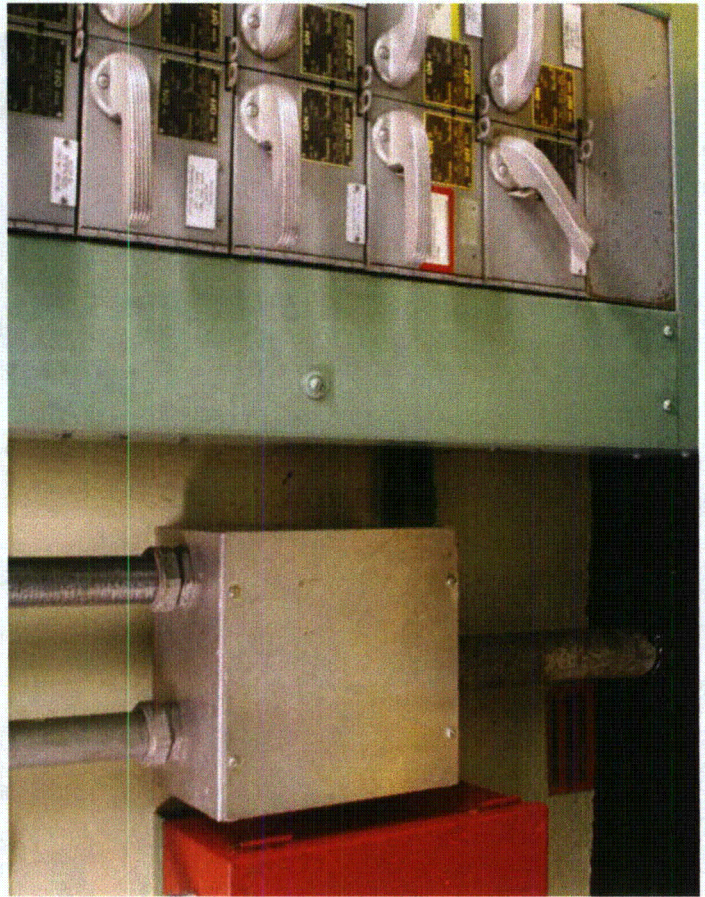
Equipment ID: 2AD025

8. Are overhead equipment, distribution systems, ceiling tiles and lighting, and masonry block walls not likely to collapse onto the equipment? Y N U N/A
*Fluorescent light fixtures hand mounted,
No ceiling tiles, no masonry walls,
Damage to component from falling fluorescent bulbs not credible.*

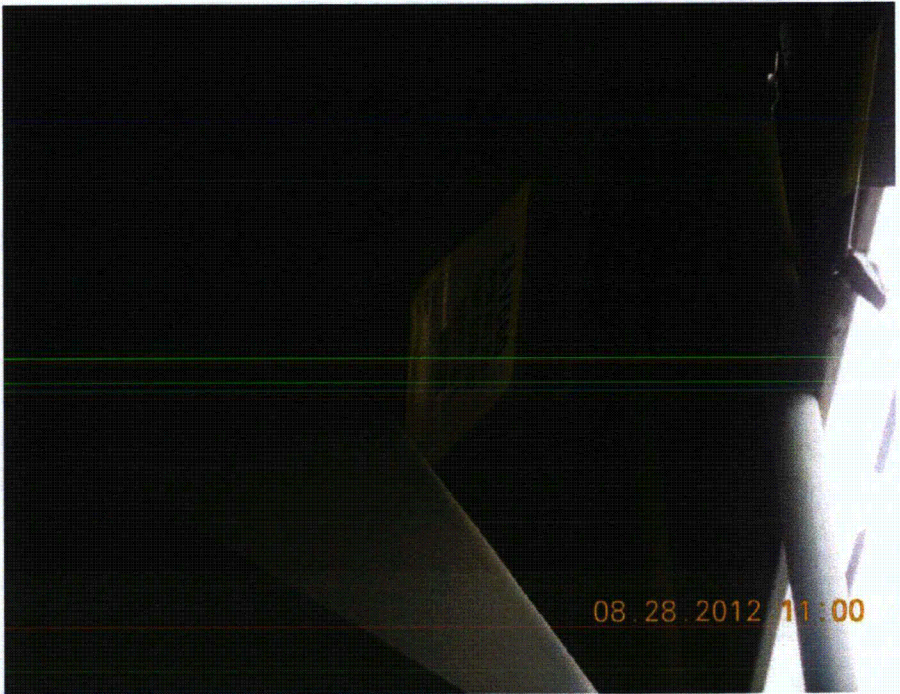
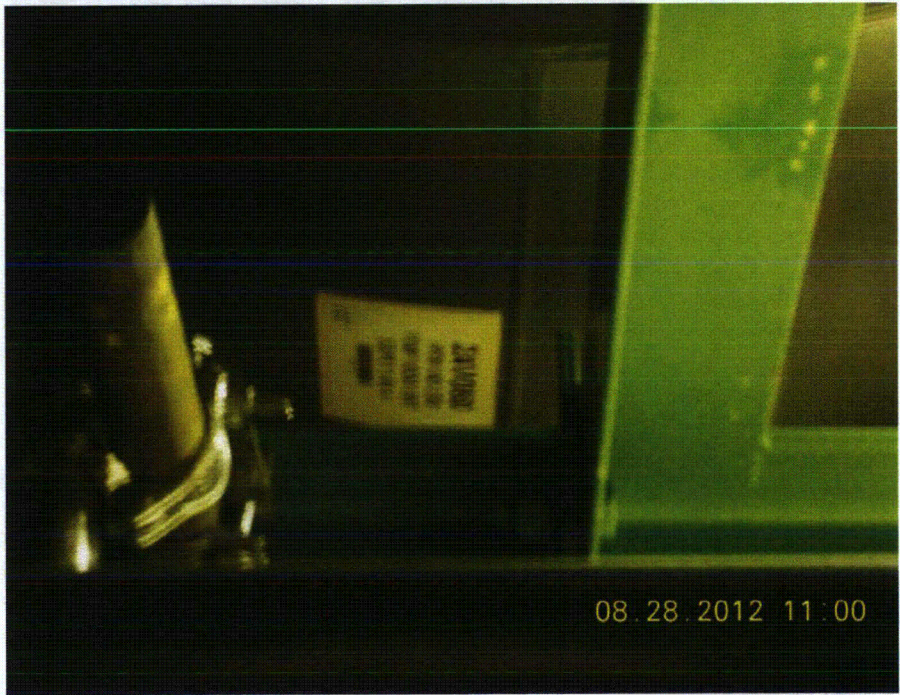
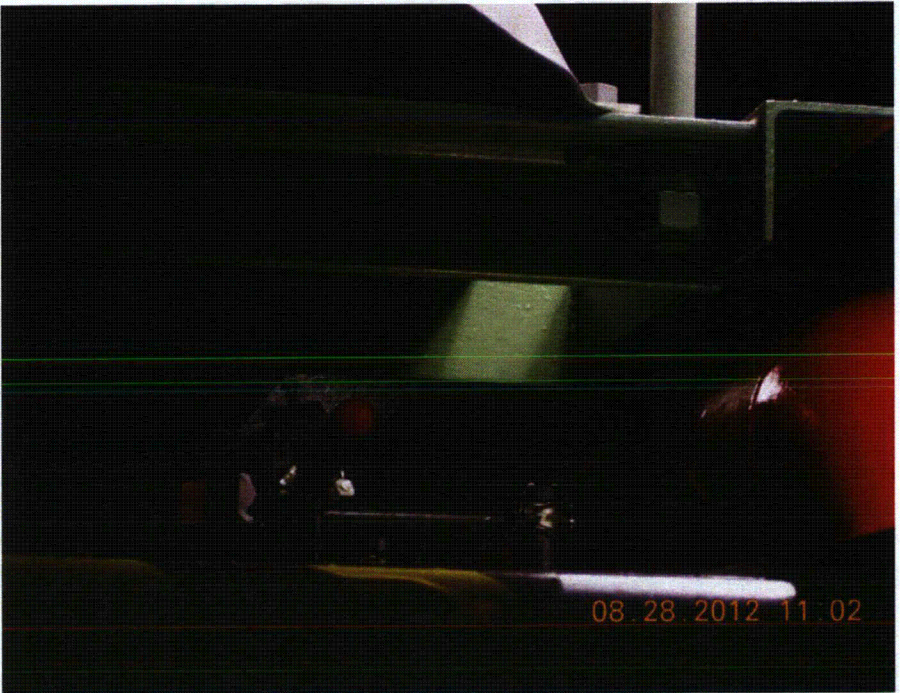
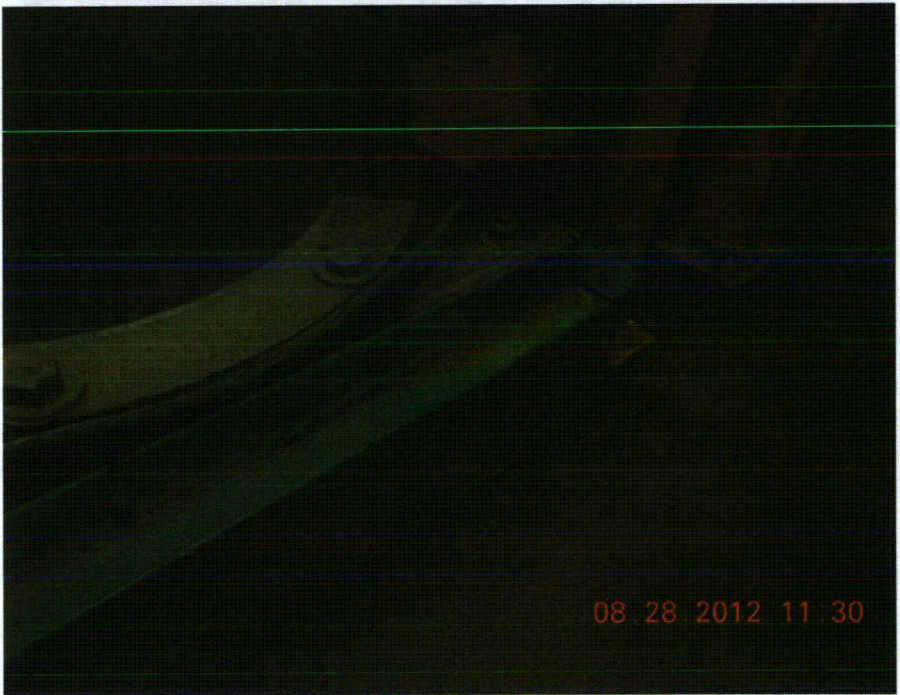
Equipment ID: 2AV060

4. Is the anchorage free of visible cracks in the concrete near the anchors? Y N U N/A
. Mounted to structural steel

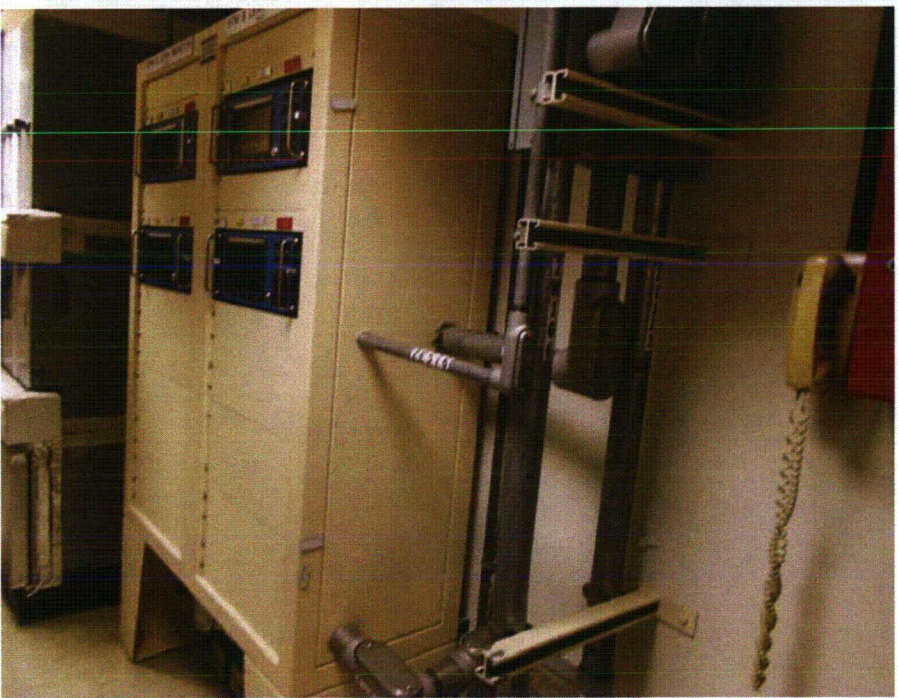
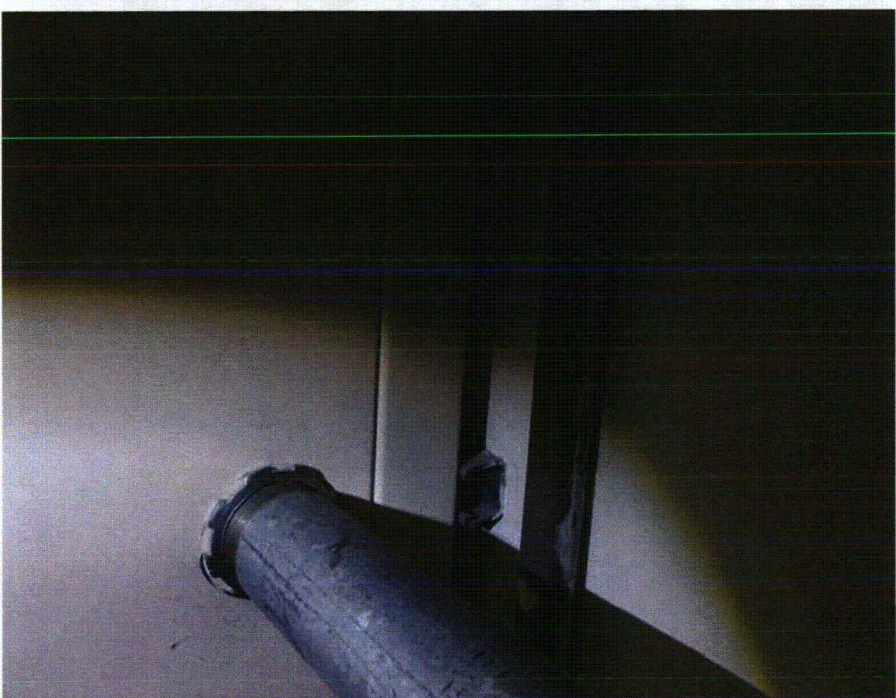
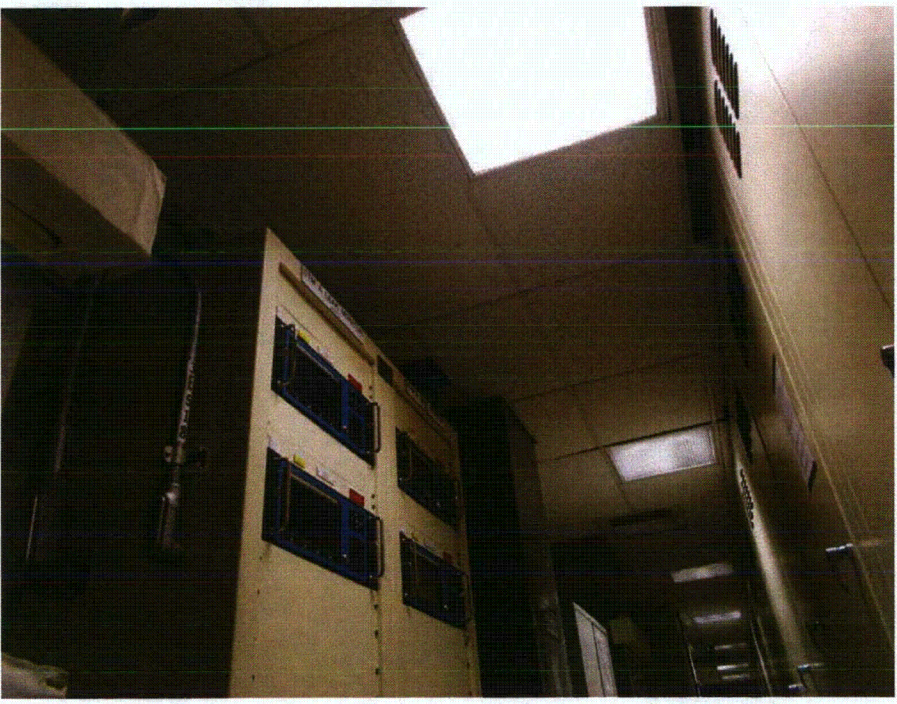
Equipment ID: 2BC270

2. Is the anchorage free of bent, broken, missing or loose hardware? Y N U N/A
mounted with 3 channels to back wall, NO floor mounting.

- 7. Are soft targets free from impact by nearby equipment or structures? Y N U N/A
No soft targets
- 8. Are overhead equipment, distribution systems, ceiling tiles and lighting, and masonry block walls not likely to collapse onto the equipment? Y N U N/A
*2'x3' ceiling tiles. No credible damage from falling ceiling tiles
Grading on fluorescent lighting.*
- 9. Do attached lines have adequate flexibility to avoid damage? Y N U N/A
- 10. Based on the above seismic interaction evaluations, is equipment free of potentially adverse seismic interaction effects? Y N U

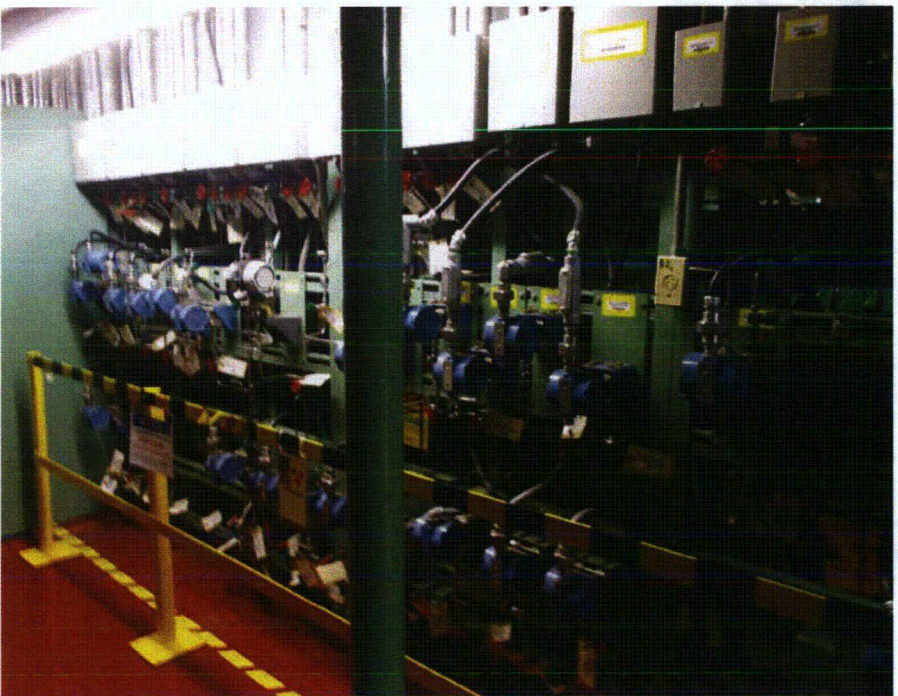
Equipment ID: 2BC065

The anchorage configuration analyzed in Calc PS-0930, REV 0, is not consistent with the existing anchorage shown on the field sketch (See SWC for 2A606). The Calc does not account for the missing anchor bolts or for the restraint from the large divider plate that is bolted to the rack structure. As installed configuration is judged acceptable. For resolution, see IR# 0149745.

*Flourescent fixture mounted to channel.
Damage from falling light bulbs not credible.
No ceiling tiles or masonry walls.*
