Seismic Walkdown Checklist (SWC)

Peach Bottom Atomic Power Station Unit 2
MPR-3815, Revision 3
Correspondence No. RS-12-173

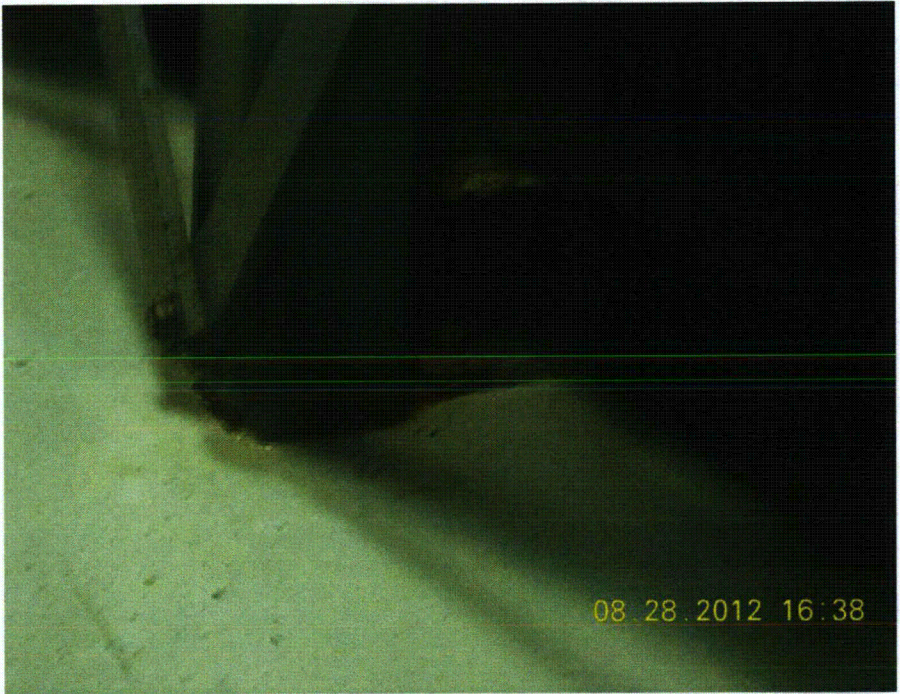
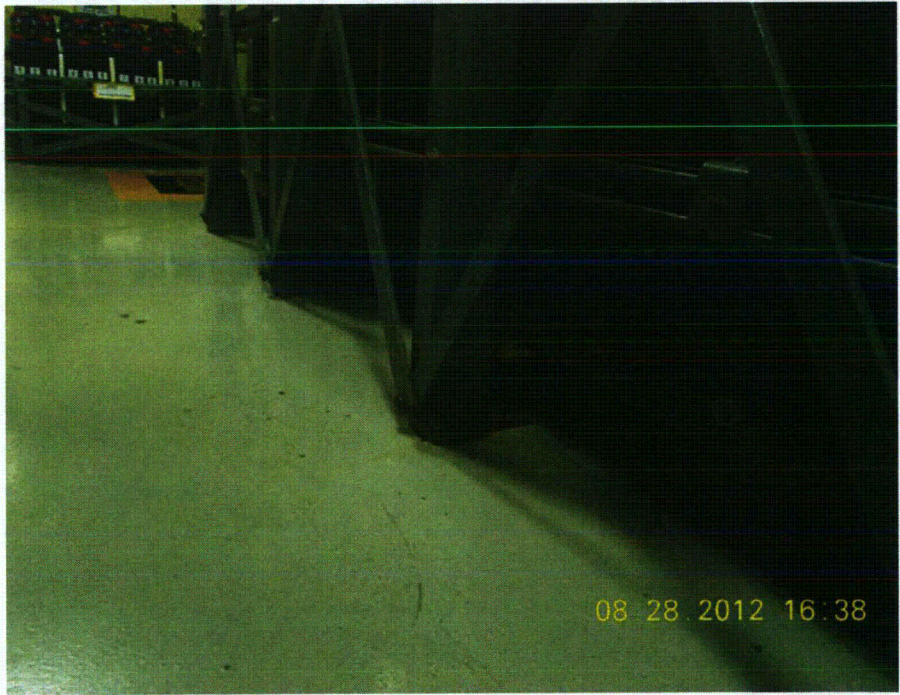
Equipment ID: 2BD001

3. Is the anchorage free of corrosion that is more than mild surface oxidation?
. Mild to moderate corrosion on one anchor bolt judged acceptable Y N U N/A
