Equipment ID No. 2BE24 Equip. Class ¹² (21) Tanks or Heat E	schangers (Vertical)
Equipment Description RHR Heat Exchanger B	gm 8/31/2012
Location: Bldg. Reactor Floor El. 746 91 Room, Area R	2-78 6
Manufacturer, Model, Etc. (optional but recommended)	·
Instructions for Completing Checklist	
This checklist may be used to document the results of the Seismic Walkdown of SWEL. The space below each of the following questions may be used to record t findings. Additional space is provided at the end of this checklist for documenting	he results of judgments and
Anchorage	:

Seismic Walkdown Checklist (SWC)	
B 900 8/31/2012	
Equipment ID No. 2AP037 Equip. Class ¹² (06) Vertical Pumps	
Equipment Description Core Spray Pump X B	gw a/31/2012
Location: Bldg. Reactor Floor El. 91 Room, Area R	
Manufacturer, Model, Etc. (optional but recommended)	
Instructions for Completing Checklist	
This checklist may be used to document the results of the Seismic Walkdown of SWEL. The space below each of the following questions may be used to record findings. Additional space is provided at the end of this checklist for documenting the space is provided at the end of this checklist for documenting the space i

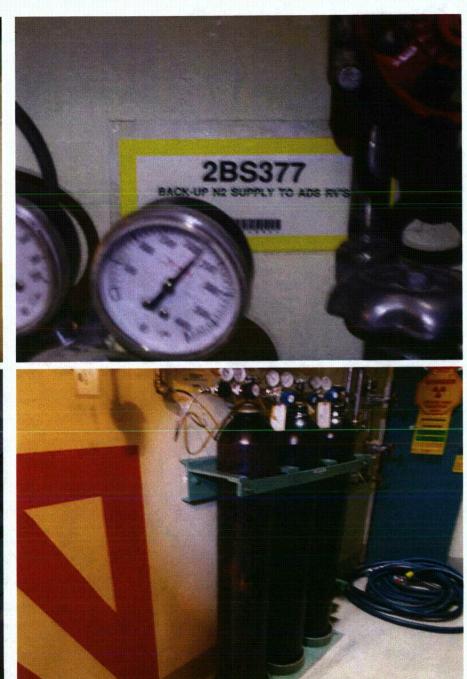
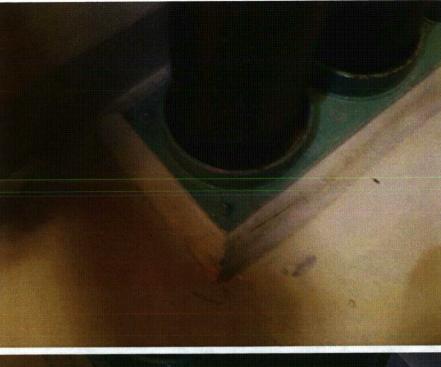
3. Is the anchorage free of corrosion that is more than mild surface oxidation?	YM UU N/AU
4. Is the anchorage free of visible cracks in the concrete near the anchors? One side of top softed, one side of top support	YØ N□ U□ N/A□ weldrel,

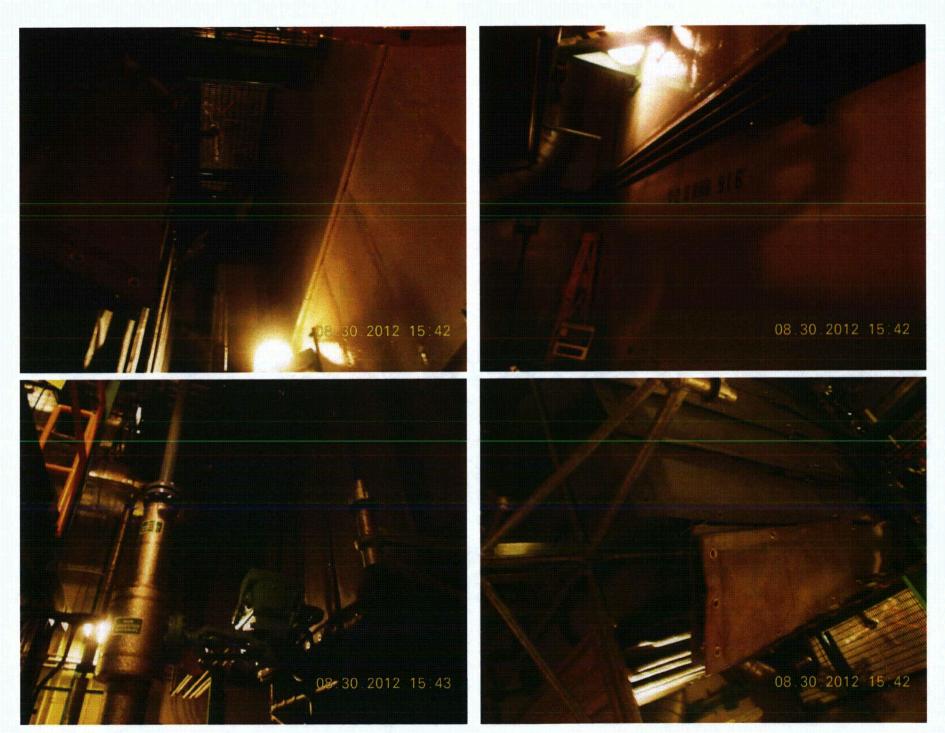
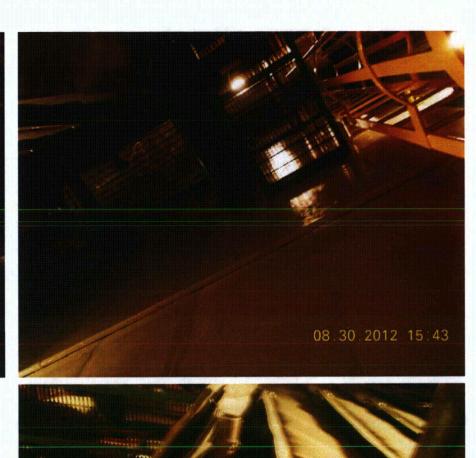
Other Adverse Conditions 11. Have you looked for and found no other seismic conditions that could adversely affect the safety functions of the equipment?	YX NO UO	
Due	Comments (Additional pages may be added as necessary) to presence of lead shielding and contaminated to of anchorage. Visible anchorage consistent w/ 0 in good condition.	omos, could no lug. M-3400, Rev	of (
and	q_{zz}

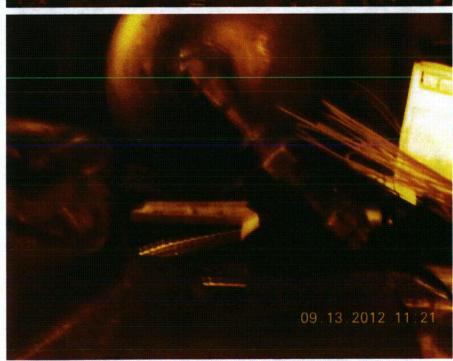
3. Is the anchorage free of corrosion that is more than mild surface oxidation? Mild to mederate surface corrosion judged acception.	yoplo Ja no oo nao

4. Is the anchorage free of visible cracks in the concrete near the anchors? • Mountain to steel support plate	YX NO UO N/AO
	RG IGHELIS
5. Is the anchorage configuration consistent with plant documentation? (Note: This question only applies if the item is one of the 50% for	YN NH UU N/AU
which an anchorage configuration verification is required.)	SEE COMMENTS KG 1014
Judged occuptable (lank frame wolded to support p	lote methor than boiled)

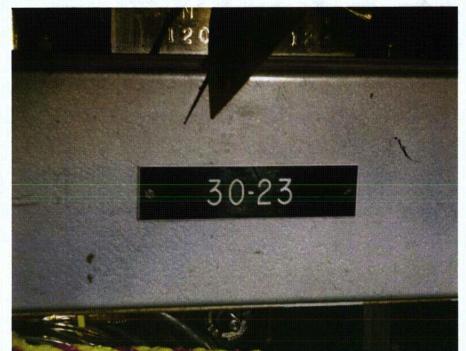
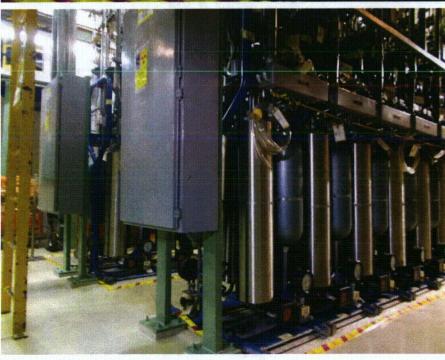
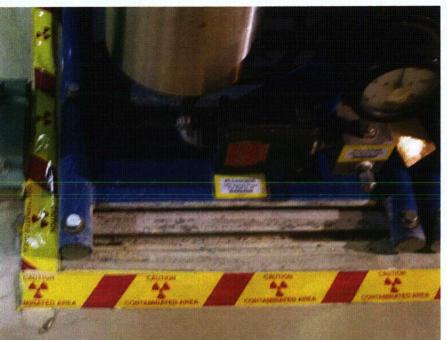
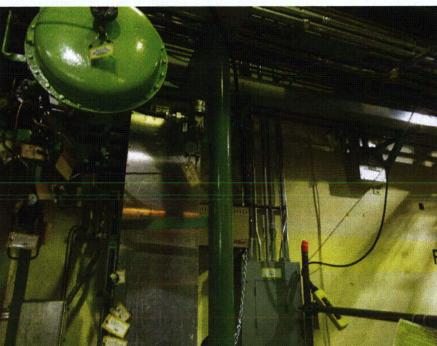
Sheet 2 of 2 BME 8/30/12 Equipment ID No. ??? _ Equip. Class¹² (00) Other Equipment Description Hydraulic Control Unit **Interaction Effects** 7. Are soft targets free from impact by nearby equipment or structures? YX NU UU N/AU 8. Are overhead equipment, distribution systems, ceiling tiles and lighting, YX NU UU N/AU and masonry block walls not likely to collapse onto the equipment? No Celling tites. No masony walls, Damage From falling light bolbs not credible. 9. Do attached lines have adequate flexibility to avoid damage? Y⊠ N□ U□ N/A□ 10. Based on the above seismic interaction evaluations, is equipment free of potentially adverse seismic interaction effects? **Other Adverse Conditions** 11. Have you looked for and found no other seismic conditions that could YKIND UD adversely affect the safety functions of the equipment? **Comments** (Additional pages may be added as necessary)

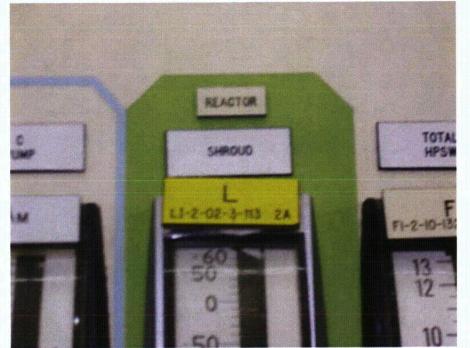
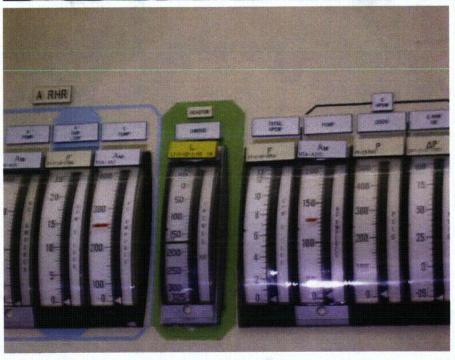
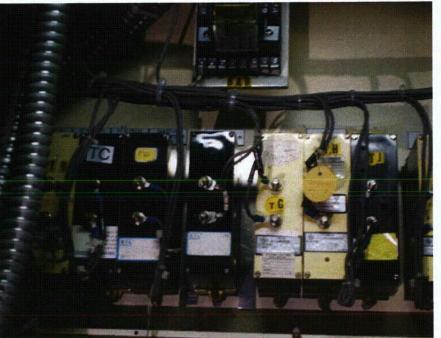
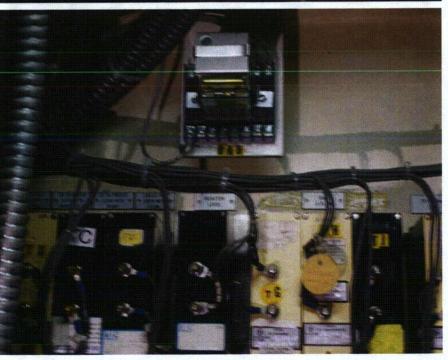
9. Do attached lines have adequate flexibility to avoid damage?	YQ NO UO N/AO	
	,	
10. Based on the above seismic interaction evaluations, is equipment free	Y⊠ N□ U□	:
of potentially adverse seismic interaction effects?	141100	gr
01 p 0101111111 11111111111111111111111

•	
Other Adverse Conditions		
11. Have very looked for and found no other gaignic conditions that gould	VCZNCS IIC	
11. Have you looked for and found no other seismic conditions that could adversely affect the safety functions of the equipment?	YN U	•
adversely affect the safety functions of the equipment:

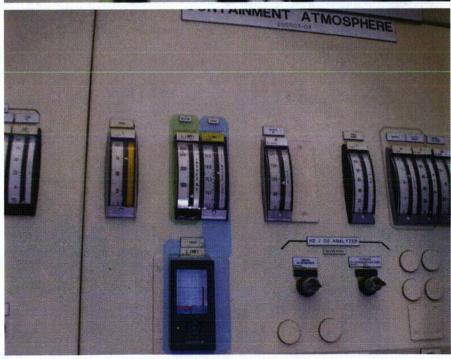
9. Do attached lines have adequate flexibility to avoid damage?	YZ NO	U N/A	
10. Based on the above seismic interaction evaluations, is equipment free of potentially adverse seismic interaction effects?	UN KA	U	
Other Adverse Conditions 11. Have you looked for and found no other seismic conditions that could	Y % N□		
adversely affect the safety functions of the equipment?	·	, · · · · ·	
Comments (Additional pages may be added as necessary)			
· · · · · · · · · · · · · · · · · · ·			
Evaluated by: Ben Jay	Date:	10/19/12

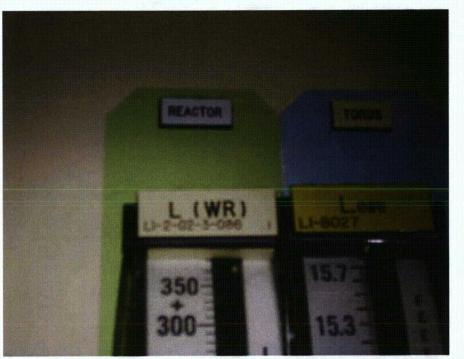
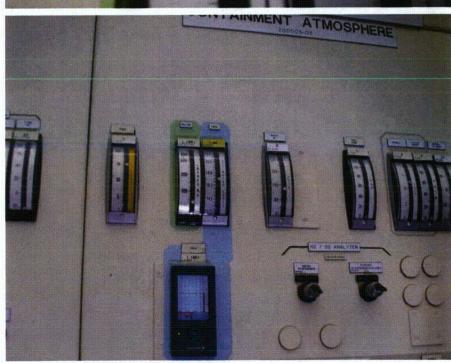
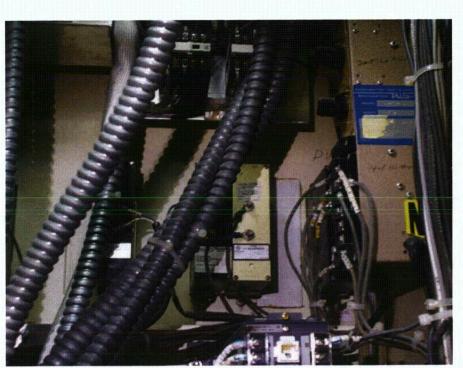
9. Do attached lines have adequate flexibility to avoid damage?	YN UU N/AU		
10. Based on the above seismic interaction evaluations, is equipment free of potentially adverse seismic interaction effects?	YN NO UO		
Other Adverse Conditions

11. Have you looked for and found no other seismic conditions that could adversely affect the safety functions of the equipment?	YK NO UO		
Comments (Additional pages may be added as necessary)			
Evaluated by: Ben Fry	Date: ///14/12
