300043 am 9/17/2012	
Equipment ID No. 30837-PANEL Equip. Class <sup>12</sup> (20) Control Panels &	& Cabinets
Equipment Description HPCI Turbine Aux Lube 0:1 Pump Starter	
Location: Bldg. Reactor Floor El. 88 Room, Area R3-13	
Manufacturer, Model, Etc. (optional but recommended)	
Instructions for Completing Checklist	
This checklist may be used to document the results of the Seismic Walkdown of SWEL. The space below each of the following questions may be used to record findings. Additional space is provided at the end of this checklist for documenting	he results of judgments and
Anchorage

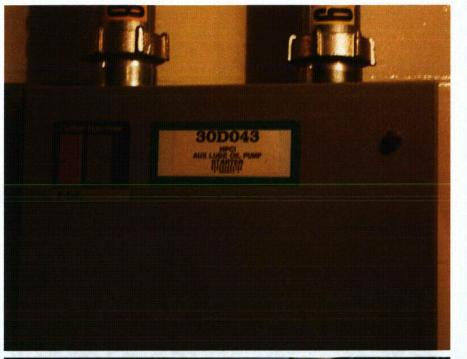
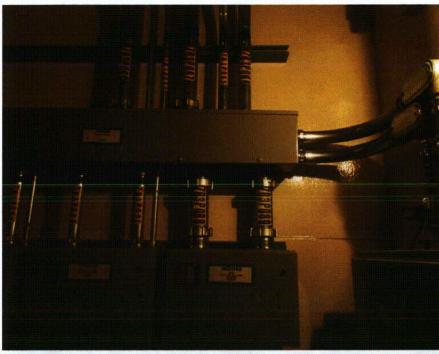
11. Have you looked for and found no other seismic conditions that could adversely affect the safety functions of the equipment?  Noted that cobinet was open for in-pagess was prevent full opening of front court; judged not	YX N□ U□ Ik, but was deped de o seismic concern
Comments (Additional pages may be added as necessary)	. 1
N/A

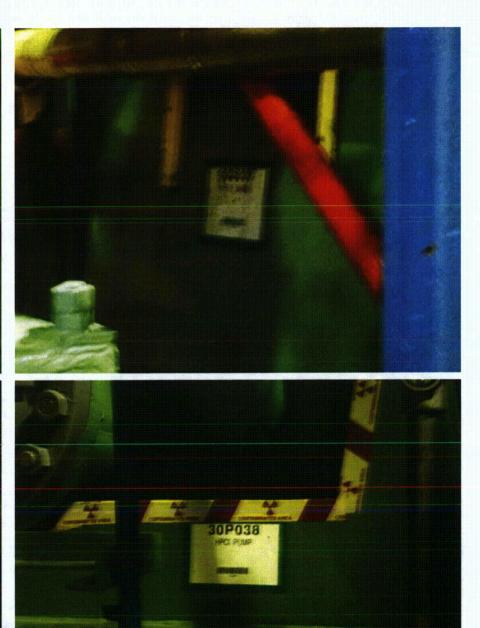
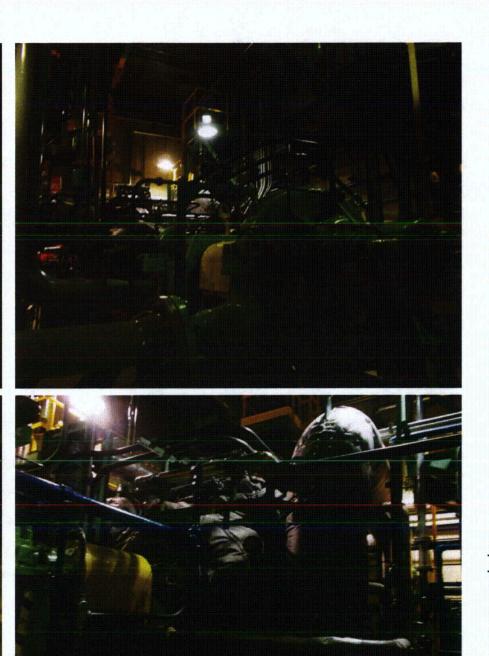
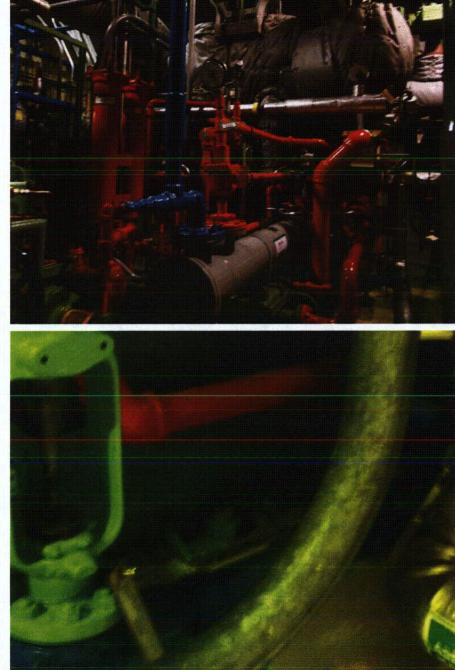
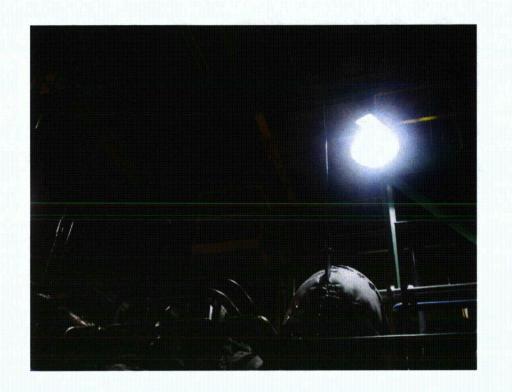
8. Are overhead equipment, distribution systems, ceiling tiles and lighting, YNN UNA and masonry block walls not likely to collapse onto the equipment?  Overhead cranes in locked home positions.  Scatteding securely mounted to structural steri.  9. Do attached lines have adequate flexibility to avoid damage?  10. Based on the above seismic interaction evaluations, is equipment free of potentially adverse seismic interaction effects?  Other Adverse Conditions  11. Have you looked for and found no other seismic conditions that could YNN UN
and masonry block walls not likely to collapse onto the equipment?  Overhead crones in locked home positions.  Scalleding securely mounted to structural steri.  9. Do attached lines have adequate flexibility to avoid damage?  10. Based on the above seismic interaction evaluations, is equipment free young not potentially adverse seismic interaction effects?  Other Adverse Conditions  11. Have you looked for and found no other seismic conditions that could young not prove the positions and found no other seismic conditions that could young not prove the positions.

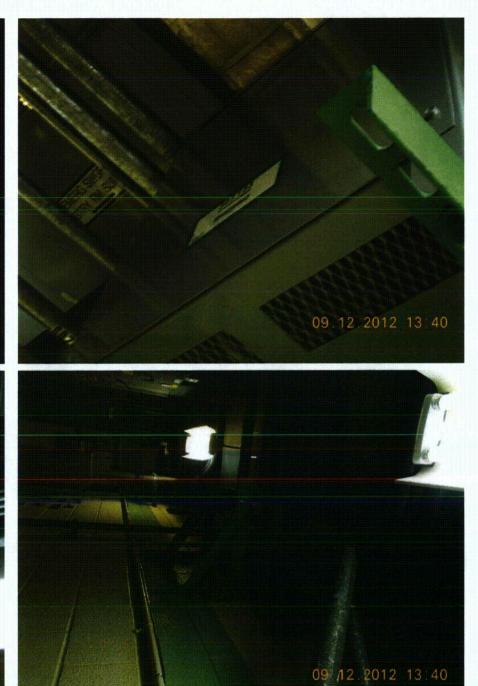
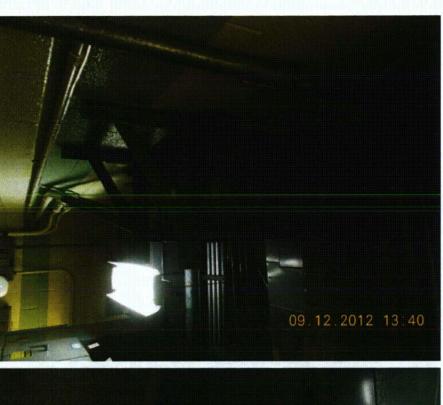
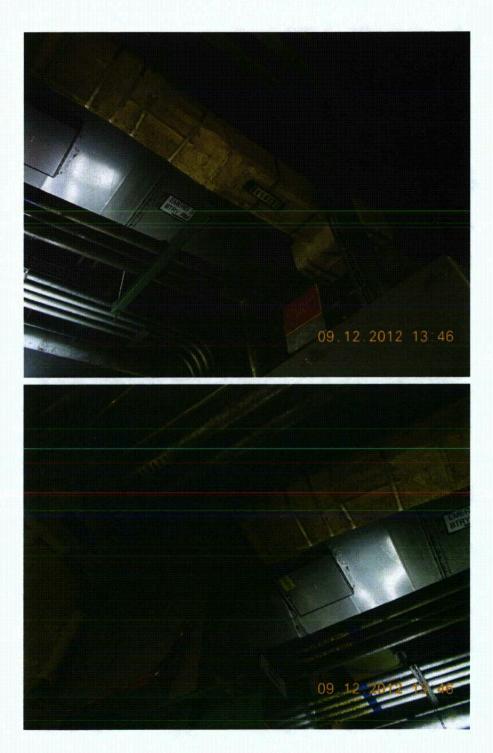
4. Is the anchorage free of visible cracks in the concrete near the anchors?  Mounted to block woll (see #8)	YX NU UU N/AU
5. Is the anchorage configuration consistent with plant documentation? (Note: This question only applies if the item is one of the 50% for which an anchorage configuration verification is required.)	Y UU UU N/AX

9. Do attached lines have adequate flexibility to avoid damage?	YN UU N/	A 🗆
10. Based on the above seismic interaction evaluations, is equipment free of potentially adverse seismic interaction effects?  Conduit # ZB3D599 is touching the top is supported by wall pendiration and ceiling hanger	YN NO UD	or, bit
is supported by wall ponetration and string in the	) 4, 1	· · · · · · · · · · · · · · · · · · ·
Other Adverse Conditions	1.47	:
	YX ND UD	1
Other Adverse Conditions  11. Have you looked for and found no other seismic conditions that could	1.47	
Other Adverse Conditions  11. Have you looked for and found no other seismic conditions that could adversely affect the safety functions of the equipment?	1.47	:
Other Adverse Conditions  11. Have you looked for and found no other seismic conditions that could adversely affect the safety functions of the equipment?  Comments (Additional pages may be added as necessary)	1.47	1

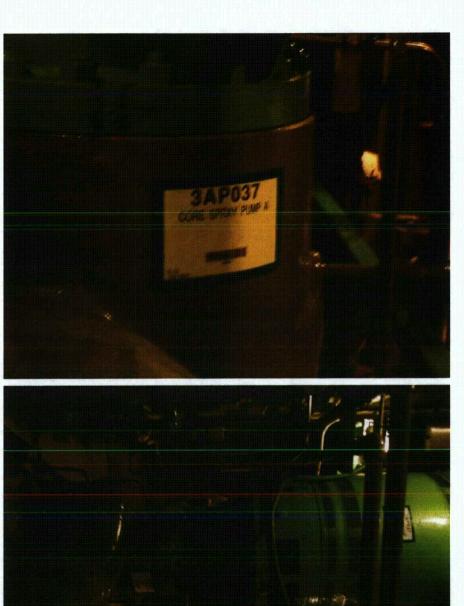
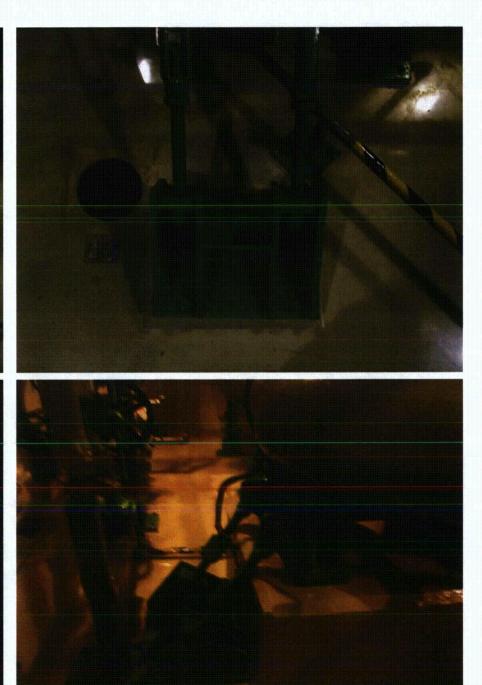
8. Are overhead equipment, distribution systems, ceiling tiles and lighting, and masonry block walls not likely to collapse onto the equipment?  Chain for hand volve HV-3-14-39037 judged not significant throat	Y <b>X</b> J			n/a□ bot	Andrew Programme

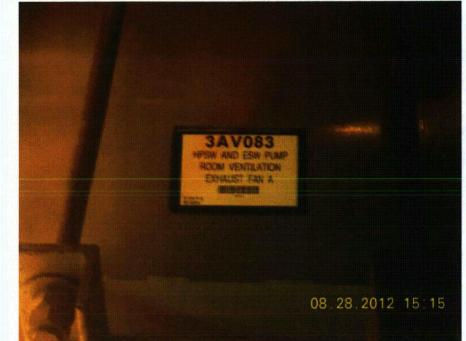
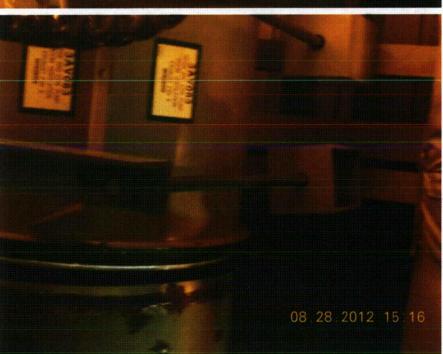
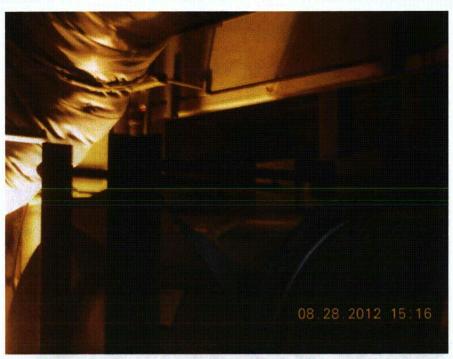
### Equipment ID: 3AV083

2. Is the anchorage free of bent, broken, missing or loose hardware?	YX N UU N/A
3. Is the anchorage free of corrosion that is more than mild surface oxidation?	YX NO UO N/AO

4. Is the anchorage free of visible cracks in the concrete near the anchors?  Mounted to structural steel	YN UU N/AU
5. Is the anchorage configuration consistent with plant documentation? (Note: This question only applies if the item is one of the 50% for which an anchorage configuration verification is required.)  • Motors Own. # M-473, Rev. 13	YX NO UO N/AO

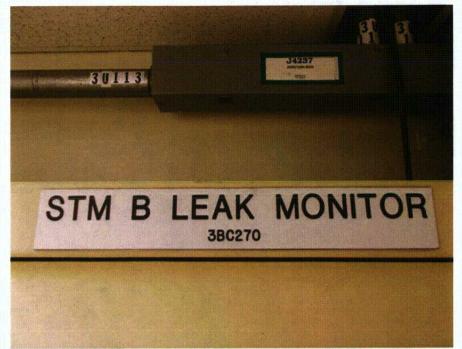
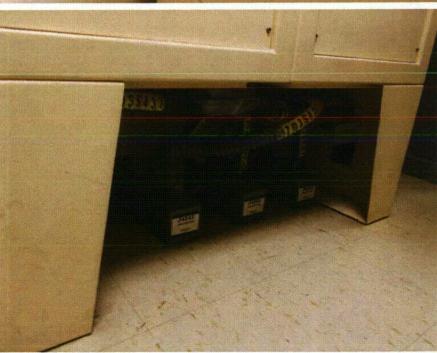
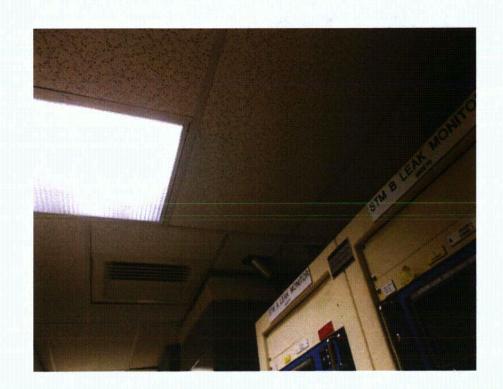
# Equipment ID: 3BC270

2. Is the anchorage free of bent, broken, missing or loose hardware?  Mounted with 3 Channels to Sach wall.  No floor mounting	Y∑ N□ U□ N/A□ .
3. Is the anchorage free of corrosion that is more than mild surface oxidation?	YM N□ U□ N/A□

7. Are soft targets free from impact by nearby equipment or structures?  No Soft targets	WAT NO UO N/AO
8. Are overhead equipment, distribution systems, ceiling tiles and lighting, and masonry block walls not likely to collapse onto the equipment?  2' + 3' ceiling tiles. No credible damage from falling

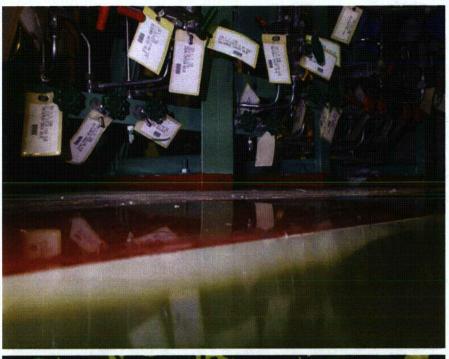
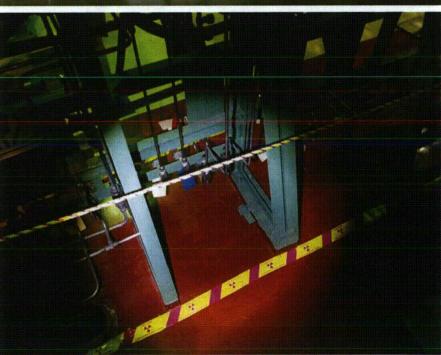
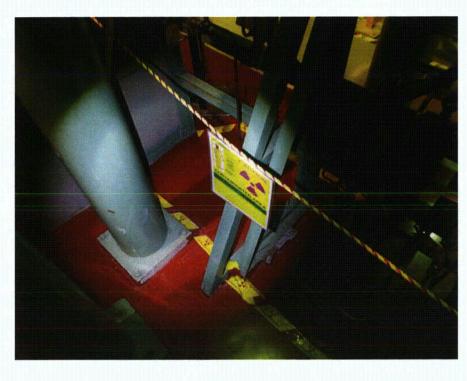
# Equipment ID: 3BC065

2. Is the anchorage free of bent, broken, missing or loose hardware?  Interior supports are anchored to floor toulite	YOND VZ)	U N/A BMF 10/15/12
3. Is the anchorage free of corrosion that is more than mild surface oxidation?	YA N	U N/A
