Equipment ID No. LT3-2-3-61 Equip. Class <sup>12</sup> (18) Instruments on I	Racks / Not on Racks
Equipment Description Reactor Vessel Water Level Transmitter	
Location: Bldg. Reactor Floor El. 165 Room, Area R3-40	
Manufacturer, Model, Etc. (optional but recommended)	
Instructions for Completing Checklist	
This checklist may be used to document the results of the Seismic Walkdown of SWEL. The space below each of the following questions may be used to record t findings. Additional space is provided at the end of this checklist for documenting the space is provided at the end of this checklist for documenting the space is provided at the end of this checklist for documenting the space.	he results of judgments and
Anchorage	
<ol> <li>Is the anchorage configuration verification required (i.e., is the item one of the 50% of SWEL items requiring such verification)?</li> </ol>	Y□ N⊠

Peach Bottom Atomic Power Station Unit 3 MPR-3812, Revision 3 Correspondence No : RS-12-173

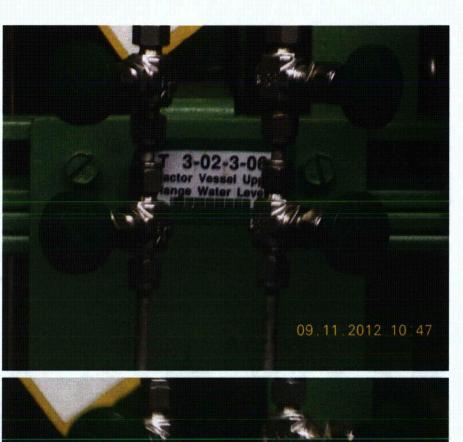
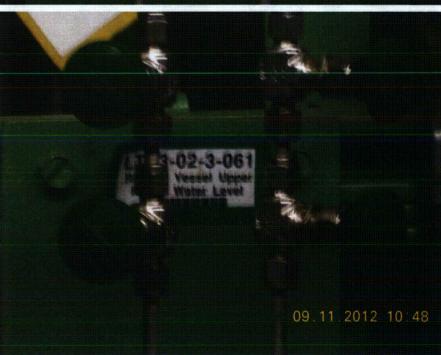
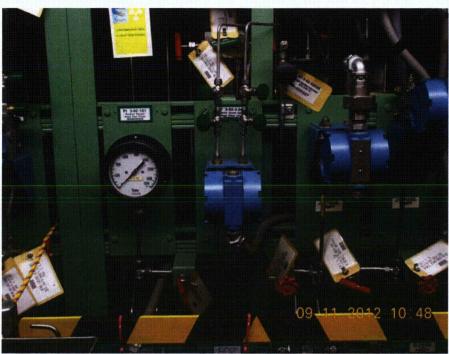
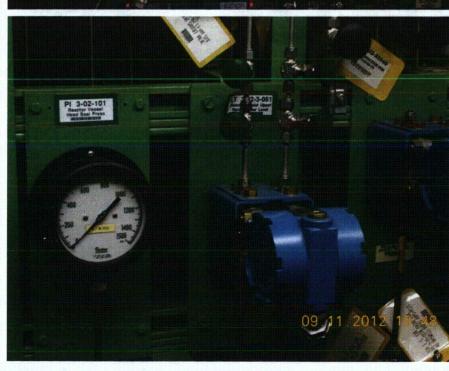
Equipment ID No. LT3-2-3-61 Equip. Class <sup>12</sup> (18) Instruments on I	Racks / Not	on Racks
Equipment Description Reactor Vessel Water Level Transmitter		
Interaction Effects  7. Are soft targets free from impact by nearby equipment or structures?  Temporary barriers blacked by profestive fonce		U□ N/A□

8. Are overhead equipment, distribution systems, ceiling tiles and lighting, and masonry block walls not likely to collapse onto the equipment?	χ <b>)</b> ν□	U N/A

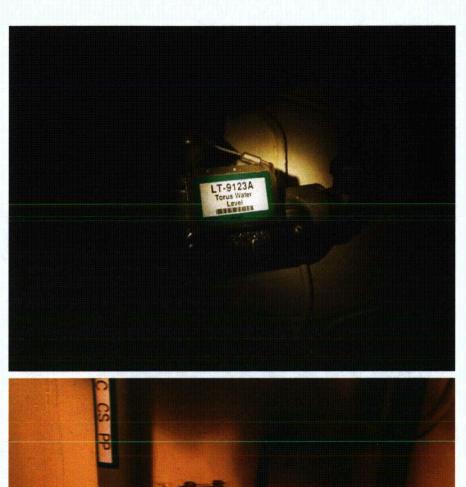
Equipment ID No. LT-9123A Equip. Class <sup>12</sup> (18) Instruments on I	Racks / Not on Racks
Equipment Description Torus Water Level Transmitter	
Location: Bldg. Reactor Floor El. 91 Room, Area R3-11	
Manufacturer, Model, Etc. (optional but recommended)	
Instructions for Completing Checklist	
This checklist may be used to document the results of the Seismic Walkdown of SWEL. The space below each of the following questions may be used to record findings. Additional space is provided at the end of this checklist for documenting the space is provided at the end of this checklist for documenting the space is provided at the end of this checklist for documenting the space is provided at the end of this checklist for documenting the space is provided at the end of this checklist for documenting the space is provided at the end of this checklist for documenting the space is provided at the end of this checklist for documenting the space is provided at the end of this checklist for documenting the space is provided at the end of this checklist for documenting the space is provided at the end of this checklist for documenting the space is provided at the end of this checklist for documenting the space is provided at the end of this checklist for documenting the space is provided at the end of this checklist for documenting the space is provided at the end of this checklist for documenting the space is provided at the end of this checklist for documenting the space is provided at the end of this checklist for documenting the space is provided at the end of this checklist for documenting the space is provided at the end of the space is provided the space is provided the space is provided the space is provided to the space	the results of judgments and

9. Do attached lines have adequate flexibility to avoid damage?	YX NO UO N/AO
10. Based on the above seismic interaction evaluations, is equipment free of potentially adverse seismic interaction effects?	YX ND UD
Other Adverse Conditions  11. Have you looked for and found no other seismic conditions that could adversely affect the safety functions of the equipment?	YX NO UO
Comments (Additional pages may be added as necessary)  N/A	
Evaluated by: Game Wigam  2. J.L	Date: 9/17/2012

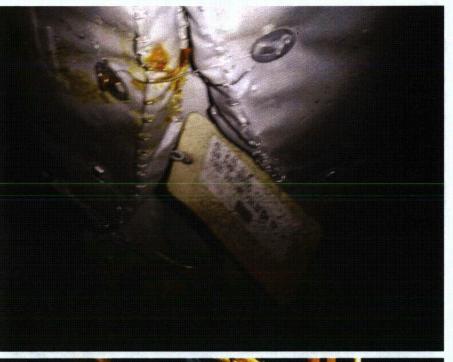
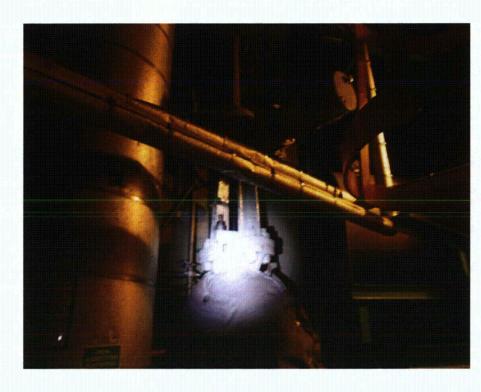
Equipment ID No. M03-10-013C Equip. Class <sup>12</sup> (08a) Motor Operated	l Valves
Equipment Description RHR Pump Torus Suction Valve	
Location: Bldg. Reactor Floor El. 91 Room, Area R3-7	
Manufacturer, Model, Etc. (optional but recommended)	
Instructions for Completing Checklist	
This checklist may be used to document the results of the Seismic Walkdown of SWEL. The space below each of the following questions may be used to record the findings. Additional space is provided at the end of this checklist for documenting the space is provided at the end of this checklist for documenting the space is provided at the end of this checklist for documenting the space is provided at the end of this checklist for documenting the space is provided at the end of this checklist for documenting the space is provided at the end of this checklist for documenting the space is provided at the end of this checklist for documenting the space is provided at the end of this checklist for documenting the space is provided at the end of this checklist for documenting the space is provided at the end of this checklist for documenting the space is provided at the end of this checklist for documenting the space is provided at the end of this checklist for documenting the space is provided at the end of this checklist for documenting the space is provided at the end of this checklist for documenting the space is provided at the end of this checklist for documenting the space is provided at the end of this checklist for documenting the space is provided the spa	he results of judgments and

10. Based on the above seismic interaction evaluations, is equipment free of potentially adverse seismic interaction effects?	¥ <b>Z</b> N□ U□
Other Adverse Conditions  11. Have you looked for and found no other seismic conditions that could adversely affect the safety functions of the equipment?	¥ N□ U□
Comments (Additional pages may be added as necessary)	
Evaluated by:	Date: 9/11/12
Ben faz	4/11/12

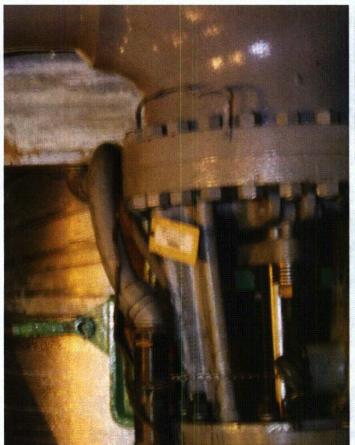
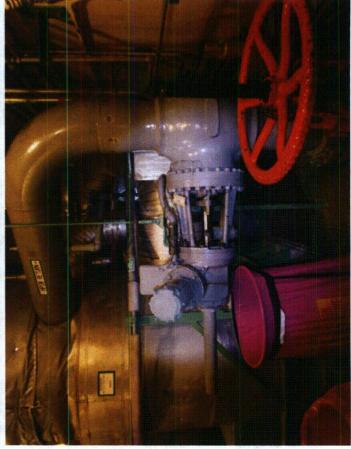
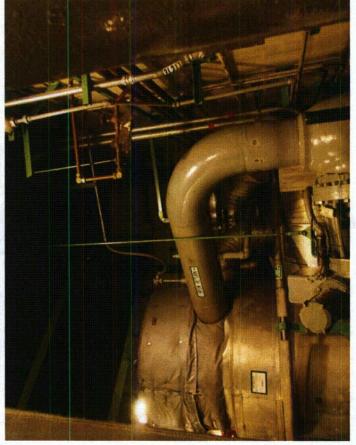
Equipment ID No. M03-10-89AC Equip. Class <sup>12</sup> (08a) Motor Operated	i Valves
Equipment Description RHR HX HPSW Outlet Valve	
Bocation: Bidg. Retictor 11001 Et. 110 10011, 110011, 110011	MF 10/4/12
Manufacturer, Model, Etc. (optional but recommended)	7
Instructions for Completing Checklist	
This checklist may be used to document the results of the Seismic Walkdown of SWEL. The space below each of the following questions may be used to record t findings. Additional space is provided at the end of this checklist for documenting	he results of judgments and
Anchorage

1. Is the anchorage configuration verification required (i.e., is the item one of the 50% of SWEL items requiring such verification)?  Line mounted valve	Y NX

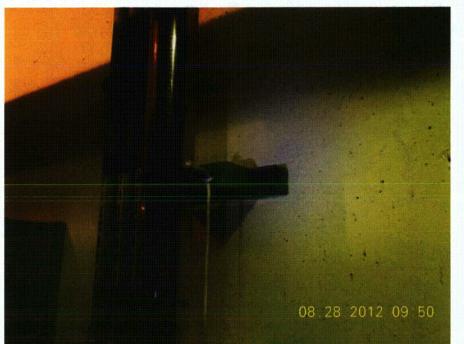
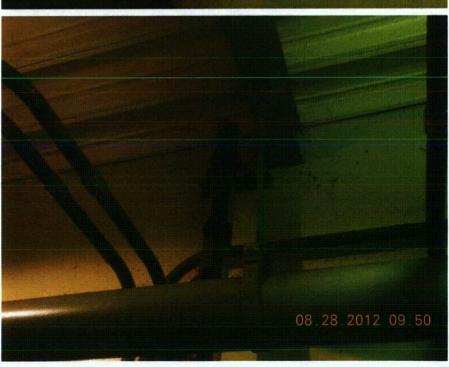
·	
Equipment ID No. Mo3-30-3233A Equip. Class <sup>12</sup> 8A - Motor O	perated
Equipment Description UNIT 3A SLUICE GATE	
Location: Bldg. ScreenhouseFloor El. 116 Room, Area 5/H-4	
Manufacturer, Model, Etc. (optional but recommended)	
Instructions for Completing Checklist	
This checklist may be used to document the results of the Seismic Walkdown of SWEL. The space below each of the following questions may be used to record findings. Additional space is provided at the end of this checklist for documenting the space is provided at the end of this checklist for documenting the space is provided at the end of this checklist for documenting the space is provided at the end of this checklist for documenting the space is provided at the end of this checklist for documenting the space is provided at the end of this checklist for documenting the space is provided at the end of this checklist for documenting the space is provided at the end of this checklist for documenting the space is provided at the end of this checklist for documenting the space is provided at the end of this checklist for documenting the space is provided at the end of this checklist for documenting the space is provided at the end of this checklist for documenting the space is provided at the end of this checklist for documenting the space is provided at the end of this checklist for documenting the space is provided at the end of this checklist for documenting the space is provided at the end of this checklist for documenting the space is provided at the end of this checklist for the space is provided the space is provided the space is provided to the space is provided the space is provided to the spa	the results of judgments and

2. Is the anchorage free of bent, broken, missing or loose hardware?  . See Commont #1	YX NO UO N/AO
3. Is the anchorage free of corrosion that is more than mild surface oxidation?  See Comment #1	YX NO UO N/AO

11. Have you looked for and found no other seismic conditions that could YX N U U adversely affect the safety functions of the equipment?  • Clearance between motor and junction box judged occeptable
Comments (Additional pages may be added as necessary)  AMA #1. Evolution only applies to motor-operator due to  inaccessability of actual sluice gate for visual inspection
Evaluated by: <u>Gamer Wagam</u> Date: <u>8/28/2012</u> 8/28/2012

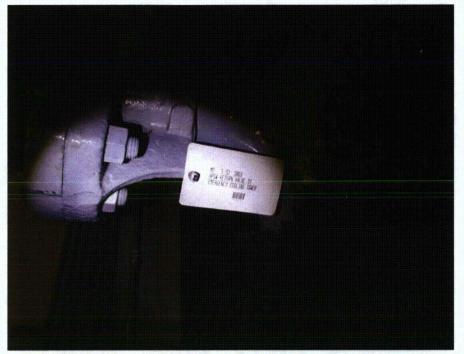
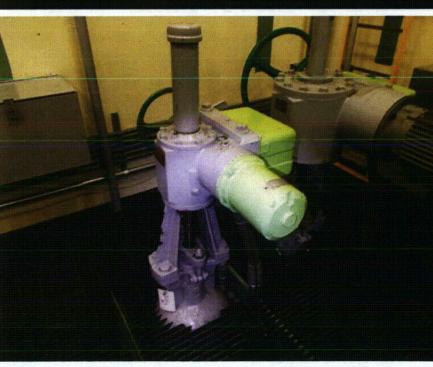
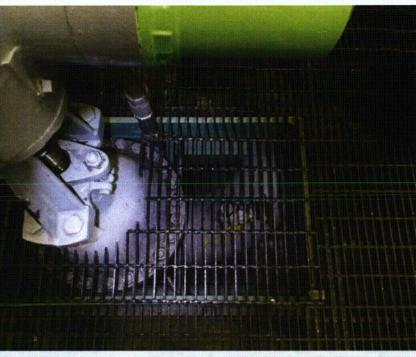
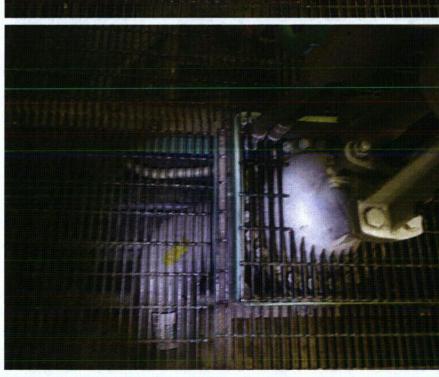
M0-3-32-3803 8/4F/ Equipment ID No. M03-32-3903 8/4F Equip. Class <sup>12</sup> (08a) Motor Operate	d Valve	es		
Equipment Description HPSW Return Valve to ECT		1.1		
Location: Bldg. <u>Diesel Generator</u> Floor El. <u>121</u> Room, Area <u>Diesel Generator</u>	/G-2			
Manufacturer, Model, Etc. (optional but recommended)			. 1	· · · · · · · · · · · · · · · · · · ·
Instructions for Completing Checklist				:
This checklist may be used to document the results of the Seismic Walkdown of SWEL. The space below each of the following questions may be used to record t findings. Additional space is provided at the end of this checklist for documenting	the resu	ılts of jı	idgments ar	
Anchorage			+ %

7. Are soft targets free from impact by nearby equipment or structures?  No soft targets	Y⊠ N□ U□ N/A□
8. Are overhead equipment, distribution systems, ceiling tiles and lighting, and masonry block walls not likely to collapse onto the equipment?  The light bubs may fall during seismic event. However, no credible damage is plansible.	YM N□ U□ N/A□

- No ceiling tiles or masony block.  9. Do attached lines have adequate flexibility to avoid damage?	YØ N□ U□ N/A□
10. Based on the above seismic interaction evaluations, is equipment free of potentially adverse seismic interaction effects?	Y⊠ N□ U□
Other Adverse Conditions

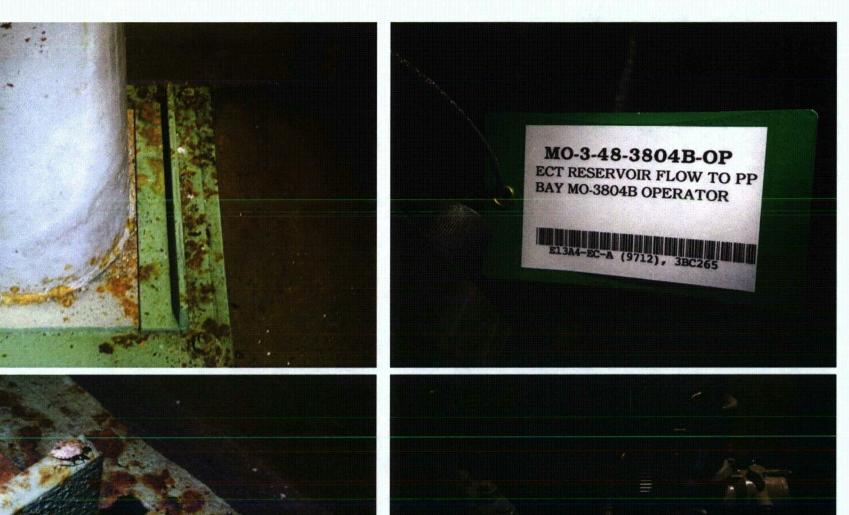
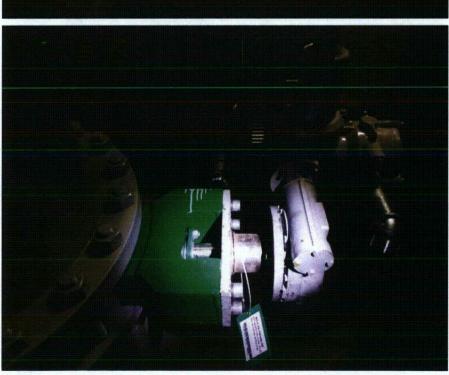
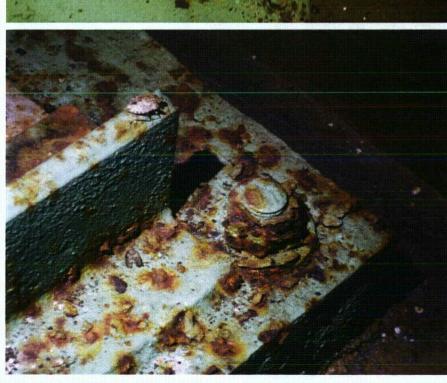
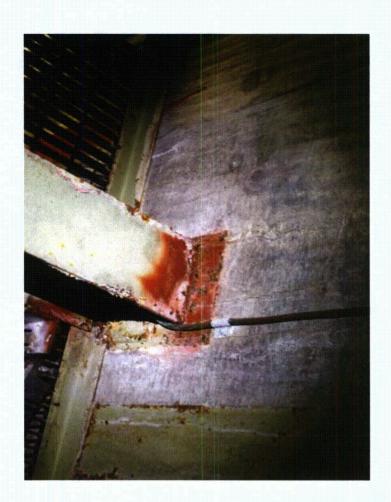
Equipment ID No. M03-48-3804B Equip. Class <sup>12</sup> (08a) Motor Operated Valves		
Equipment Description HPSW Bay Inlet Inner Valve		
Location: Bldg. <u>Emergency</u> Floor El. <u>114</u> Room, Area <u>E</u> C (V	CT-1 Valve pit)	
Manufacturer, Model, Etc. (optional but recommended)		<u> </u>
Instructions for Completing Checklist  This checklist may be used to document the results of the Seismic Walkdown of an item of equipment on the SWEL. The space below each of the following questions may be used to record the results of judgments and findings. Additional space is provided at the end of this checklist for documenting other comments.		
Anchorage

2. Is the anchorage free of bent, broken, missing or loose hardware?  Line mounted equipment	YKŲ N□ U	<b>I□ N/A□</b> := 1
3. Is the anchorage free of corrosion that is more than mild surface oxidation?	ŶØIN□U	「□ N/A□

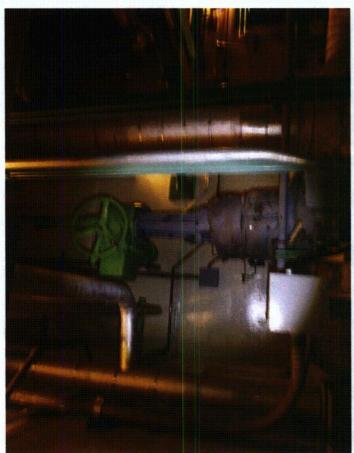
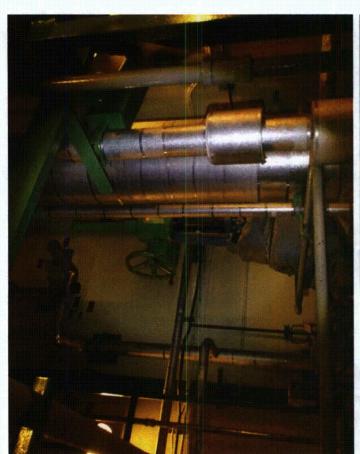
Seismic Walkdown Checklist (SWC)	•
Equipment ID No. CV3-10-0134 [Fluid Equipment ID No. CV3-10-3677A Equipment Description Equipment Description RHR Pump Discharge Control Valve	d Valves
Equipment Description RHR Pump Discharge Control Valve	
Location: Bldg. Reactor 18. Floor El. 91 Room, Area R3-5	
Manufacturer, Model, Etc. (optional but recommended)	
Instructions for Completing Checklist  This checklist may be used to document the results of the Seismic Walkdown of SWEL. The space below each of the following questions may be used to record findings. Additional space is provided at the end of this checklist for documenting the space is provided at the end of this checklist for documenting the space is provided at the end of this checklist for documenting the space is provided at the end of this checklist for documenting the space is provided at the end of this checklist for documenting the space is provided at the end of this checklist for documenting the space is provided at the end of this checklist for documenting the space is provided at the end of this checklist for documenting the space is provided at the end of this checklist for documenting the space is provided at the end of this checklist for documenting the space is provided at the end of this checklist for documenting the space is provided at the end of this checklist for documenting the space is provided at the end of this checklist for documenting the space is provided at the end of this checklist for documenting the space is provided at the end of this checklist for documenting the space is provided at the end of this checklist for documenting the space is provided at the end of this checklist for documenting the space is provided at the end of this checklist for documenting the space is provided at the end of this checklist for documenting the space is provided at the end of the space is provided a	the results of judgments and

Anchorage	
1. Is the anchorage configuration verification required (i.e., is the item one of the 50% of SWEL items requiring such verification)?  Line Mountal	Y NE

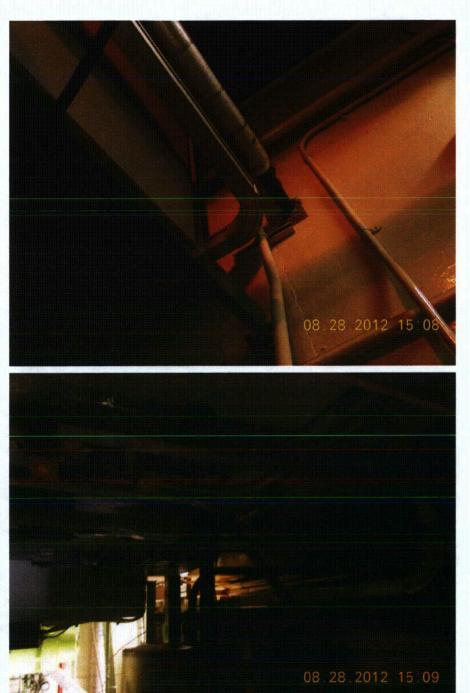
Seismic Walkdown Checklist (SWC)	
MM 3/2013	
Equipment ID No. P020223-3(2)  Equipment ID No. P020223-3(2)  Equipment ID No. P02023-3(2)  Equipment ID No. P020223-3(2)  Equipmen	•
Equipment ID No. — P020223-3(2) Equip. Class <sup>12</sup> (10) Air Handlers  POD-3-40 H-30223-03 MO 10/23/12	· · · · · · · · · · · · · · · · · · ·
Equipment Description HPSW Pump Room A Loop Supply Damper	
Location: Bldg. Pump Structure Floor El. 112 Room, Area P.	/H-9
Manufacturer, Model, Etc. (optional but recommended)	
Instructions for Completing Checklist	·
This checklist may be used to document the results of the Seismic Walkdown of SWEL. The space below each of the following questions may be used to record t findings. Additional space is provided at the end of this checklist for documenting.	he results of judgments and
<u>Anchorage</u>	1

3. Is the anchorage free of corrosion that is more than mild surface	YX NO UO N/AO
oxidation?	
4. Is the anchorage free of visible cracks in the concrete near the anchors?  Mounted to structurol steel, attached by w	YX N□ U□ N/A□

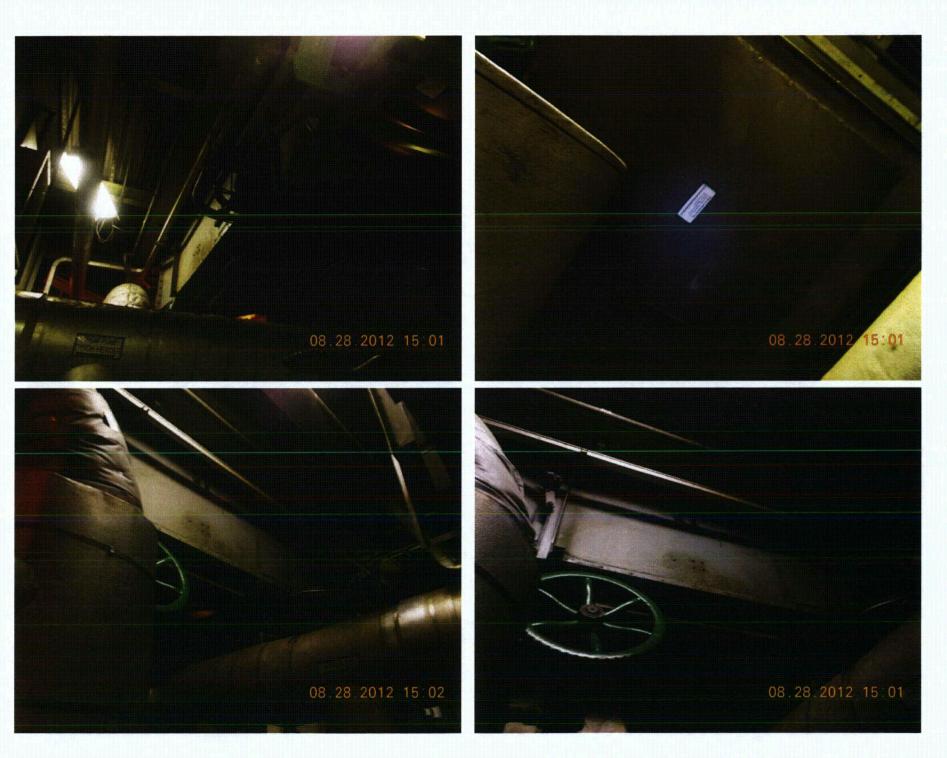
POD-3-40H-30223-04 Mb	
Equipment ID No. PO 3023-4 Equip. Class 12 (10) Air Handle	975
Equipment Description HASW Pump Room BLoop Exhoust D	
Location: Bldg Pump Structure Floor El. 112 Room, Area P/H-9	
Manufacturer, Model, Etc. (optional but recommended)	
Instructions for Completing Checklist	
This checklist may be used to document the results of the Seismic Walkdown of SWEL. The space below each of the following questions may be used to record t findings. Additional space is provided at the end of this checklist for documenting.	he results of judgments and
Anchorage

3. Is the anchorage free of corrosion that is more than mild surface oxidation?	YM NO UO N/AO
4. Is the anchorage free of visible cracks in the concrete near the anchors?  No positive connection between dumper and support for of tropeze style support, unit judged to move with sevent in a concern	yN N□ U□ N/A□ ome; bosed on flexibility upports in a seismic

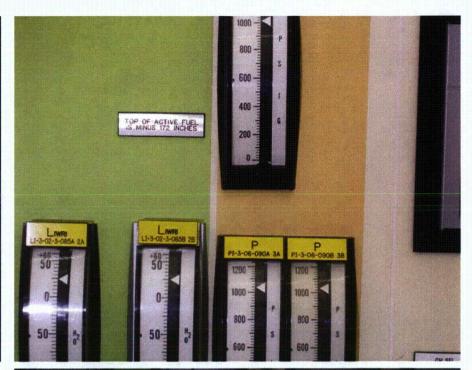
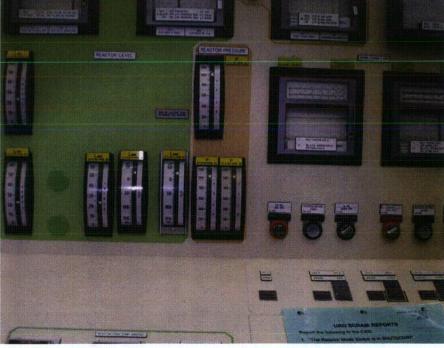
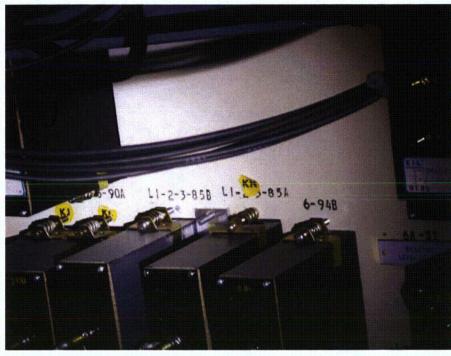
Equipment ID No. PI3-6-90A Equip. Class <sup>12</sup> (20) Control Panels	& Cabinets
Equipment Description Reactor Wide Range Pressure Indicator	
Location: Bldg. <u>Turbine</u> Floor El. <u>165</u> Room, Area <u>T</u>	3-100
Manufacturer, Model, Etc. (optional but recommended)	
Instructions for Completing Checklist	
This checklist may be used to document the results of the Seismic Walkdown of SWEL. The space below each of the following questions may be used to record findings. Additional space is provided at the end of this checklist for documenting the space is provided at the end of this checklist for documenting the space is provided at the end of this checklist for documenting the space is provided at the end of this checklist for documenting the space is provided at the end of this checklist for documenting the space is provided at the end of this checklist for documenting the space is provided at the end of this checklist for documenting the space is provided at the end of this checklist for documenting the space is provided at the end of this checklist for documenting the space is provided at the end of this checklist for documenting the space is provided at the end of this checklist for documenting the space is provided at the end of this checklist for documenting the space is provided at the end of this checklist for documenting the space is provided at the end of this checklist for documenting the space is provided at the end of this checklist for documenting the space is provided to the space	the results of judgments and

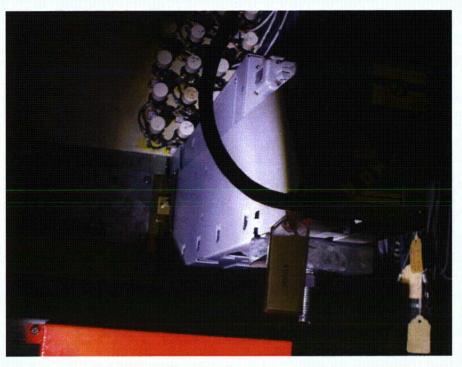
BME 10/19/12	•
PR/RR Equipment ID No. PR3-2-3-404B Equip. Class <sup>12</sup> (20) Control Panels of	& Cabinets
Equipment Description Reactor Pressure / Drywell Gas Recorder 10/31/12	
Location: Bldg. <u>Turbine</u> Floor El. <u>165</u> Room, Area <u>T</u>	3-100
Manufacturer, Model, Etc. (optional but recommended)	
Instructions for Completing Checklist	:
This checklist may be used to document the results of the Seismic Walkdown of SWEL. The space below each of the following questions may be used to record findings. Additional space is provided at the end of this checklist for documenting the space is provided at the end of this checklist for documenting the space is provided at the end of this checklist for documenting the space is provided at the end of this checklist for documenting the space is provided at the end of this checklist for documenting the space is provided at the end of this checklist for documenting the space is provided at the end of this checklist for documenting the space is provided at the end of this checklist for documenting the space is provided at the end of this checklist for documenting the space is provided at the end of this checklist for documenting the space is provided at the end of this checklist for documenting the space is provided at the end of this checklist for documenting the space is provided at the end of this checklist for documenting the space is provided at the end of this checklist for documenting the space is provided at the end of this checklist for documenting the space is provided at the end of this checklist for documenting the space is provided at the end of this checklist for the space is provided the space is provided the space is provided to the space is provided the space is provided to the spa	the results of judgments and

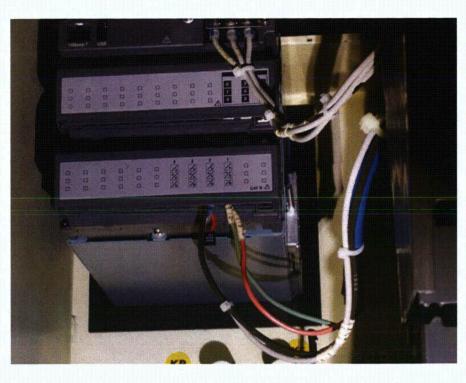
PR/TR-5805 BMF 10/19/12	
Equipment ID No PR-5805 Equip. Class <sup>12</sup> (20) Control Panels &	& Cabinets
Equipment Description Containment Pressure/ Temp. 16/31/12	
Location: Bldg. <u>Turbine</u> Floor El. <u>165</u> Room, Area <u>T</u>	3-100
Manufacturer, Model, Etc. (optional but recommended)	
Instructions for Completing Checklist  This checklist may be used to document the results of the Seismic Walkdown of SWEL. The space below each of the following questions may be used to record findings. Additional space is provided at the end of this checklist for documenting the space is provided at the end of this checklist for documenting the space is provided at the end of this checklist for documenting the space is provided at the end of this checklist for documenting the space is provided at the end of this checklist for documenting the space is provided at the end of this checklist for documenting the space is provided at the end of this checklist for documenting the space is provided at the end of this checklist for documenting the space is provided at the end of this checklist for documenting the space is provided at the end of this checklist for documenting the space is provided at the end of this checklist for documenting the space is provided at the end of this checklist for documenting the space is provided at the end of this checklist for documenting the space is provided at the end of this checklist for documenting the space is provided at the end of this checklist for documenting the space is provided at the end of this checklist for documenting the space is provided the space is pro	the results of judgments and

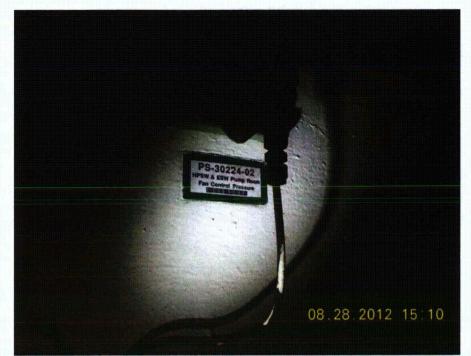
Equipment ID No. PS30224-2 Equip. Class <sup>12</sup> (18) Instruments on I	Racks / Not	on Racks
Equipment Description HPSW Pump Room B Loop Pressure Switch		
Location: Bldg. Pump Structure Floor El. 112 Room, Area P.	/H-9	
Manufacturer, Model, Etc. (optional but recommended)		
Instructions for Completing Checklist		
This checklist may be used to document the results of the Seismic Walkdown of SWEL. The space below each of the following questions may be used to record findings. Additional space is provided at the end of this checklist for documenting.	the results o	f judgments and
Anchorage

11. Have you looked for and found no other seismic conditions that could adversely affect the safety functions of the equipment?  Nearby scattleding securely built	YX NU UU	
Comments (Additional pages may be added as necessary)	***************************************	
N/A		
Evaluated by: York Wicken	Date: 9/17/2018	
76 gd	9/17/2012

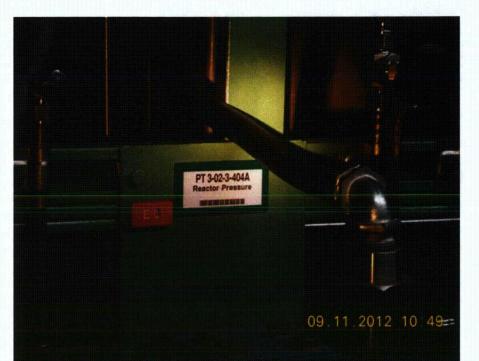
Equipment ID No. PT3-2-3-404A Equip. Class <sup>12</sup> (18) Instruments on	Racks / Not on Racks
Equipment Description Reactor Pressure Transmitter	
Location: Bldg. Reactor Floor El. 165 Room, Area R3-40	
Manufacturer, Model, Etc. (optional but recommended)	·
Instructions for Completing Checklist	
This checklist may be used to document the results of the Seismic Walkdown of SWEL. The space below each of the following questions may be used to record findings. Additional space is provided at the end of this checklist for documenting the space is provided at the end of this checklist for documenting the space is provided at the end of this checklist for documenting the space is provided at the end of this checklist for documenting the space is provided at the end of this checklist for documenting the space is provided at the end of this checklist for documenting the space is provided at the end of this checklist for documenting the space is provided at the end of this checklist for documenting the space is provided at the end of this checklist for documenting the space is provided at the end of this checklist for documenting the space is provided at the end of this checklist for documenting the space is provided at the end of this checklist for documenting the space is provided at the end of this checklist for documenting the space is provided at the end of this checklist for documenting the space is provided at the end of this checklist for documenting the space is provided at the end of this checklist for documenting the space is provided the space is provided the space is provided the space is provided to the space is	the results of judgments and

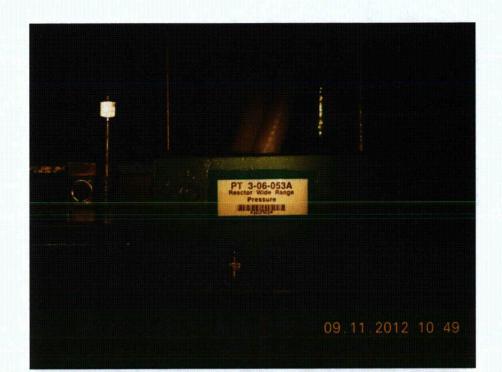
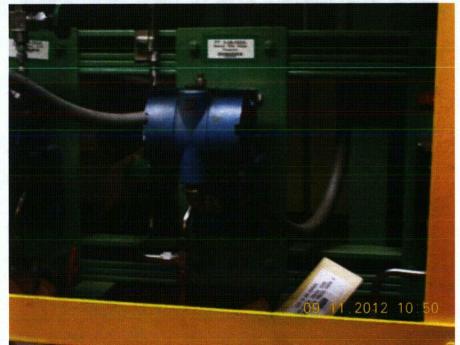
Equipment ID No. <u>PT3-6-53A</u> Equip. Class <sup>12</sup> (18) Instruments on 1	Racks / Not on Racks
Equipment Description Reactor Wide Range Pressure Transmitter	
Location: Bldg. Reactor Floor El. 165 Room, Area R3-40	
Manufacturer, Model, Etc. (optional but recommended)	
Instructions for Completing Checklist	<u></u>
This checklist may be used to document the results of the Seismic Walkdown of SWEL. The space below each of the following questions may be used to record findings. Additional space is provided at the end of this checklist for documenting.	the results of judgments and
Anchorage

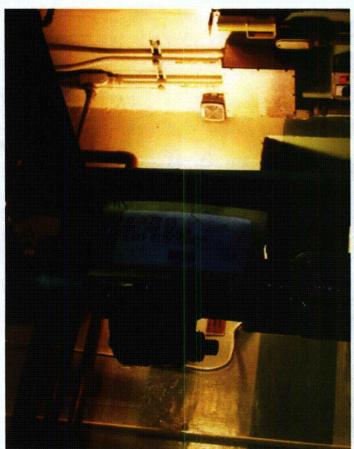
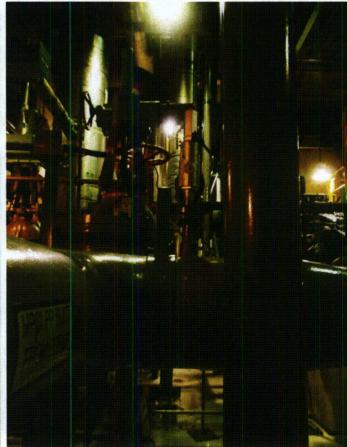
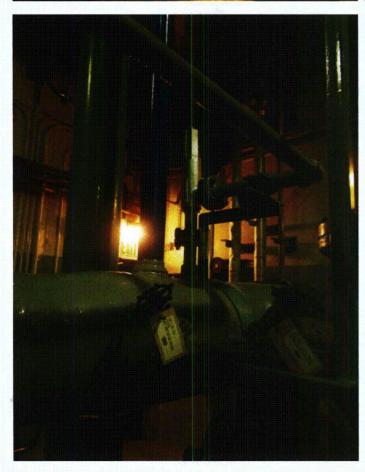
Equipment ID No. RV3-23-034 Equip. Class <sup>12</sup> (07) Fluid (Air/Hyd)	Valves
Equipment Description HPCI Pump Suction Header Relief Valve	
Location: Bldg. Reactor Floor El. 88 Room, Area R3-13	
Manufacturer, Model, Etc. (optional but recommended)	
Instructions for Completing Checklist	:/
This checklist may be used to document the results of the Seismic Walkdown of SWEL. The space below each of the following questions may be used to record t findings. Additional space is provided at the end of this checklist for documenting.	he results of judgments and
Anchorage	.:

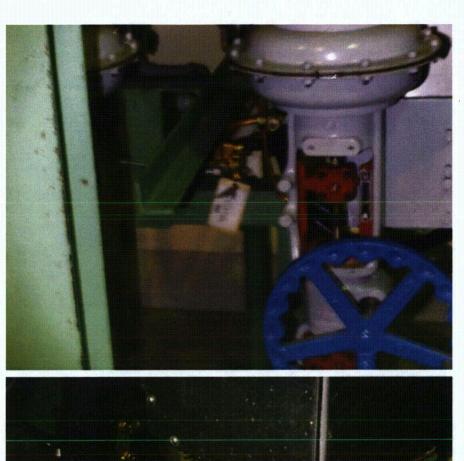
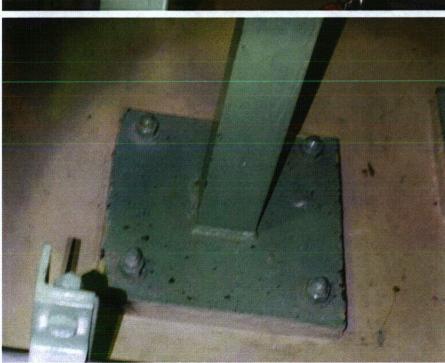
8. Are overhead equipment, distribution systems, ceiling tiles and lighting, and masonry block walls not likely to collapse onto the equipment?  No II/I concerns identified	YEZ-NO UO N/AO

9. Do attached lines have adequate flexibility to avoid damage?	YZNO UO N/AO	
10. Based on the above seismic interaction evaluations, is equipment free of potentially adverse seismic interaction effects?	YIND UD	
Other Adverse Conditions  11. Have you looked for and found no other seismic conditions that could adversely affect the safety functions of the equipment?	YEND UD	
Comments (Additional pages may be added as necessary)		
Evaluated by: Jan Jay	Date: 9/25/12 9/25/12

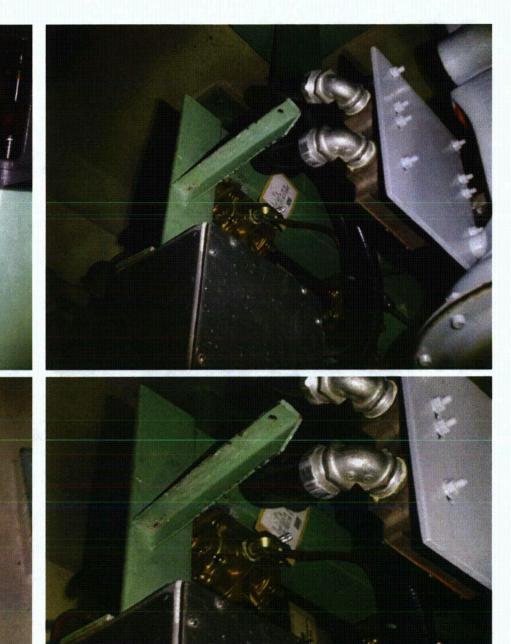
Equipment ID No. SV3-3-35B Equip. Class <sup>12</sup> (08b) Solenoid Opera	ated Valving
•••	
Equipment Description Instrument Air Solenoid Valve	M
Location: Bldg. Reactor Floor El. 135 Room, Area R3-23-	3-22
Manufacturer, Model, Etc. (optional but recommended)	
Instructions for Completing Checklist  This checklist may be used to document the results of the Seismic Walkdown of SWEL. The space below each of the following questions may be used to record the findings. Additional space is provided at the end of this checklist for documenting the space is provided at the end of this checklist for documenting the space is provided at the end of this checklist for documenting the space is provided at the end of this checklist for documenting the space is provided at the end of this checklist for documenting the space is provided at the end of this checklist for documenting the space is provided at the end of this checklist for documenting the space is provided at the end of this checklist for documenting the space is provided at the end of this checklist for documenting the space is provided at the end of this checklist for documenting the space is provided at the end of this checklist for documenting the space is provided at the end of this checklist for documenting the space is provided at the end of this checklist for documenting the space is provided at the end of this checklist for documenting the space is provided at the end of this checklist for documenting the space is provided at the end of this checklist for documenting the space is provided at the end of this checklist for documenting the space is provided the space i	he results of judgments and

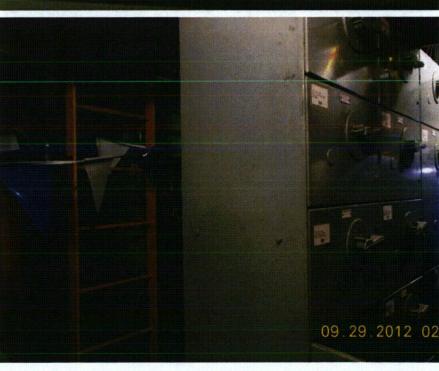
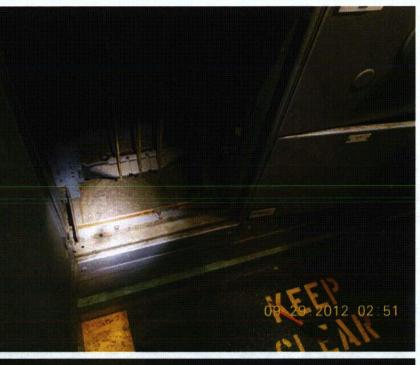
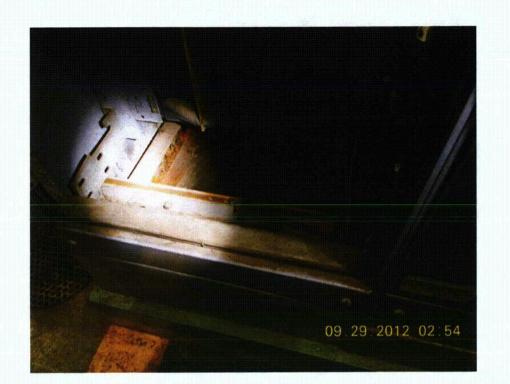
1. Is the anchorage configuration verification required (i.e., is the item one of the 50% of SWEL items requiring such verification)?	Y NX
2. Is the anchorage free of bent, broken, missing or loose hardware?  Anchorage - Good condition	YZ NO UO N/AO

3. Is the anchorage free of corrosion that is more than mild surface oxidation? Mild corrosion deemed acceptable	YZ NO UO N/AO
4. Is the anchorage free of visible cracks in the concrete near the anchors?	YZ NO UO N/AO

9. Do attached lines have adequate flexibility to avoid damage?	YEND UD N/AD
10. Based on the above seismic interaction evaluations, is equipment free of potentially adverse seismic interaction effects? Scaffolding a cutage related language secure	temporary
Other Adverse Conditions  11. Have you looked for and found no other seismic conditions that could adversely affect the safety functions of the equipment?	YZ NO UO
Comments (Additional pages may be added as necessary)	
Evaluated by: M. oghbaci	Date: 10/4/12
Jun Column	10/8/12

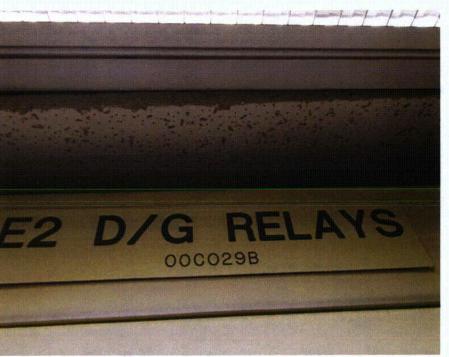
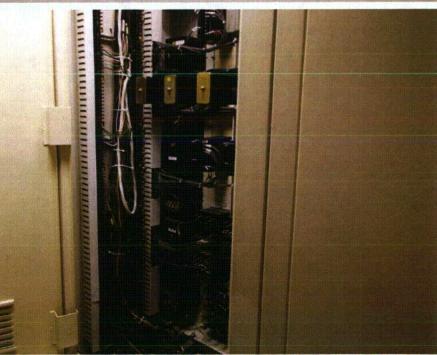
Equipment ID No. 00C29B Equip. Class 12 (20) Control Panels & Cabinets  Equipment Description Emergency Protection Relay Board  Location: Bldg. Turbine Floor El. 165 Room, Area T2-100  Manufacturer, Model, Etc. (optional but recommended)  Instructions for Completing Checklist			
			This checklist may be used to document the results of the Seismic Walkdown of an item of equipment on the SWEL. The space below each of the following questions may be used to record the results of judgments and findings. Additional space is provided at the end of this checklist for documenting other comments.
			<u>Anchorage</u>

- No housekeeping (SSNES observed).		
	·	
Evaluated by: Ben Frz	Date: 9/25/12	
N. Oghbaci	9/25/12

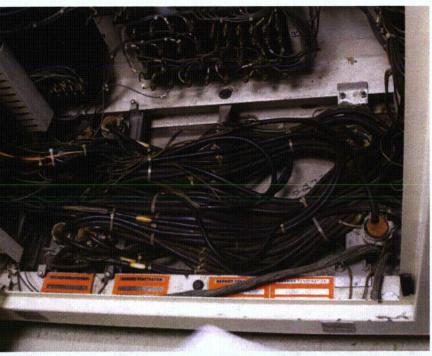
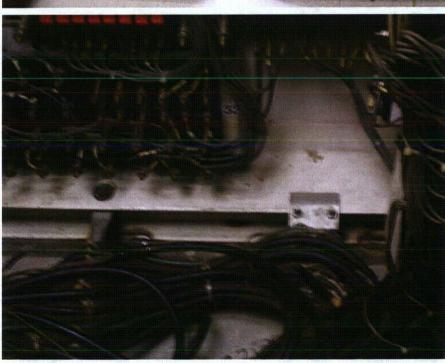
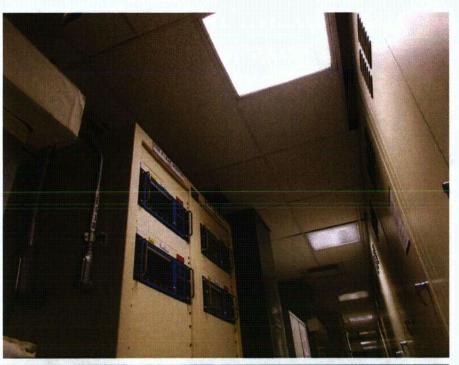
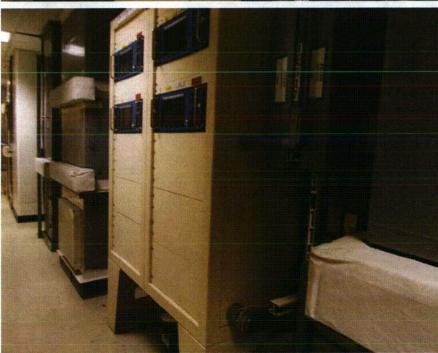
3. Is the anchorage free of corrosion that is more than mild surface  y N□ U□ N/A□  oxidation?			
4. Is the anchorage free of visible cracks in the concrete near the anchors? YN NO UN N/AD  embedded channel in concrete. No cracks around embedded channel.

- Cabiret bolted to adjacent cabinets.  - Anchorage confirmed per 13805 S-1197 Sheet 10 3, Rev 0, and Sheet 20 3, Rev 6  6. Based on the above anchorage evaluations, is the anchorage free of YN NU U  potentially adverse seismic conditions?

7. Are soft targets free from impact by nearby equipment or structures?  No 5'oft targets outside of panel	YO NO UO N/AO	
8. Are overhead equipment, distribution systems, ceiling tiles and lighting, and masonry block walls not likely to collapse onto the equipment?  2' × 2' ce, Ing files. Damage not eved, ble from	YM NO UO N/AO	
	falling tiles

9. Do attached lines have adequate flexibility to avoid damage?  No a Hacked lines	Y⊠ N□ U□ N/A□	
10. Based on the above seismic interaction evaluations, is equipment free of potentially adverse seismic interaction effects?	YM NU UU	
Other Adverse Conditions	$\mathcal{L}_{ij} = \mathcal{L}_{ij} = \mathcal{L}_{ij}^{ij} \mathcal{L}_{ij} = \mathcal{L}_{ij}^{ij}$
