Seismic Walkdown Checklist (SWC)

Equipment ID No. I-1605-95-SPB Equip. Class¹² ZO

Equipment Description SOLID STATE PROT SYS CAR-TEN B

Location: Bldg. CONTROL Floor El. 220 Room, Area 165

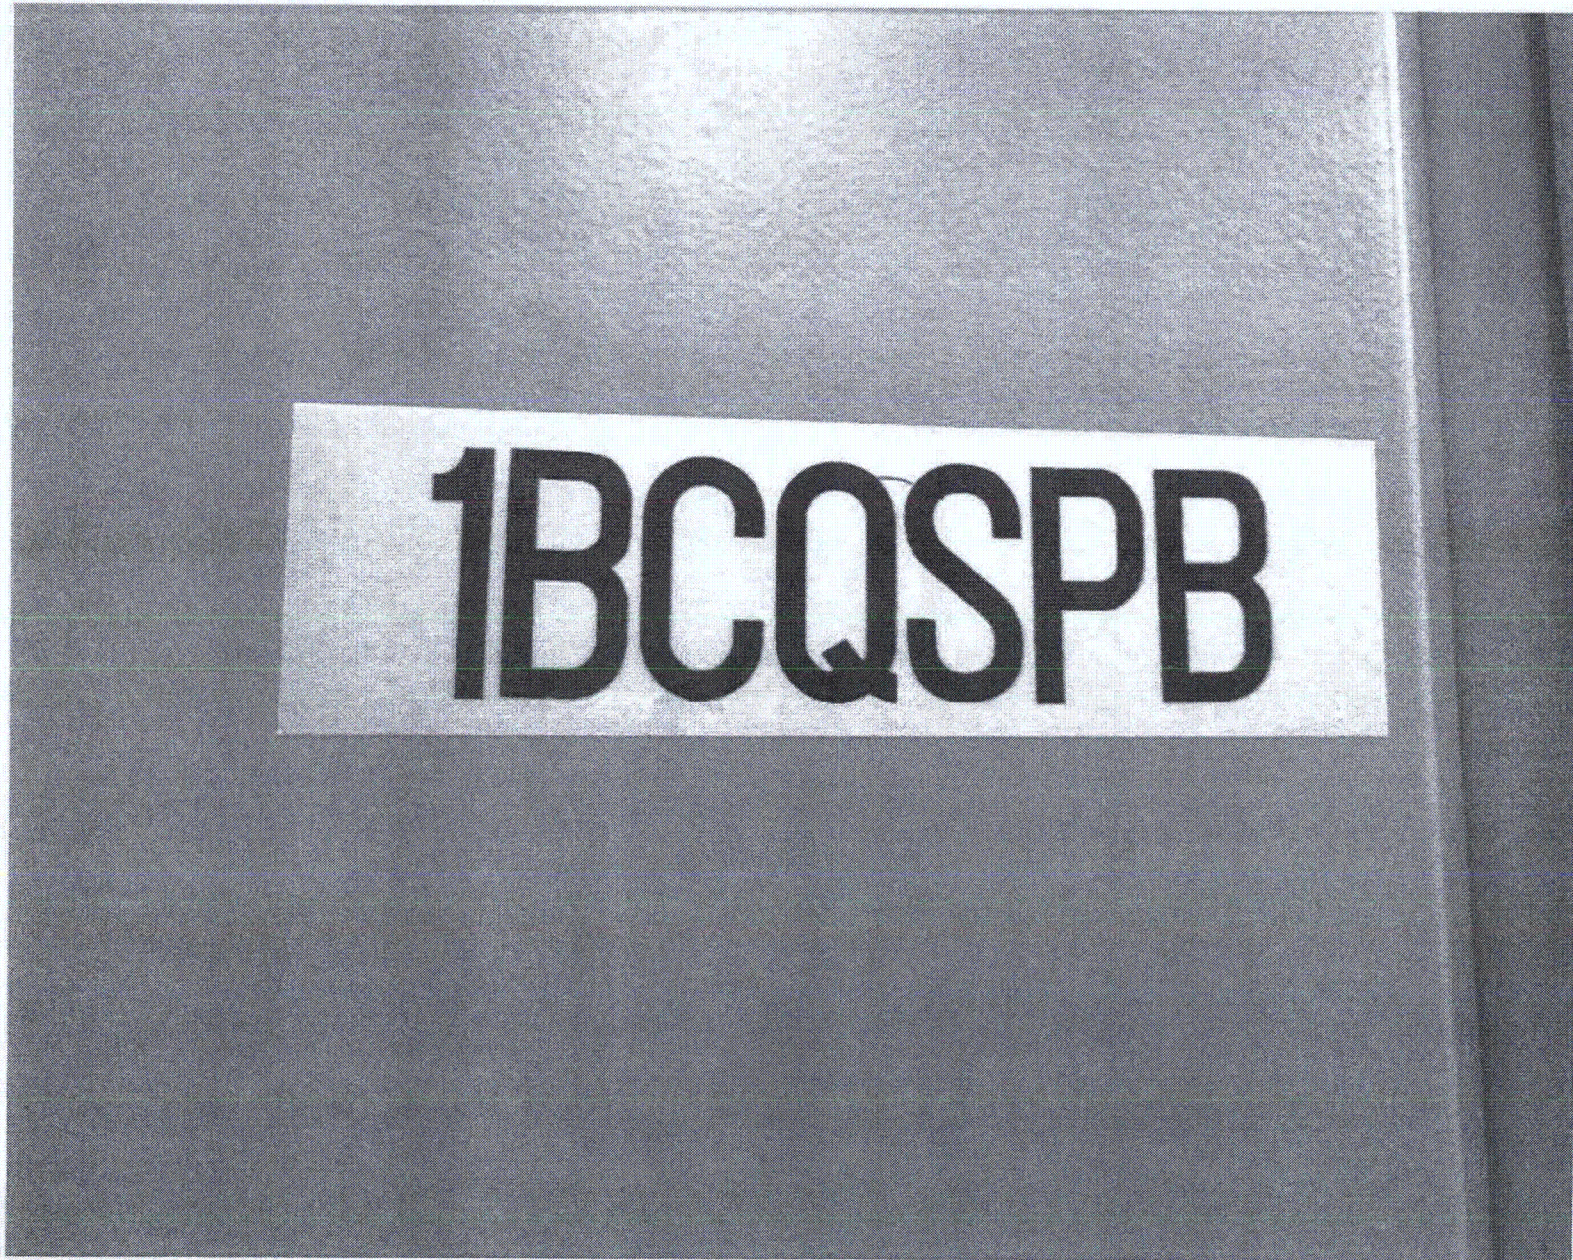
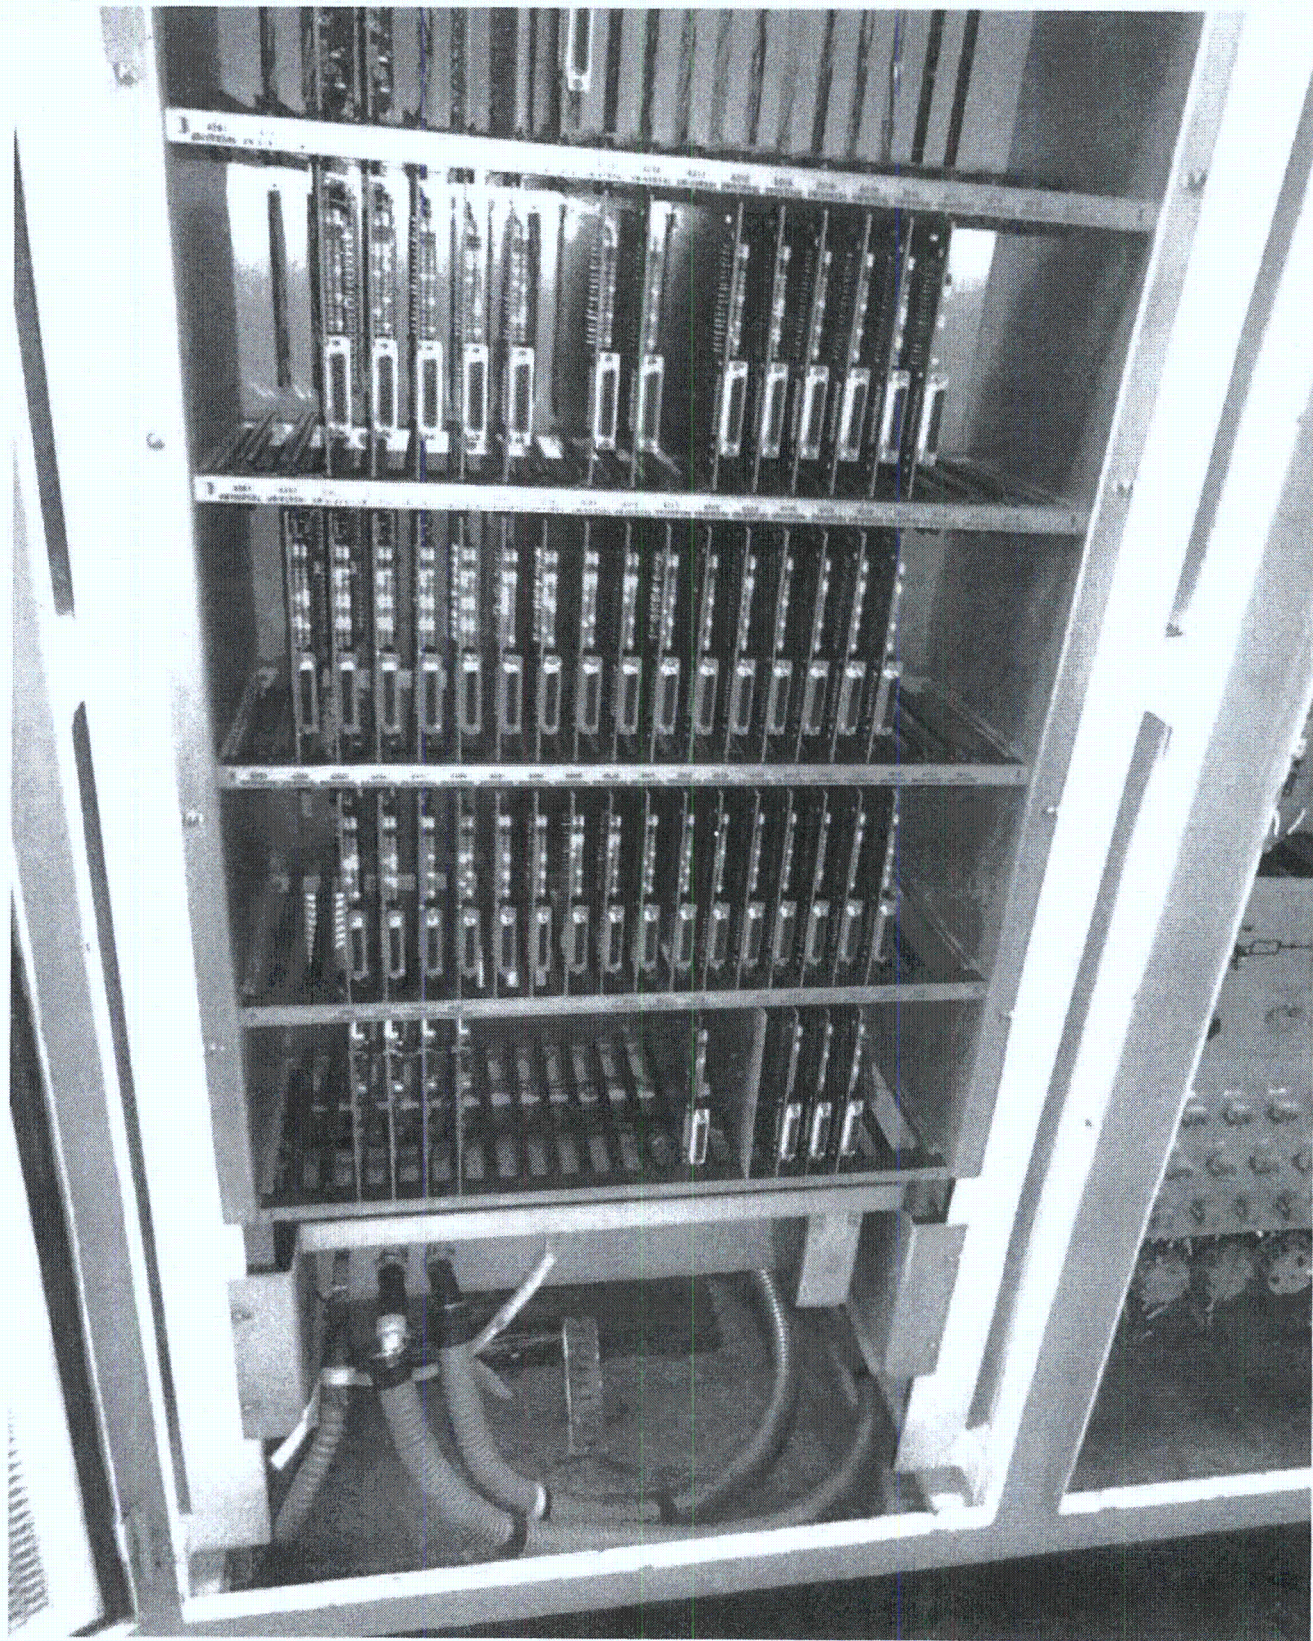
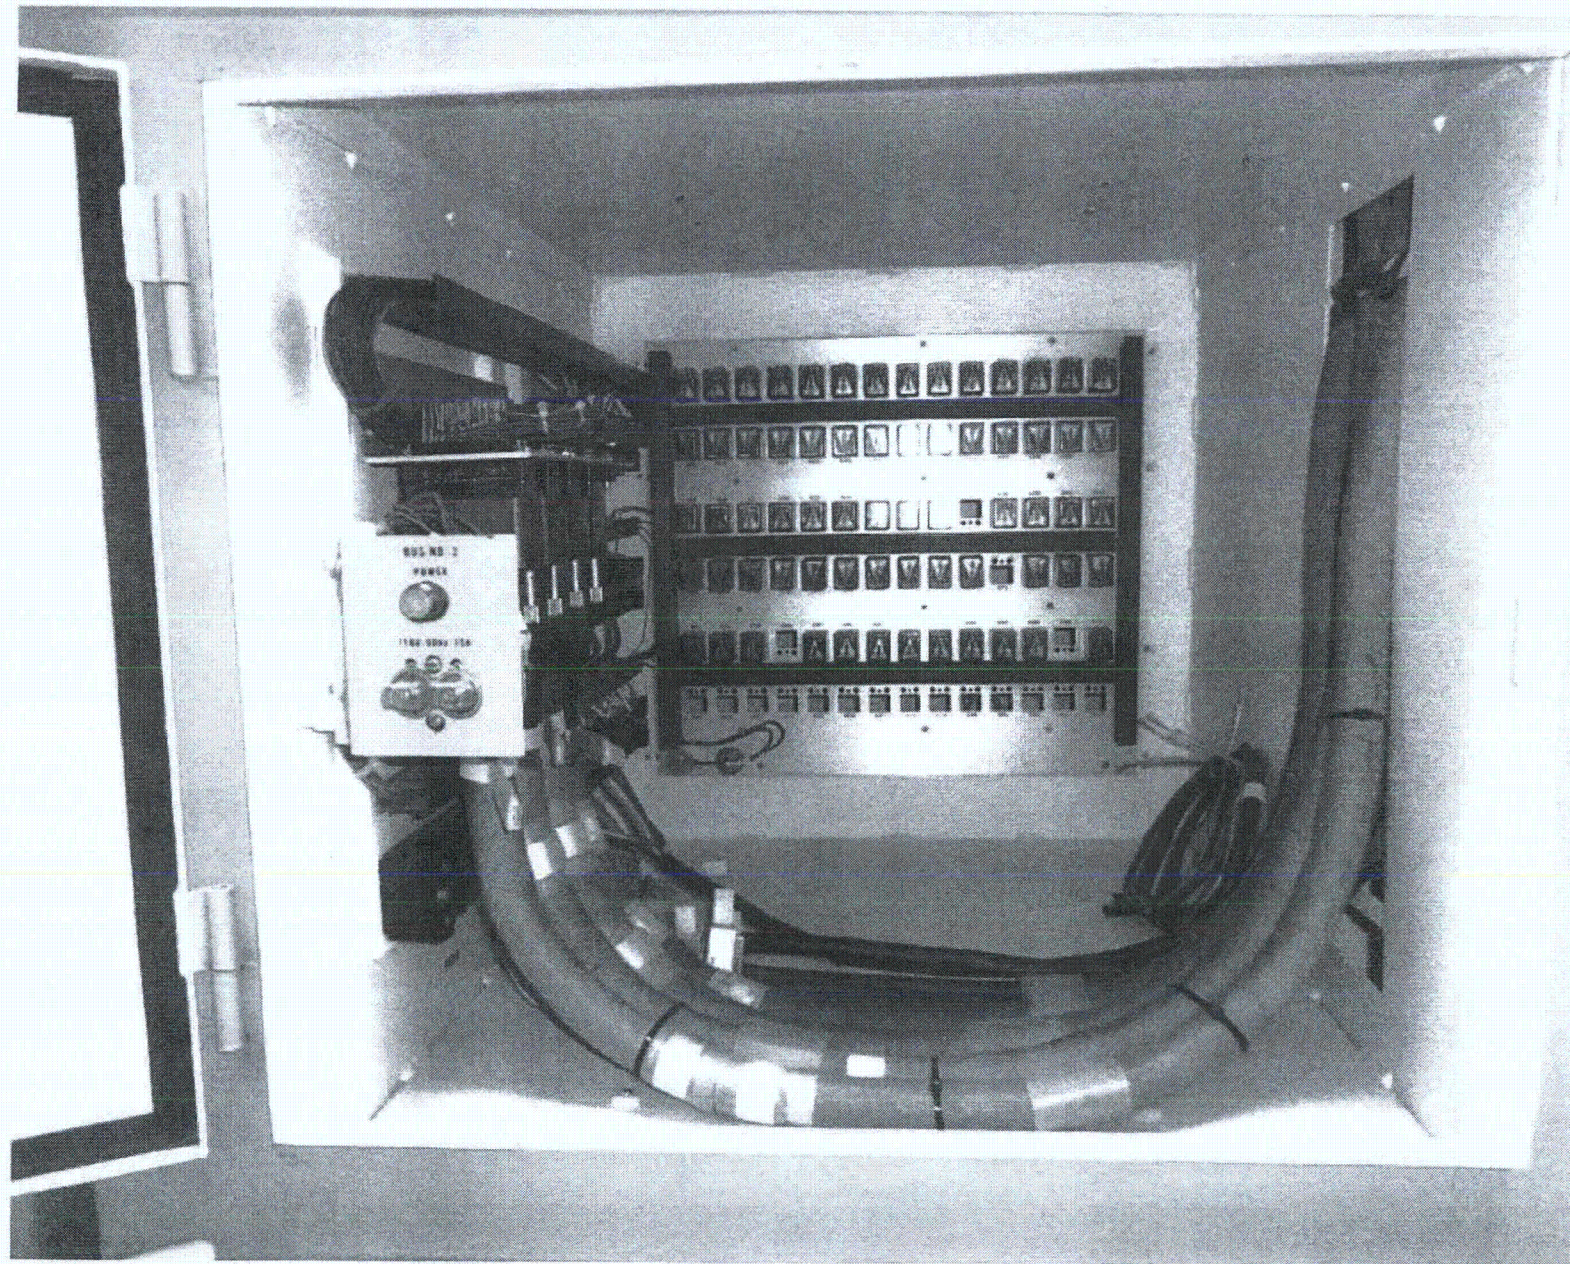
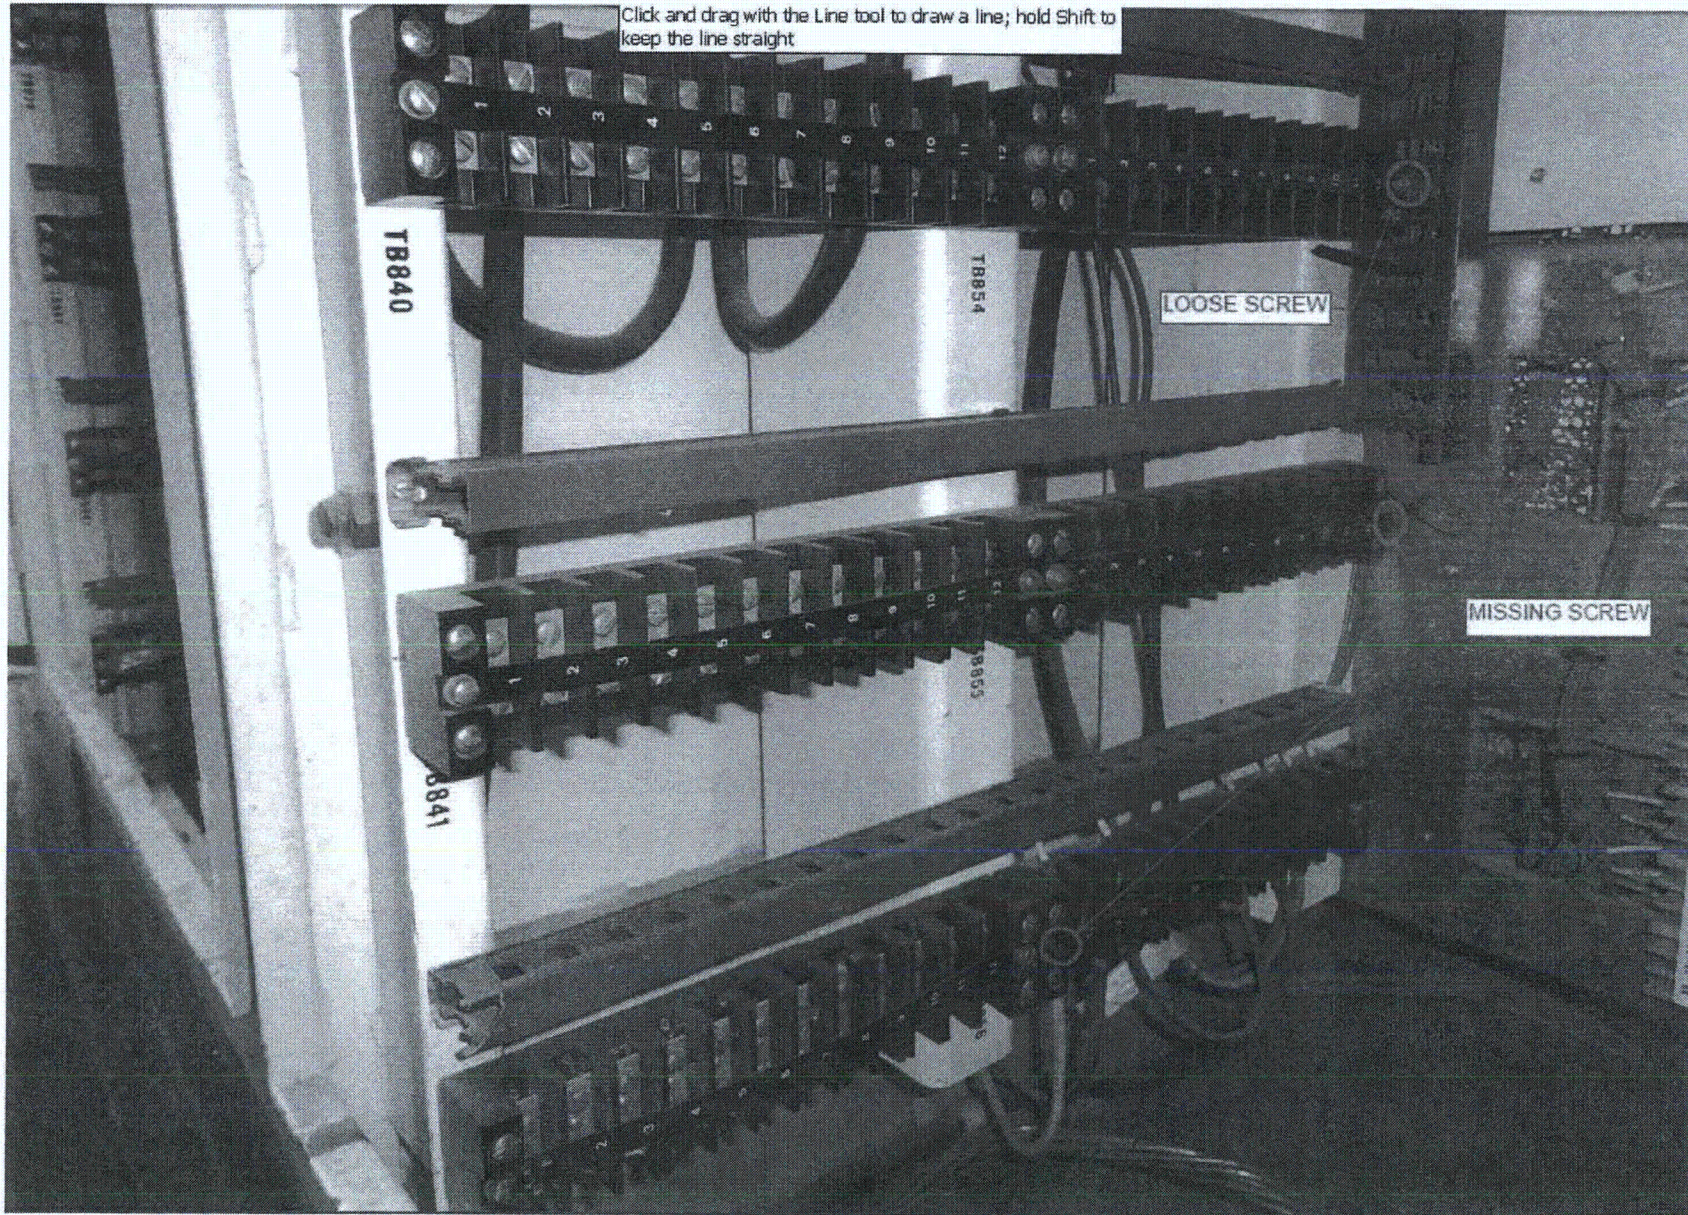
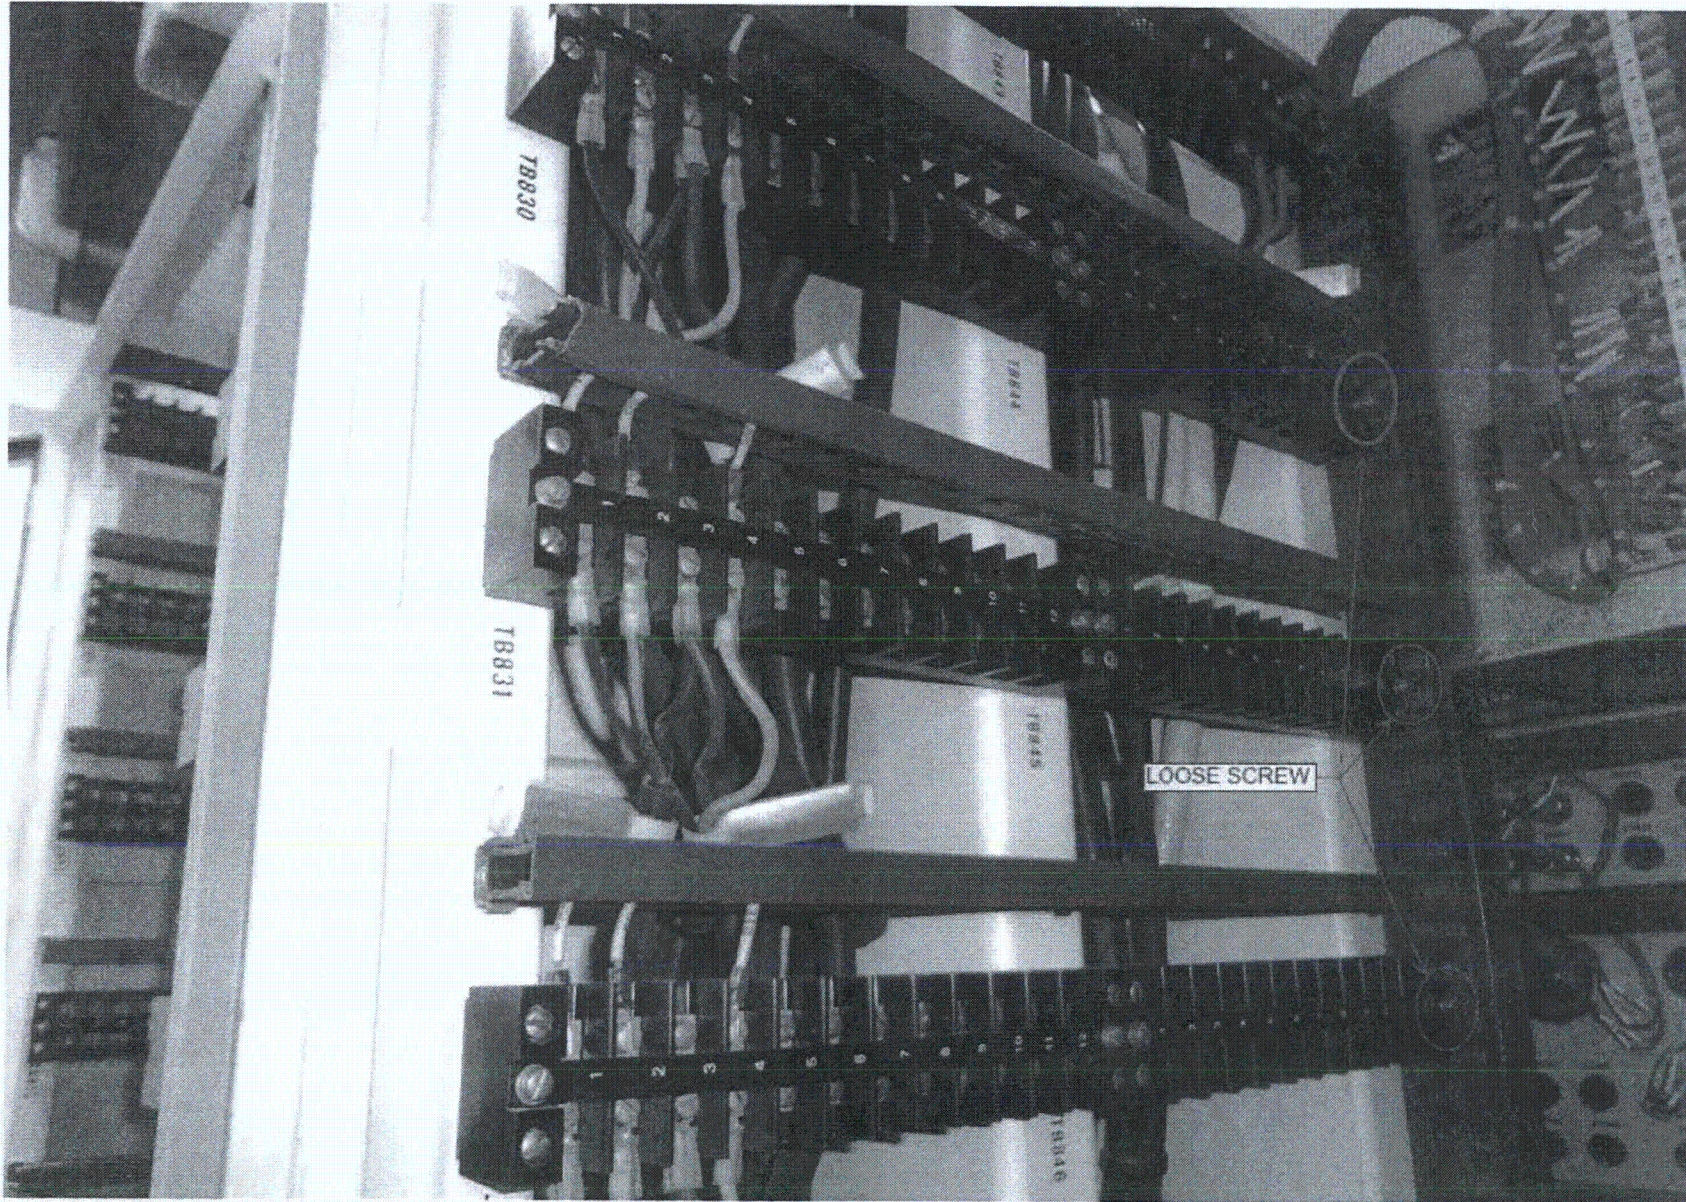
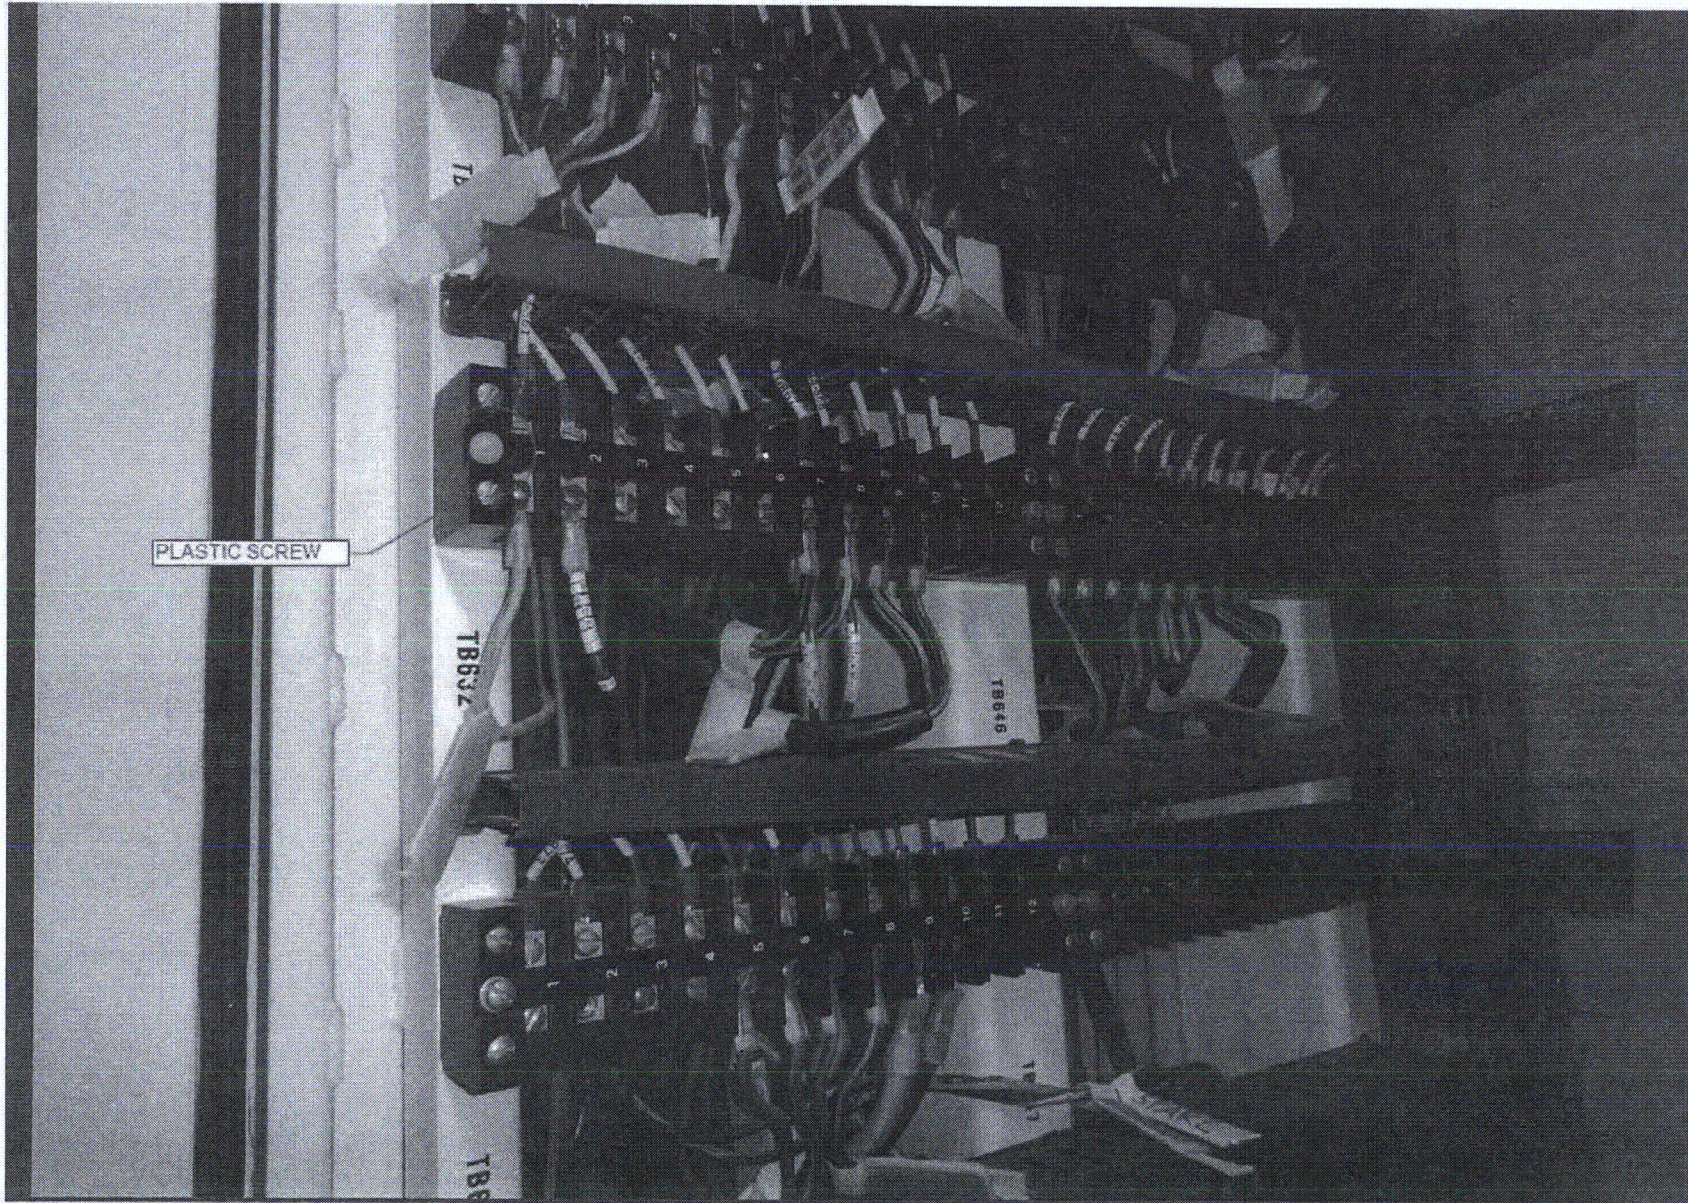
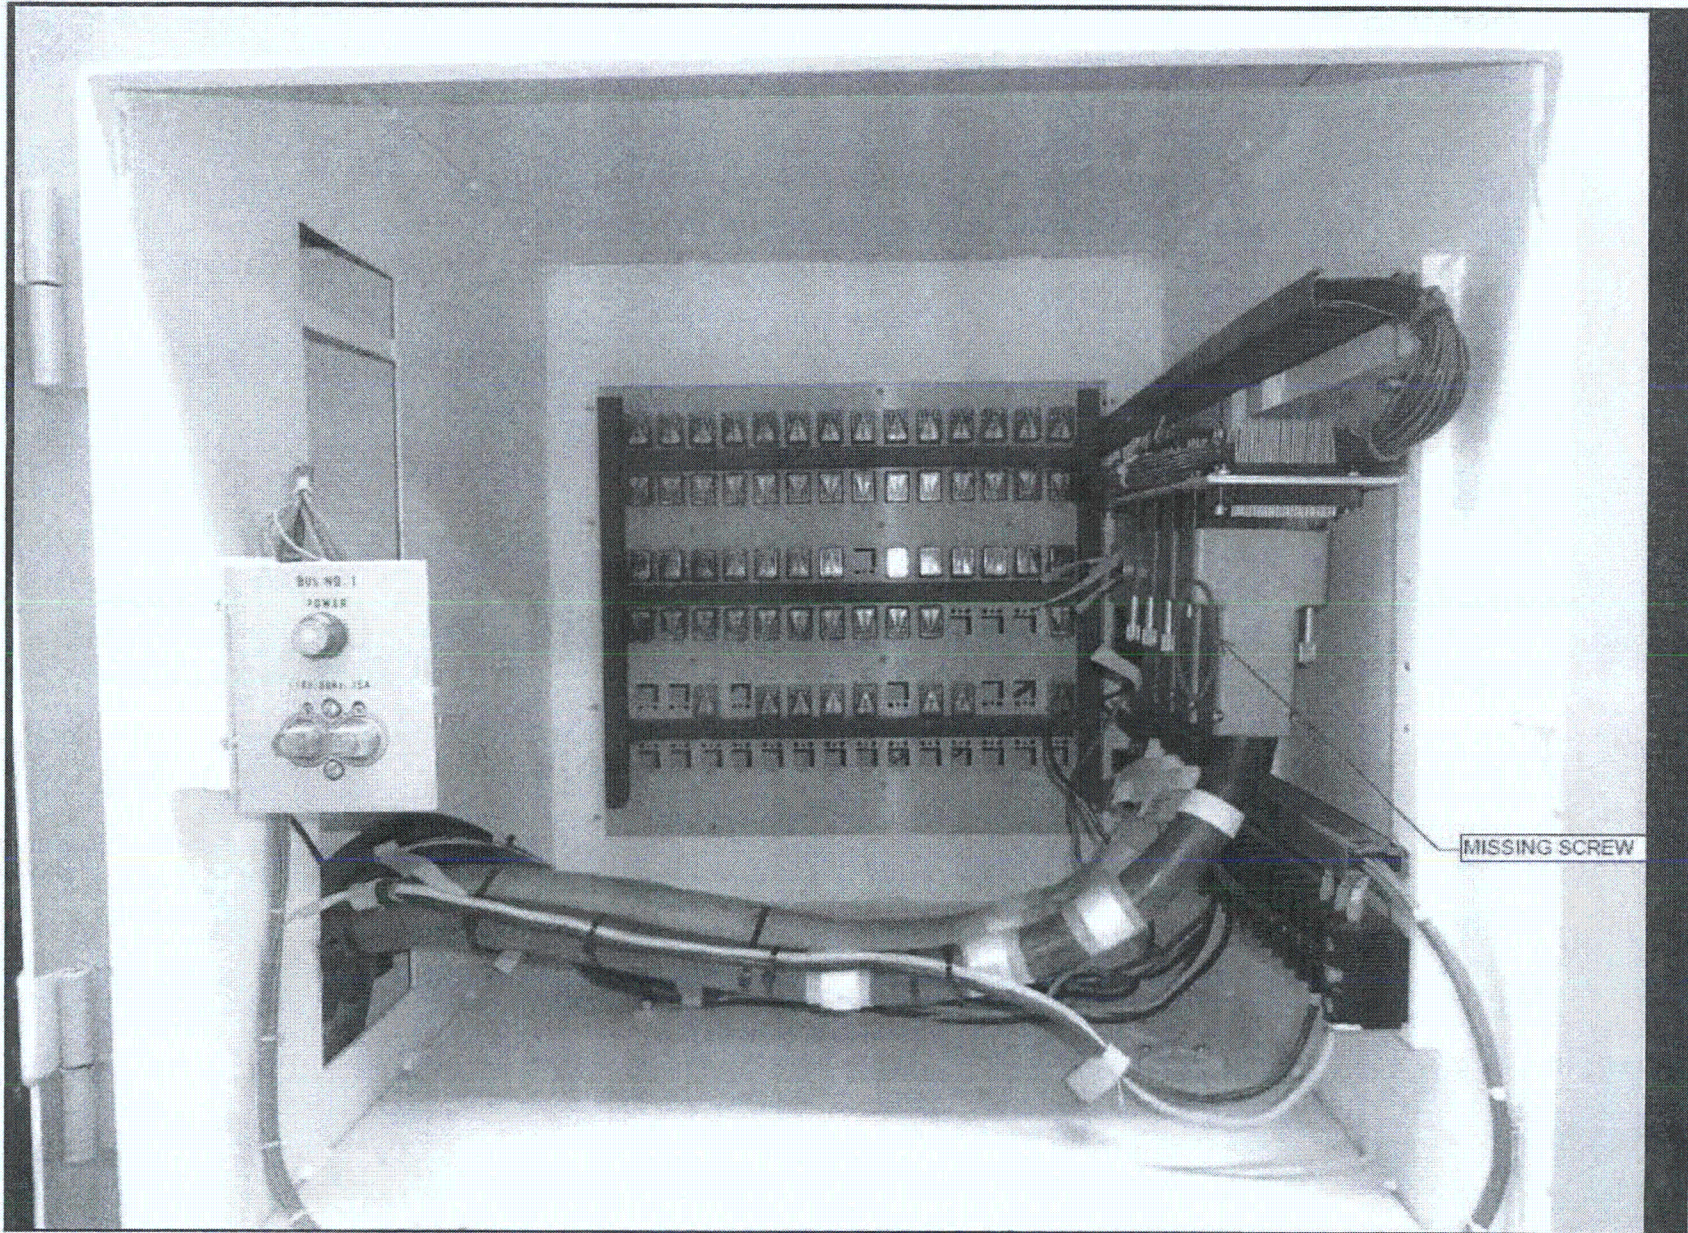
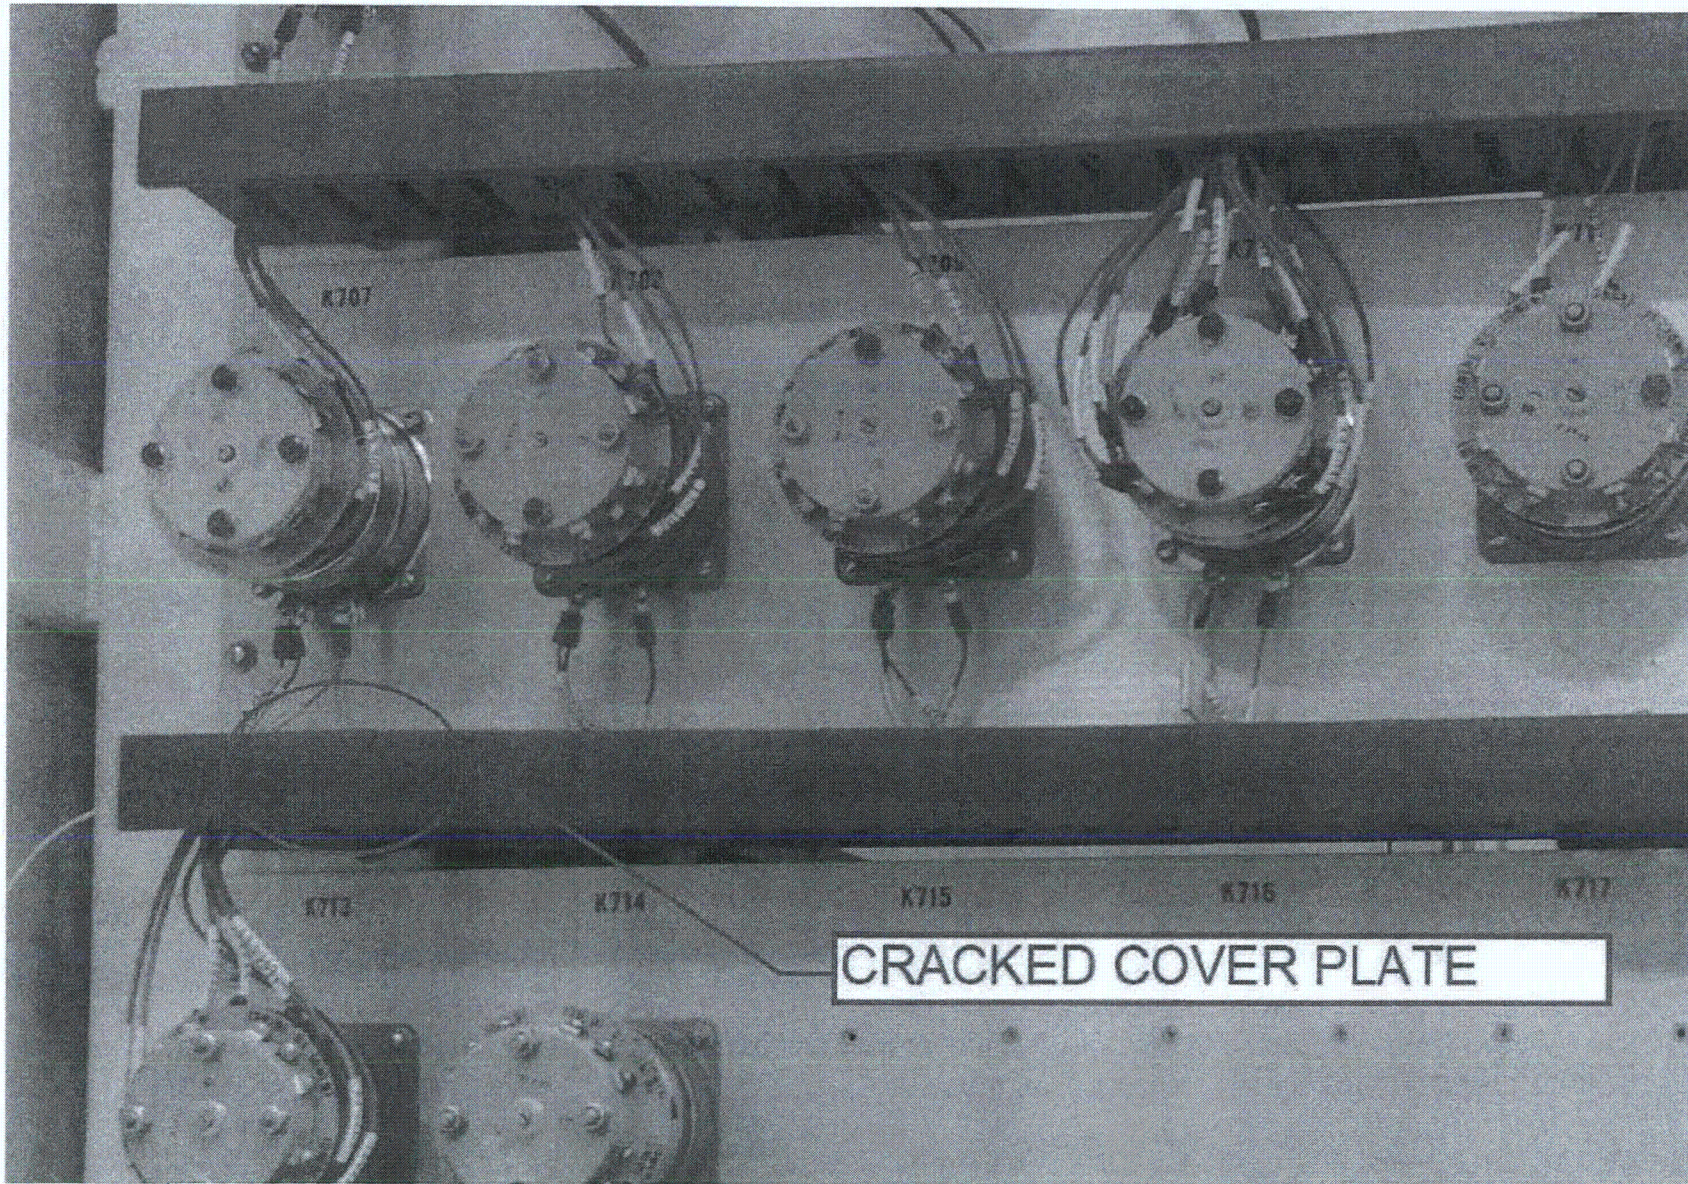
A VISUAL INSPECTION OF THE INTERNAL COMPONENTS OF THIS CABINET WAS PERFORMED TO CHECK FOR SEISMIC ADEQUACY TO INCLUDE ANY EVIDENCE OF INTERNAL COMPONENTS NOT ADEQUATELY SECURED, CHECKED TO ENSURE FASTENERS CONNECTING ADJACENT CABINETS WERE IN PLACE, AND EVIDENCE OF OTHER SEISMIC CONDITIONS. NO SIGNIFICANT ADVERSE CONDITIONS WERE FOUND. SOME MINOR ISSUES ARE DOCUMENTED IN THE "COMMENTS" SECTION BELOW.

FOUND MISSING 1/2 LOOSE SCREWS USED TO SECURE PROTECTIVE COVERS, TERMINAL BLOCKS, 1/2 ALSO A CRACKED CABLE TRAY INSIDE THE CABINET. THE SEISMIC WALKDOWN TEAM JUDGED THAT THIS CONDITION DOES NOT REPRESENT A SEISMIC OR OPERABILITY CONCERN. THESE CONDITIONS WERE REPORTED UNDER CR 527627

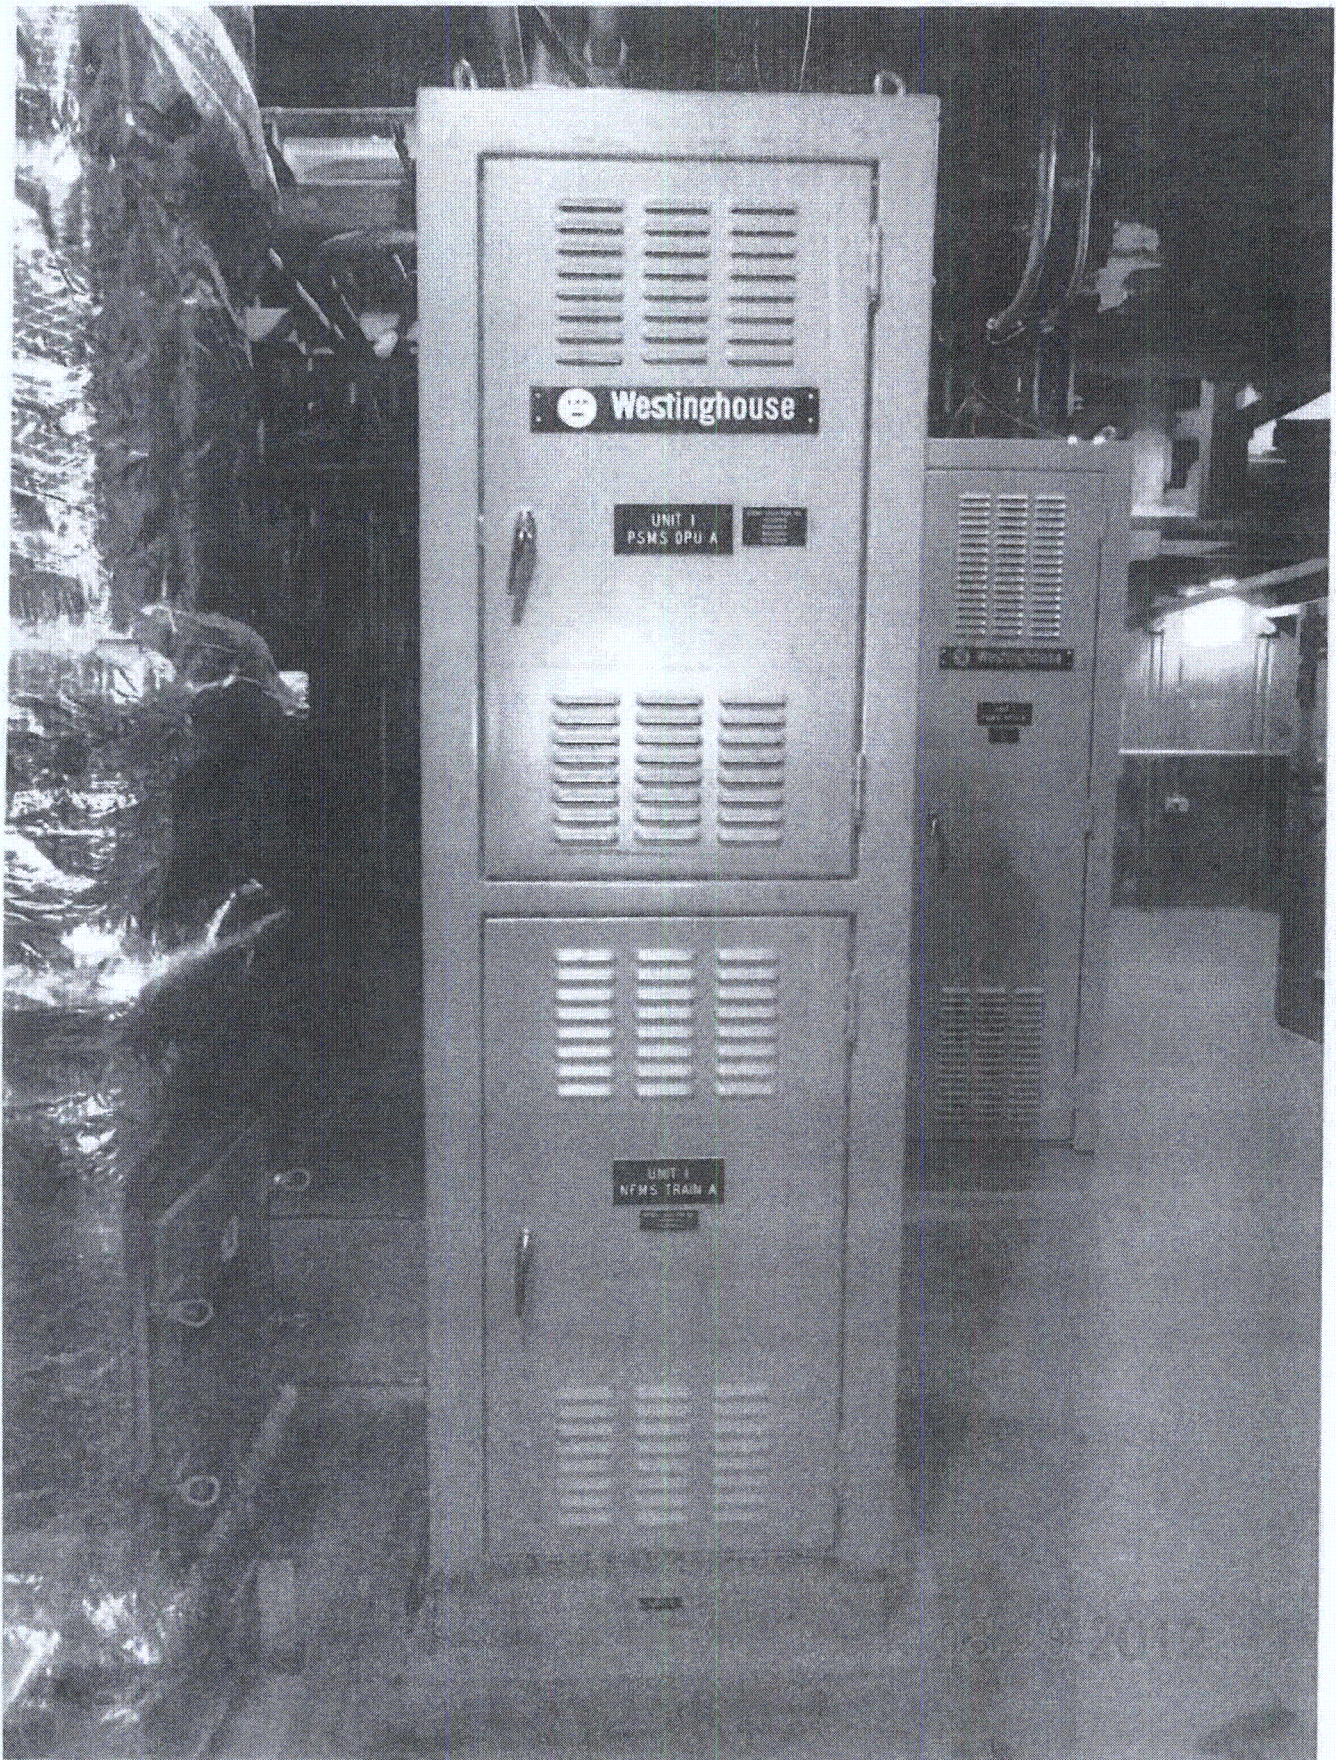
A VISUAL INSPECTION OF THE INTERNAL COMPONENTS OF THE CABINET WAS PERFORMED TO CHECK FOR SEISMIC ADEQUACY TO INCLUDE ANY EVIDENCE OF INTERNAL COMPONENTS NOT ADEQUATELY SECURED, CHECKED TO ENSURE FASTENERS CONNECTING ADJACENT CABINETS WERE IN PLACE, AND EVIDENCE OF OTHER SEISMIC CONDITIONS.

NO SIGNIFICANT ADVERSE CONDITIONS WERE FOUND. SOME MINOR ISSUES ARE DOCUMENTED IN THE "COMMENTS" SECTION BELOW

FOUND SOME SCREWS MISSING USED TO SECURE PROTECTIVE COVERS INSIDE THE CABINET. THE SEISMIC WALKDOWN TEAM JUDGED THAT THIS CONDITION DOES NOT REPRESENT A SEISMIC OR OPERABILITY CONCERN. THIS CONDITION HAS BEEN REPORTED THROUGH CR 527695
