Seismic Walkdown Checklist (SWC)

Equipment ID No. I-1605-95-SPB Equip. Class¹² ZO

Equipment Description SOLID STATE PROT SYS CAR-TEN B

Location: Bldg. CONTROL Floor El. 220 Room, Area 165

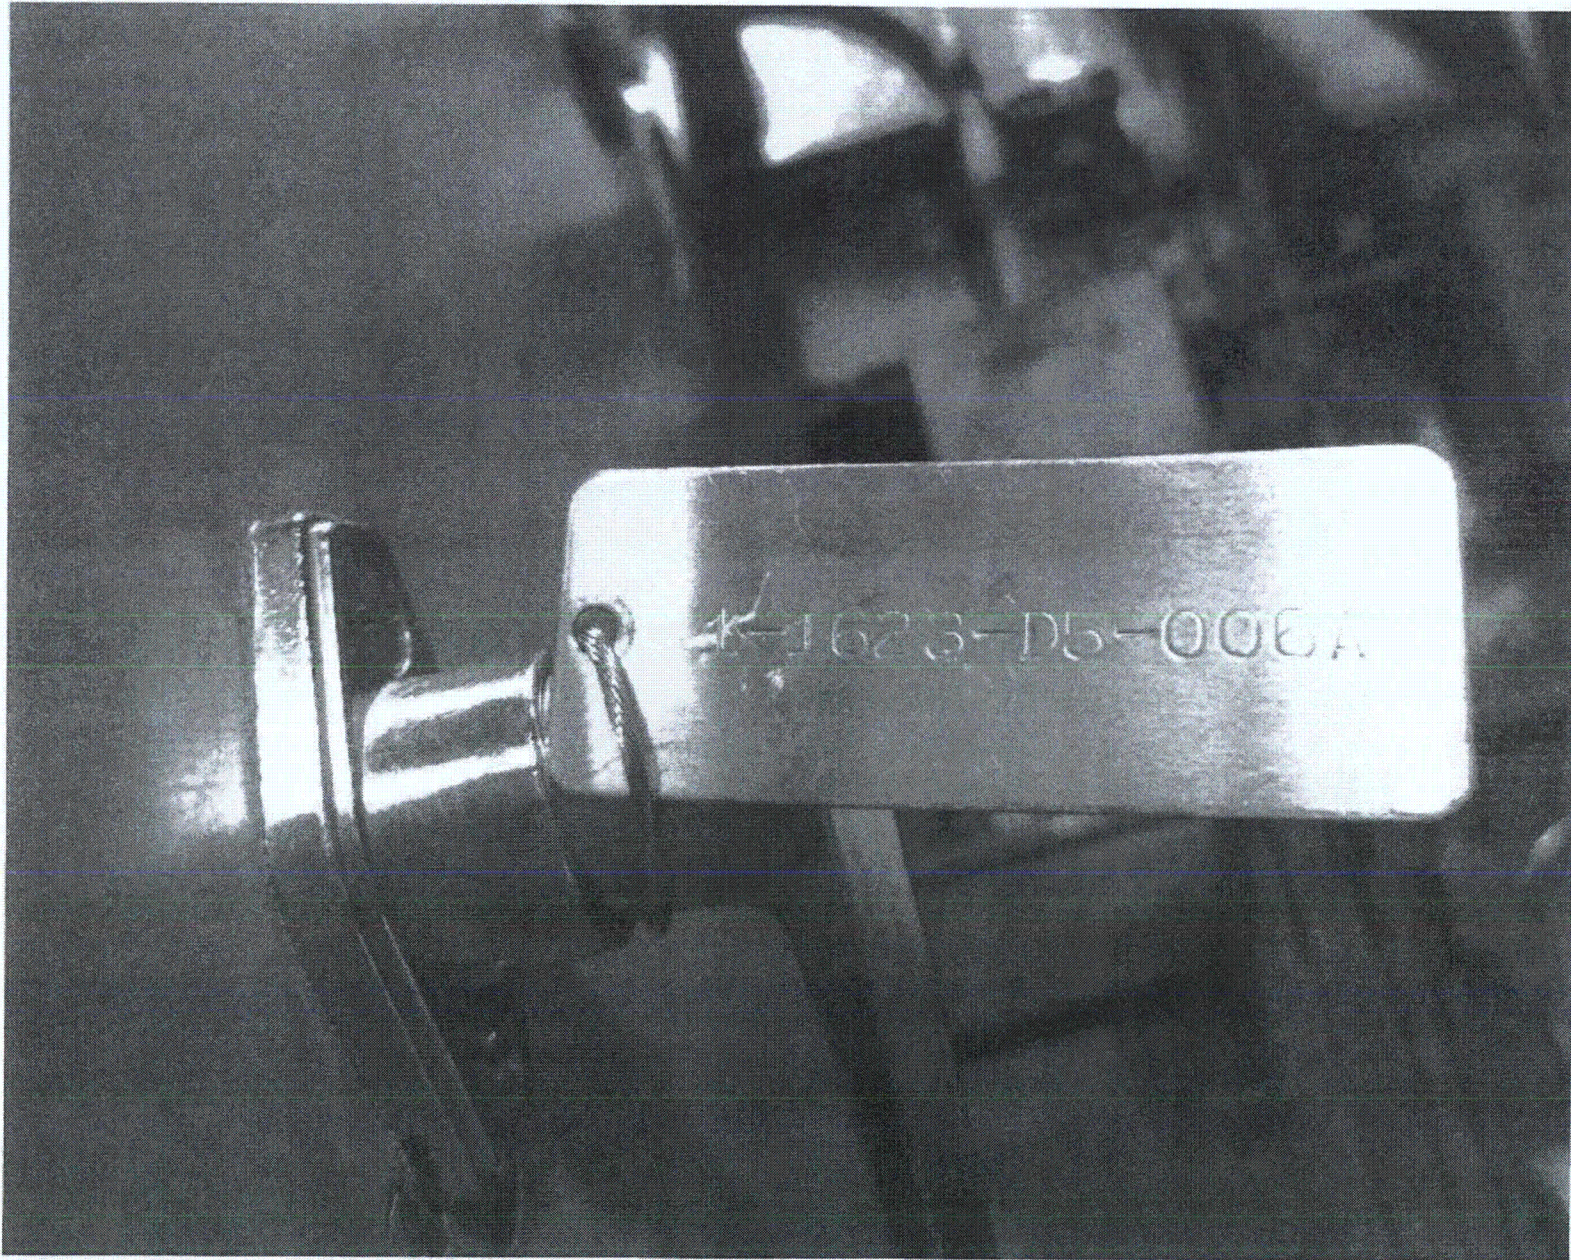
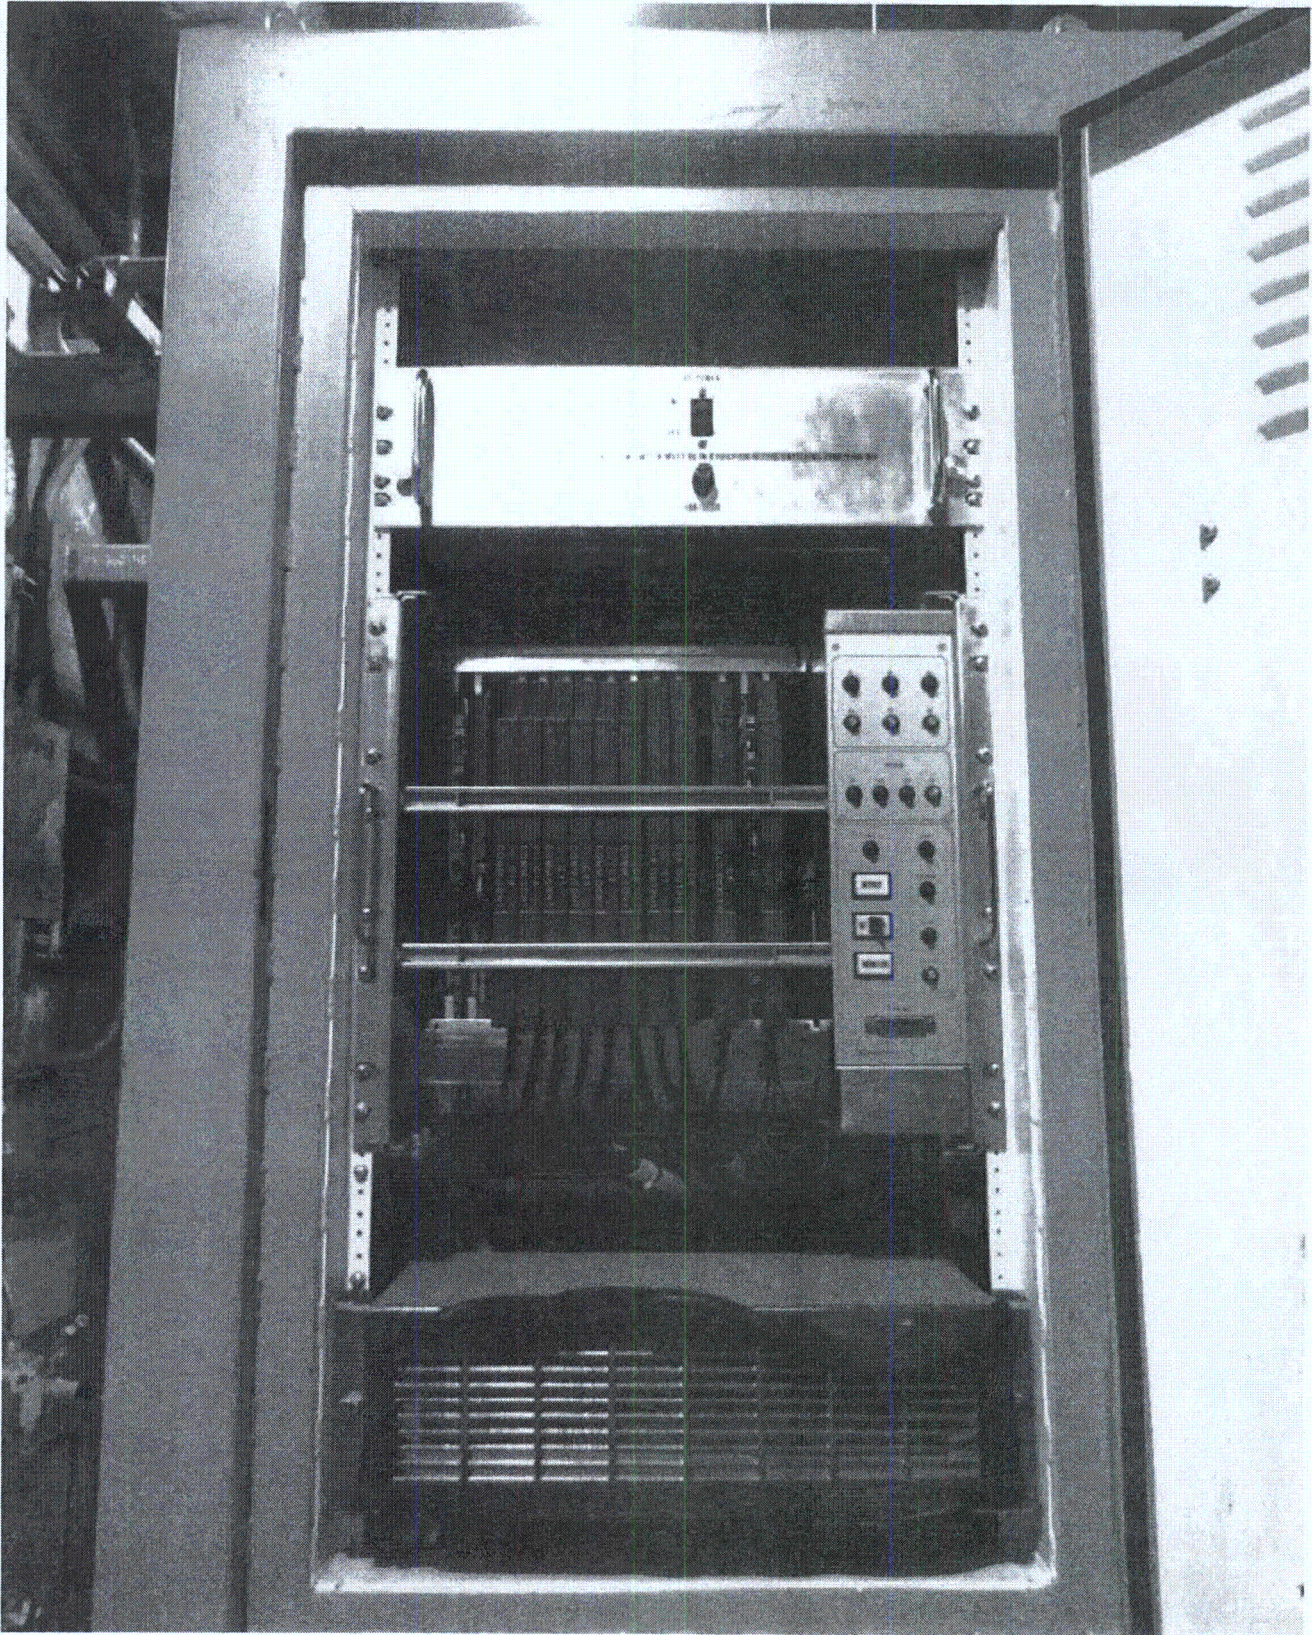
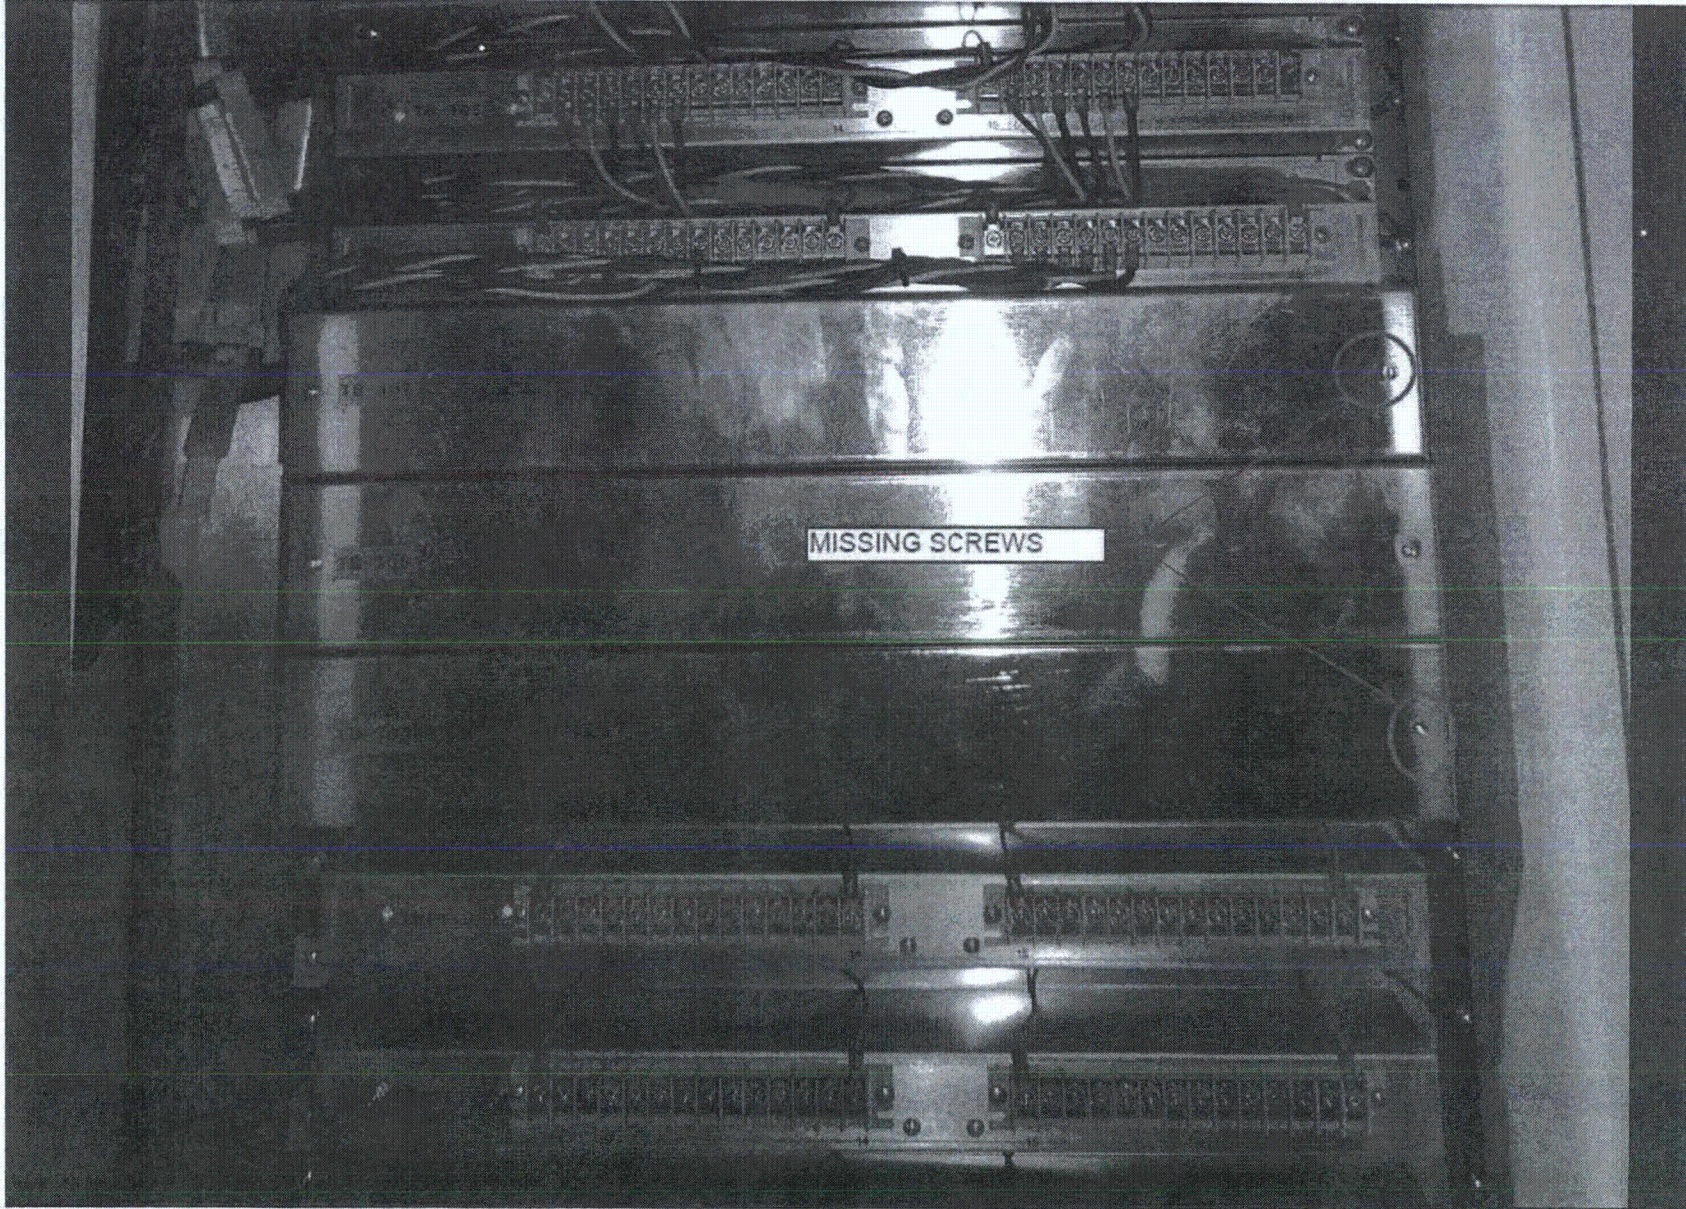
A VISUAL INSPECTION OF THE INTERNAL COMPONENTS OF THE CABINET WAS PERFORMED TO CHECK FOR SEISMIC ADEQUACY TO INCLUDE ANY EVIDENCE OF INTERNAL COMPONENTS NOT ADEQUATELY SECURED, CHECKED TO ENSURE FASTENERS CONNECTING ADJACENT CABINETS WERE IN PLACE, AND EVIDENCE OF OTHER SEISMIC CONDITIONS.

NO SIGNIFICANT ADVERSE CONDITIONS WERE FOUND. SOME MINOR ISSUES ARE DOCUMENTED IN THE "COMMENTS" SECTION BELOW

FOUND SOME SCREWS MISSING USED TO SECURE PROTECTIVE COVERS INSIDE THE CABINET. THE SEISMIC WALKDOWN TEAM JUDGED THAT THIS CONDITION DOES NOT REPRESENT A SEISMIC OR OPERABILITY CONCERN. THIS CONDITION HAS BEEN REPORTED THROUGH CR 527695

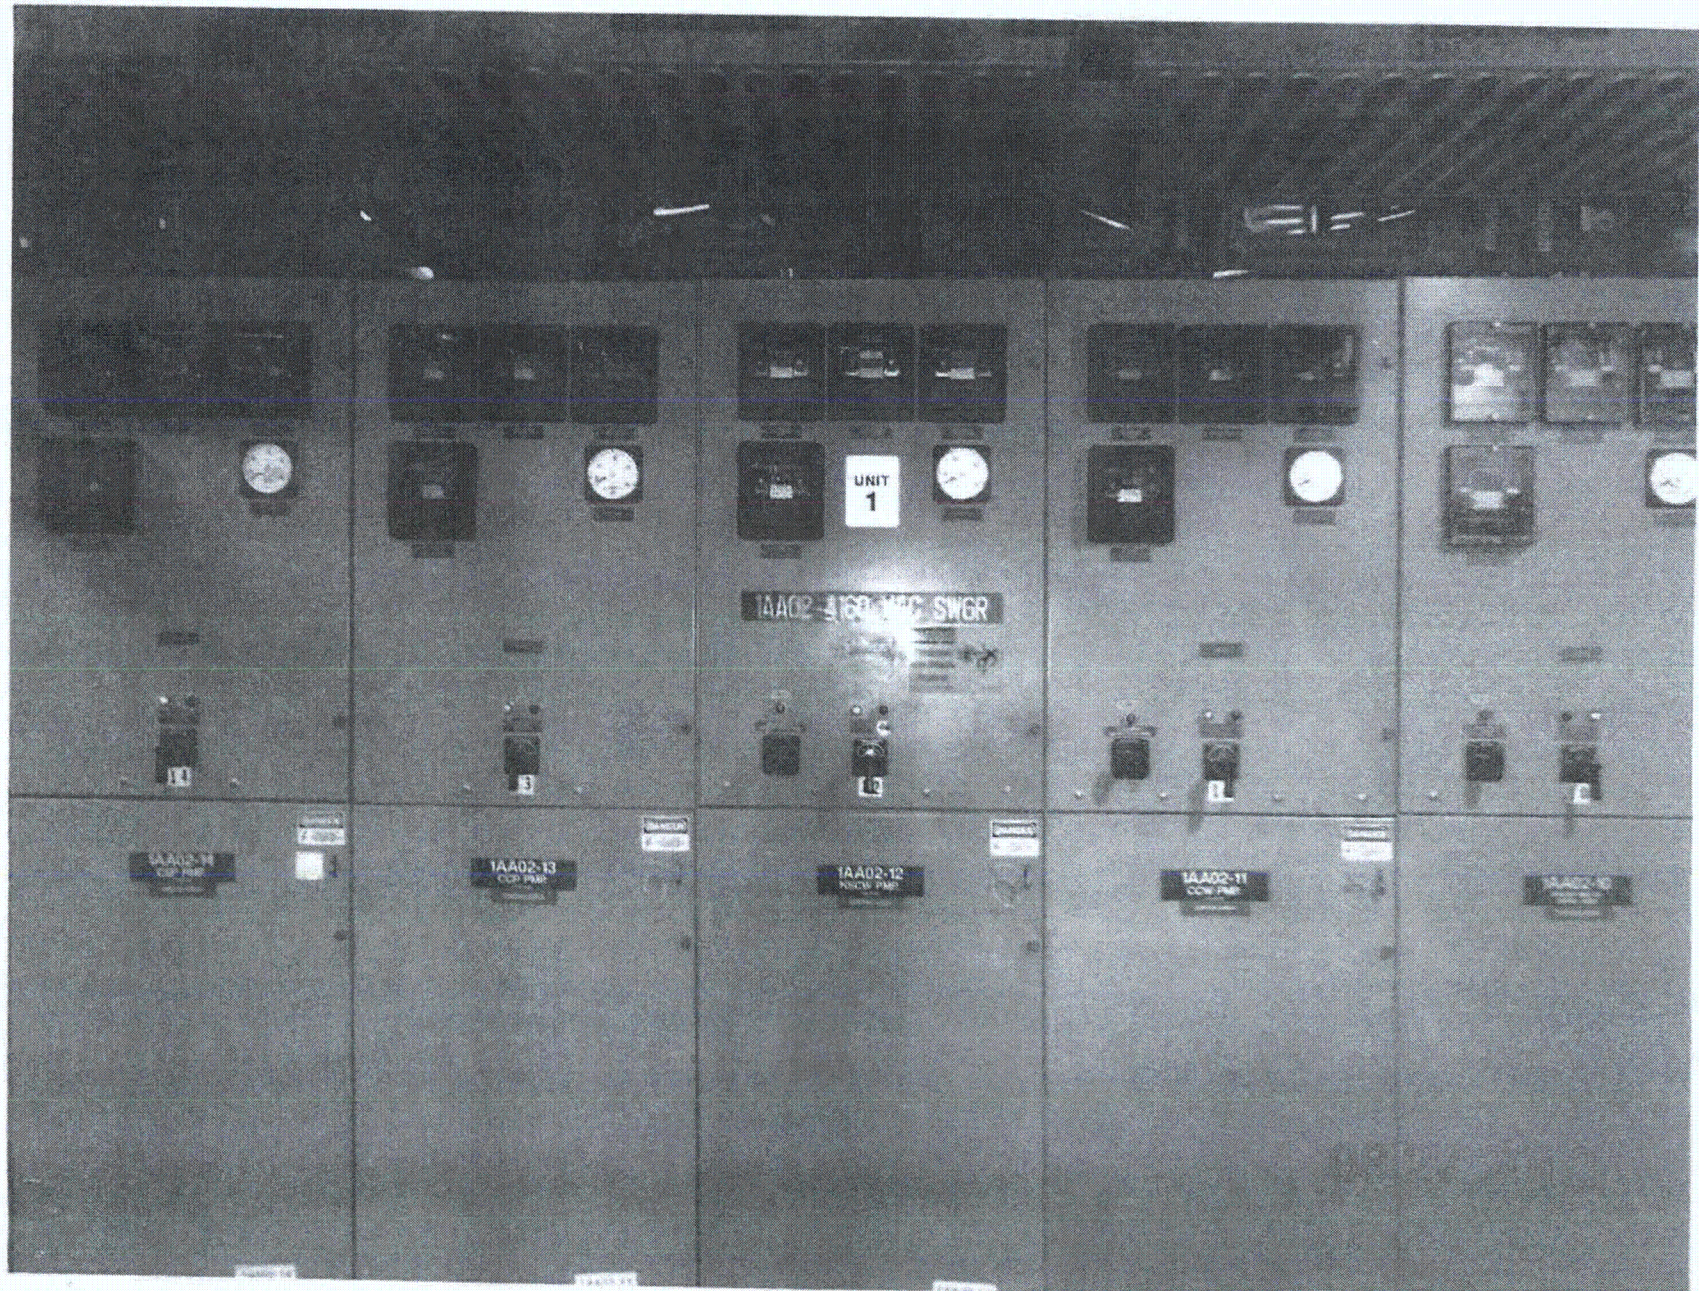
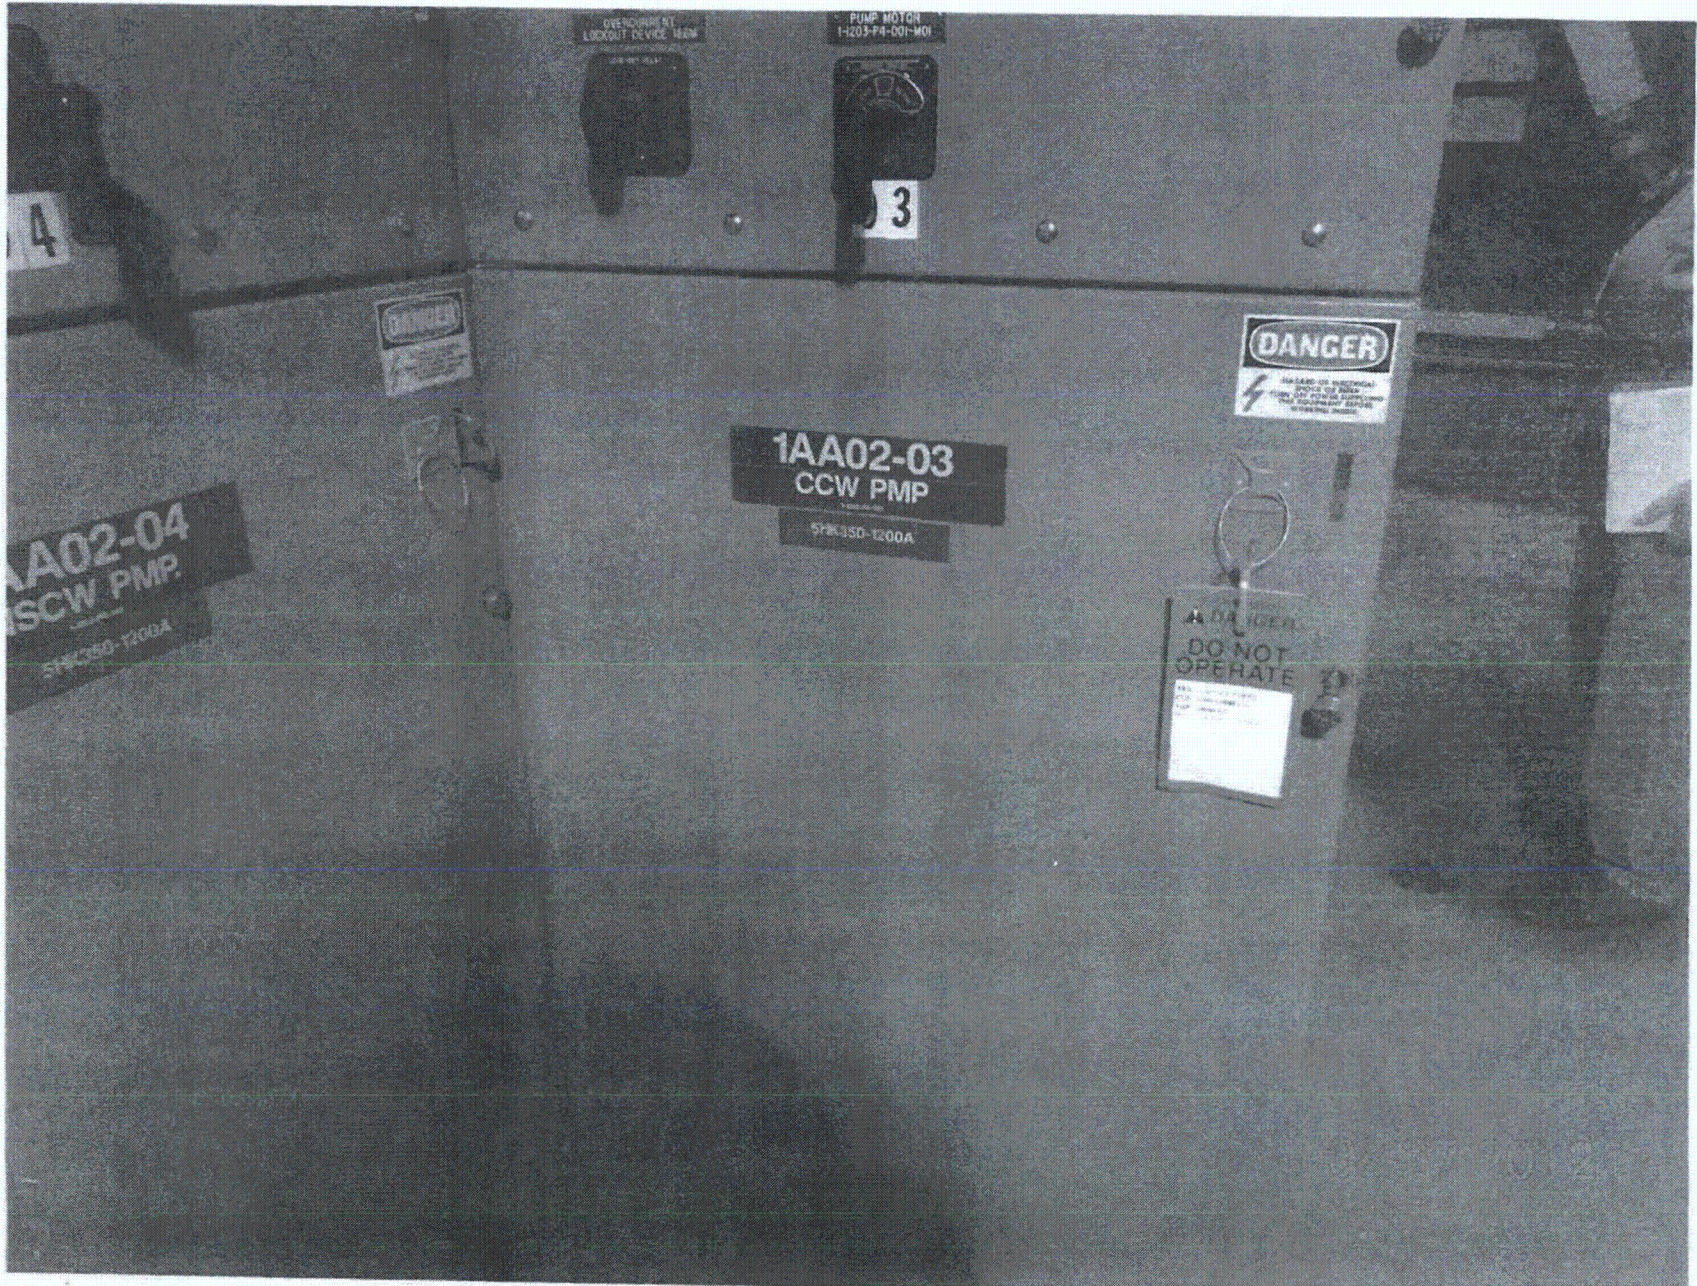
- 9. Do attached lines have adequate flexibility to avoid damage? Y N U N/A
 2 ductwork extensions from the top of the cabinet appear to be rigidly connected at bays 1AA02-01 and -05. Refer to CR 517078.

Comment 1: SEE 1-1623-DS-006A FOR AREA WALK-BY CHECKLIST (AWC).
 Comment 2: Visual inspection of all front welds except bays 1AA02-00 and -02 was performed. Full inspection of 1AA02-03 was performed (front, rear, plug, fillet). Based on the number and good condition of inspected welds, the anchorage of the panel is determined to be acceptable. Full inspection of the anchorage is required during an outage. MWD 8/27/12

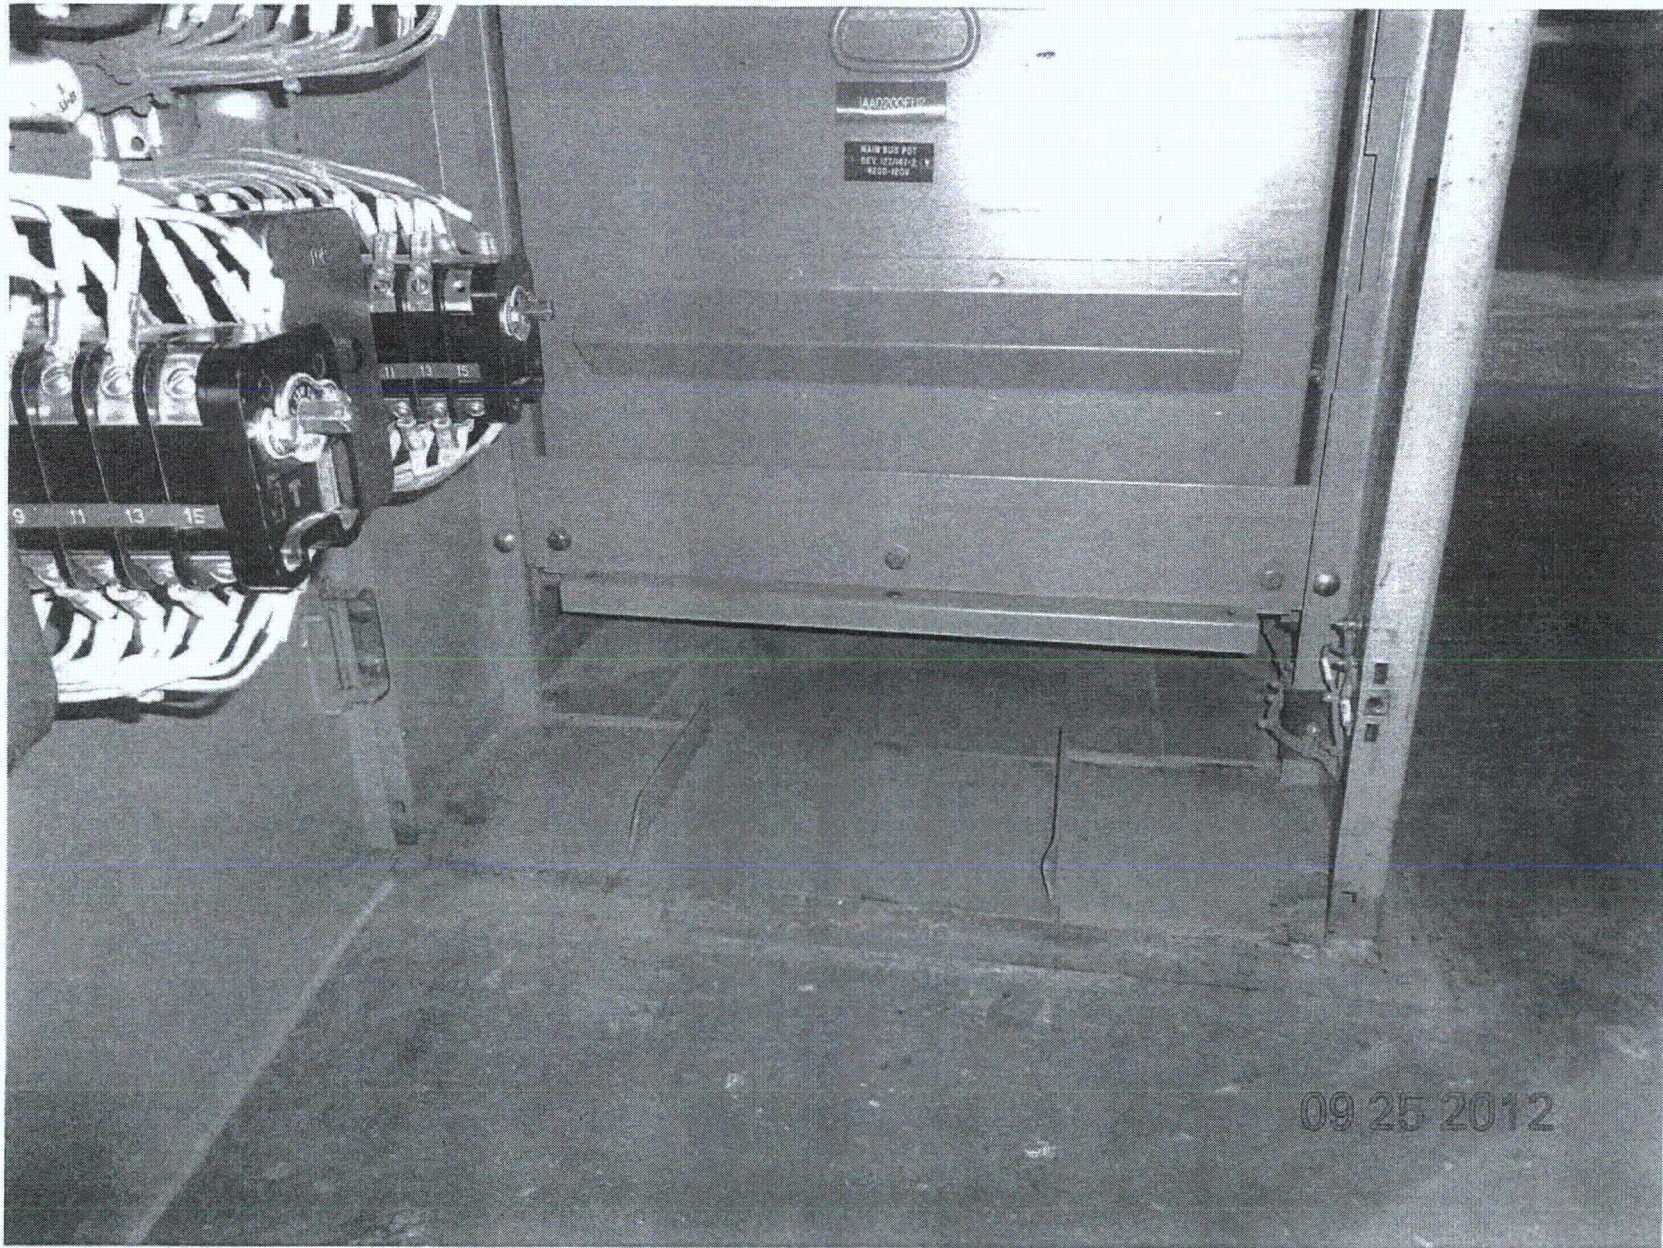
9. Do attached lines have adequate flexibility to avoid damage? Y N U N/A
 A condition report 517078 was generated for a possible case of a rigid connection on the SWC dated on 8/27/12. Technical Evaluation 519183 resulted as a related record of the condition report to investigate this possible condition. The technical evaluation was resolved on 10/22/12 resulting in a no rigid connection case. *Jose R. Hernandez 10/23/12*

11. Have you looked for and found no other seismic conditions that could adversely affect the safety functions of the equipment? Y N U
 A visual inspection of the internal components of this cabinet was performed to check for seismic adequacy to include any evidence of internal components not adequately secured, checked to ensure fasteners connecting adjacent cabinets were in place, and evidence of other seismic conditions. No adverse conditions were found.

① By performing the internal inspection of this cabinet, the welds referred on comment 2 of the SWC dated on 8/27/12 it was possible to complete the anchorage verification on this component. No adverse conditions were found and the anchorage configuration is consistent with the plant configuration.
