Seismic Walkdown Checklist (SWC)

Equipment ID No. I-1605-95-SPB Equip. Class¹² ZO

Equipment Description SOLID STATE PROT SYS CAR-TEN B

Location: Bldg. CONTROL Floor El. 220 Room, Area 165

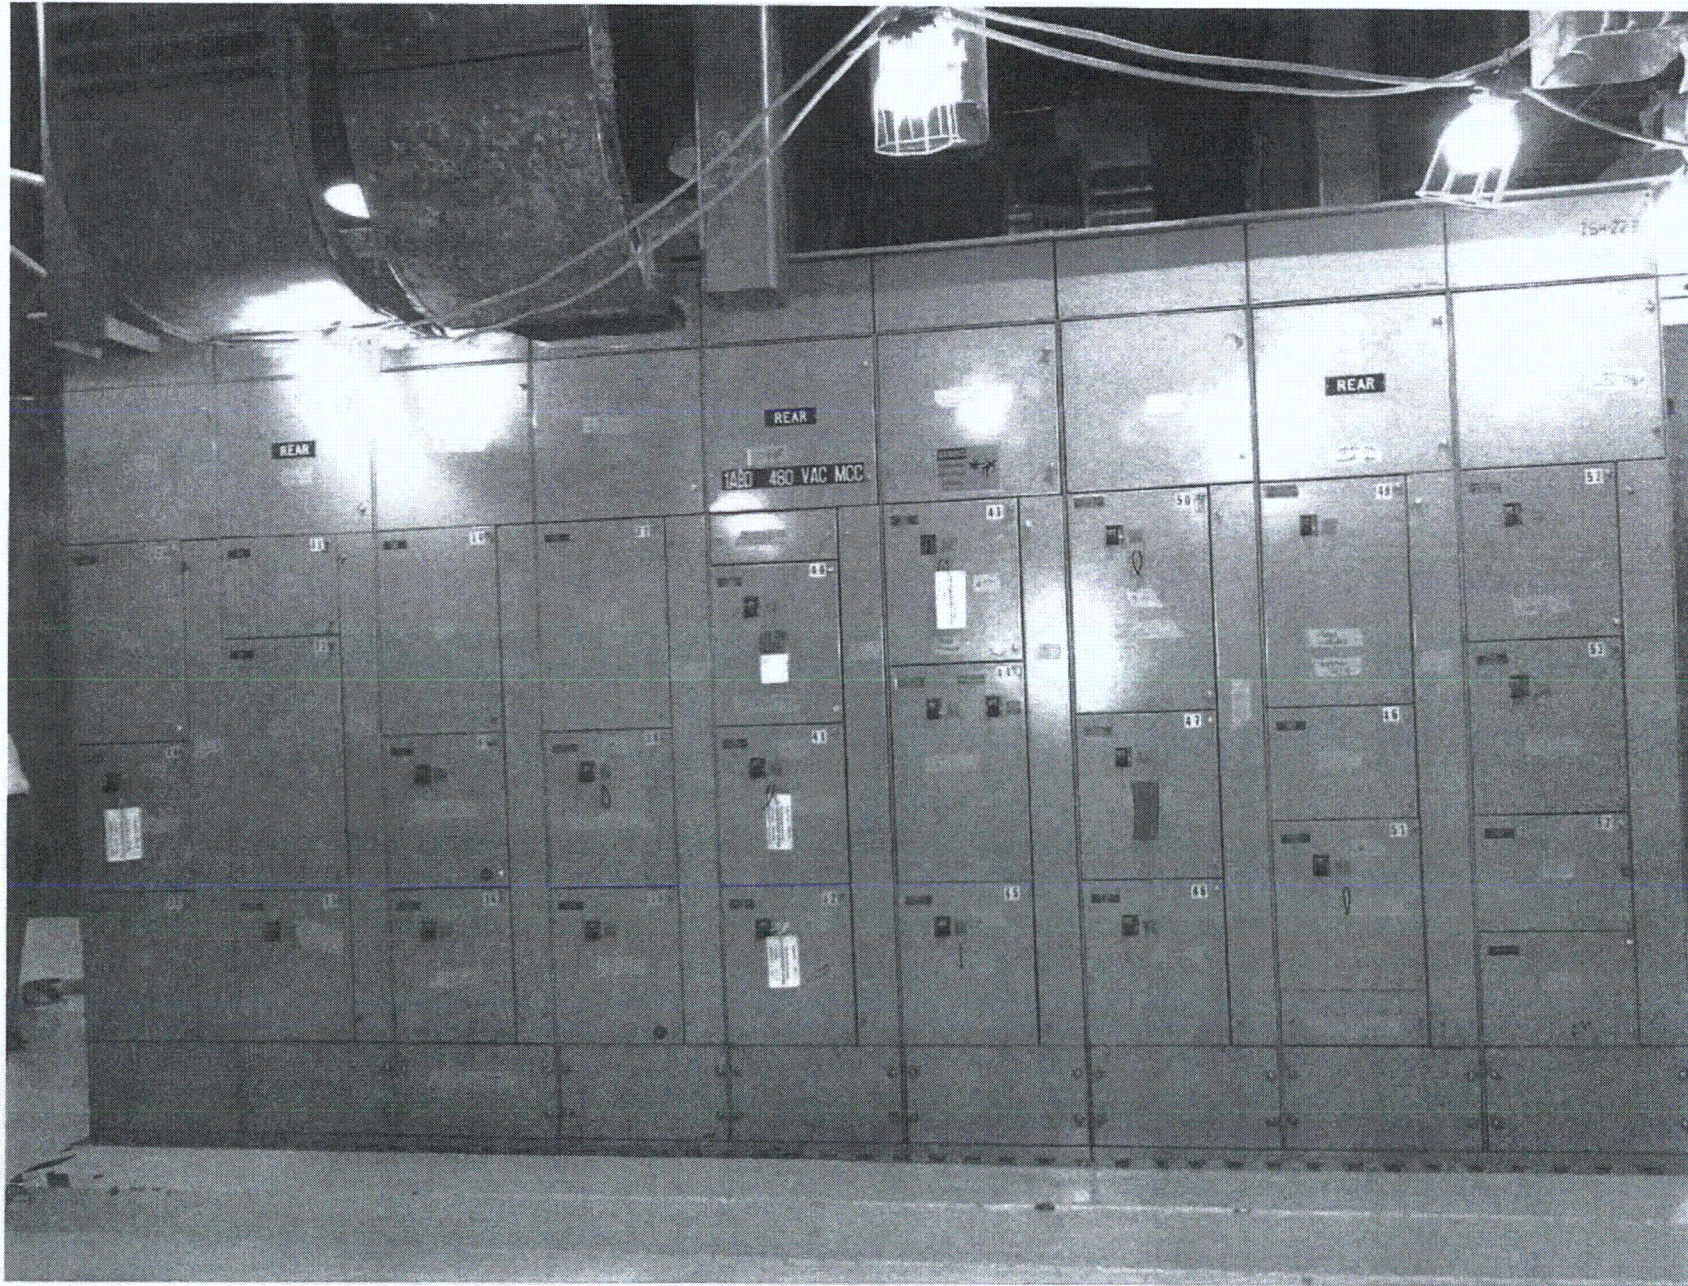
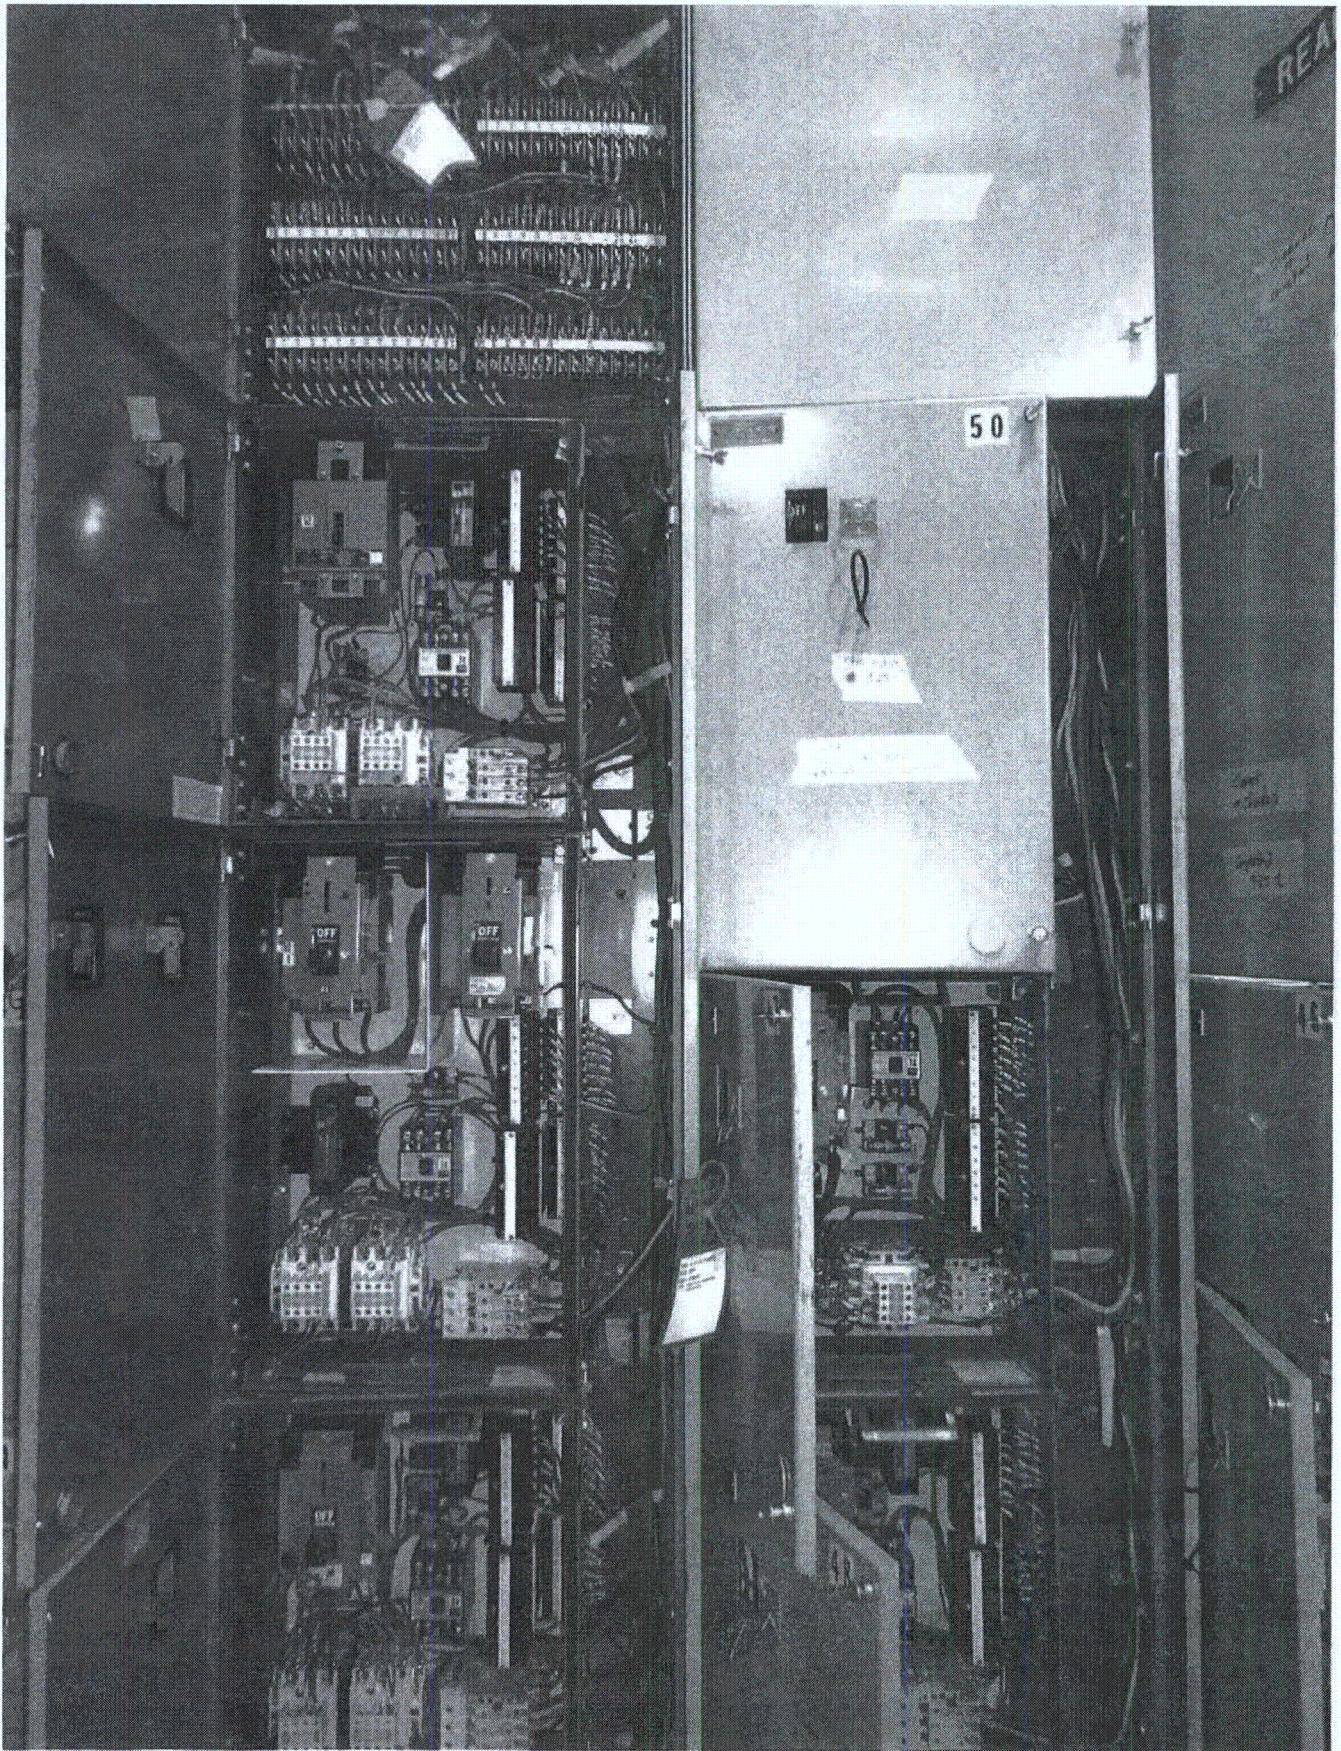
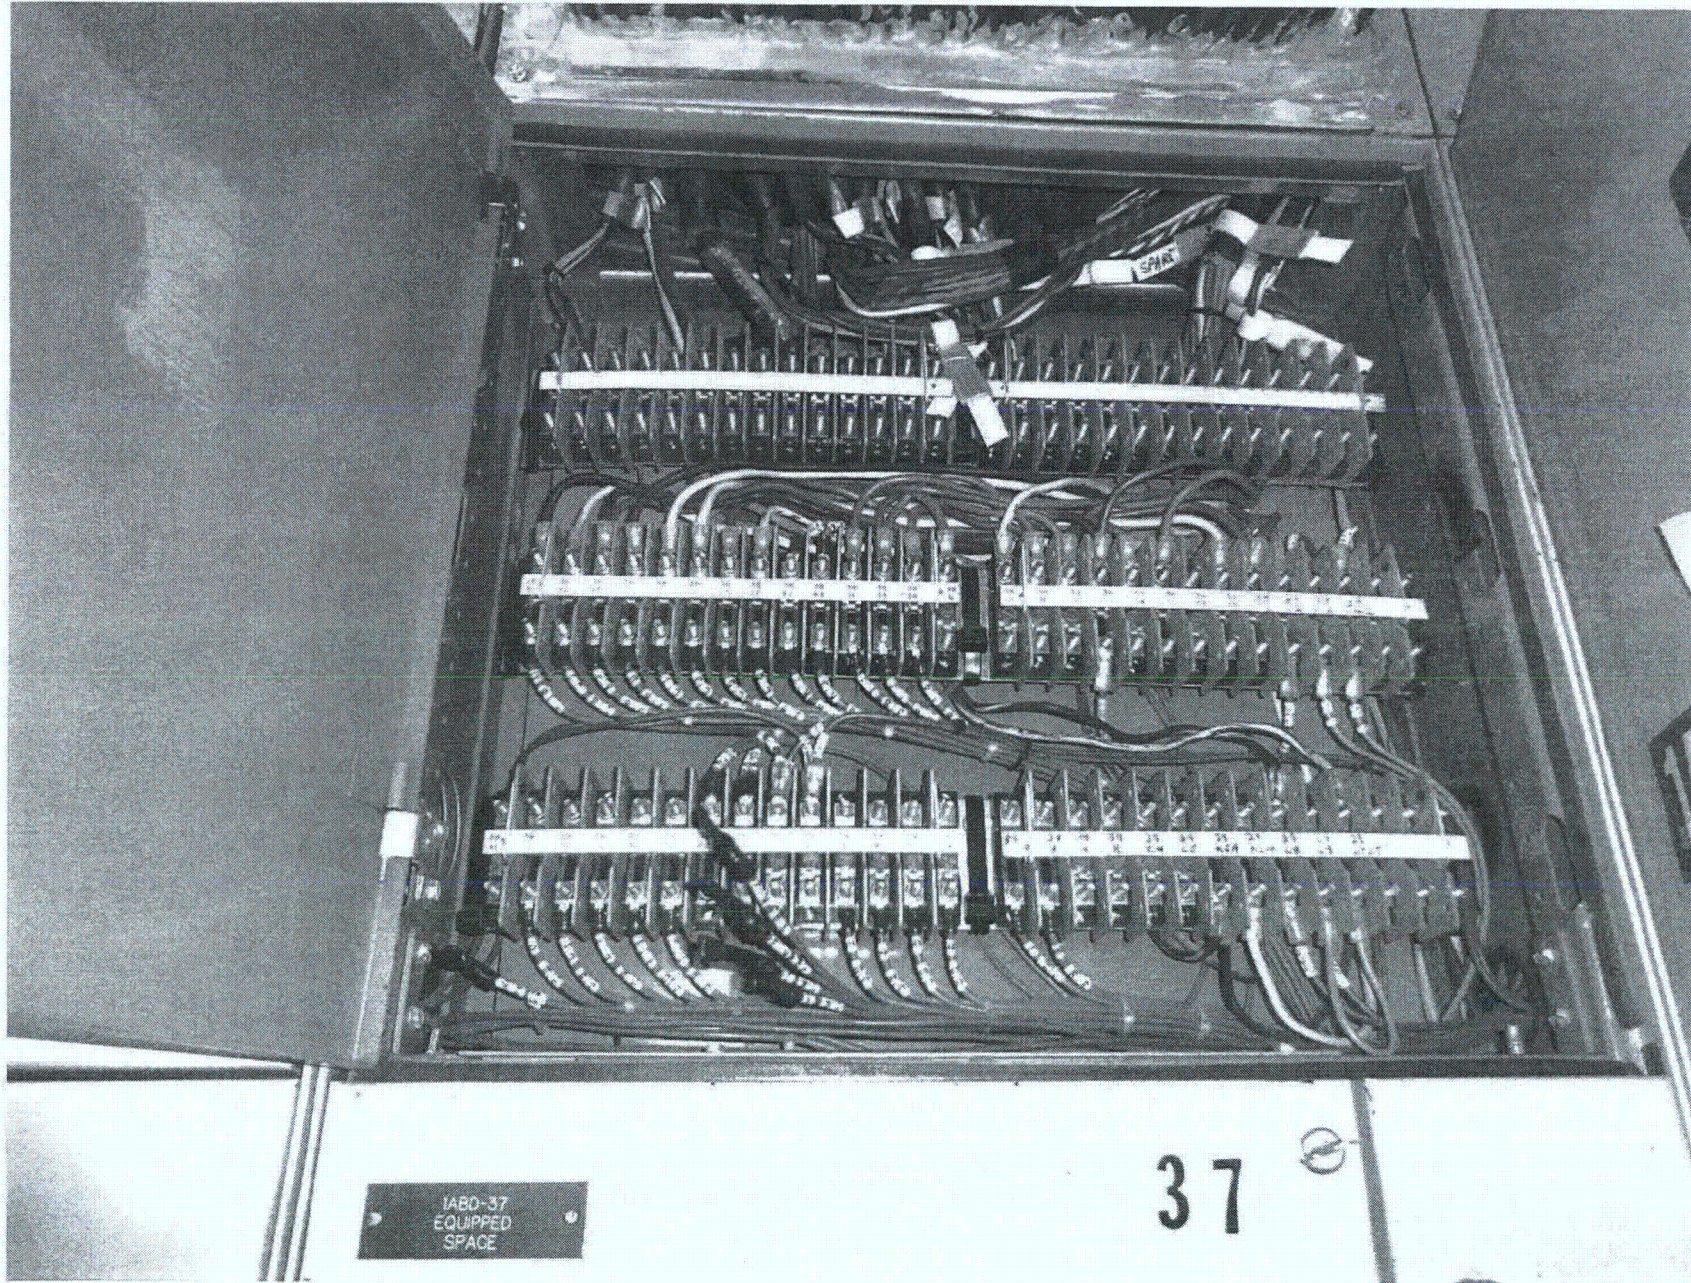
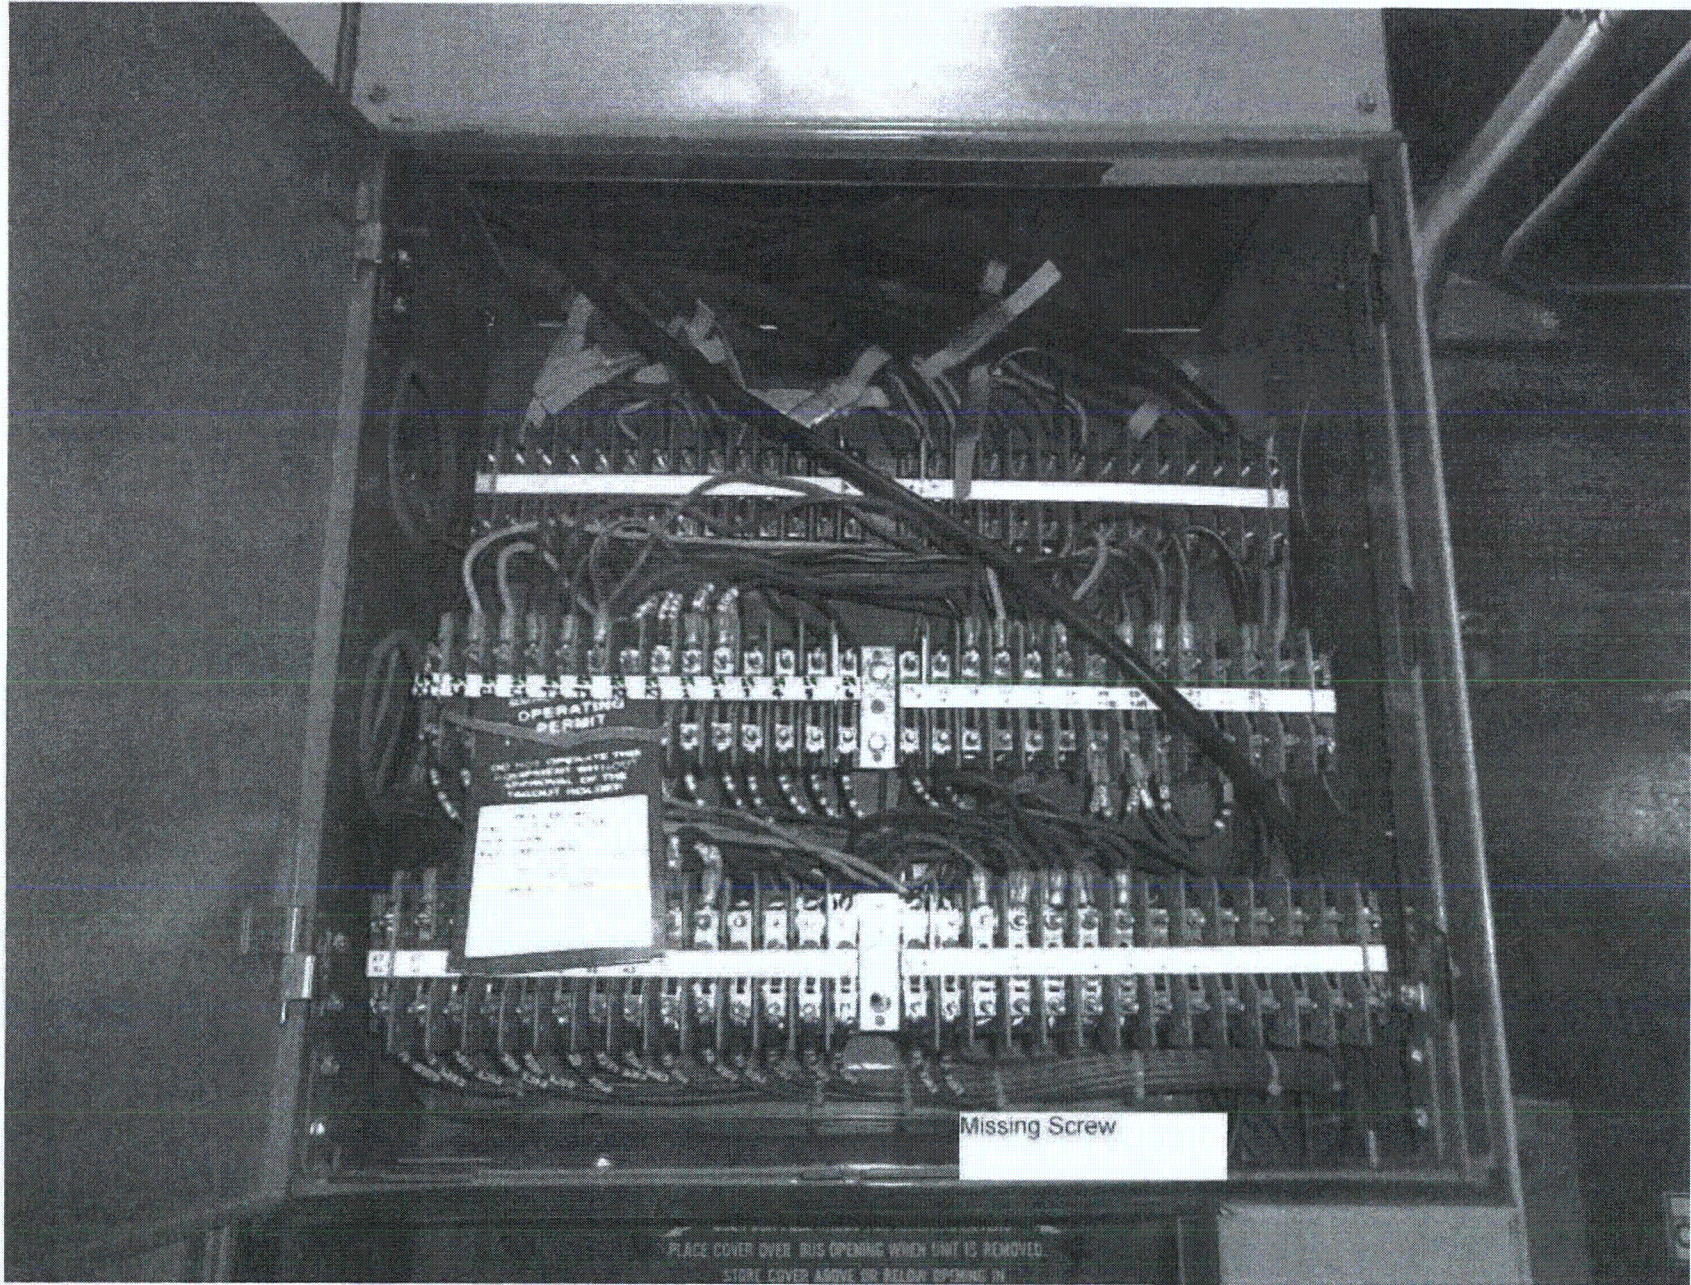
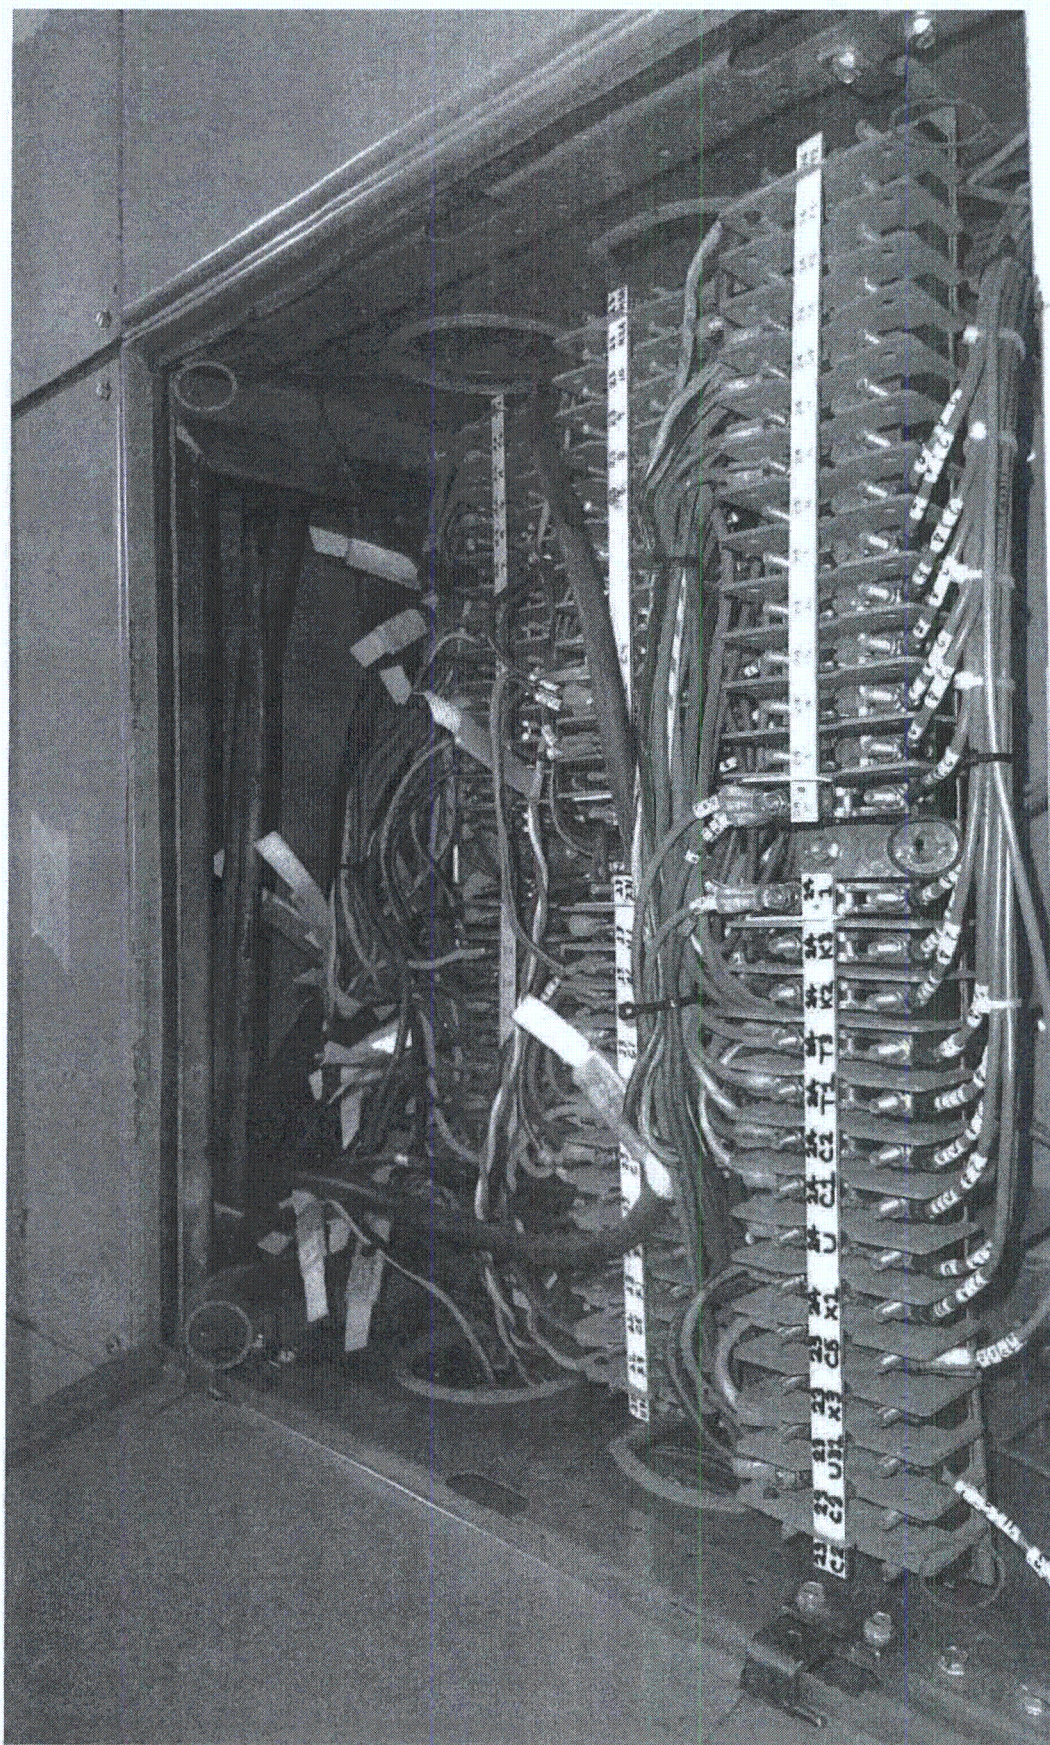
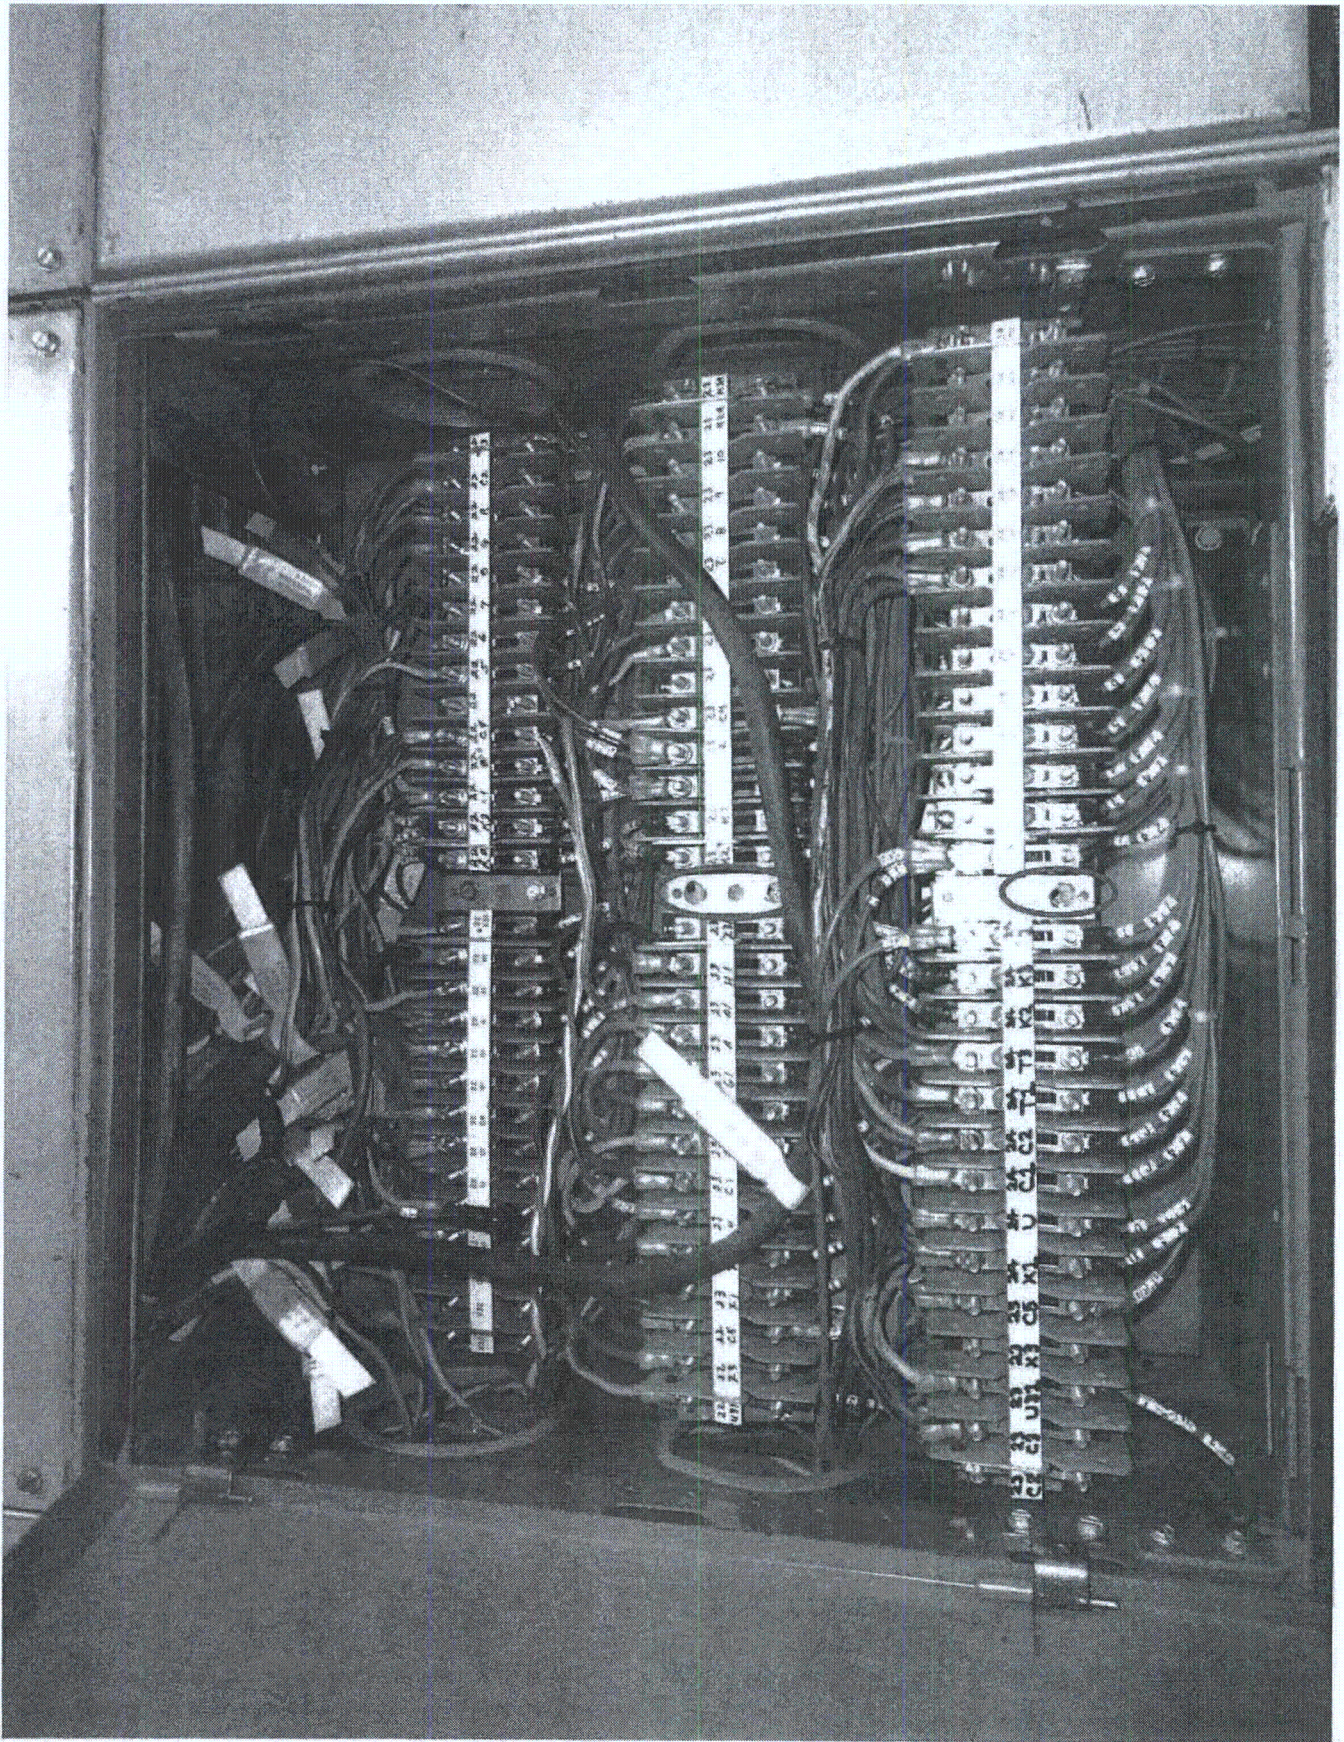
11. Have you looked for and found no other seismic conditions that could adversely affect the safety functions of the equipment? A visual inspection of the internal components of this cabinet was performed to check for seismic adequacy to include any evidence of internal components not adequately secured, checked to ensure fasteners connecting adjacent cabinets were in place, and evidence of other seismic conditions. Some inconsistencies and issues were found. They are documented on the "comments" section of this checklist. Y N U

- ① There was found some missing nuts and screws used to secure cover plates and protective covers. The seismic walkdown team judged that these findings do not represent an operability or vulnerability concern.
- ② There was found some missing screws used to secure terminal blocks. The seismic walkdown judged that this condition needs to be evaluated for seismic vulnerability.

Both findings were documented on the condition report 325343.
