**Seismic Walkdown Checklist (SWC)**

Equipment ID No. 1-1805-Y3-1D6E Equip. Class<sup>12</sup> 16

Equipment Description RHR 150 VLV INVERTER

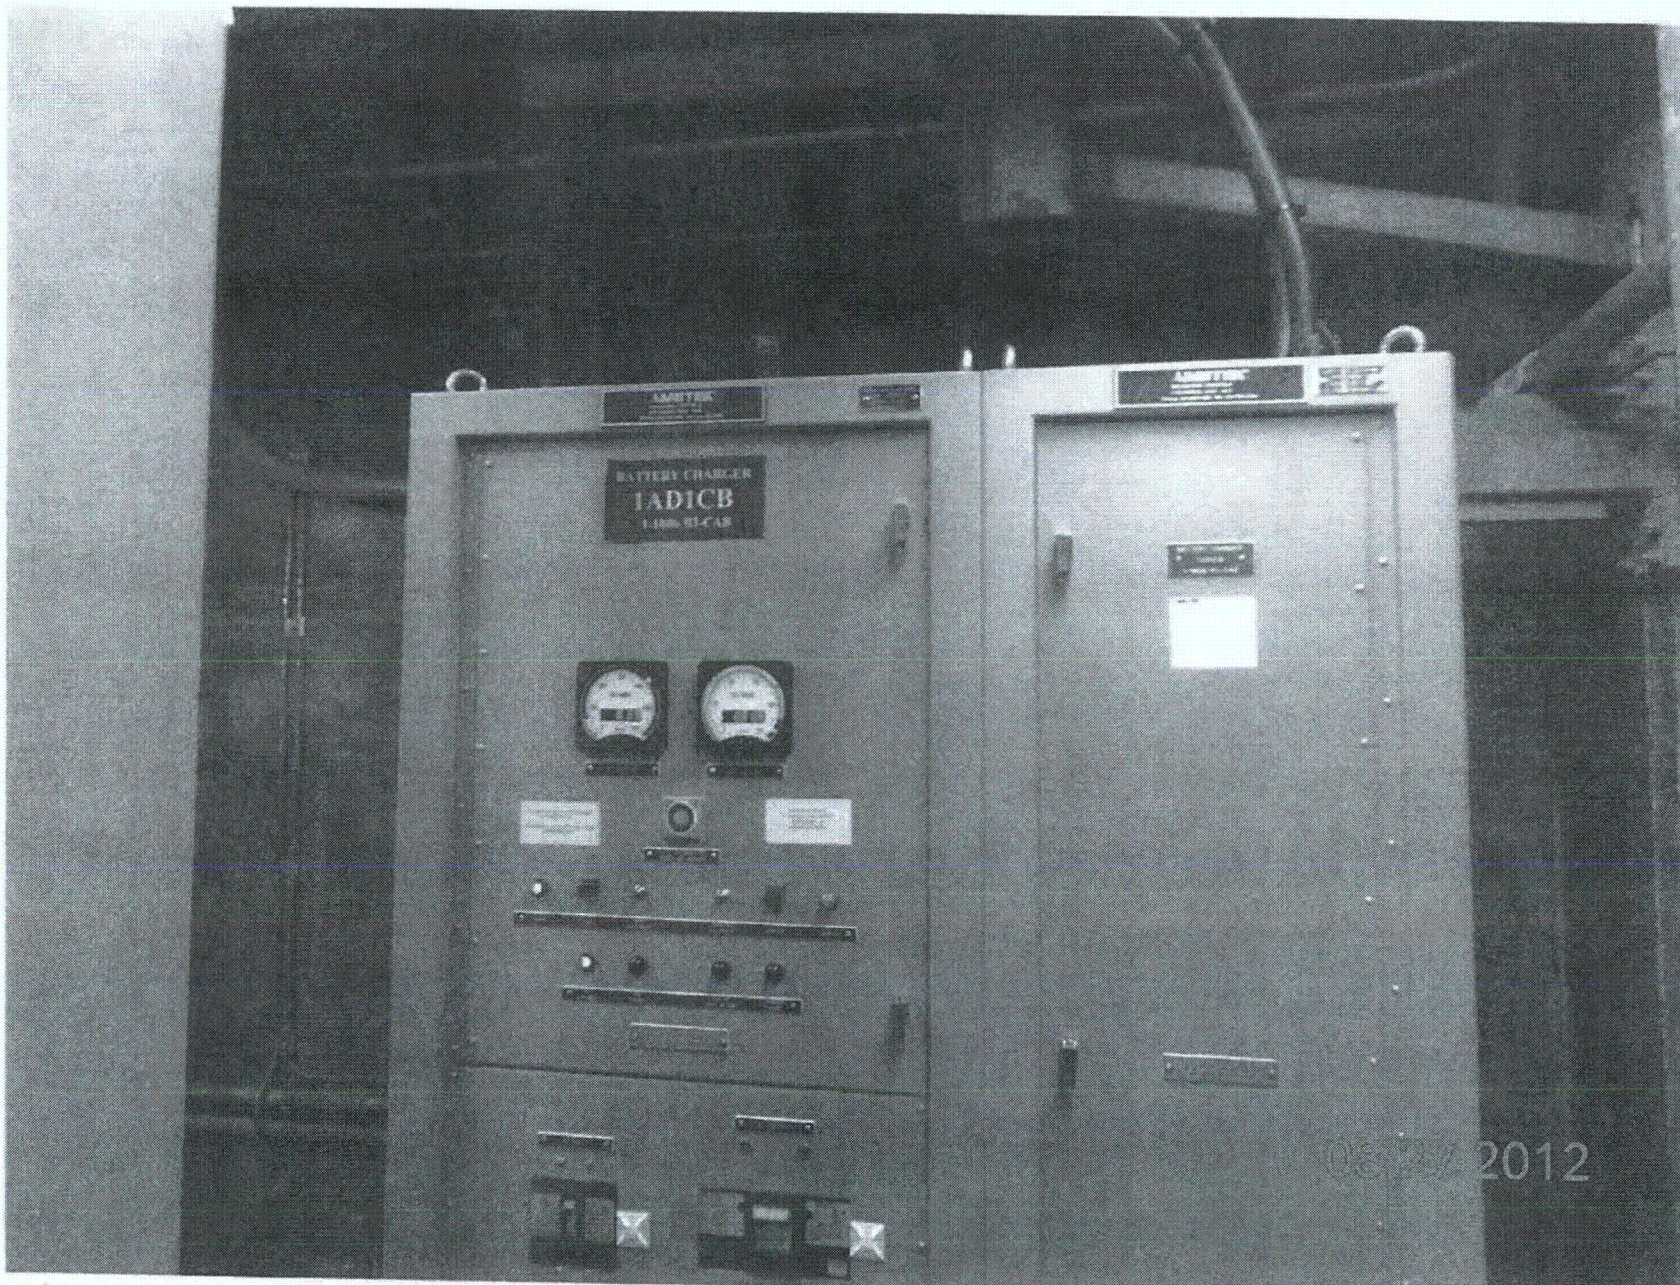
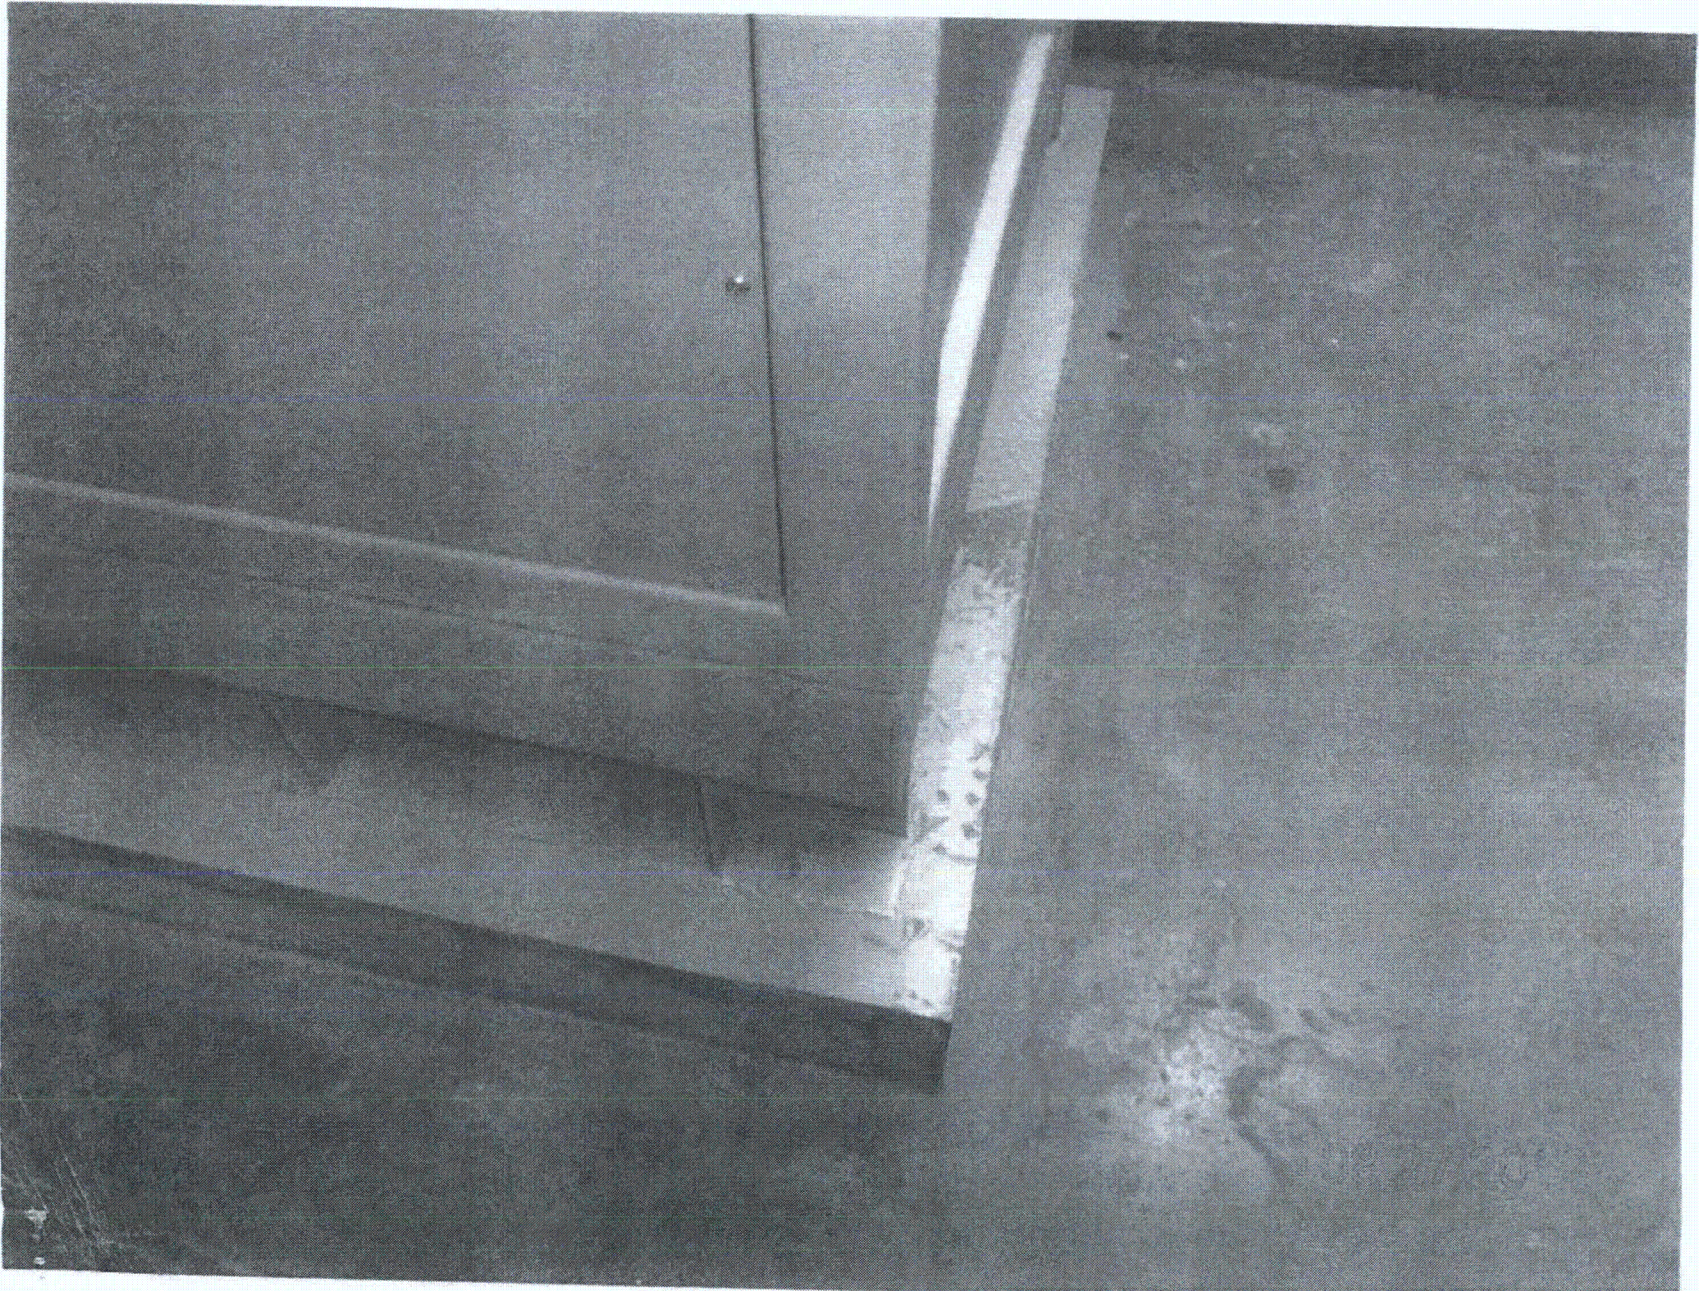
2. Is the anchorage free of bent, broken, missing or loose hardware?  Y  N  U  N/A  
*Weld Battery Charger Base frame to embed steel at four corners*

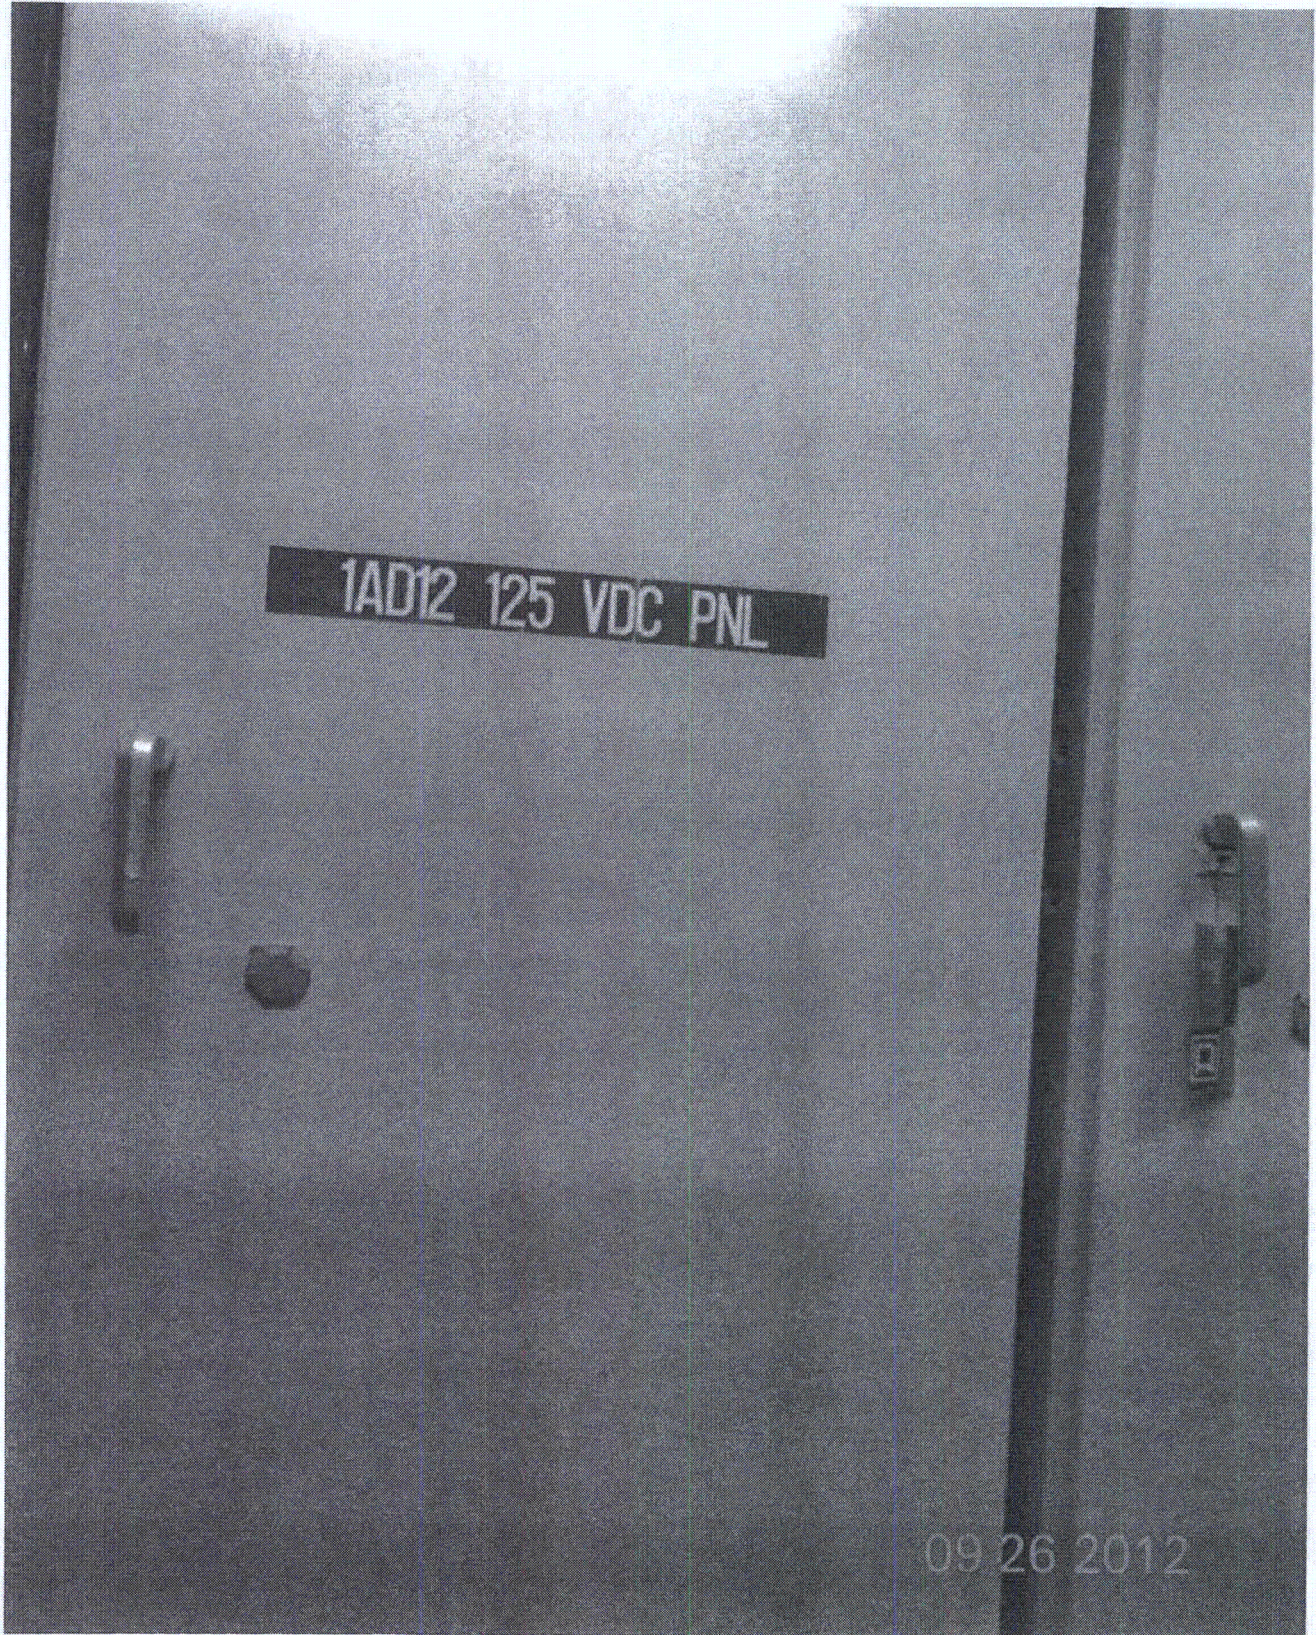
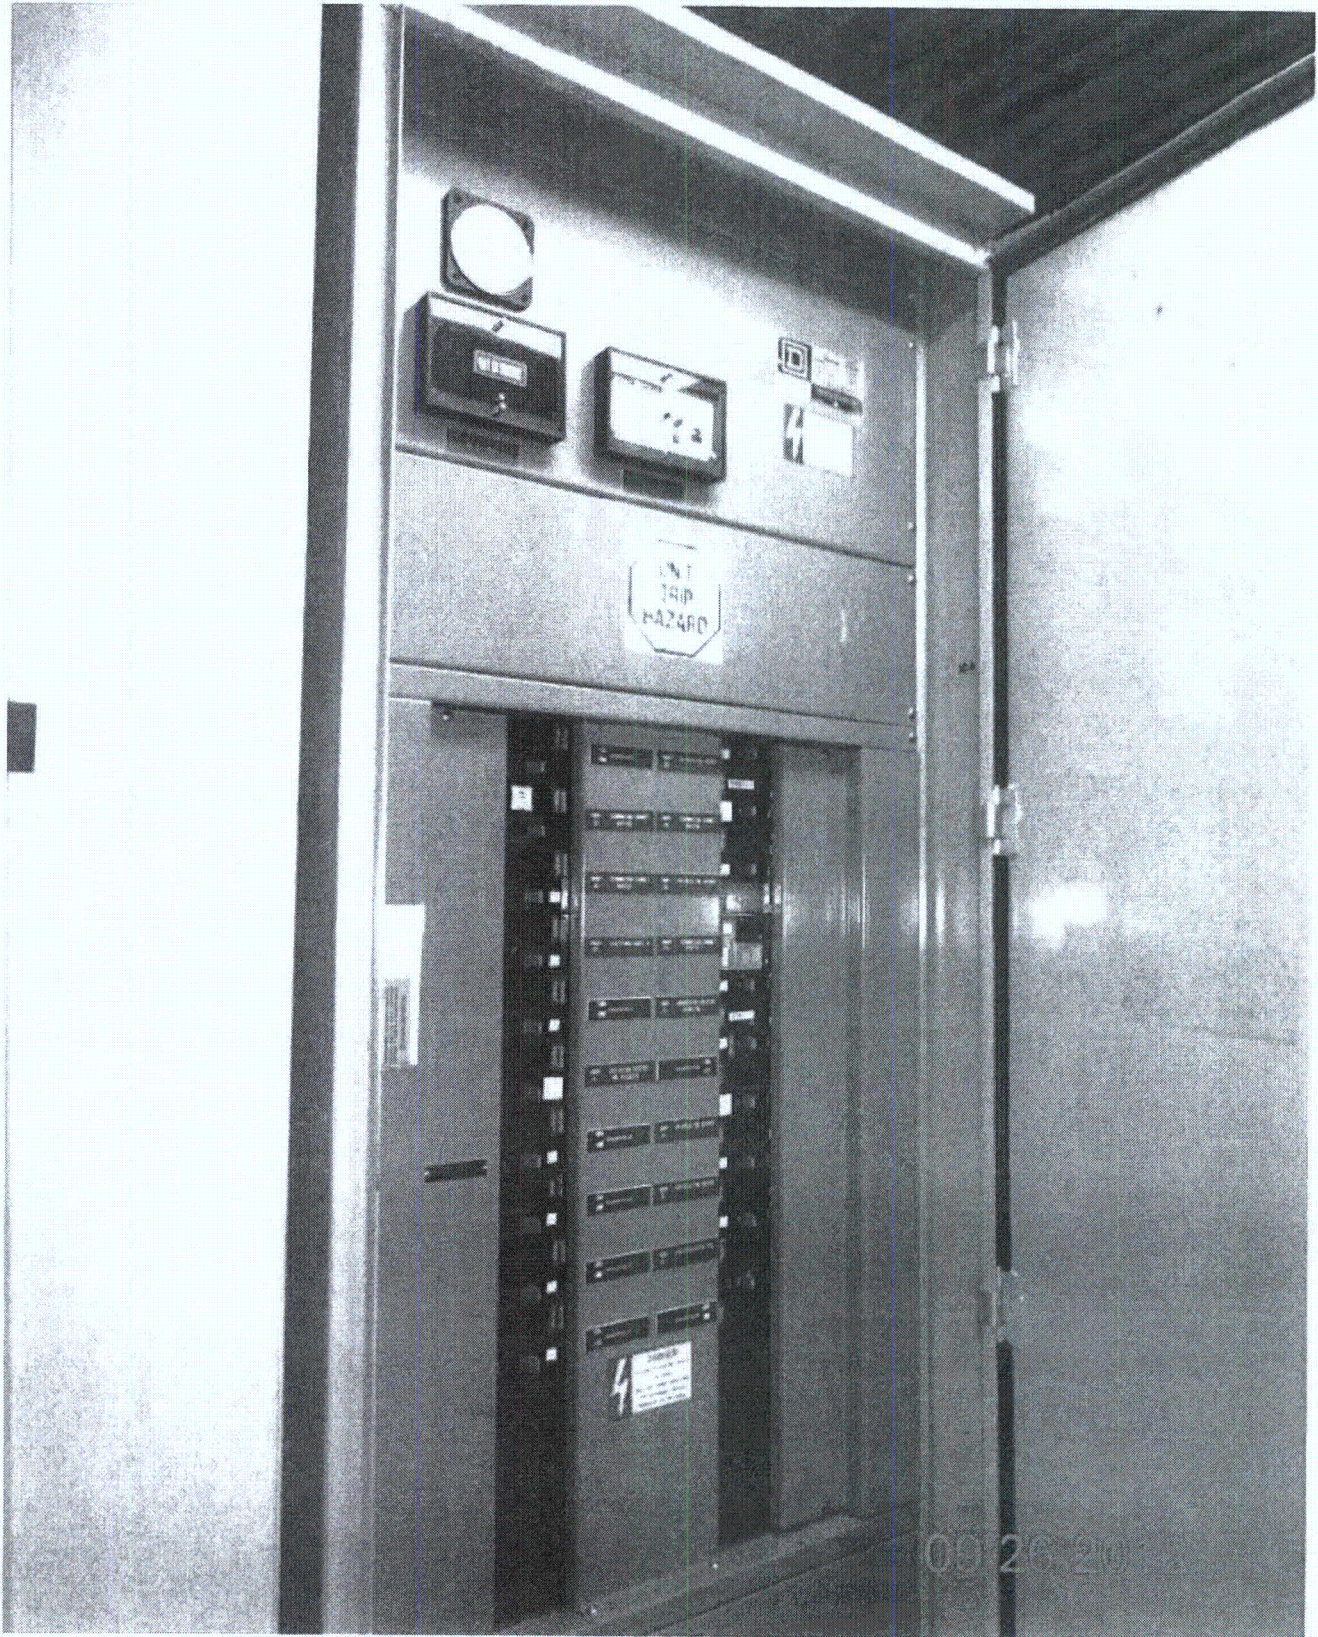
11. Have you looked for and found no other seismic conditions that could adversely affect the safety functions of the equipment? Y  N  U   
A visual inspection of the internal components of this cabinet was performed to check for seismic adequacy to include any evidence of internal components not adequately secured, checked to ensure fasteners connecting adjacent cabinets were in place, and evidence of other adverse seismic conditions. One fastener that connects the inner frame is missing. See "Comments" section for details.

It was found that one (1) bolt that connects the inner frame with the cabinet was missing. An evaluation of this condition needs to be performed to determine seismic adequacy. Condition report 534560 was generated.

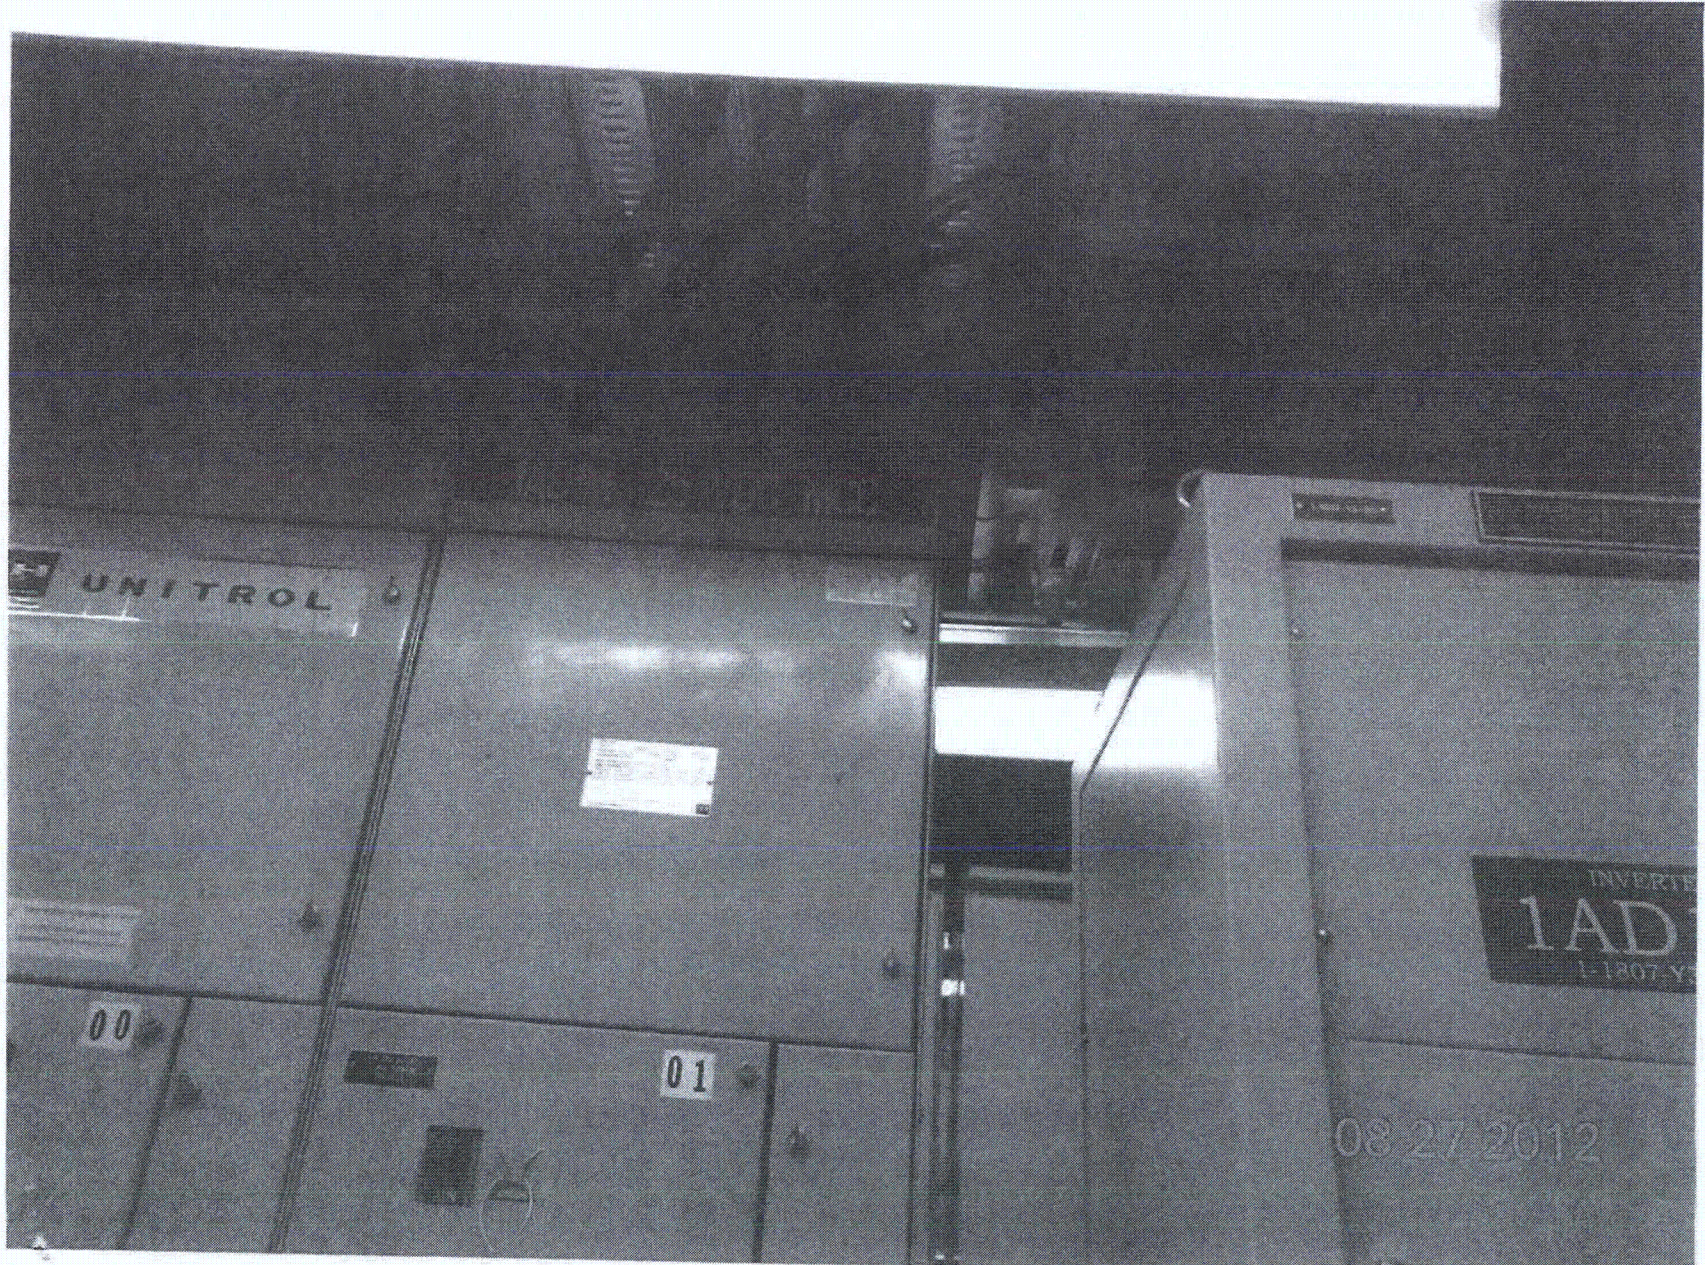
2. Is the anchorage free of bent, broken, missing or loose hardware?  Y  N  U  N/A  
*MCC base welded to base.*

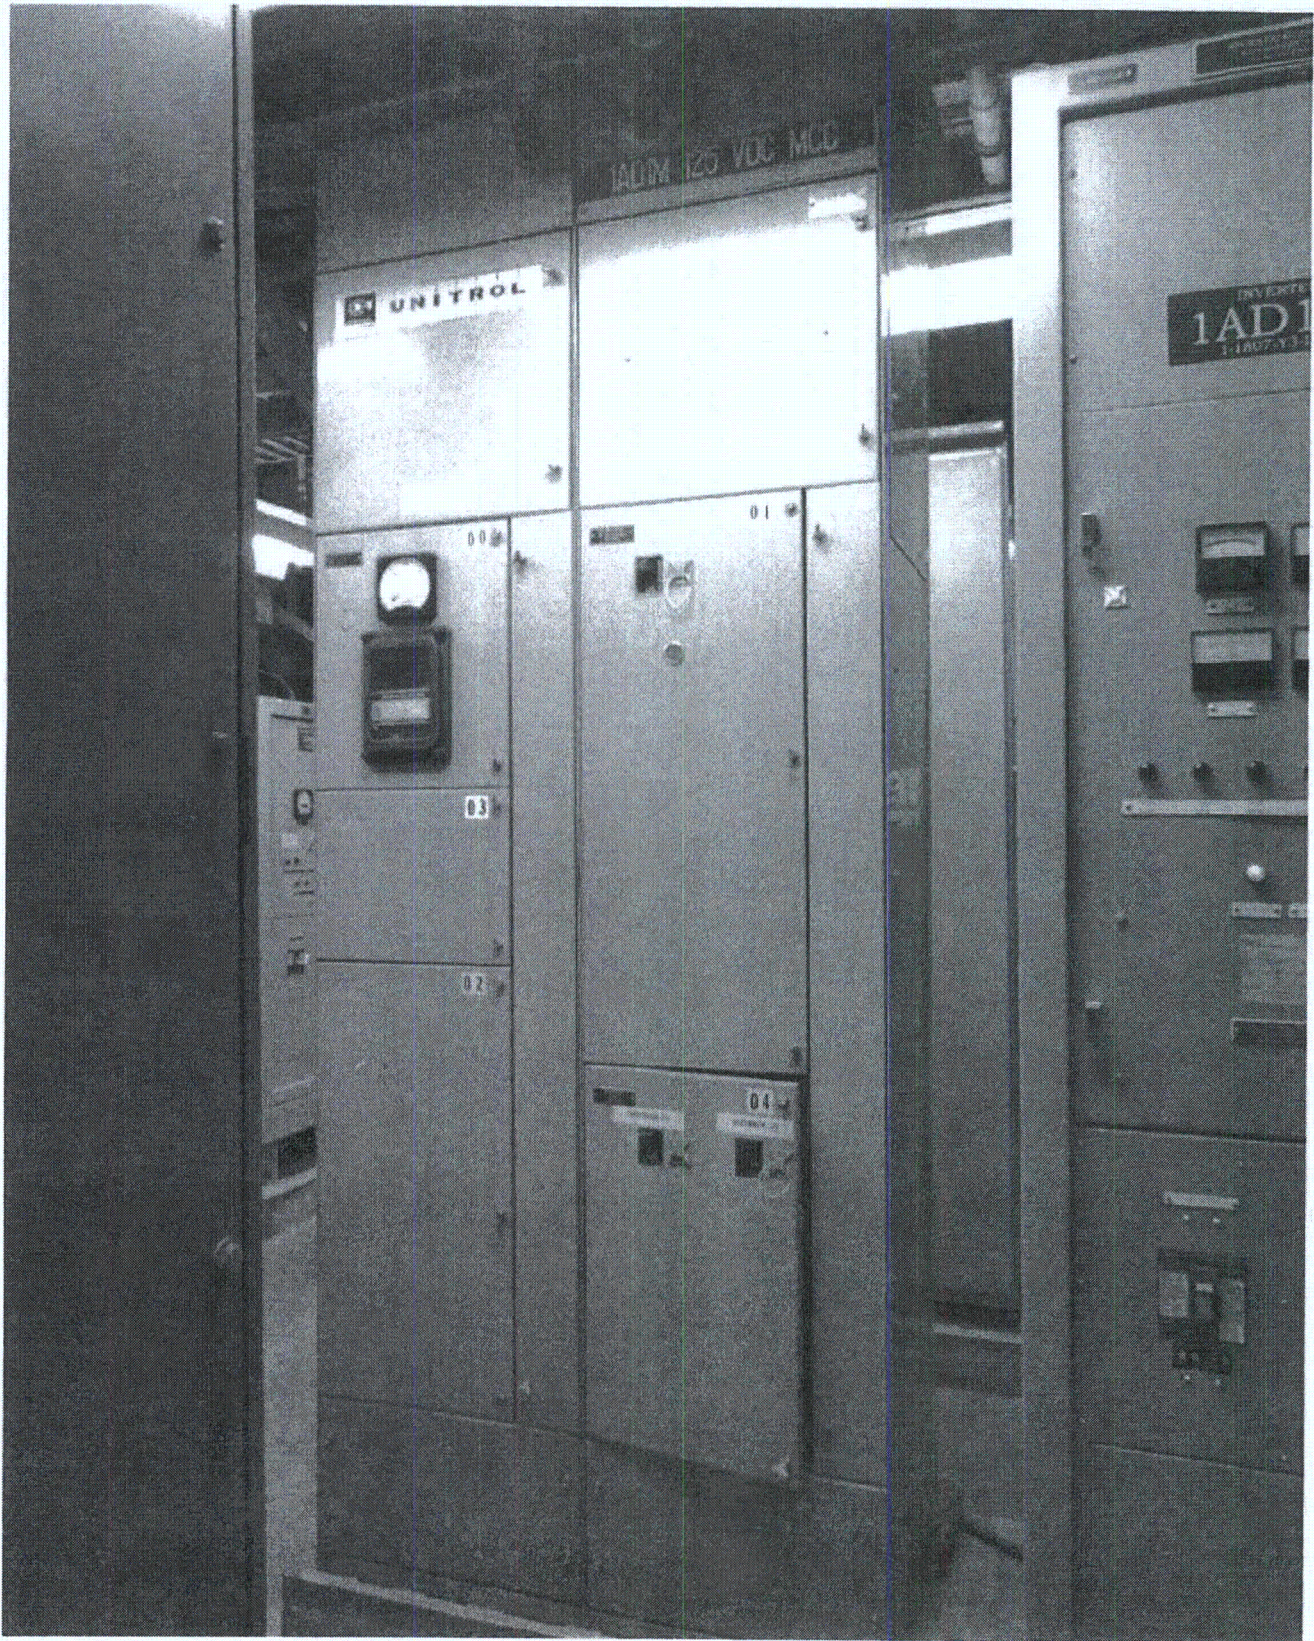
<C4>

11. Have you looked for and found no other seismic conditions that could adversely affect the safety functions of the equipment? A visual inspection of the internal components of this cabinet was performed to check for seismic adequacy to include any evidence of internal components not adequately secured, checked to ensure fasteners connecting adjacent cabinets were in place and evidence of other adverse conditions. Y  N  U   
No adverse conditions were found.

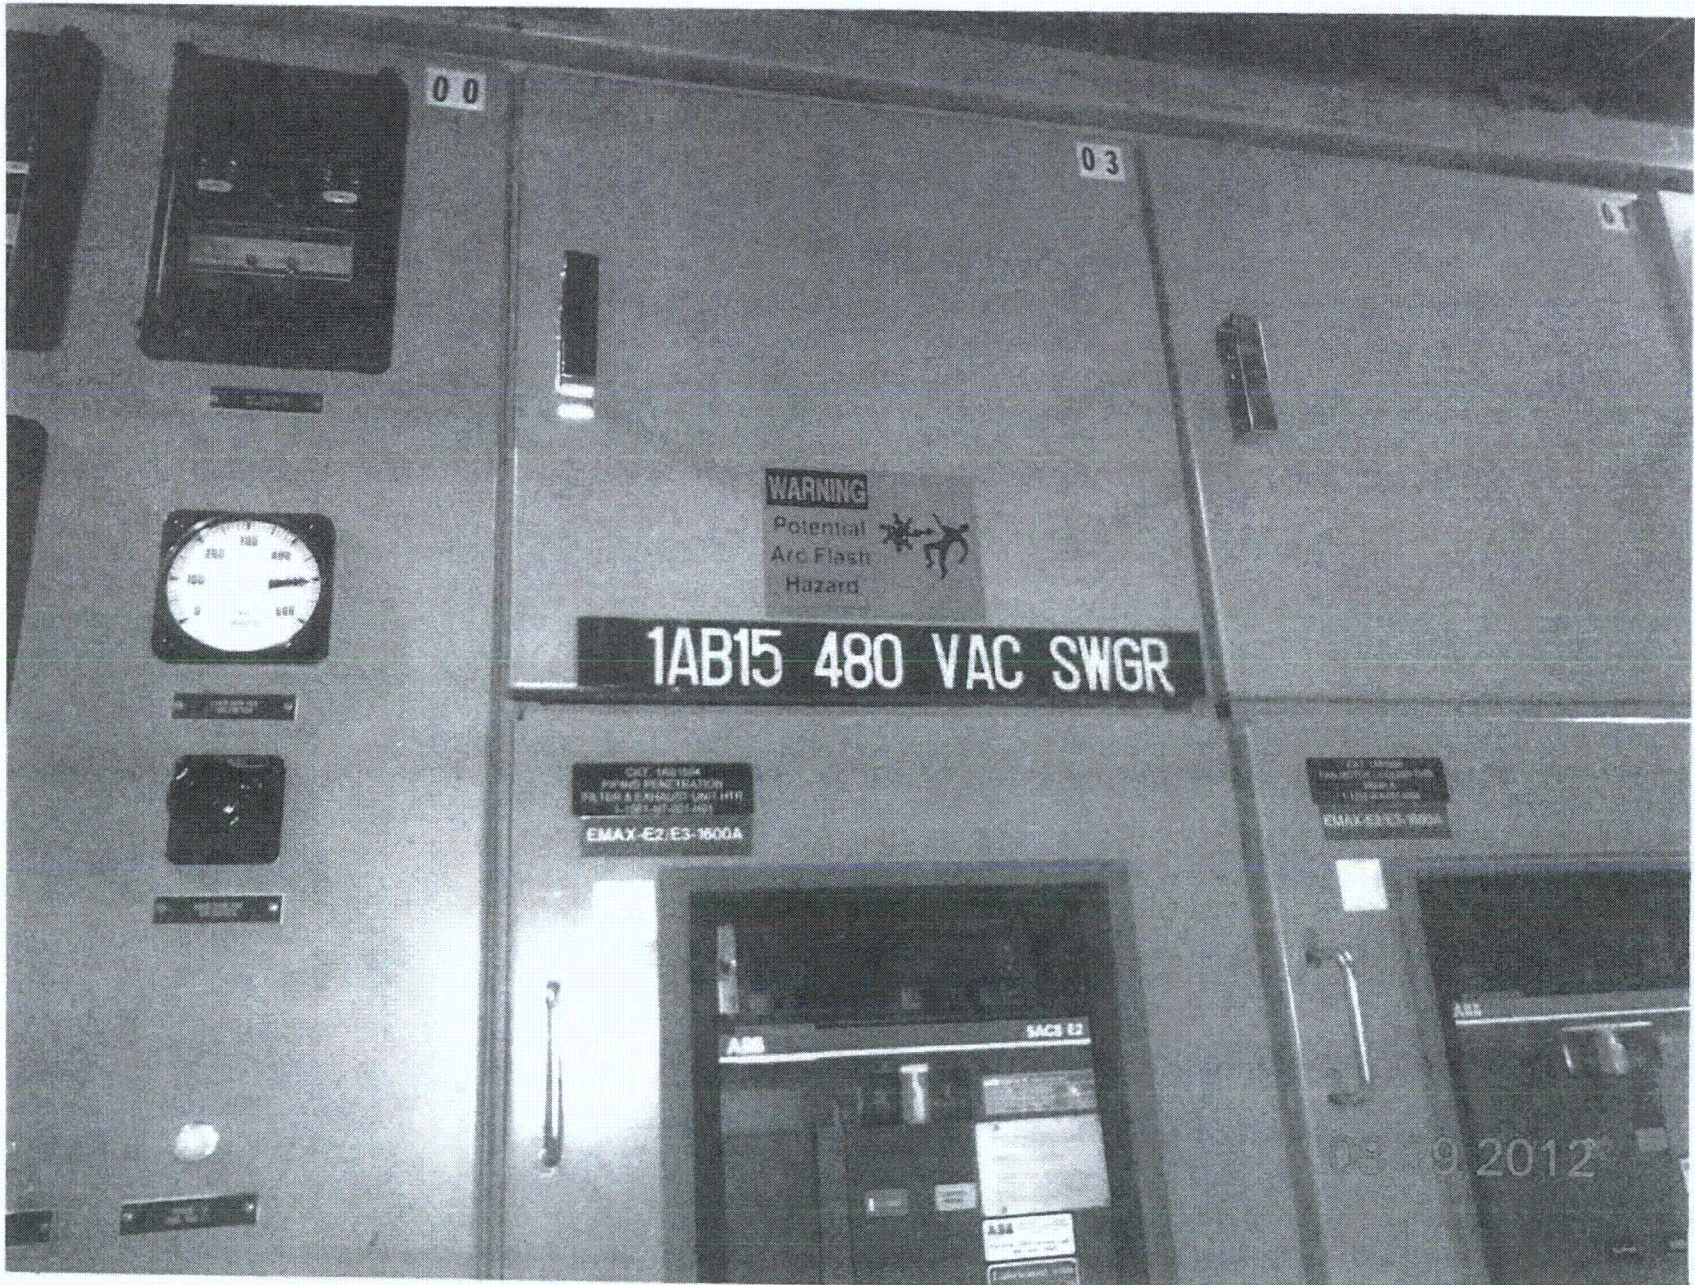
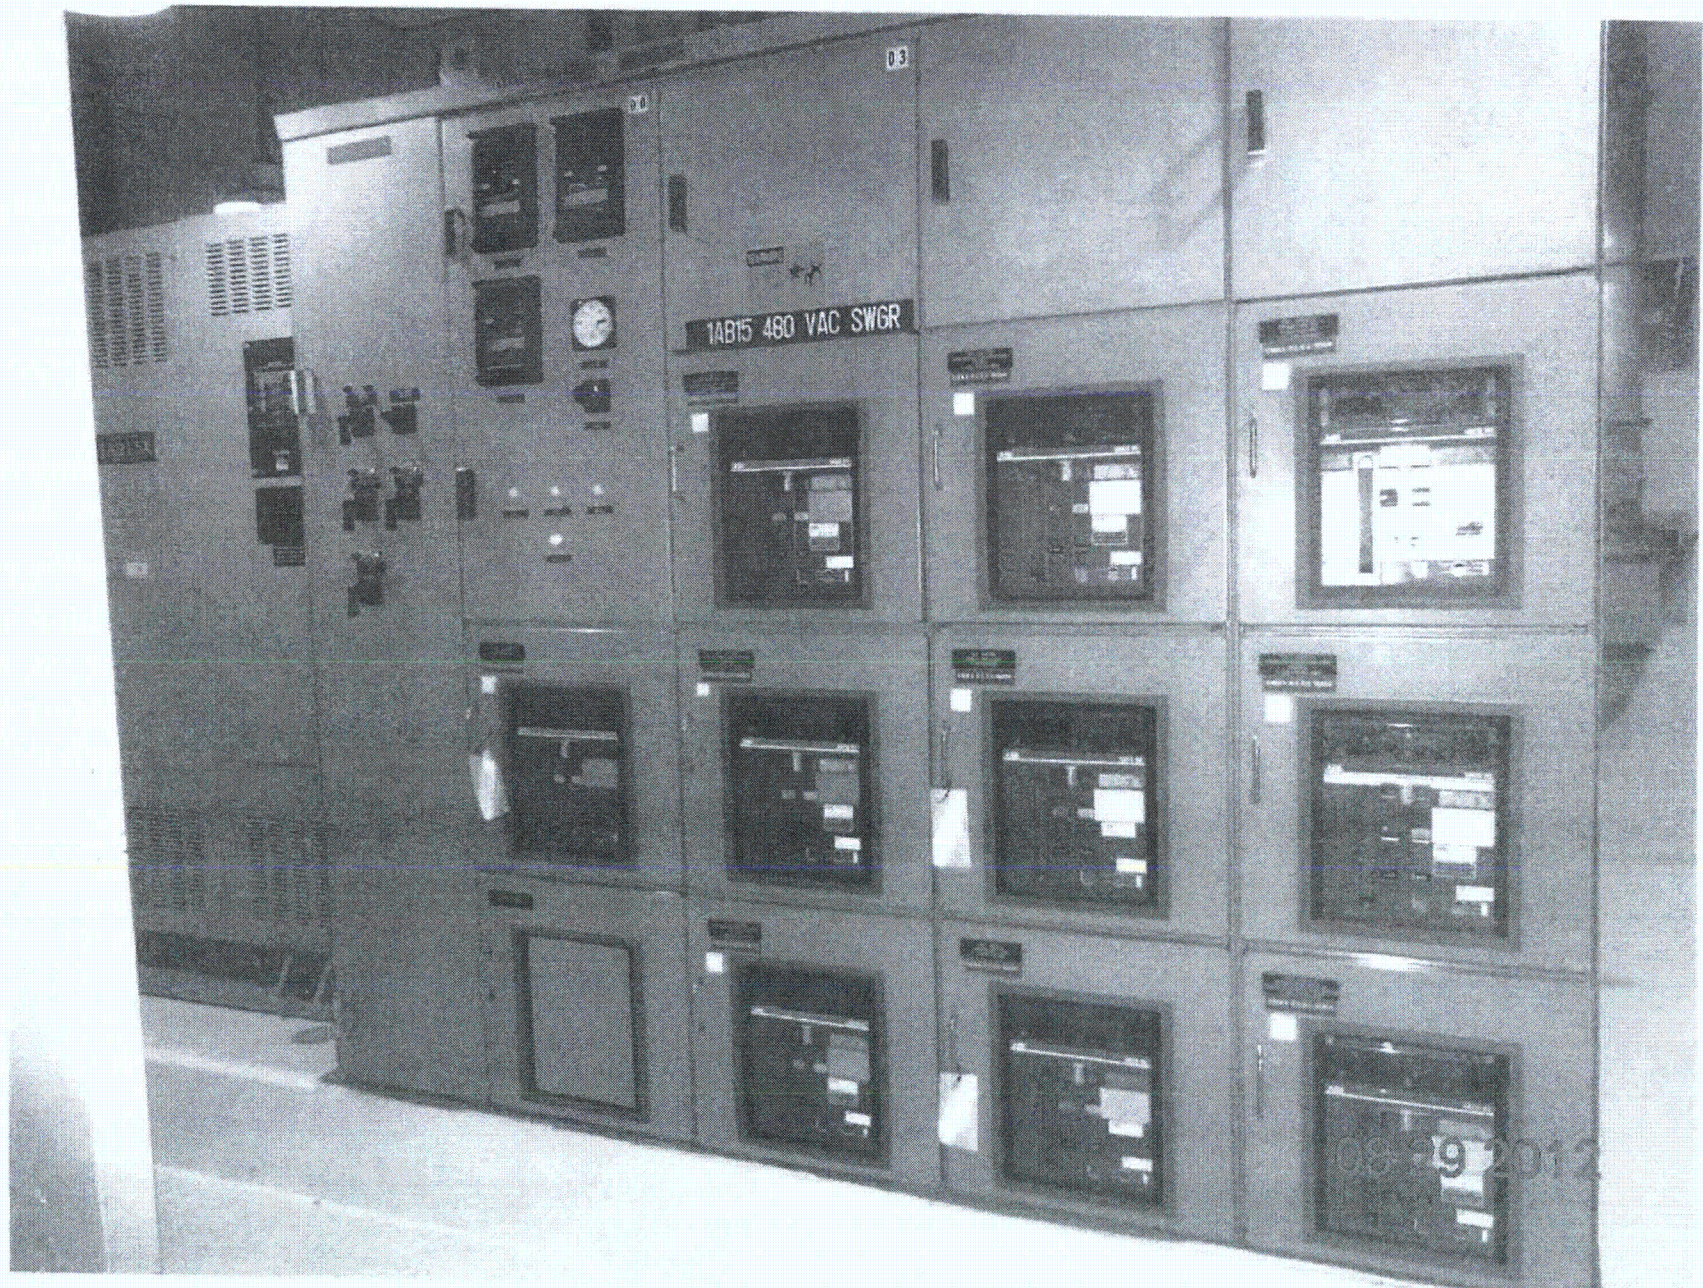
- 11. Have you looked for and found no other seismic conditions that could adversely affect the safety functions of the equipment?  Y  N  U  
GAP BETWEEN SWITCHGEAR & TRANSFORMER IS ≈ 2" ACCEPTABLE
