Status: Y N U**Seismic Walkdown Checklist (SWC)**Equipment ID No. 1-1805-53-015 Equip. Class¹² ZEquipment Description 480V Switchgear 1AD15Location: Bldg. Aux/41 Floor El. 119'-3" Room, Area RD105

Seismic Walkdown Checklist (SWC)

Equipment Description 480V Switchgear IAB15

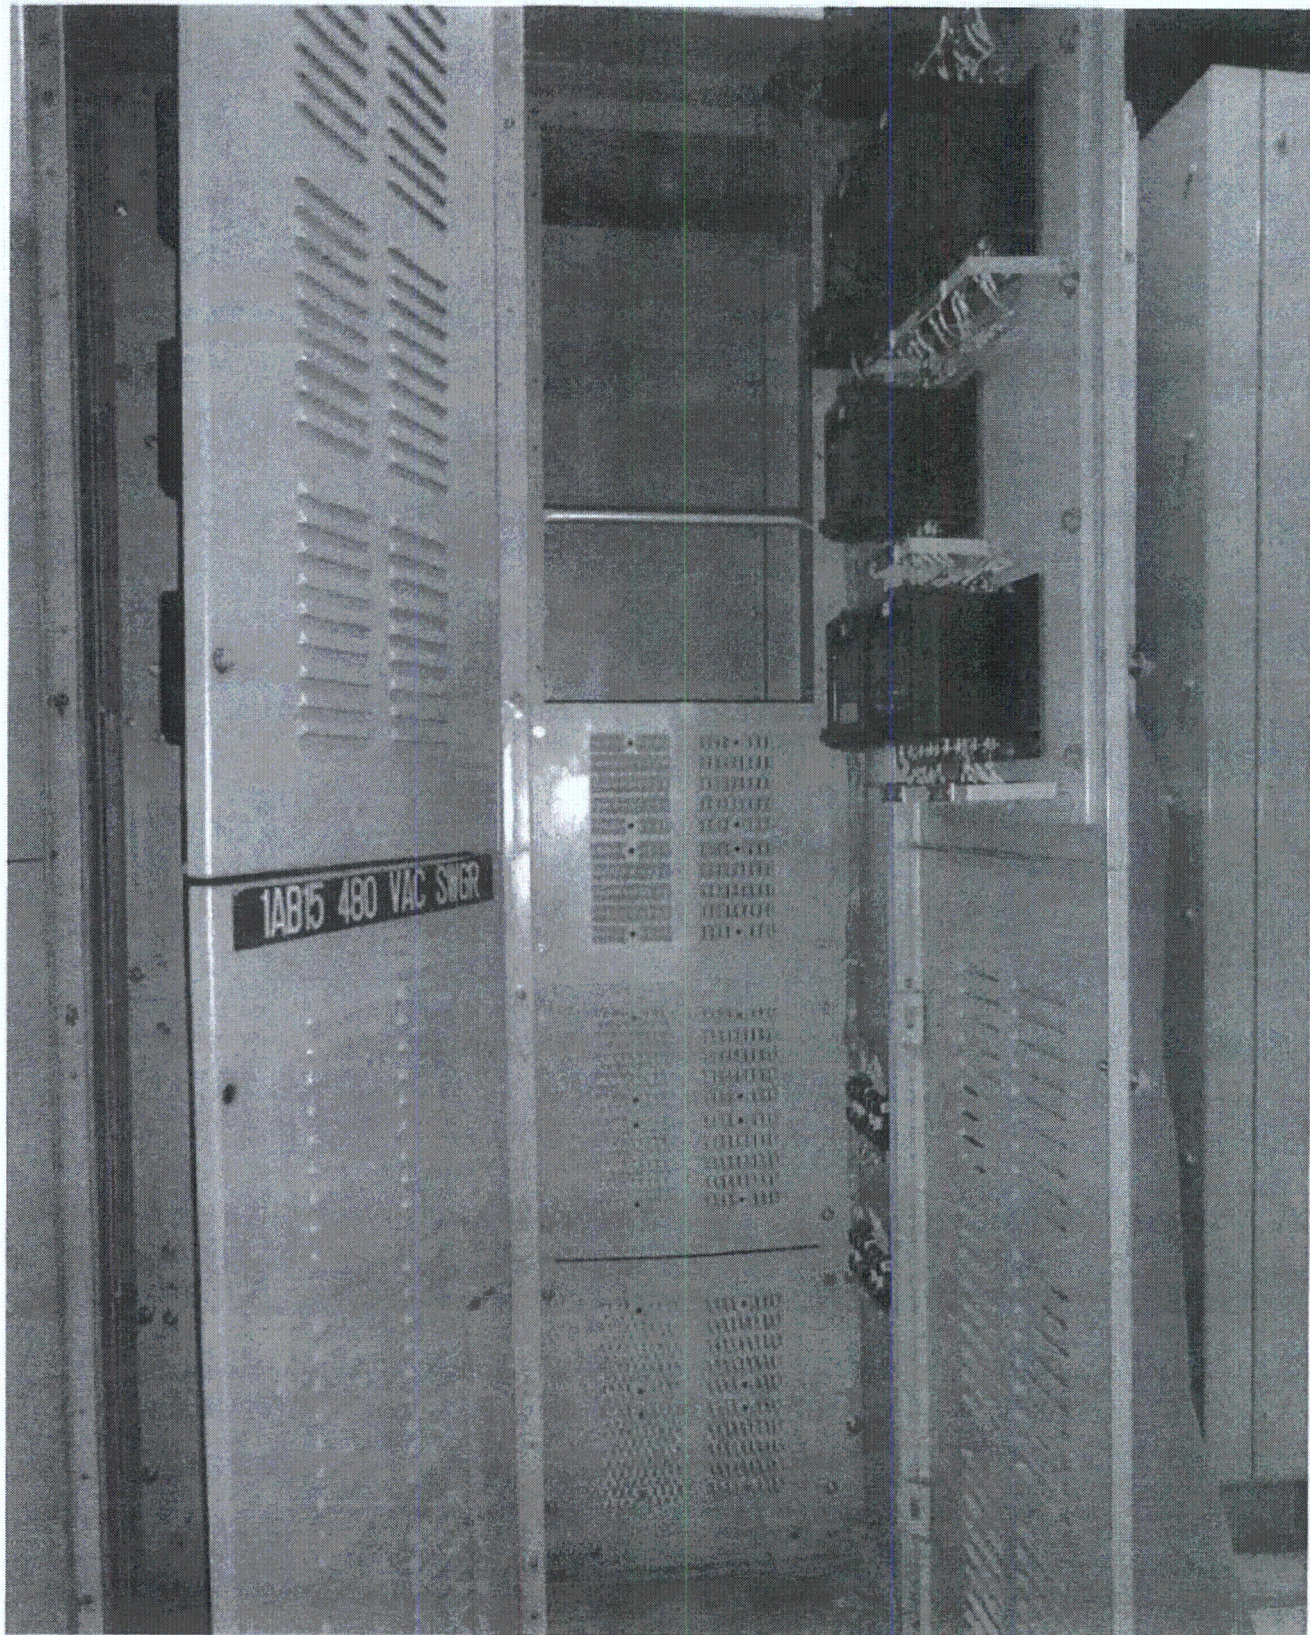
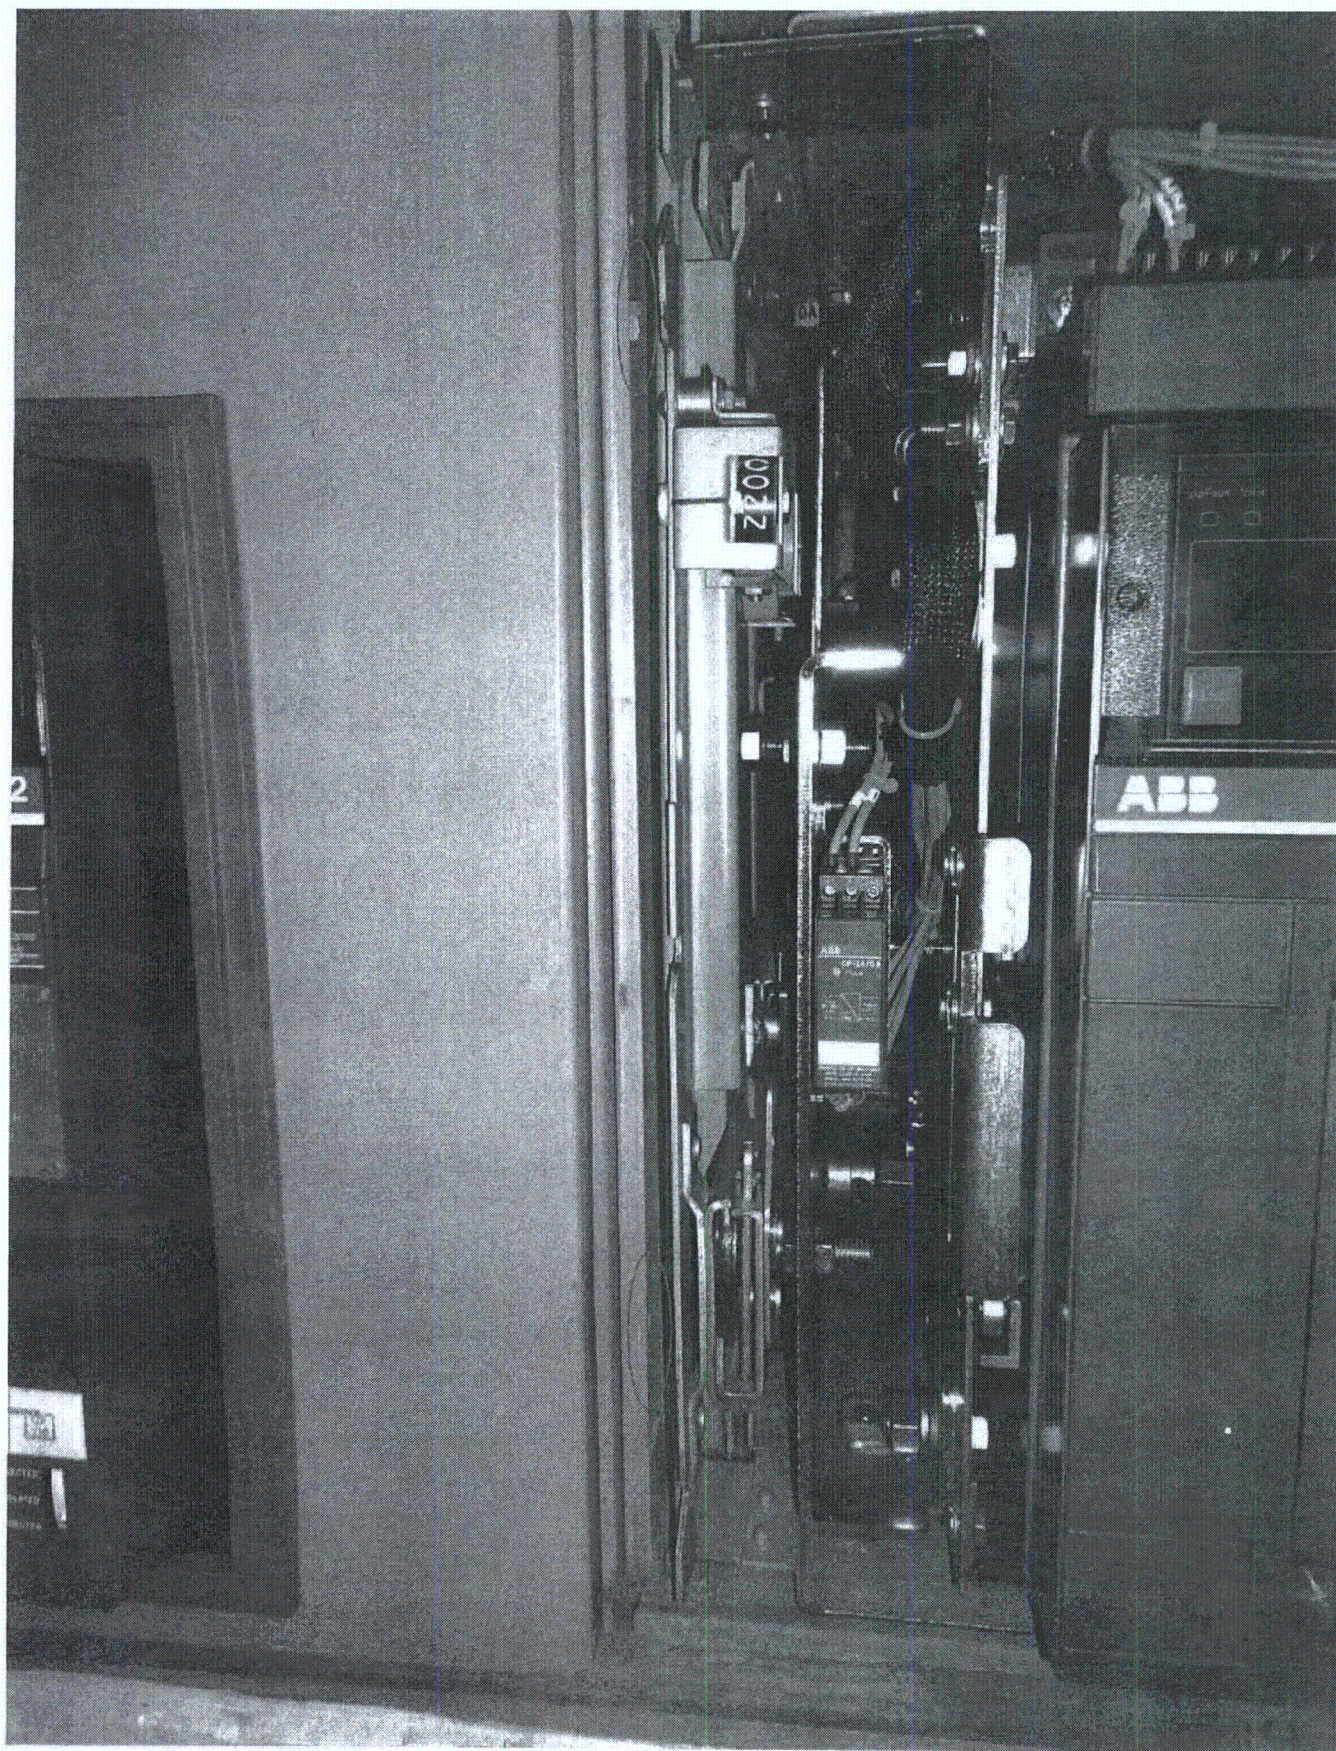
11. Have you looked for and found no other seismic conditions that could adversely affect the safety functions of the equipment? Y N U
A visual inspection of the internal components of this cabinet was performed to check for seismic adequacy to include any evidence of internal components not adequately secured, checked for fasteners connecting adjacent cabinets were in place, and evidence of other adverse seismic conditions. An interconnecting fastener was found to be missing. See "Comments" for further details.

Found one (1) interconnecting fastener missing between bays IAB1510 and IAB1506 on the lower left side of IAB1510. It was judged by this seismic walkdown team that this condition must be evaluated for seismic adequacy of this cabinet. Reference condition report 525340 generated for this case.

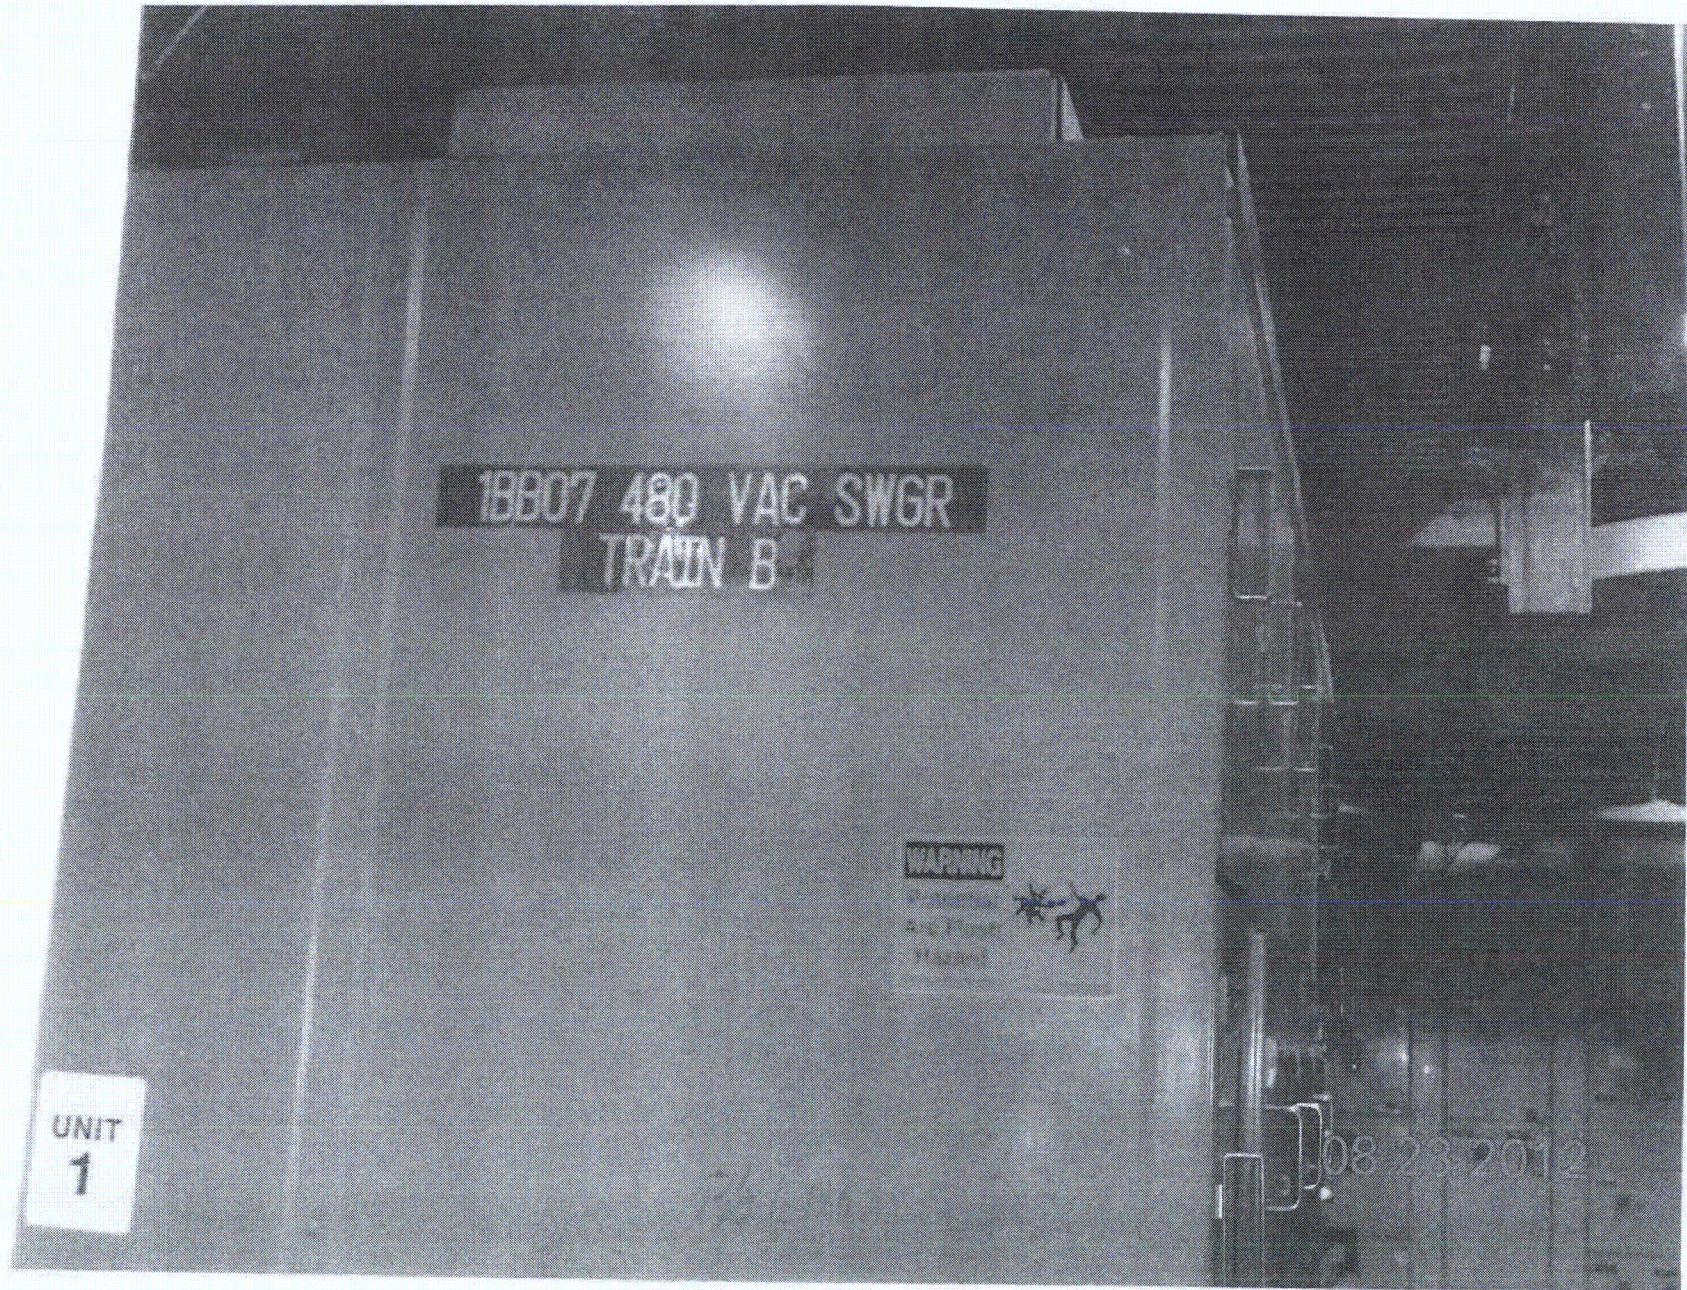
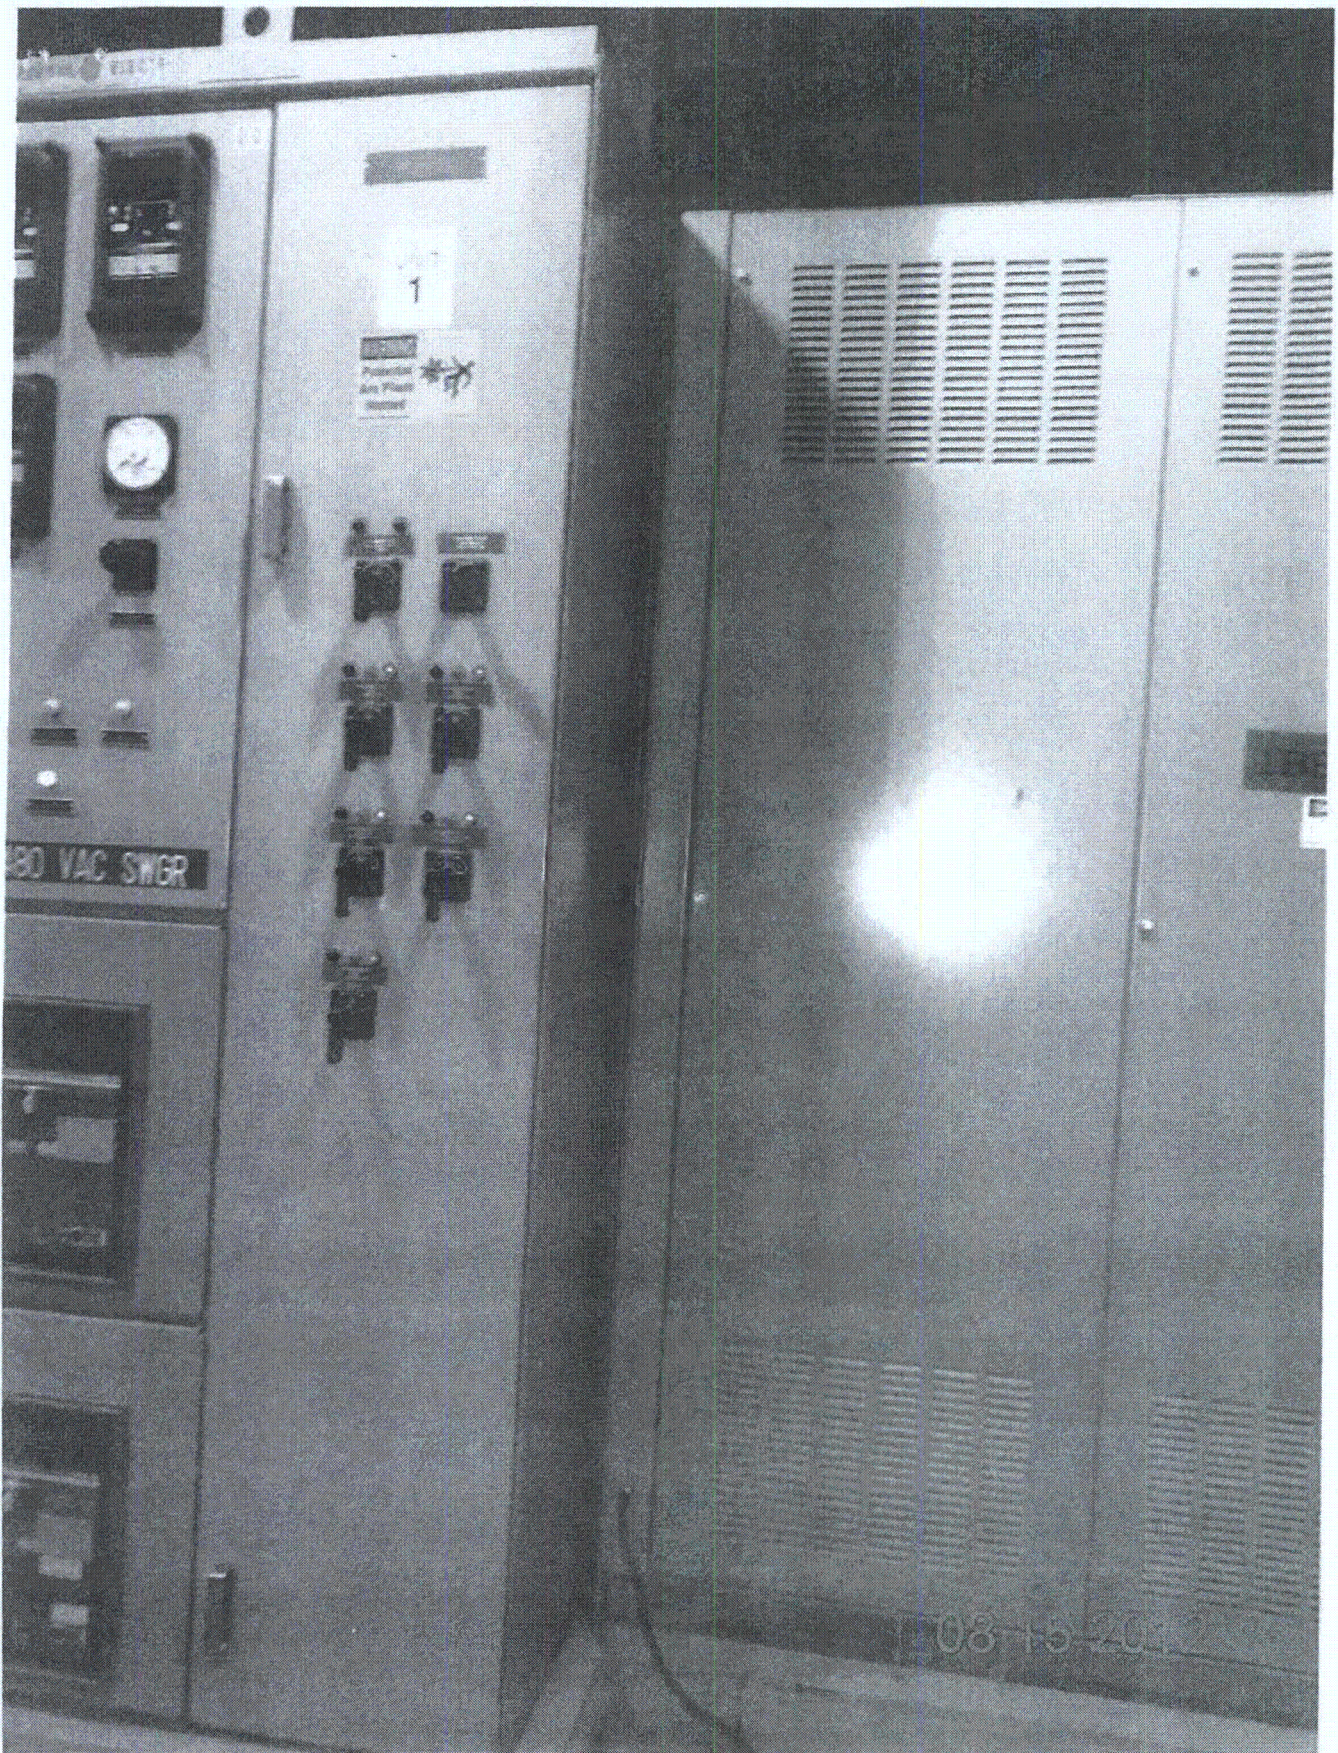
2. Is the anchorage free of bent, broken, missing or loose hardware? Y N U N/A
MINOR OXIDATION ON A SURFACE FOR FEW WELDS, ACCEPTABLE

VENTILATION DUCT, SMALL CONDUIT AND ELECT GROUNDING BETWEEN 1B807 480VAC SWITCHGEAR AND 1B807X TRANSFORMER CAN BE SEEN AT 2" GAP. HOWEVER, THESE CONNECTIONS ARE NOT FIXED AT SWITCHGEAR SIDE, NO CONCERN FOR SPATIAL INTERACTION.
