Status: Y N U**Seismic Walkdown Checklist (SWC)**Equipment ID No. 1-1805-53-015 Equip. Class¹² ZEquipment Description 480V Switchgear 1AD15Location: Bldg. Aux/41 Floor El. 119'-3" Room, Area RD105

Seismic Walkdown Checklist (SWC)

Equipment Description 480V Switchgear IAB15

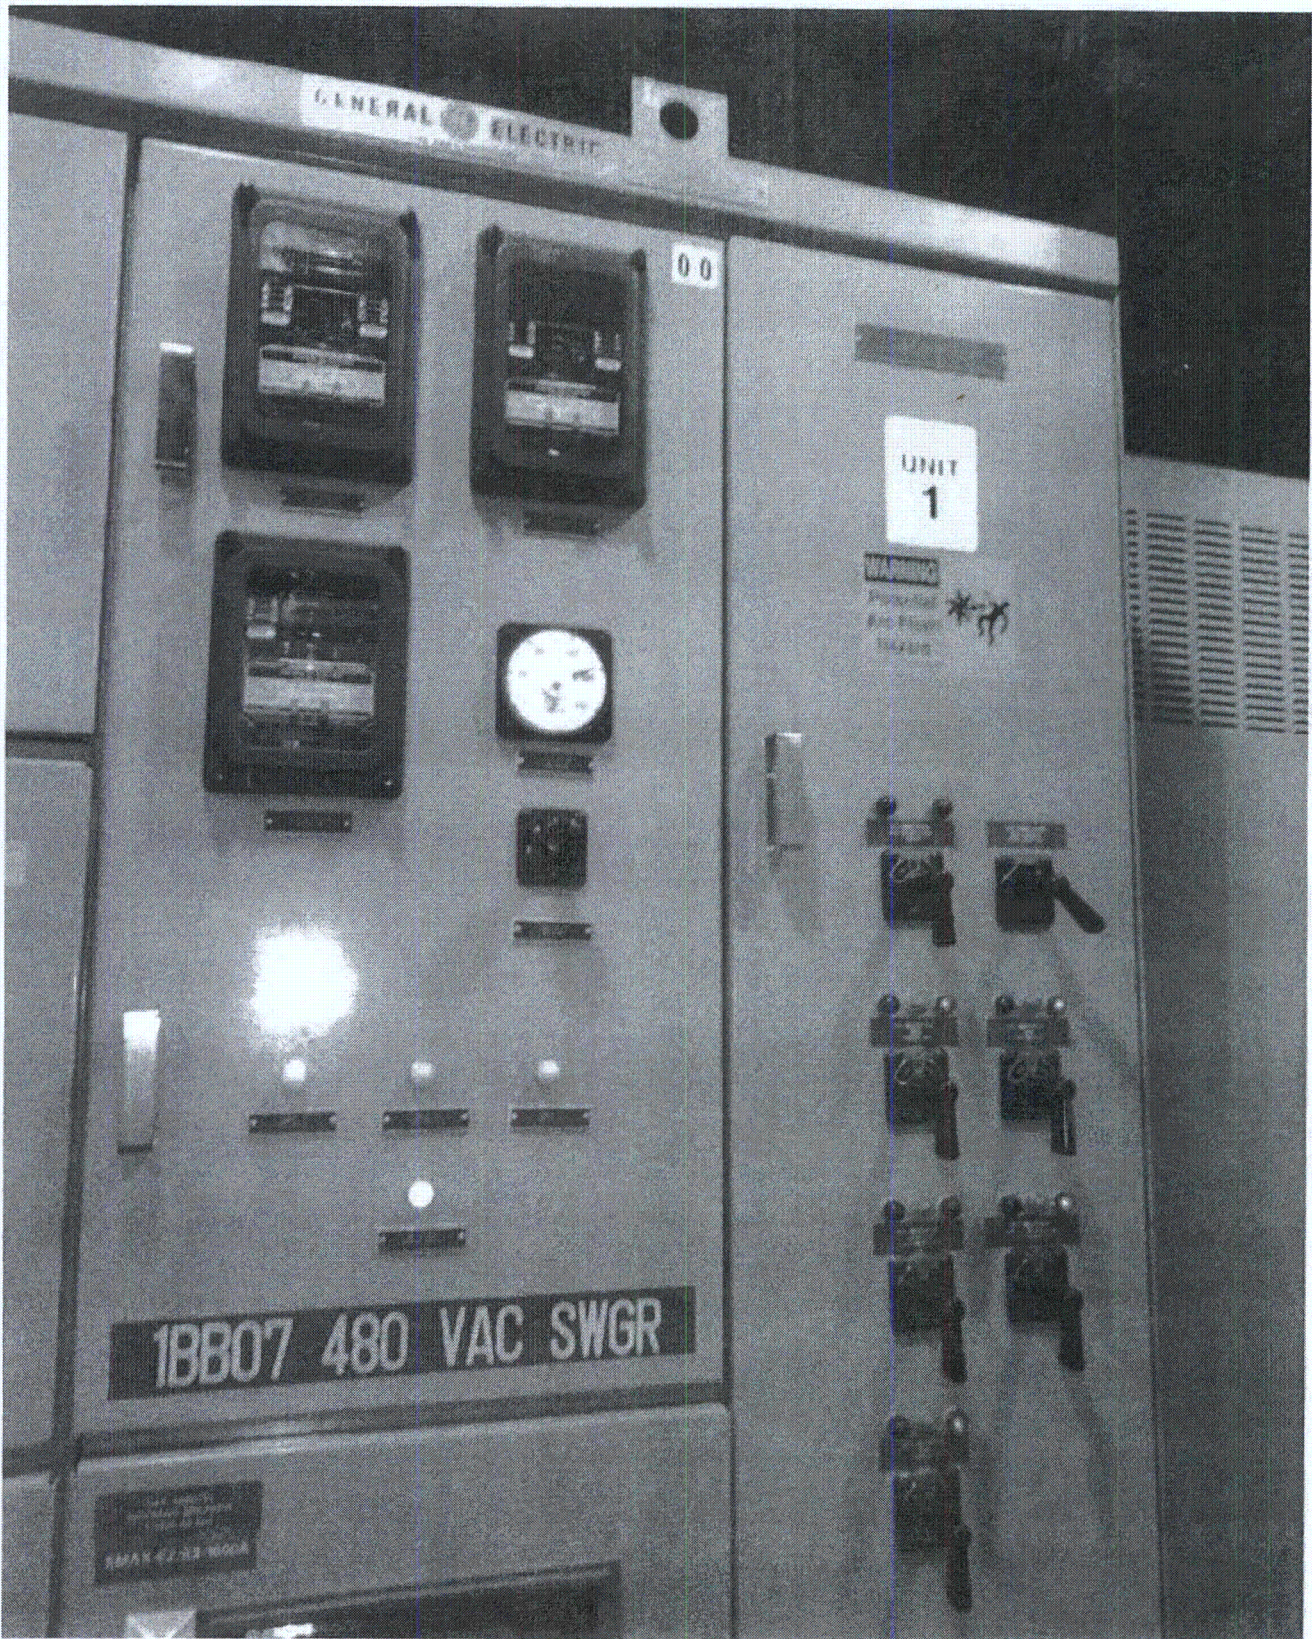
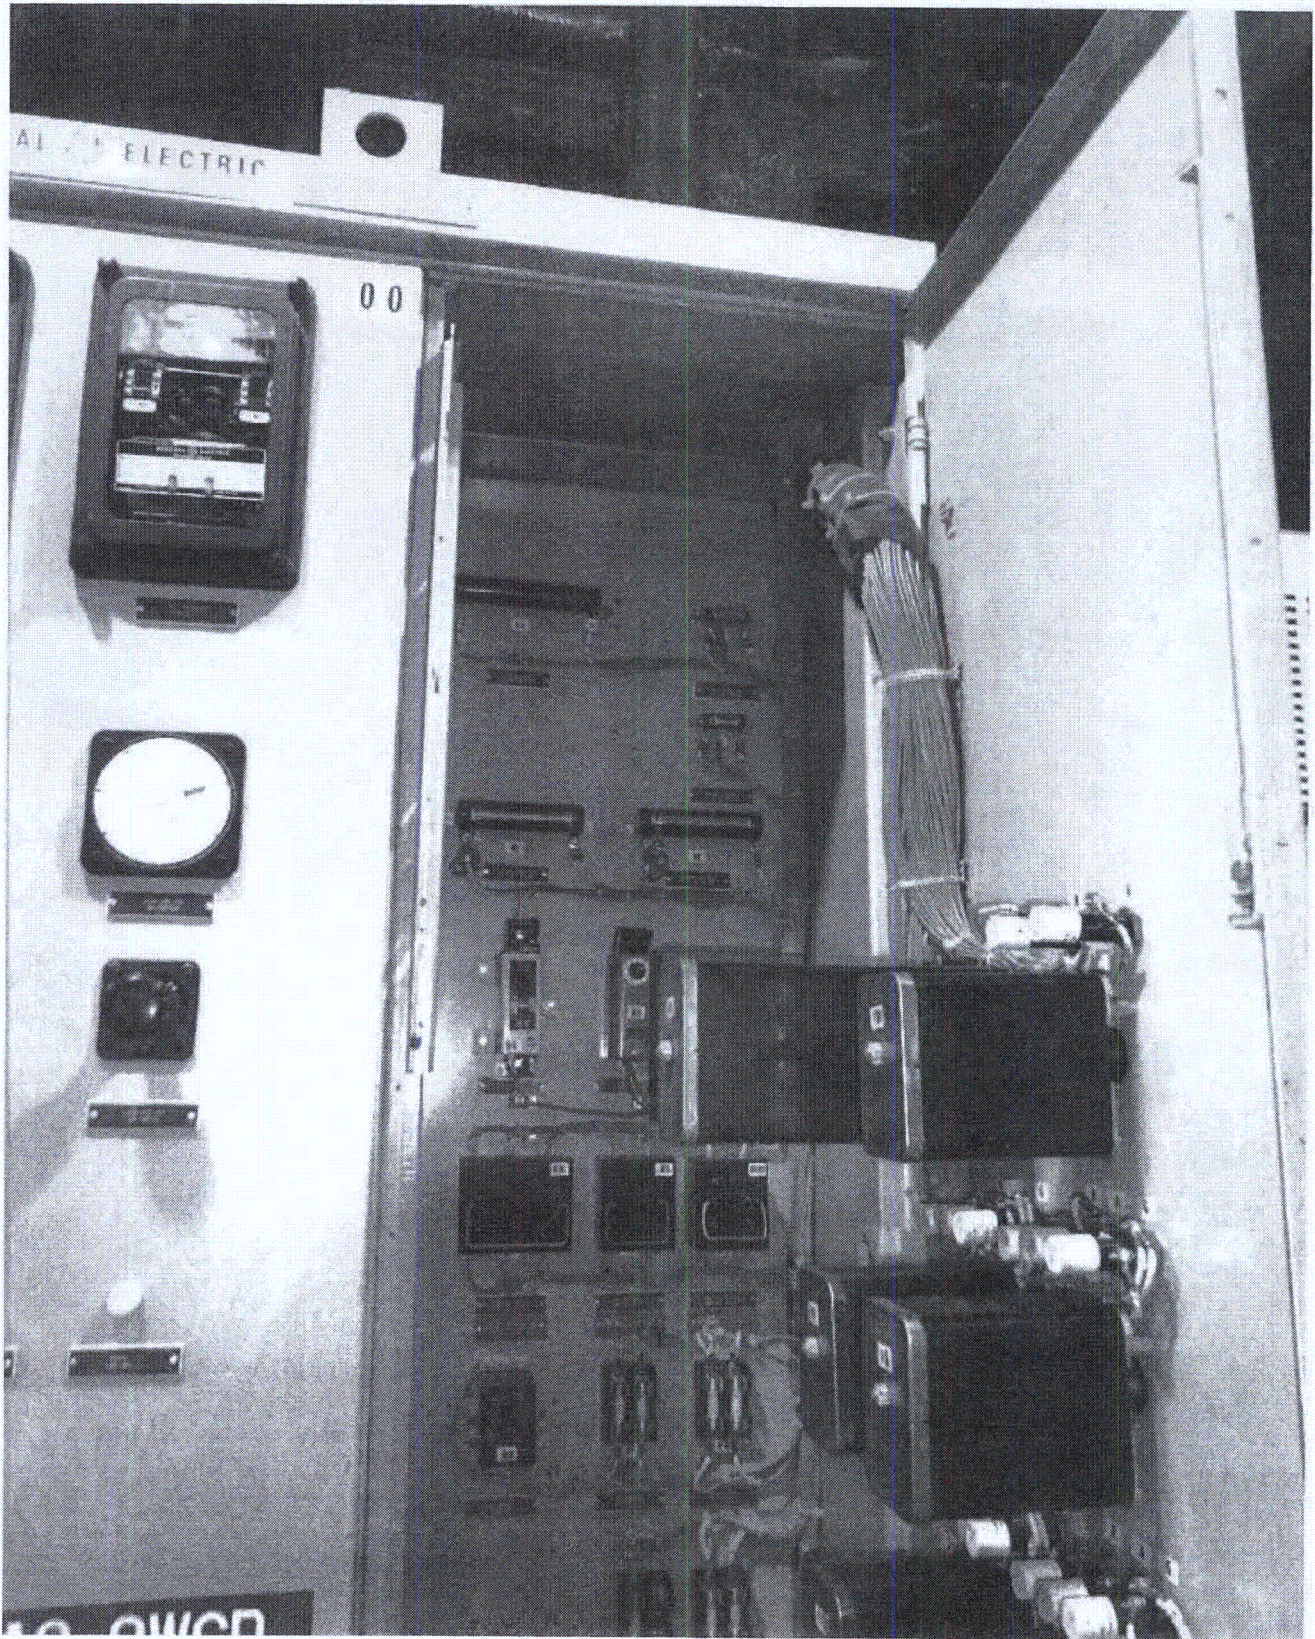
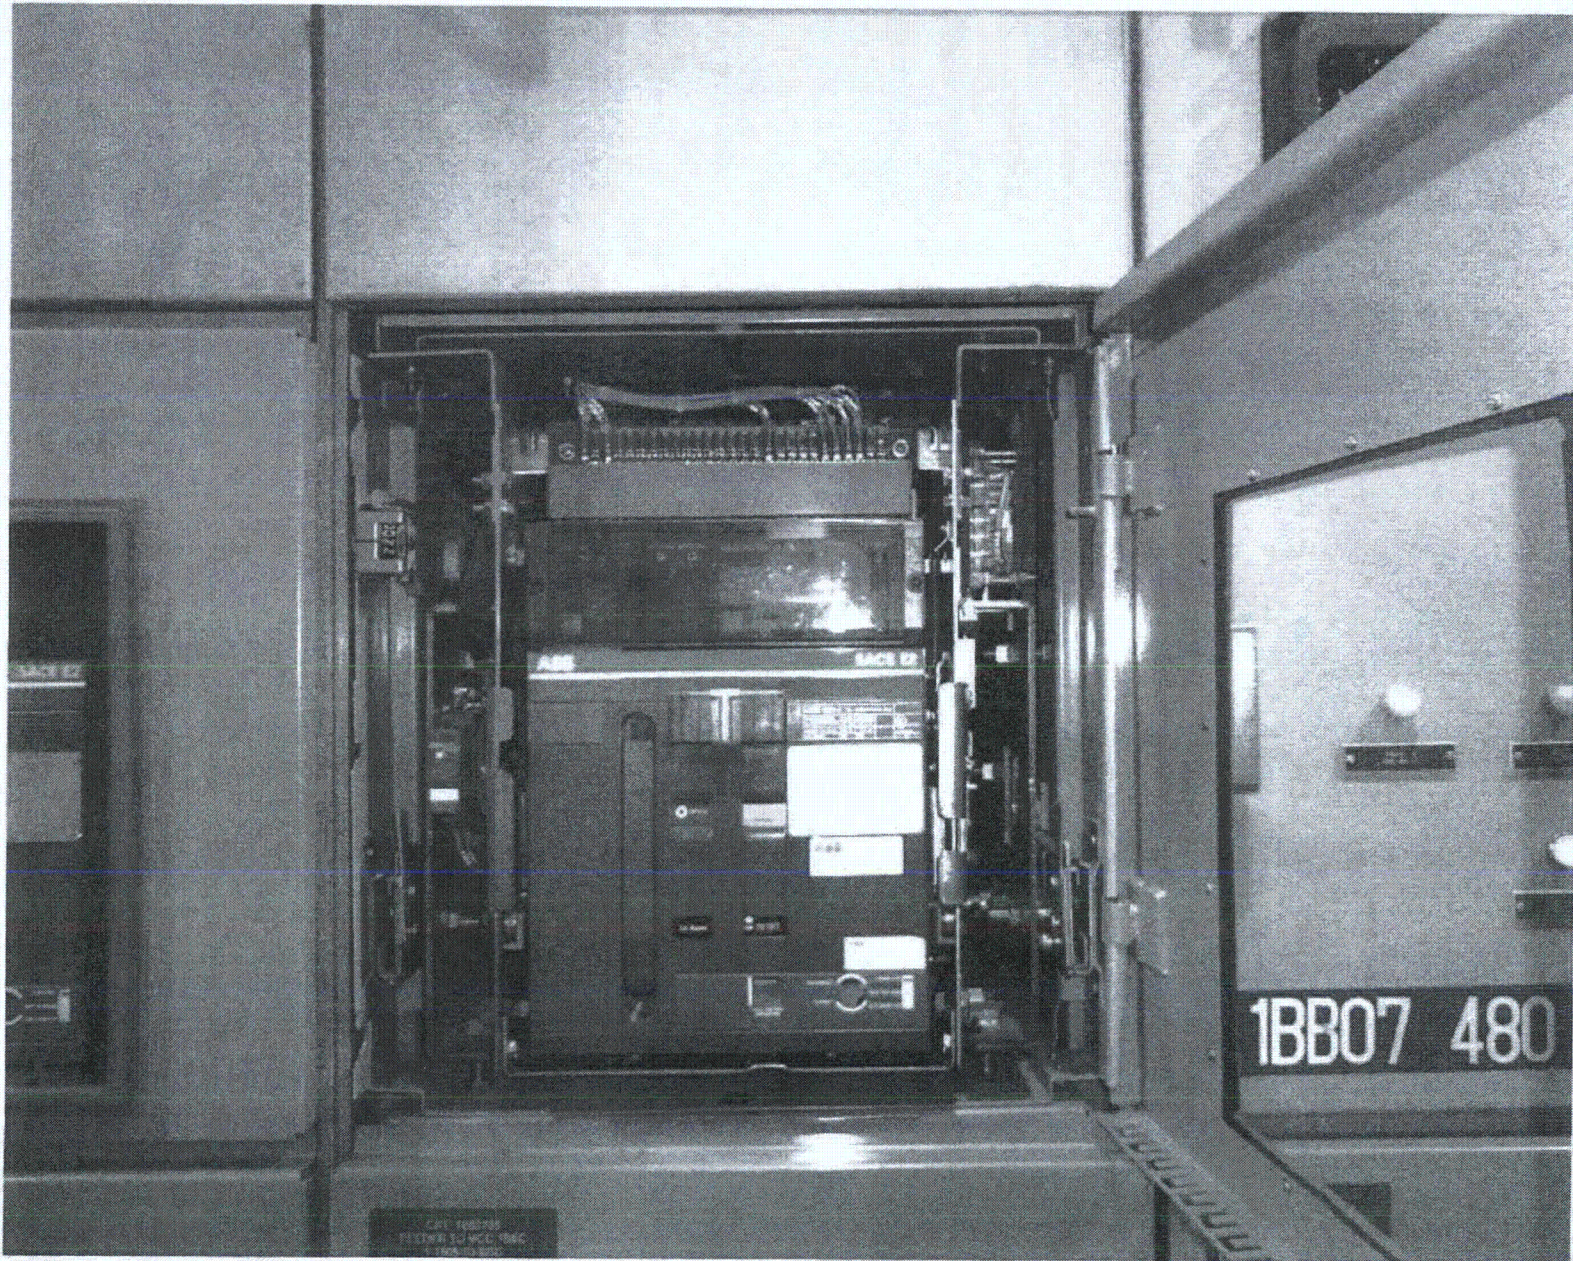
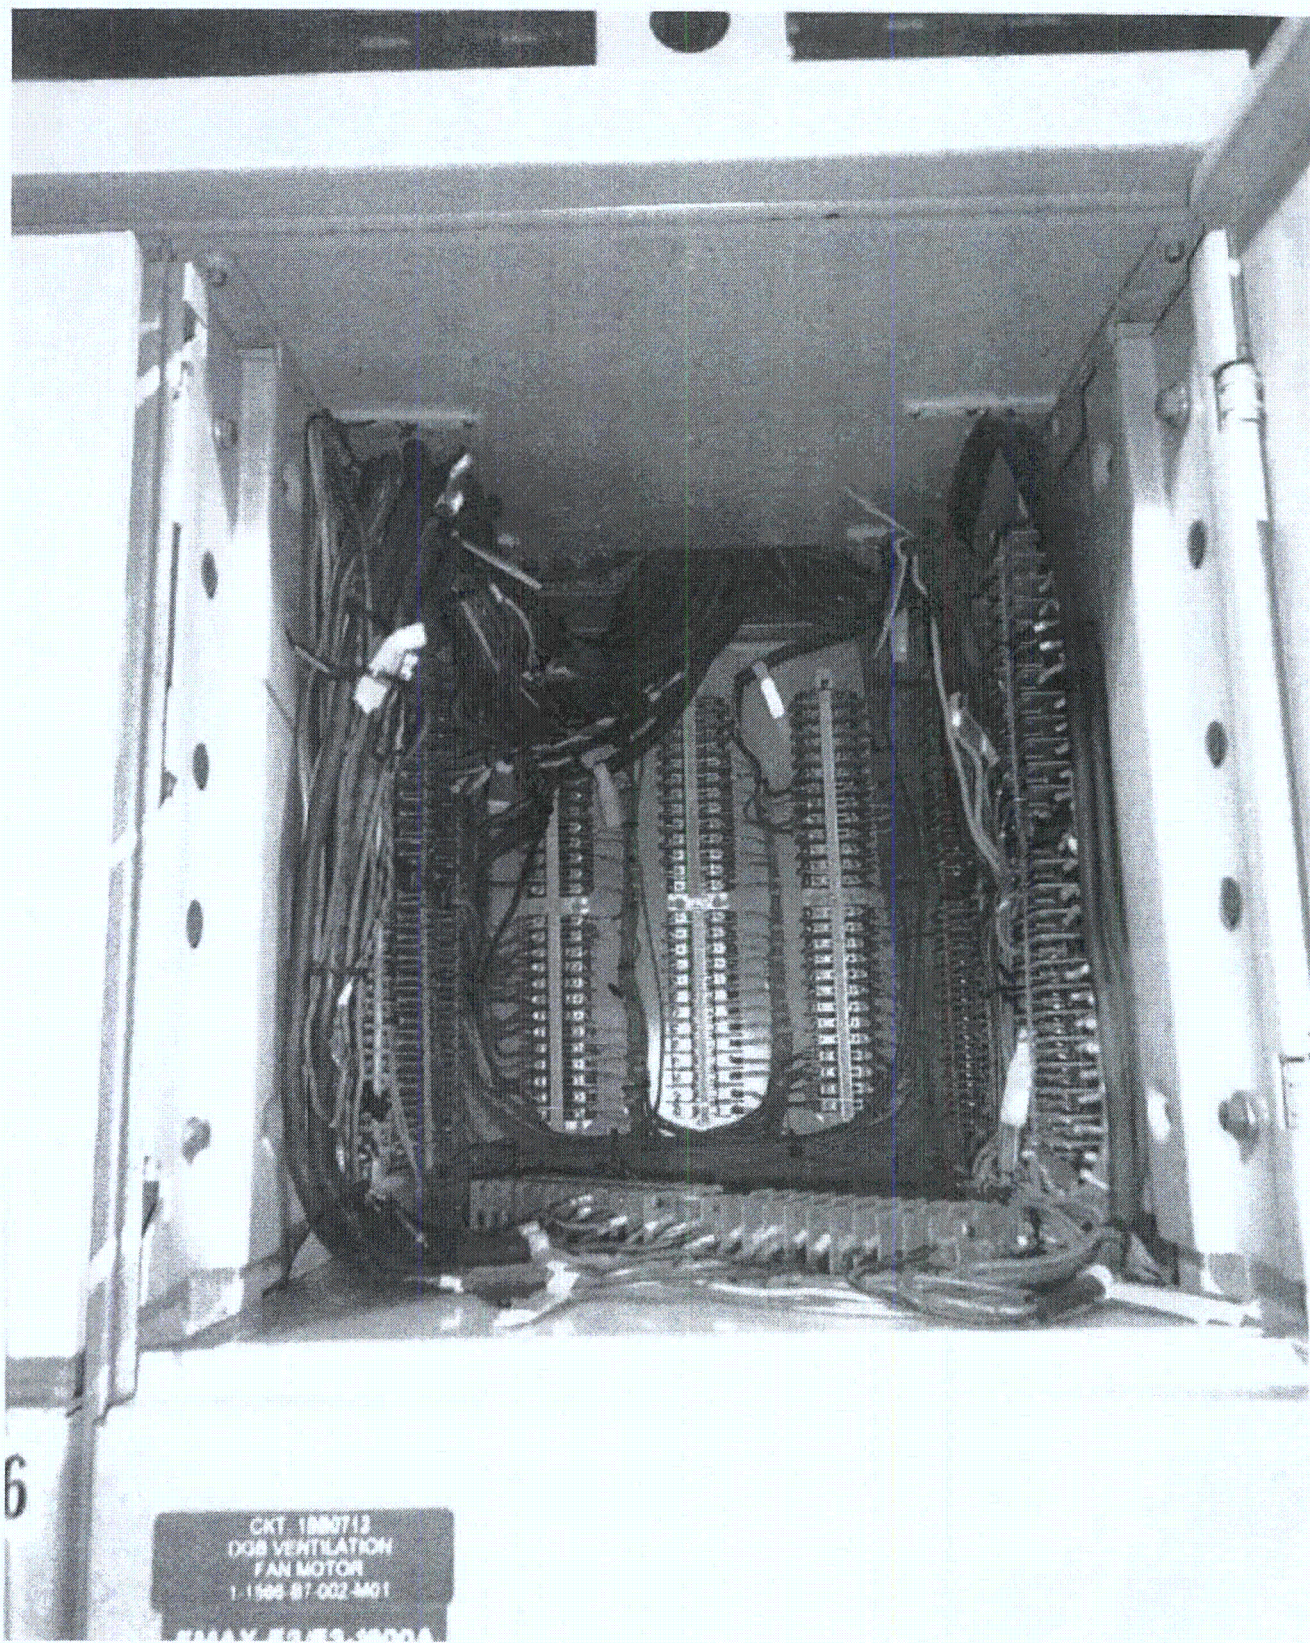
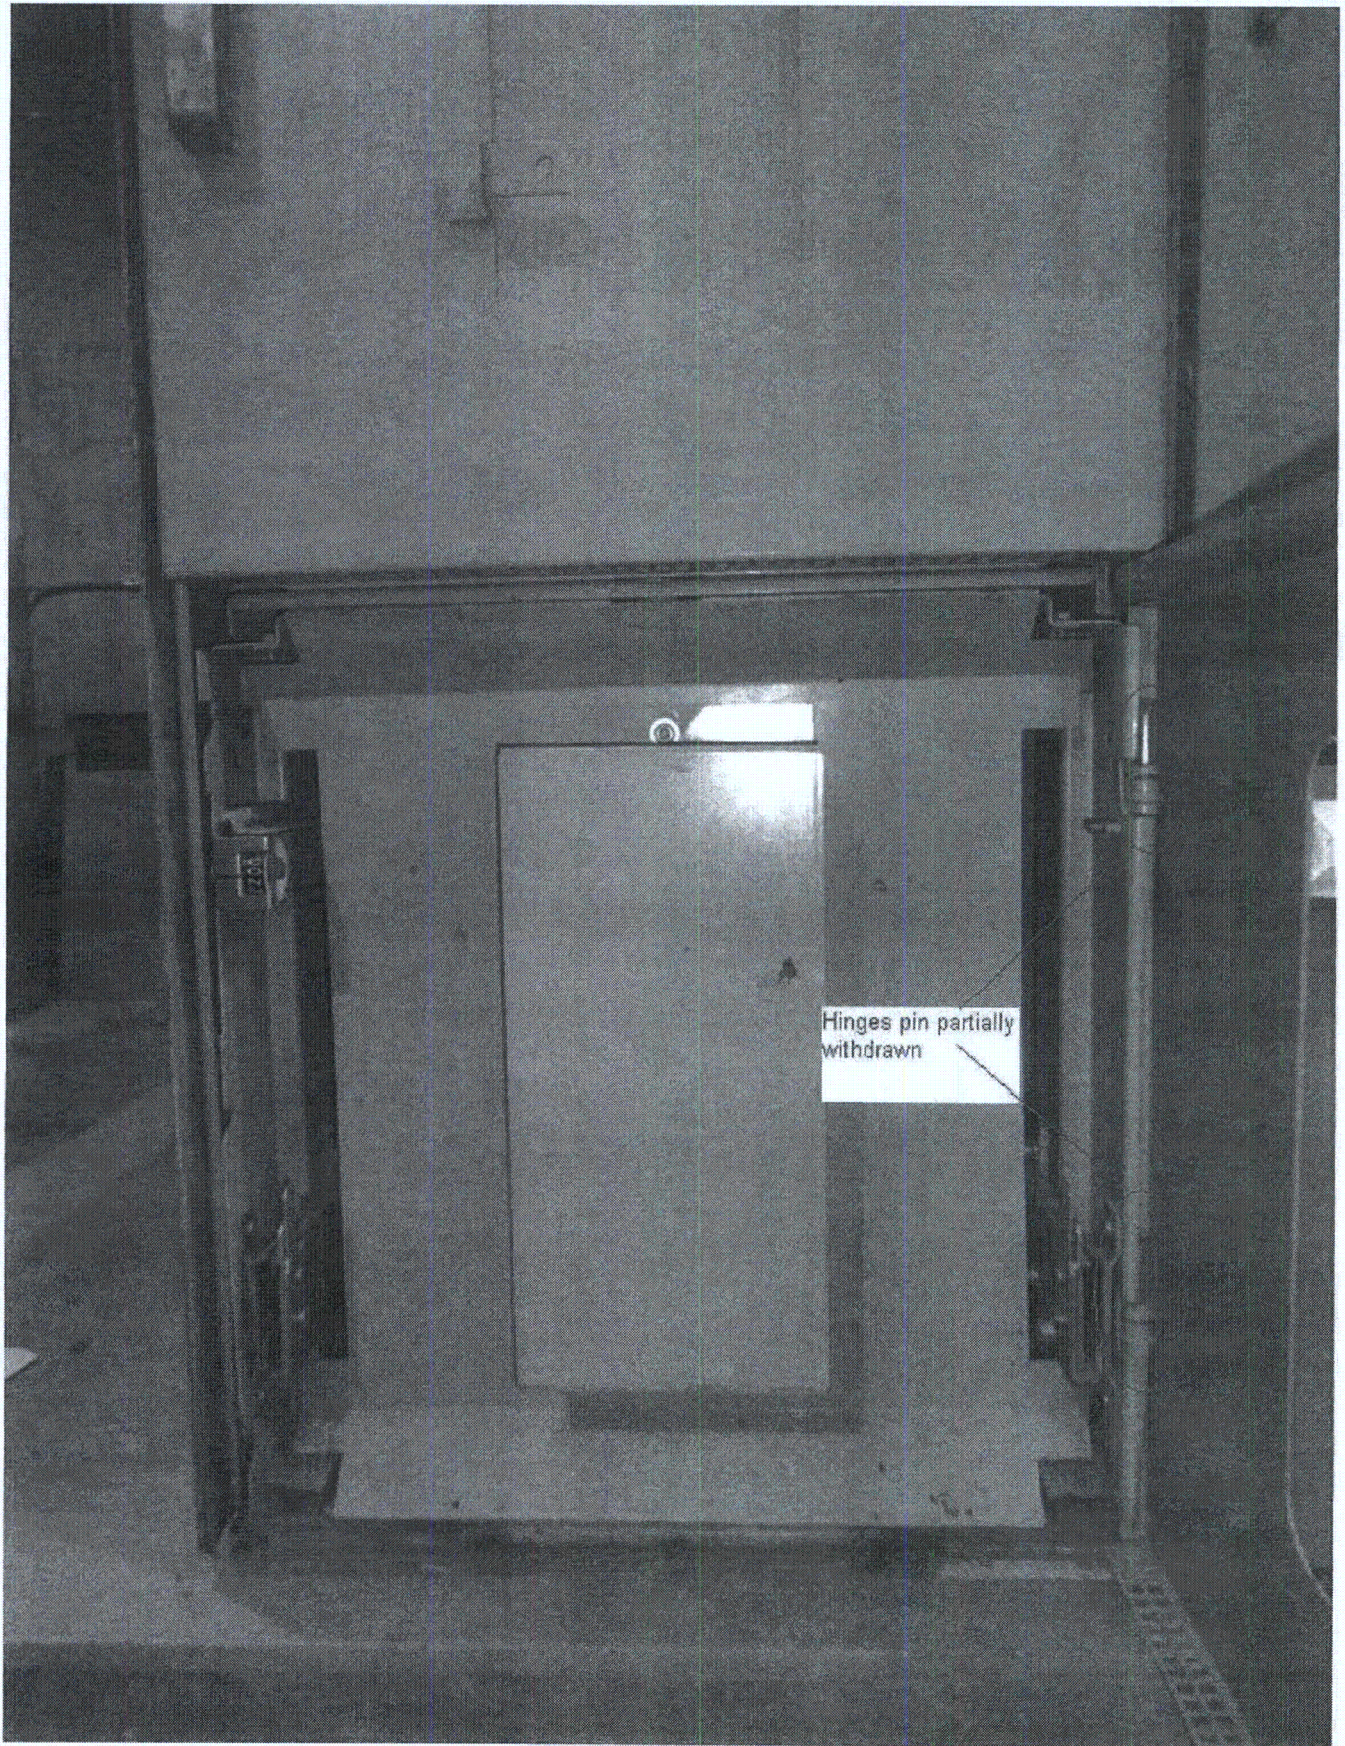
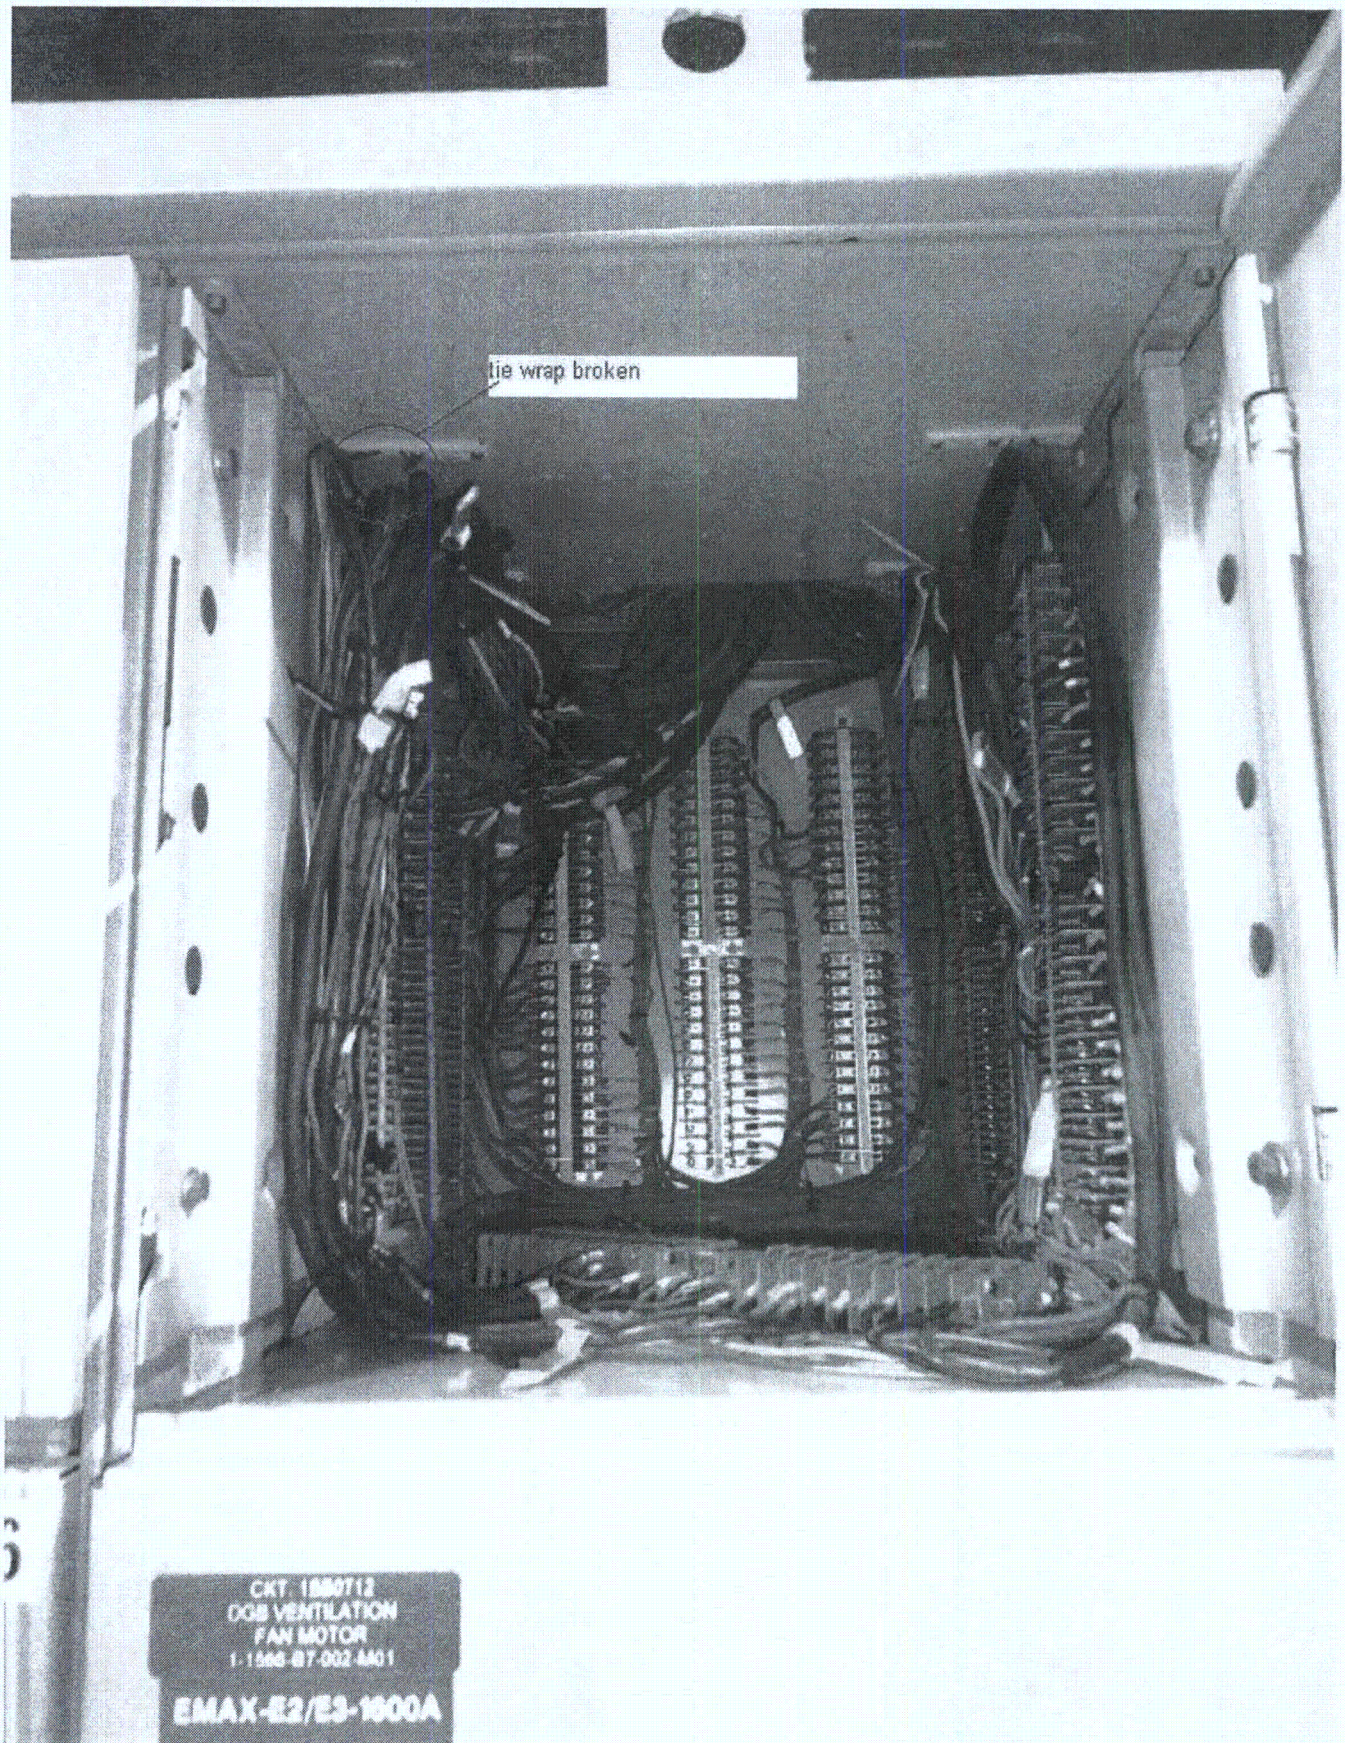
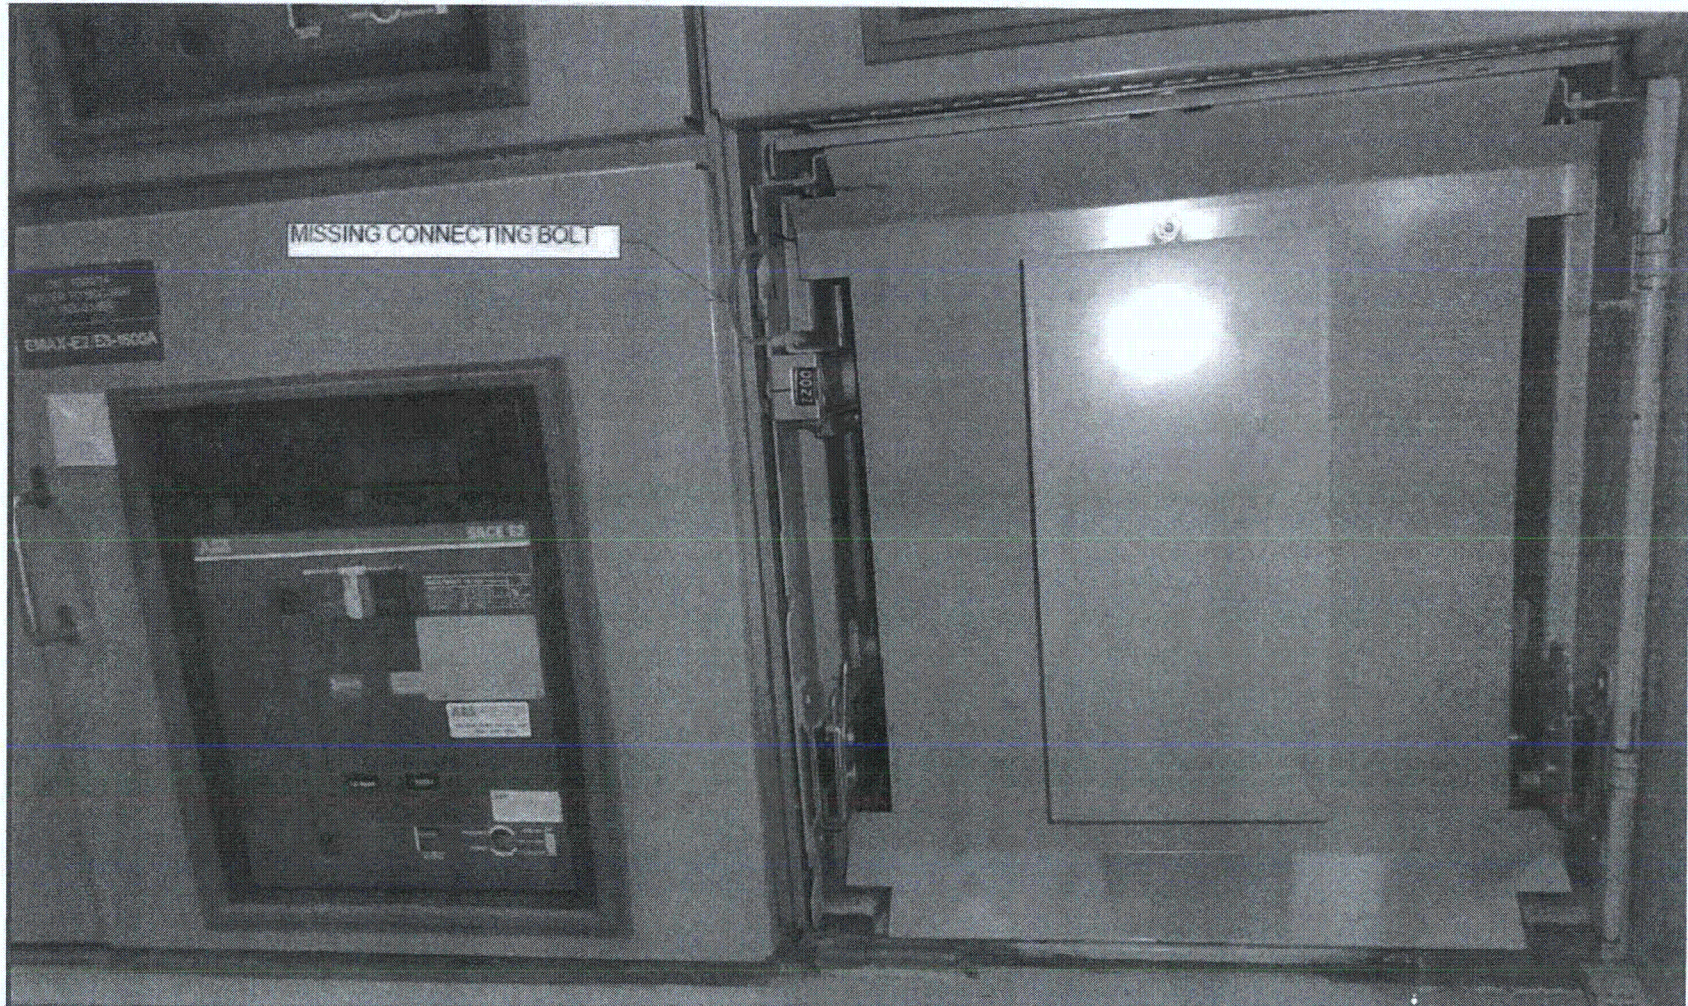
A visual inspection of the internal components of this cabinet was performed to check for seismic adequacy to include any evidence of internal components not adequately secured, checked to ensure fasteners connecting adjacent cabinets were in place, and evidence of other adverse seismic conditions. The findings are documented on the "Comments" section of this document.

- ① Found 1 inter connecting fastener missing which connects cabinet's bays 1B0710 and 1B0714. Condition Report 527135 has been generated to evaluate seismic adequacy.
- ② Found 1 tie wrap broken used to support a cable bundle in bay 11. This is not a seismic or vulnerability concern. Ref. CR 528379
- ③ Found 2 (two) door hinge pins partially with drawn on bay 18. This is not a seismic or vulnerability concern. CR 528379
